DEKRA's commission No. : PKOL(W)/LODZ/49564/26/05/27  
commission/ damage No. : PS23/01953  
Date of commission: 27-05-2026

**DEKRA Poland - Headquarters**  
02-673 Warszawa, ul. Konstruktorska 12A

PKO Leasing SA  
Świętokrzyska 36  
00-116 Warszawa

Group of objects (Eurotax)	cars
EC code (Eurotax)	0153622
Manufacturer	BMW
Model	Seria 3 [G20] 18-22
Type / version	320e Sport Line aut
Body type	sedan
Number of doors / seats	4/5
Curb weight [kg]	1765
Gross vehicle weight [kg]	2300
Wheelbase 1/2	2851
Engine type	spark ignition
Pollution reduction system	GPF
Engine capacity [ccm]	1998
Engine Power [hp/kW]	163/120
Gearbox	automatic
Registration /record No.	SG638CC
VIN / serial number	WBA5Y91040FL61629
Date of first registration	15-10-2021
Date of next. tech. test	15-10-2026
Year of manufacture	2021 (year has been verified with the manufacturer's base)
Readout [km]	88 347 (read)
Body color / type of coating	white/UNI

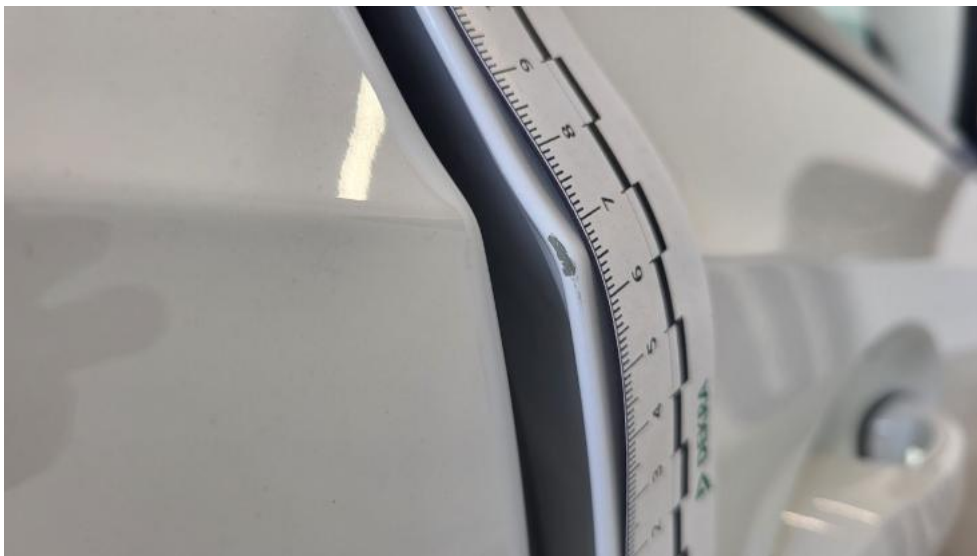
**Photo 43.**

Drzwi przednie P - Rysa/odprysk 1

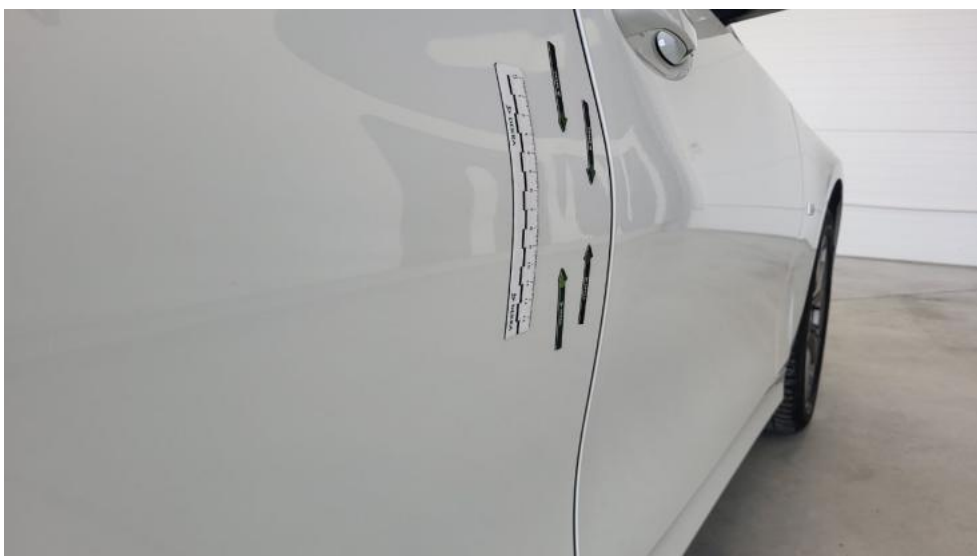
**Photo 44.**

Drzwi tylne P - Wgniecenie/odkształcenie 1

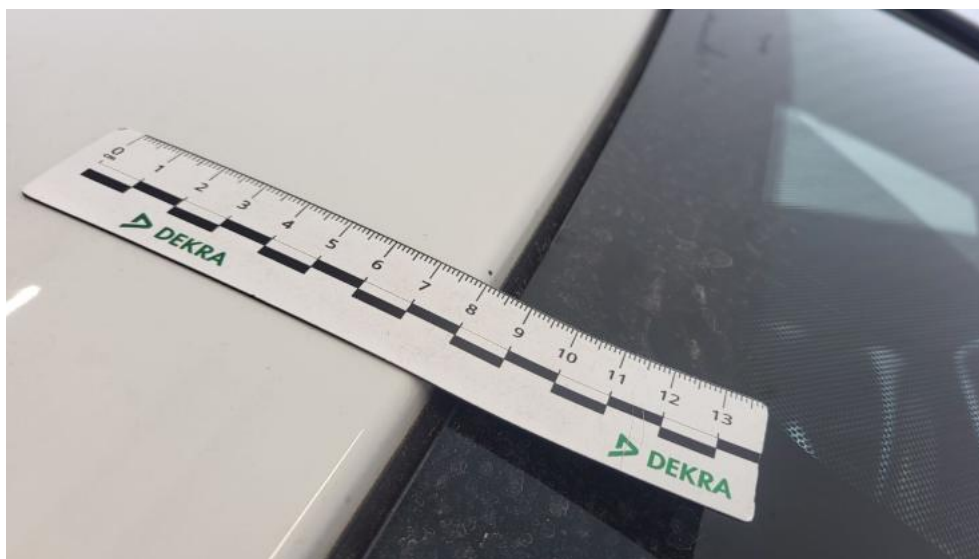
**Photo 51.**  
Dach - Rysa/odprysk 1

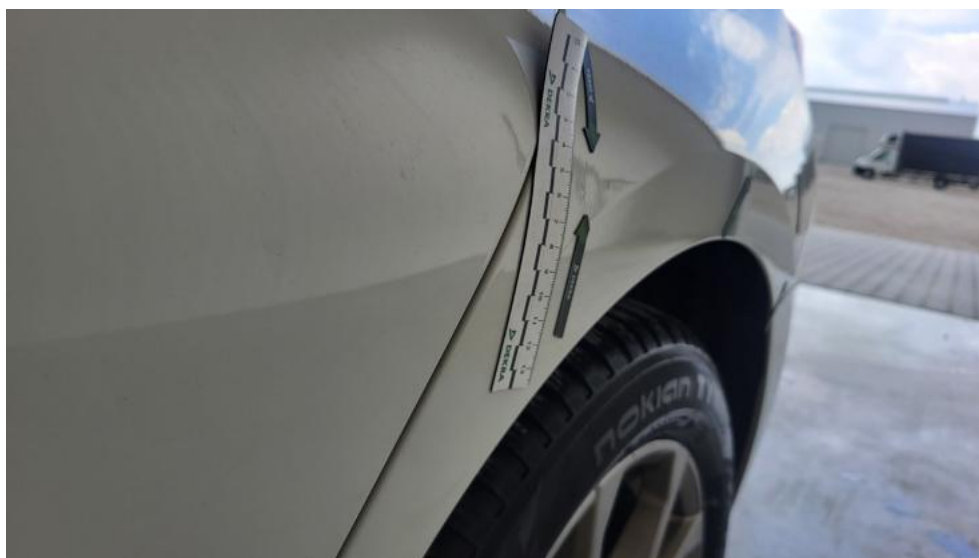
**Photo 52.**  
Błotnik tylny L / Ściana boczna L - Wgniecenie/odkształcenie 1

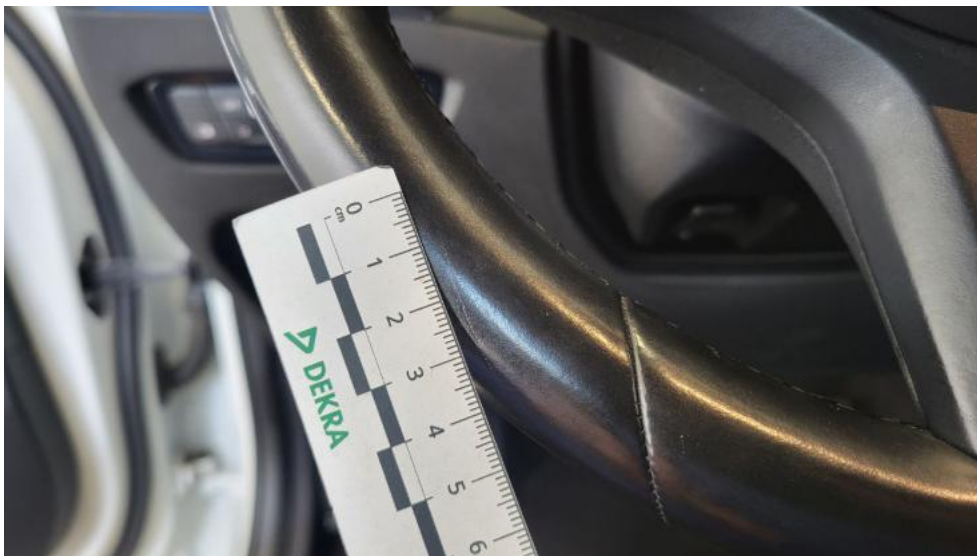
**Photo 59.**

Koło kierownicy - Rysa/odprysk 1

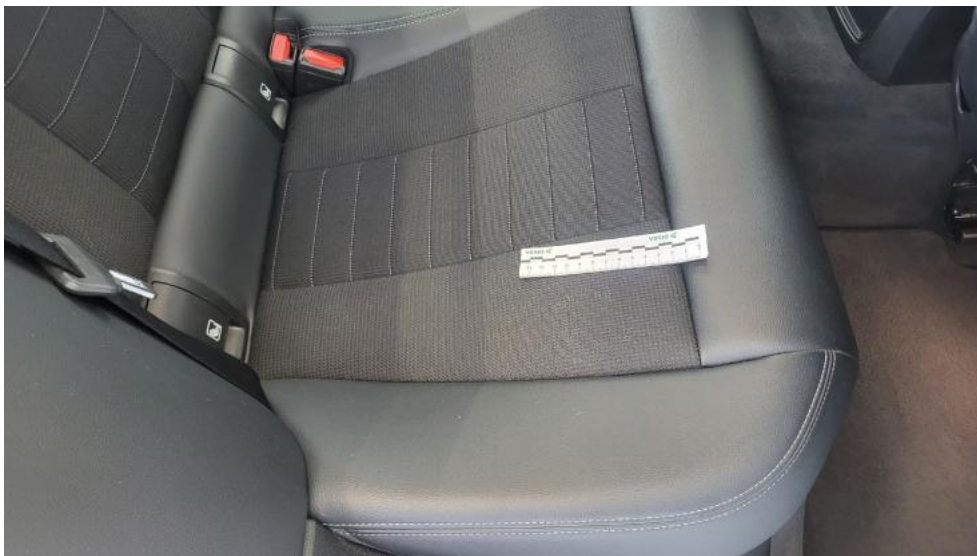
**Photo 63.**  
Kanapa tyl. - Inne 2
