DEKRA's commission No. : PKOL(W)/LODZ/68614/26/07/23  
commission/ damage No. : 22/009233  
Date of commission: 23-07-2026

| Manufacturer | MAZDA |
| Model | MX-30 EV 20- |
| VIN / serial number | JMZDR1WBJ00117587 |

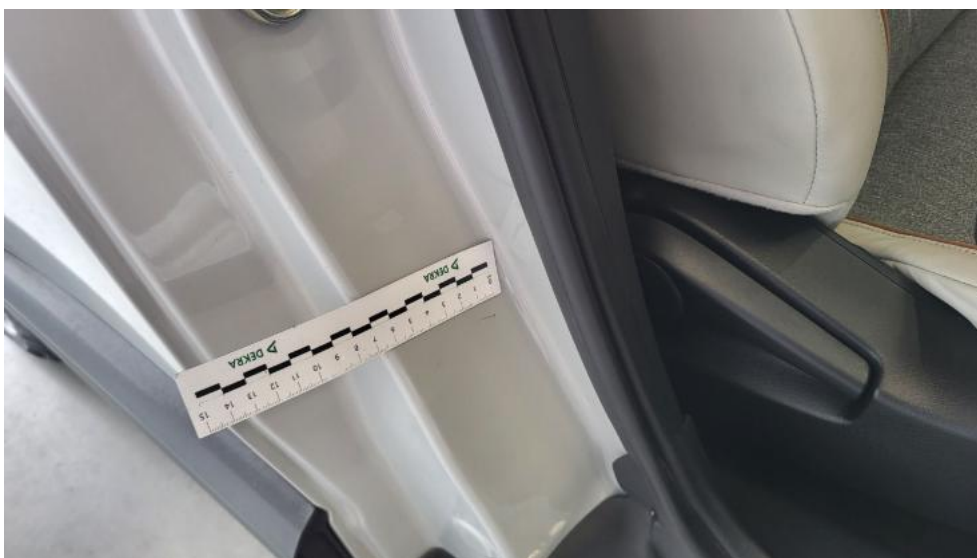
**Photo 56.**

Drzwi tylne P - Rysa/odprysk 1

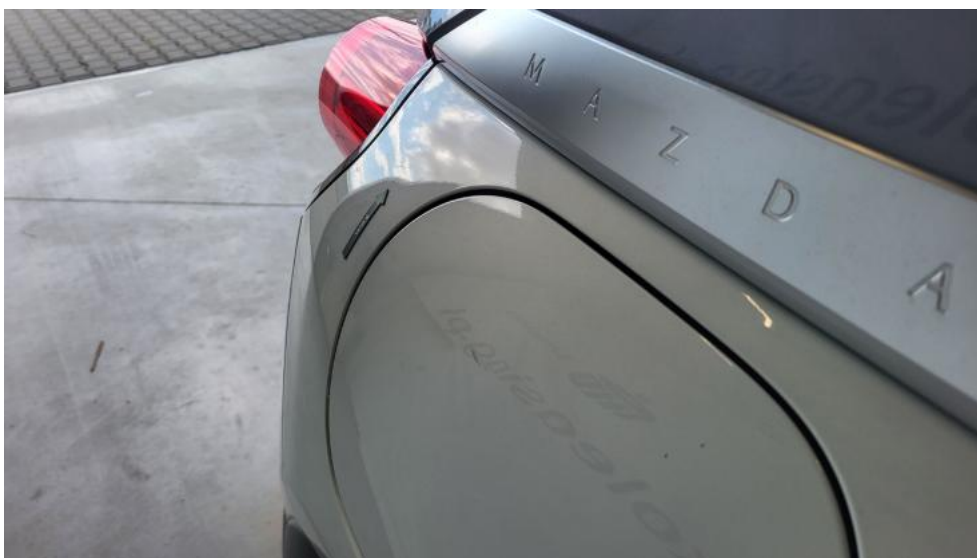
**Photo 58.**

Błotnik tylny P / Ściana boczna P - Wgniecenie/odkształcenie 2

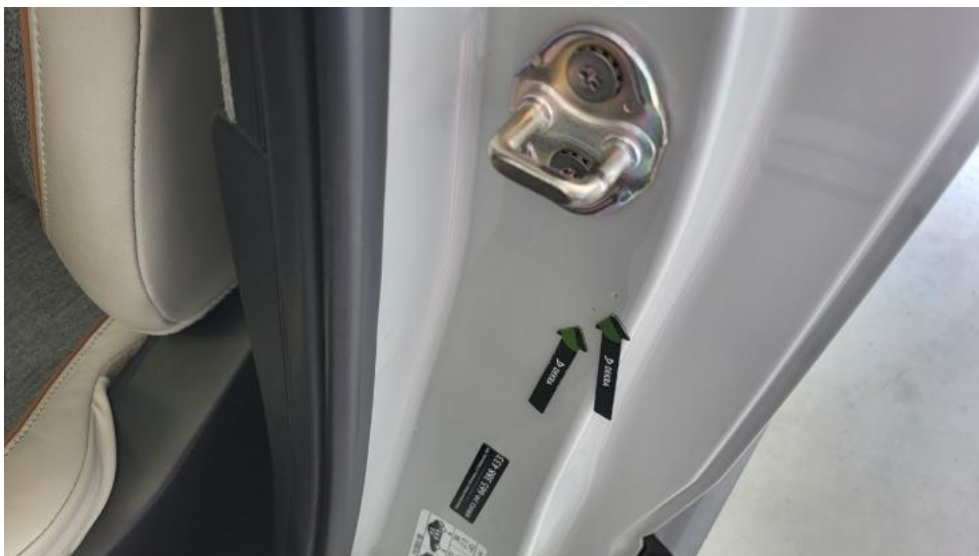
**Photo 66.**

Drzwi tylne L - Wgniecenie/odkształcenie 1

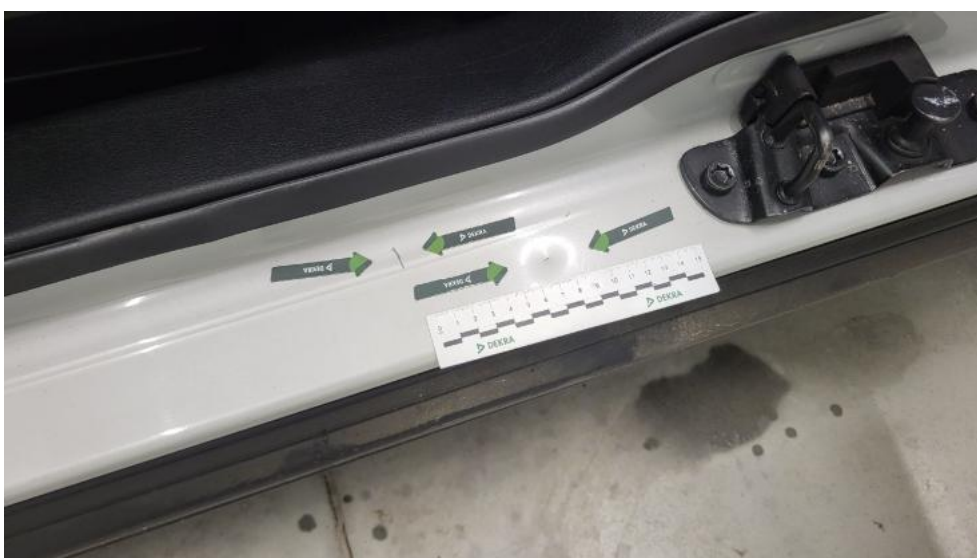
**Photo 70.**  
Próg L - Wgniecenie/odkształcenie 1

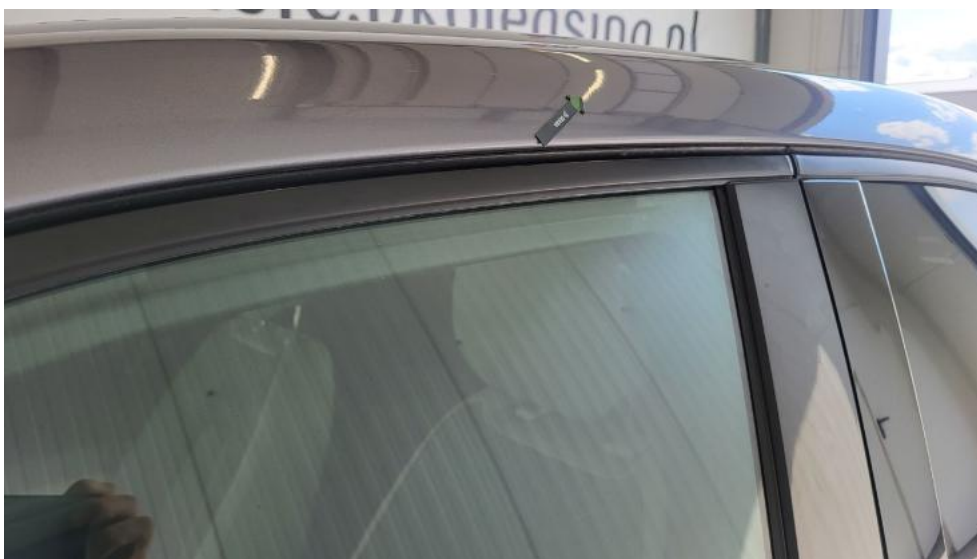
**Photo 71.**

Słupek przedni L - Wgniecenie/odkształcenie 1

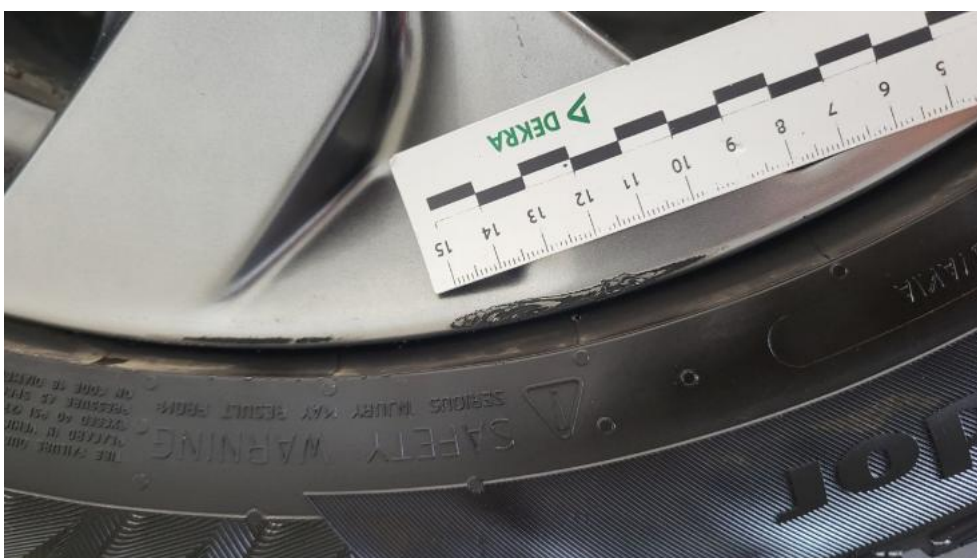
**Photo 72.**

Felga Aluminiowa przednia L - Rysa/odprysk 1

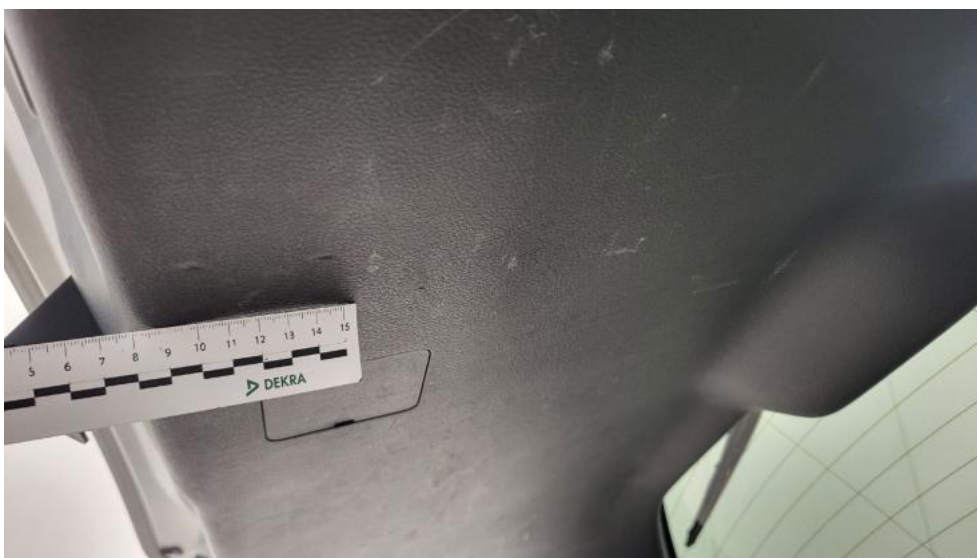
**Photo 74.**

Wykładzina pokrywy tylnej - Rysa/odprysk 1
