DEKRA's commission No. : PKOL(W)/LODZ/72289/25/09/24  
commission/ damage No. : 20/042657  
Date of commission: 24-09-2025

**DEKRA Poland - Headquarters**  
02-673 Warszawa, ul. Konstruktorska 12A

| Manufacturer | KIA |
| Type / version | Sorento 2.0 CRDI Business Line aut |

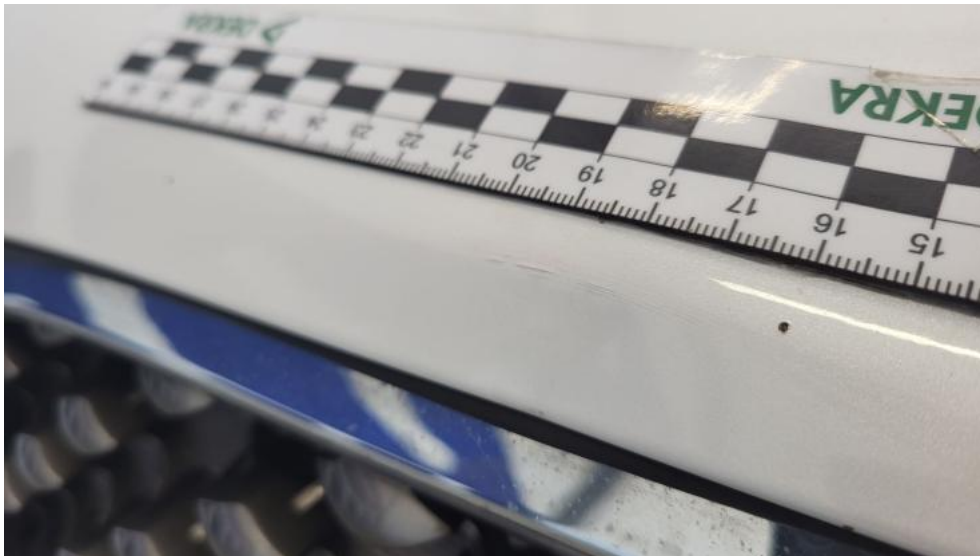
**Photo 47.**

Pokrywa komory silnika - Pęknięcie/rozerwanie 1

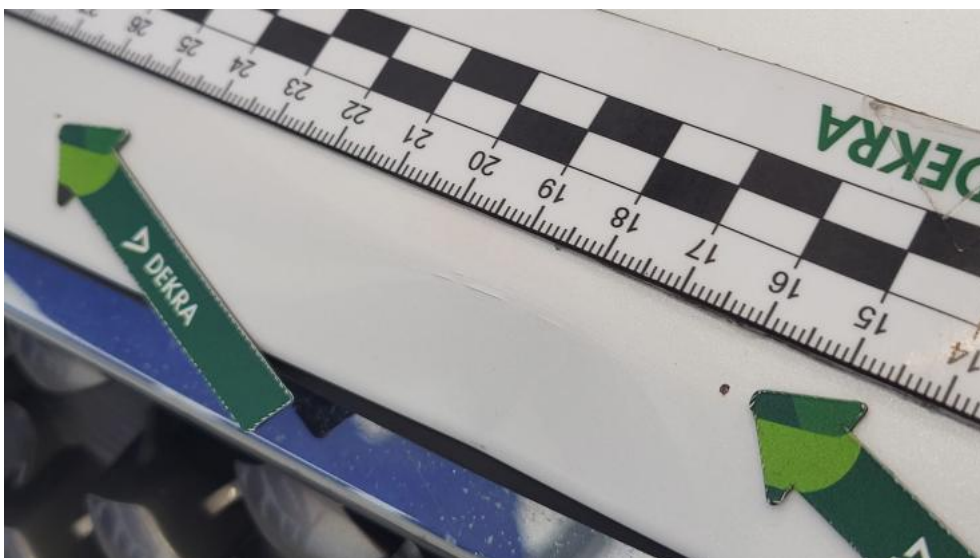
**Photo 48.**

Pokrywa komory silnika - Inne 1

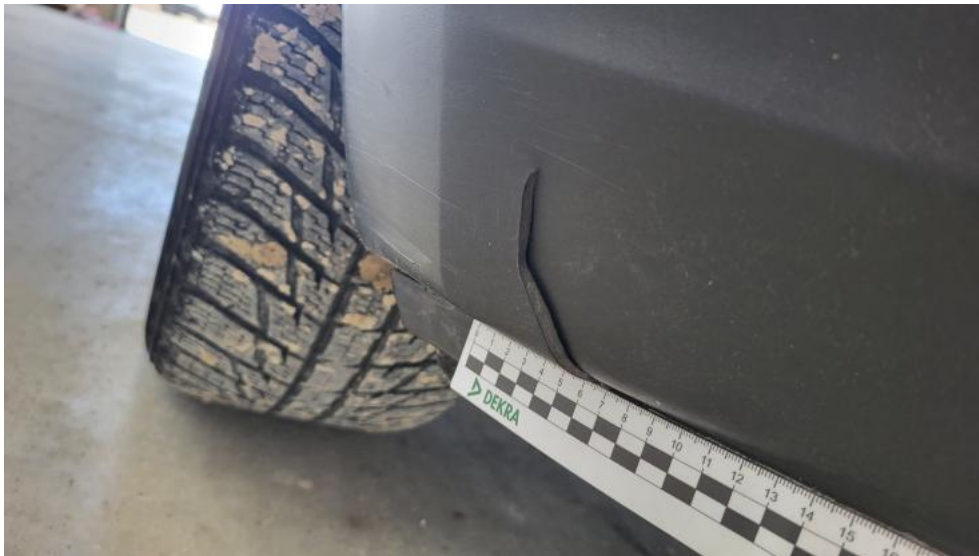
**Photo 51.**

Zderzak przedni cz dolna - Pęknięcie/rozerwanie 1

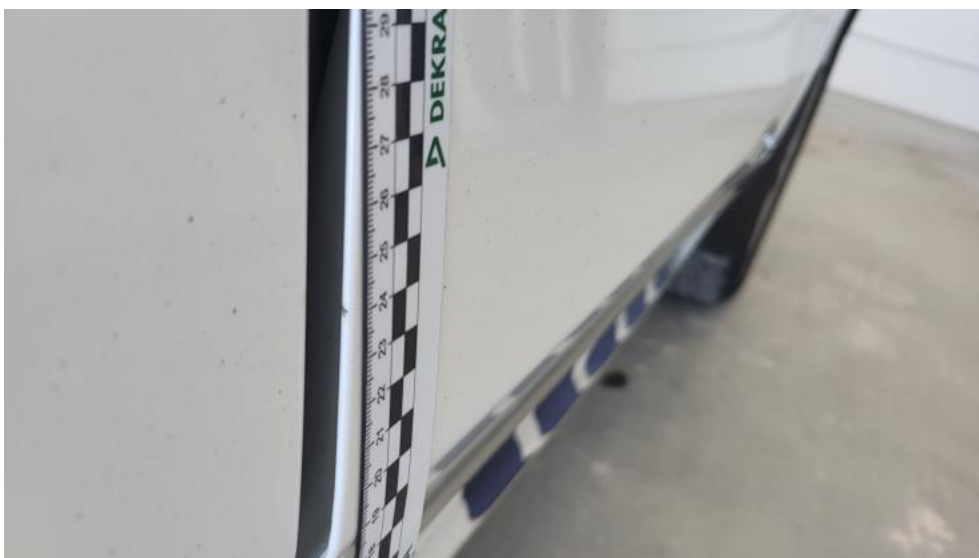
**Photo 52.**

Drzwi przednie P - Rysa/odprysk 1

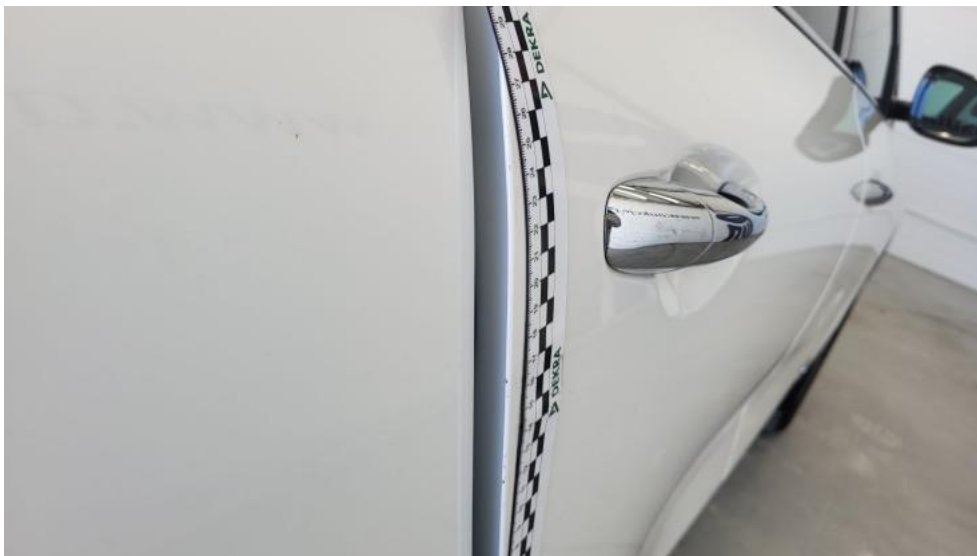
**Photo 53.**

Drzwi tylne P - Rysa/odprysk 1

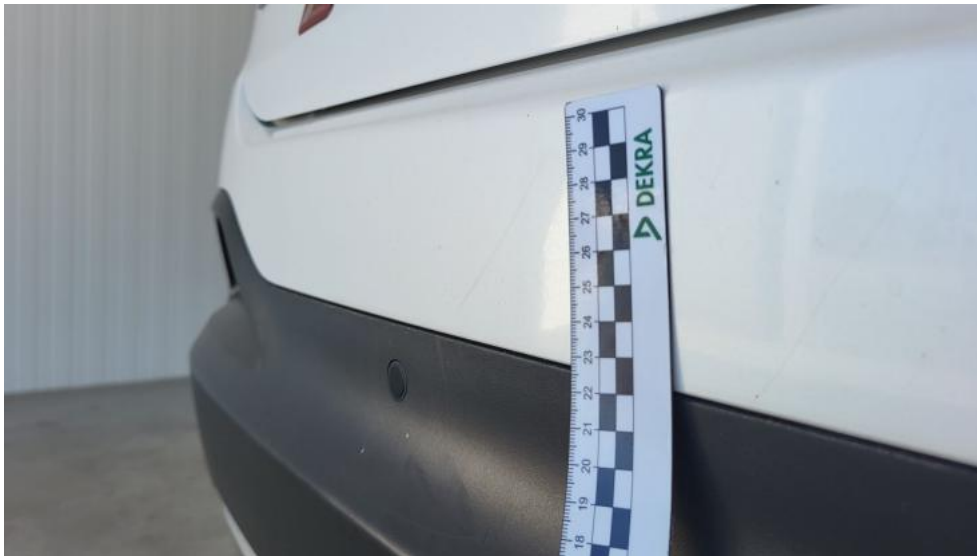
**Photo 57.**

Zderzak tylny - Wgniecenie/odkształcenie 1

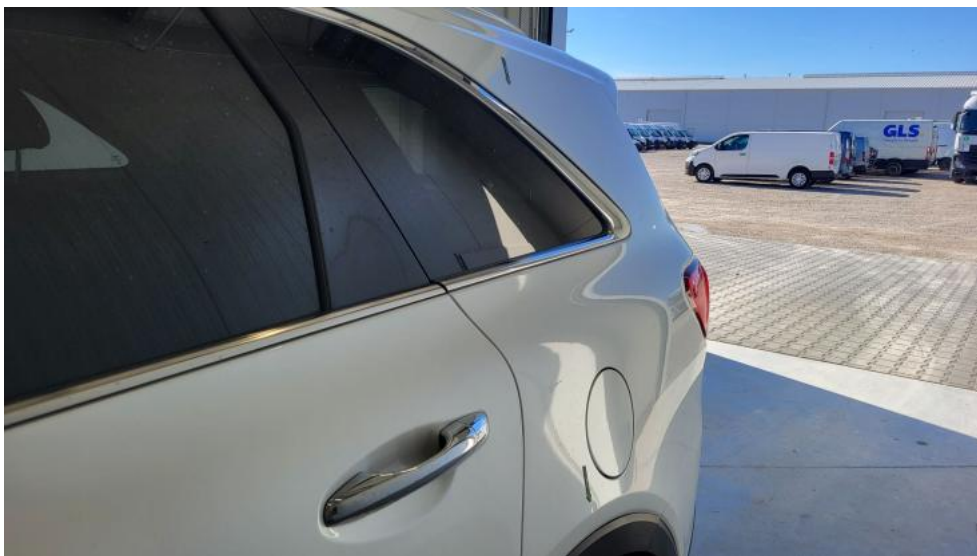
**Photo 58.**

Ścianka tylna L / Ścianka boczna L - Wgniecenie/odkształcenie 1

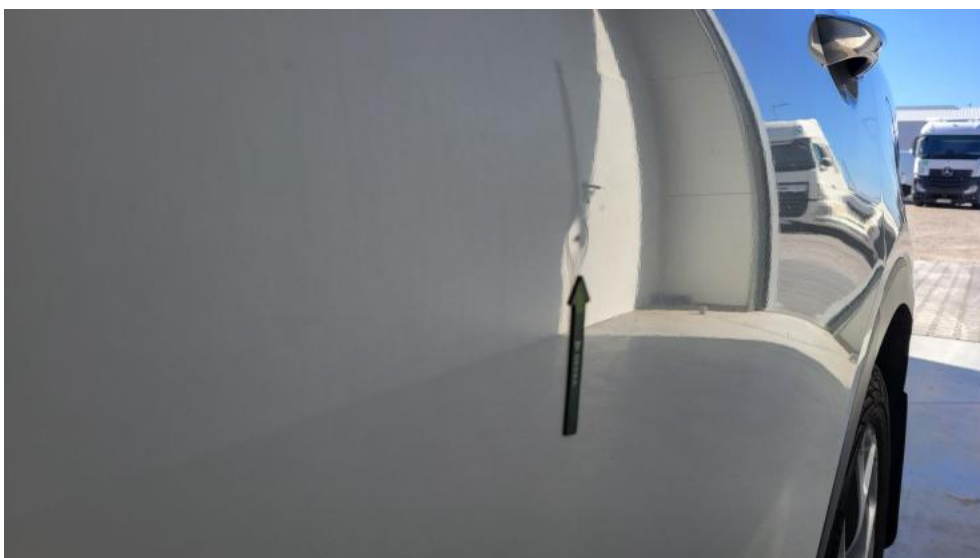
**Photo 60.**

Drzwi tylne L - Wgniecenie/odkształcenie 1

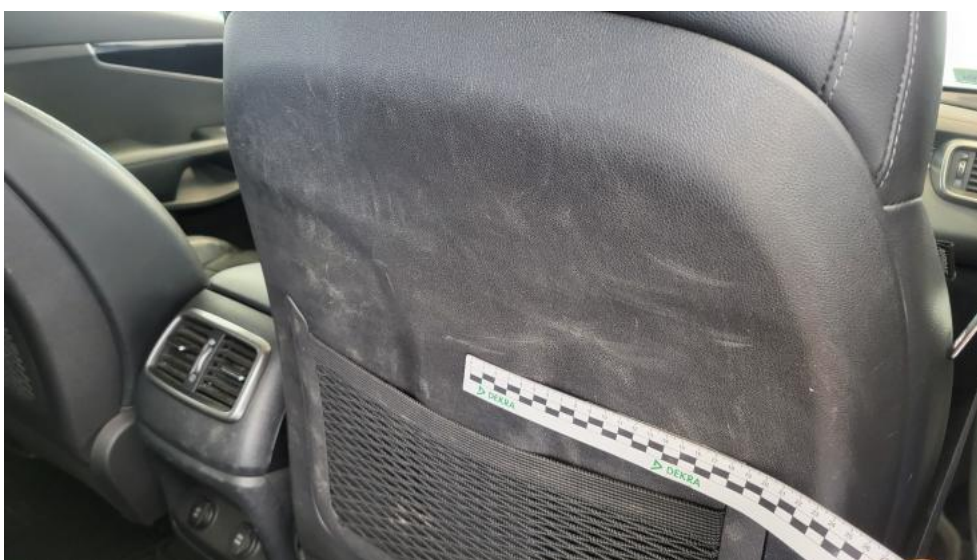
**Photo 64.**

Fotel prz. praw. - Inne 1
