DEKRA's commission No. : PKOL(W)/LODZ/89518/25/11/19  
commission/ damage No. : 23/040509  
Date of commission: 19-11-2025

**Vehicle data**

| Type / version | Grandland X 1.5 CDTI Innovation S&S aut |
| Registration /record No. | KK3907C |

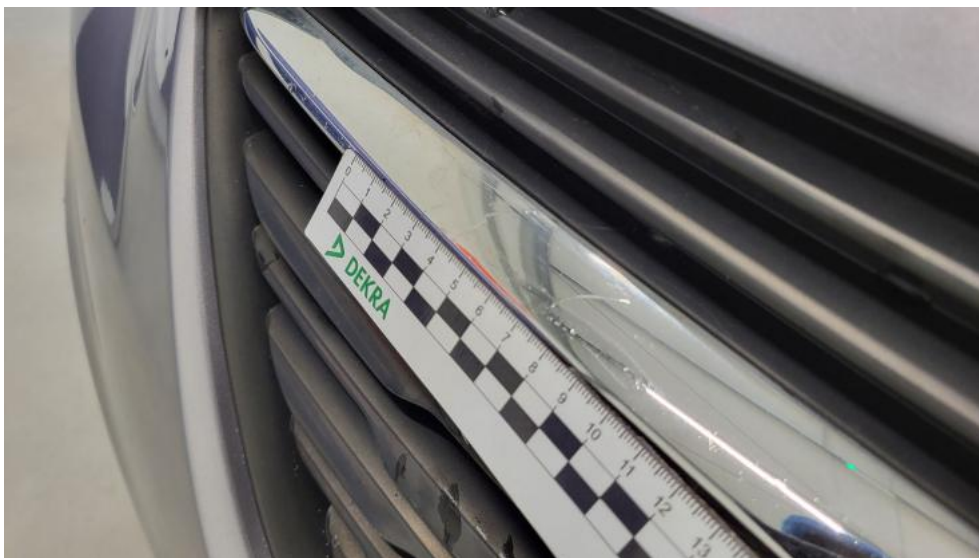
**Photo 38.**

Atrapa przednia - Rysa/odprysk 1

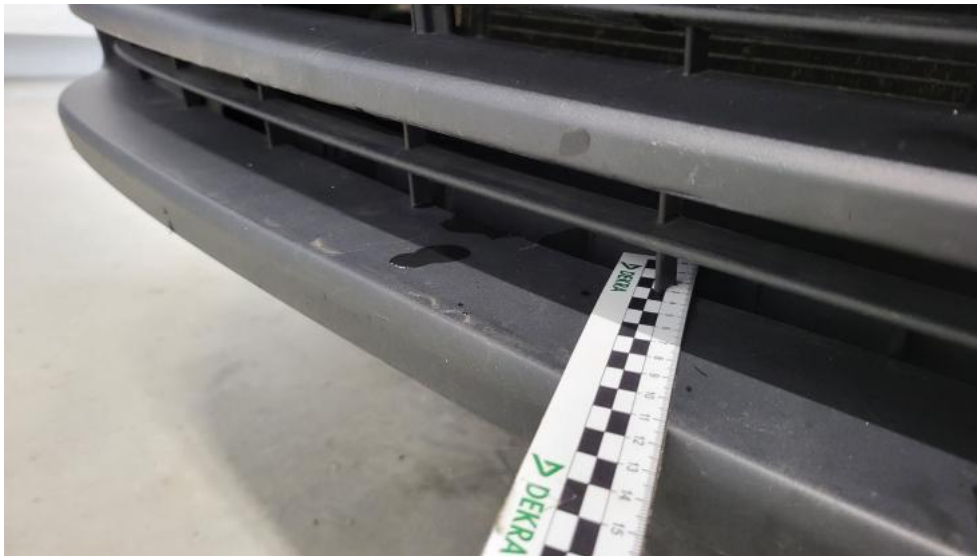
**Photo 40.**

Krata zderzaka prz. - Pęknięcie/rozerwanie 1

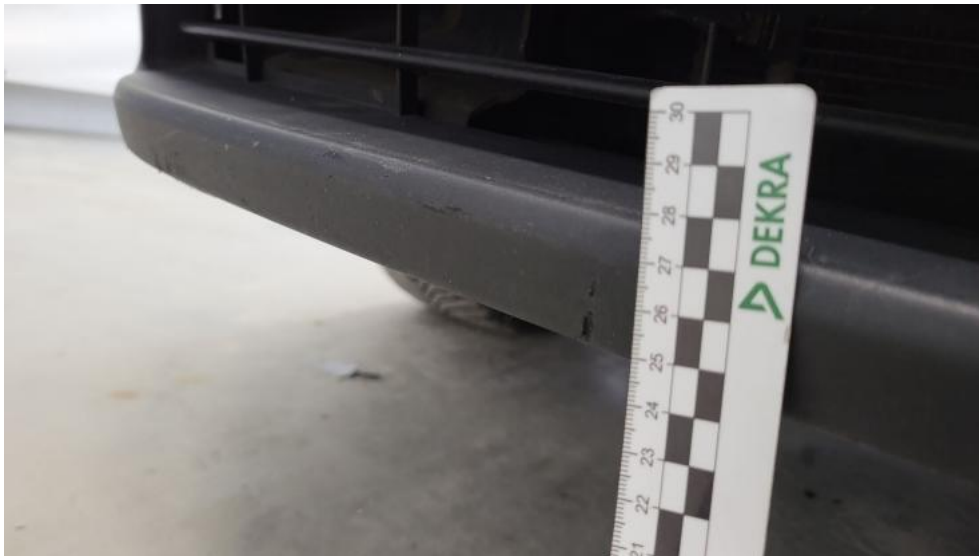
**Photo 41.**

Spoiler zderzaka przedniego - Rysa/odprysk 1

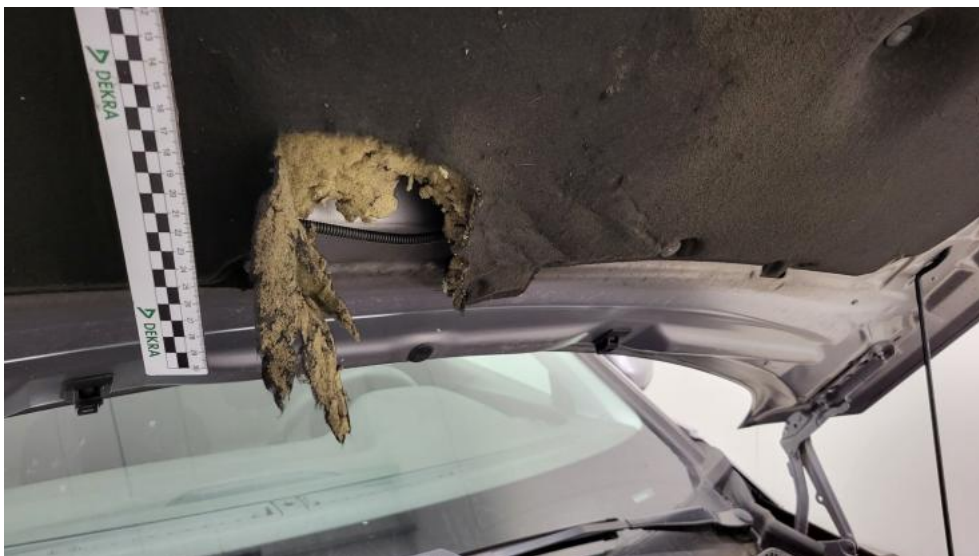
**Photo 42.**

Wykładzina pokrywy komory silnika - Pęknięcie/rozerwanie 1

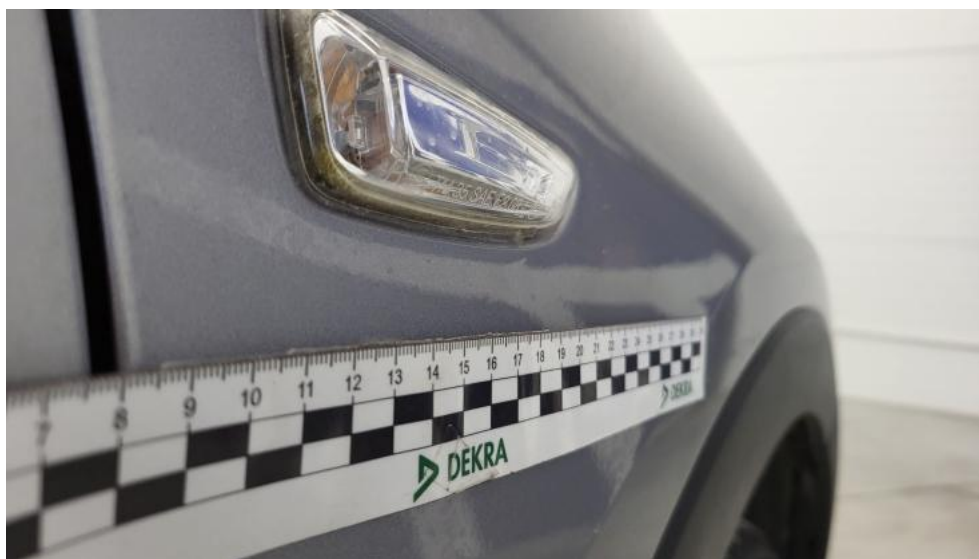
**Photo 43.**

Błotnik przedni P - Wgniecenie/odkształcenie 1

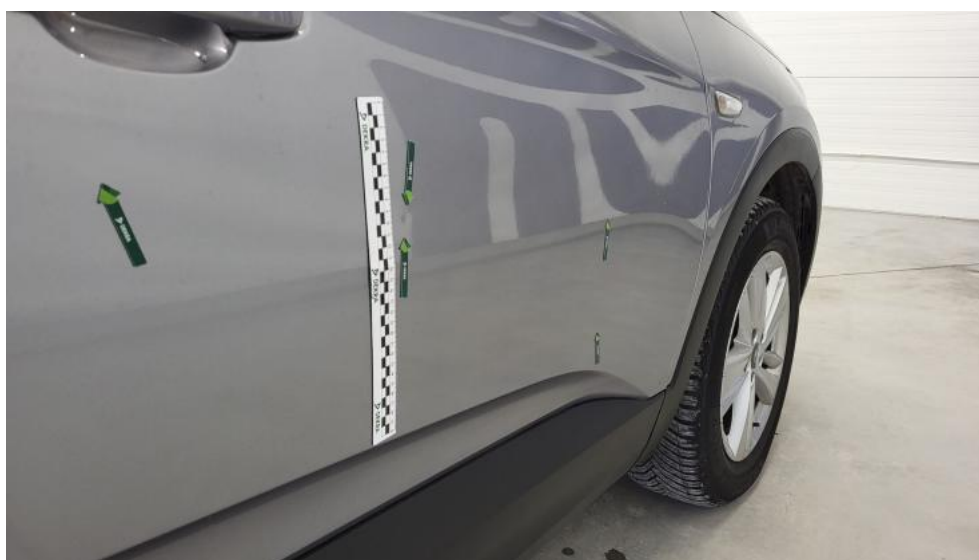
**Photo 44.**

Drzwi przednie P - Wgniecenie/odkształcenie 1

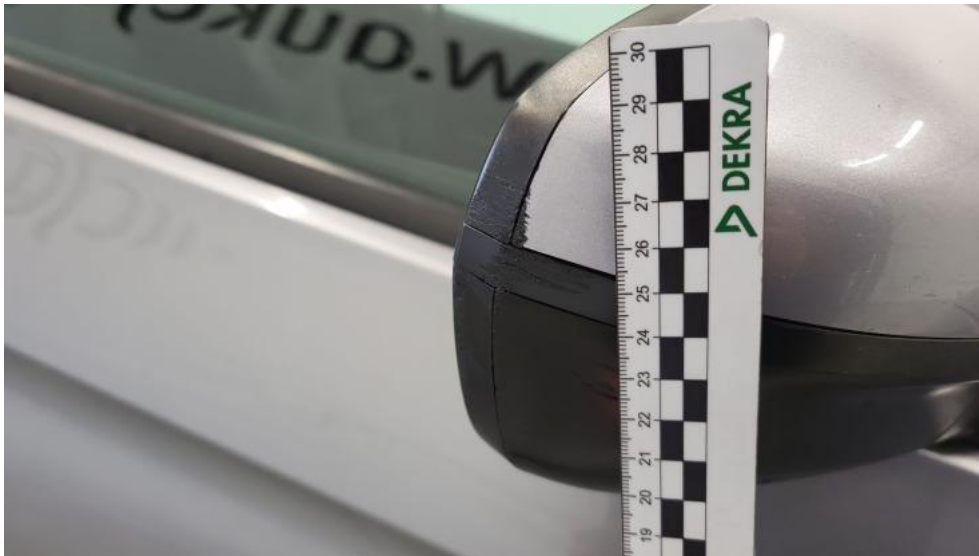
**Photo 47.**

Lusterko zew P - Rysa/odprysk 1

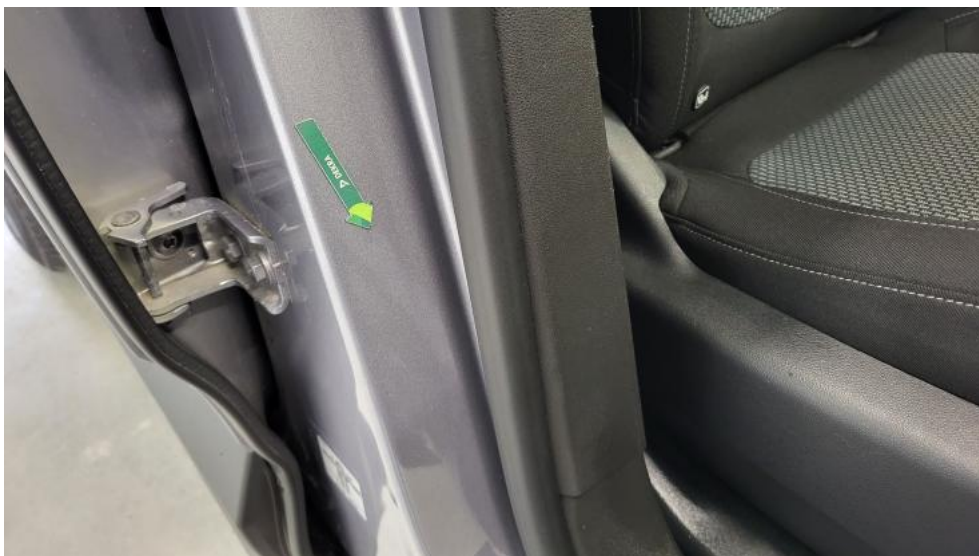
**Photo 48.**

Słupek środkowy P - Wgniecenie/odkształcenie 1

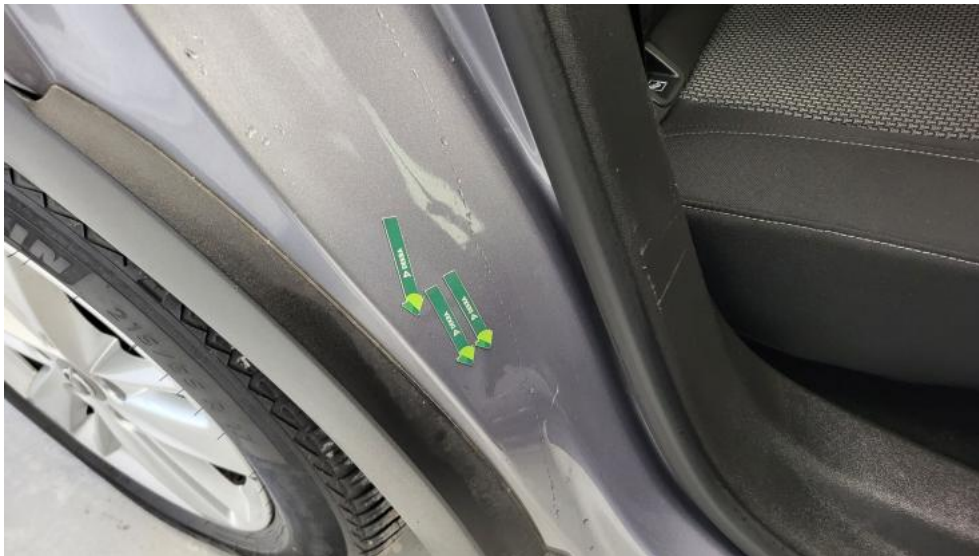
**Photo 51.**

Błotnik tylny P / Ściana boczna P() - Wgniecenie/odkształcenie 3

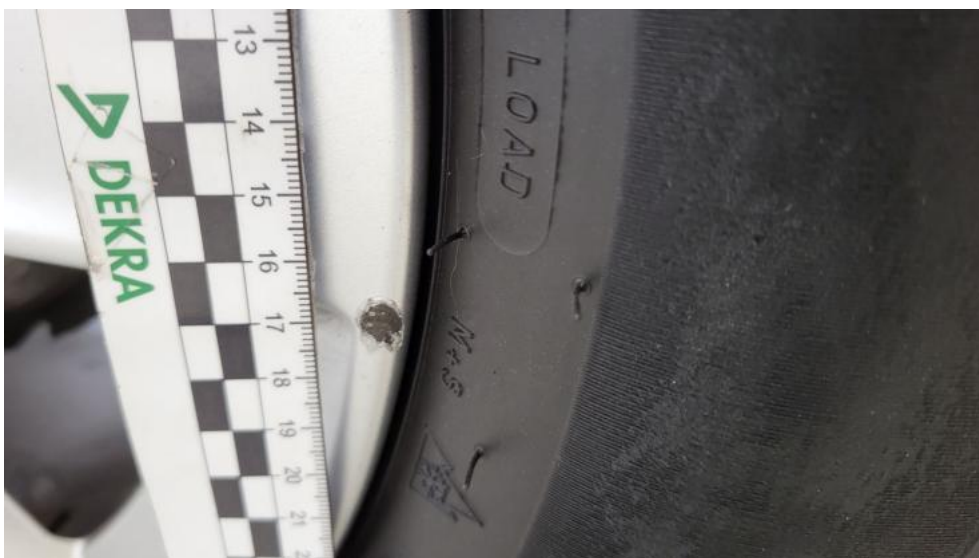
**Photo 52.**

Felga aluminiowa tylna P - Rysa/odprysk 1

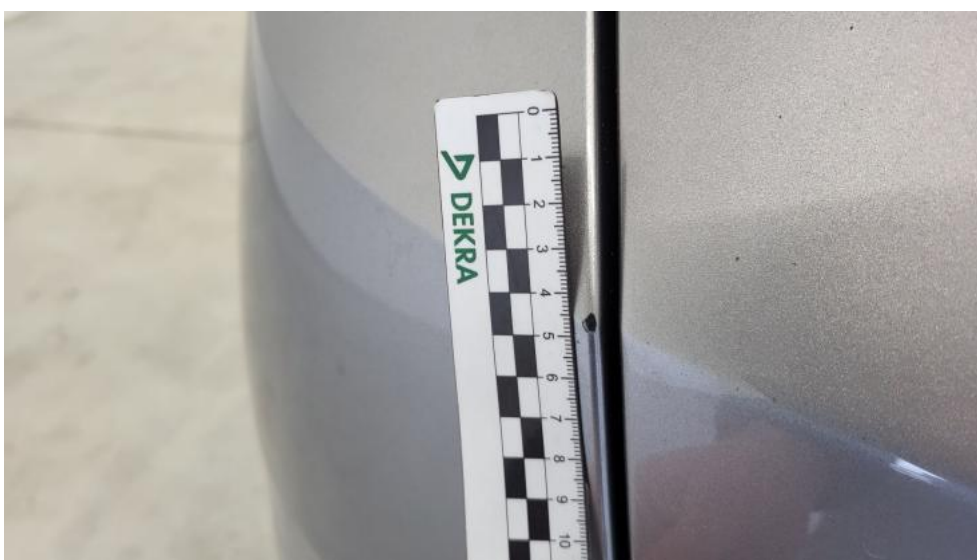
**Photo 54.**

Zderzak tylny cz L - Rysa/odprysk 1

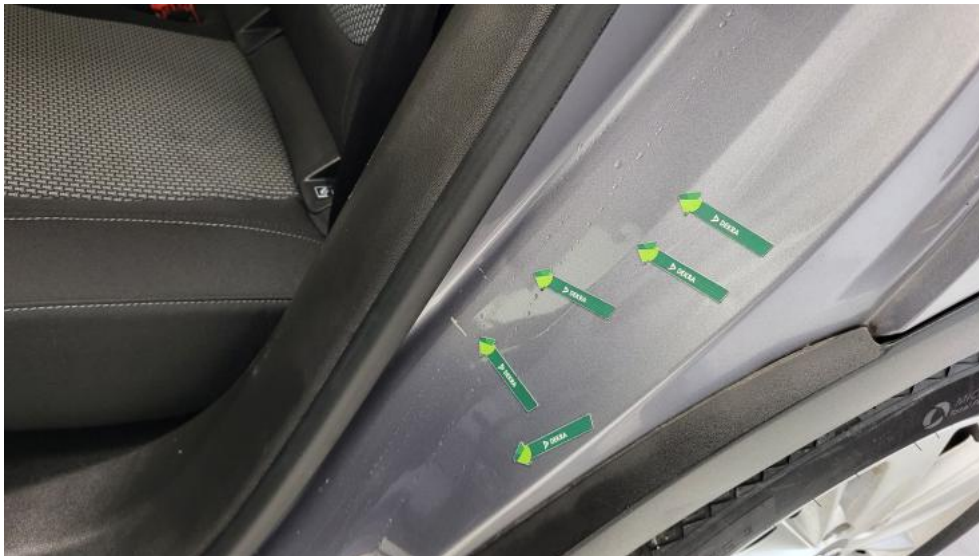
**Photo 59.**

Błotnik tylny L / Ściana boczna L - Wgniecenie/odkształcenie 2

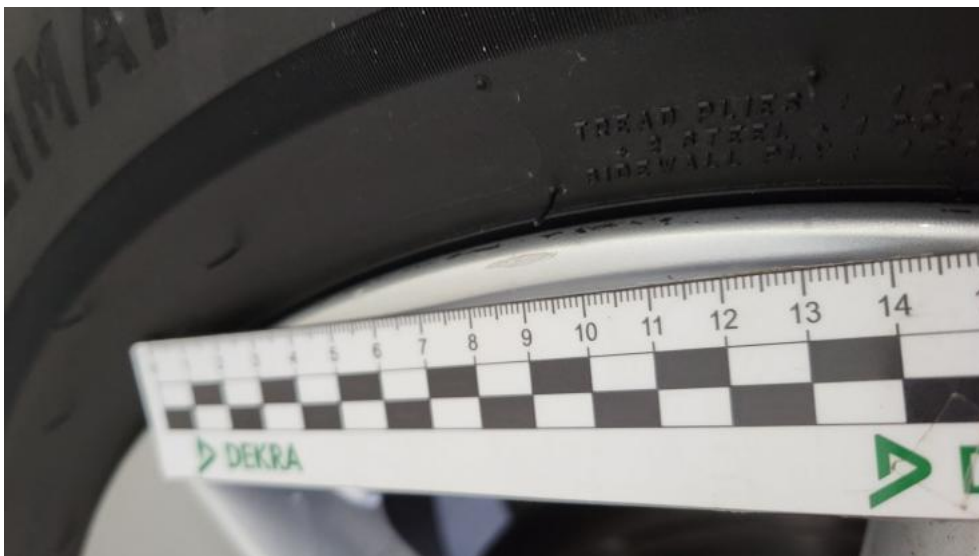
**Photo 60.**

Felga aluminiowa tylna L - Rysa/odprysk 1

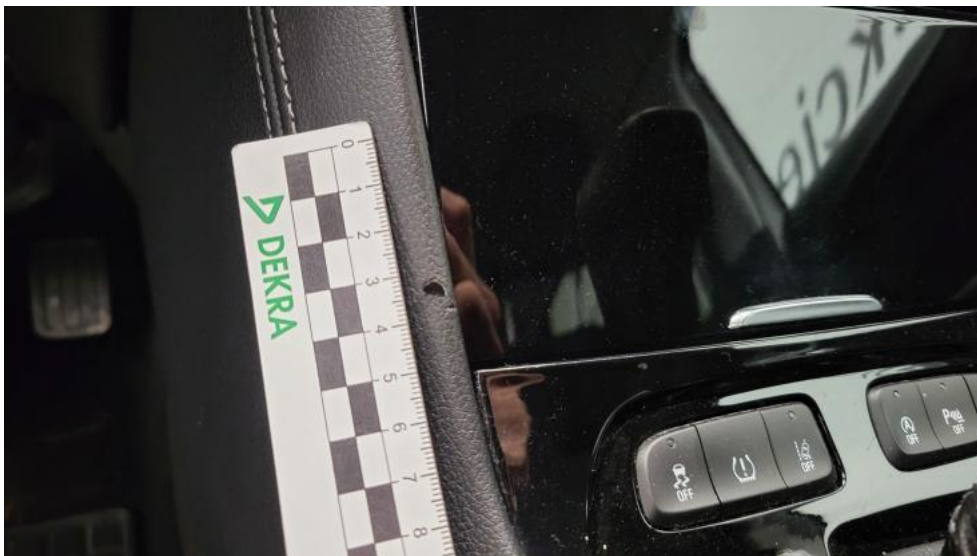
**Photo 67.**

Konsola środkowa - Pęknięcie/rozerwanie 1

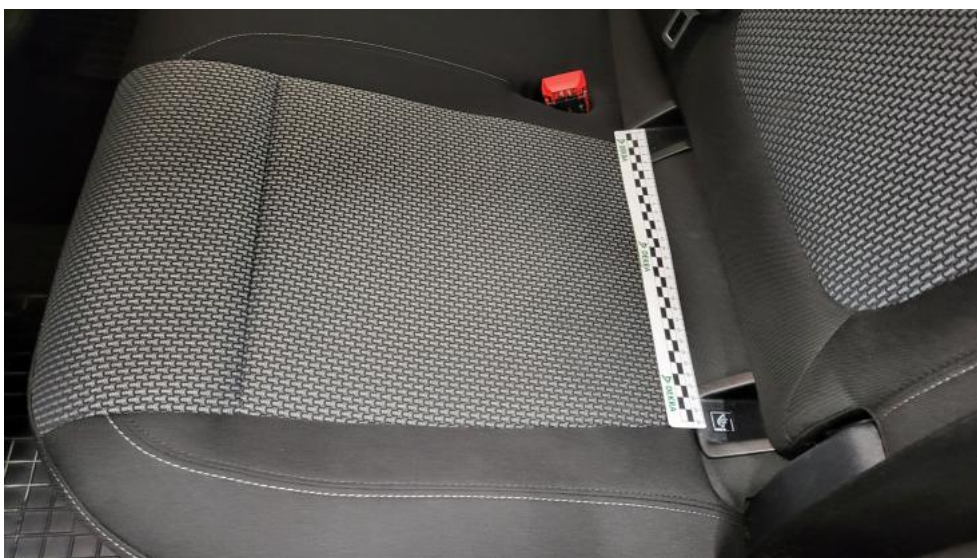
**Photo 68.**

Kanapa tyl. - Inne 1

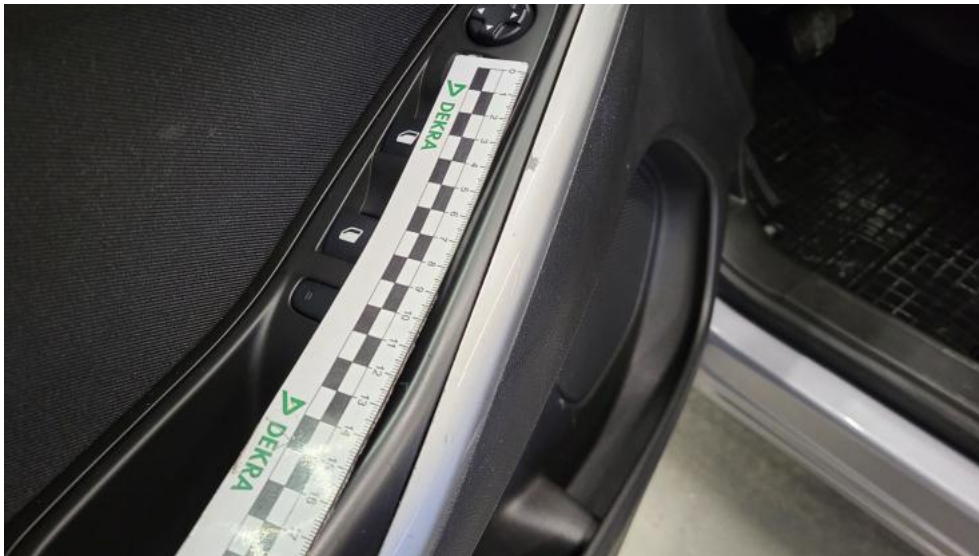
**Photo 69.**

Tapicerka drzwi przednich L - Rysa/odprysk 1

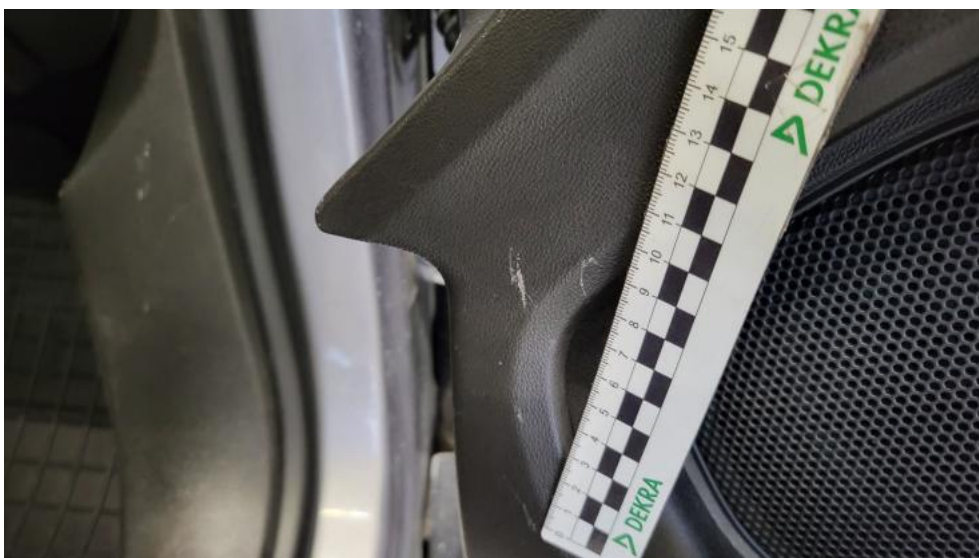
**Photo 70.**

Tapicerka drzwi przednich P - Rysa/odprysk 1

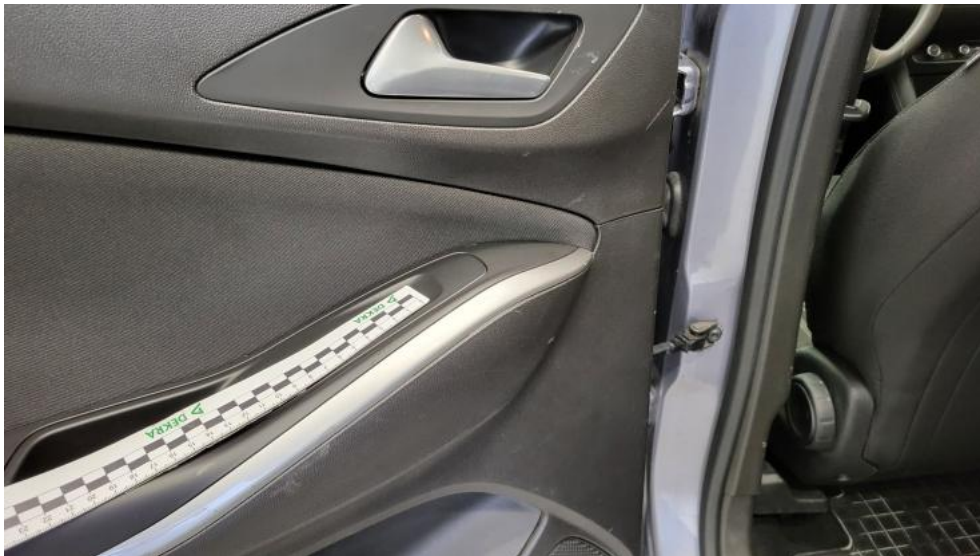
**Photo 71.**

Tapicerka drzwi tylnych L - Rysa/odprysk 1

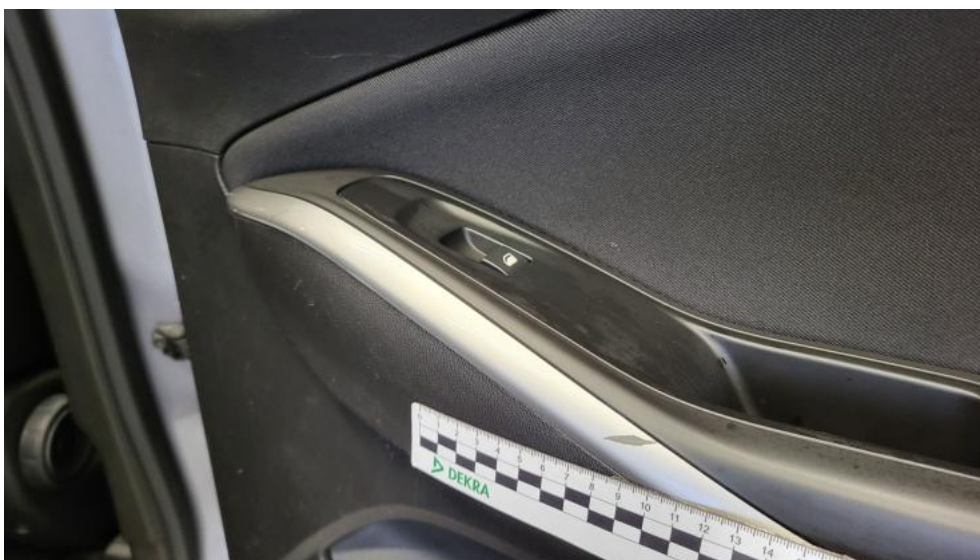
**Photo 72.**

Tapicerka drzwi tylnych P - Rysa/odprysk 1

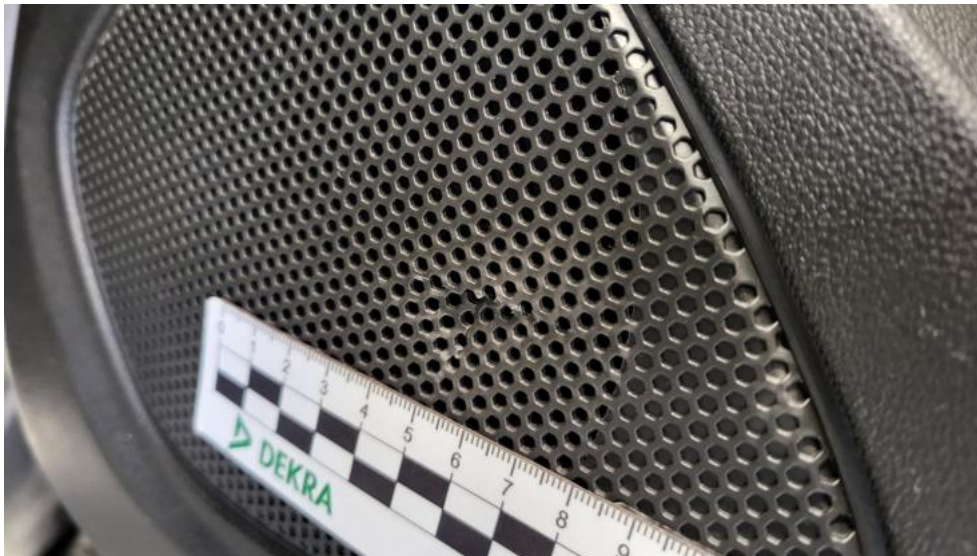
**Photo 73.**

Tapicerka drzwi tylnych P - Pęknięcie/rozerwanie 1

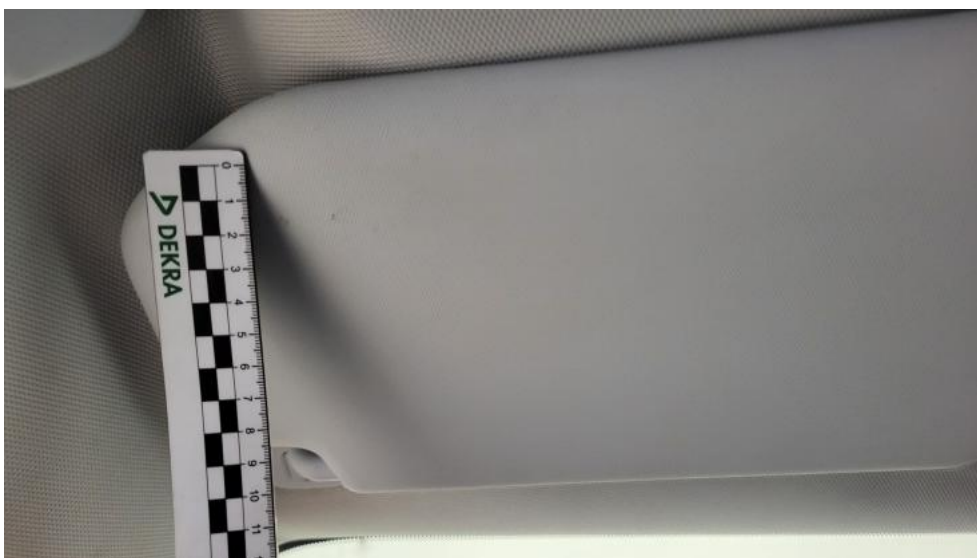
**Photo 74.**

Osłona p/słoneczna lewa - Inne 1

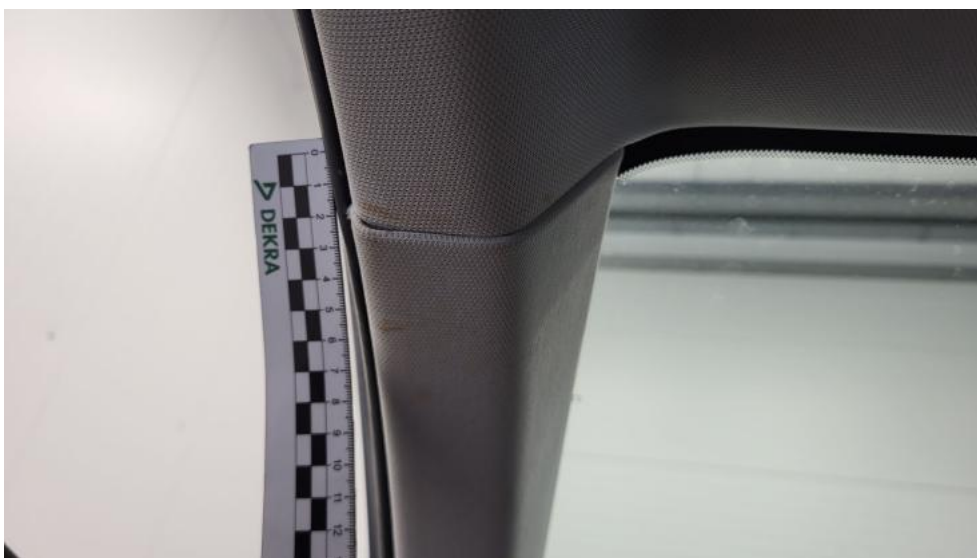
**Photo 76.**

Wykładzina(y) słupka przedniego L - Inne 1

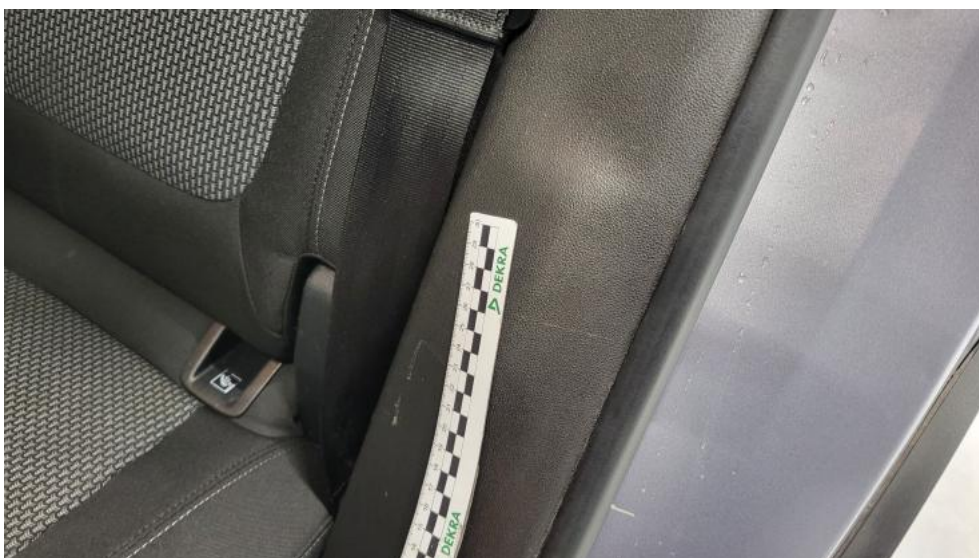
**Photo 78.**

Wykładzina(y) słupka tylnego L - Rysa/odprysk 1
