DEKRA's commission No. : PKOL(W)/LODZ/95349/25/12/04  
commission/ damage No. : 22/024500  
Date of commission: 04-12-2025

| Type / version | Superb 1.4 TSI Plug-In Hybrid L&K DSG |

Measurement of thickness of the vehicle lacquer coating

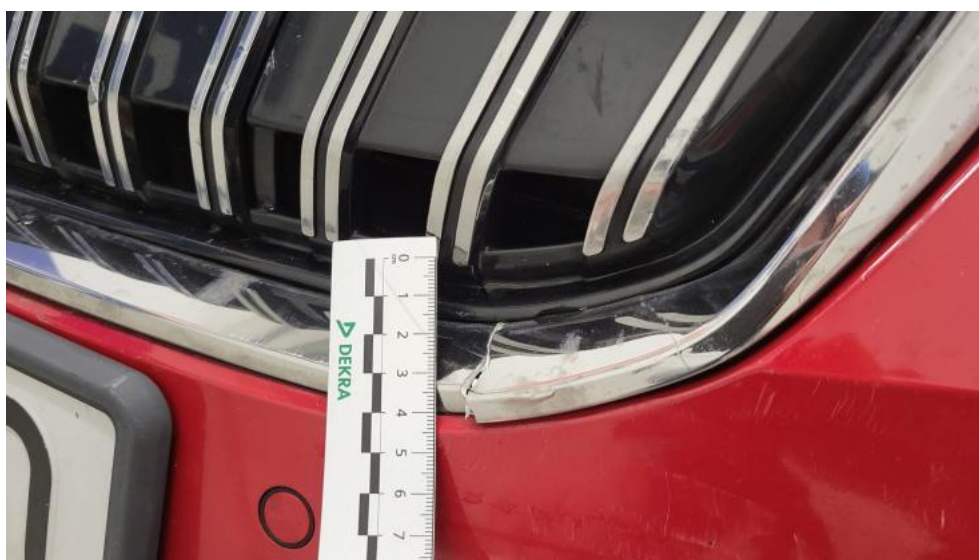
**Photo 52.**

Atrapa przednia - Pęknięcie/rozerwanie 1

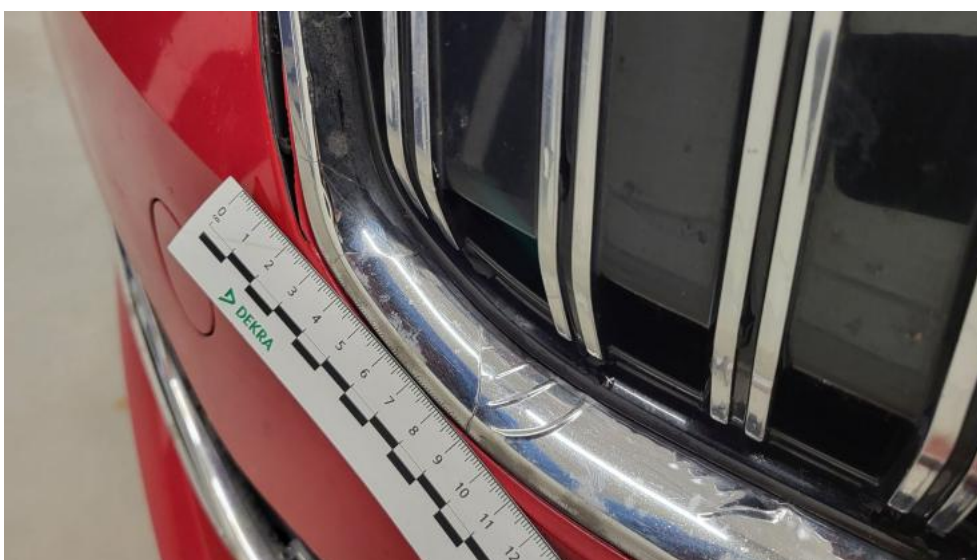
**Photo 54.**

Atrapa przednia() - Pęknięcie/rozerwanie 3

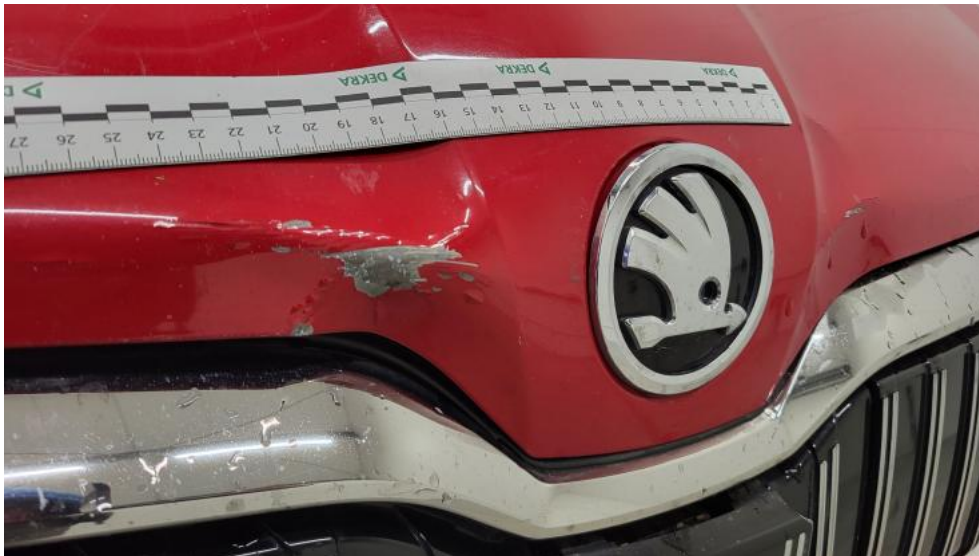
**Photo 57.**

Pokrywa komory silnika - Pęknięcie/rozerwanie 1

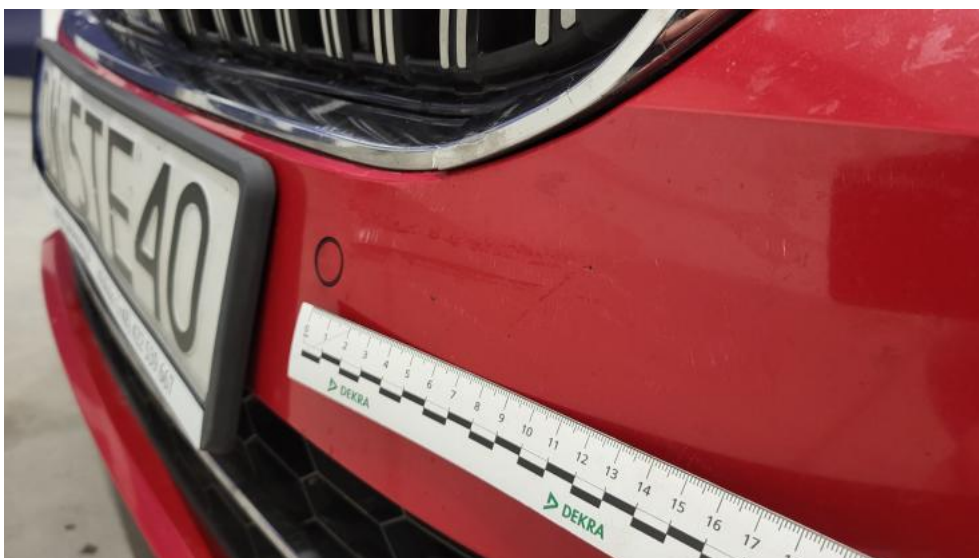
**Photo 58.**

Zderzak - Rysa/odprysk 1

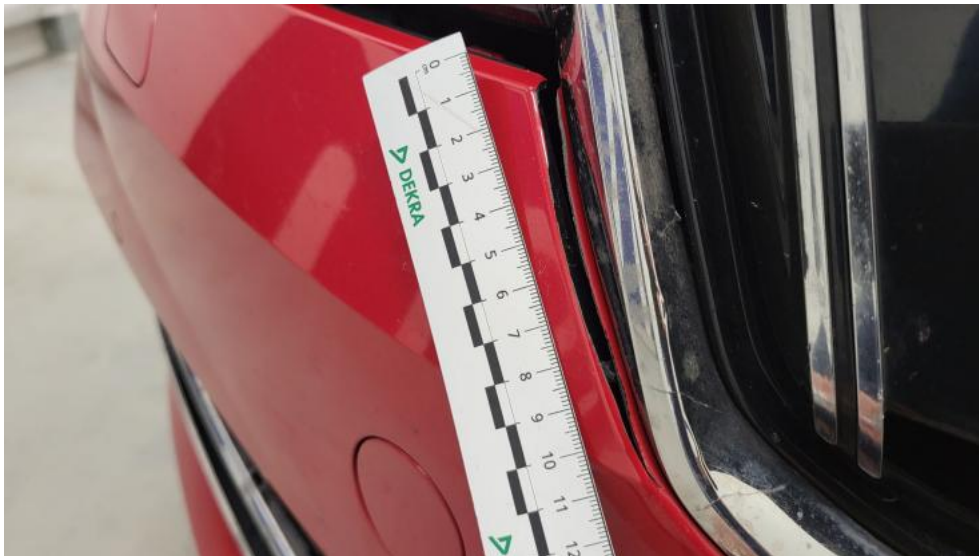
**Photo 59.**

Zderzak - Pęknięcie/rozerwanie 1

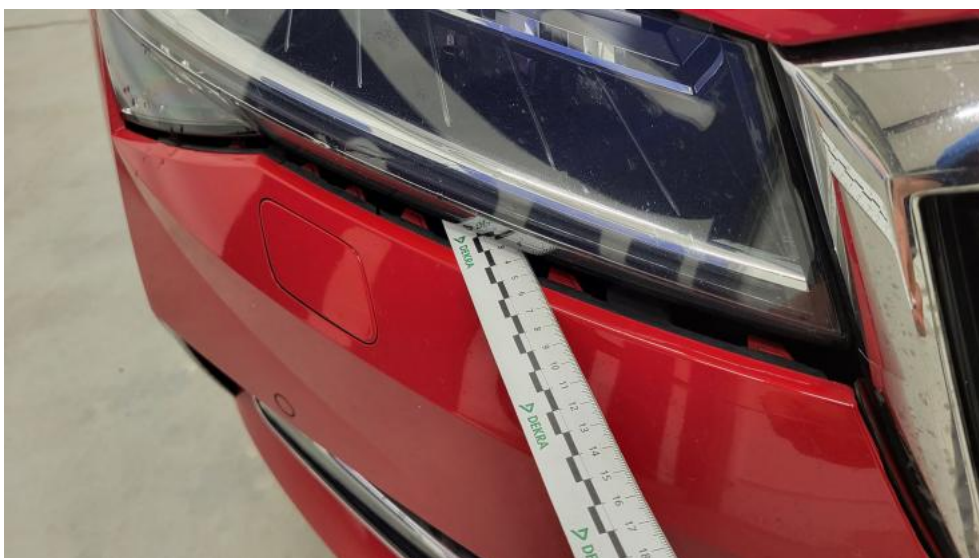
**Photo 60.**

Zderzak - Inne 1

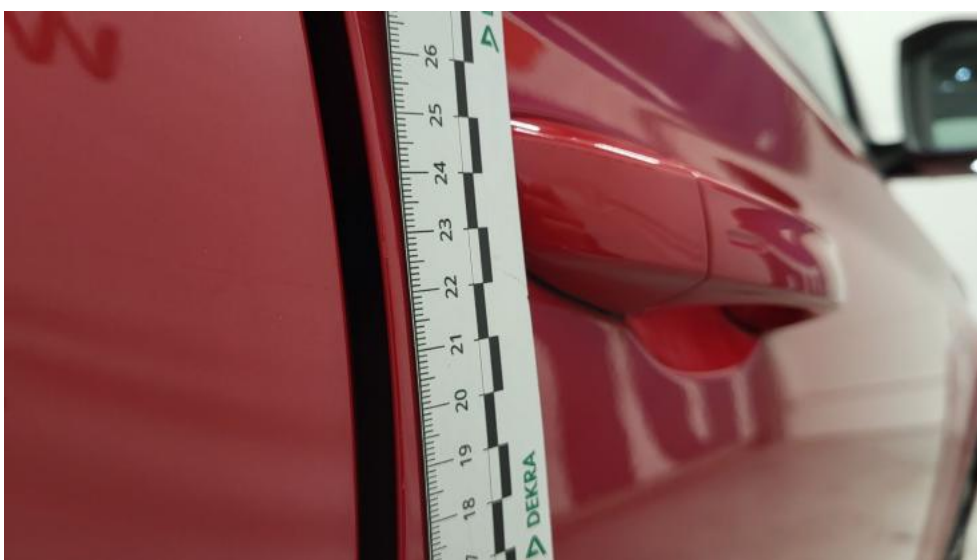
**Photo 62.**

Drzwi przednie P - Rysa/odprysk 1

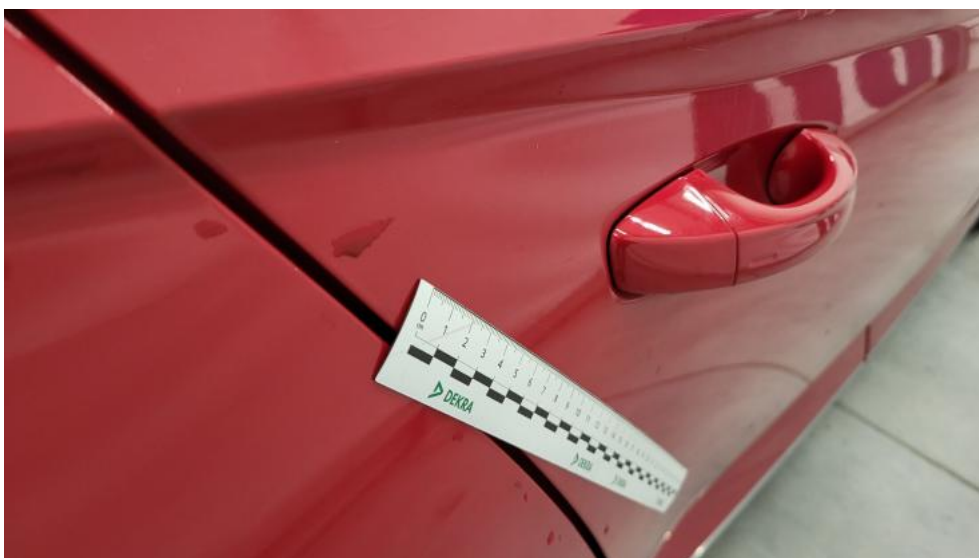
**Photo 64.**

Drzwi tylne P - Rysa/odprysk 2

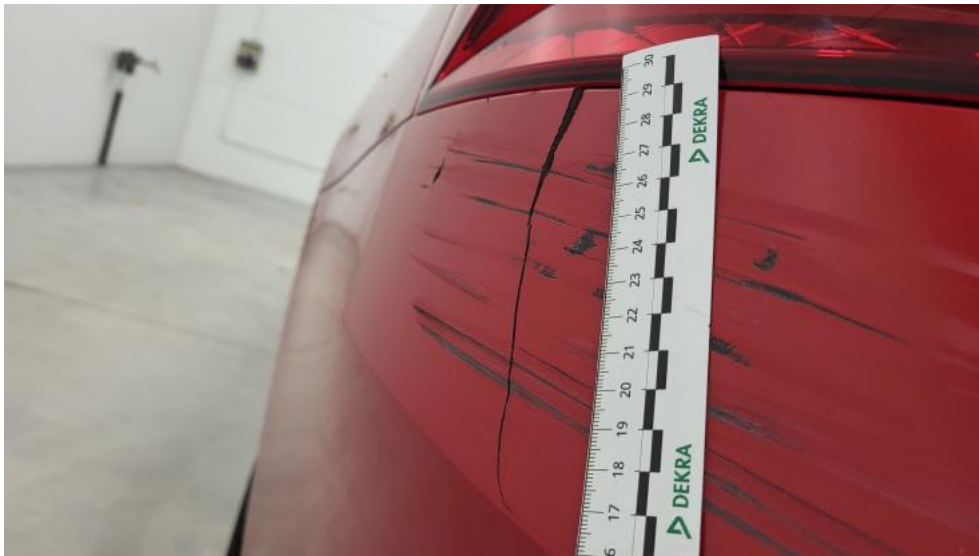
**Photo 69.**

Zderzak tylny - Pęknięcie/rozerwanie 1

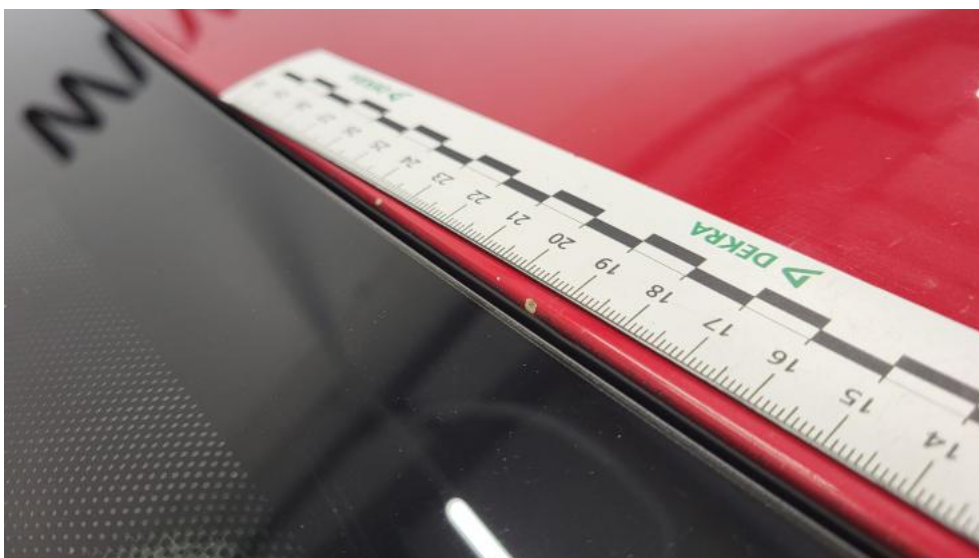
**Photo 70.**

Dach - Rysa/odprysk 1

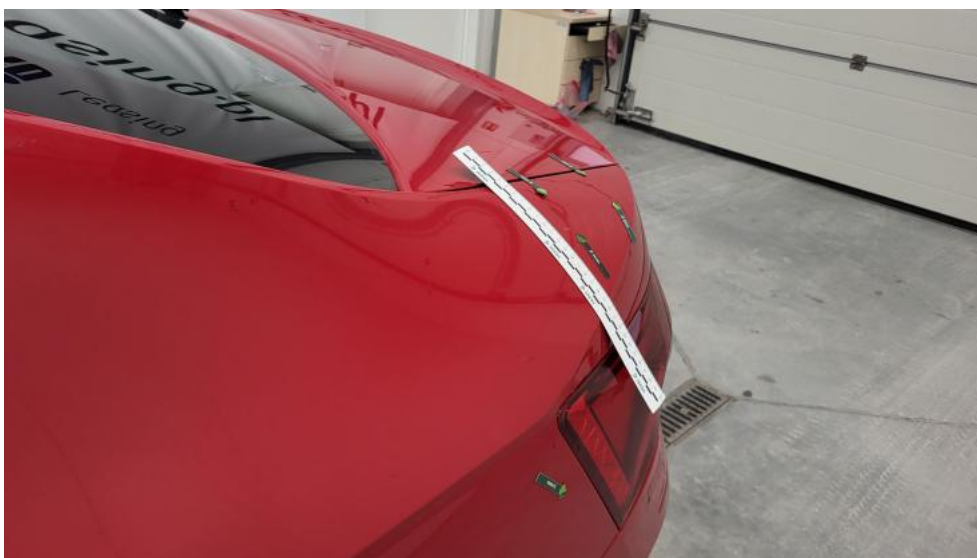
**Photo 72.**

Błotnik tylny L / Ściana boczna L - Wgniecenie/odkształcenie 1

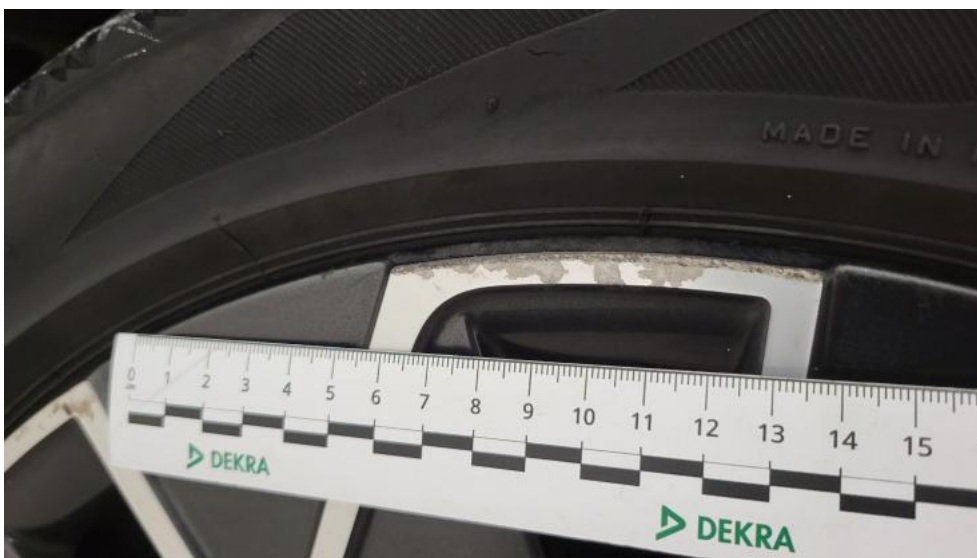
**Photo 74.**

Felga aluminiowa tylna L - Rysa/odprysk 1

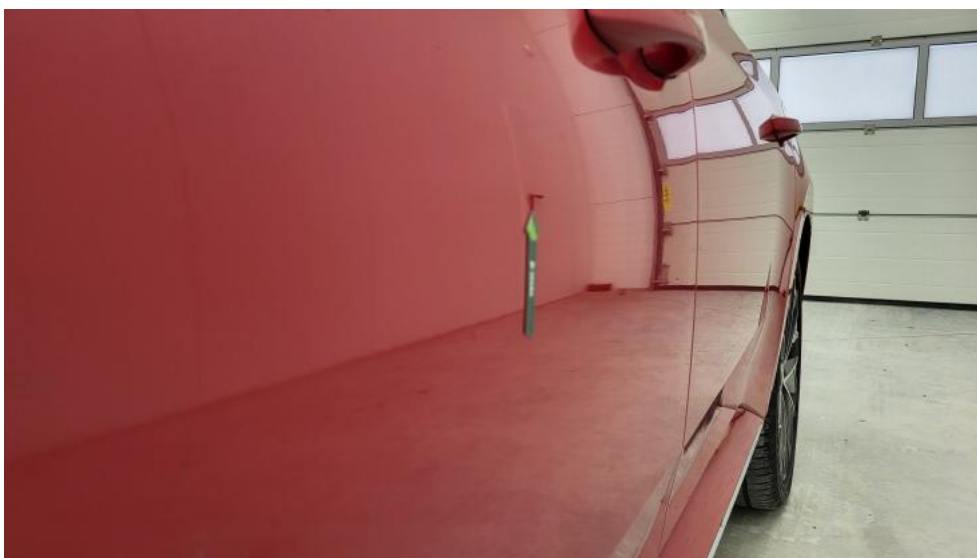
**Photo 76.**

| No. of controlled item | Controlled item | Measured range of thickness of the lacquer coat [ $\mu\text{m}$ ] |
|---|---|---|
| 4 | Front left door | 150 - 2000 |

Drzwi przed L - Wgniecenie/odkształcenie 1

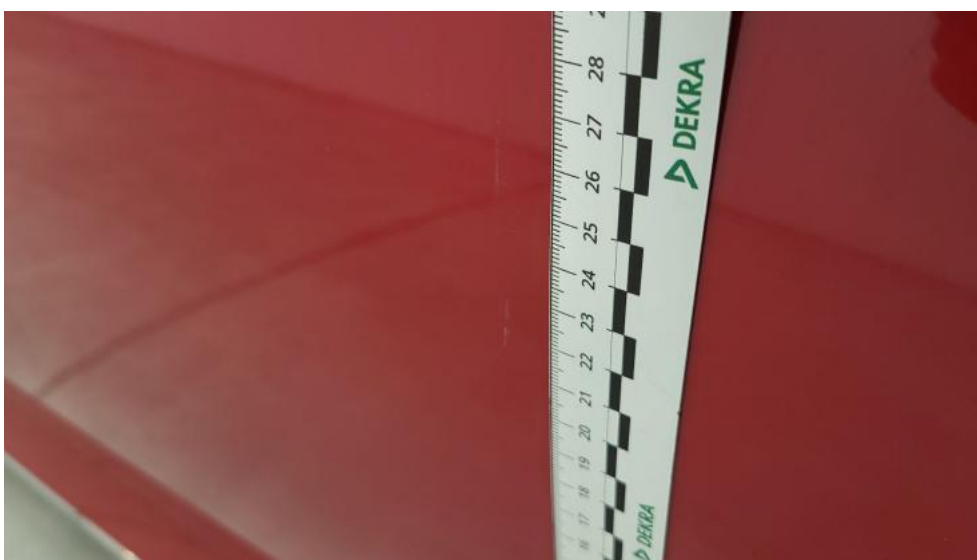
**Photo 78.**

Drzwi tylne L - Rysa/odprysk 2

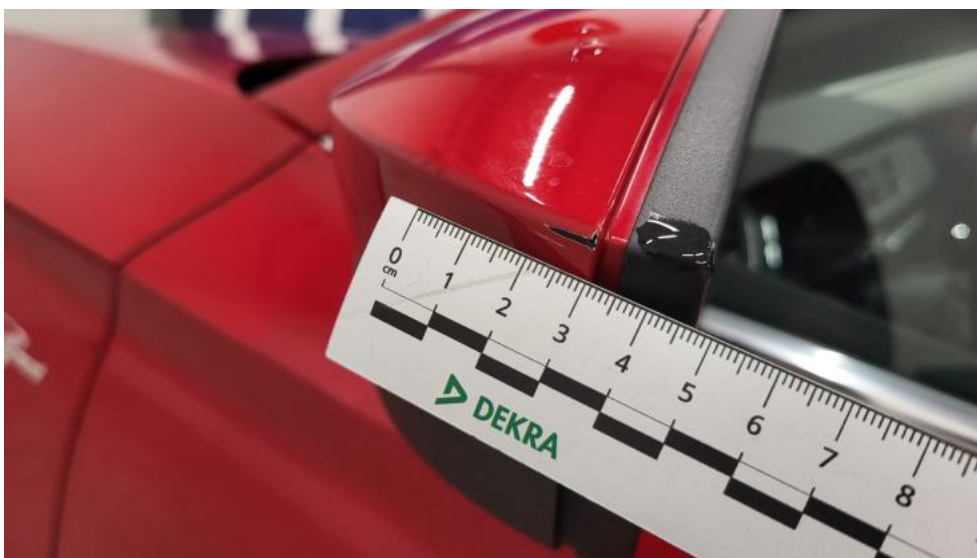
**Photo 80.**

Lusterko zew L - Rysa/odprysk 1

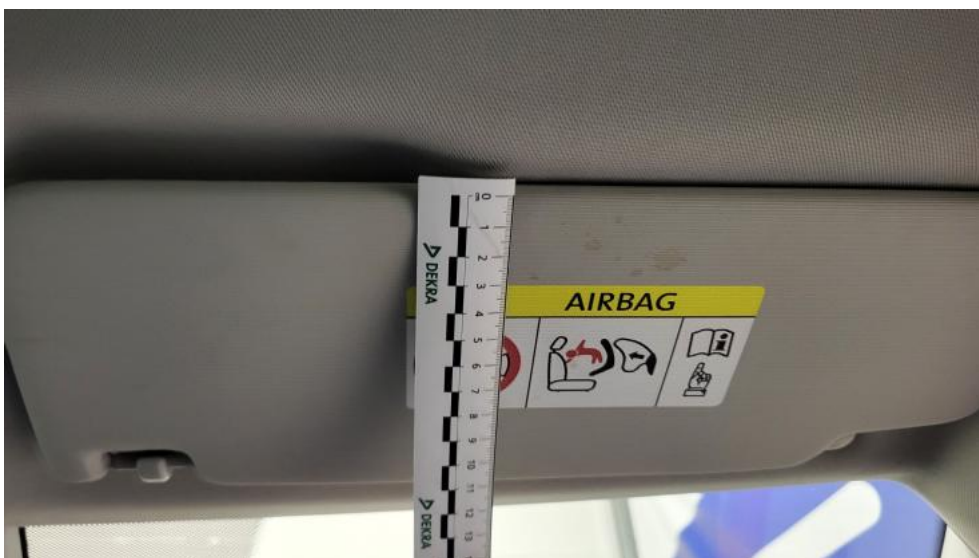
**Photo 82.**

Osłona p/słoneczna prawa - Inne 1
