DEKRA's commission No. : PKOL(W)/LODZ/82237/24/10/23  
 commission/ damage No. : B/O/WR/2018/08/0014  
 Date of commission: 23-10-2024

**Vehicle data**

Group of objects (Eurotax)	jeeps
EC code (Eurotax)	0103316
Manufacturer	BMW
Model	X5 [F15/F85] 13-18
Type / version	X5 xDrive40d
Body type	KOM
Number of doors / seats	5/5
Curb weight [kg]	2110
Gross vehicle weight [kg]	2865
Wheelbase 1/2	2933
Engine type	Automatic ignition
Pollution reduction system	DPF
Engine capacity [ccm]	2993
Engine Power [hp/kW]	313/230
Gearbox	automatic 8- gear
Registration /record No.	DSWJH87
VIN / serial number	WBAKS610200N68039
Date of first registration	17-03-2017
Date of next. tech. test	15-03-2025
Year of manufacture	2017 (year has been verified with the manufacturer's base)
Readout [km]	220 608 (read)
Body color / type of coating	black/double-layered, metallized

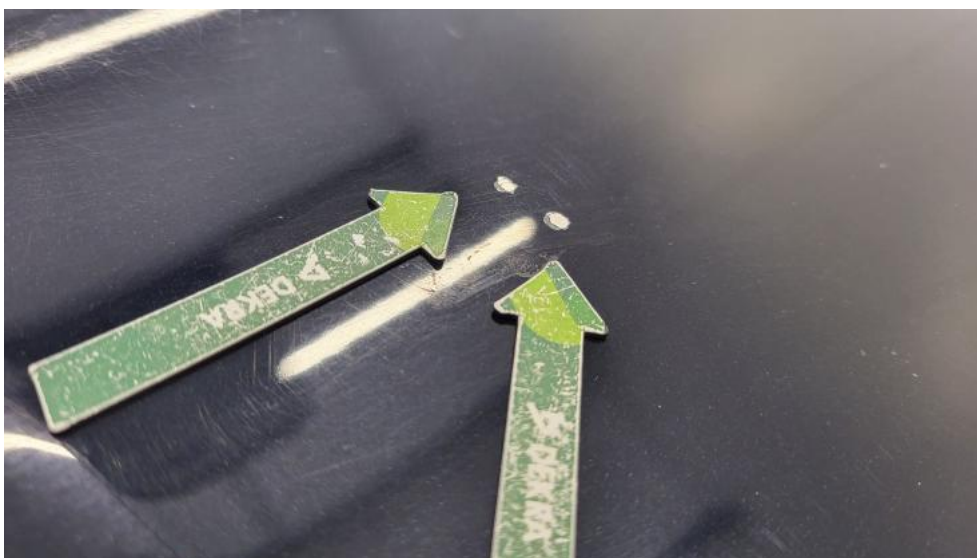
**Photo 42.**  
Pokrywa komory silnika - Rysa/odprysk 1

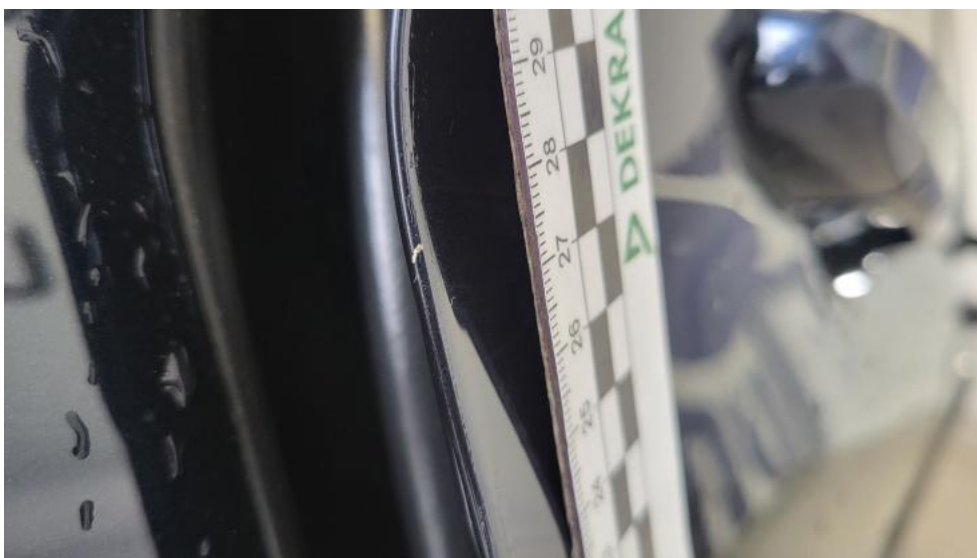
**Photo 54.**

Drzwi tylne P - Rysa/odprysk 1

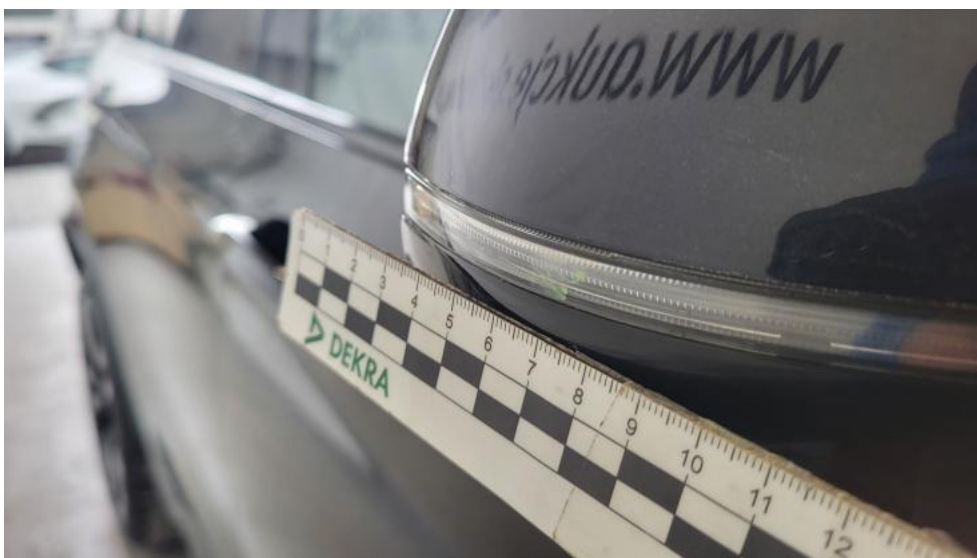
**Photo 56.**  
Lusterko zew P - Rysa/odprysk 1

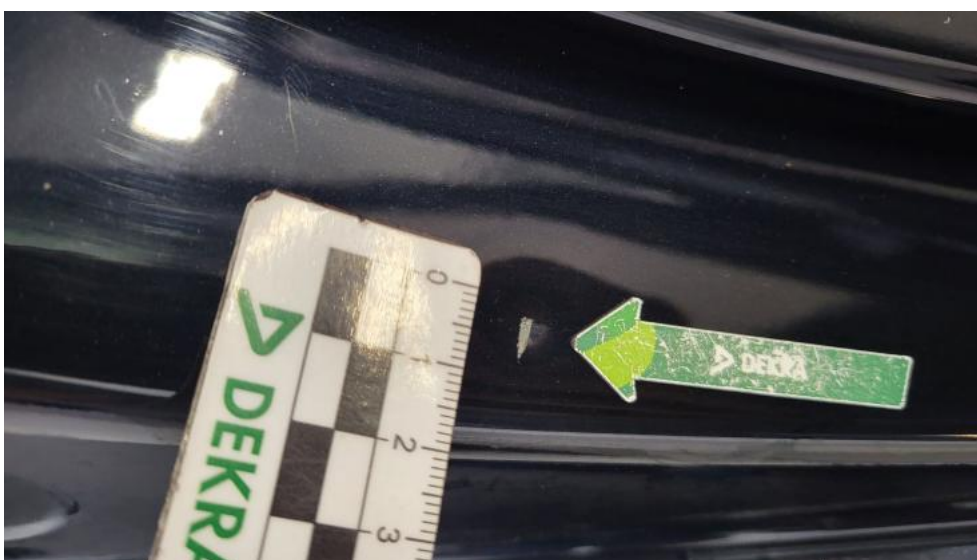
**Photo 58.**  
Próg P - Rysa/odprysk 1

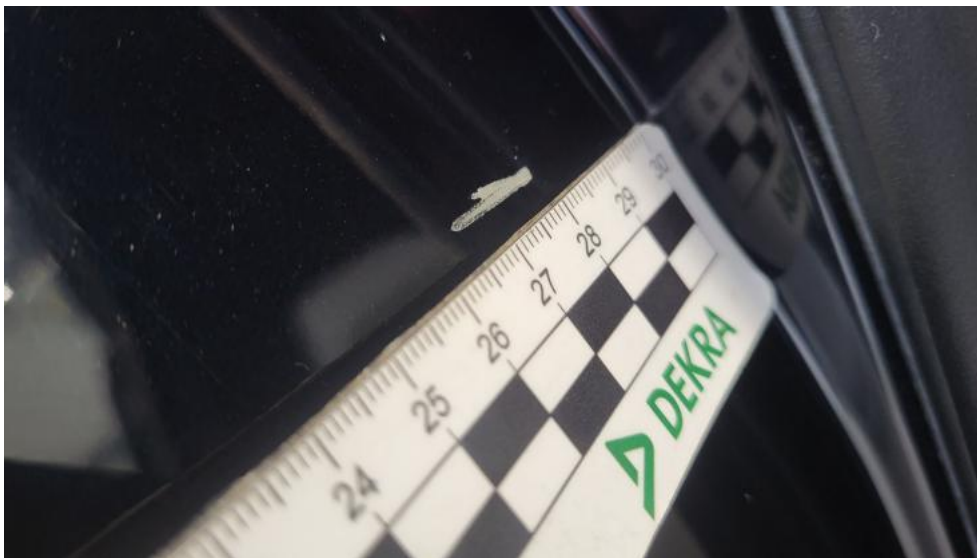
**Photo 61.**

Błotnik tylny P / Ściana boczna P - Rysa/odprysk 1

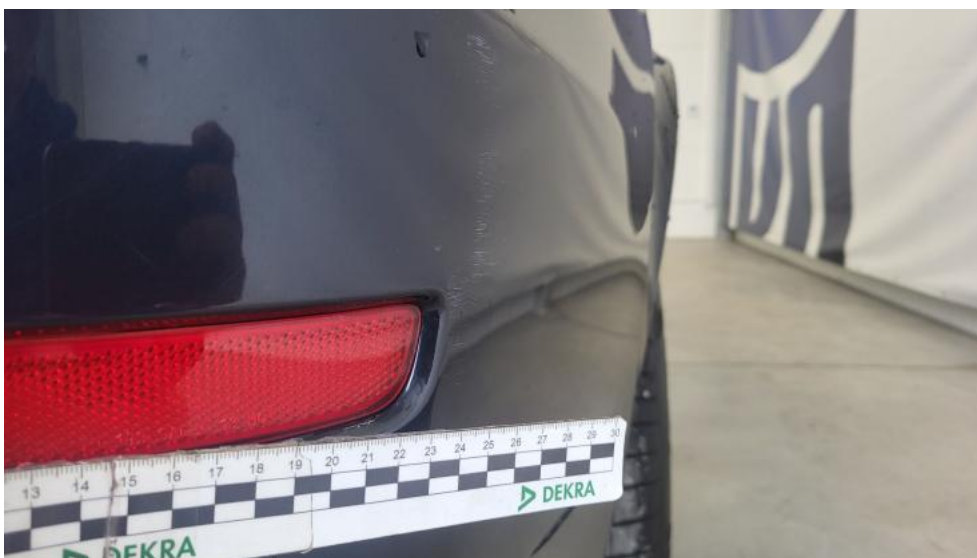
**Photo 64.**  
Zderzak tylny - Rysa/odprysk 1

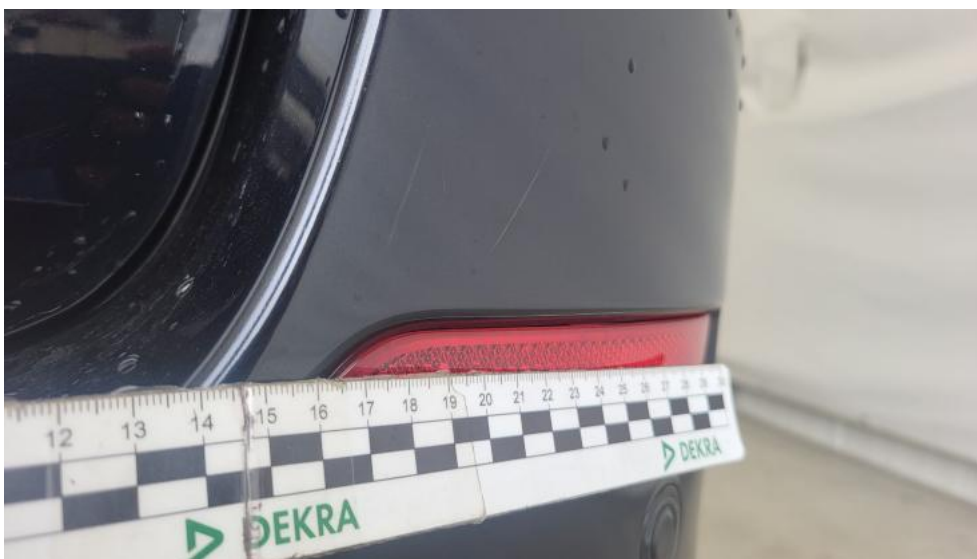
**Photo 65.**

Zderzak tylny - Rysa/odprysk 2

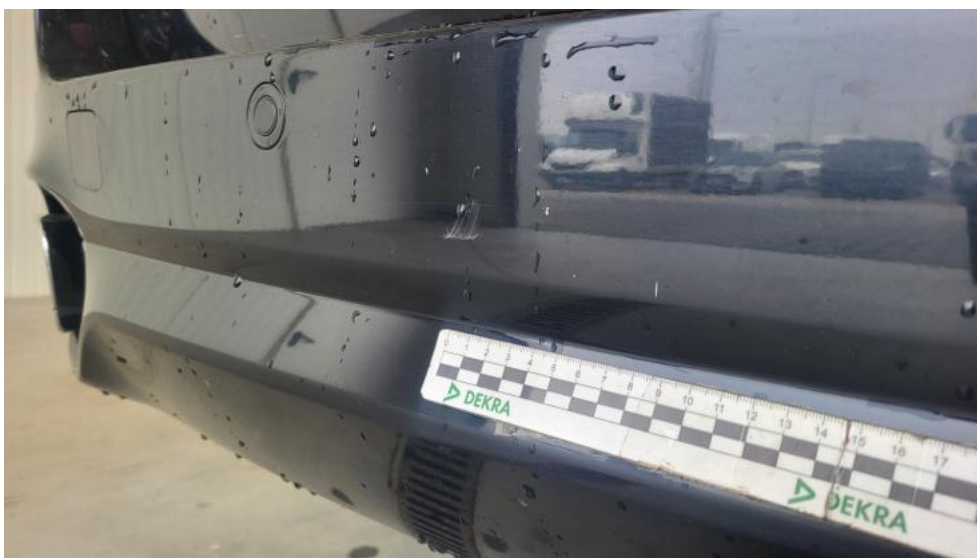
**Photo 66.**

Zderzak tylny() - Rysa/odprysk 3

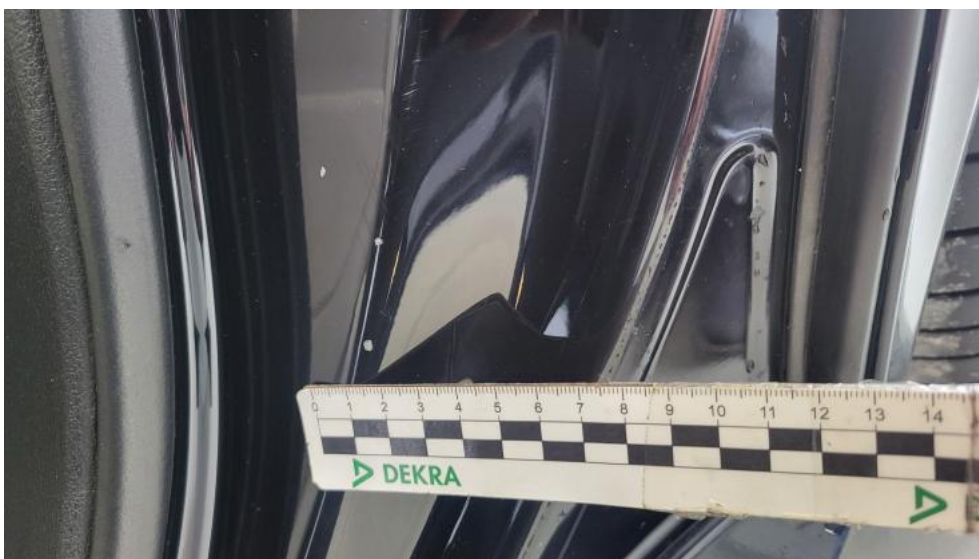
**Photo 69.**  
Błotnik tylny L / Ściana boczna L - Rysa/odprysk 2

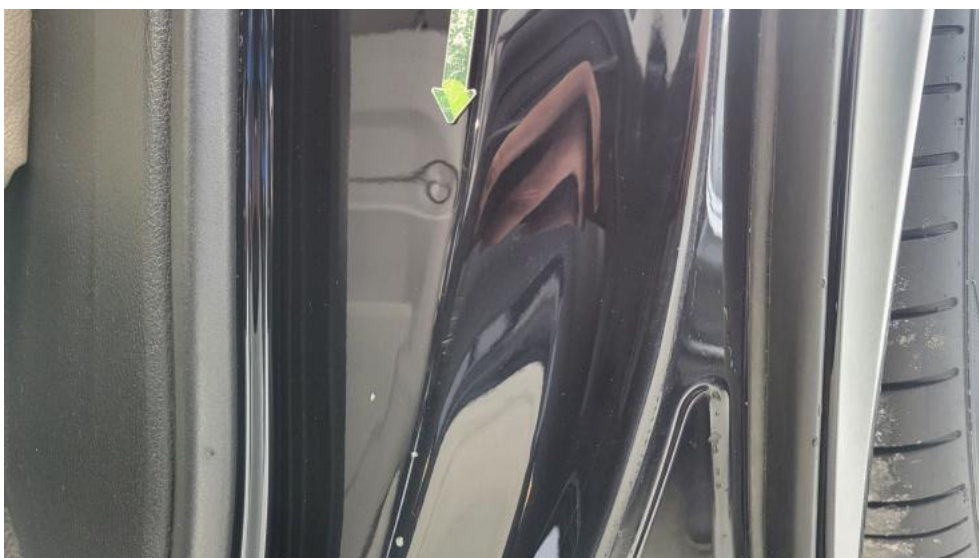
**Photo 70.**  
Błotnik tylny L / Ściana boczna L - Wgniecenie/odkształcenie 1

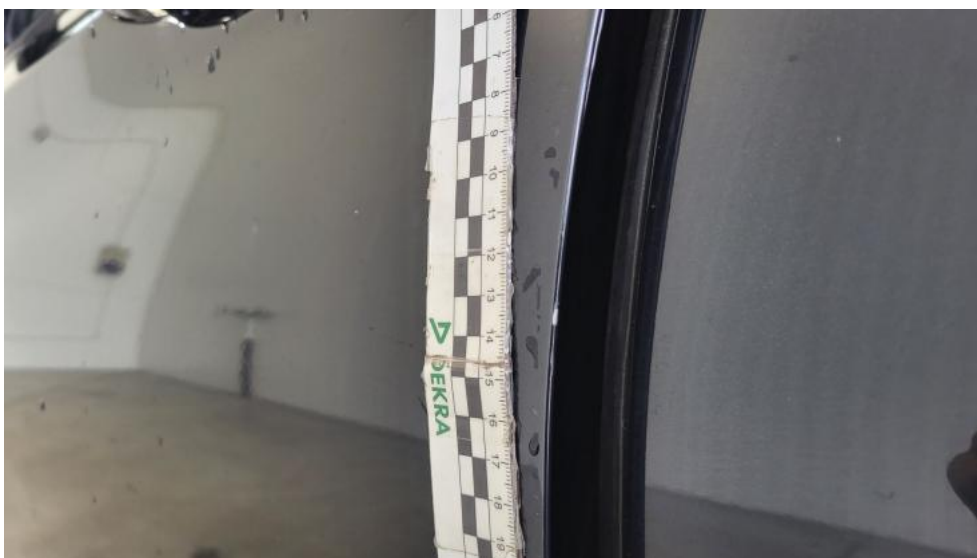
**Photo 72.**

Drzwi przed L - Rysa/odprysk 2

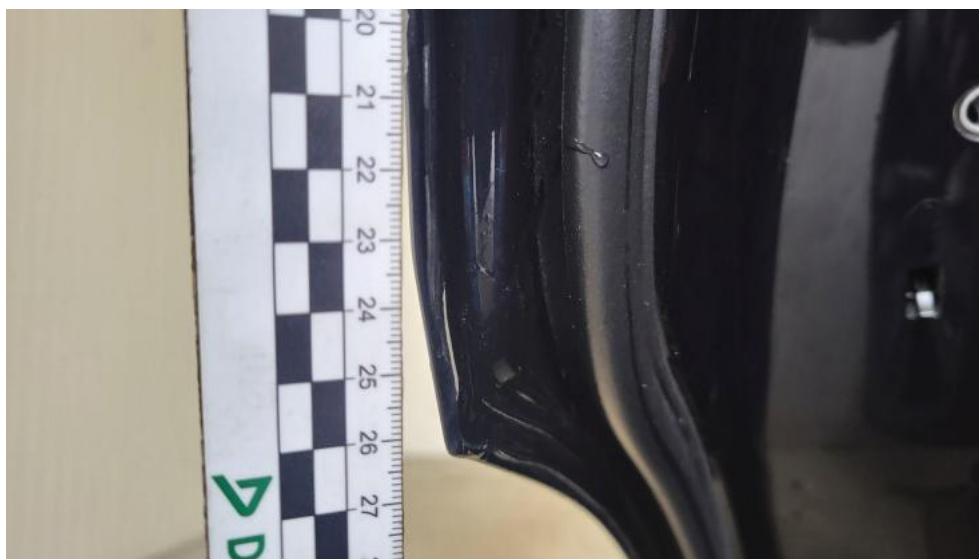
**Photo 75.**

Drzwi tylne L - Rysa/odprysk 1

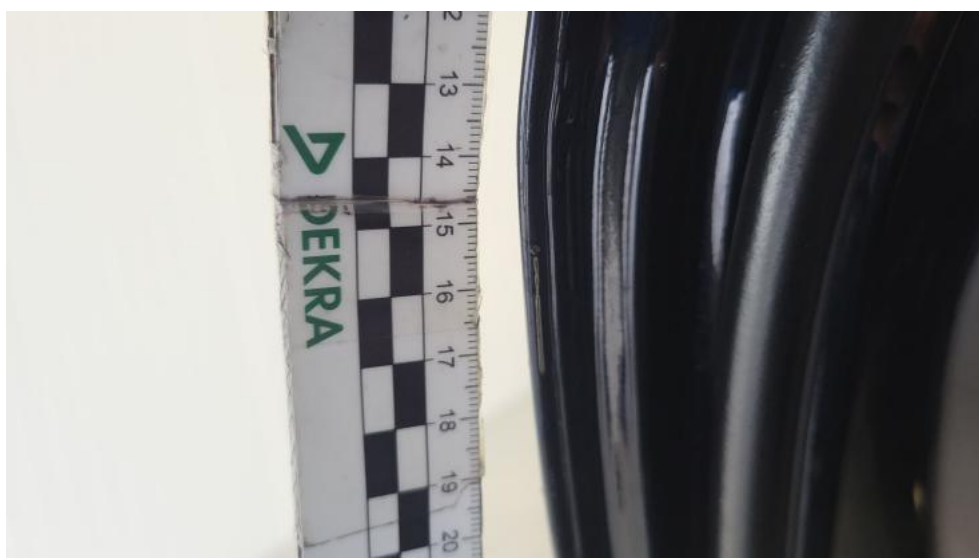
**Photo 76.**

Drzwi tylne L - Rysa/odprysk 2
