DEKRA's commission No. : PKOL(W)/LODZ/19291/25/03/17  
commission/ damage No. : FUTURA  
Date of commission: 17-03-2025

PKO Leasing SA  
Świętokrzyska 36  
00-116 Warszawa

**Vehicle data**

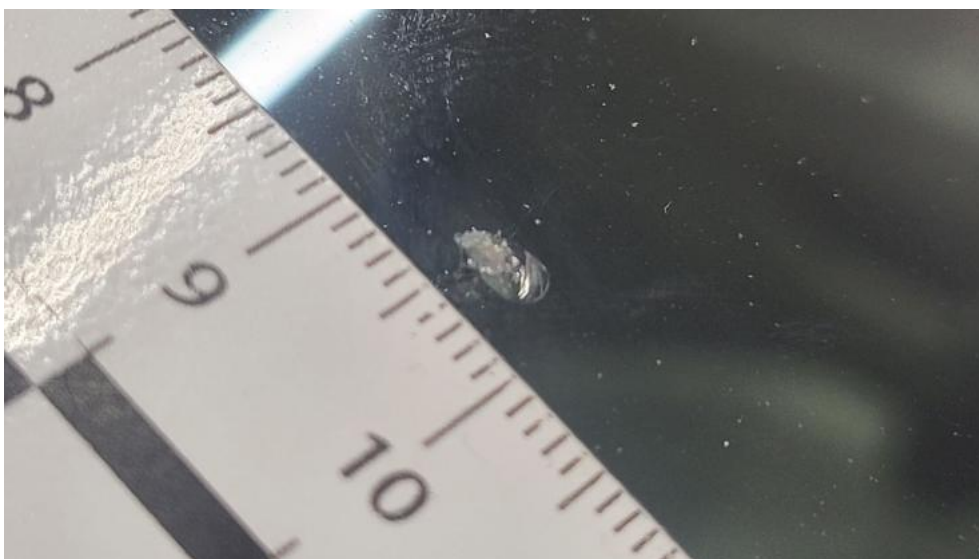
Rysy na samochodzie. Pojazd posiada hak. Niesprawne przyciski funkcyjne w obu kluczykach, groty prawidłowe. Aktywna kontrolka ciśnienia w kołach. Odpryski na szybie czołowej. Liczne wgniecenia.

**Photo 45.**  
Szyba czołowa - Pęknięcie/rozerwanie 1

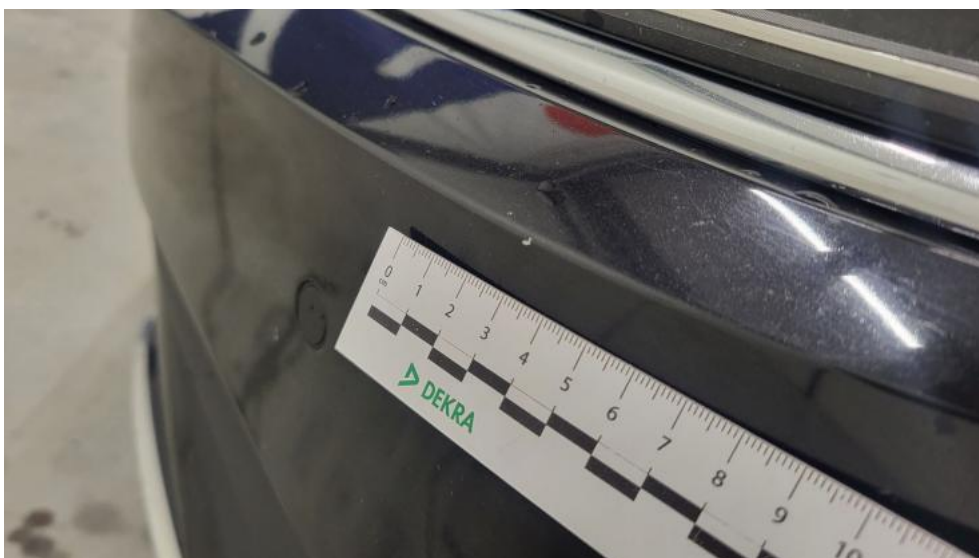
**Photo 46.**  
Zderzak - Rysa/odprysk 1

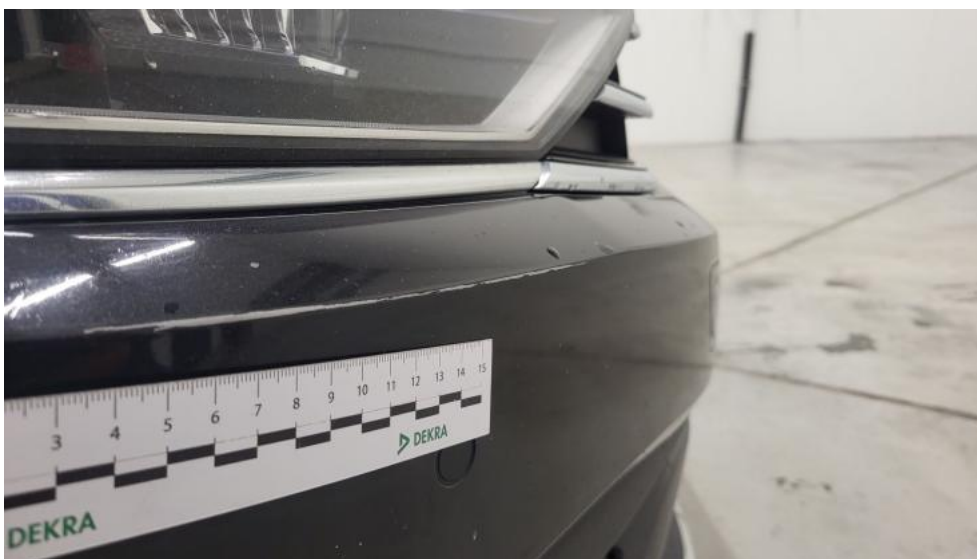
**Photo 47.**  
Zderzak - Rysa/odprysk 2

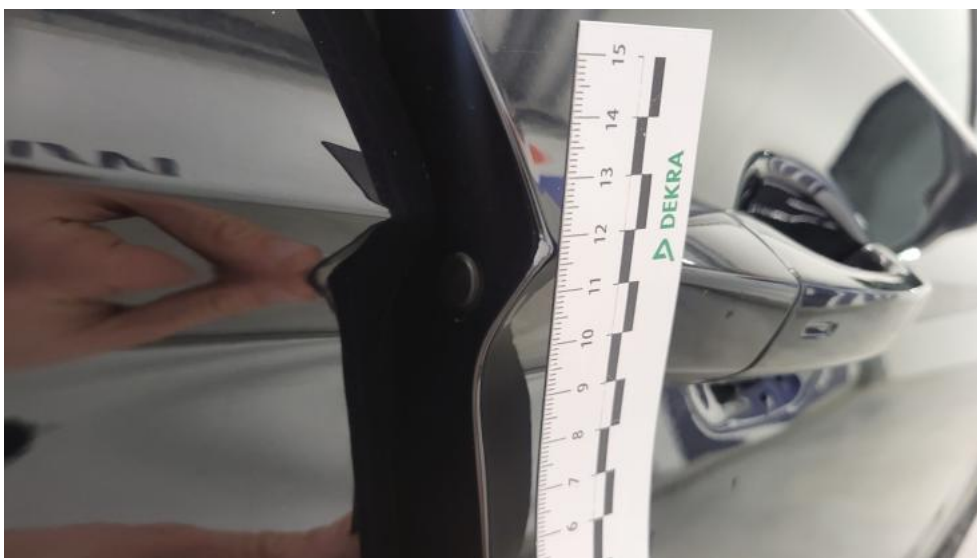
**Photo 48.**  
Drzwi przednie P - Rysa/odprysk 1

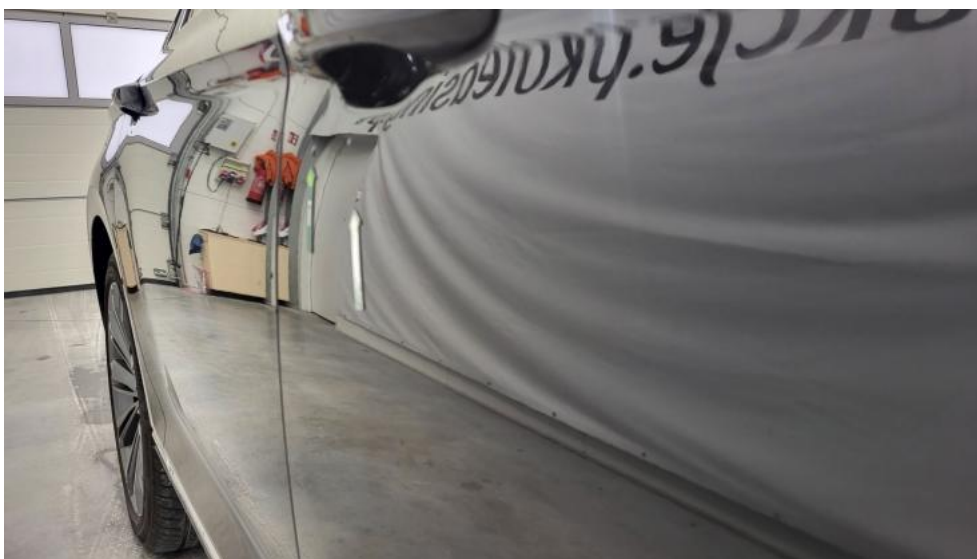
**Photo 49.**  
Drzwi przednie P - Wgniecenie/odkształcenie 1

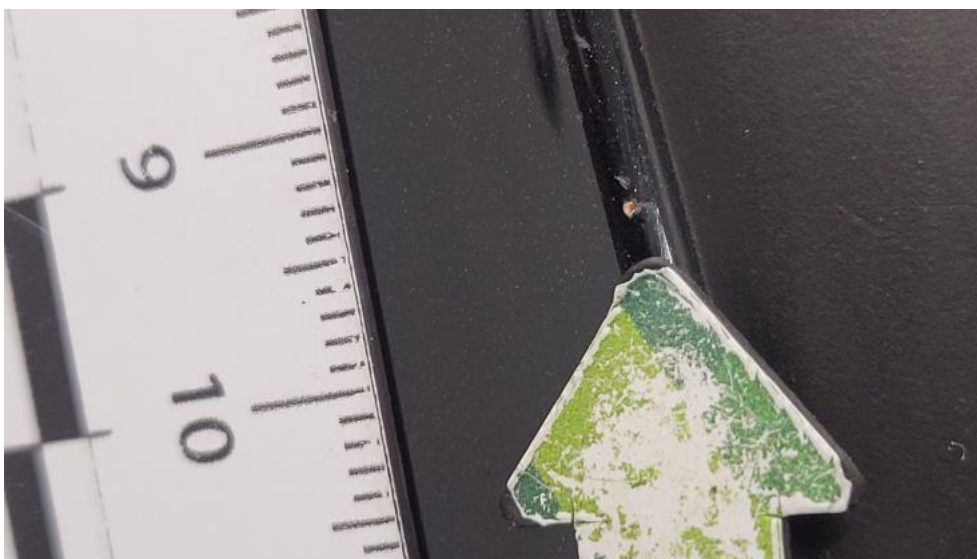
**Photo 51.**

Stupek przedni P - Inne 1

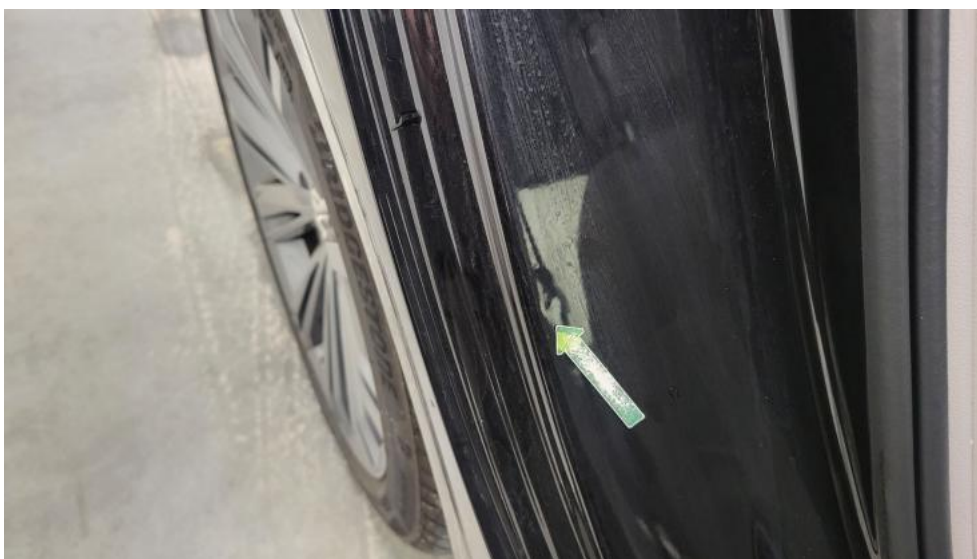
**Photo 53.**  
Błotnik tylny P / Ściana boczna P - Wgniecenie/odkształcenie 1

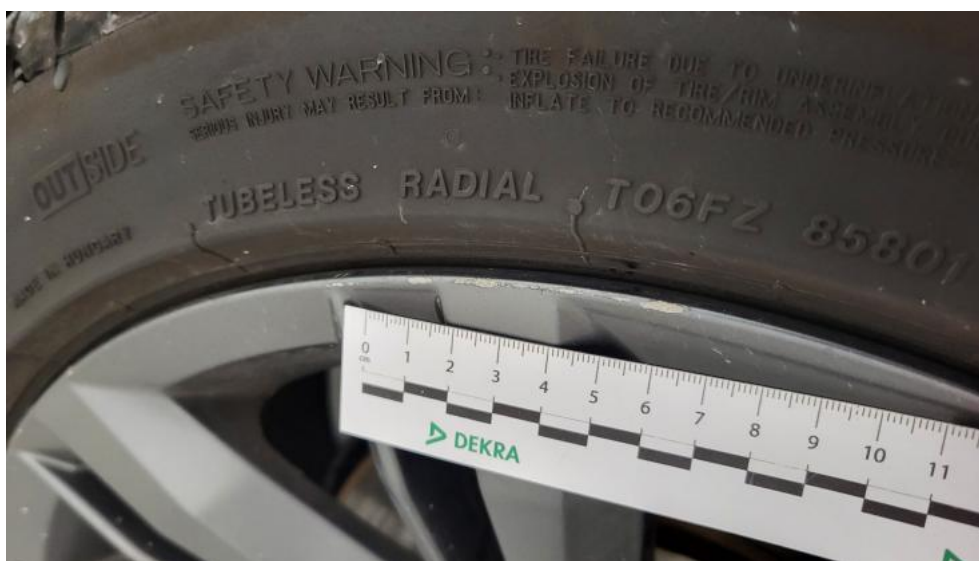
**Photo 55.**  
Felga aluminiowa tylna P - Rysa/odprysk 1

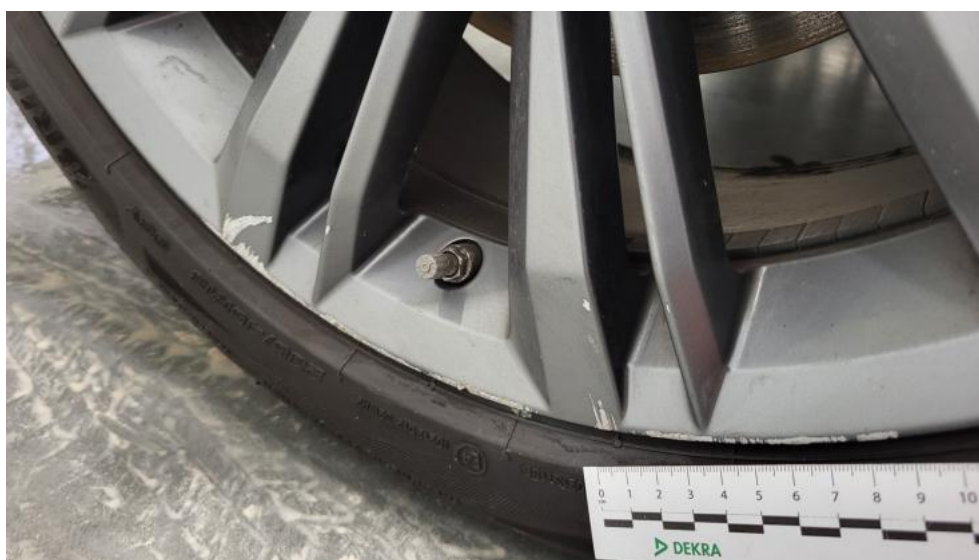
**Photo 56.**  
Felga aluminiowa tylna P - Rysa/odprysk 2

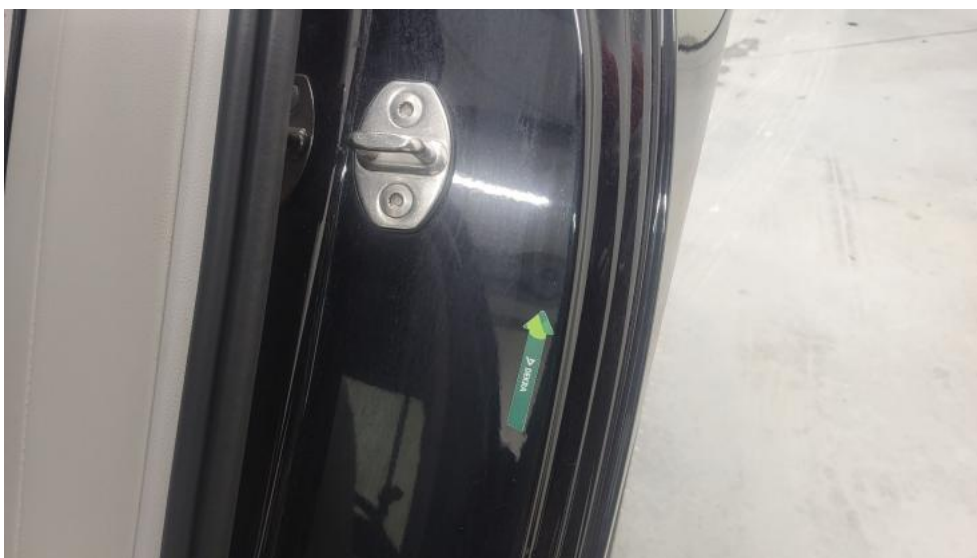
**Photo 64.**  
Błotnik tylny L / Ściana boczna L() - Wgniecenie/odkształcenie 3

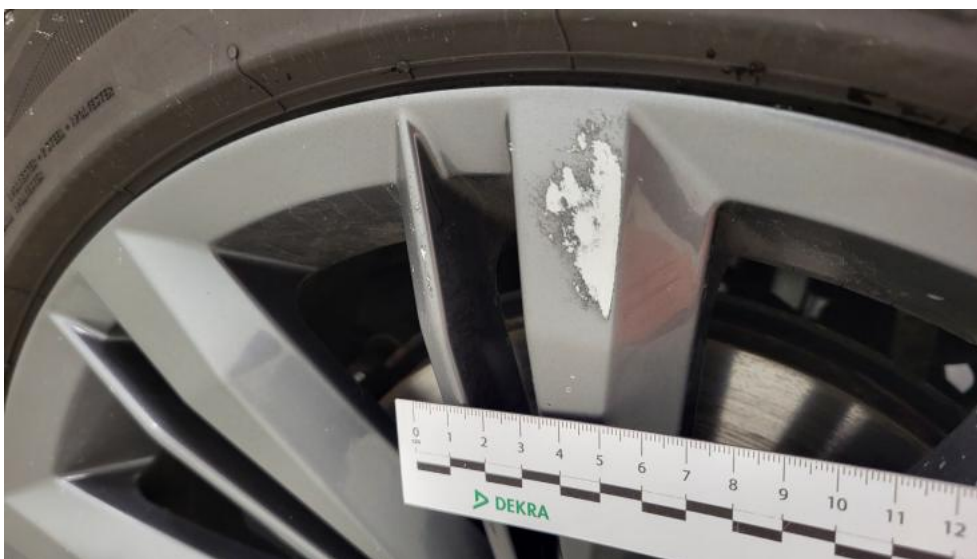
**Photo 65.**  
Felga aluminiowa tylna L - Rysa/odprysk 1

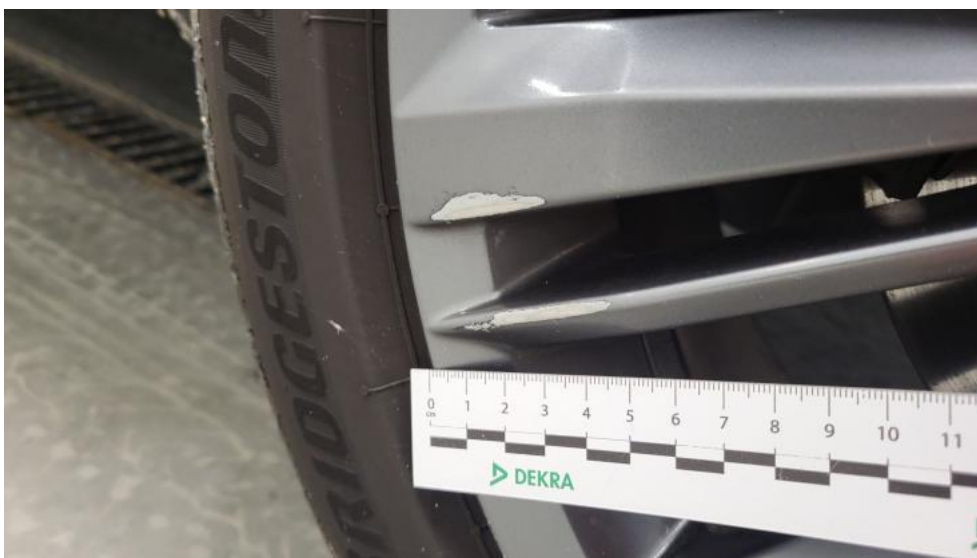
**Photo 66.**  
Felga aluminiowa tylna L - Rysa/odprysk 2

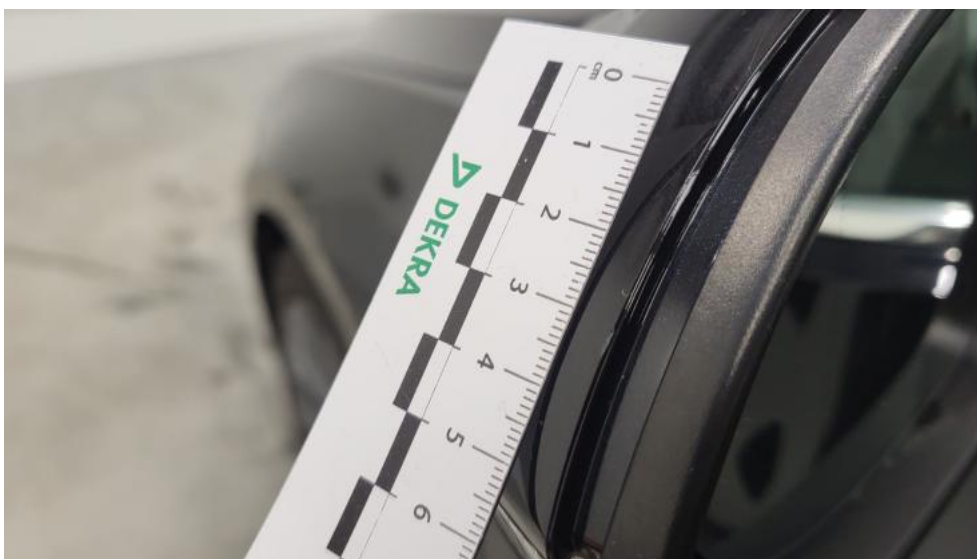
**Photo 67.**

Lusterko zew L - Rysa/odprysk 1

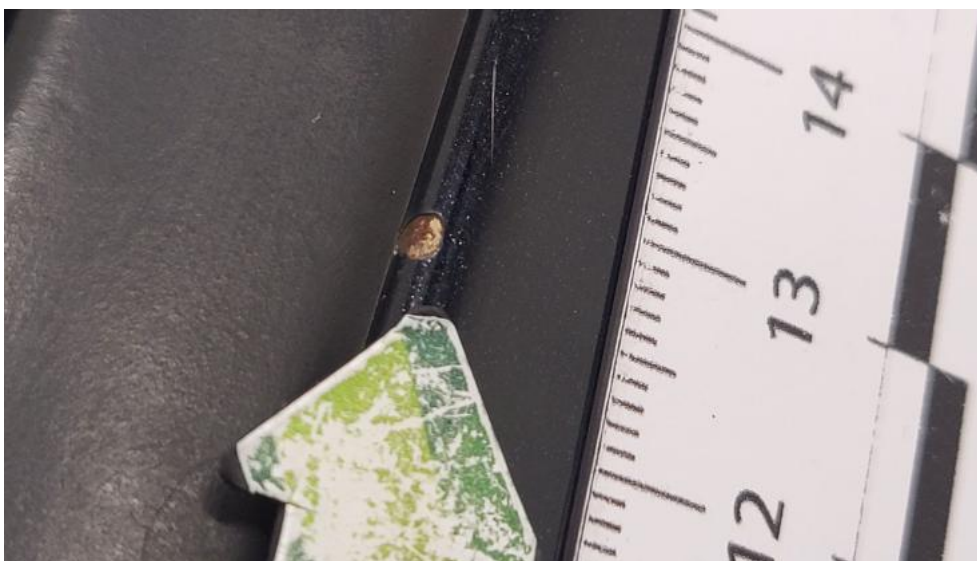
**Photo 69.**

Stupek przedni L - Inne 1

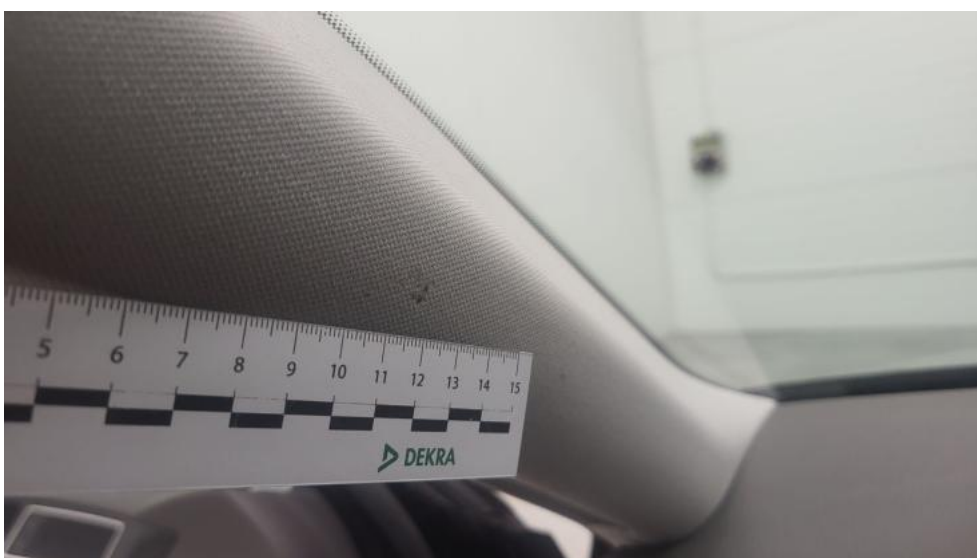
**Photo 74.**  
Wykładzina(y) słupka przedniego L - Inne 1

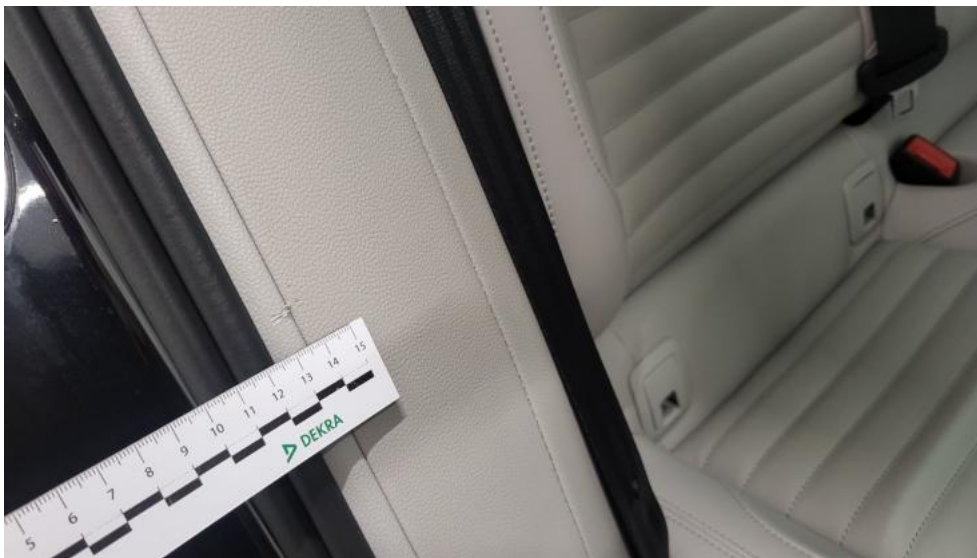
**Photo 75.**

Wykładzina(y) słupka tylnego P - Rysa/odprysk 1
