DEKRA's commission No. : PKOL(W)/LODZ/27474/25/04/15  
commission/ damage No. : 23/005316  
Date of commission: 15-04-2025

**DEKRA Poland - Headquarters**  
02-673 Warszawa, ul. Konstruktorska 12A

| Manufacturer | MERCEDES-BENZ |
| Type / version | A 45 S AMG 4-Matic 8G-DCT |

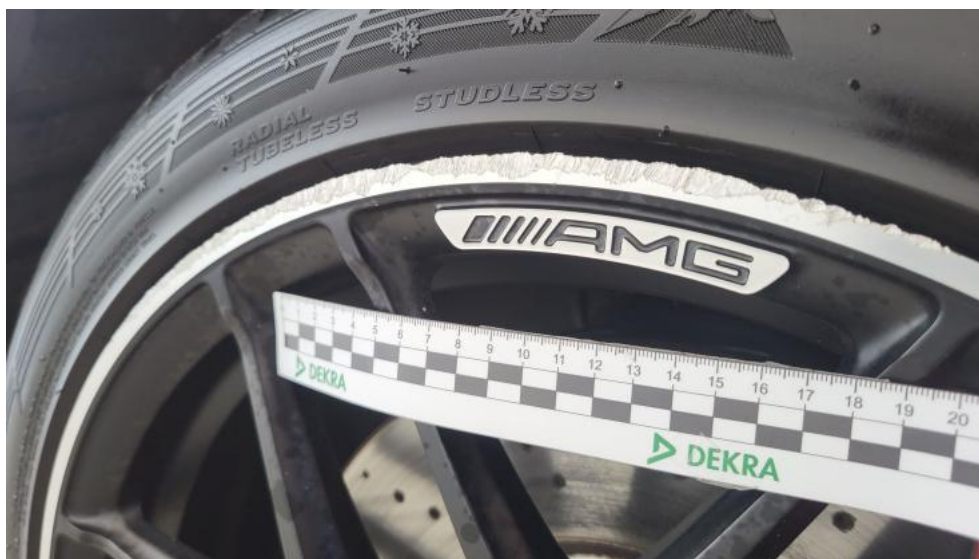
**Photo 49.**

Felga aluminiowa przednia P - Rysa/odprysk 1

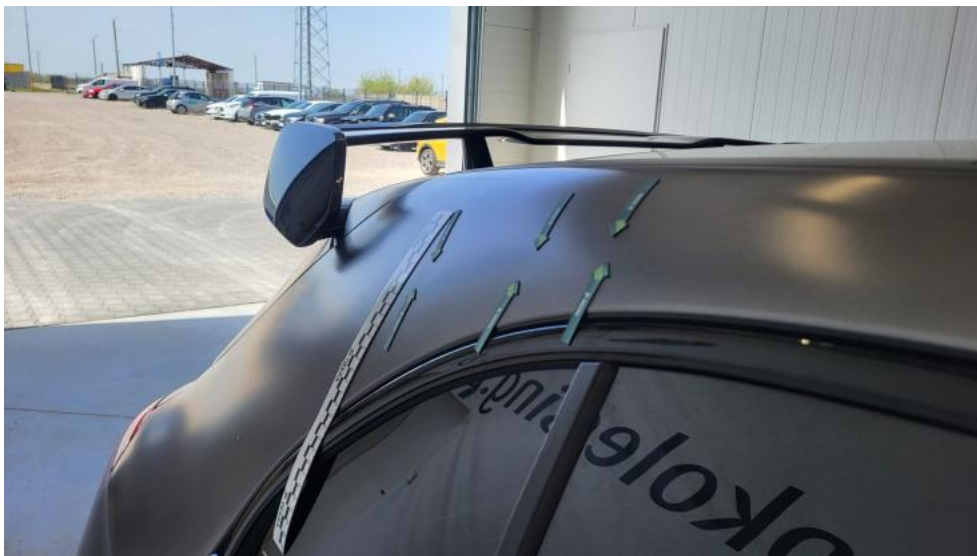
**Photo 53.**

Błotnik tylny P / Ściana boczna P - Wgniecenie/odkształcenie 1

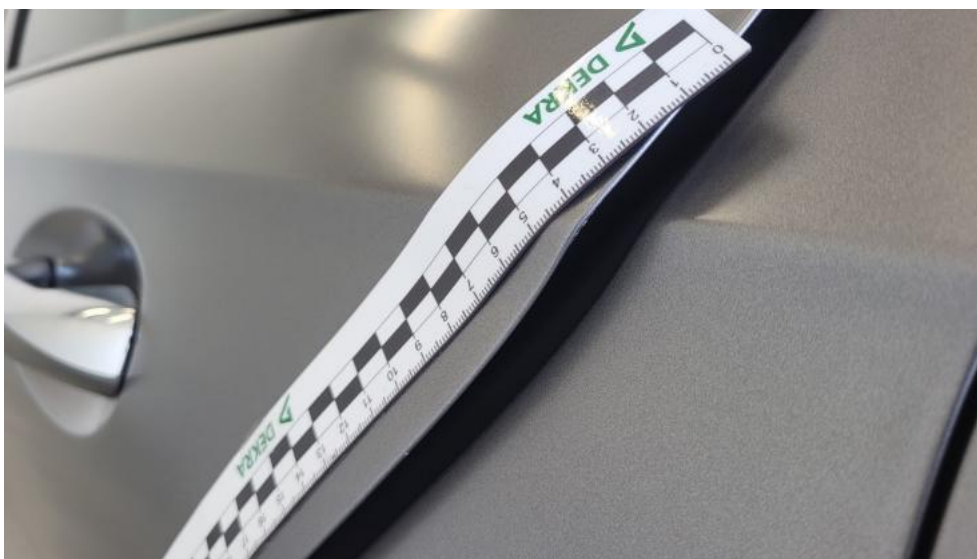
**Photo 57.**

Drzwi tylne L - Rysa/odprysk 1

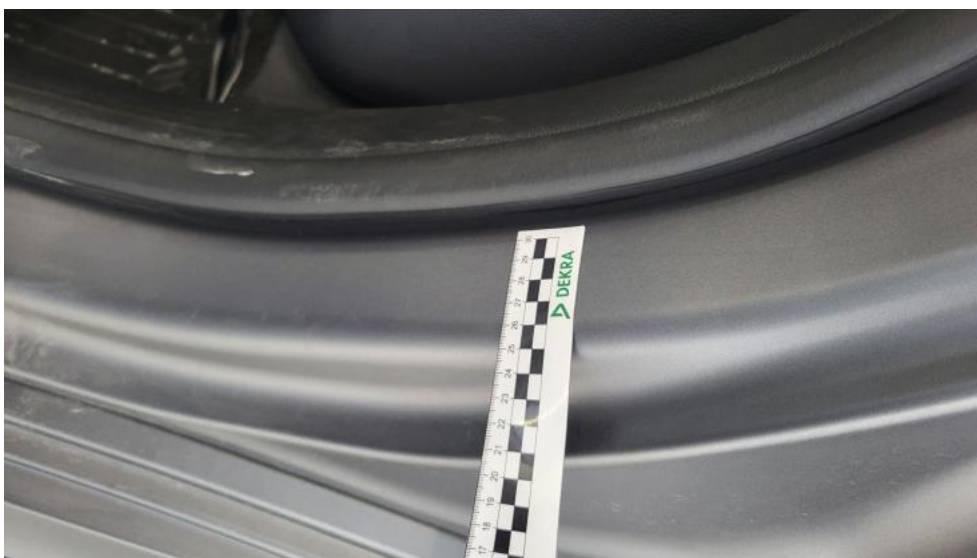
**Photo 58.**

Próg L - Rysa/odprysk 1

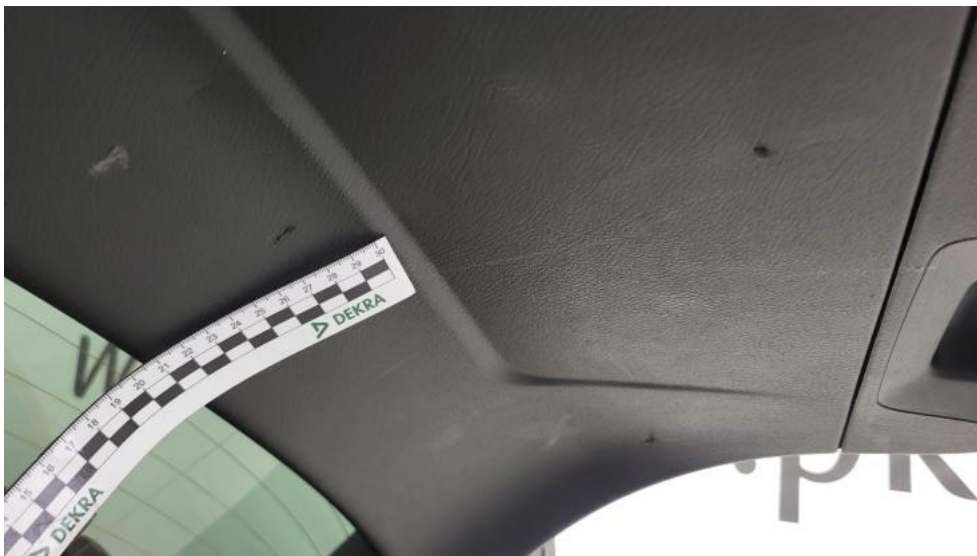
**Photo 61.**

Wykładzina pokrywy tylnej - Rysa/odprysk 1
