DEKRA's commission No. : PKOL(W)/LODZ/73884/25/09/30  
commission/ damage No. : 24/038139  
Date of commission: 30-09-2025

**DEKRA Poland - Headquarters**  
02-673 Warszawa, ul. Konstruktorska 12A

| Model | Camry 18-20 |
| Type / version | Camry 2.5 Hybrid Executive CVT |

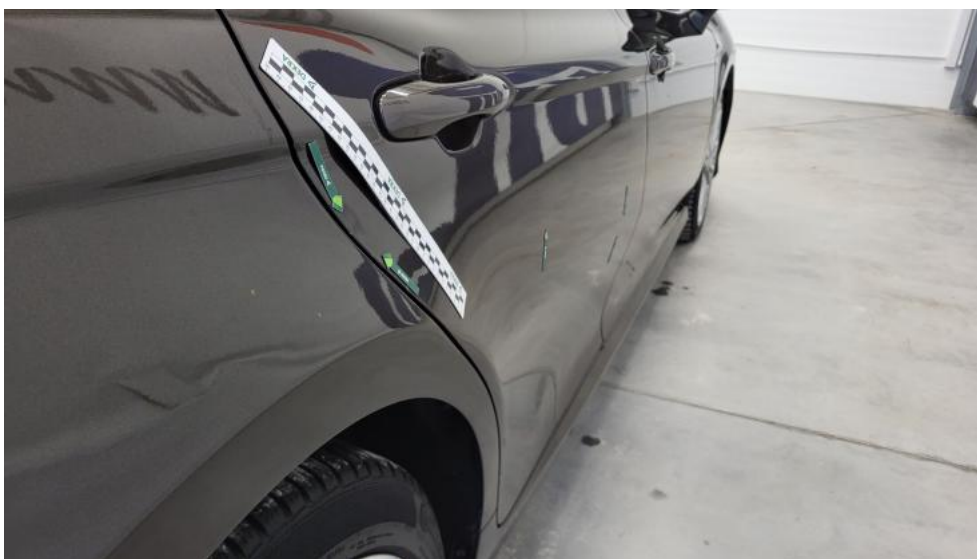
**Photo 51.**

Drzwi tylne P - Wgniecenie/odkształcenie 1

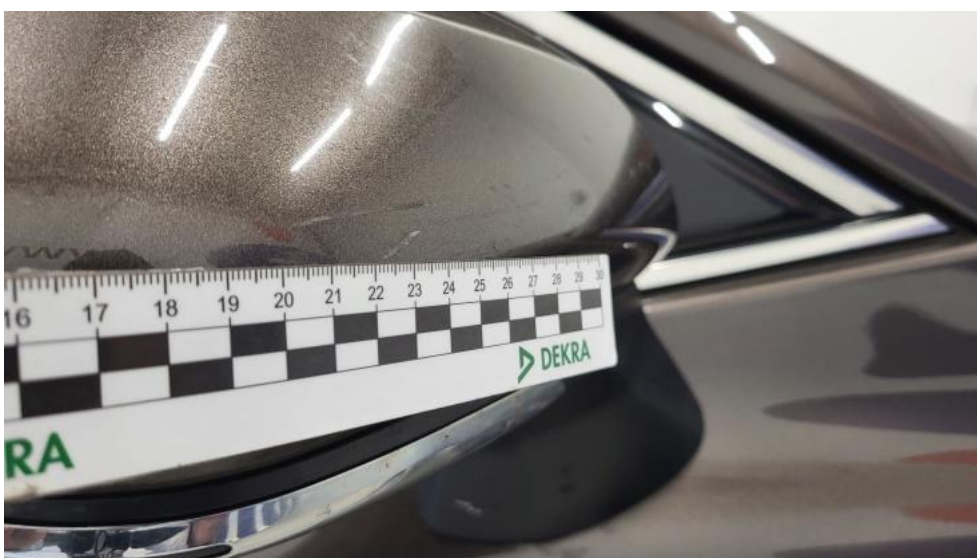
**Photo 52.**

Lusterko zew P - Rysa/odprysk 1

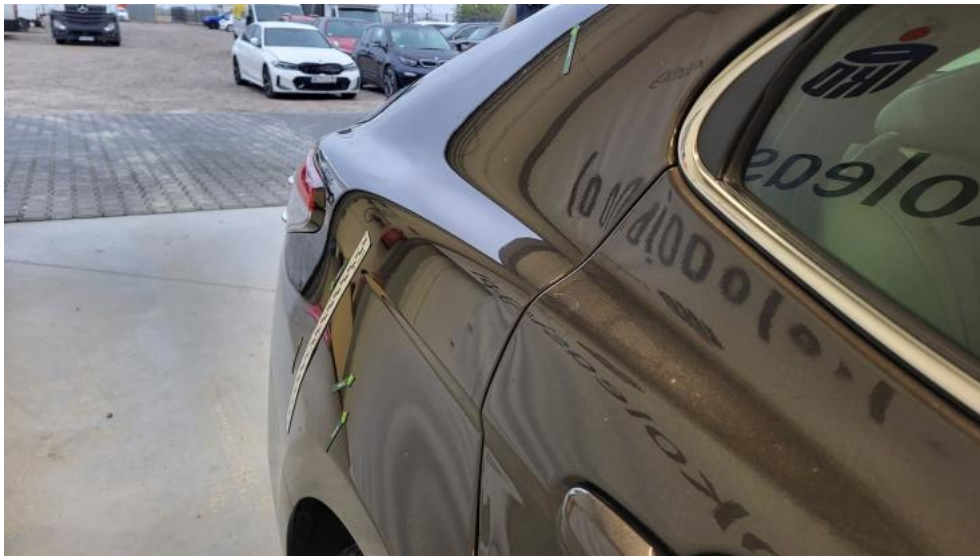
**Photo 53.**

Błotnik tylny P / Ściana boczna P - Wgniecenie/odkształcenie 1

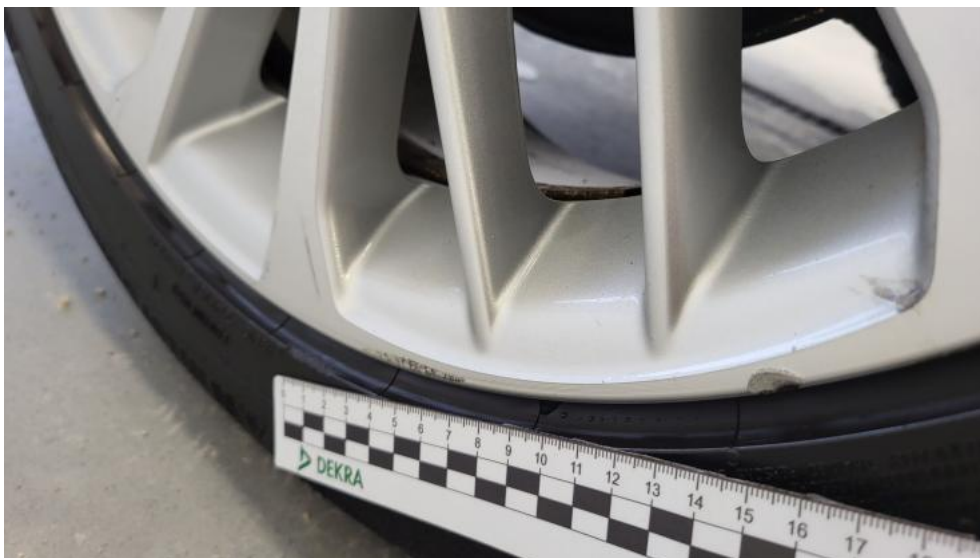
**Photo 54.**

Felga aluminiowa tylna P - Rysa/odprysk 1

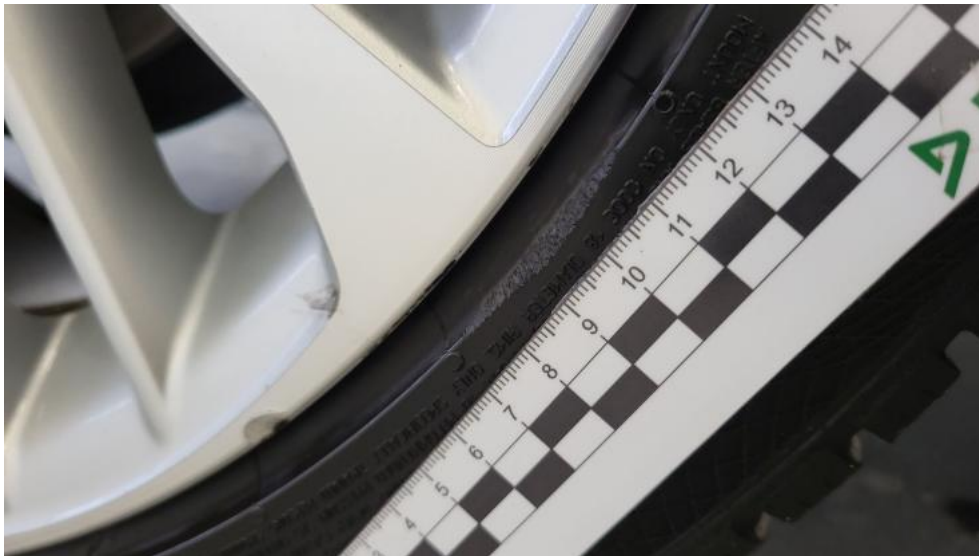
**Photo 55.**

Opona tylna P - Inne 1

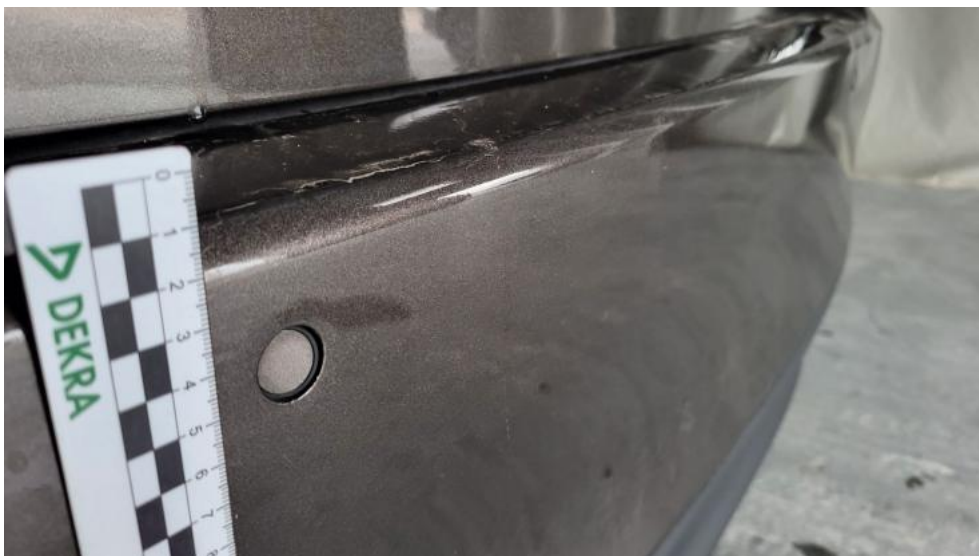
**Photo 56.**

Dostarczono ksero pozwolenia czasowego. Rysy na samochodzie. Widoczne wady lakiernicze. Niesprawne czujniki parkowania tył.

Czujniki parkowania tył - Inne 1

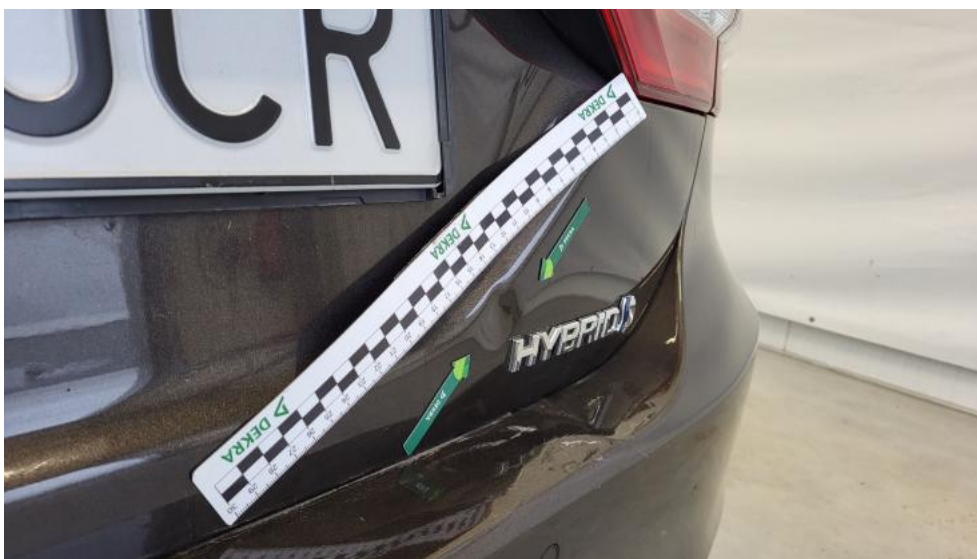
**Photo 57.**

Pokrywy bagażnika - Wgniecenie/odkształcenie 1

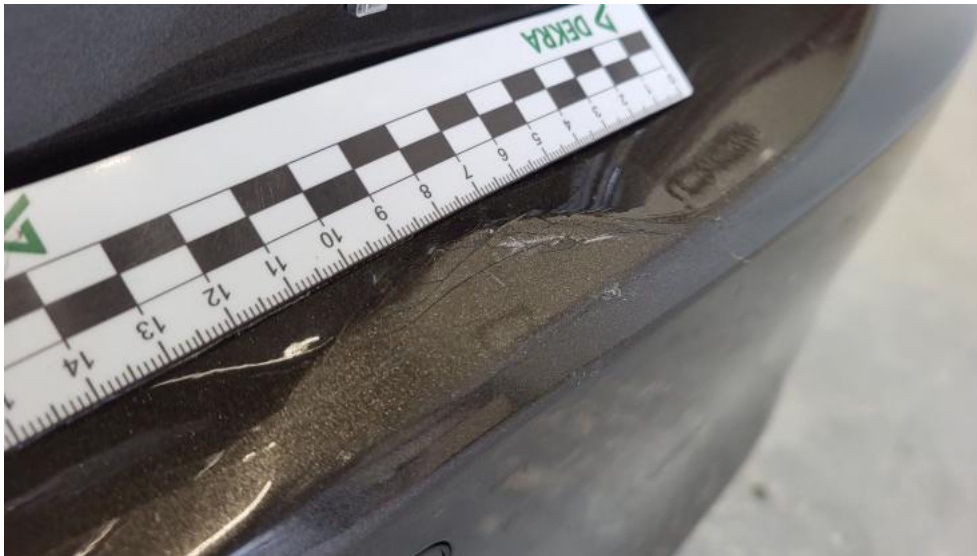
**Photo 59.**

Zderzak tylny - Pęknięcie/rozerwanie 1

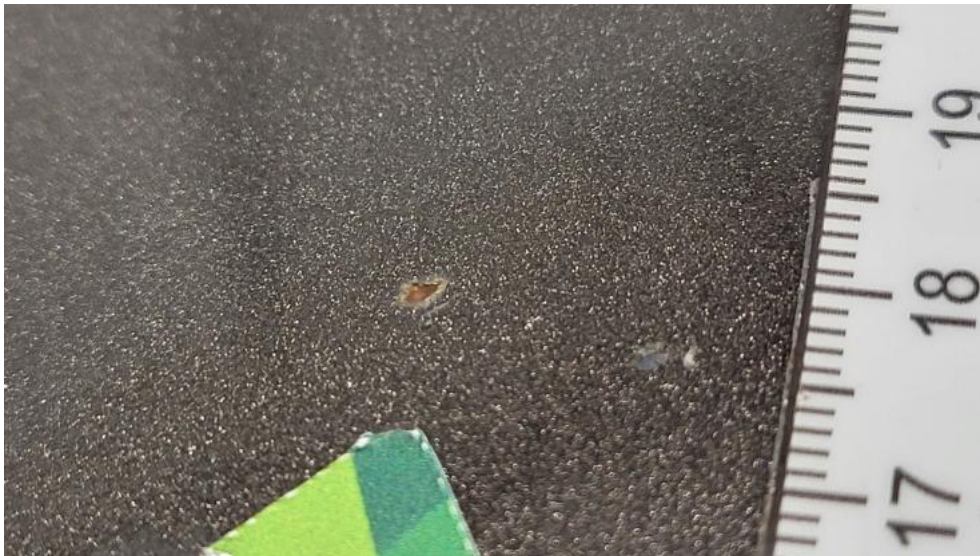
**Photo 61.**

Dach - Inne 1

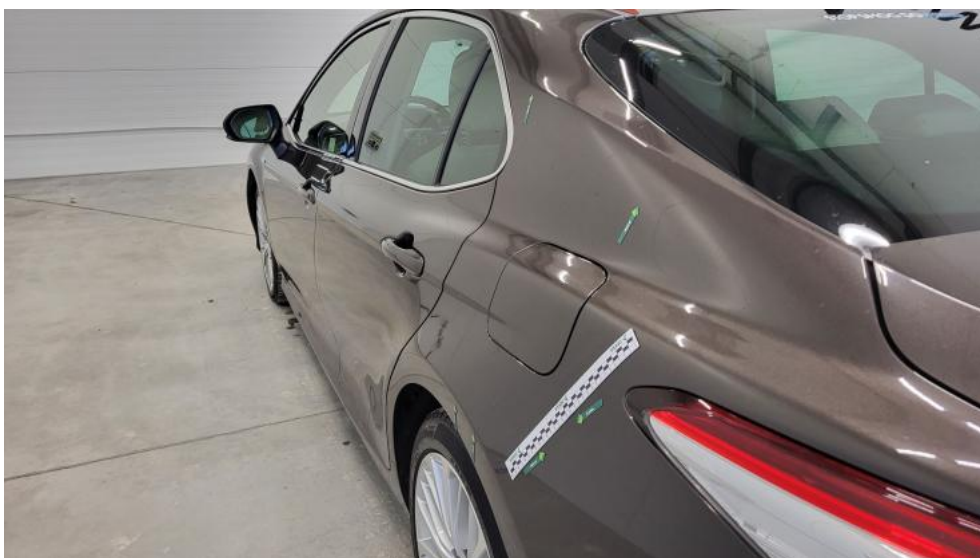
**Photo 62.**

Błotnik tylny L / Ściana boczna L - Wgniecenie/odkształcenie 1

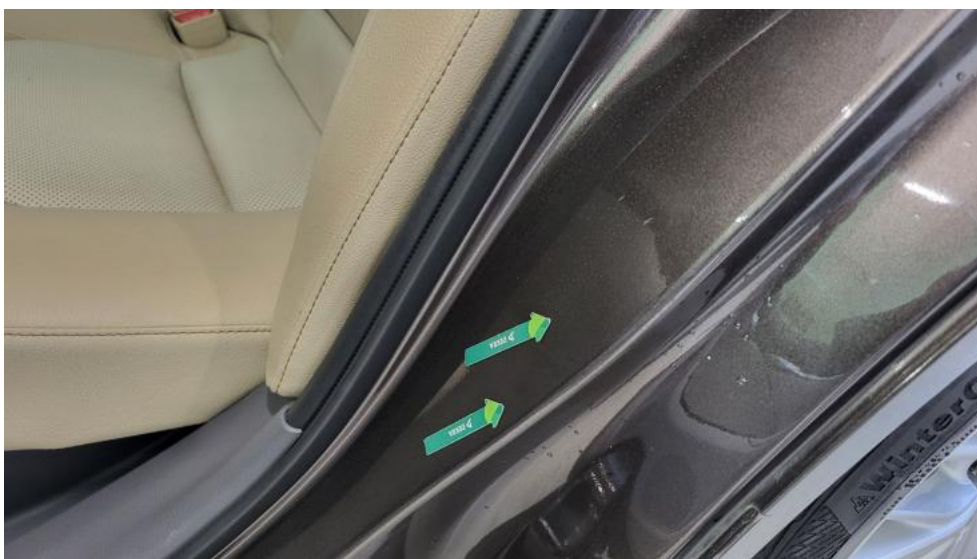
**Photo 63.**

Błotnik tylny L / Ściana boczna L - Wgniecenie/odkształcenie 2

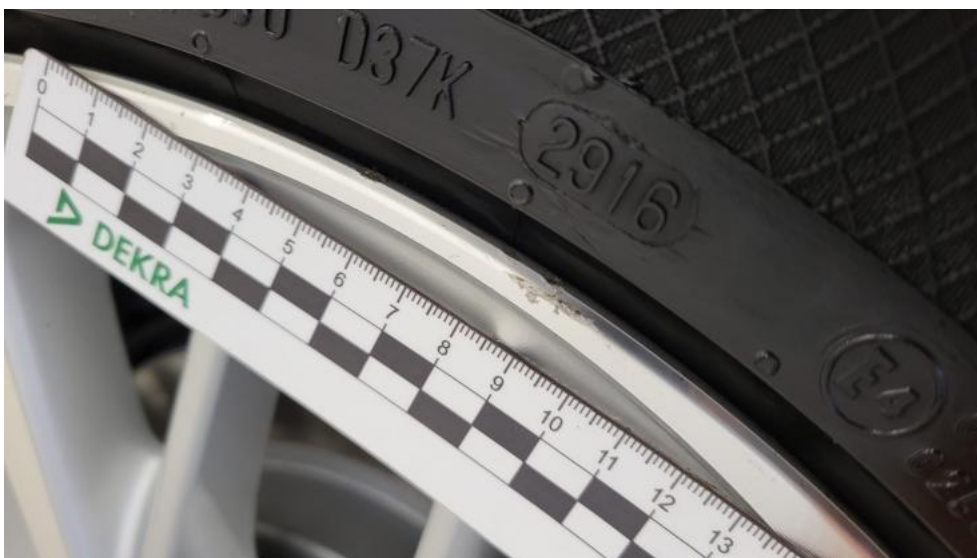
**Photo 64.**

Felga aluminiowa tylna L - Rysa/odprysk 1

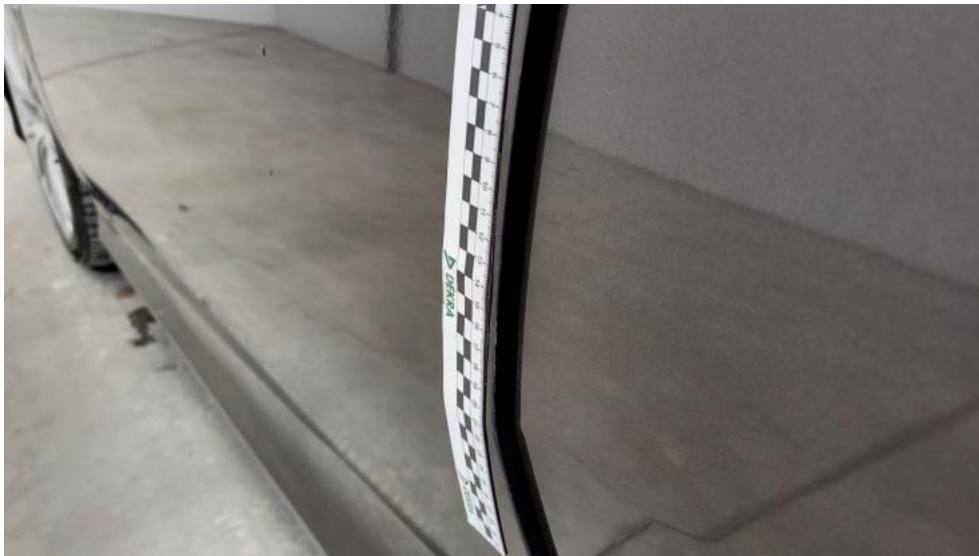
**Photo 65.**

Drzwi przed L - Rysa/odprysk 1

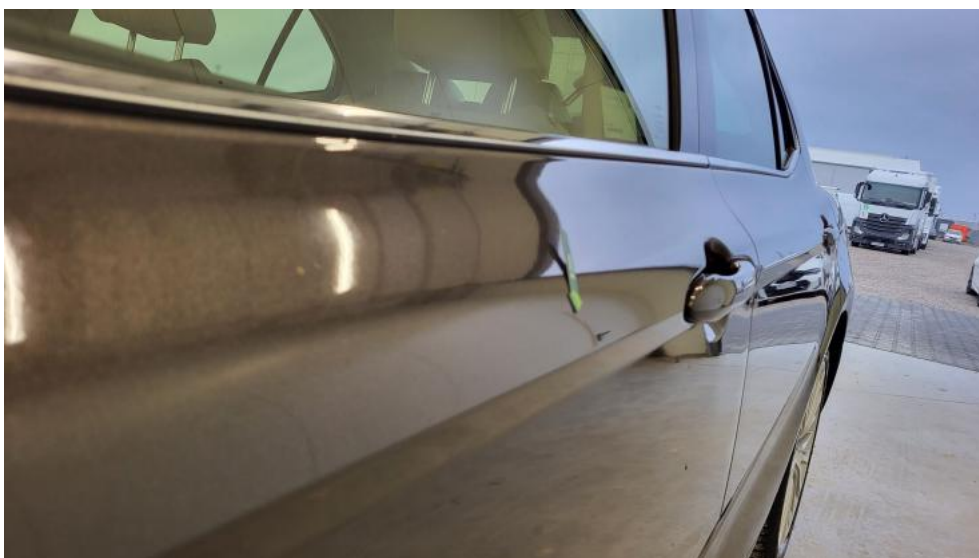
**Photo 66.**

Drzwi przed L - Wgniecenie/odkształcenie 1

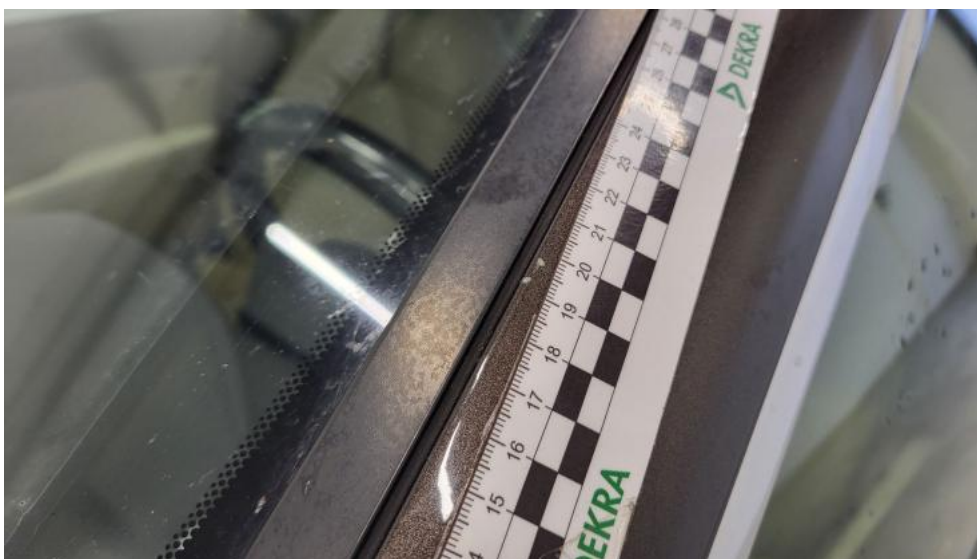
**Photo 69.**

Słupek przedni L - Rysa/odprysk 1

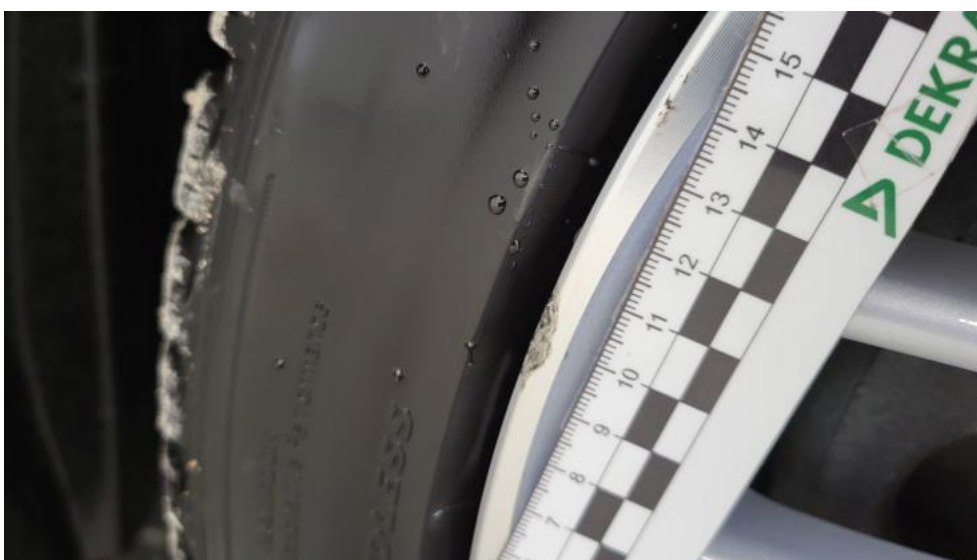
**Photo 70.**

Felga Aluminiowa przednia L - Rysa/odprysk 1

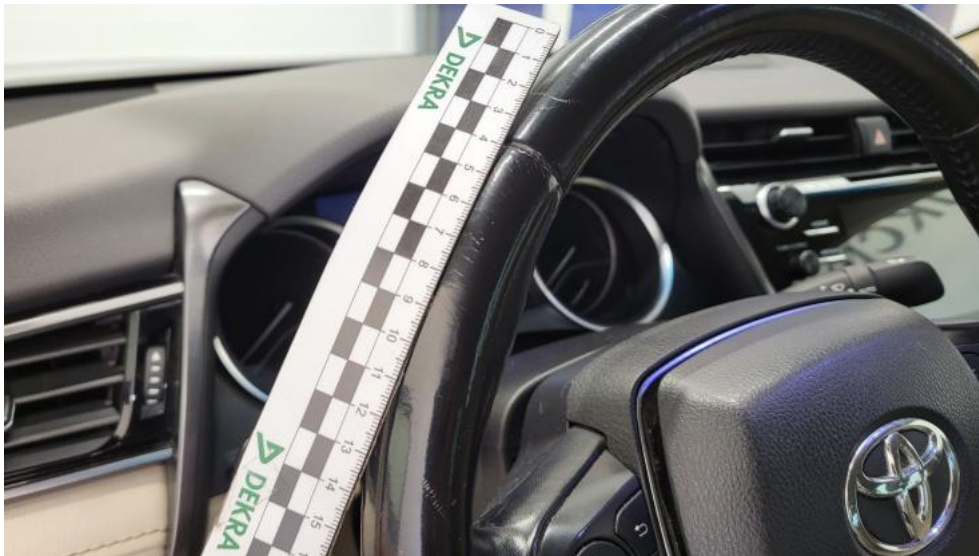
**Photo 73.**

Koło kierownicy - Rysa/odprysk 1

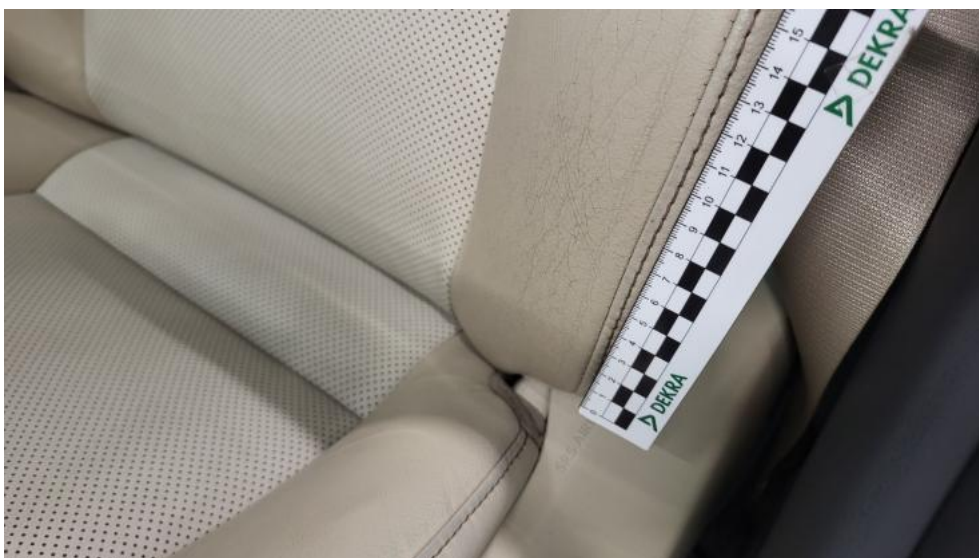
**Photo 74.**

Fotel prz. lew. - Inne 1

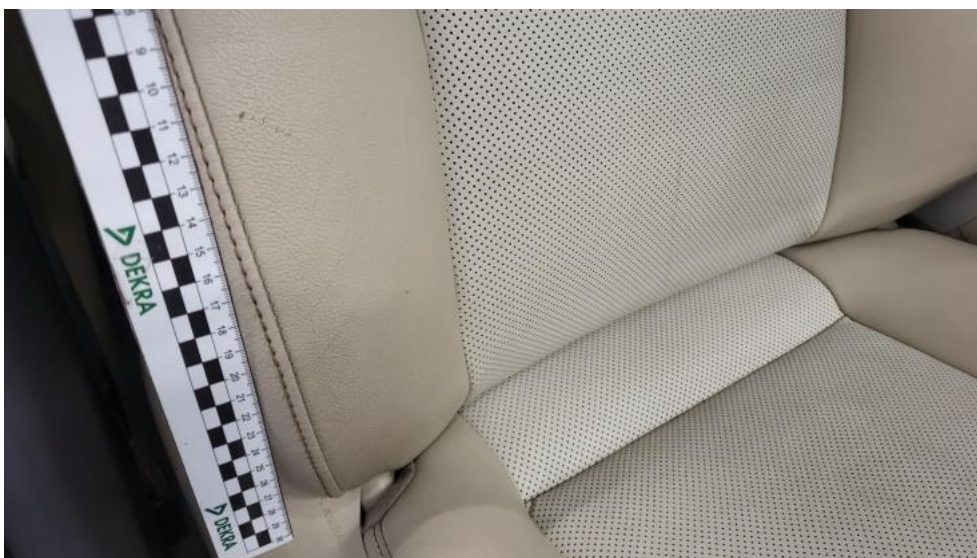
**Photo 76.**

Fotel prz. praw. - Inne 2
