DEKRA's commission No. : PKOL(W)/LODZ/61000/25/08/19  
commission/ damage No. : 24/011087  
Date of commission: 19-08-2025

**DEKRA Poland - Headquarters**  
02-673 Warszawa, ul. Konstruktorska 12A

| Manufacturer | CUPRA |
| Type / version | Formentor 1.5 TSI DSG |

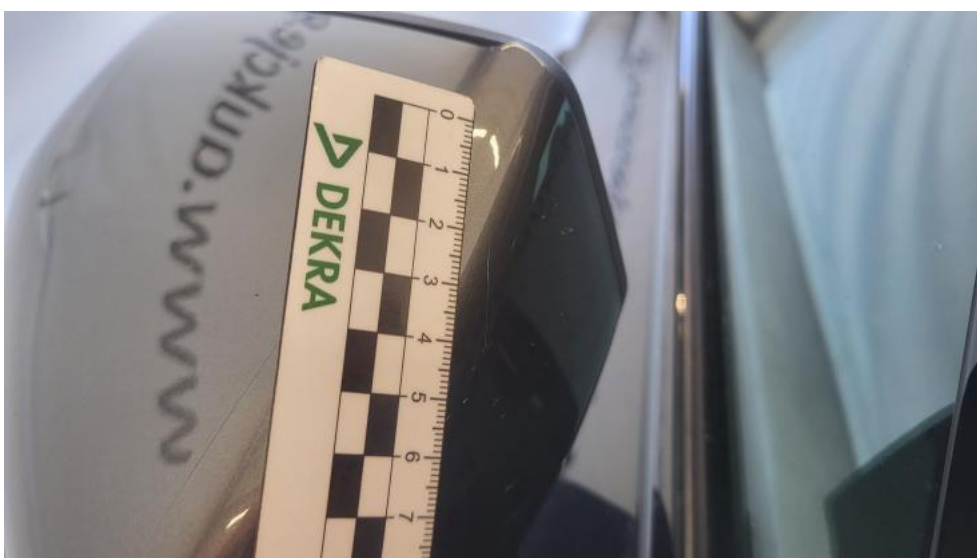
**Photo 38.**

Lusterko zew P - Rysa/odprysk 1

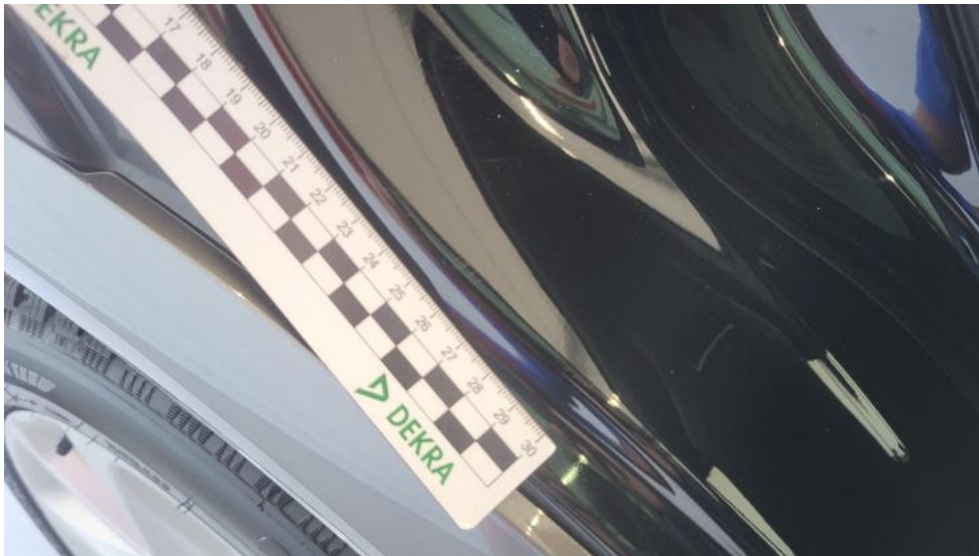
**Photo 39.**

Błotnik tylny P / Ściana boczna P - Rysa/odprysk 1

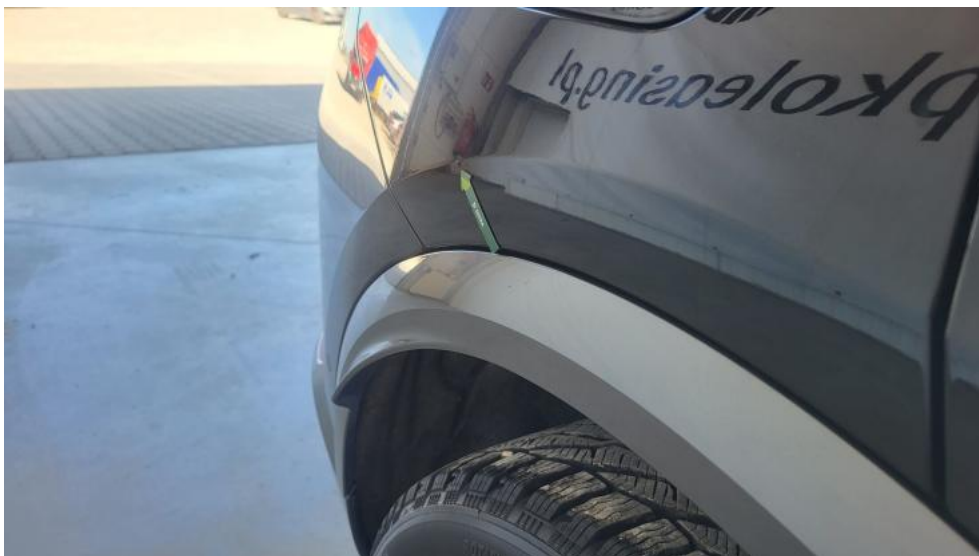
**Photo 40.**

Błotnik tylny P / Ściana boczna P - Wgniecenie/odkształcenie 1

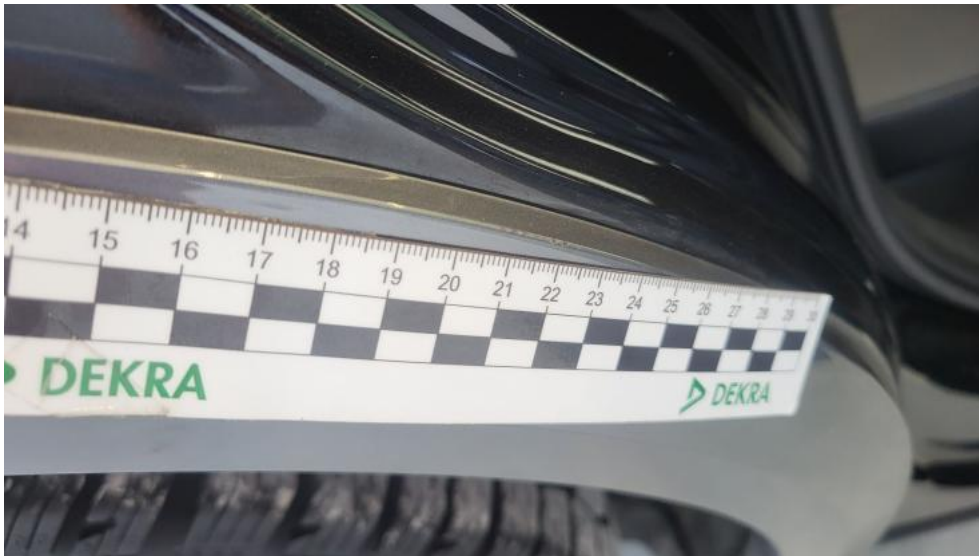
**Photo 41.**

Listwa krawędzi błotnika tyl P - Rysa/odprysk 1

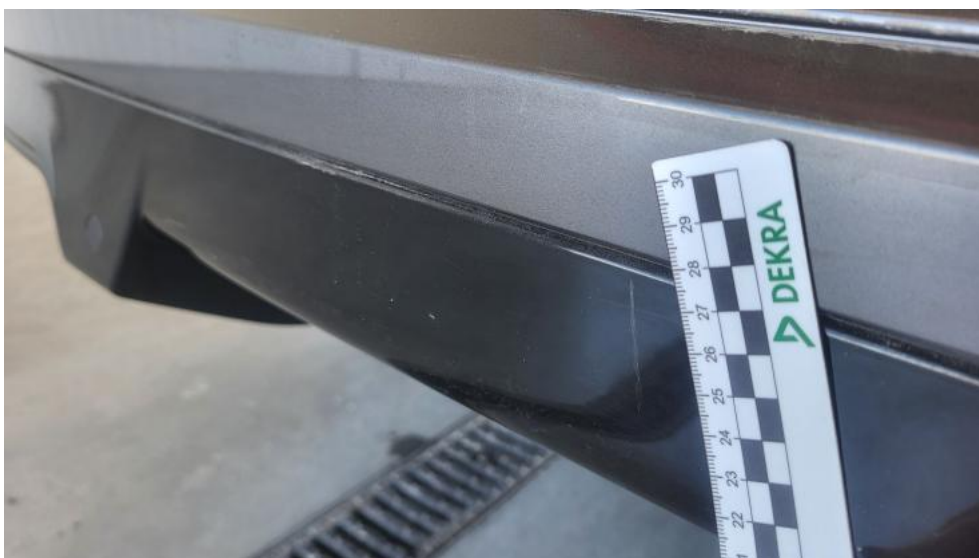
**Photo 42.**

Zderzak tylny cz dolna - Rysa/odprysk 1

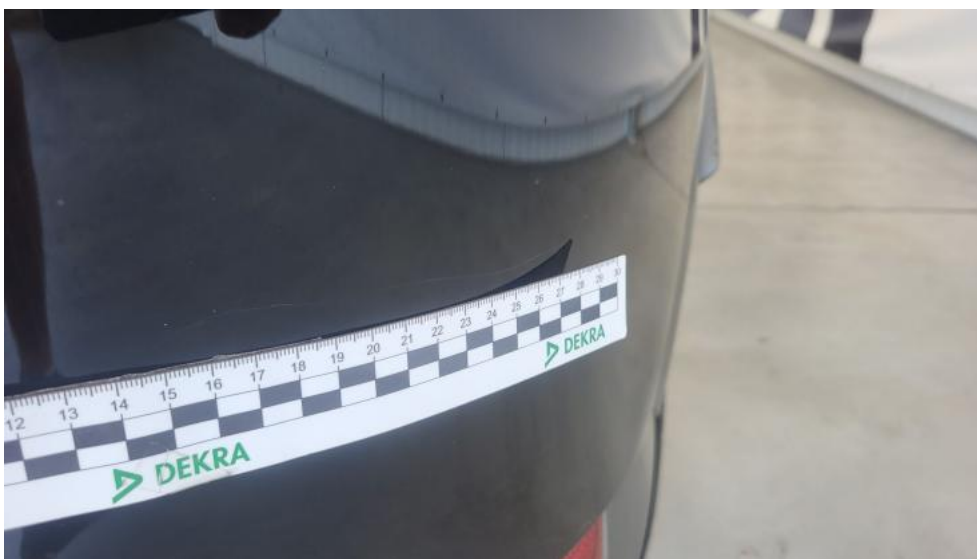
**Photo 43.**

Zderzak tylny cz P - Rysa/odprysk 1

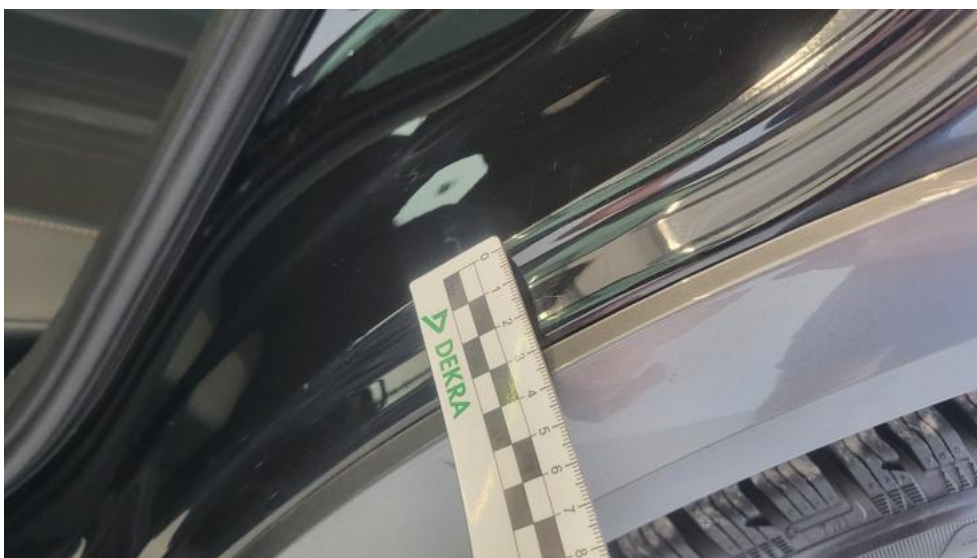
**Photo 44.**

Błotnik tylny L / Ściana boczna L - Rysa/odprysk 1

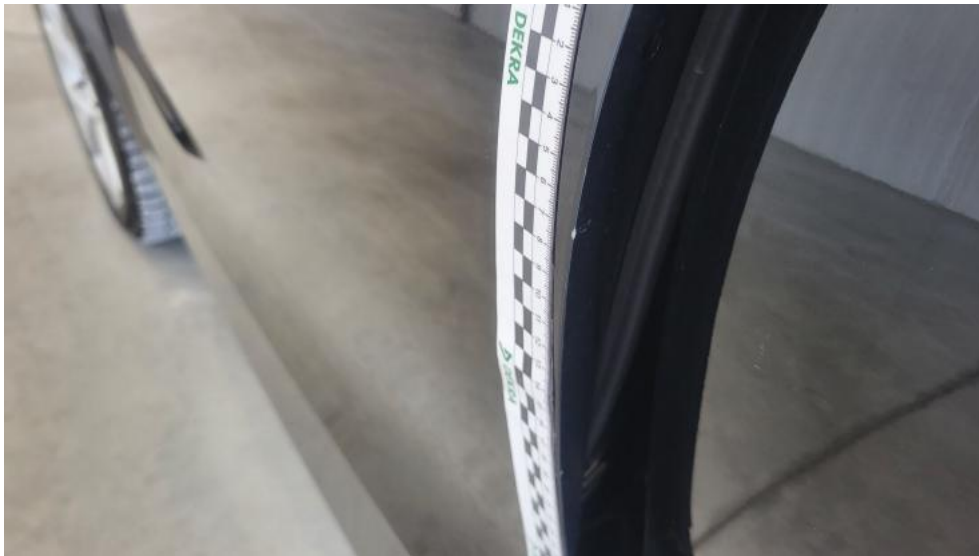
**Photo 45.**

Drzwi przed L - Rysa/odprysk 1

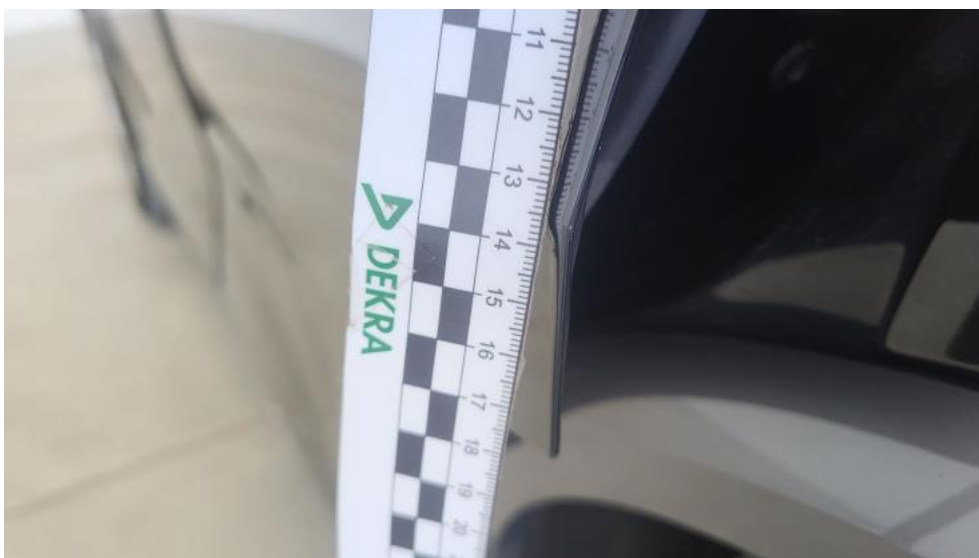
**Photo 46.**

Drzwi tylne L - Rysa/odprysk 1

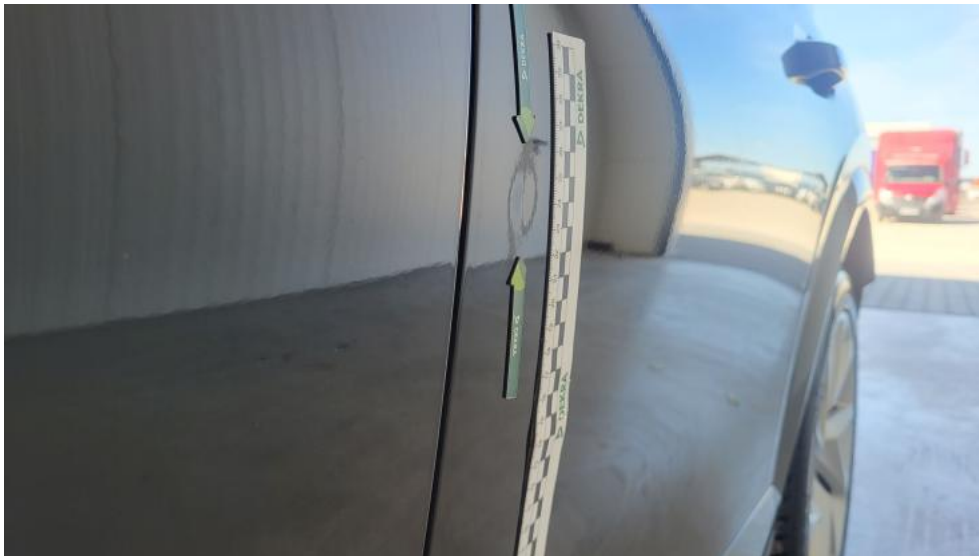
**Photo 47.**

Drzwi tylne L - Wgniecenie/odkształcenie 1

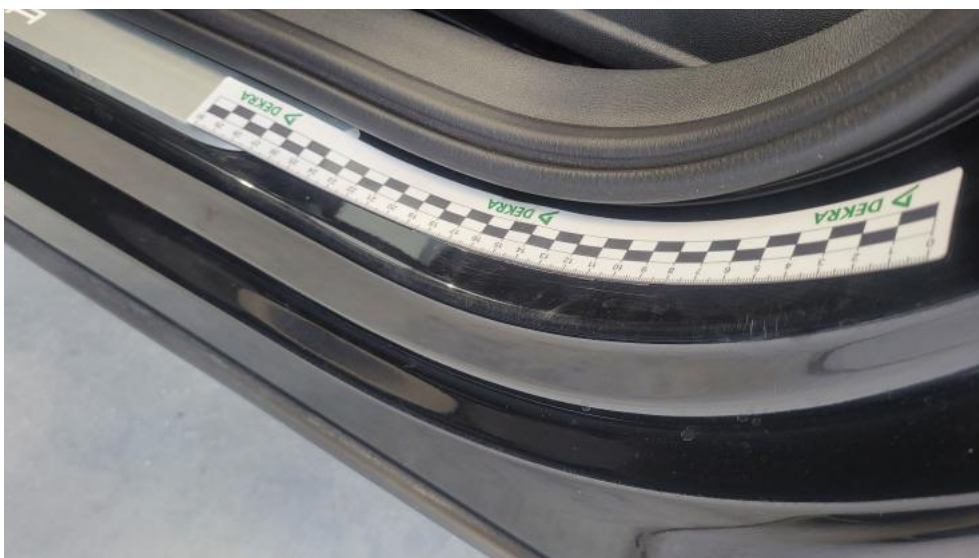
**Photo 48.**

Próg L - Rysa/odprysk 1

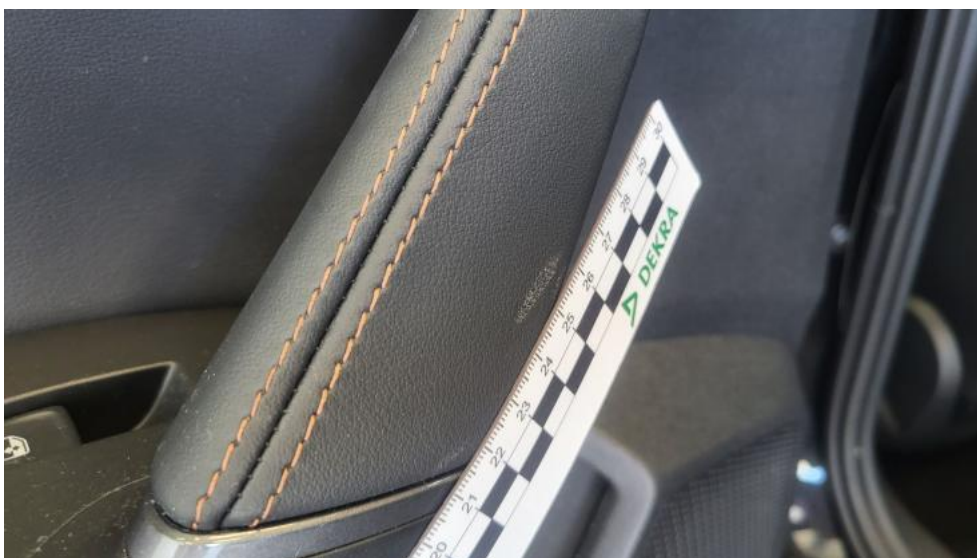
**Photo 52.**  
Uchwyt drzwi tyl L - Rysa/odprysk 1

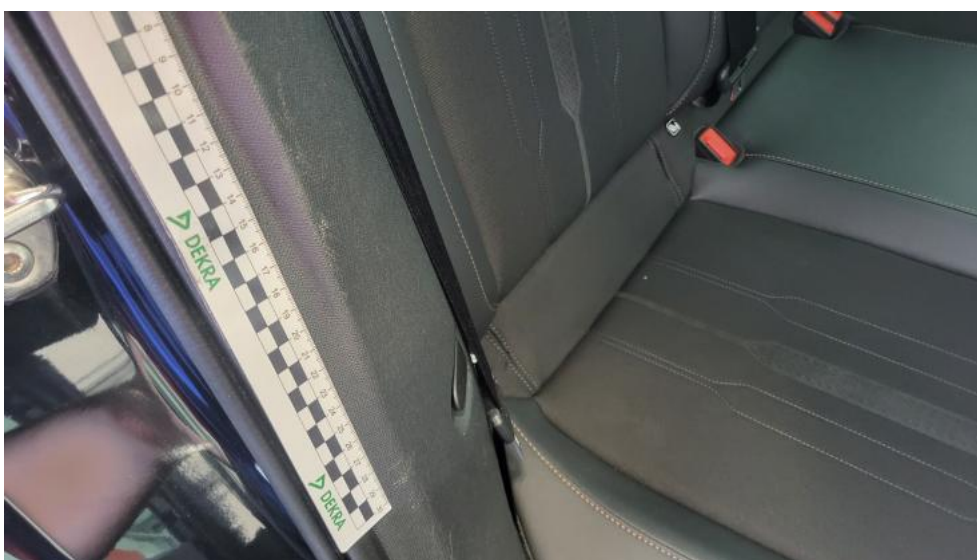
**Photo 54.**

Wykładzina(y) słupka tylnego P - Rysa/odprysk 1

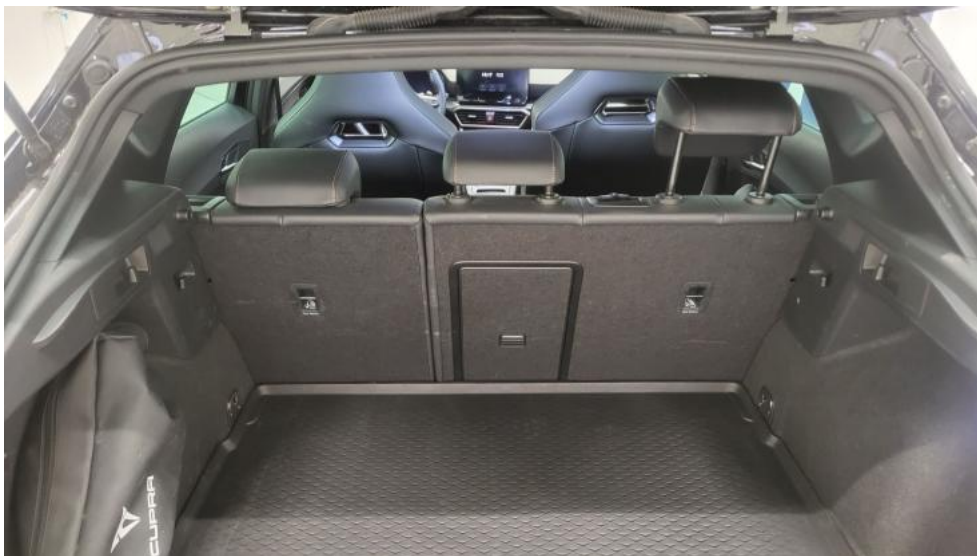
**Photo 55.**

Rysy na samochodzie. Brak półki bagażnika. Odpryski na szybie czołowej.

Półka/roleta tylna - Inne 1
