DEKRA's commission No. : PKOL(W)/LODZ/54788/25/07/25  
commission/ damage No. : 01497/EO/23  
Date of commission: 25-07-2025

**Vehicle data**

| Manufacturer | BMW |
| Type / version | 530i xDrive M Sport sport-aut |

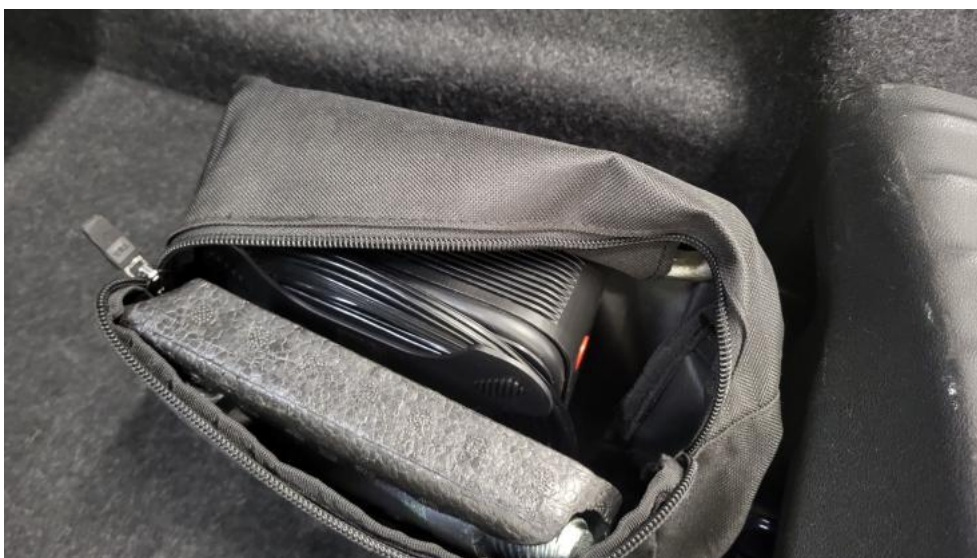
**Photo 36.**

Rysy na samochodzie. Brak grota w jednym z kluczyków. Brak płynu zestawu naprawczego. Aktywna kontrolka ciśnienia w kołach. Awaria kontroli ciśnienia opon.

Zestaw naprawczy koła

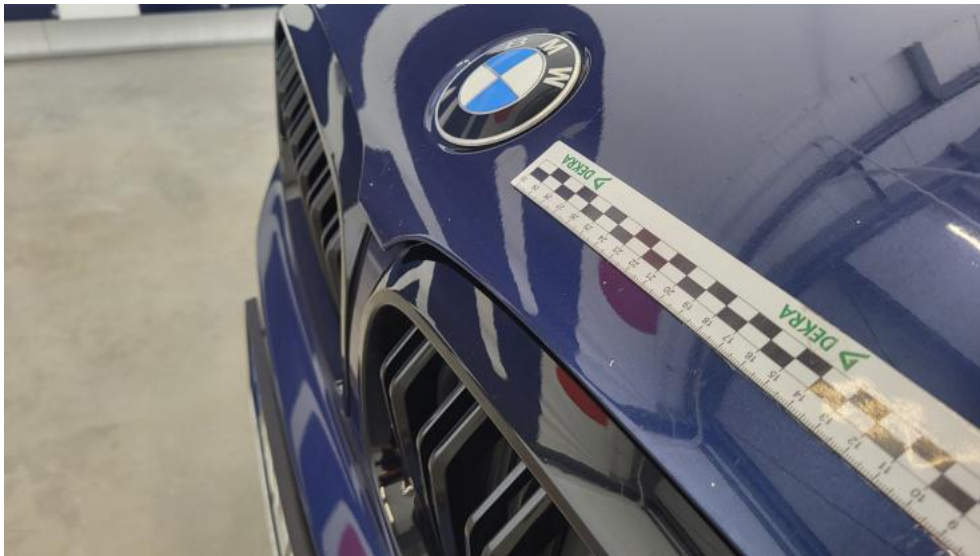
**Photo 43.**

Pokrywa komory silnika - Rysa/odprysk 1

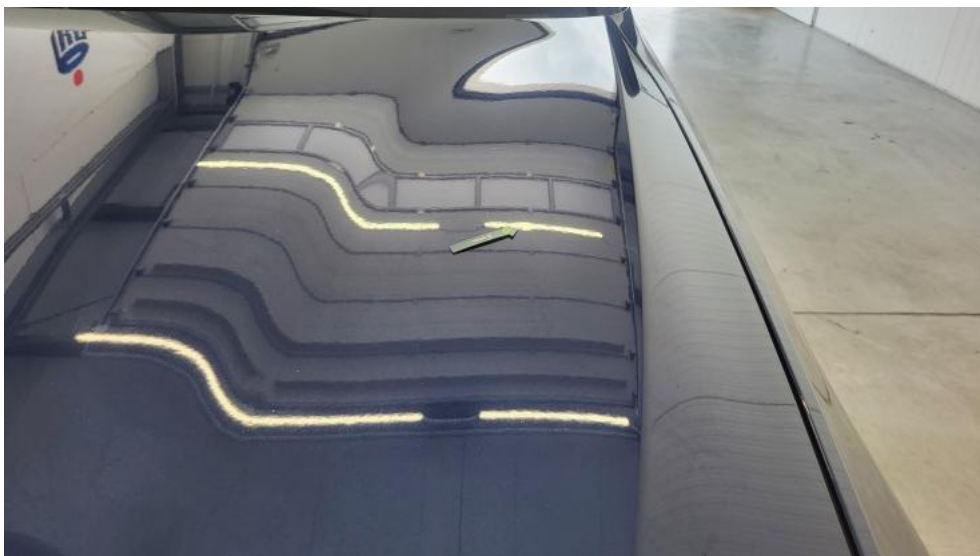
**Photo 44.**

Pokrywa komory silnika - Wgniecenie/odkształcenie 1

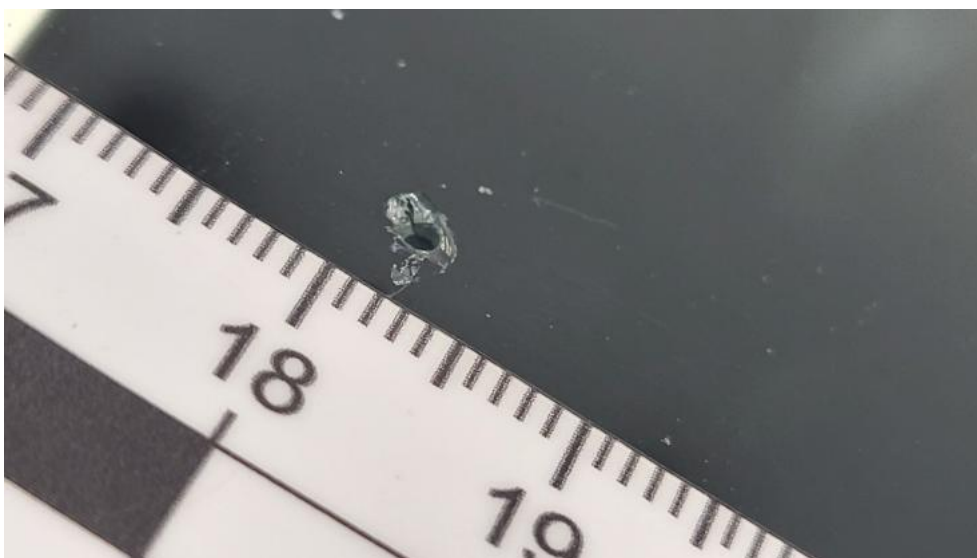
**Photo 46.**

Szyba czołowa - Pęknięcie/rozerwanie 1

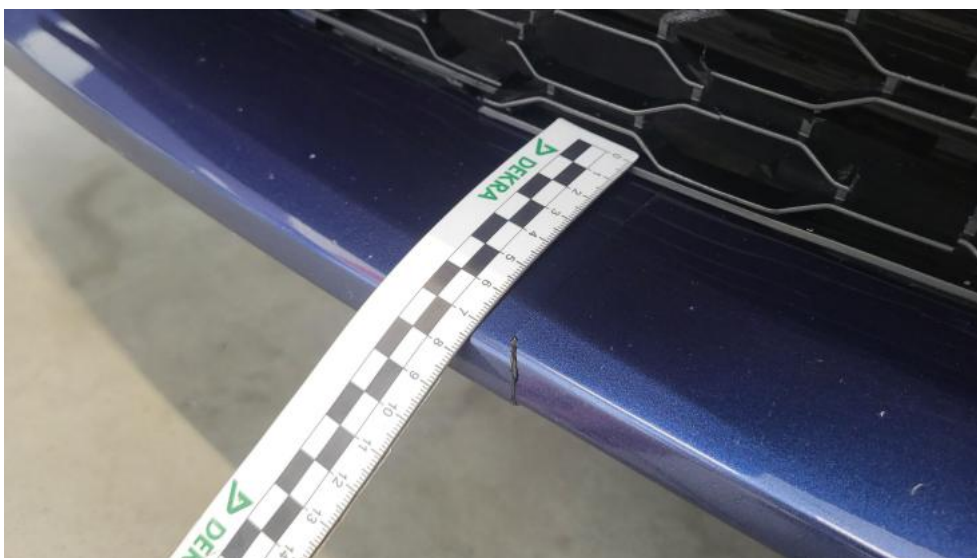
**Photo 50.**

Zderzak - Pęknięcie/rozerwanie 1

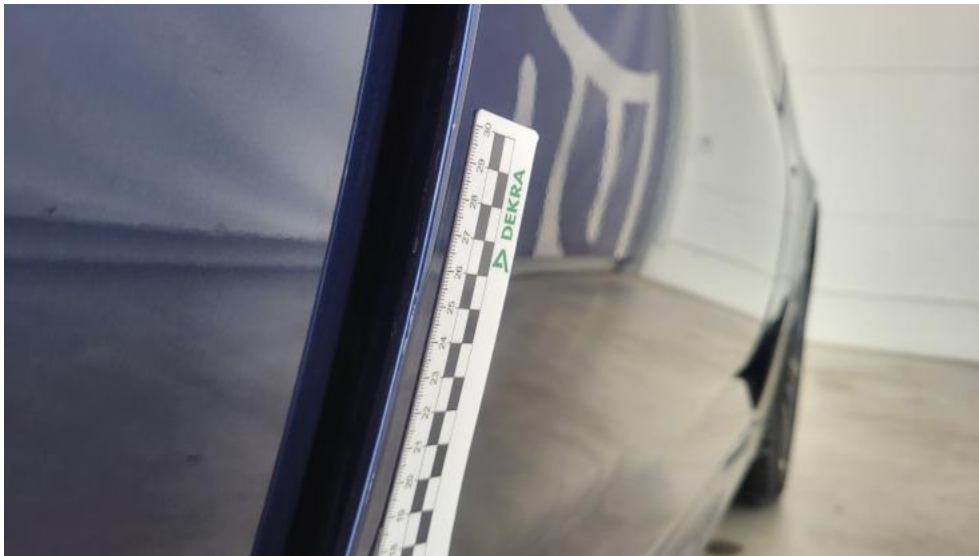
**Photo 53.**

Drzwi przednie P - Rysa/odprysk 1

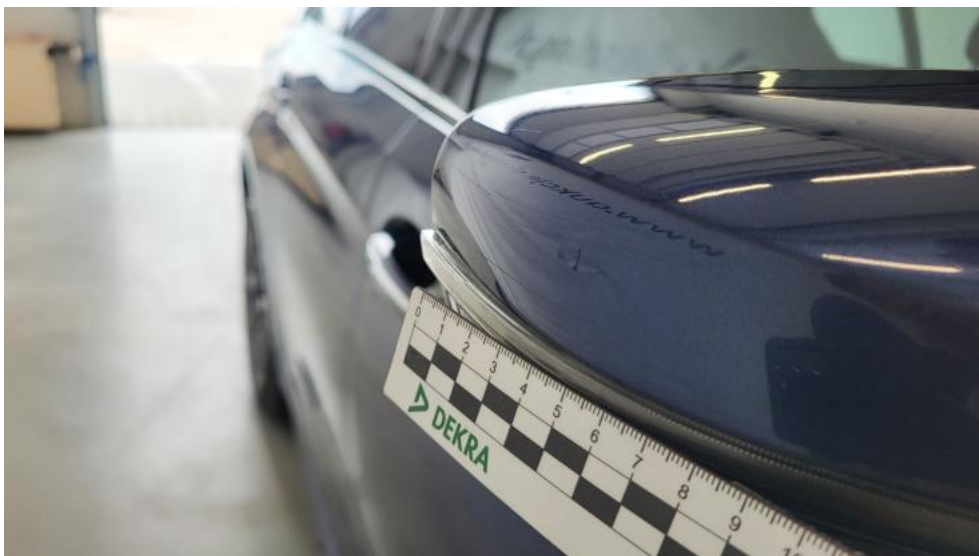
**Photo 54.**

Lusterko zew P - Rysa/odprysk 1

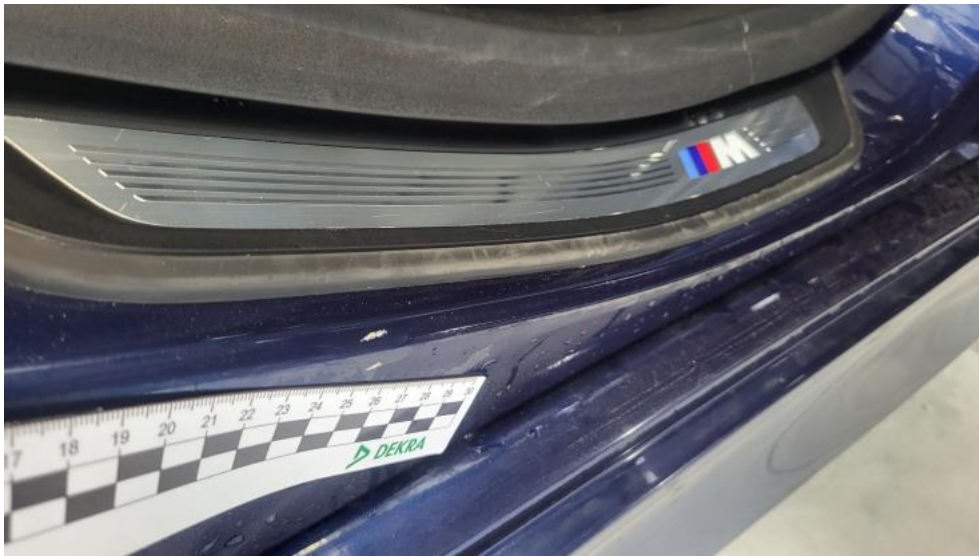
**Photo 55.**

Próg P - Rysa/odprysk 1

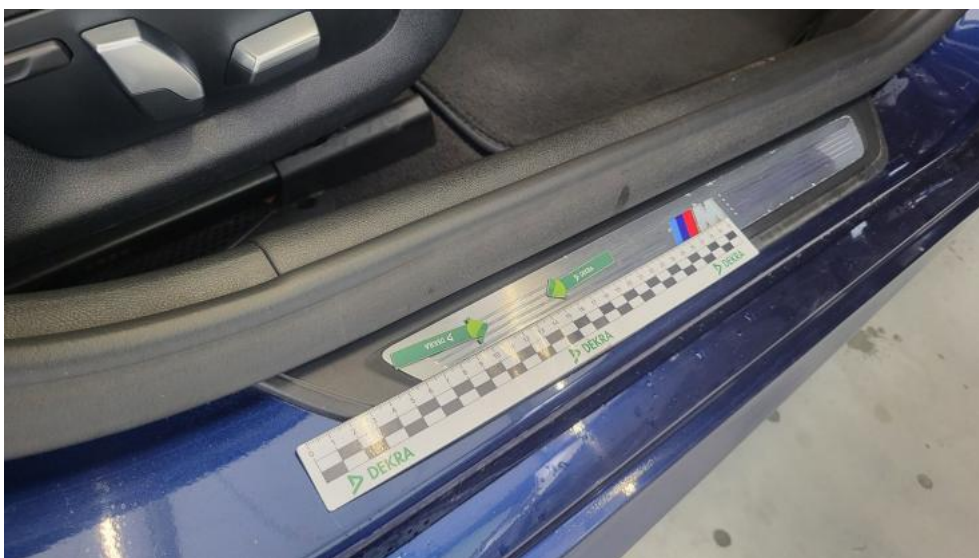
**Photo 56.**

Próg P - Wgniecenie/odkształcenie 1

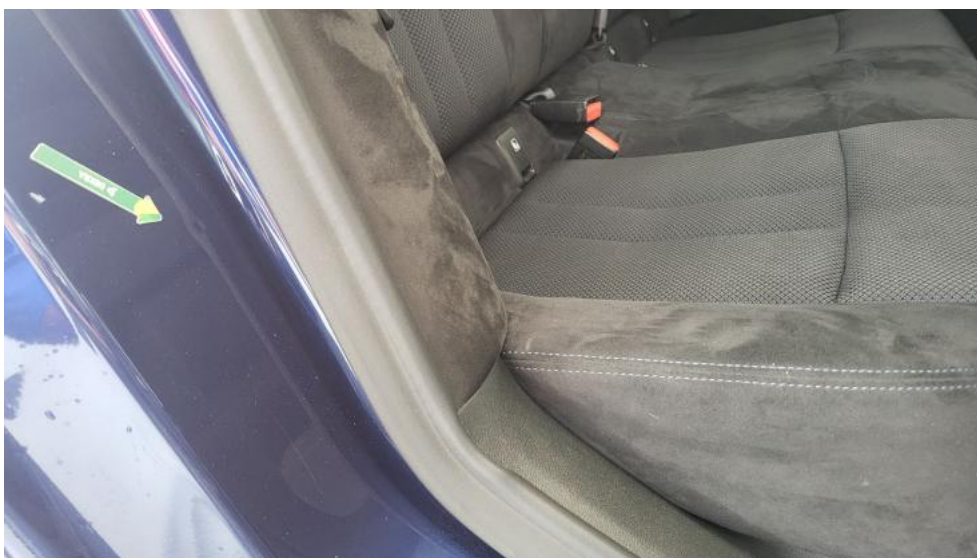
**Photo 58.**

Błotnik tylny P / Ściana boczna P - Wgniecenie/odkształcenie 1

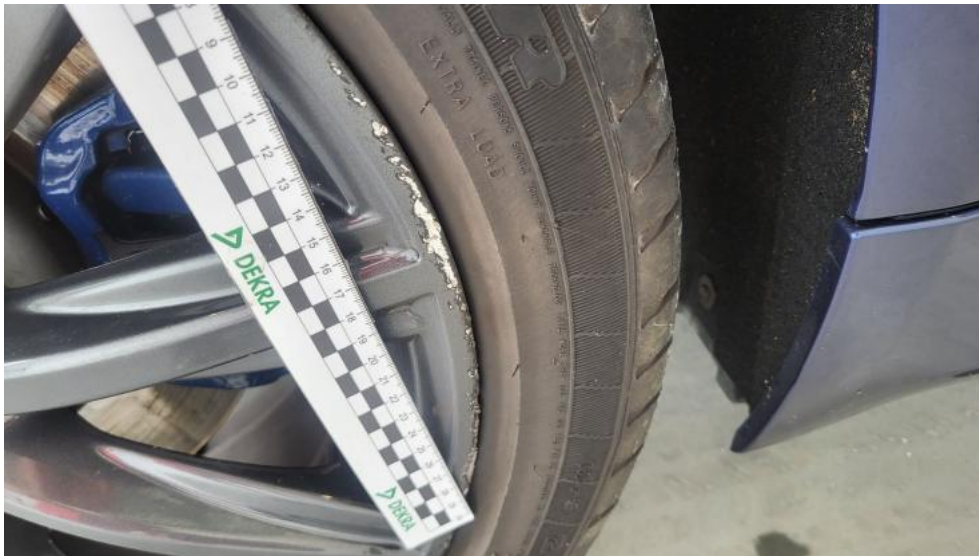
**Photo 59.**

Felga aluminiowa tylna P - Rysa/odprysk 1

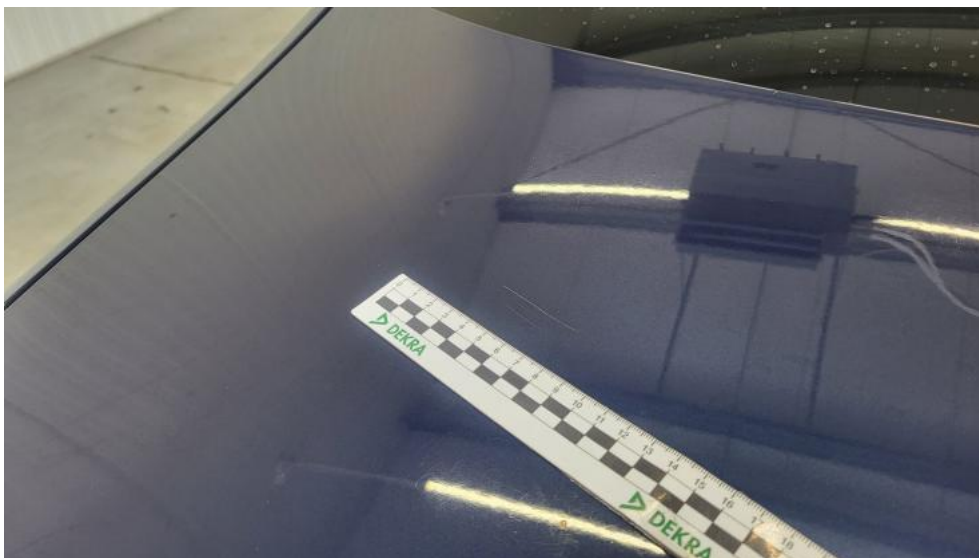
**Photo 60.**

Pokrywy bagażnika - Rysa/odprysk 1

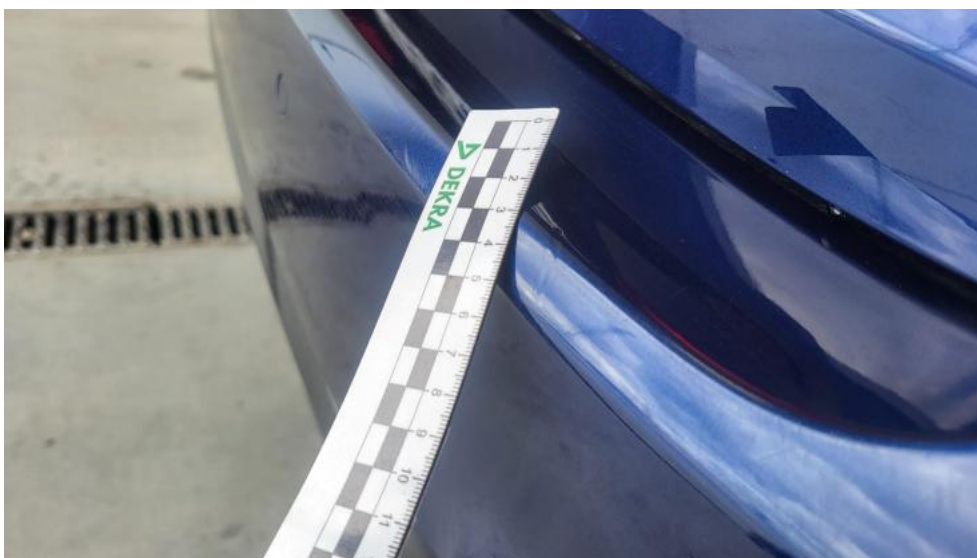
**Photo 64.**

Zderzak tylny - Wgniecenie/odkształcenie 2

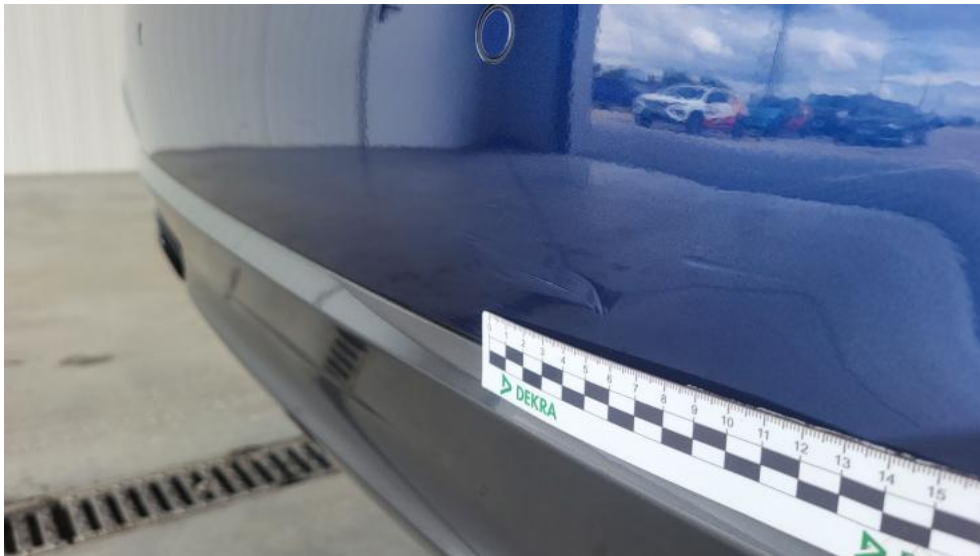
**Photo 65.**

Zderzak tylny() - Wgniecenie/odkształcenie 3

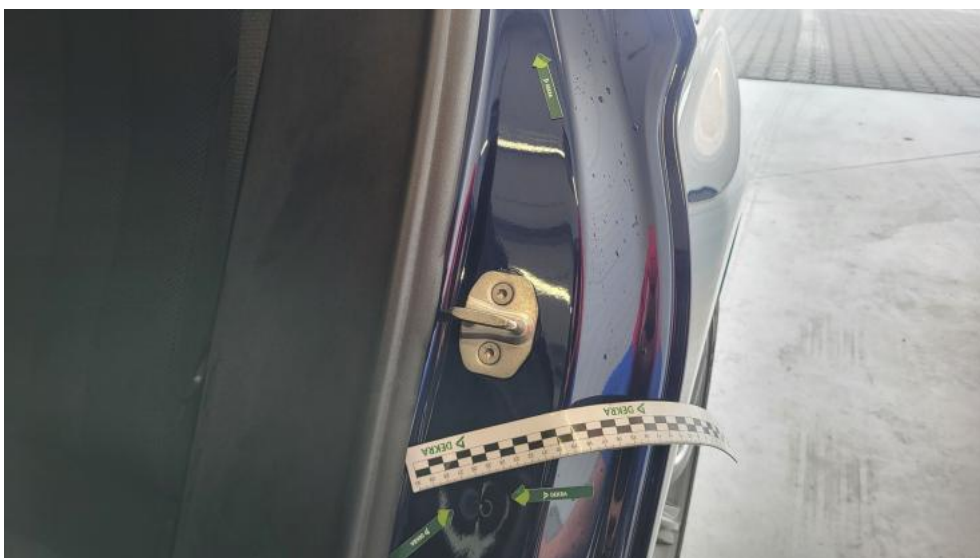
**Photo 66.**

Ścianka tylna L / Ścianka boczna L - Wgniecenie/odkształcenie 1

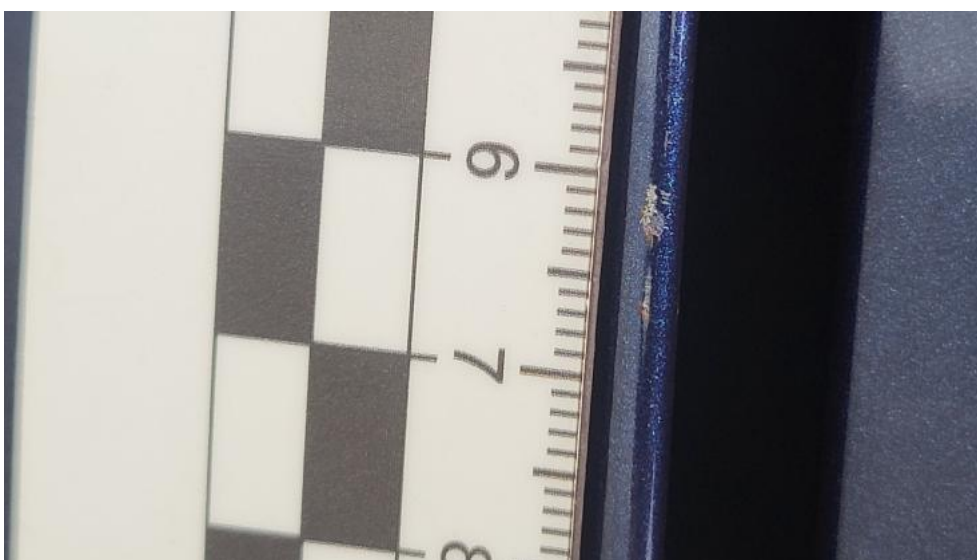
**Photo 70.**

Drzwi przed L - Inne 1

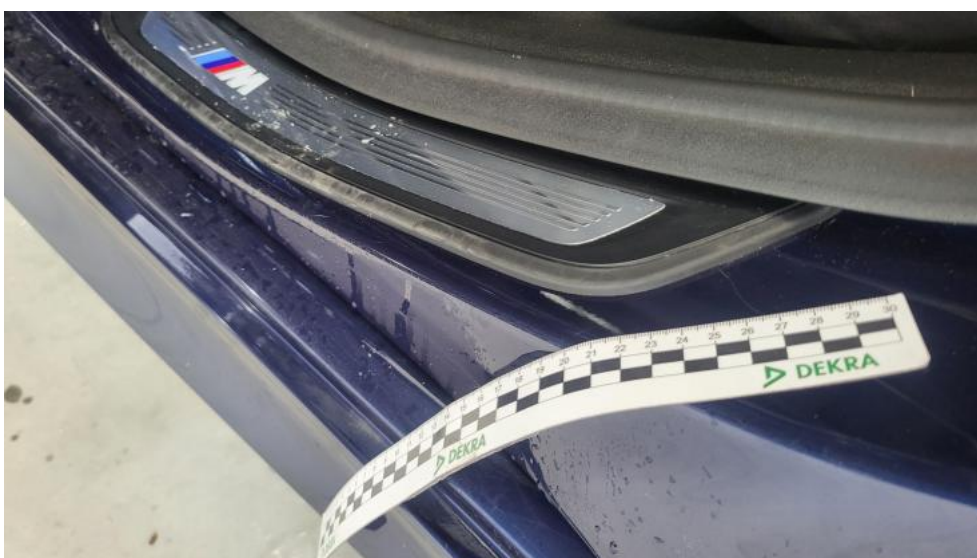
**Photo 74.**

Próg L - Rysa/odprysk 1

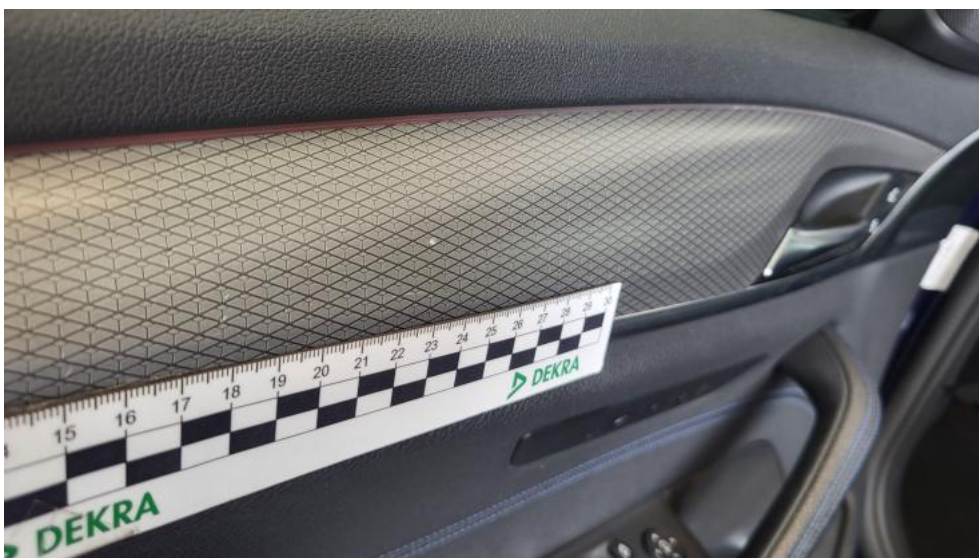
**Photo 76.**

Tapicerka drzwi przednich L - Rysa/odprysk 1

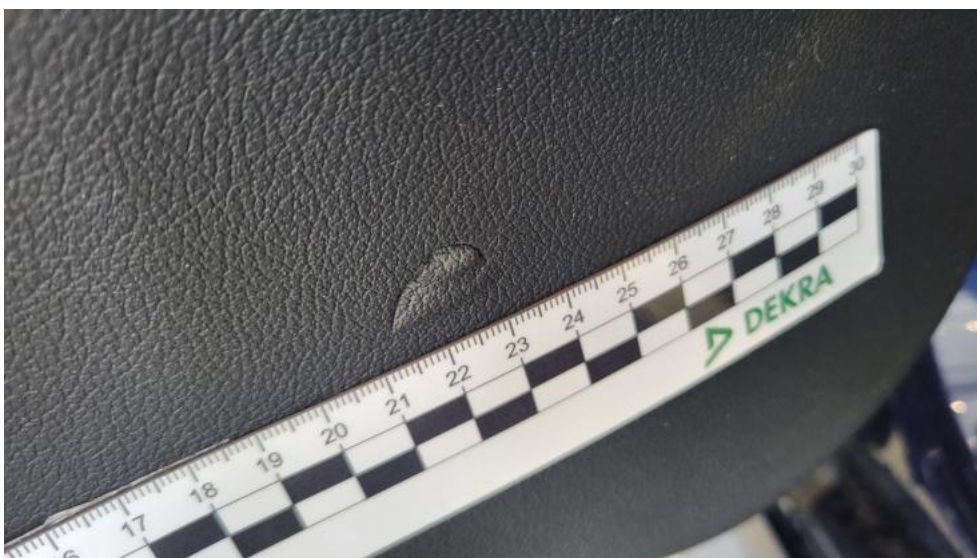
**Photo 78.**

Tapicerka drzwi tylnych L - Pęknięcie/rozerwanie 1

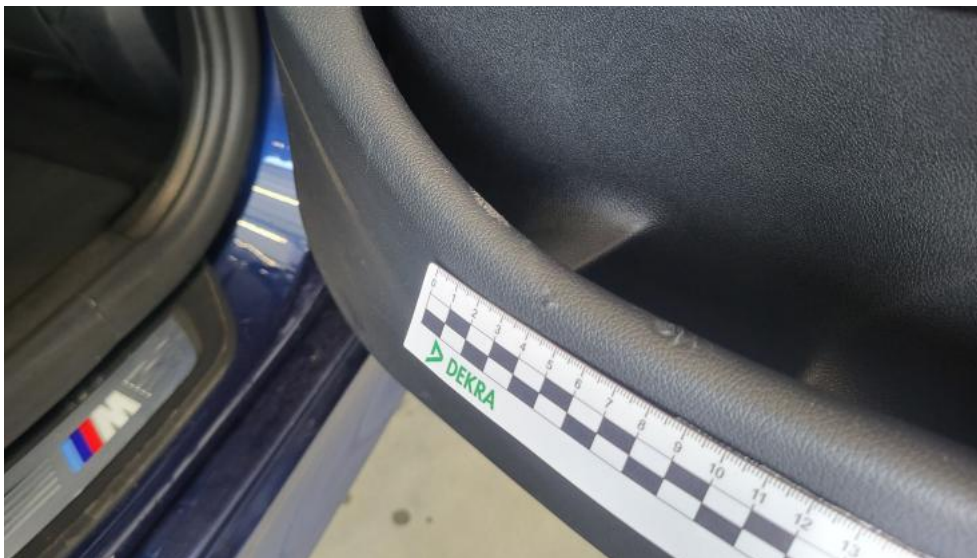
**Photo 79.**

Tapicerka drzwi tylnych P - Wgniecenie/odkształcenie 1
