DEKRA's commission No. : PKOL(W)/LODZ/92962/25/11/28  
commission/ damage No. : 20/052733  
Date of commission: 28-11-2025

**DEKRA Poland - Headquarters**  
02-673 Warszawa, ul. Konstruktorska 12A

| Manufacturer | FORD |
| Model | Focus Kombi 18-21 |

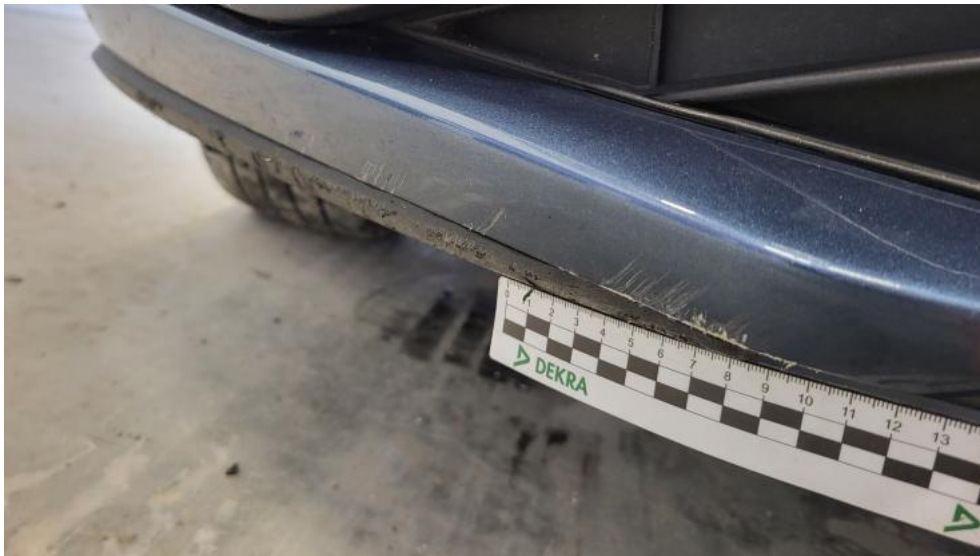
**Photo 41.**

Zderzak - Rysa/odprysk 2

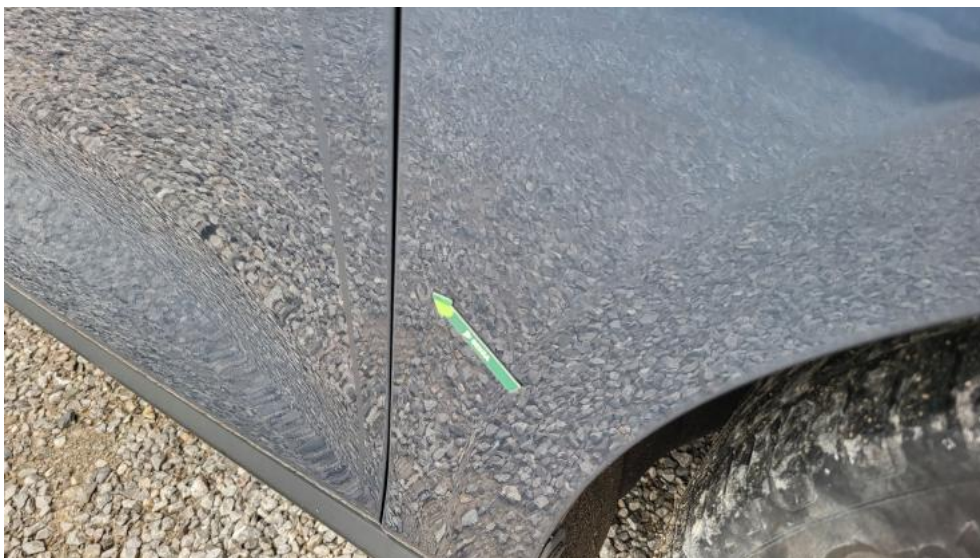
**Photo 42.**

Łotnik przedni P - Wgniecenie/odkształcenie 1

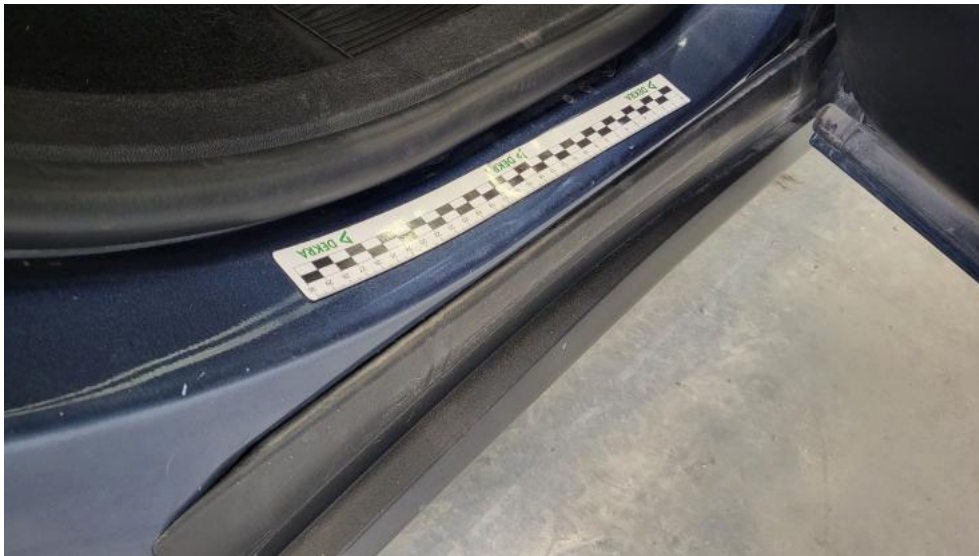
**Photo 47.**

Próg P - Rysa/odprysk 1

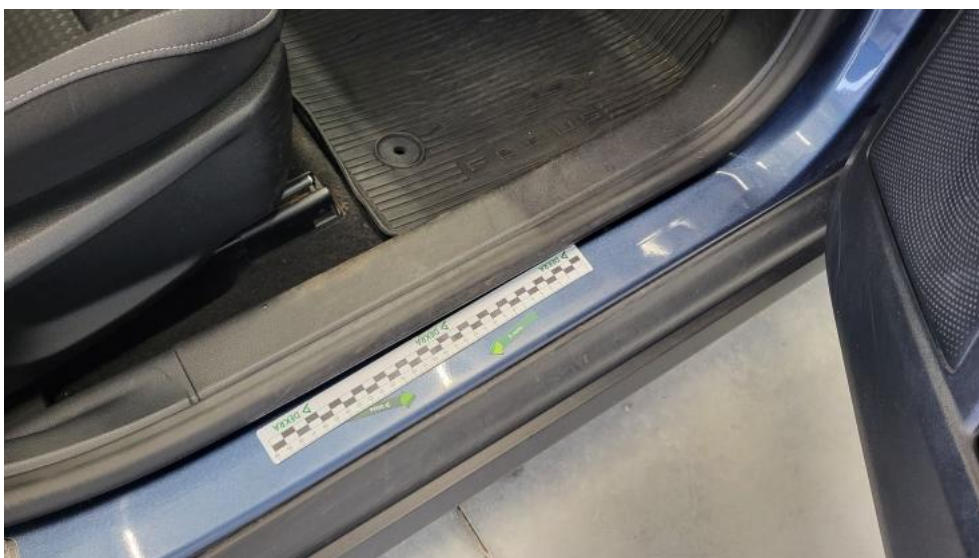
**Photo 48.**

Próg P - Wgniecenie/odkształcenie 1

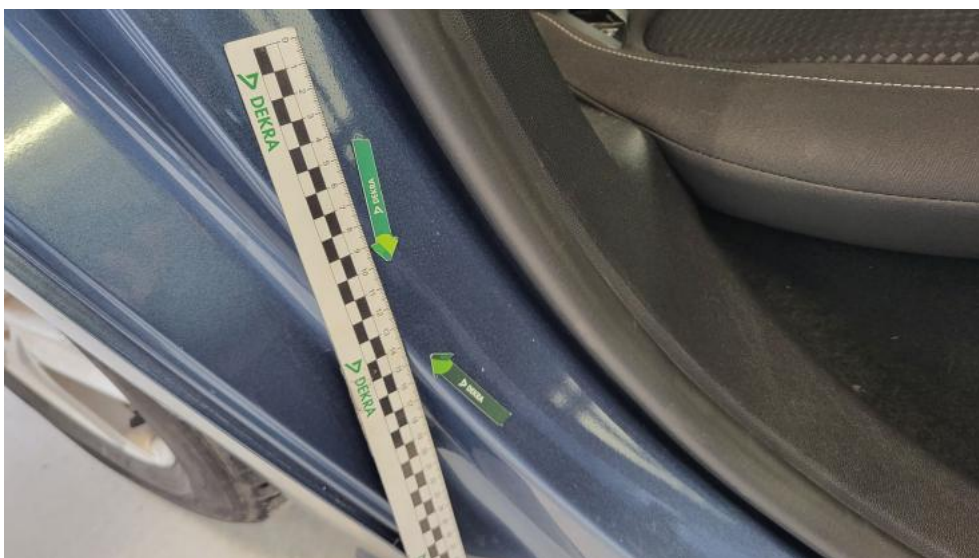
**Photo 50.**

Łotnik tylny P / Ściana boczna P - Wgniecenie/odkształcenie 1

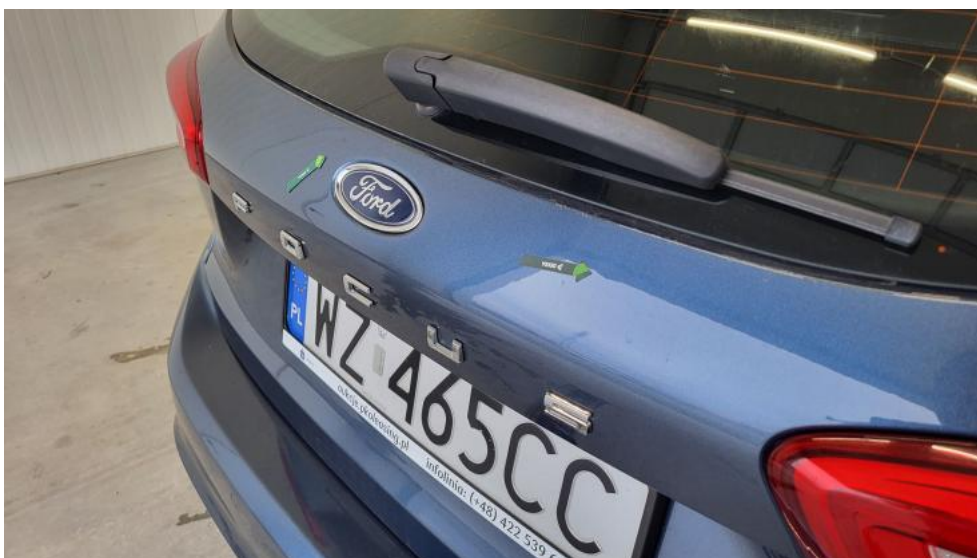
**Photo 52.**

Pokrywy bagażnika - Wgniecenie/odkształcenie 1

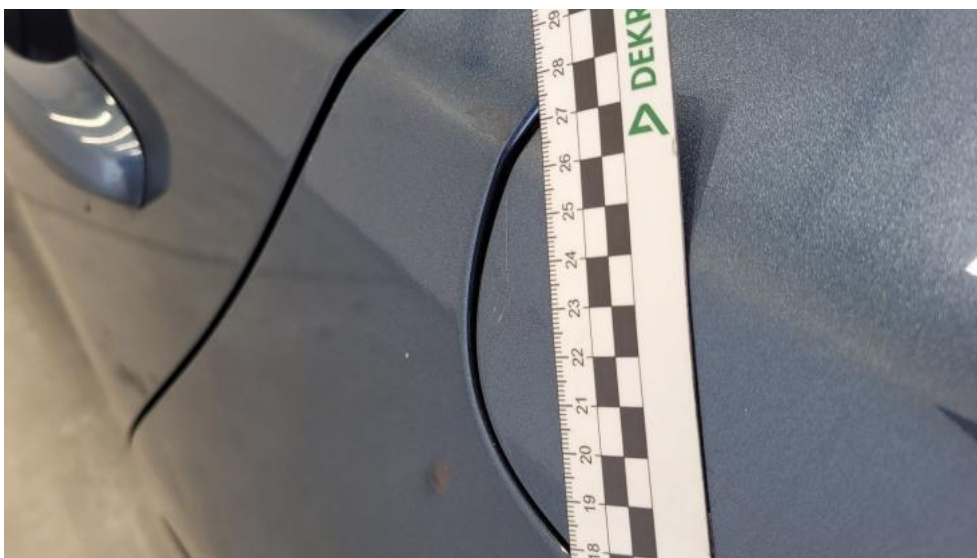
**Photo 54.**

Błotnik tylny L / Ściana boczna L - Rysa/odprysk 1

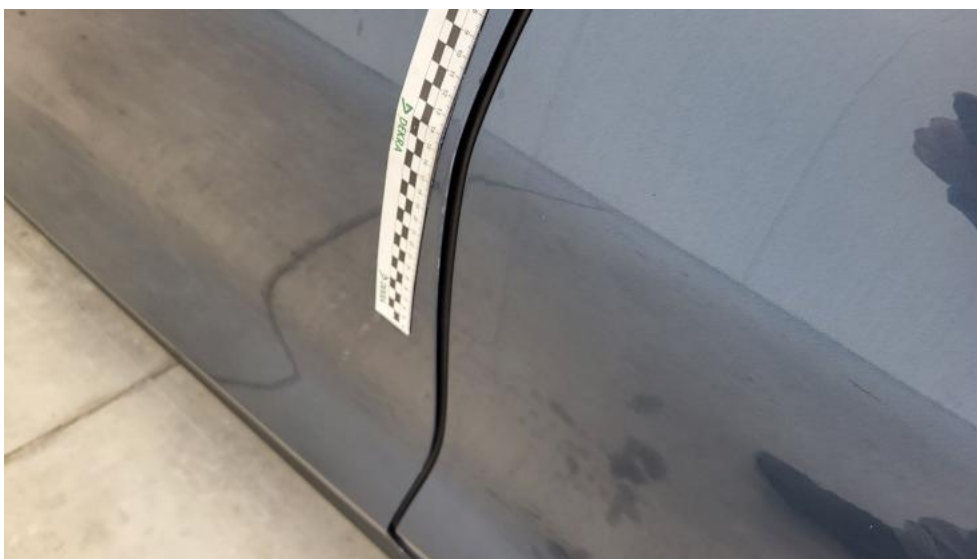
**Photo 57.**

Drzwi przed L - Rysa/odprysk 1

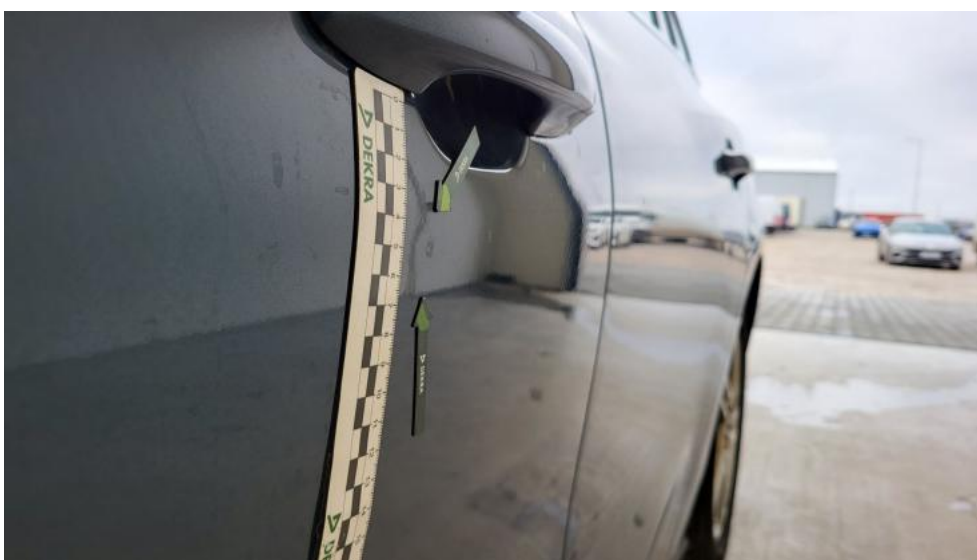
**Photo 58.**

Drzwi przed L - Wgniecenie/odkształcenie 1

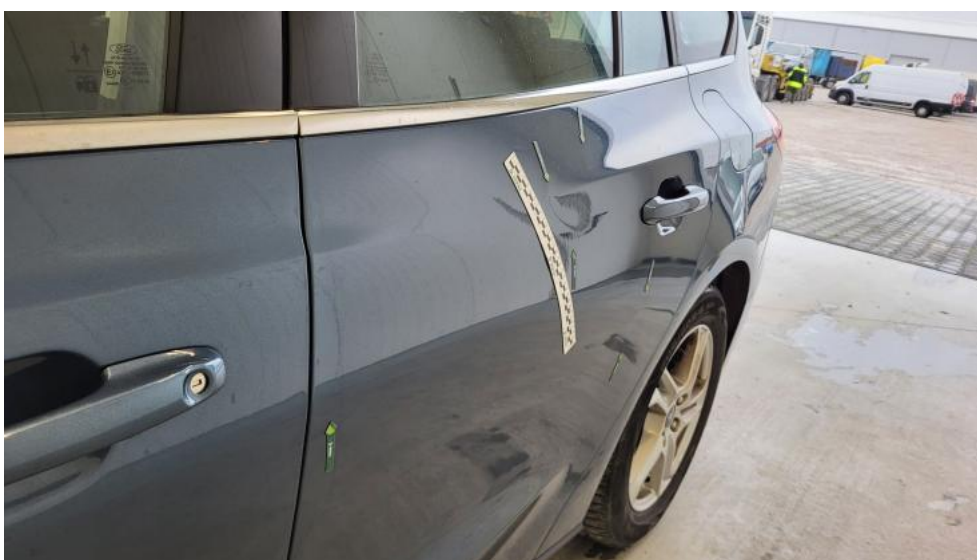
**Photo 60.**

Drzwi tylne L - Wgniecenie/odkształcenie 1

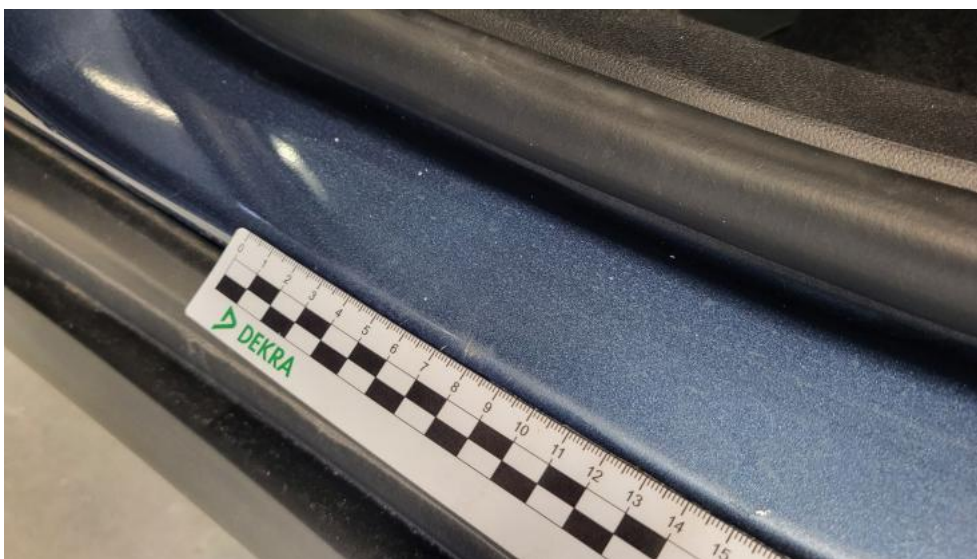
**Photo 61.**

Próg L - Rysa/odprysk 1

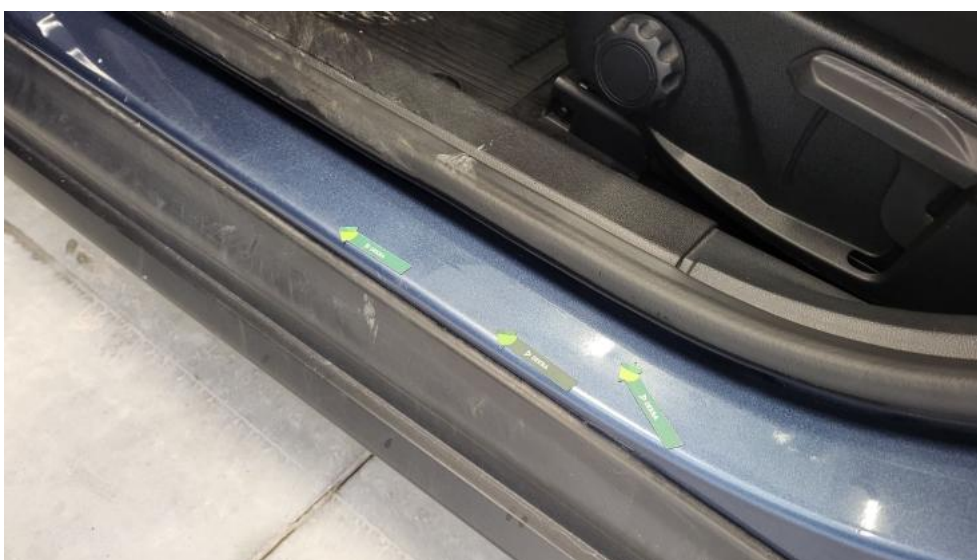
**Photo 62.**

Próg L - Wgniecenie/odkształcenie 1

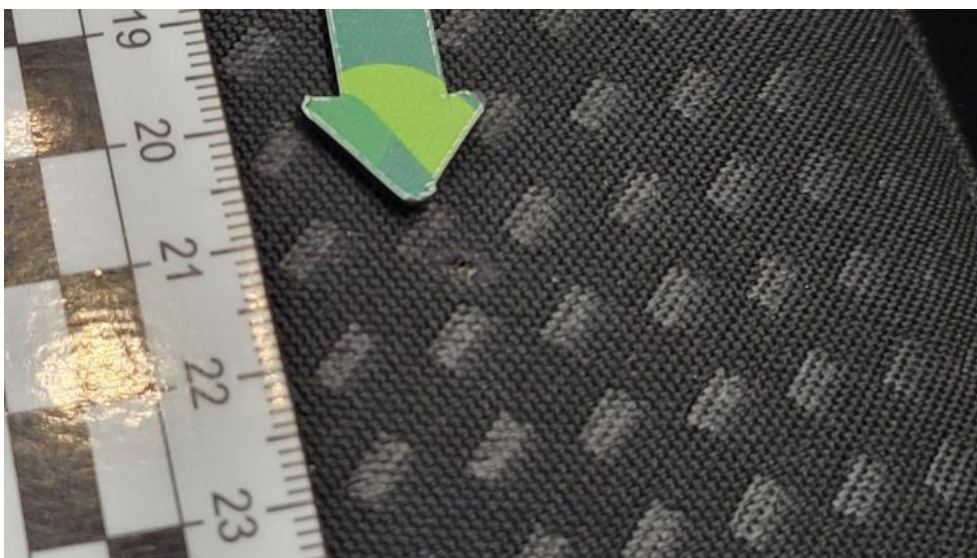
**Photo 66.**

Fotel prz. praw. - Inne 1

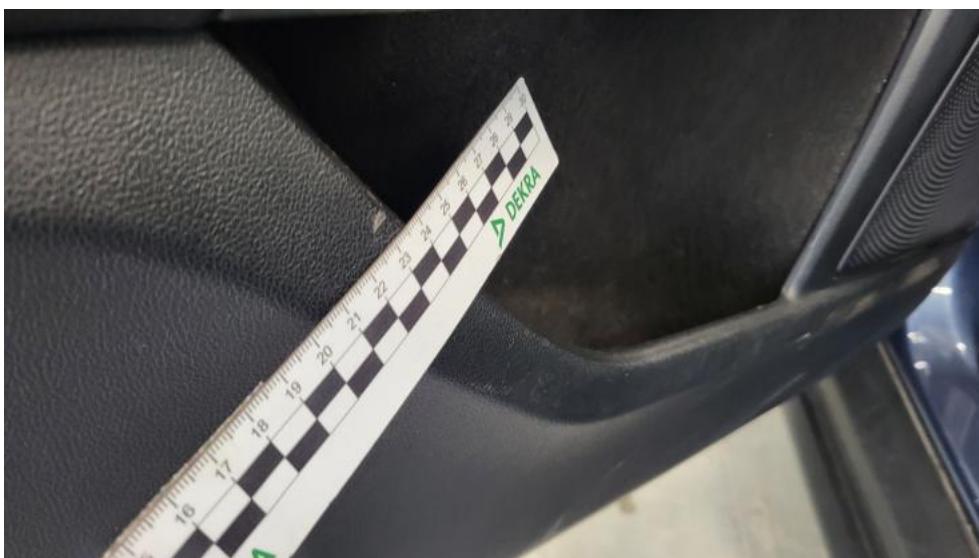
**Photo 68.**  
Tapicerka drzwi przednich L - Rysa/odprysk 1

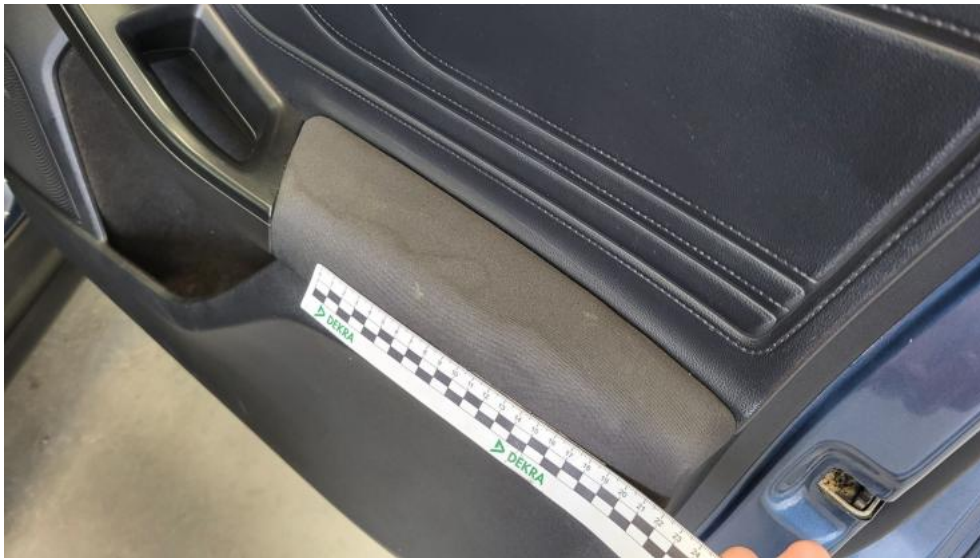
**Photo 69.**

Tapicerka drzwi przednich P - Inne 1

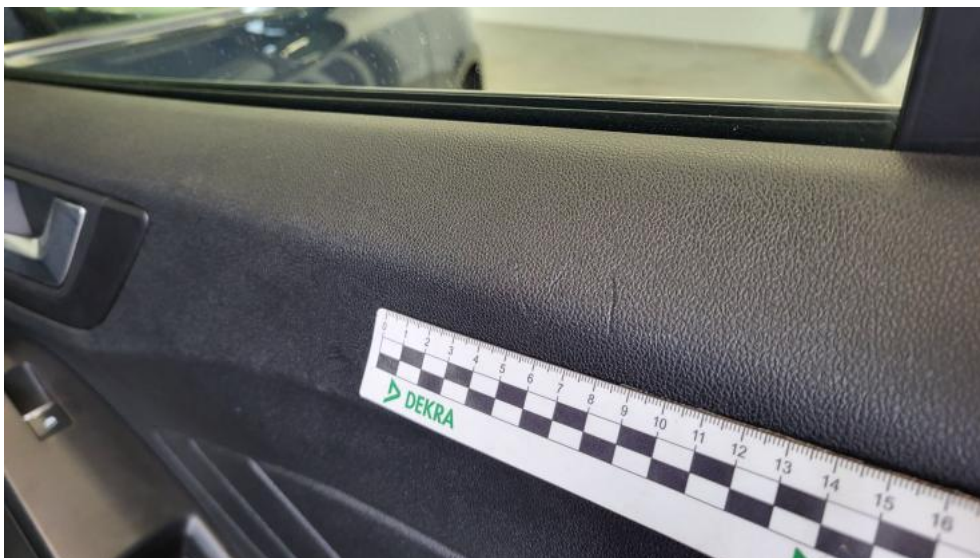
**Photo 70.**

Tapicerka drzwi tylnych P - Rysa/odprysk 1

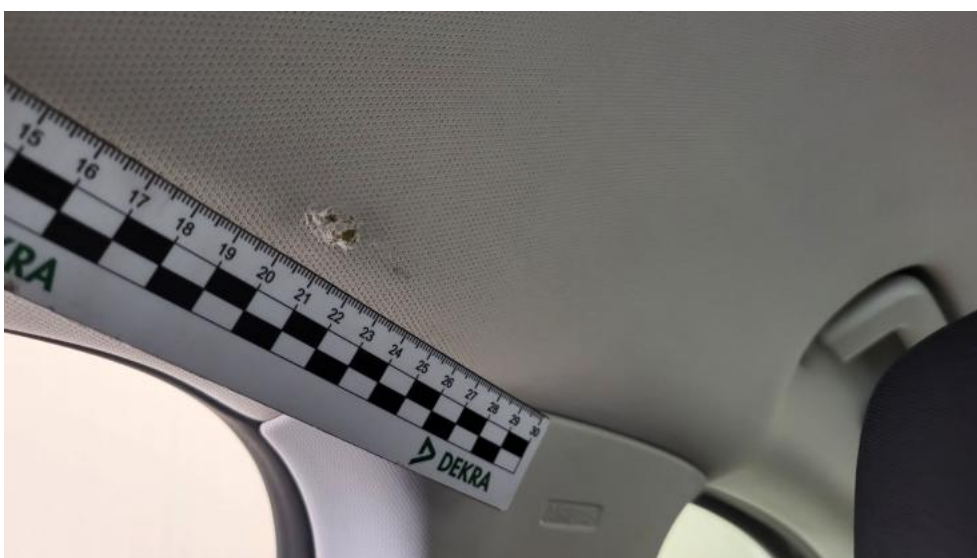
**Photo 72.**

Podsufitka - Pęknięcie/rozerwanie 1

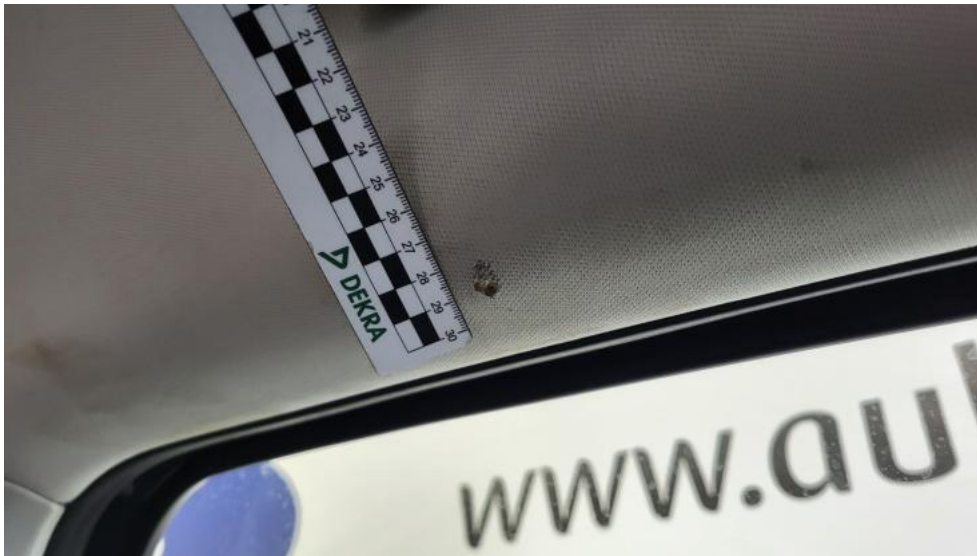
**Photo 73.**

Podsufitka - Pęknięcie/rozerwanie 2

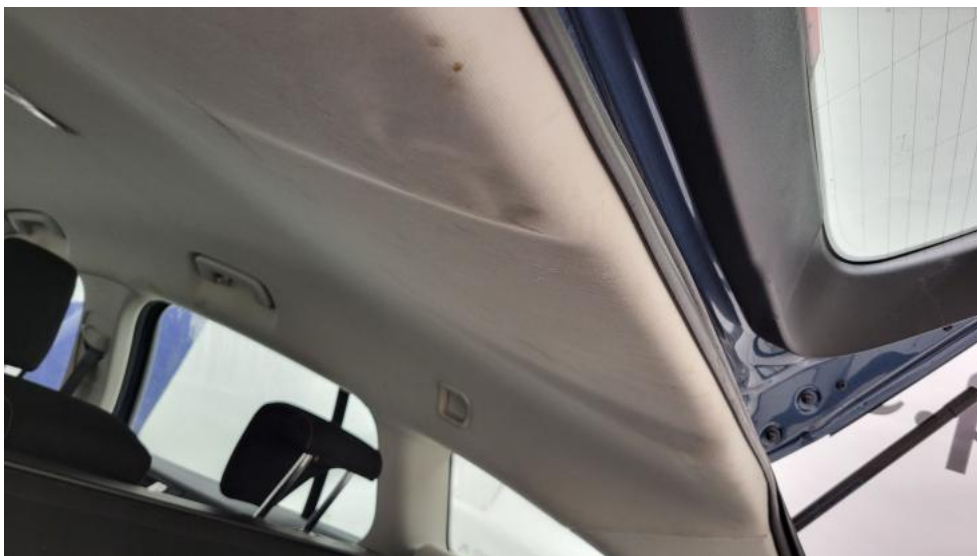
**Photo 74.**

Podsufitka - Inne 1

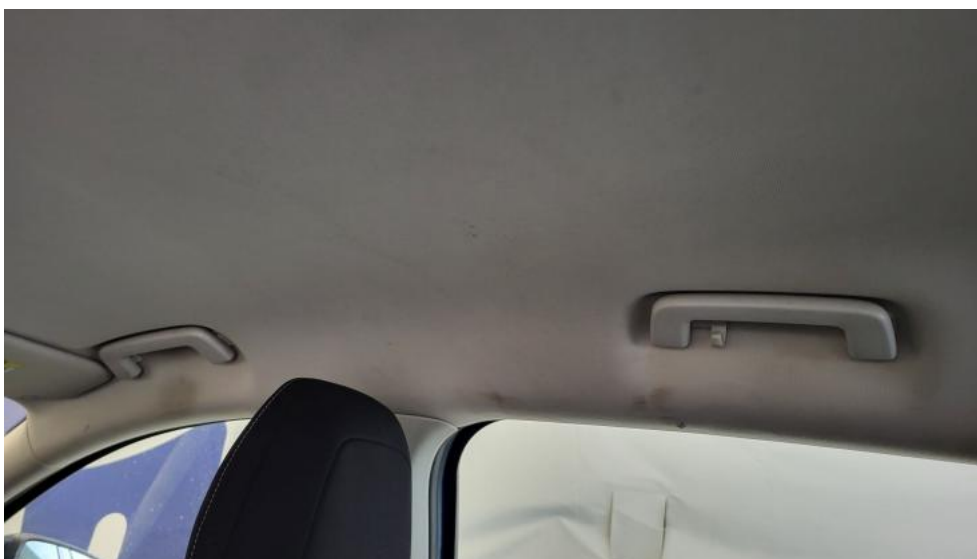
**Photo 75.**  
Podsufitka - Inne 2

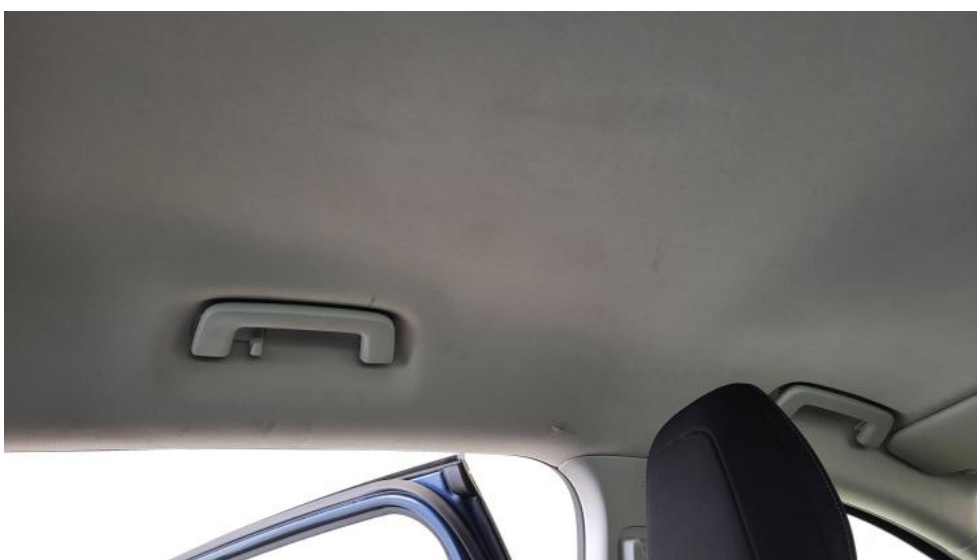
**Photo 76.**  
Podsufitka() - Inne 3

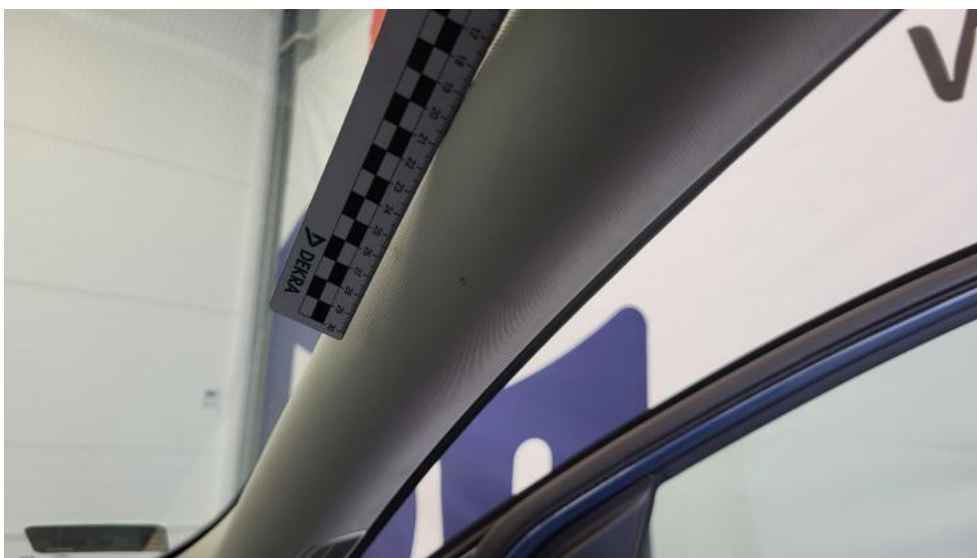
**Photo 78.**

Wykładzina(y) słupka przedniego P - Inne 1

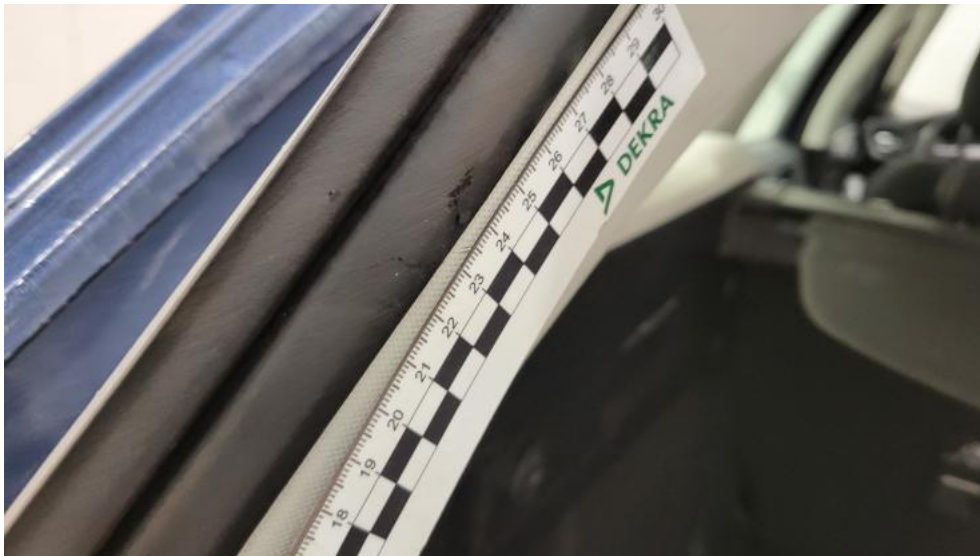
**Photo 81.**

Uszczelka pokryw tylniej - Rysa/odprysk 1

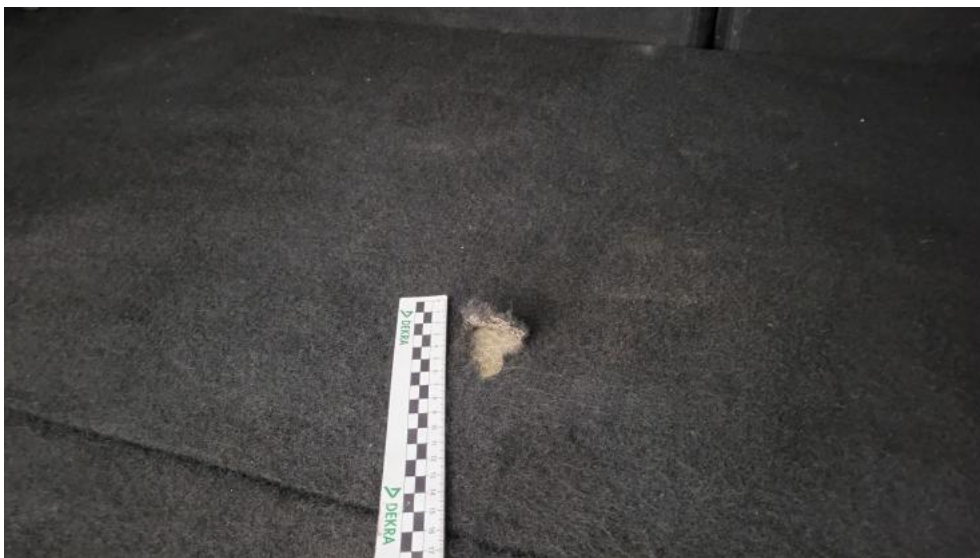
**Photo 82.**

Wykładzina podłogi bagażnika - Pęknięcie/rozerwanie 1

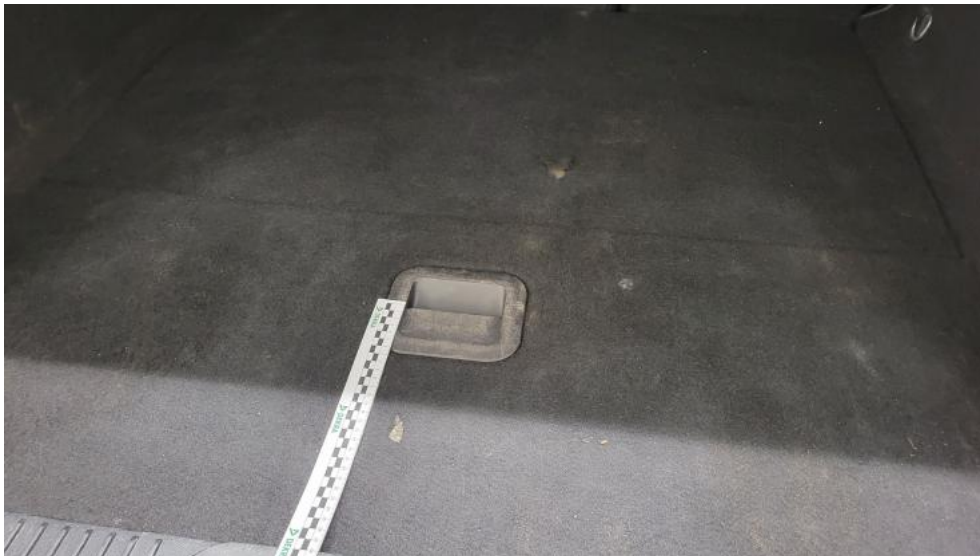
**Photo 83.**

Wykładzina podłogi bagażnika - Inne 1

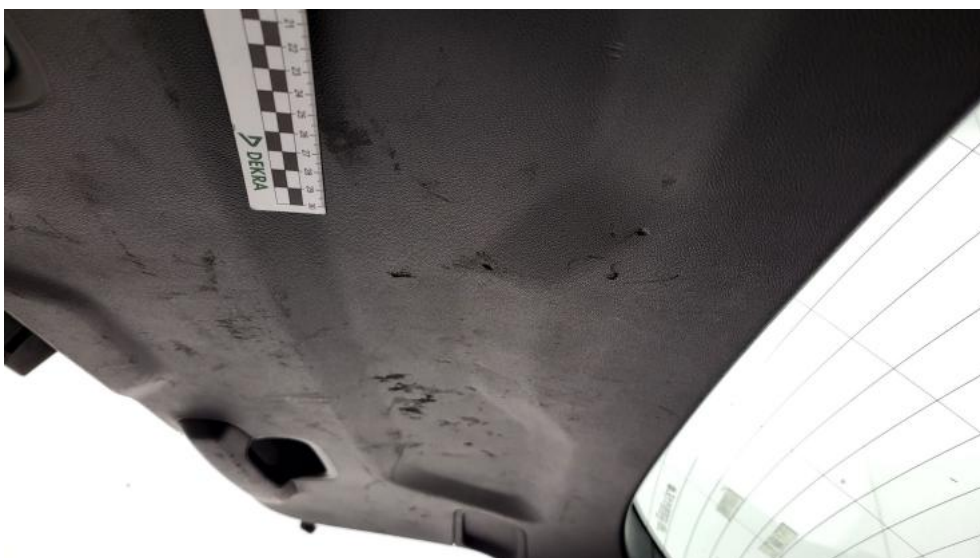
**Photo 84.**

Wykładzina pokrywy tylnej - Rysa/odprysk 1

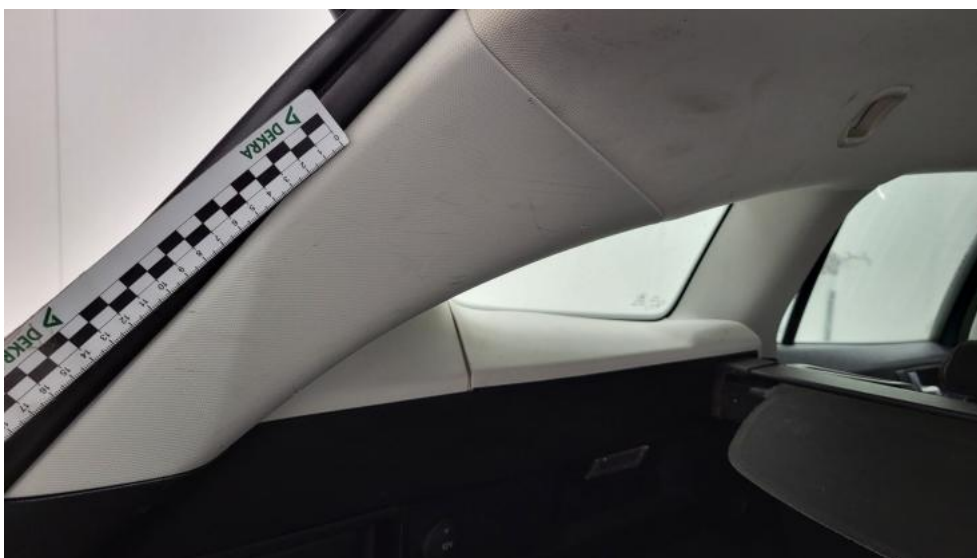
**Photo 86.**

Wykładzina przestrzeni bagażowej - Inne 2
