DEKRA's commission No. : PKOL(W)/LODZ/76737/26/08/17  
commission/ damage No. : 23/012901  
Date of commission: 17-08-2026

**Kacper Sosnowski (WSP)**  
DEKRA Polska - współpraca O/Warszawa  
**inż. Dariusz Pawliszyn**  
DEKRA Polska - O. Poznań

| Manufacturer | BMW |
| Type / version | X7 M60i xDrive mHEV sport-aut |

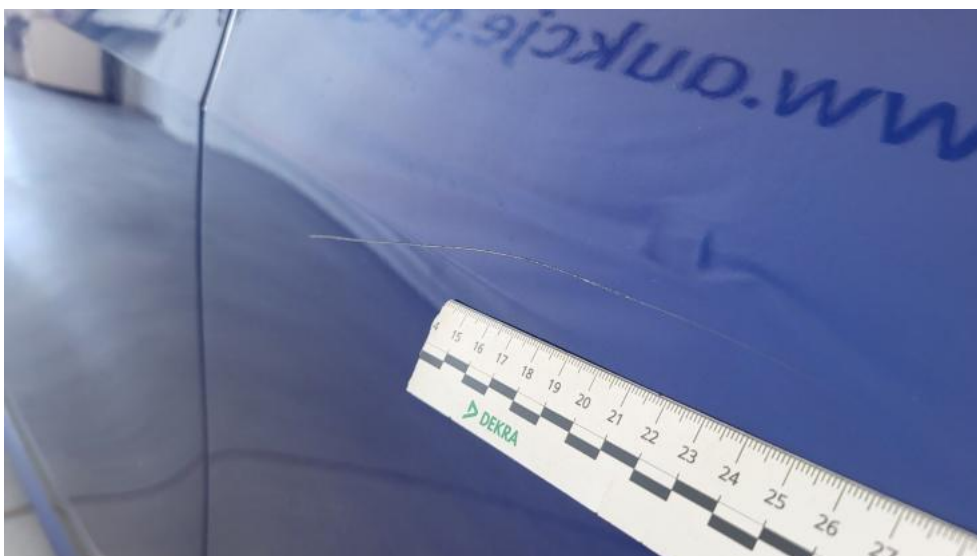
**Photo 50.**

Światnik przedni P - Rysa/odprysk 1

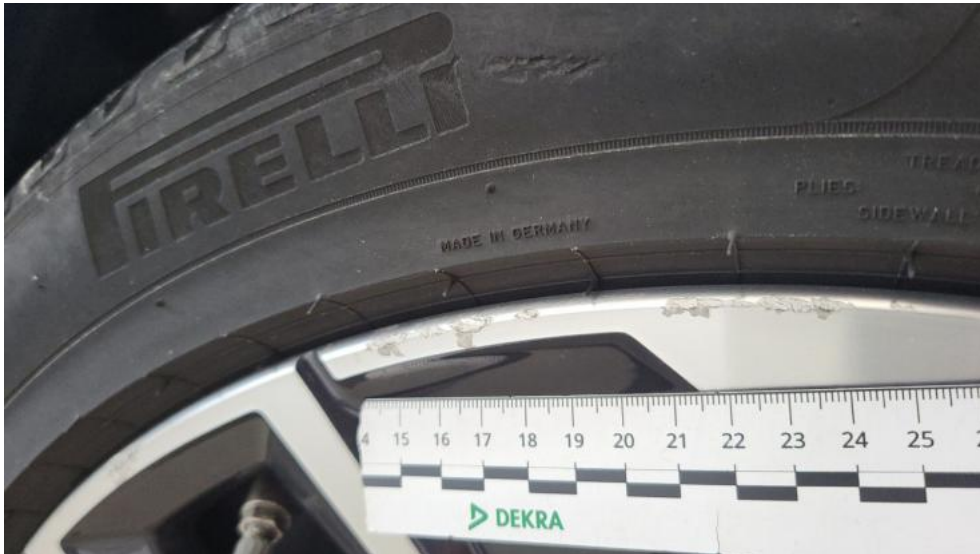
**Photo 51.**

Felga aluminiowa przednia P - Rysa/odprysk 1

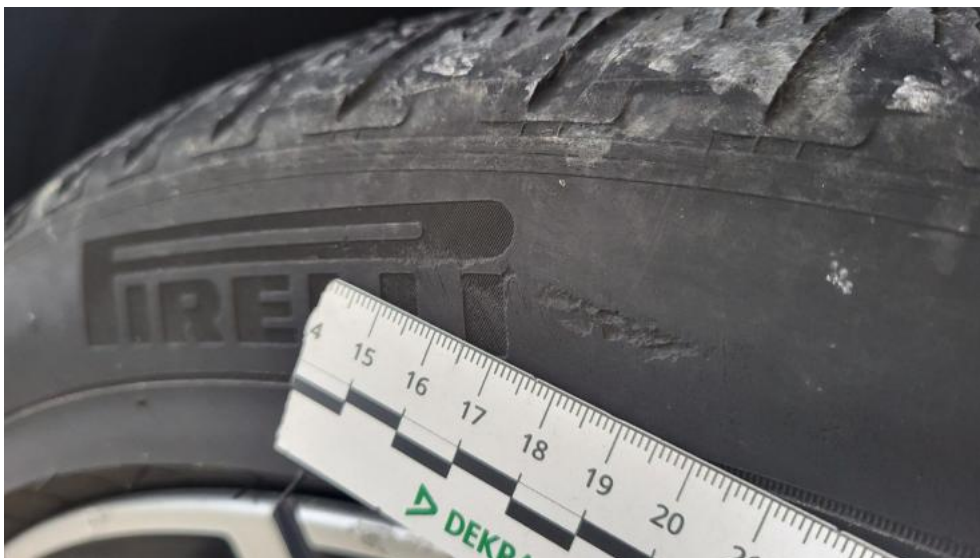
**Photo 52.**

Opona przednia P - Pęknięcie/rozerwanie 1

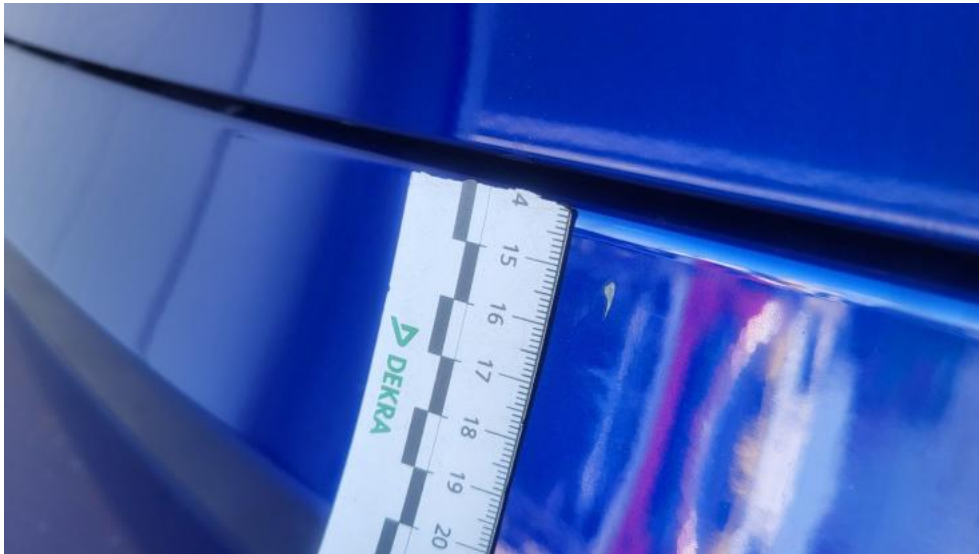
**Photo 59.**

Pokrywy bagażnika - Rysa/odprysk 1

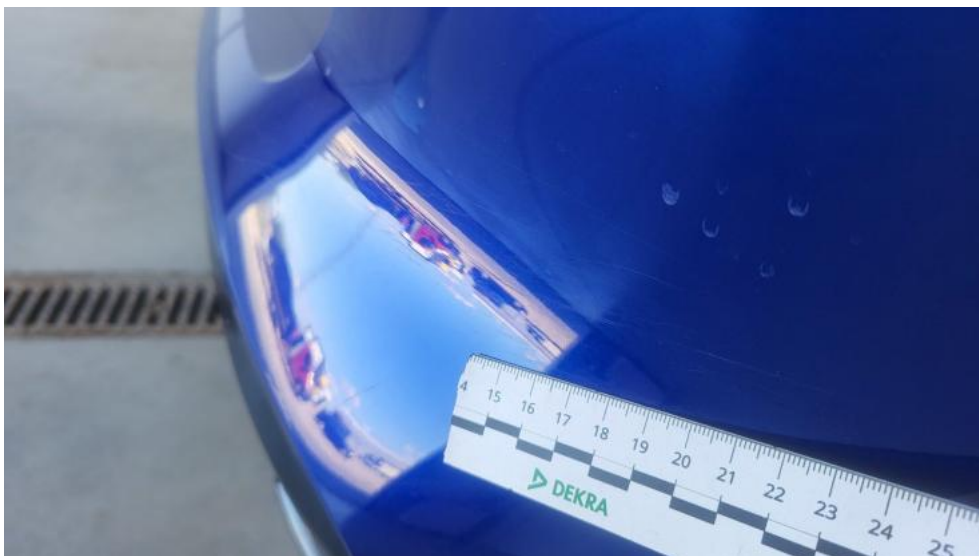
**Photo 60.**

Zderzak tylny - Rysa/odprysk 1

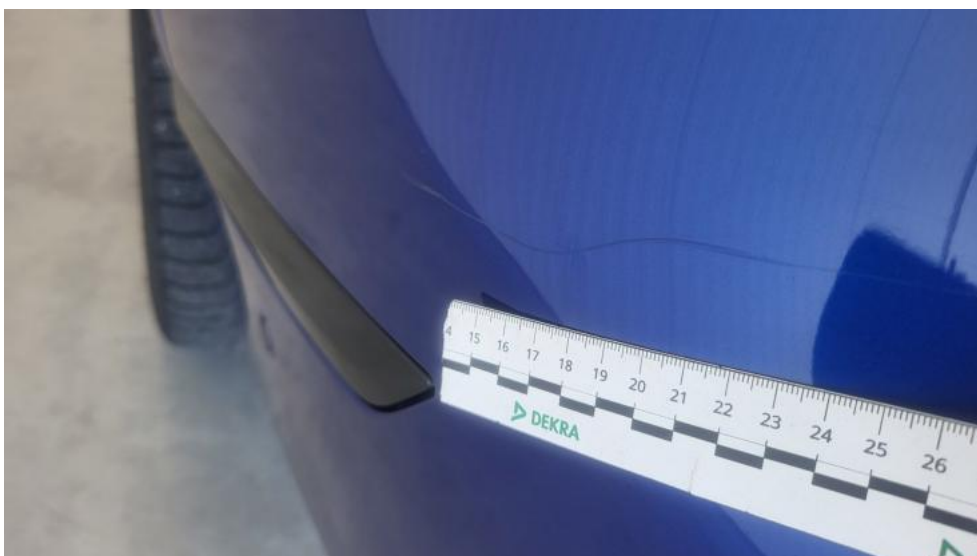
**Photo 62.**

Zderzak tylny() - Rysa/odprysk 3

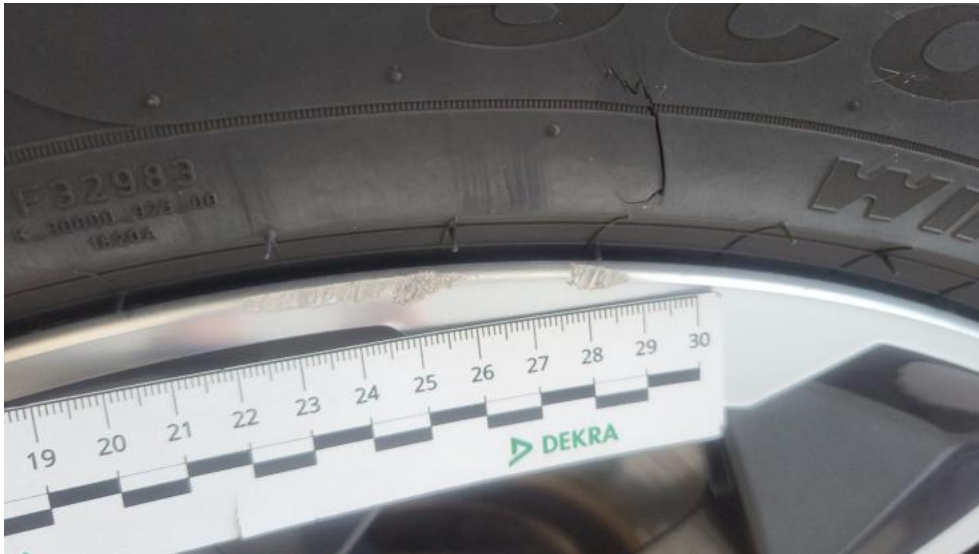
**Photo 63.**

Felga aluminiowa tylna L - Rysa/odprysk 1

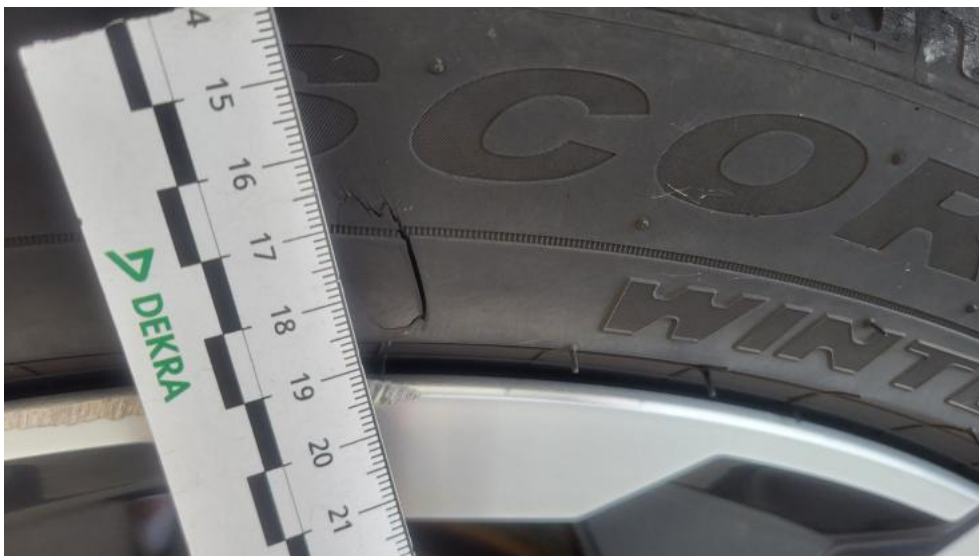
**Photo 64.**

Opona tylna L - Pęknięcie/rozerwanie 1

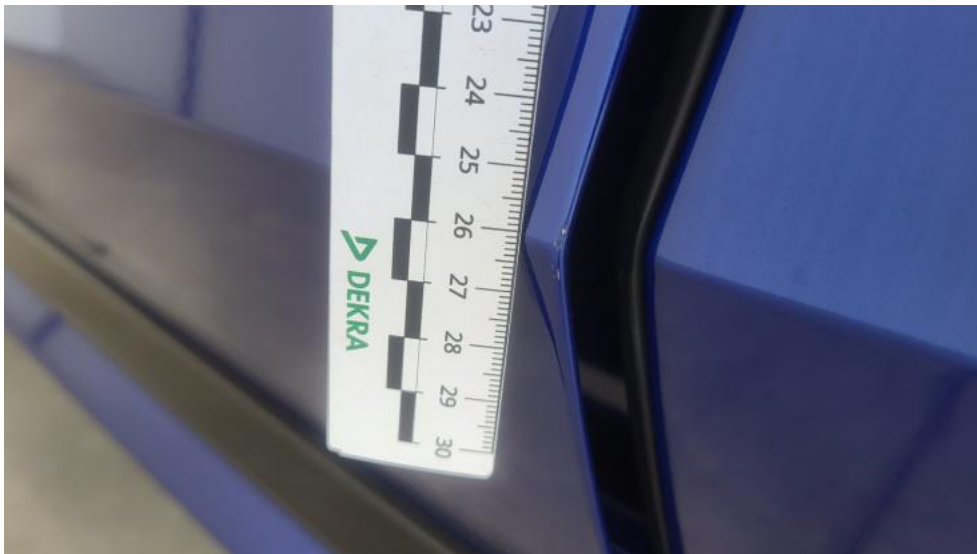
**Photo 65.**

Drzwi przed L - Rysa/odprysk 1

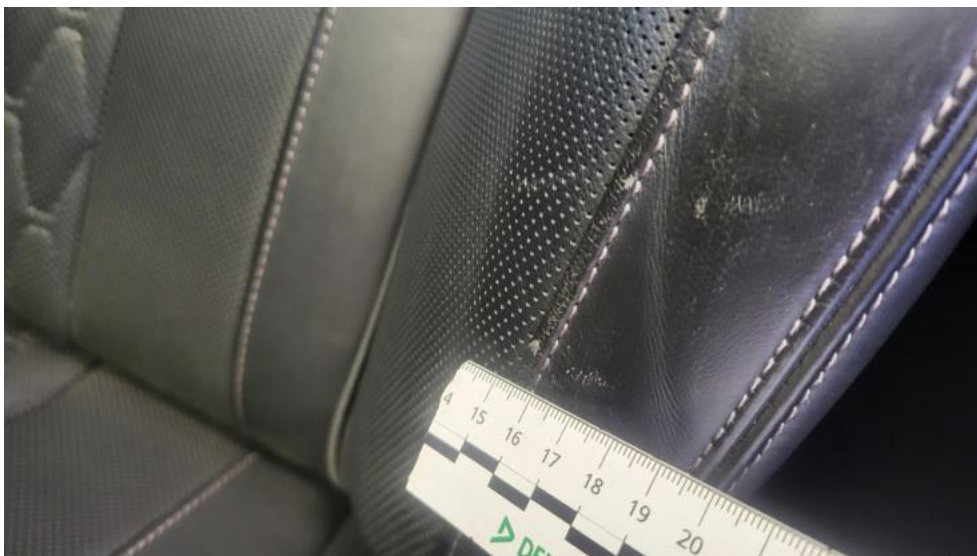
**Photo 71.**

Fotel prz. lew. - Rysa/odprysk 1
