DEKRA's commission No. : PKOL(W)/LODZ/78584/26/08/21  
commission/ damage No. : 24/022138  
Date of commission: 21-08-2026

**Vehicle data**

| Manufacturer | AUDI |
| Model | A3 Sportback 20-24 |

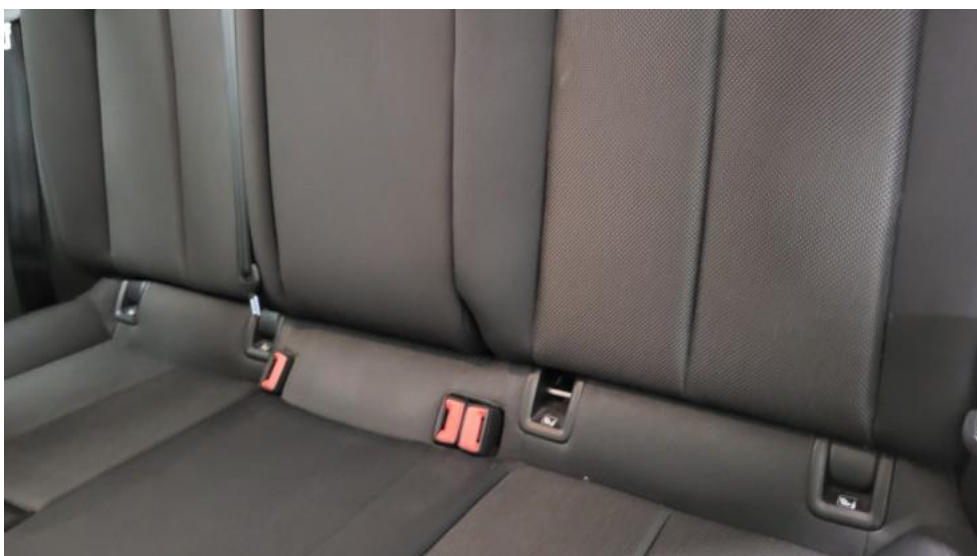
**Photo 38.**

Zaślepka ISFOIX - brak

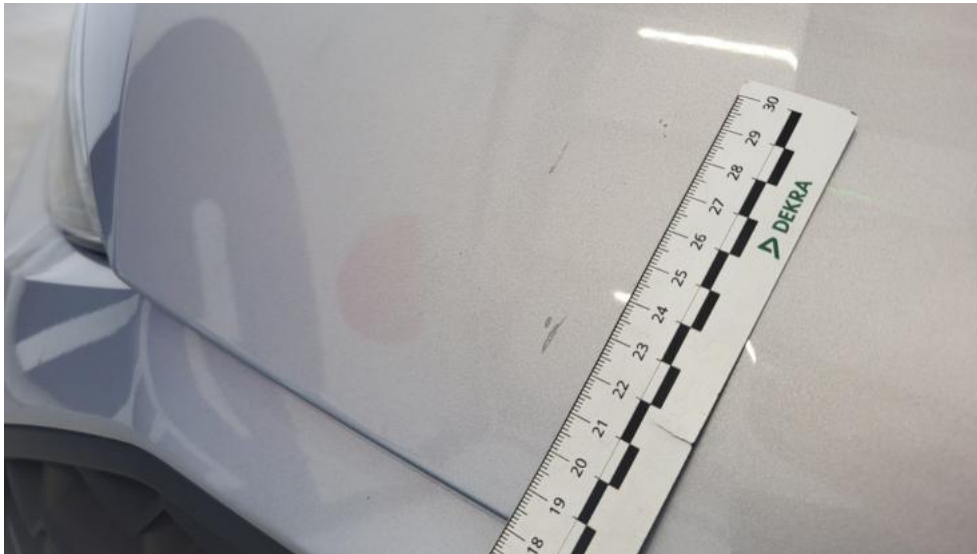
**Photo 39.**

Pokrywa komory silnika - Rysa/odprysk 1

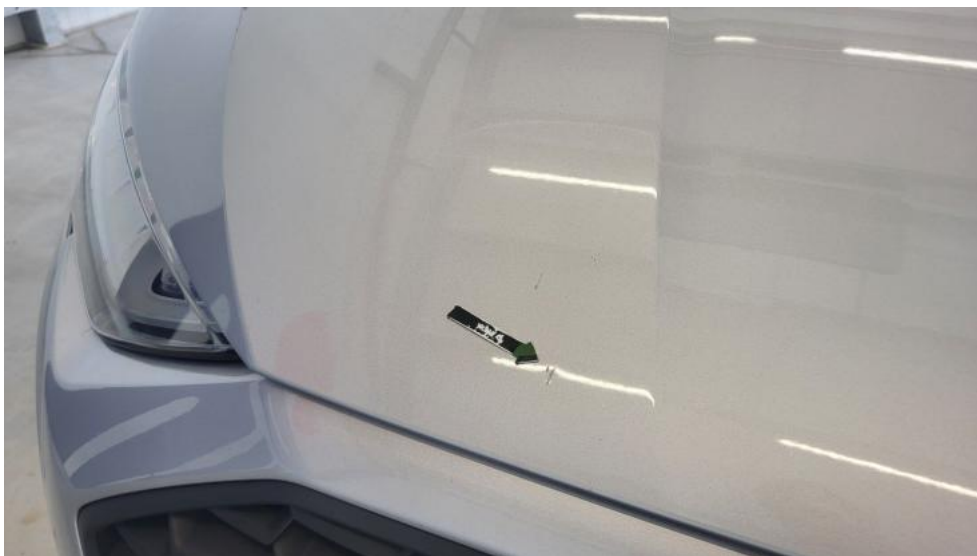
**Photo 40.**

Pokrywa komory silnika - Wgniecenie/odkształcenie 1

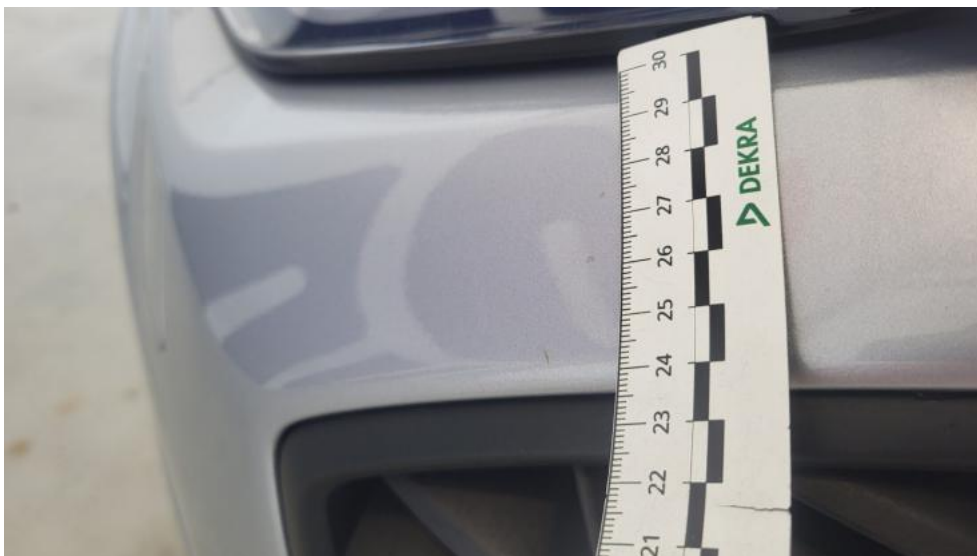
**Photo 41.**

Zderzak - Rysa/odprysk 1

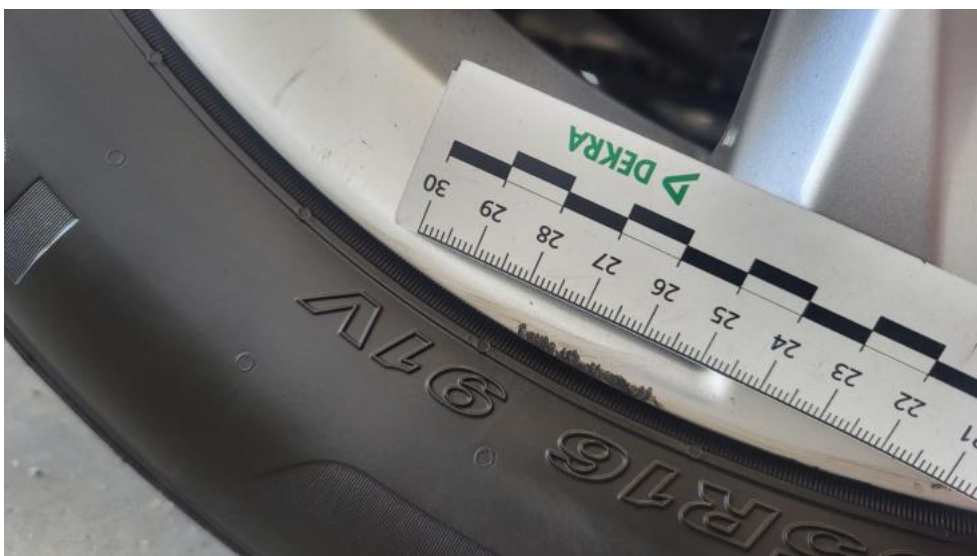
**Photo 42.**

Felga aluminiowa przednia P - Rysa/odprysk 1

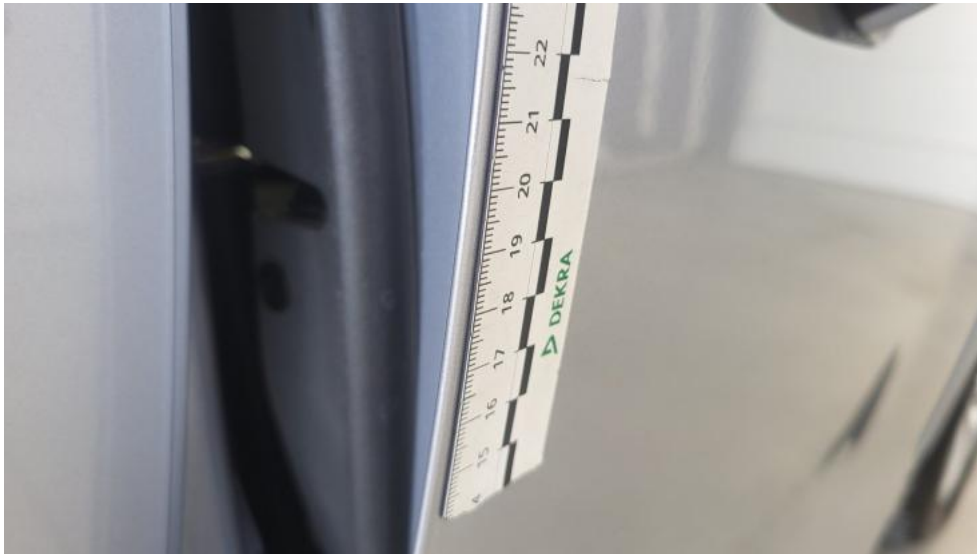
**Photo 43.**

Drzwi przednie P - Rysa/odprysk 1

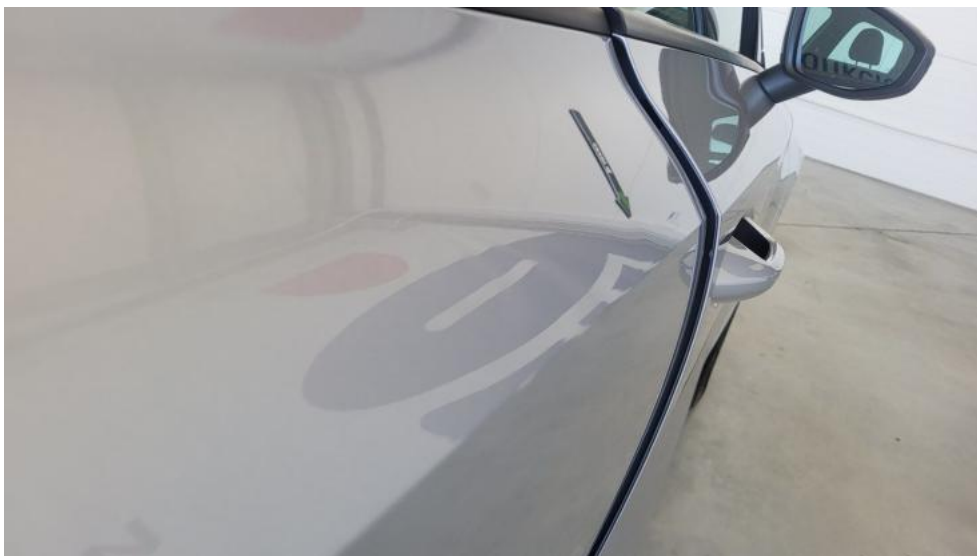
**Photo 44.**

Drzwi tylne P - Wgniecenie/odkształcenie 1

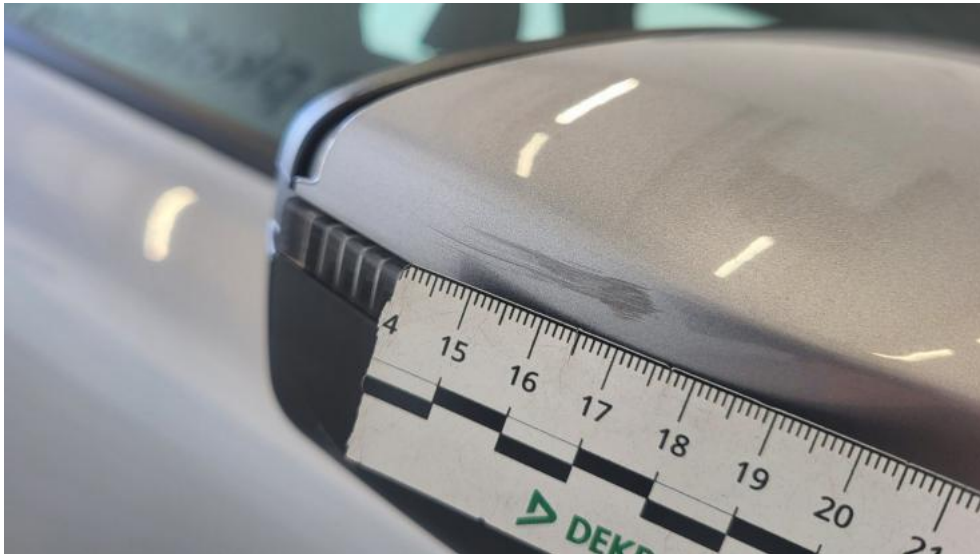
**Photo 45.**

Lusterko zew P - Rysa/odprysk 1

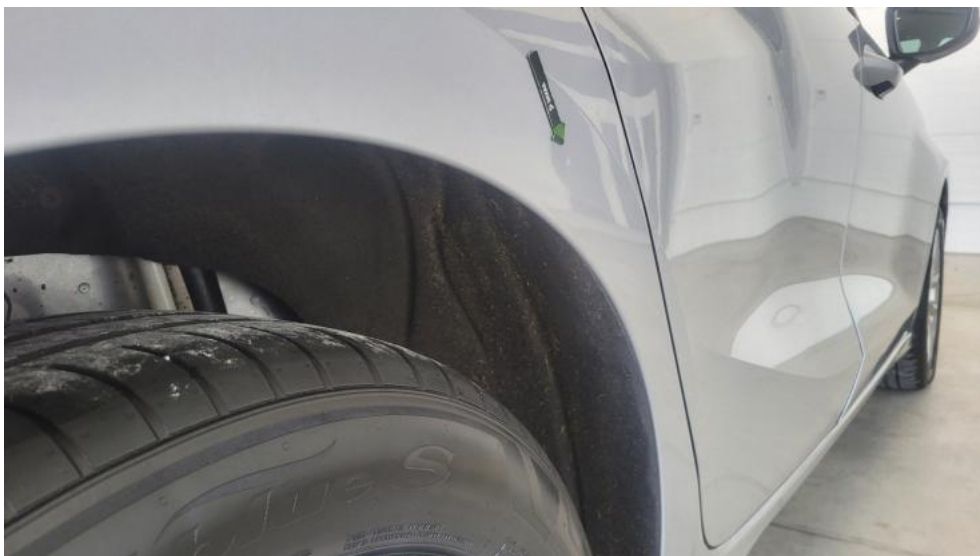
**Photo 46.**

Łotnik tylny P / Ściana boczna P - Wgniecenie/odkształcenie 1

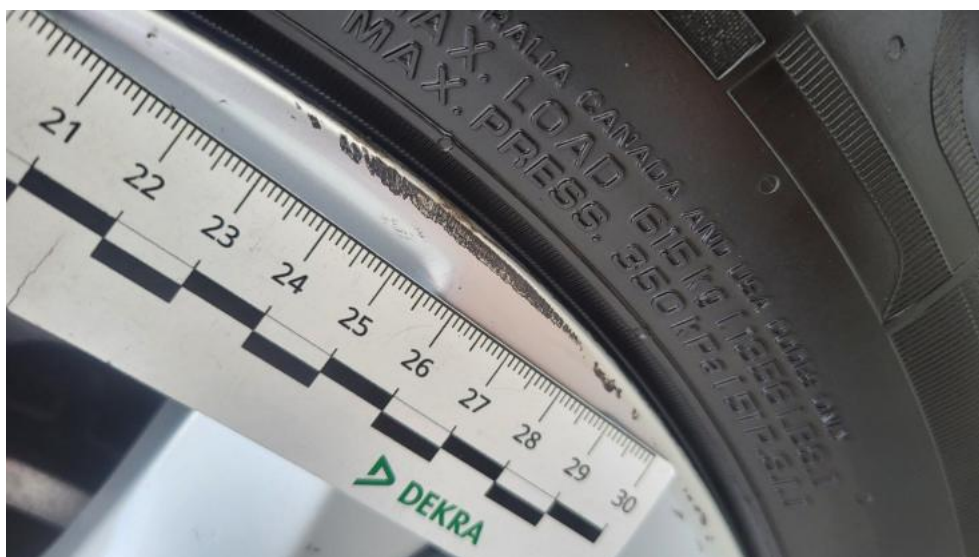
**Photo 47.**

Felga aluminiowa tylna P - Rysa/odprysk 1

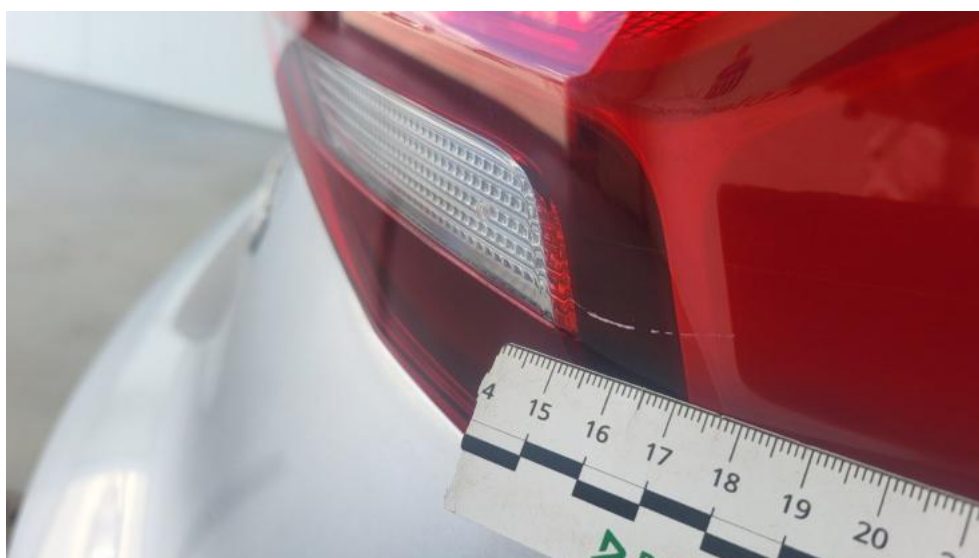
**Photo 48.**

Lampa tylna zew P - Rysa/odprysk 1

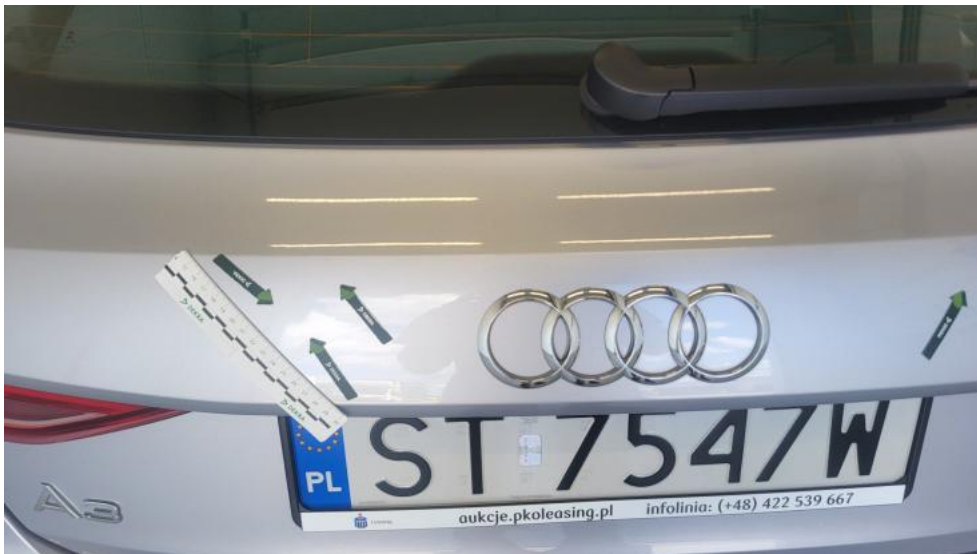
**Photo 49.**

Pokrywy bagażnika - Wgniecenie/odkształcenie 1

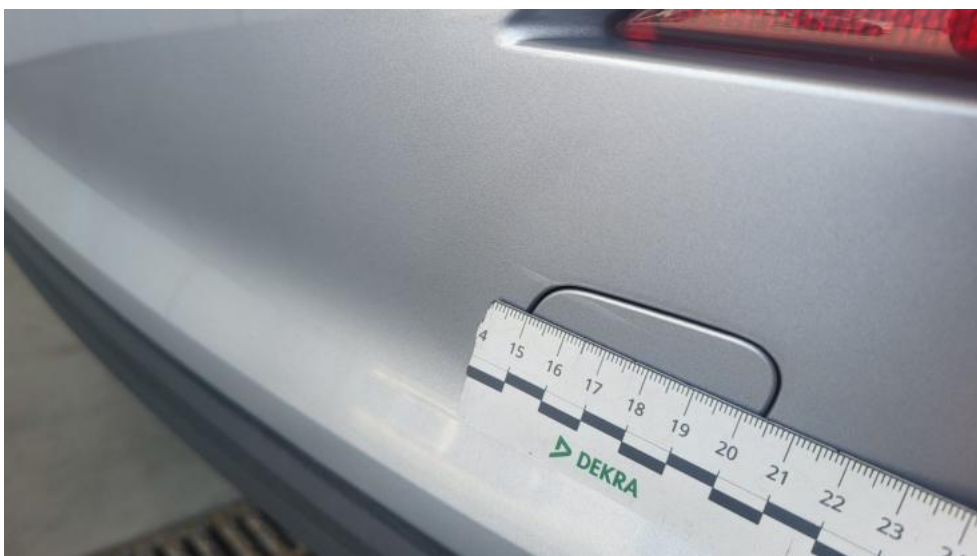
**Photo 50.**

Zaślepka tyl haka hol. - Rysa/odprysk 1

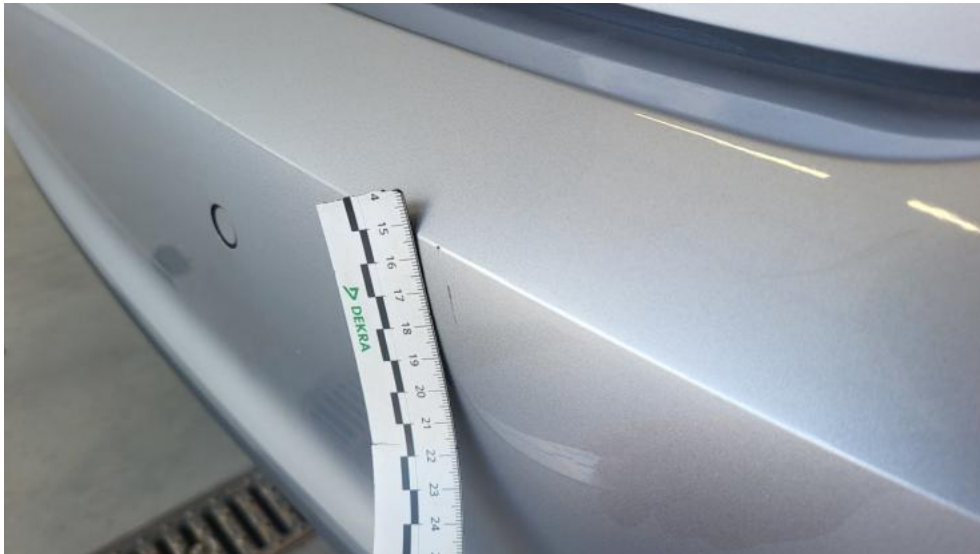
**Photo 51.**

Zderzak tylny - Rysa/odprysk 1

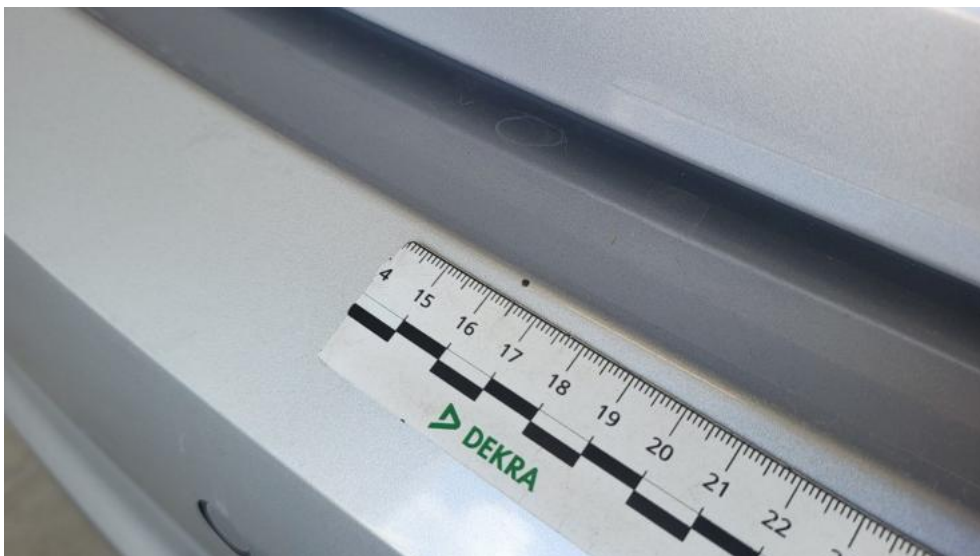
**Photo 52.**

Zderzak tylny - Rysa/odprysk 2

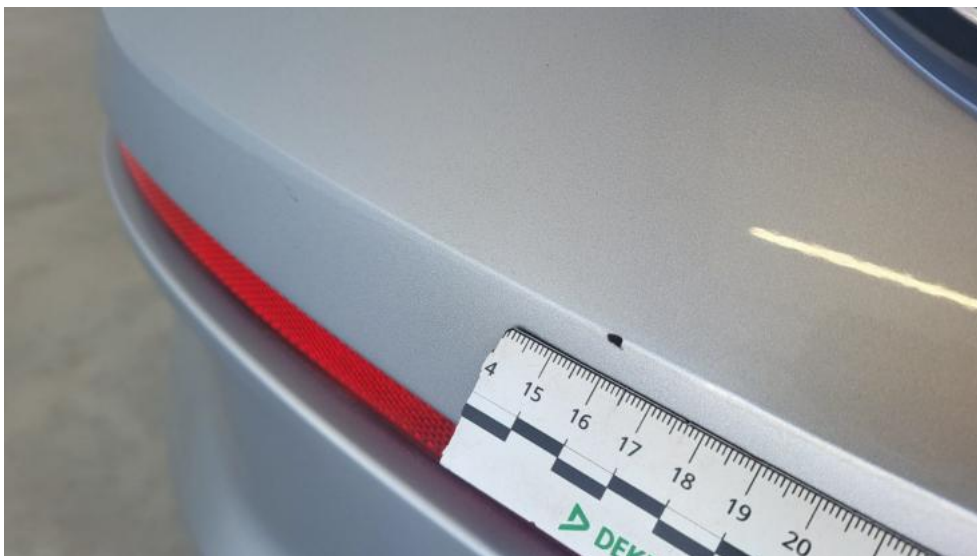
**Photo 53.**

Zderzak tylny() - Rysa/odprysk 3

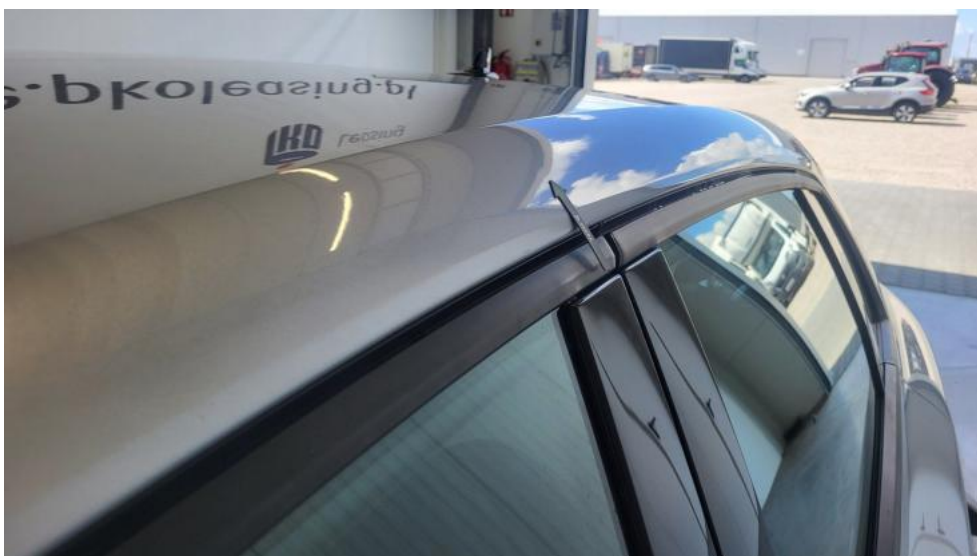
**Photo 54.**

Błotnik tylny L / Ściana boczna L - Wgniecenie/odkształcenie 1

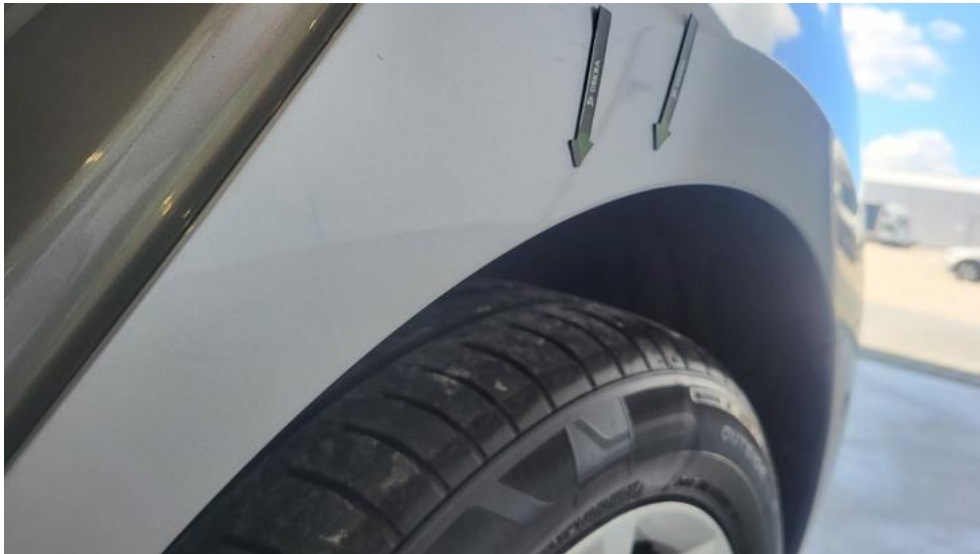
**Photo 55.**

Błotnik tylny L / Ściana boczna L - Wgniecenie/odkształcenie 2

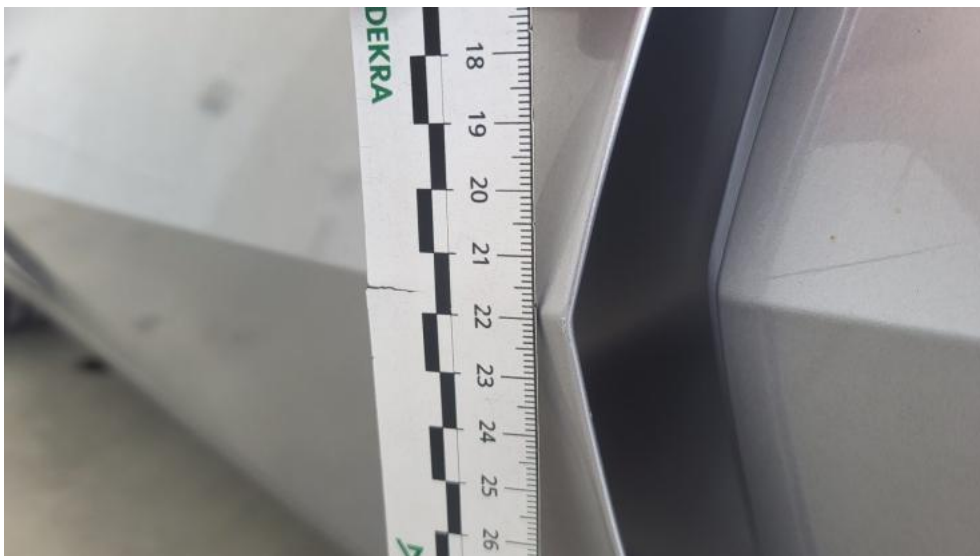
**Photo 56.**

Drzwi przed L - Rysa/odprysk 1

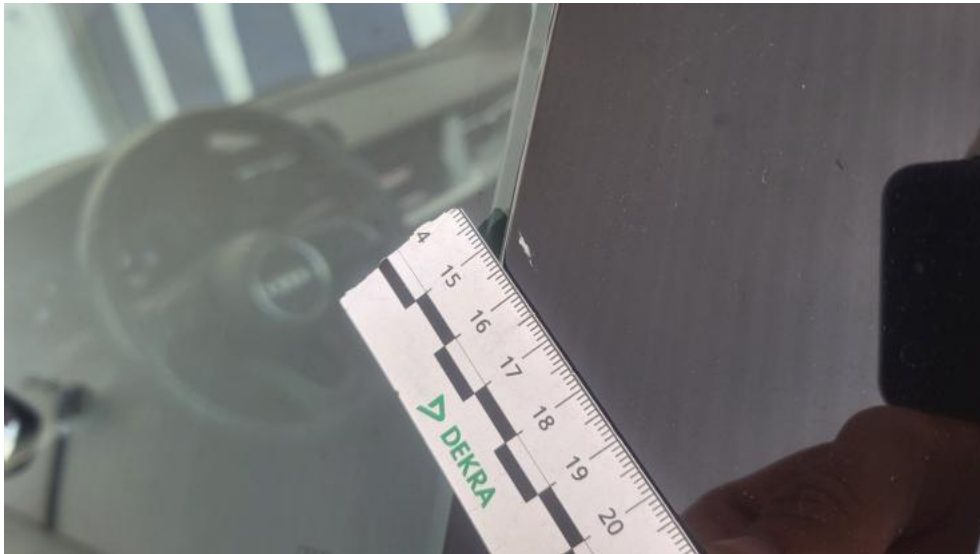
**Photo 57.**

Drzwi przed L - Rysa/odprysk 2

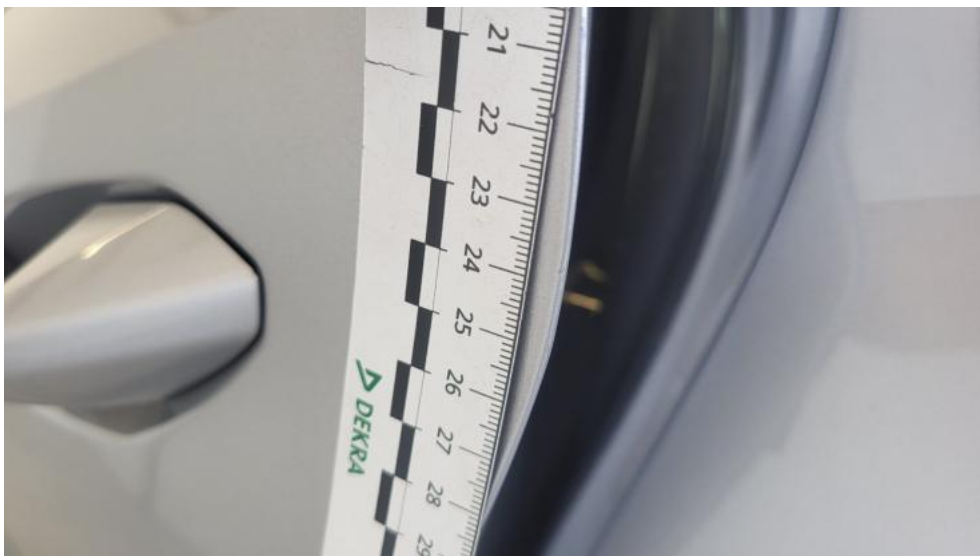
**Photo 58.**

Drzwi tylne L - Rysa/odprysk 1

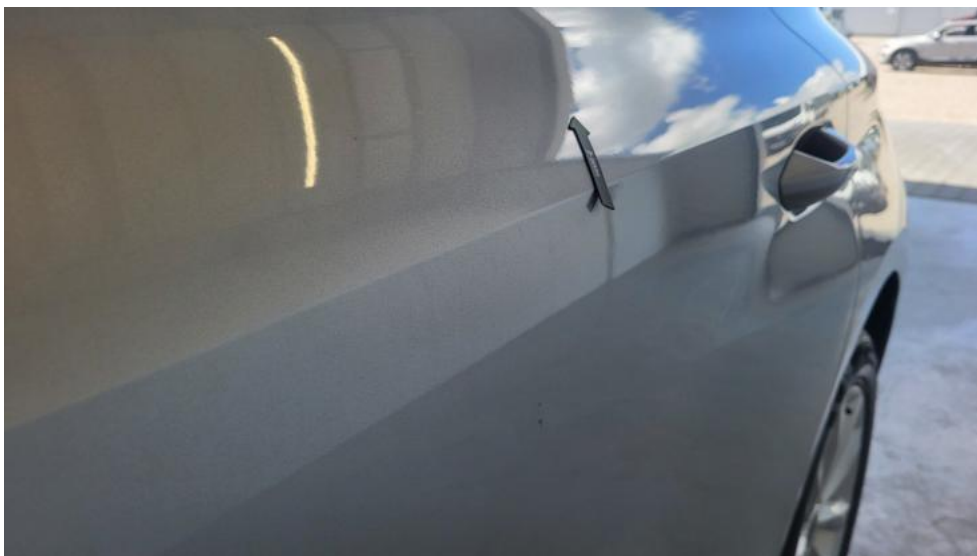
**Photo 59.**

Drzwi tylne L - Wgniecenie/odkształcenie 1

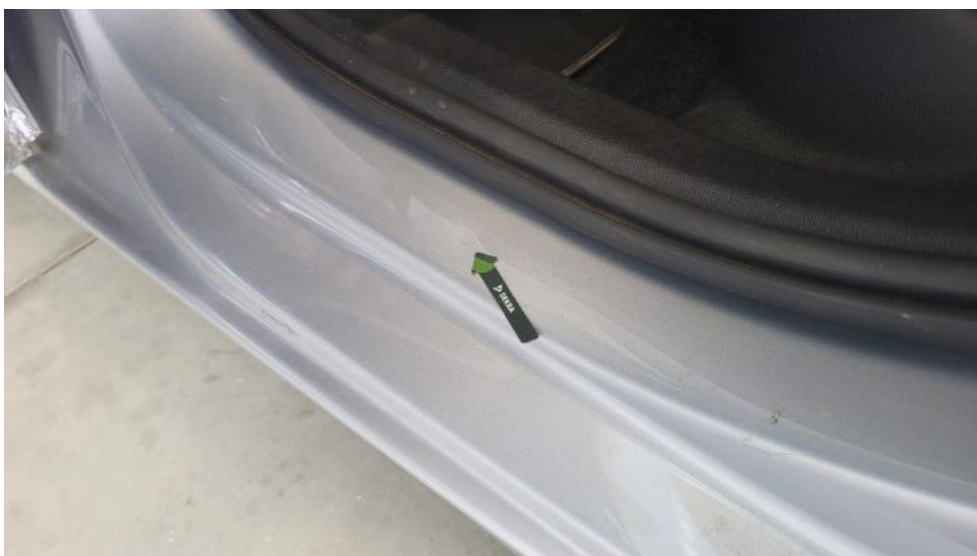
**Photo 60.**

Próg L - Wgniecenie/odkształcenie 1

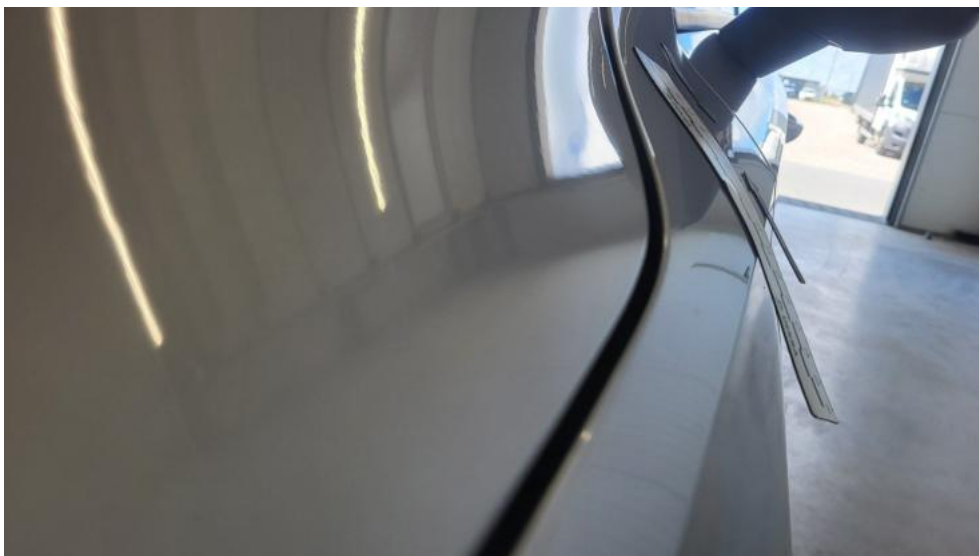
**Photo 62.**

Błotnik przedni L - Wgniecenie/odkształcenie 1

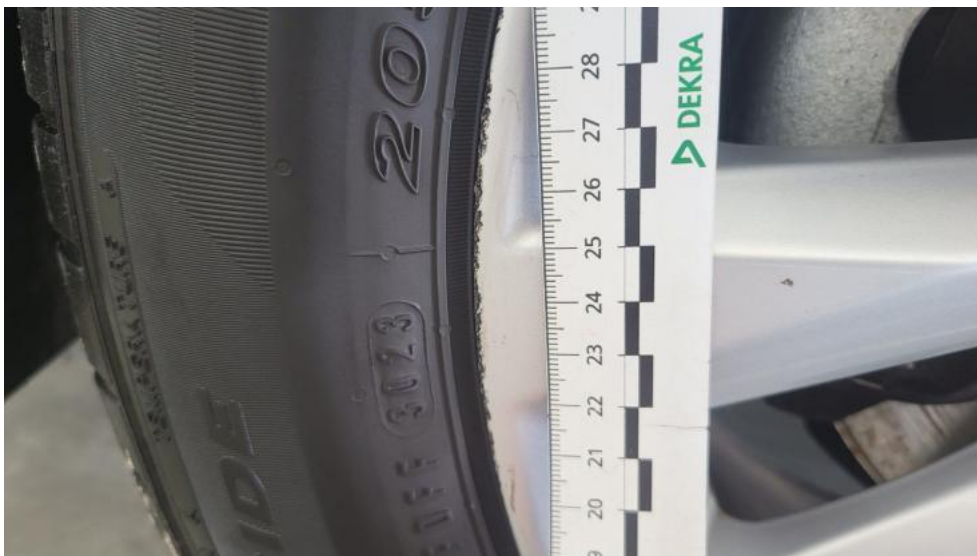
**Photo 63.**

Felga Aluminiowa przednia L - Rysa/odprysk 1

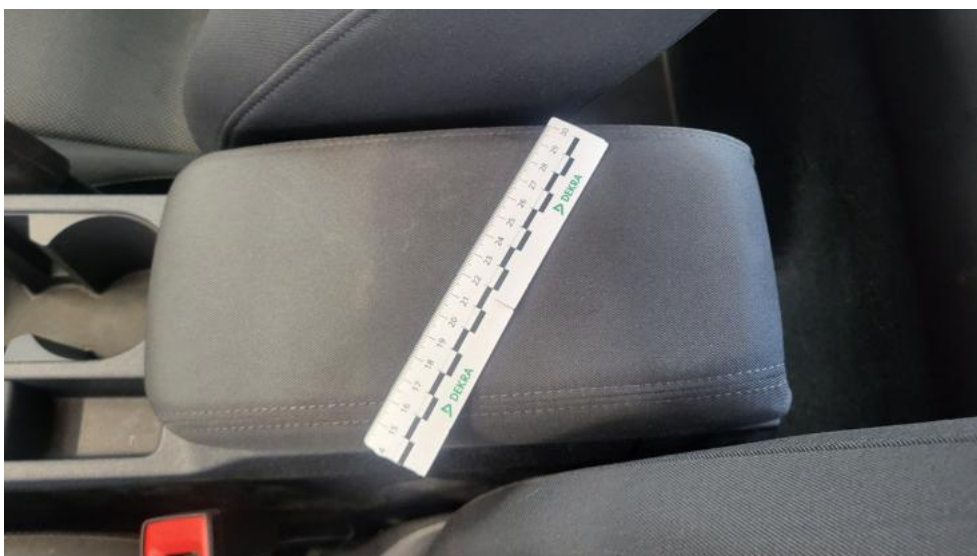
**Photo 64.**

Podłokietnik środkowy przedni - Inne 1

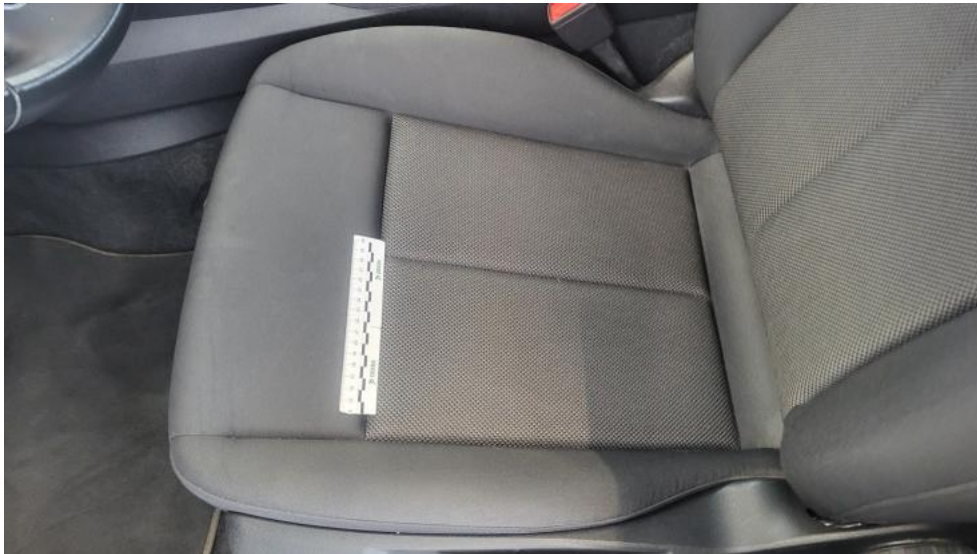
**Photo 65.**

Fotel prz. lew. - Inne 1

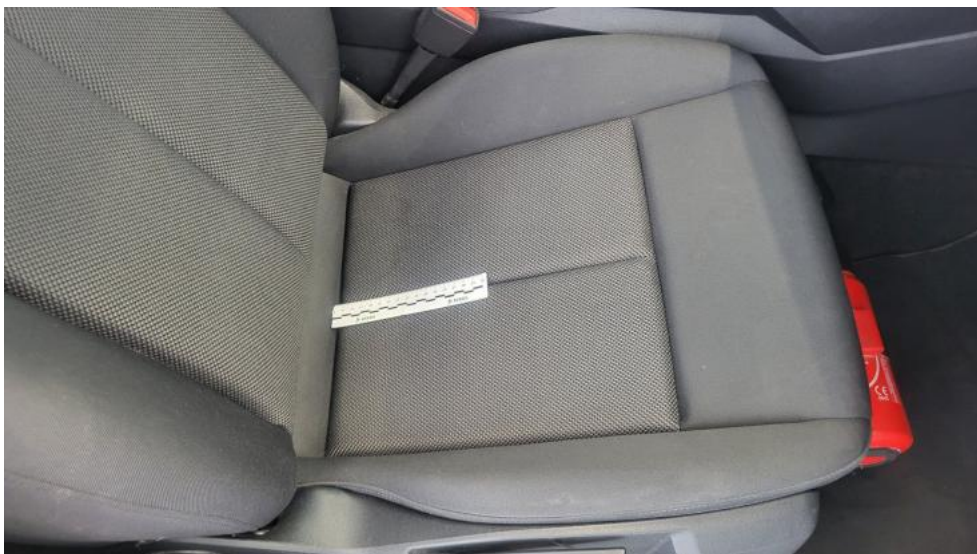
**Photo 66.**

Fotel prz. praw. - Inne 1

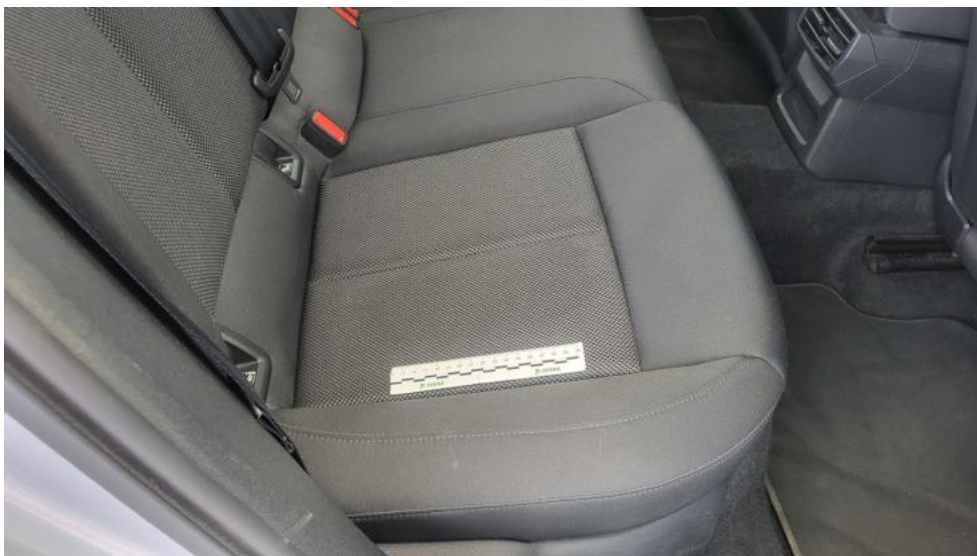
**Photo 67.**

Kanapa tyl. - Inne 1
