DEKRA's commission No. : PKOL(W)/LODZ/81599/26/09/01  
commission/ damage No. : 26/010890  
Date of commission: 01-09-2026

**Vehicle data**

| Manufacturer | MAZDA |
| Model | MX-30 EV 20- |

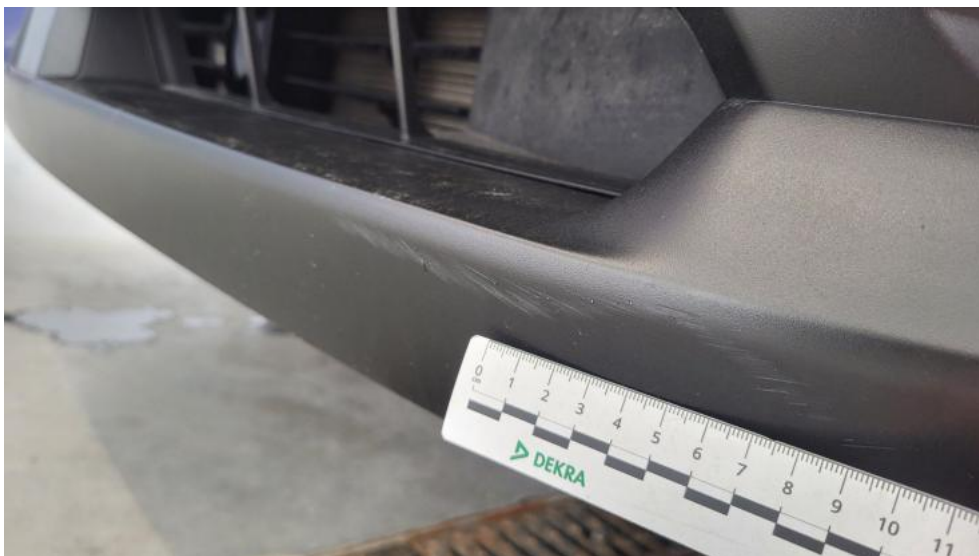
**Photo 40.**

Zderzak przedni cz dolna - Rysa/odprysk 1

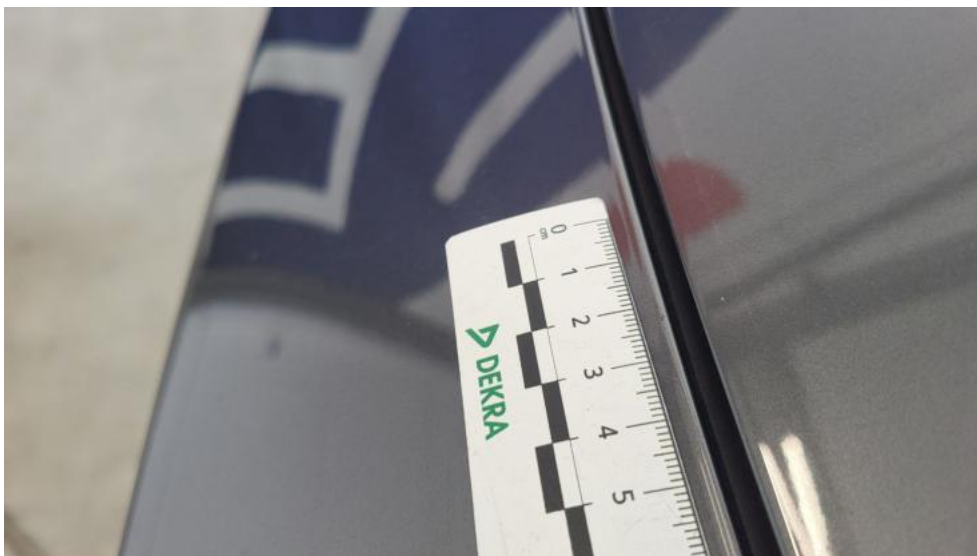
**Photo 41.**

Zderzak przedni cz górna - Rysa/odprysk 1

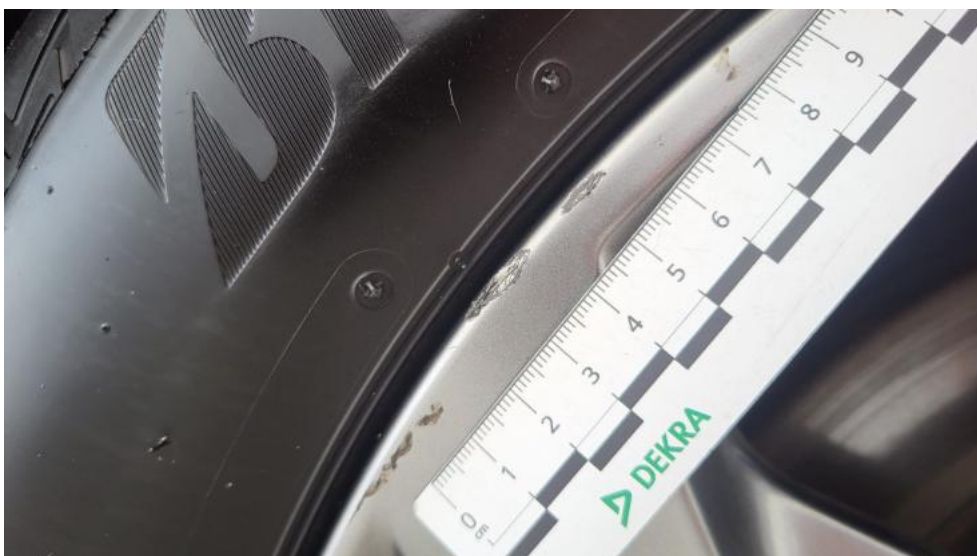
**Photo 42.**

Felga aluminiowa przednia P - Rysa/odprysk 1

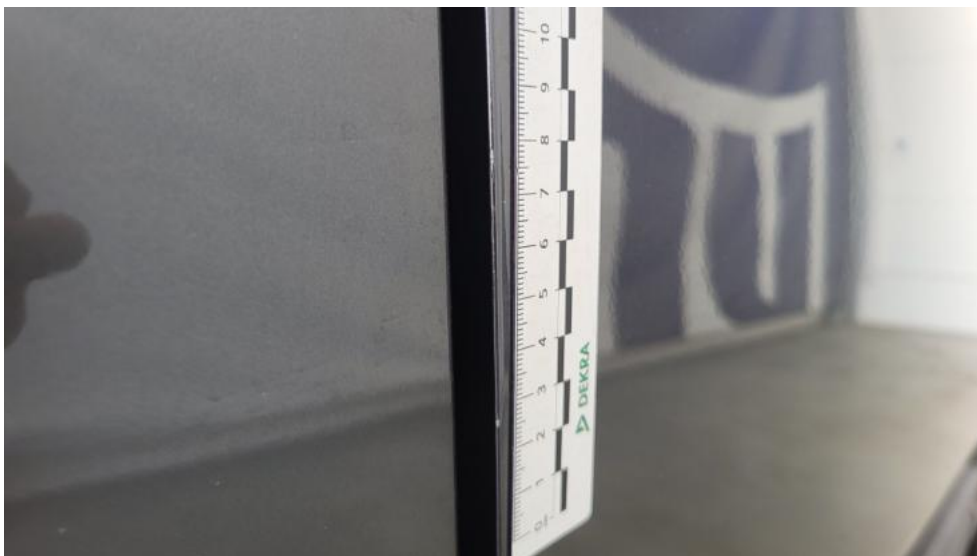
**Photo 43.**

Drzwi przednie P - Rysa/odprysk 1

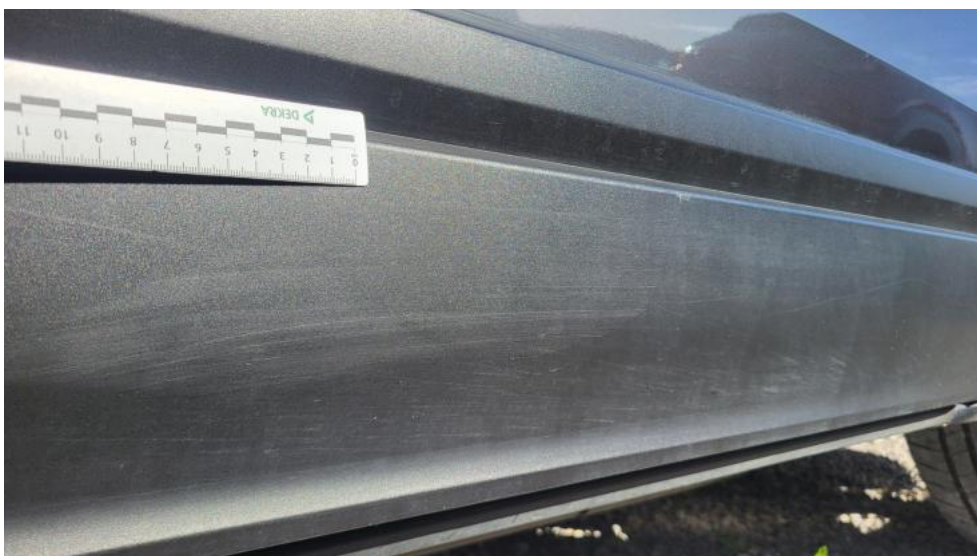
**Photo 44.**

Listwa drzwi przednich P - Rysa/odprysk 1

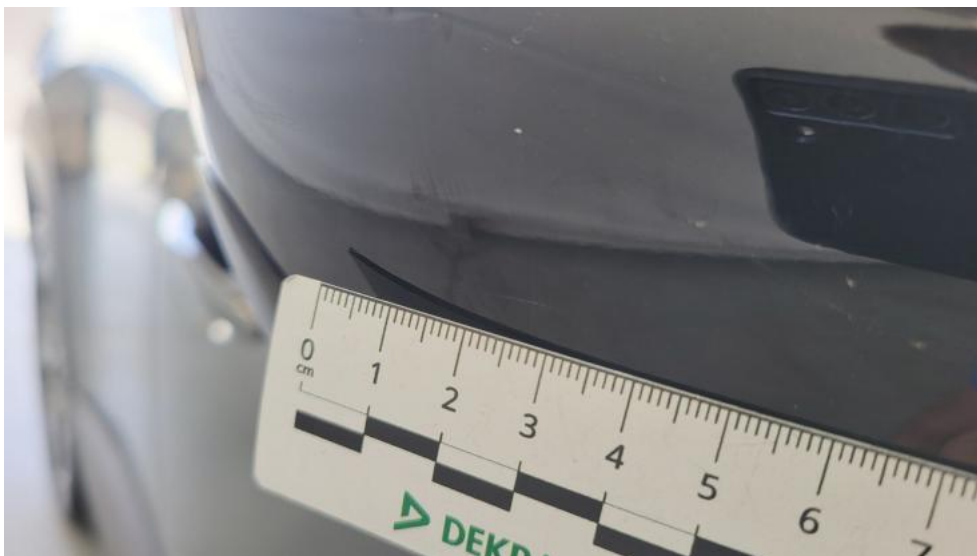
**Photo 45.**

Lusterko zew P - Rysa/odprysk 1

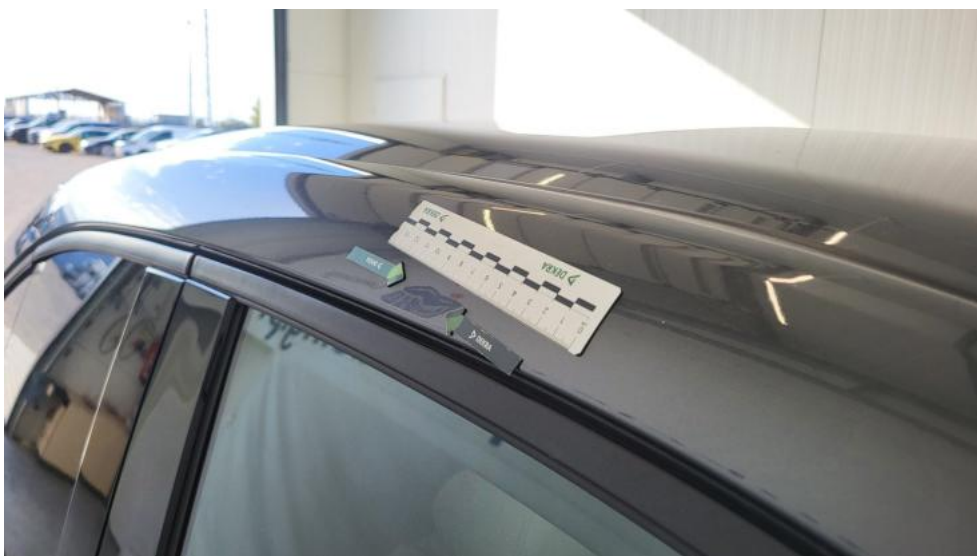
**Photo 46.**

Słupek przedni P - Wgniecenie/odkształcenie 1

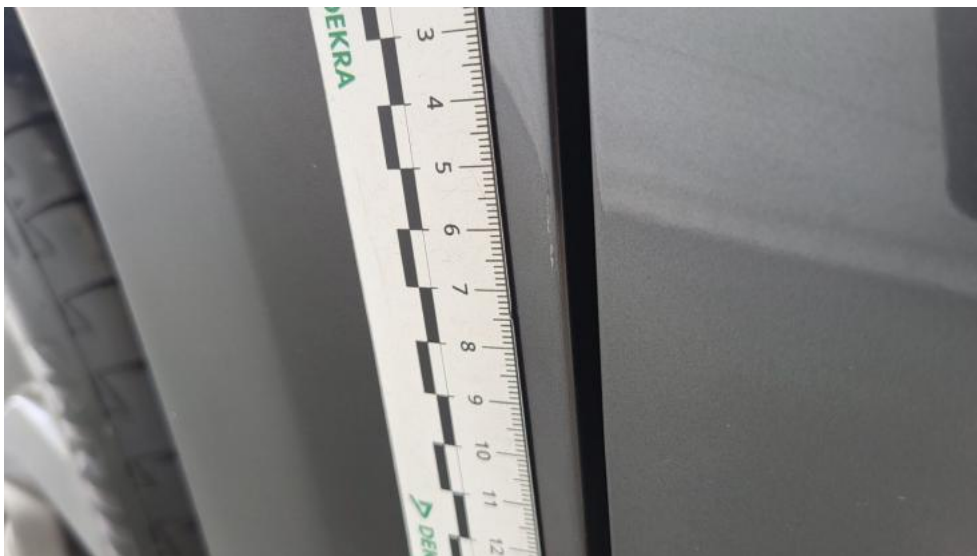
**Photo 47.**

Błotnik tylny P / Ściana boczna P - Rysa/odprysk 1

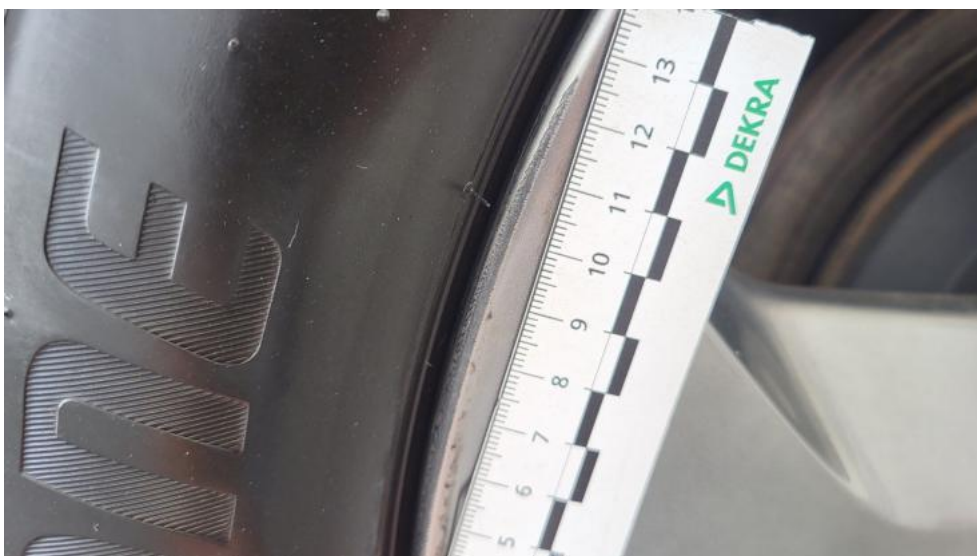
**Photo 48.**

Felga aluminiowa tylna P - Rysa/odprysk 1

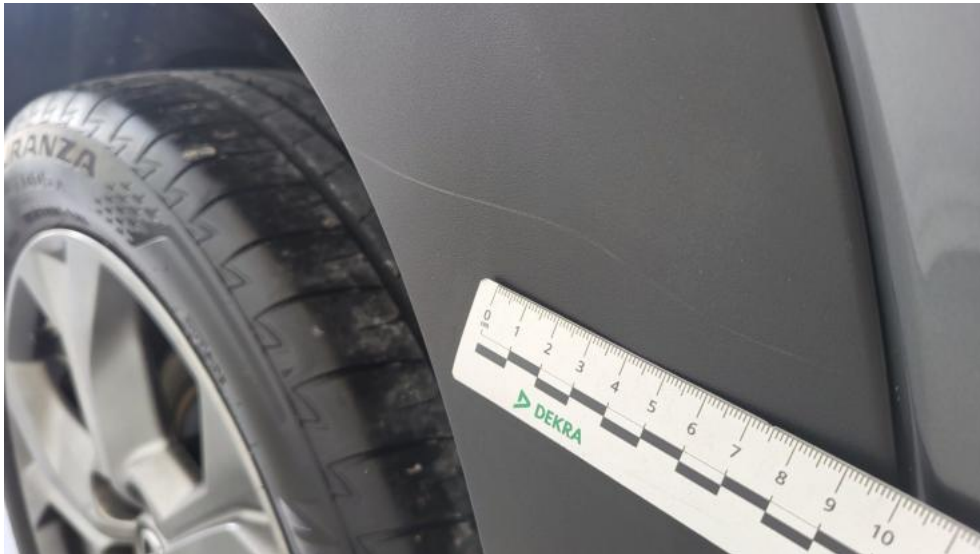
**Photo 49.**

Listwa krawędzi błotnika tyl P - Rysa/odprysk 1

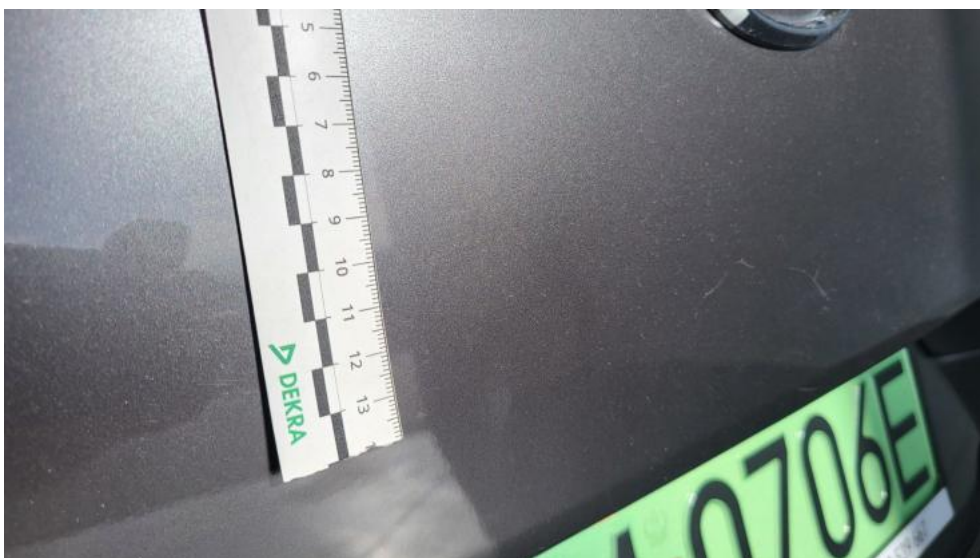
**Photo 50.**

Pokrywy bagażnika - Wgniecenie/odkształcenie 1

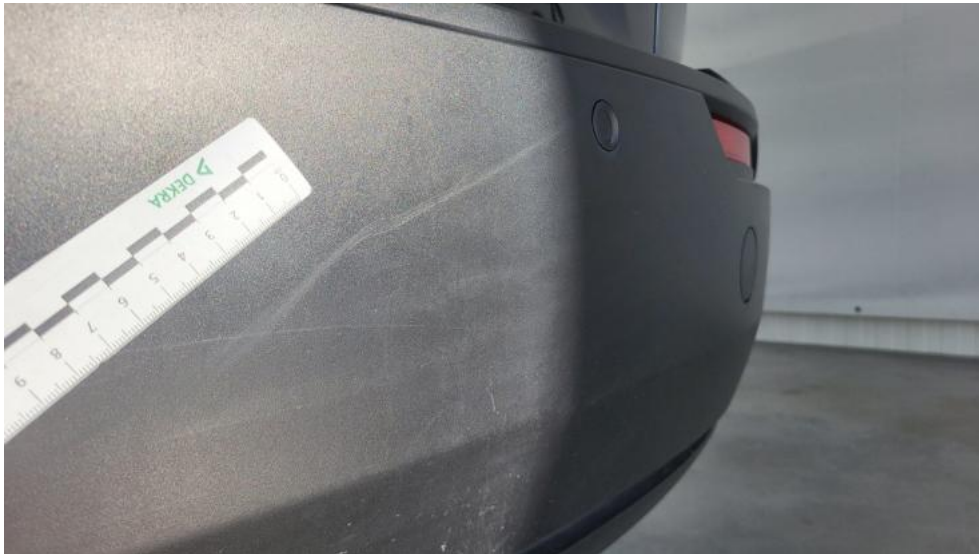
**Photo 51.**

Zderzak tylny - Rysa/odprysk 1

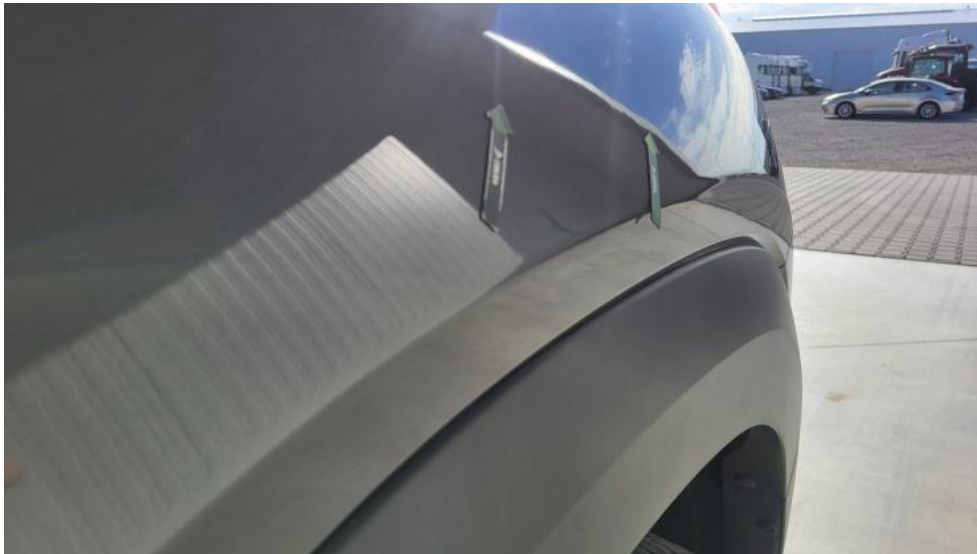
**Photo 53.**

Błotnik tylny L / Ściana boczna L - Wgniecenie/odkształcenie 1

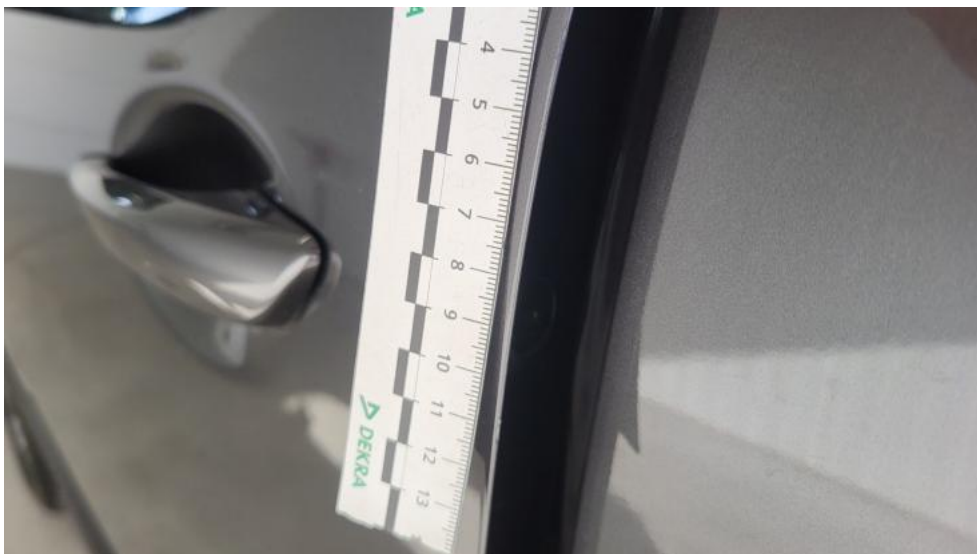
**Photo 54.**

Drzwi przed L - Rysa/odprysk 1

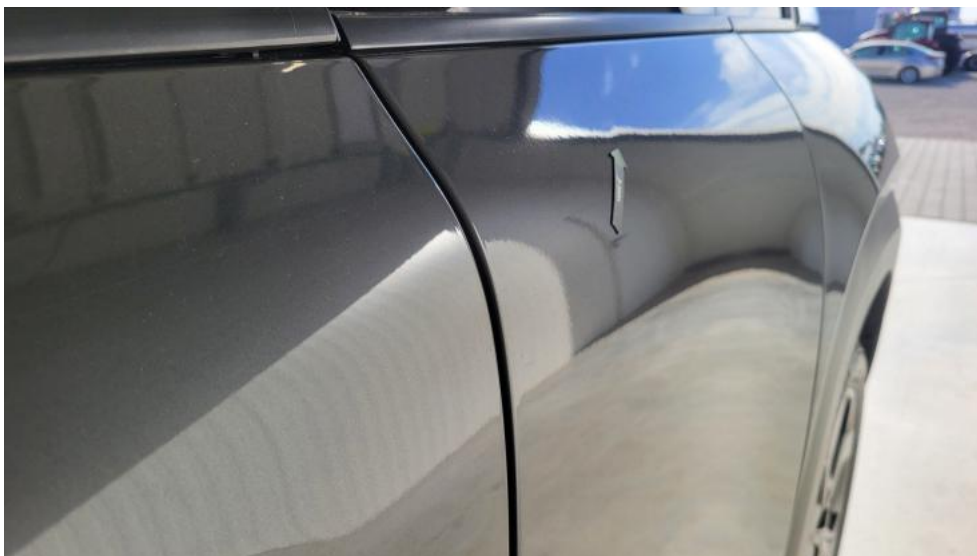
**Photo 55.**

Drzwi tylne L - Wgniecenie/odkształcenie 1

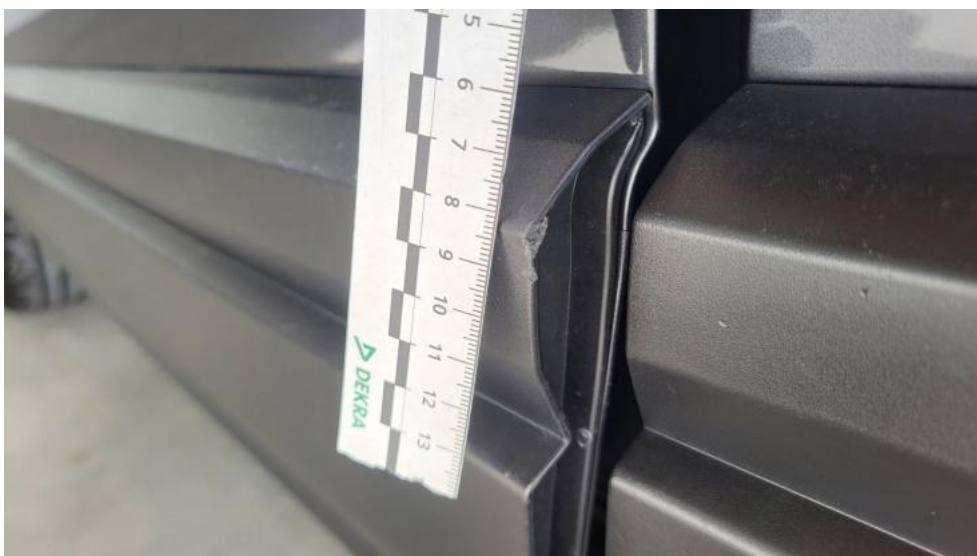
**Photo 56.**

Listwa drzwi przednich L - Rysa/odprysk 1

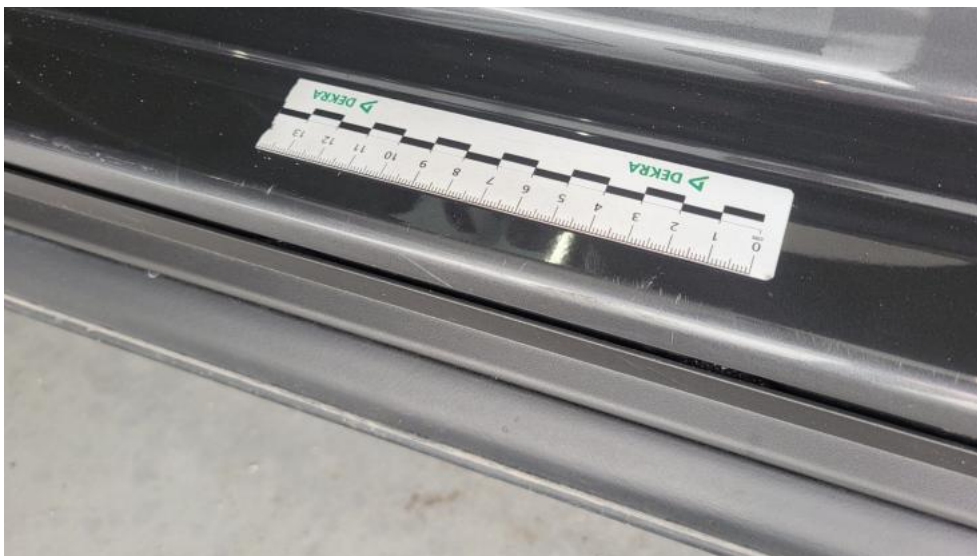
**Photo 57.**  
Próg L - Rysa/odprysk 1

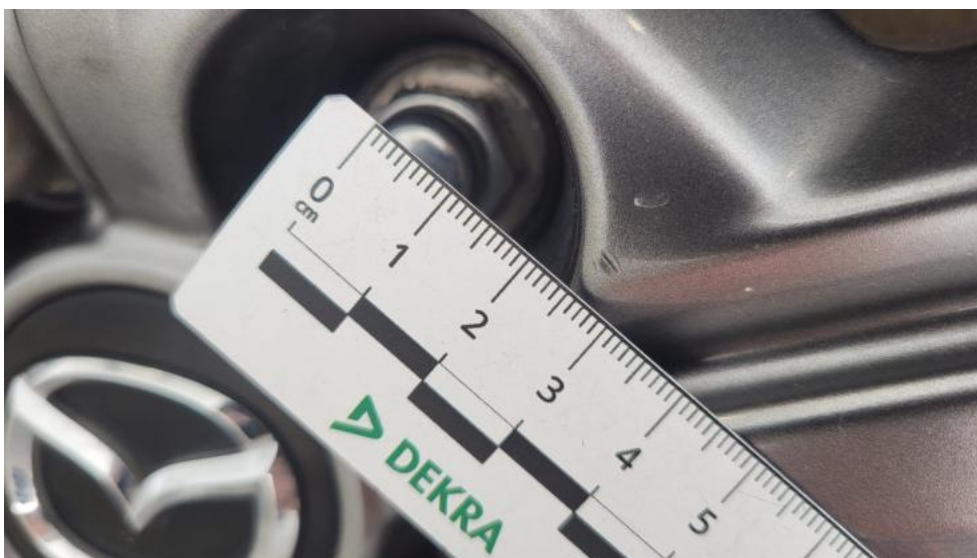
**Photo 58.**  
Felga Aluminiowa przednia L - Rysa/odprysk 1

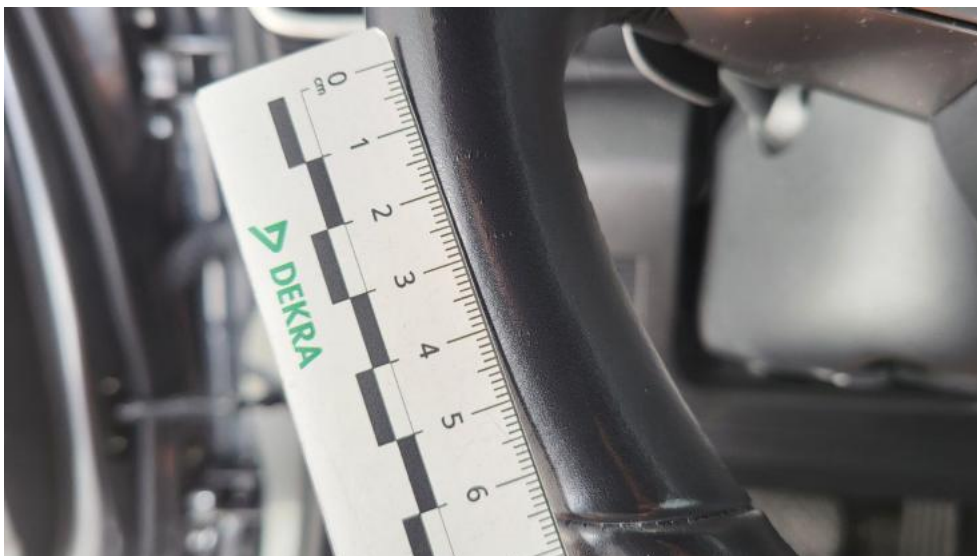
**Photo 59.**

Koło kierownicy - Rysa/odprysk 1

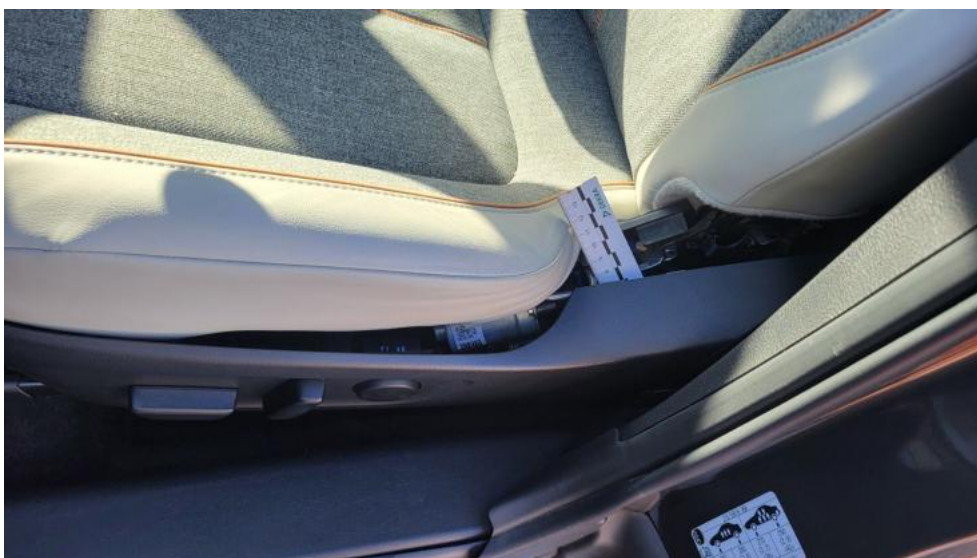
**Photo 60.**

Fotel prz. lew. - Inne 1

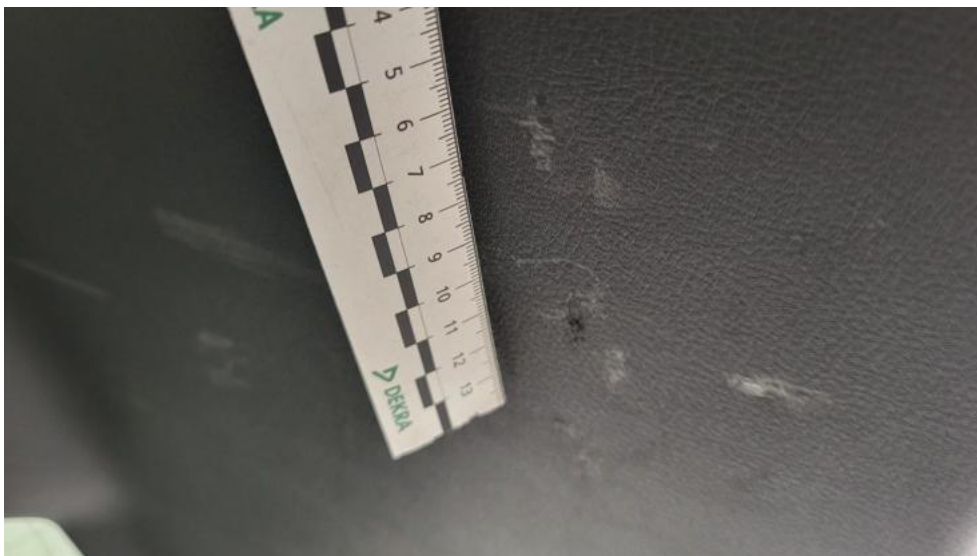
**Photo 61.**

Wykładzina pokrywy tylnej - Rysa/odprysk 1
