DEKRA's commission No. : PKOL(W)/LODZ/94506/26/10/08  
commission/ damage No. : 23/044732  
Date of commission: 08-10-2026

**DEKRA Poland - Headquarters**  
02-673 Warszawa, ul. Konstruktorska 12A

| Manufacturer | BMW |
| Type / version | X7 M50i sport-aut |

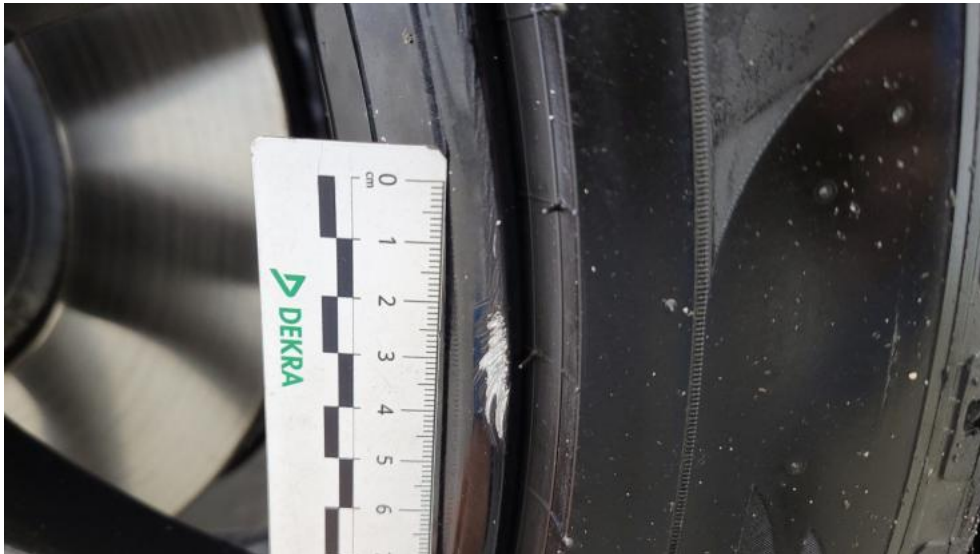
Felga aluminiowa przednia P - Rysa/odprysk 1

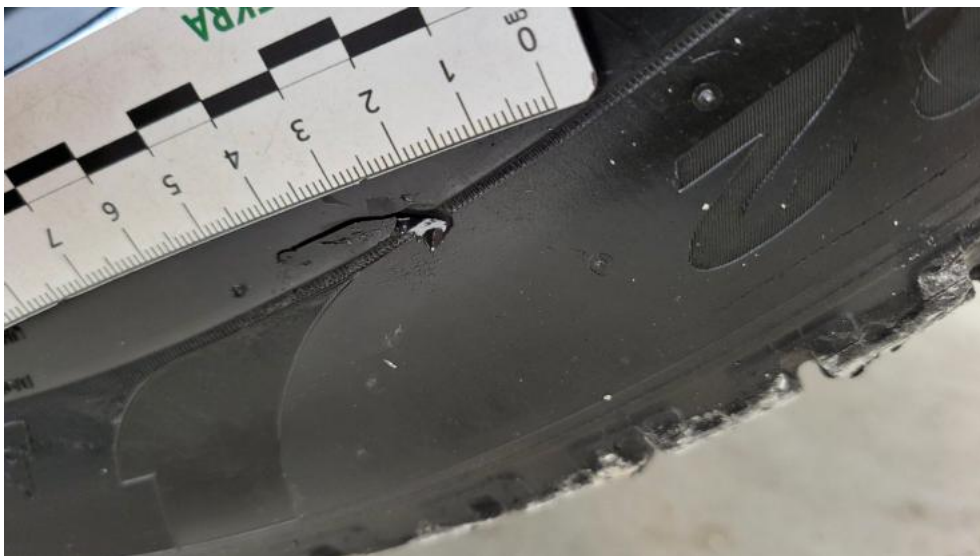
Opona przednia P - Pęknięcie/rozerwanie 1

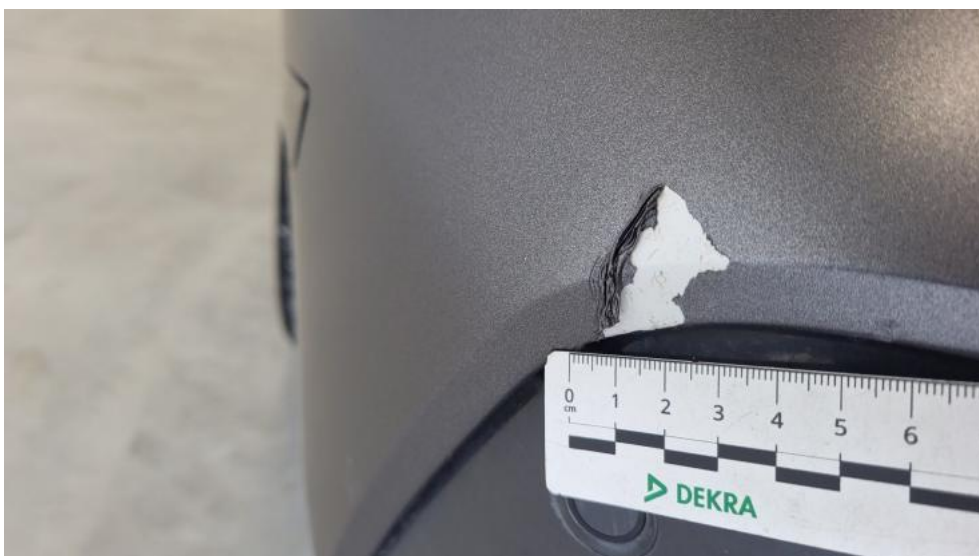
Zderzak tylny - Rysa/odprysk 1

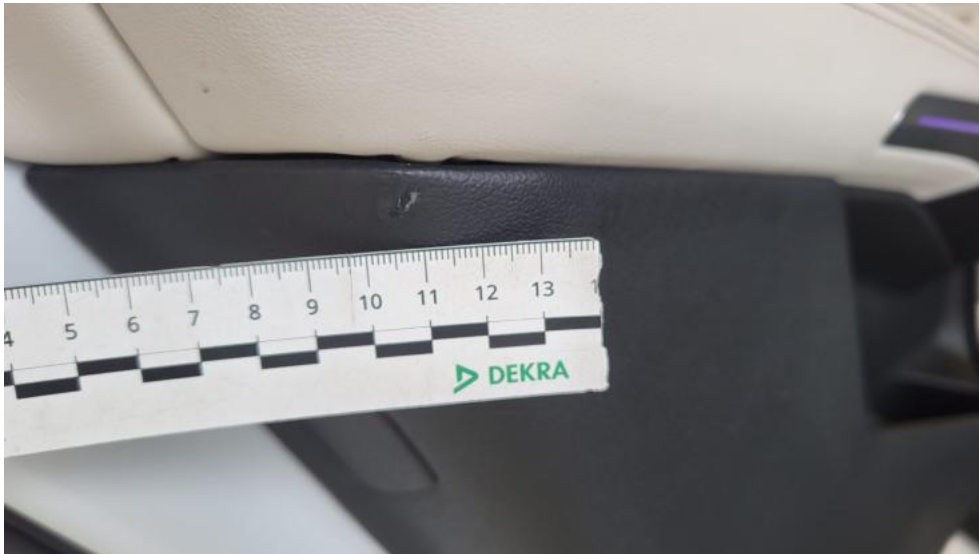
Tapicerka drzwi tylnych L - Pęknięcie/rozerwanie 1

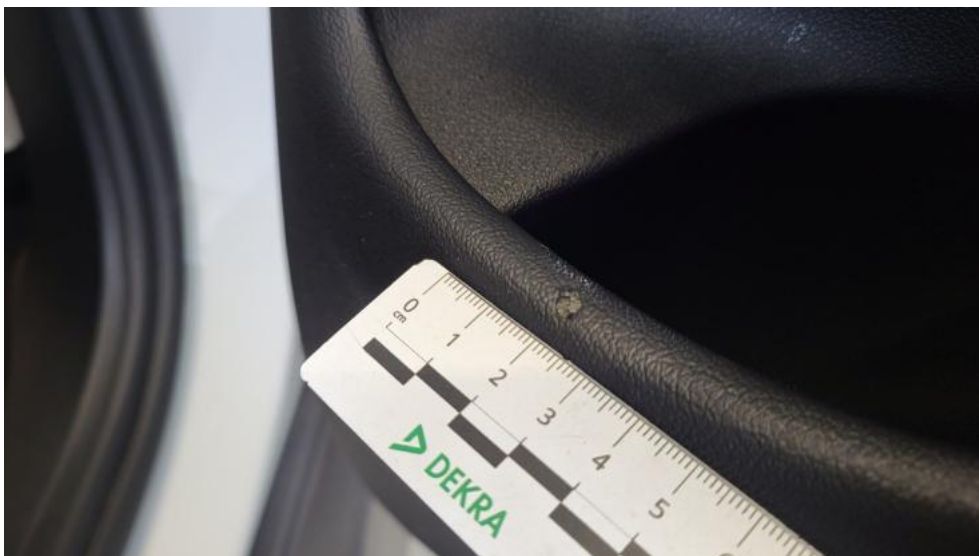
Tapicerka drzwi tylnych P - Pęknięcie/rozerwanie 1

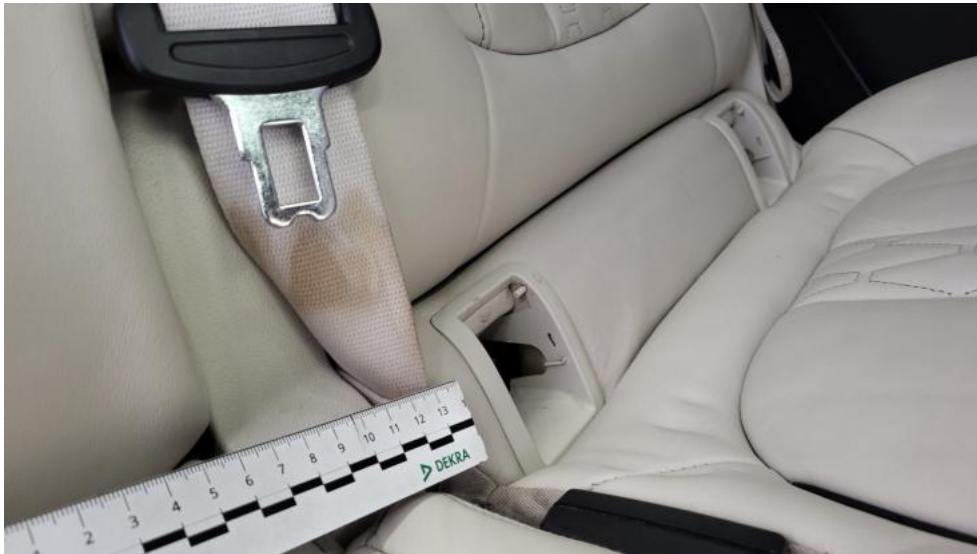
Pas bezpieczeństwa tylny środkowy - Inne 1
