DEKRA's commission No. : PKOL(W)/LODZ/96020/26/10/14  
commission/ damage No. : 23/032240  
Date of commission: 14-10-2026

**DEKRA Poland - Headquarters**  
02-673 Warszawa, ul. Konstruktorska 12A

| Manufacturer | AUDI |
| Type / version | R8 V10 RWD Performance |

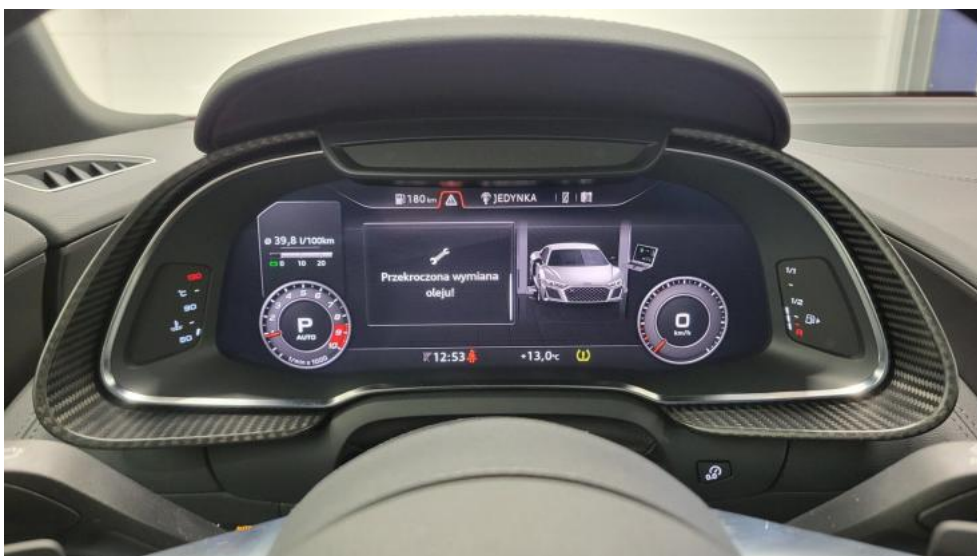
**Photo 24.**

Aktywna kontrolka ciśnienia w kołach. Przekroczona wymiana oleju od 106 dni. Dostarczono ksero pozwolenia czasowego. Widoczne wady lakiernicze. Lewy reflektor jaśniejszy od prawego. Odpryski na szybie czołowej.

Zestaw wskaźników - serwis

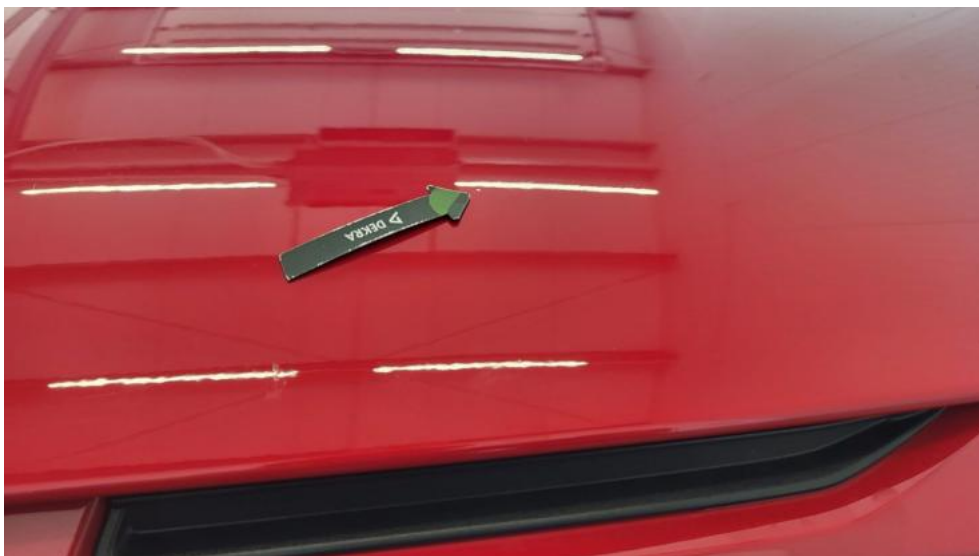
**Photo 58.**

Pokrywa komory silnika - Wgniecenie/odkształcenie 1

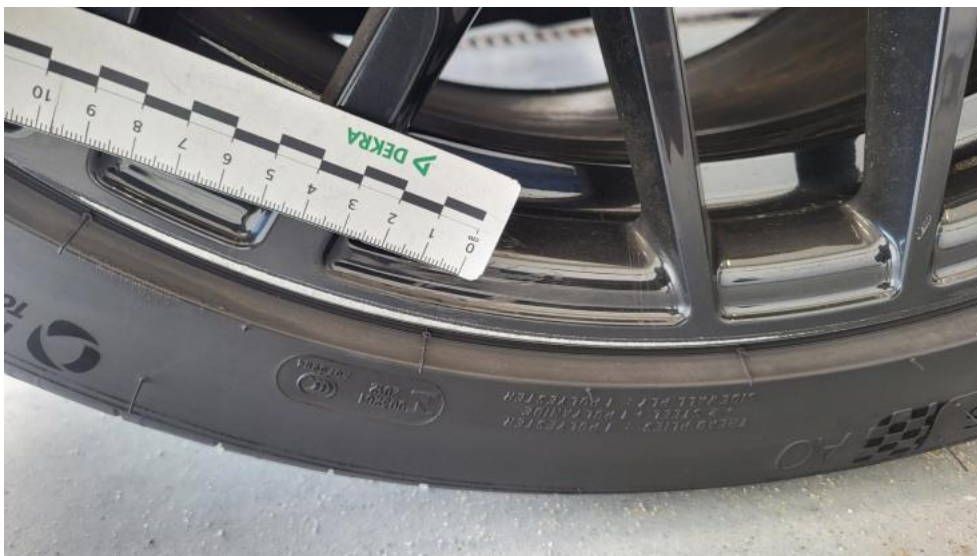
**Photo 65.**

Felga aluminiowa tylna P - Rysa/odprysk 1

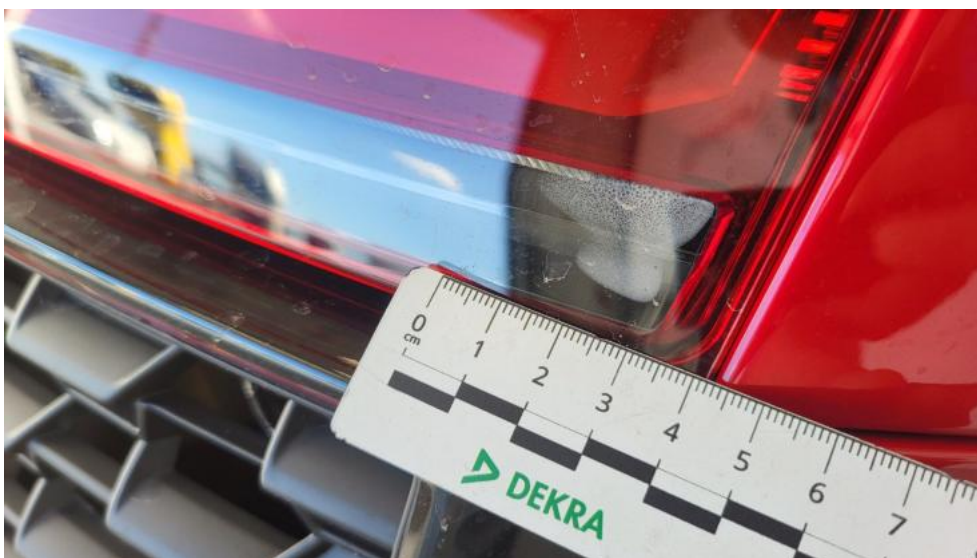
**Photo 66.**

Lampa zespolona tylna P - Inne 1

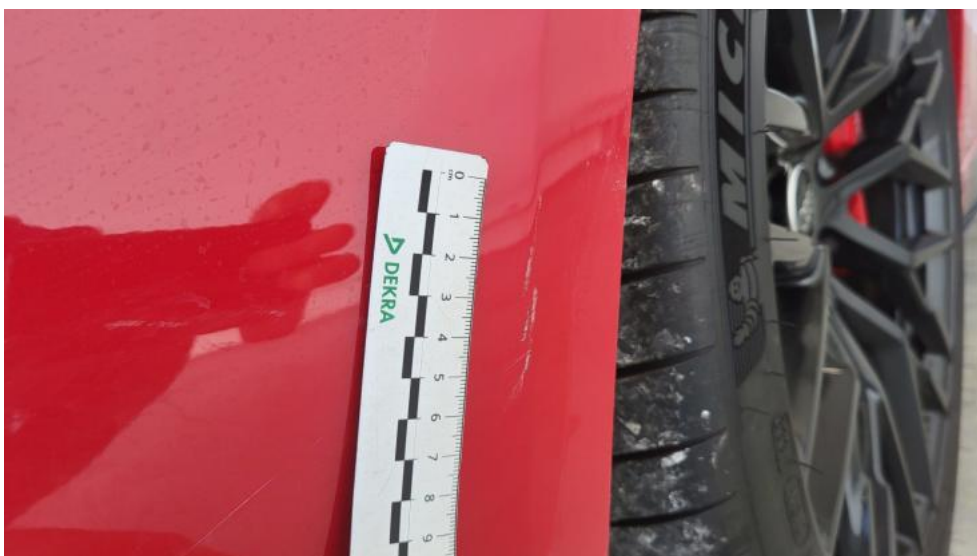
**Photo 68.**

Zderzak tylny - Rysa/odprysk 2

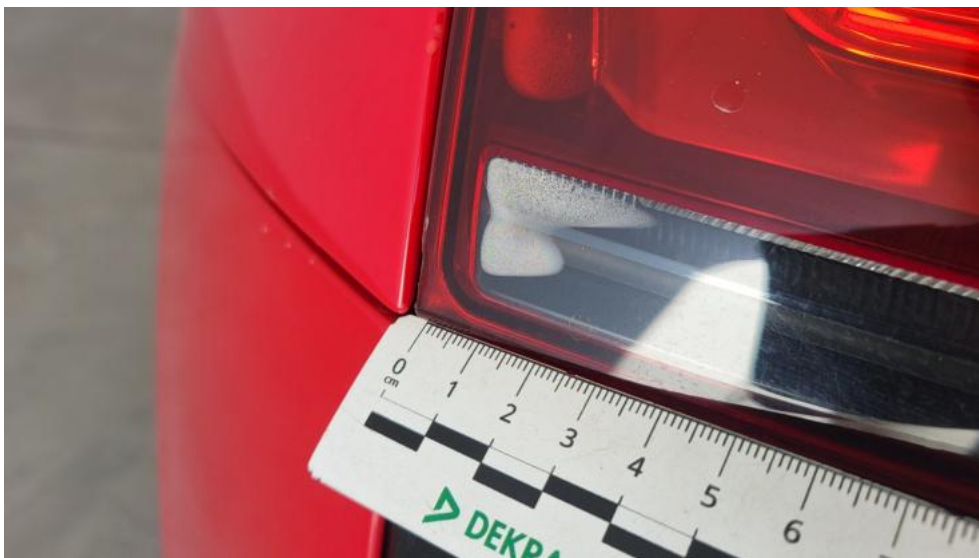
**Photo 70.**

Lampa zespolona tylna L - Inne 1

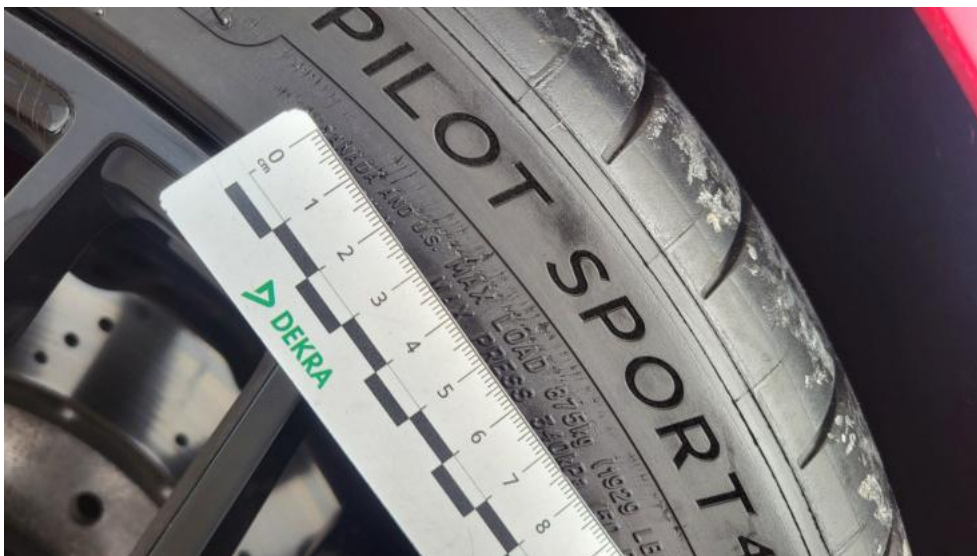
**Photo 71.**

Opona tylna L - Pęknięcie/rozerwanie 1

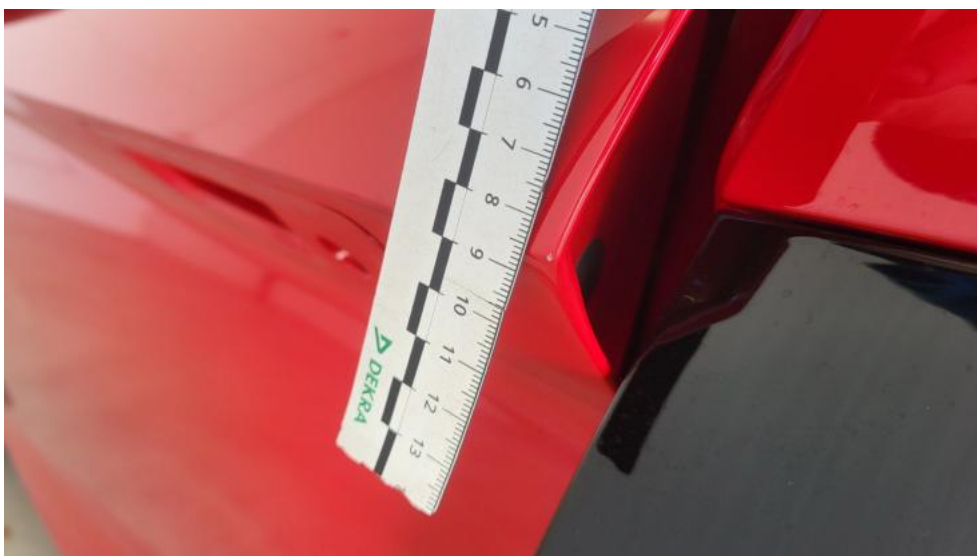
**Photo 72.**

Drzwi przed L - Rysa/odprysk 1

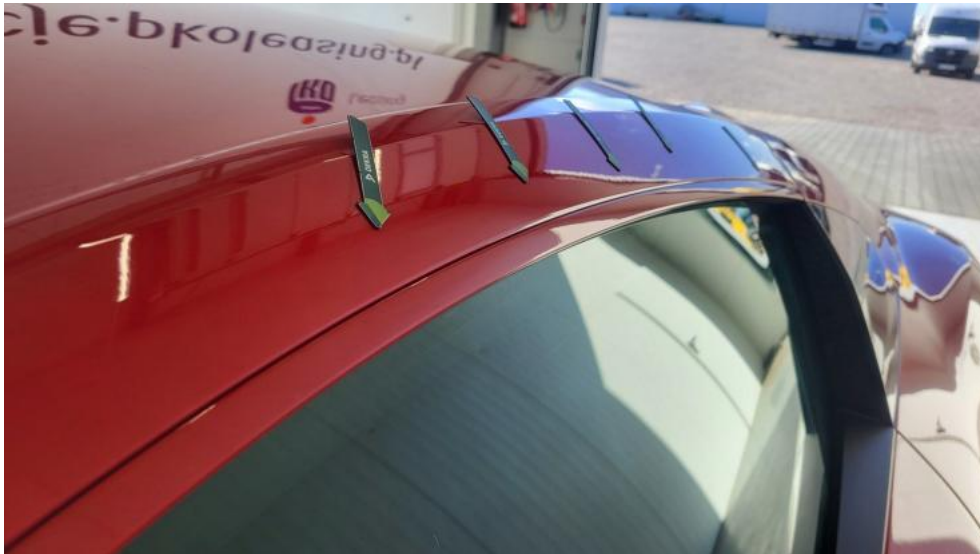
**Photo 73.**

Słupek przedni L - Wgniecenie/odkształcenie 1

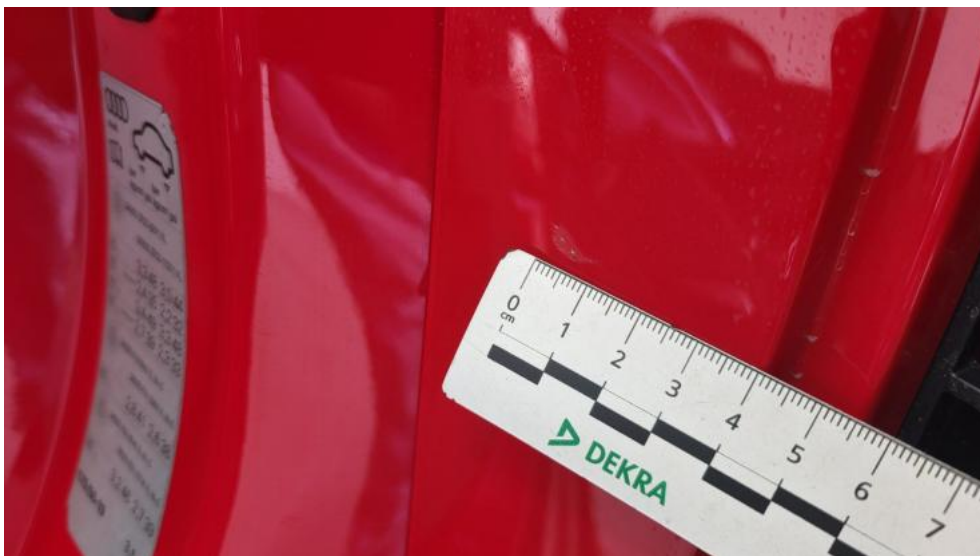
**Photo 74.**

Słupek środkowy L - Rysa/odprysk 1

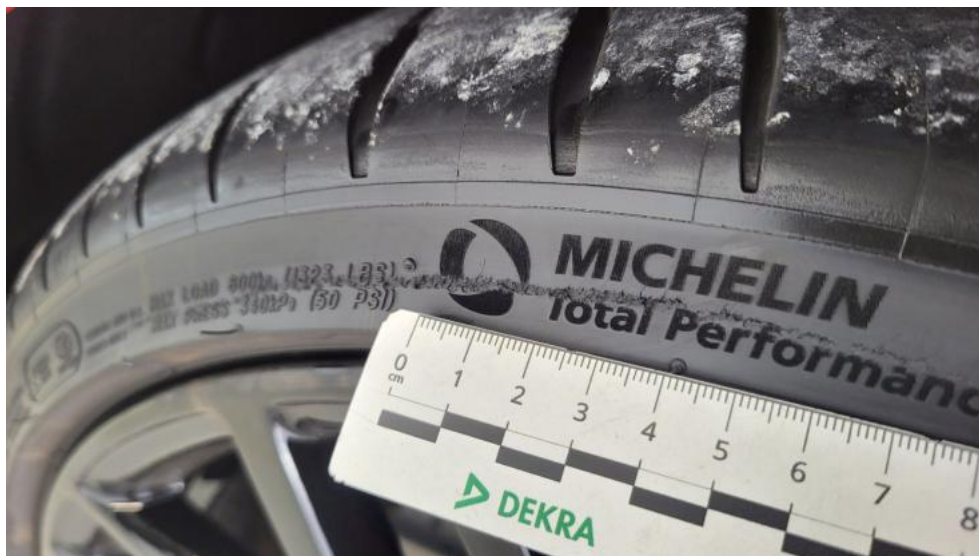
**Photo 75.**

Opona przednia L - Pęknięcie/rozerwanie 1

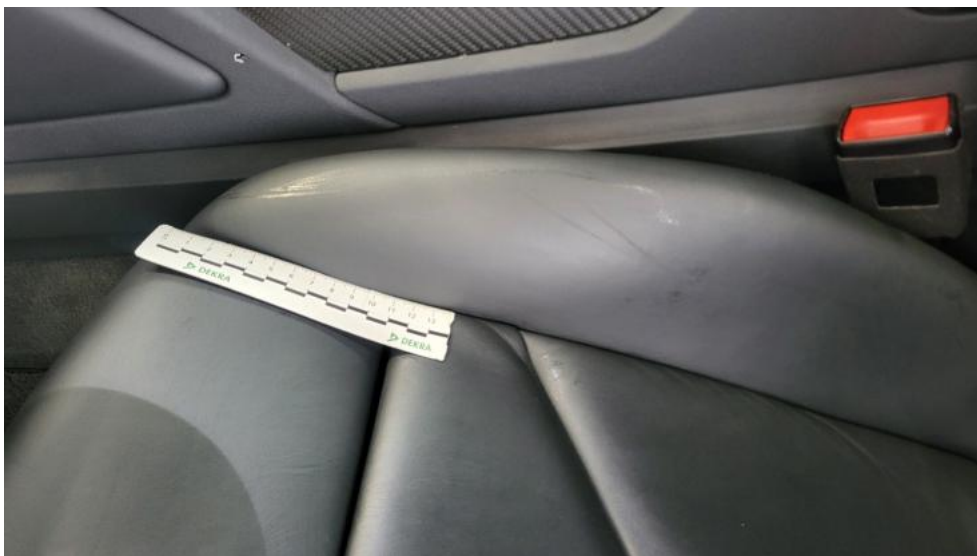
**Photo 77.**

Fotel prz. lew. - Inne 1

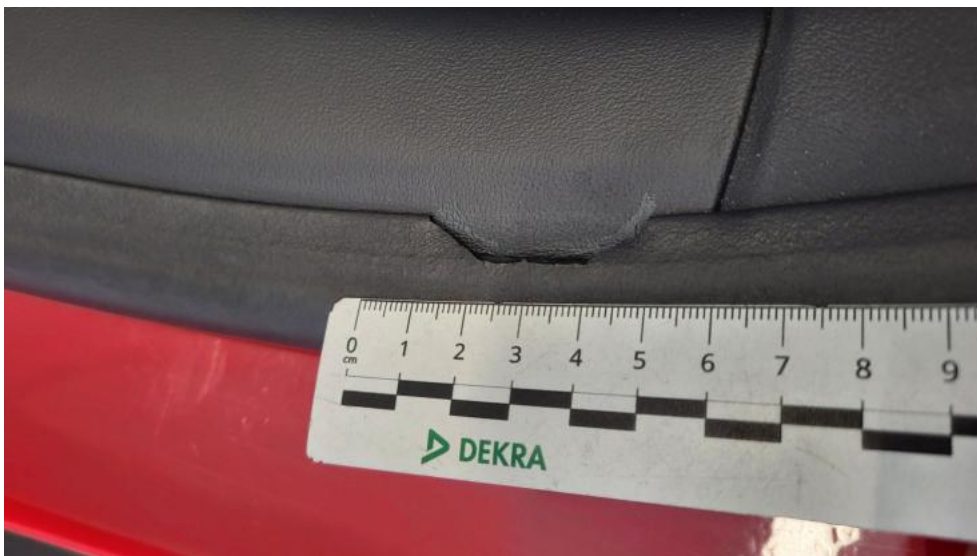
**Photo 81.**

Uszczelka drzwi przednich L - Pęknięcie/rozerwanie 1

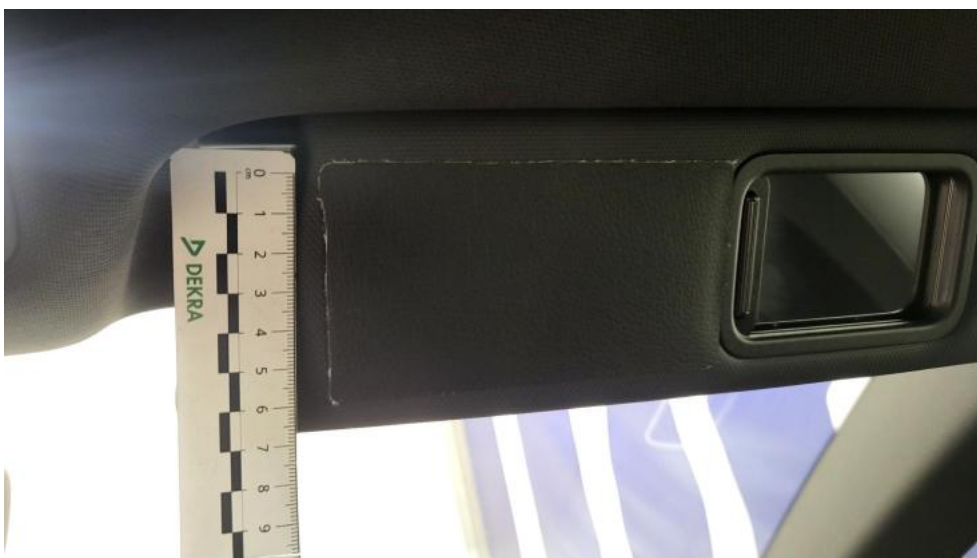
**Photo 82.**

Osłona p/słoneczna prawa - Inne 1

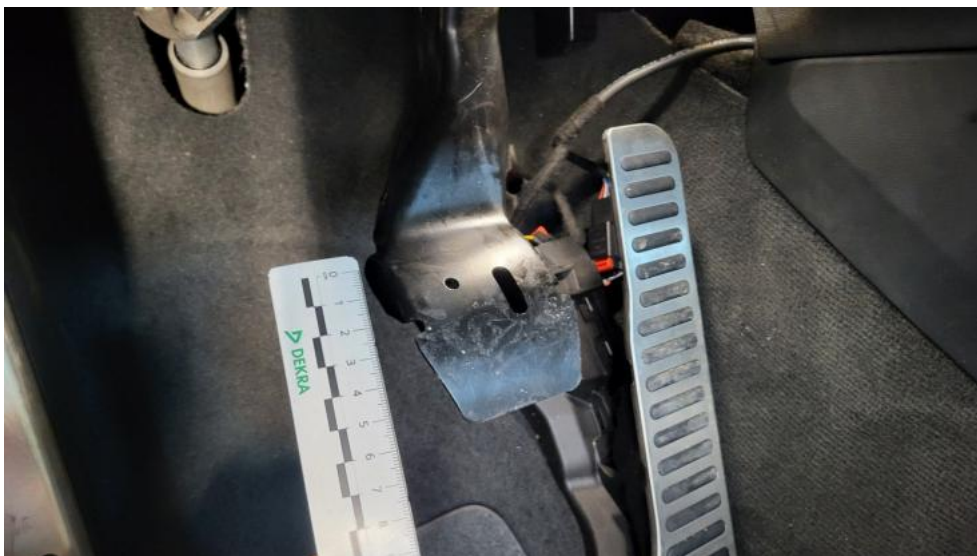
**Photo 83.**

Pedały - Inne 1
