DEKRA's commission No. : PKOL(W)/LODZ/03993/26/01/16  
commission/ damage No. : 22/028047  
Date of commission: 16-01-2026

| Manufacturer | TOYOTA |
| Type / version | Corolla 2.0 Hybrid Selection |
| Registration /record No. | CB897NW |

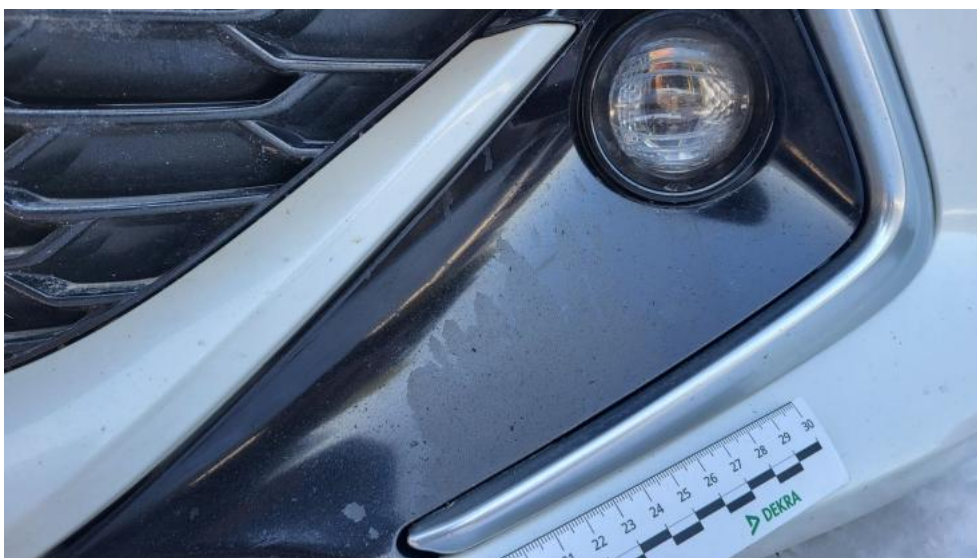
**Photo 38.**  
Kratka/zaślepka halogenu L - Inne 1

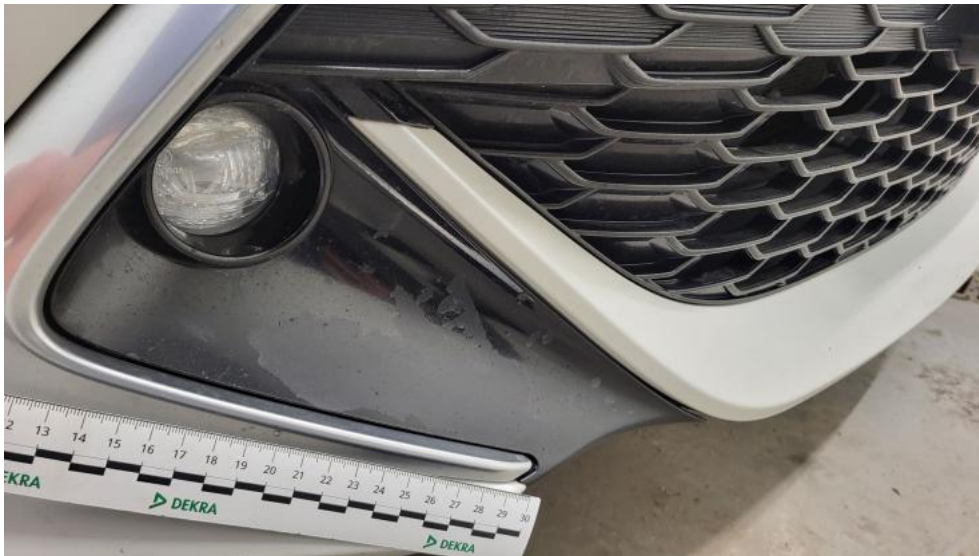
Kratka/zaślepka halogenu P - Inne 1

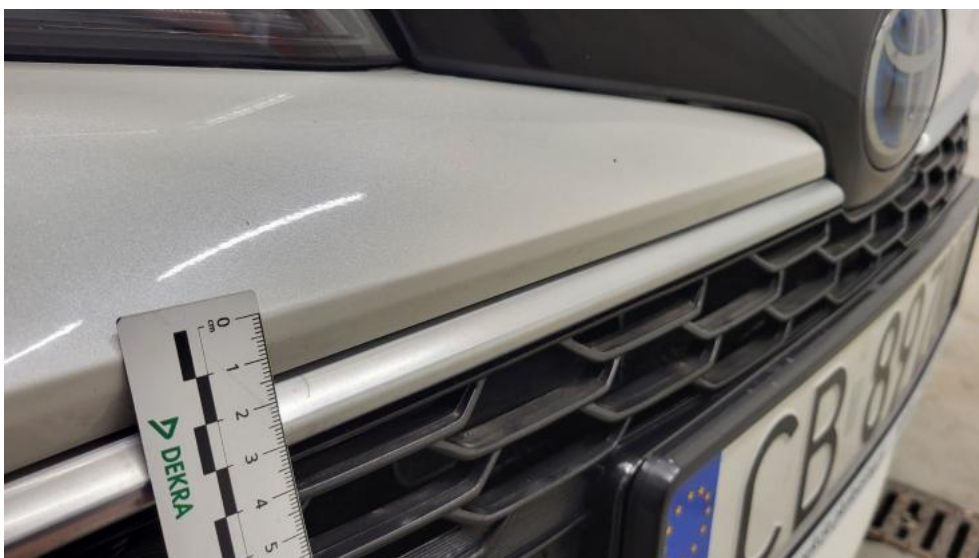
Listwa śr zderzaka przedniego - Pęknięcie/rozerwanie 1

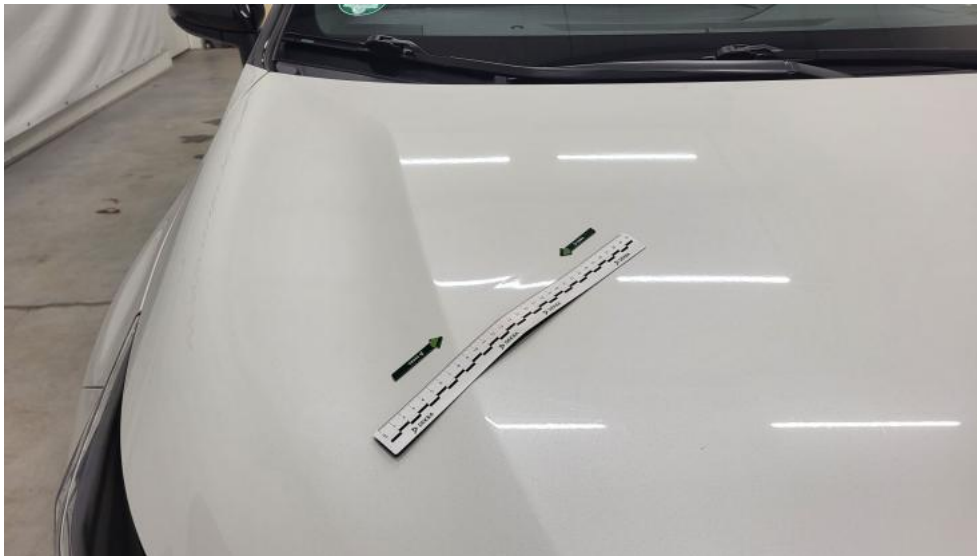
Pokrywa komory silnika - Wgniecenie/odkształcenie 1

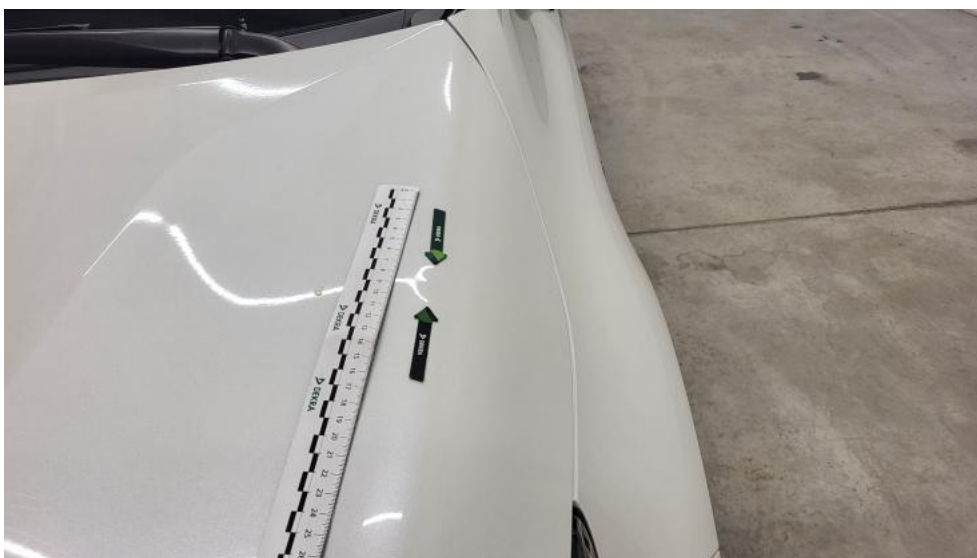
Pokrywa komory silnika - Wgniecenie/odkształcenie 2

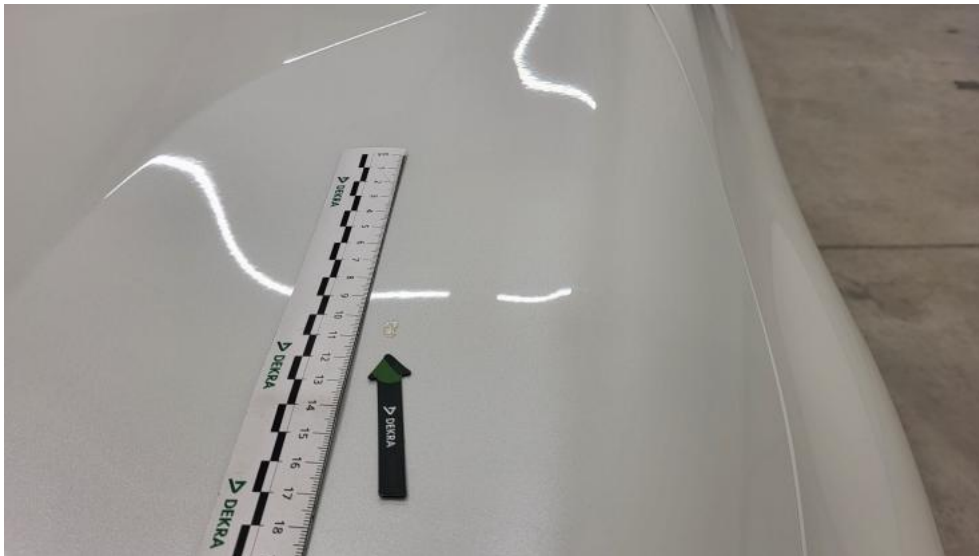
Pokrywa komory silnika - Inne 1

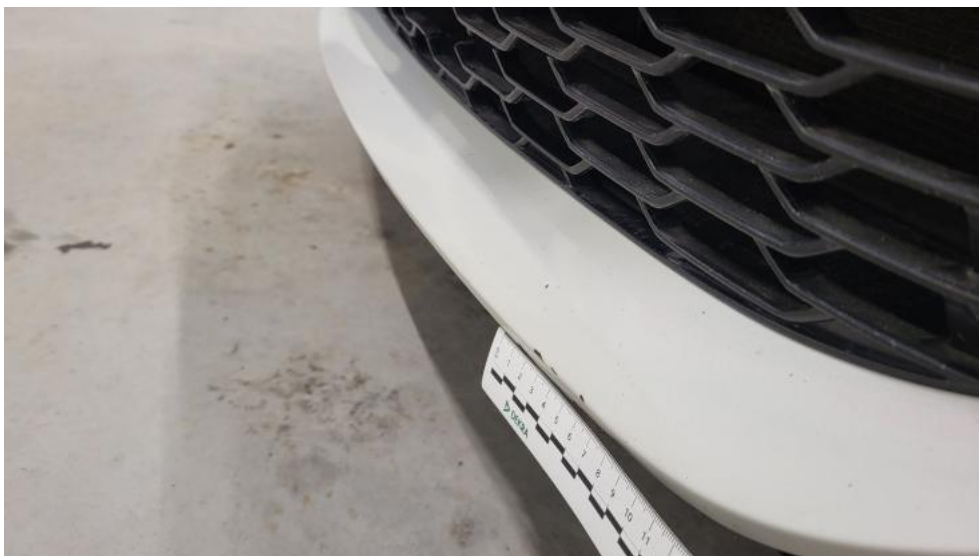
Spoiler zderzaka przedniego - Wgniecenie/odkształcenie 1

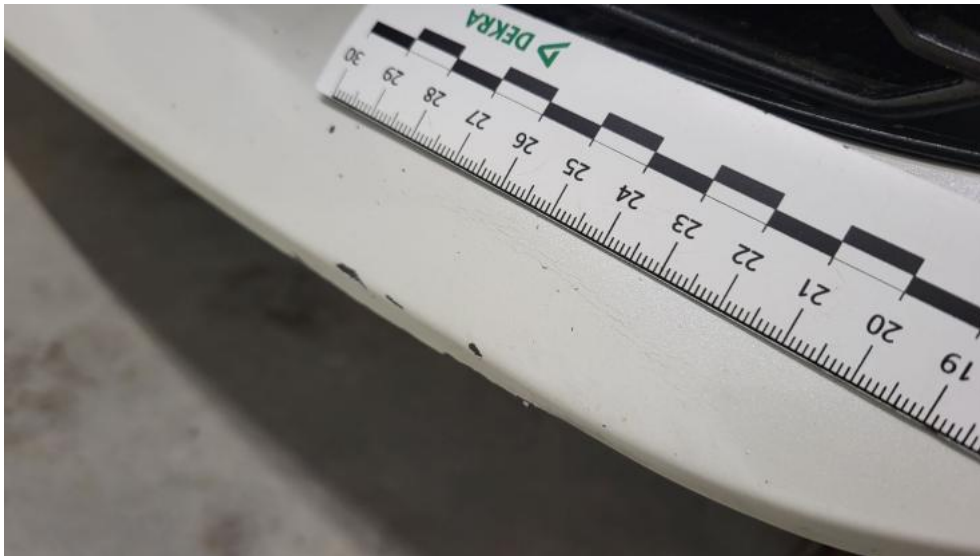
Spoiler zderzaka przedniego - Pęknięcie/rozerwanie 1

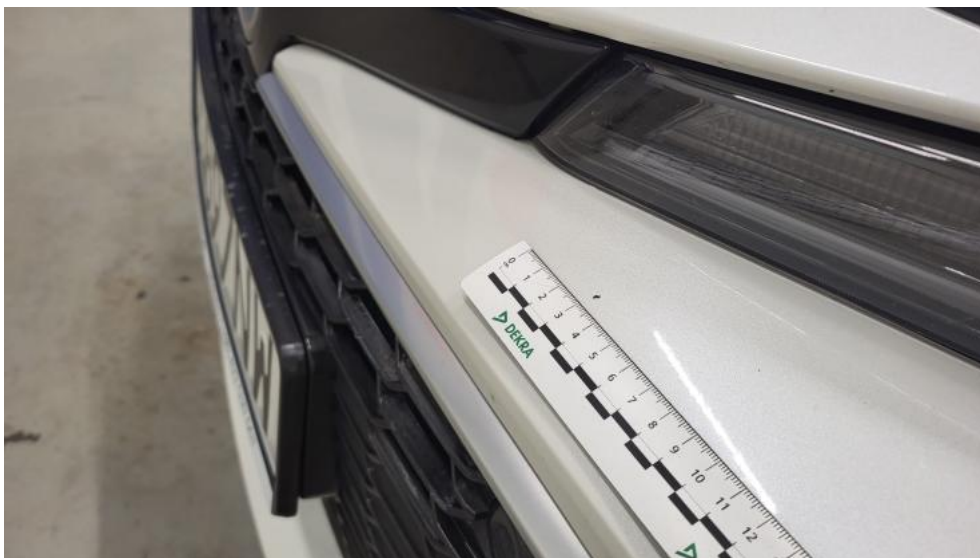
Zderzak - Rysa/odprysk 1

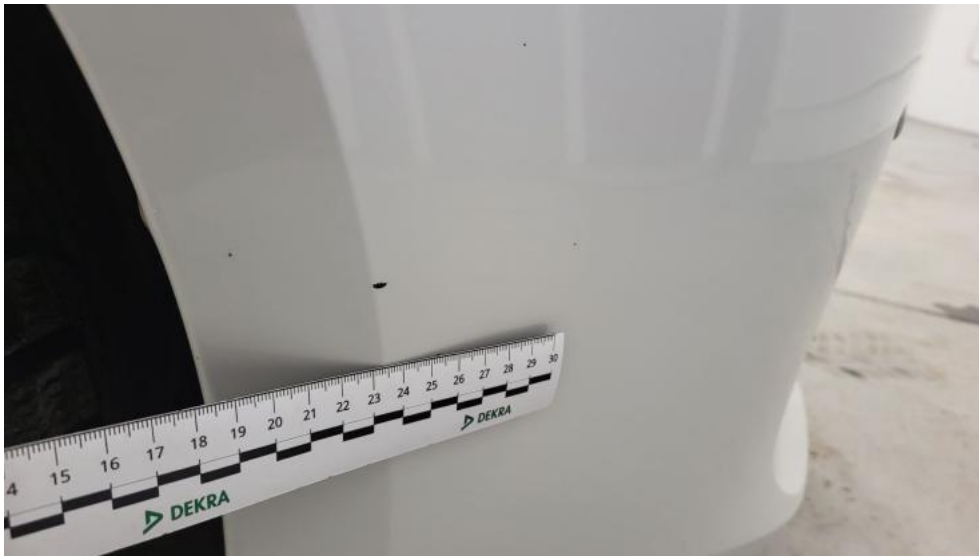
Zderzak - Rysa/odprysk 2

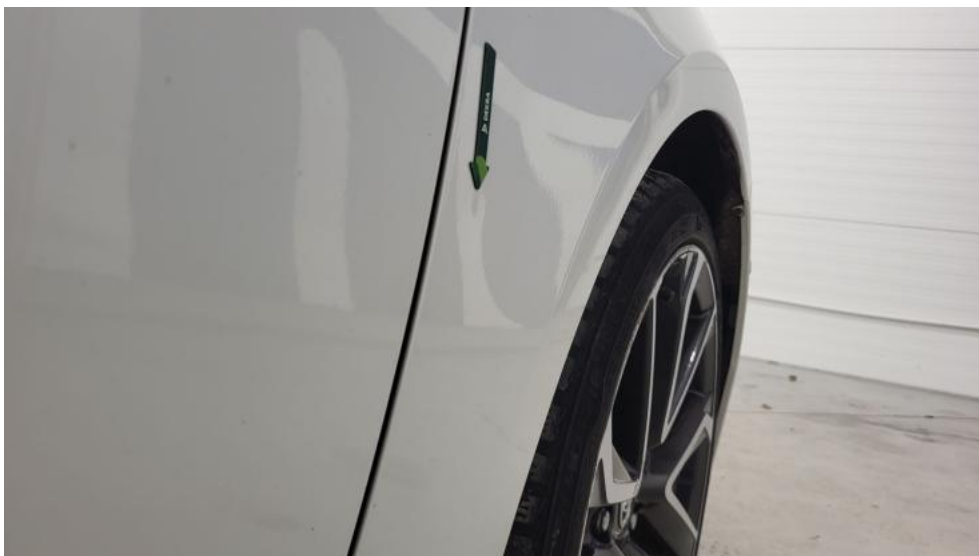
Błotnik przedni P - Wgniecenie/odkształcenie 1

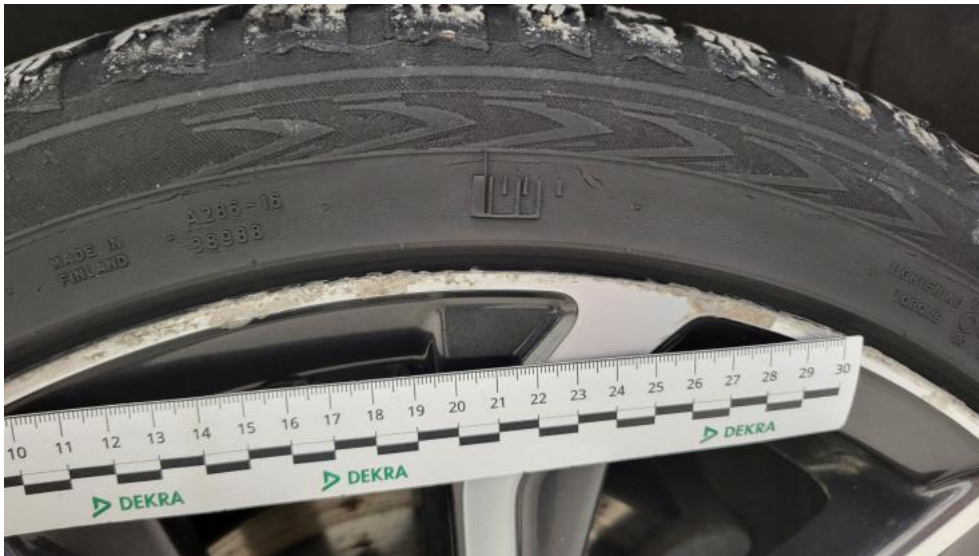
Felga aluminiowa przednia P - Rysa/odprysk 1

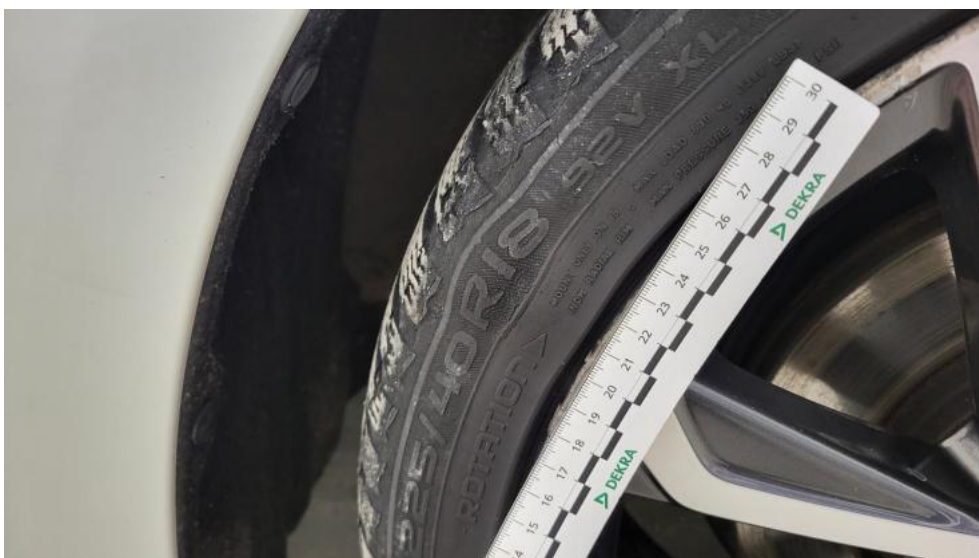
Opona przednia P - Wgniecenie/odkształcenie 1

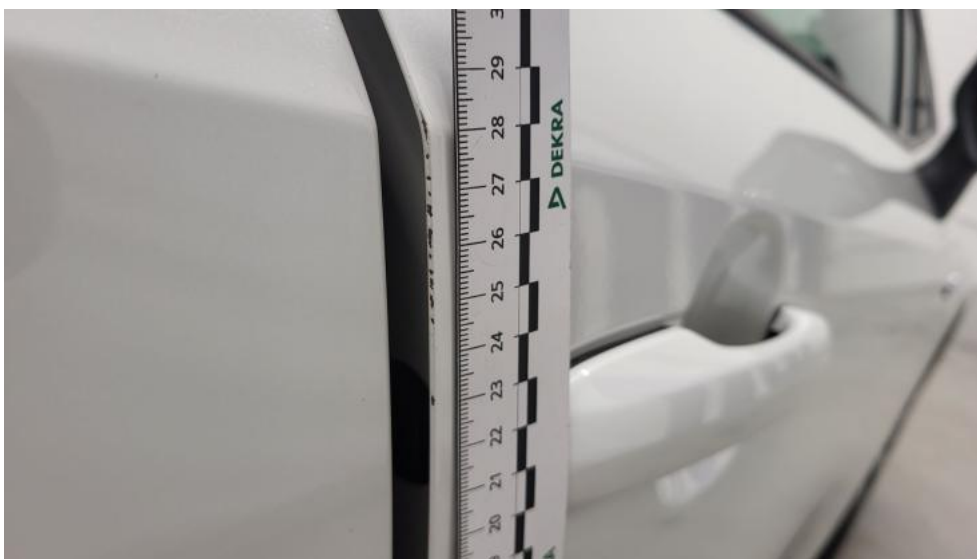
Drzwi przednie P - Rysa/odprysk 1

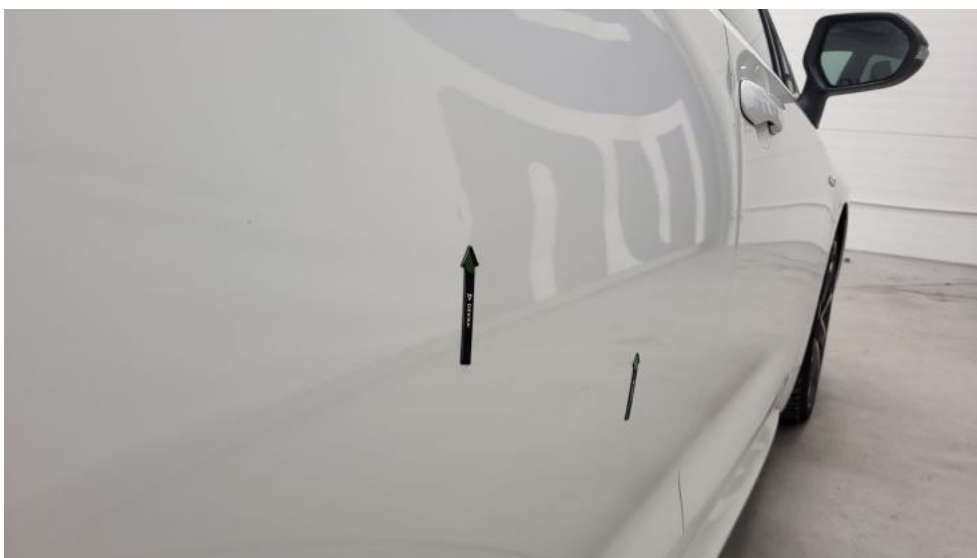
Drzwi tylne P - Wgniecenie/odkształcenie 1

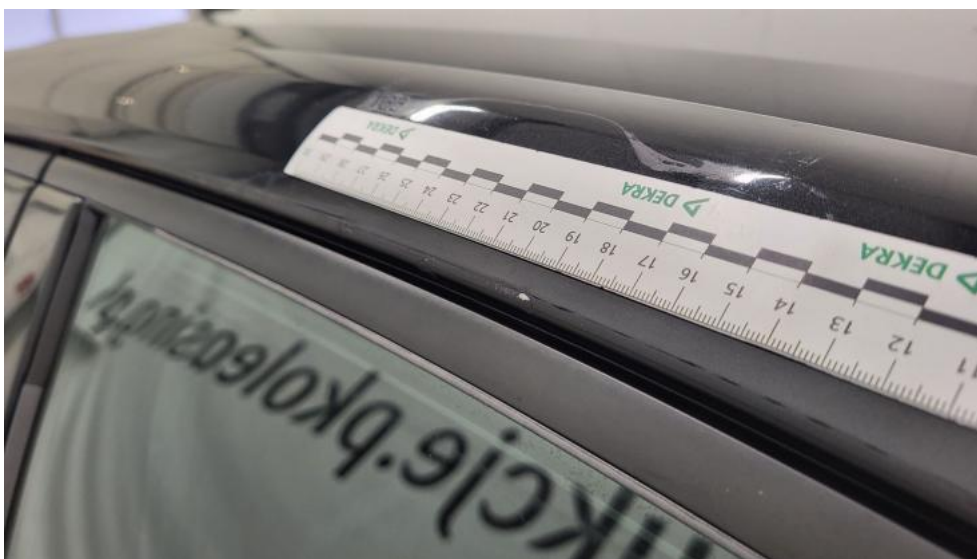
Słupek przedni P - Rysa/odprysk 1

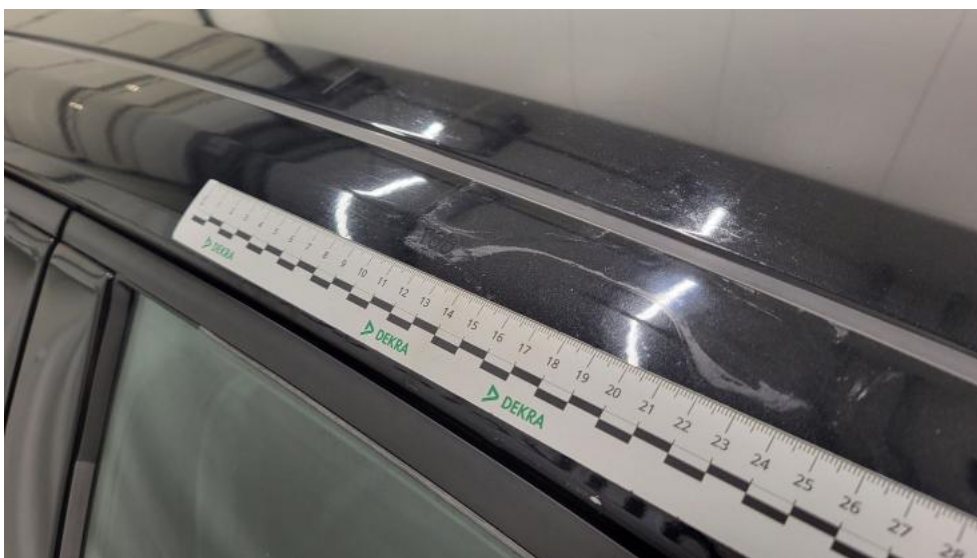
Słupek przedni P - Inne 1

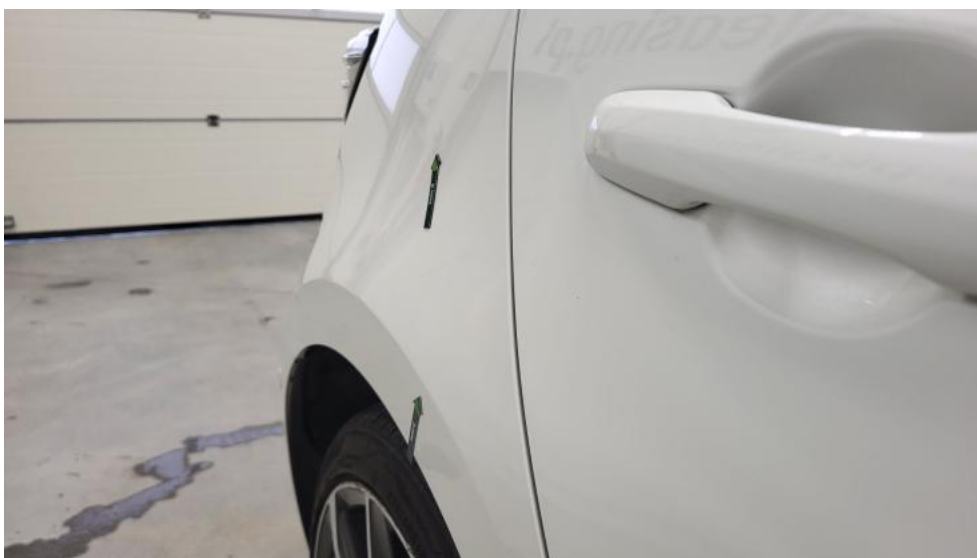
Błotnik tylny P / Ściana boczna P - Wgniecenie/odkształcenie 1

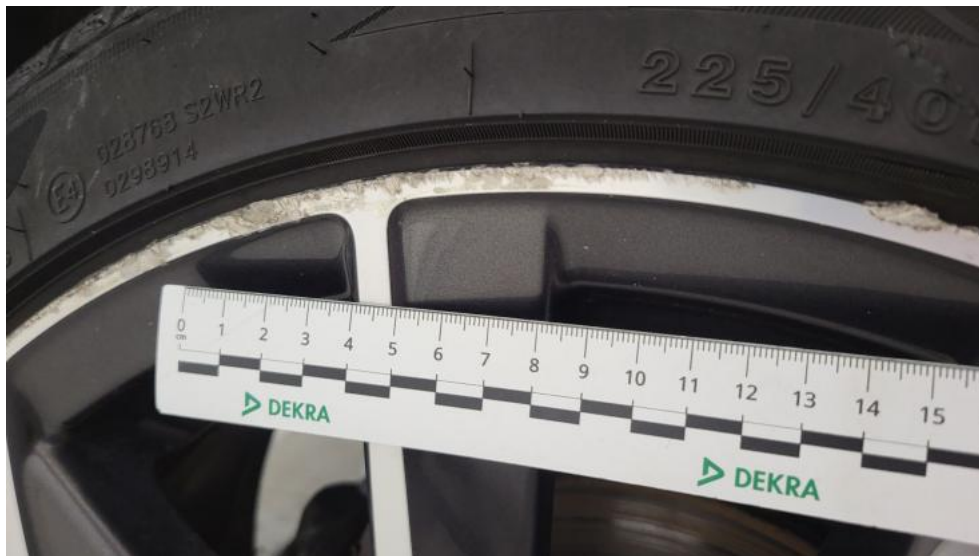
Felga aluminiowa tylna P - Rysa/odprysk 1

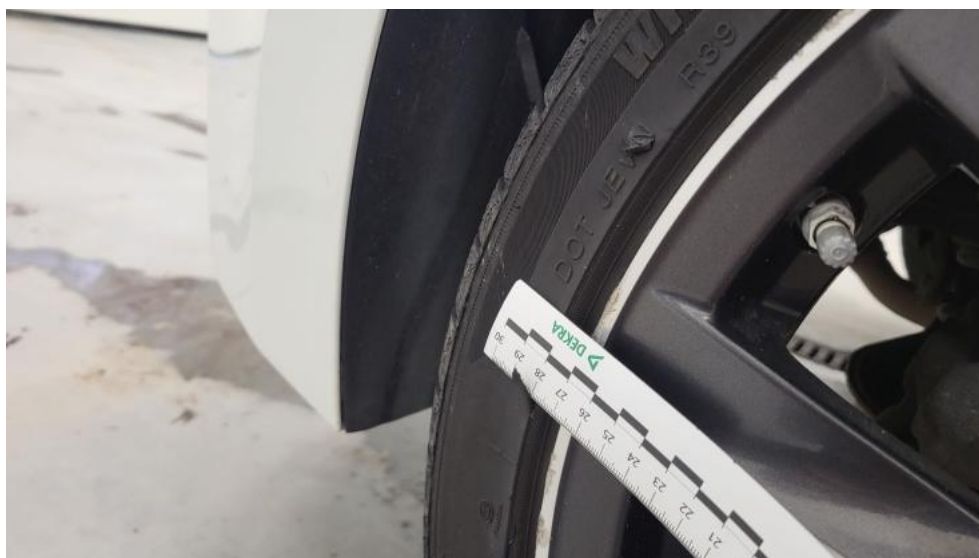
Opona tylna P - Pęknięcie/rozerwanie 1

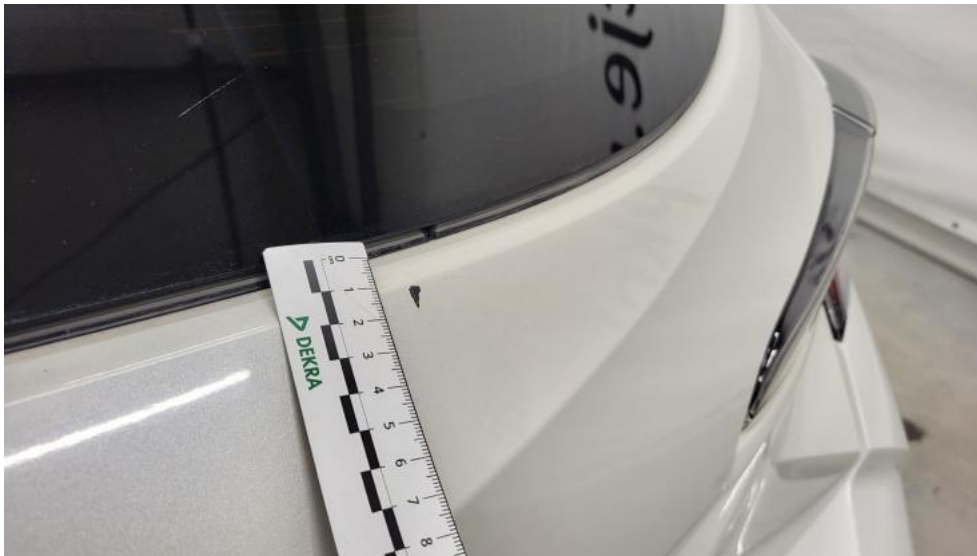
Pokrywy bagażnika - Rysa/odprysk 1

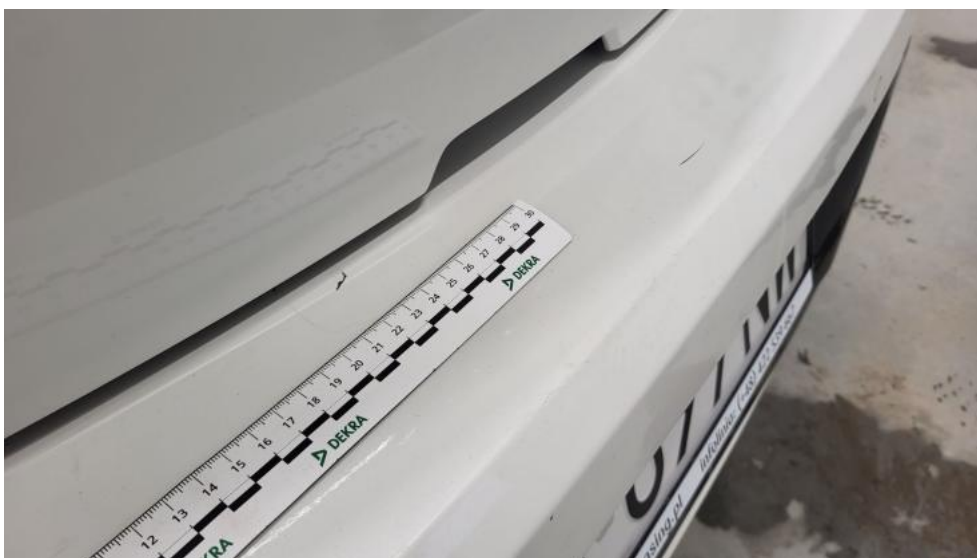
Zderzak tylny - Rysa/odprysk 1

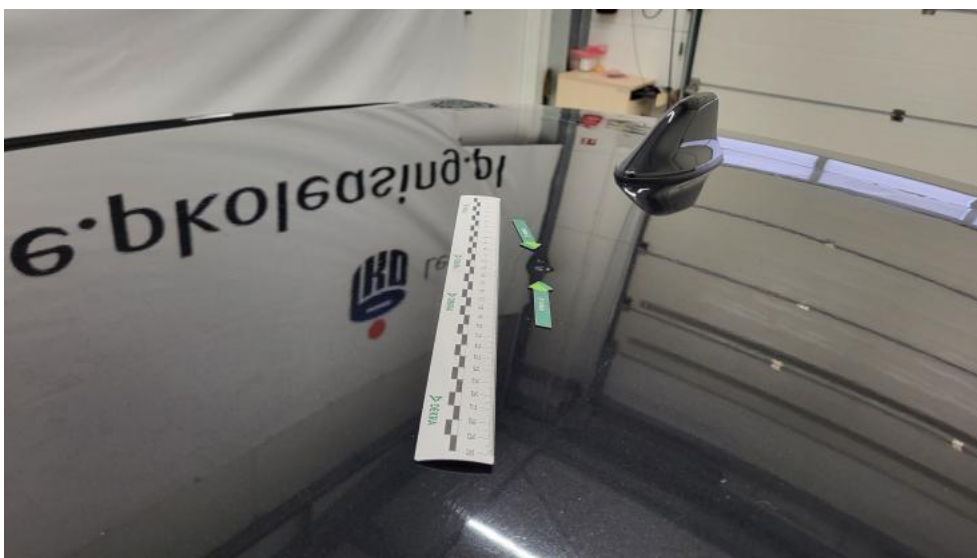
Dach - Wgniecenie/odkształcenie 1

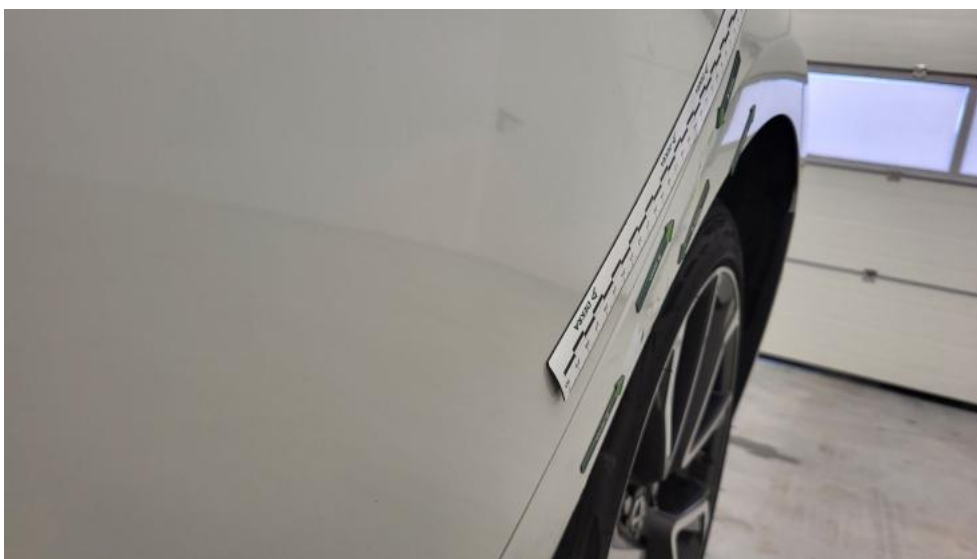
| No. of controlled item | Controlled item | Measured range of thickness of the lacquer coat [ $\mu\text{m}$ ] |
|---|---|---|
| 9 | Rear left fender | 150 - 1000 |

Błotnik tylny L / Ściana boczna L - Wgniecenie/odkształcenie 1

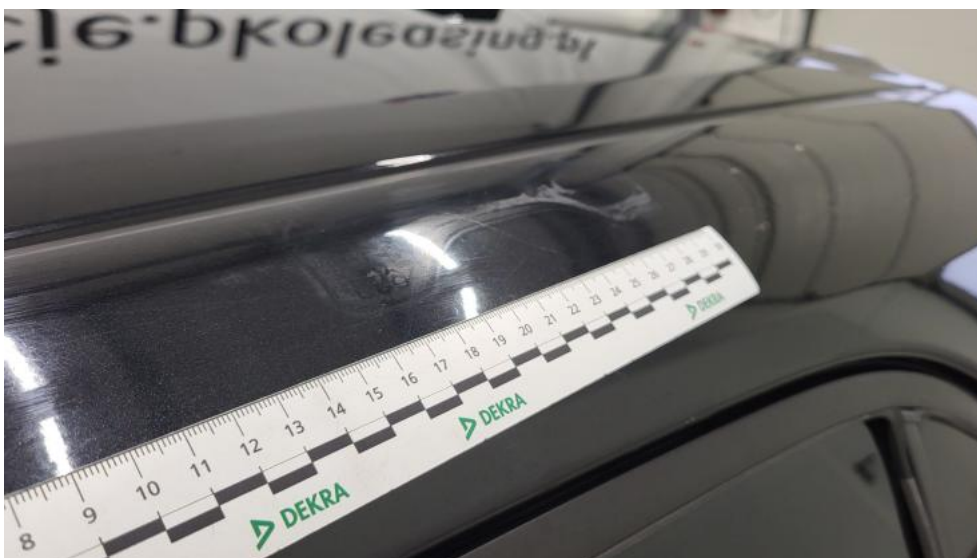
Błotnik tylny L / Ściana boczna L - Inne 1

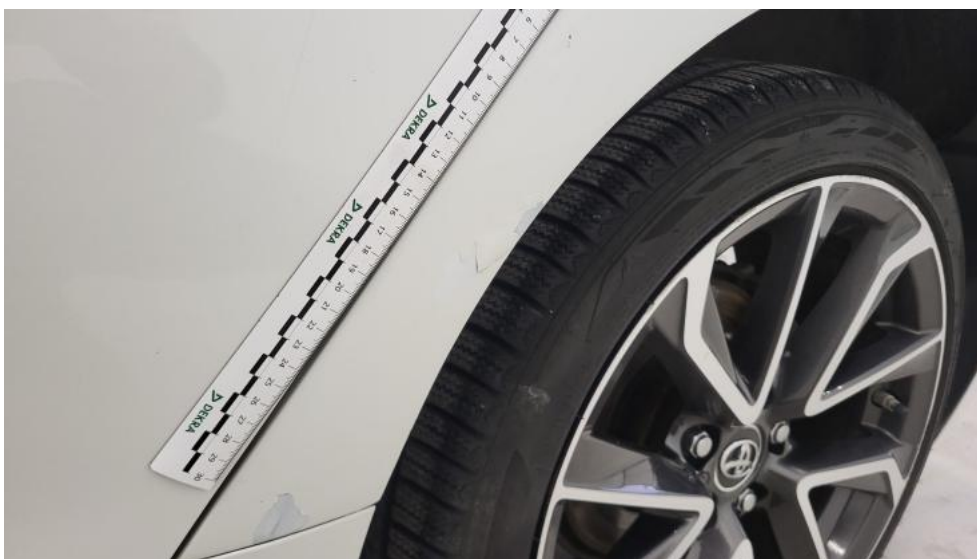
Ścianka tylna L / Ścianka boczna L - Inne 2

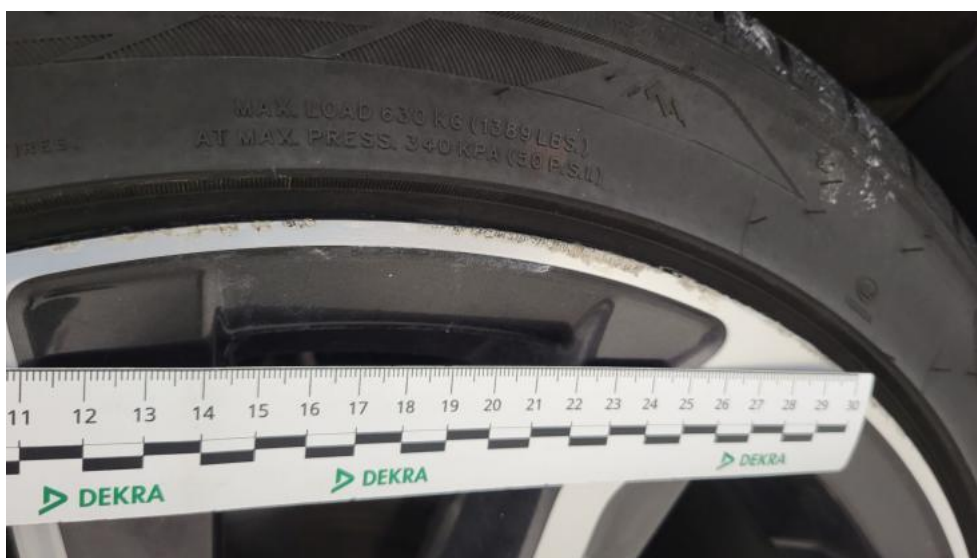
Felga aluminiowa tylna L - Rysa/odprysk 1

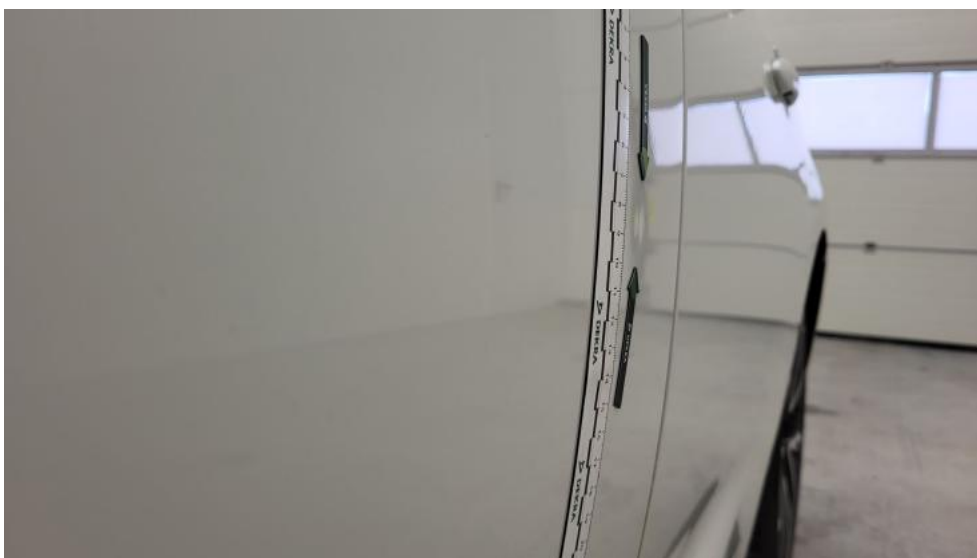
Drzwi przed L - Wgniecenie/odkształcenie 1

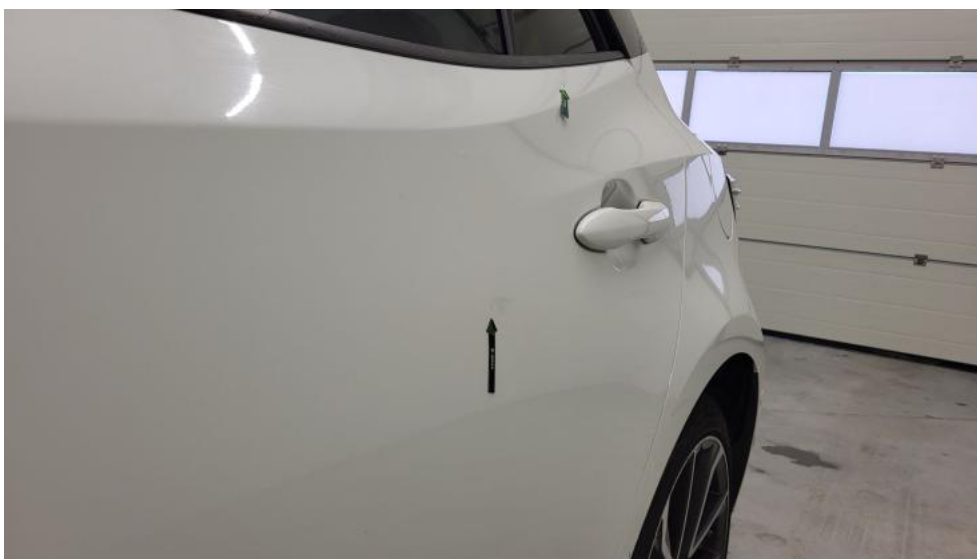
Drzwi tylne L - Wgniecenie/odkształcenie 1

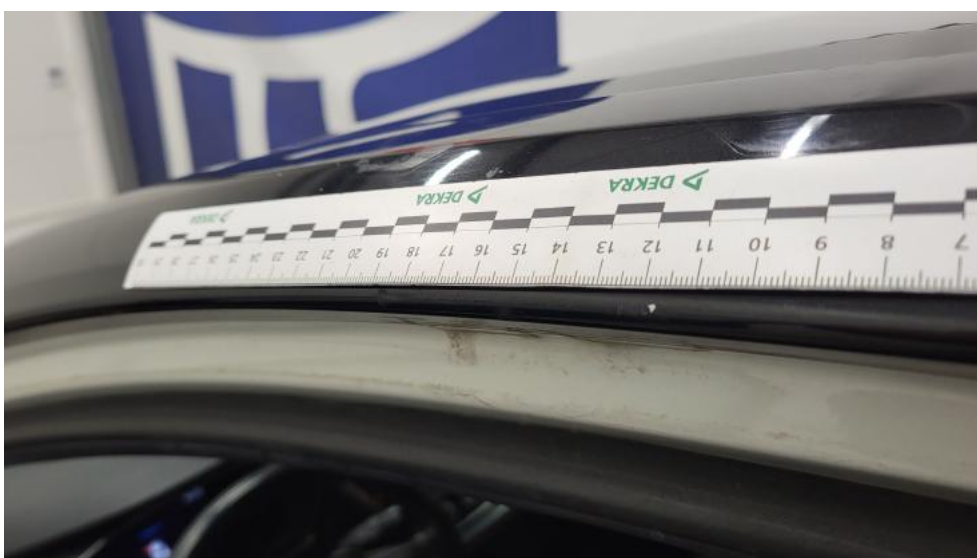
Słupek przedni L - Rysa/odprysk 1

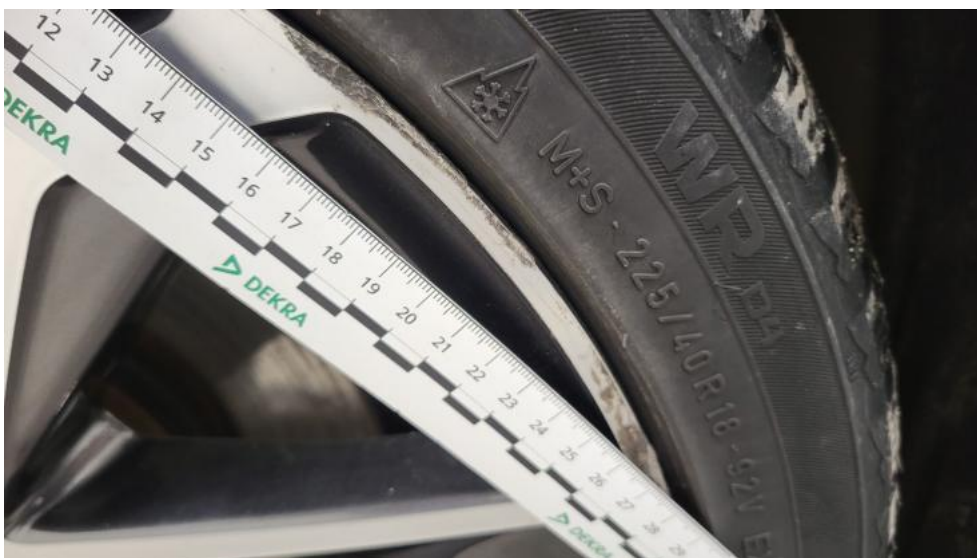
Felga Aluminiowa przednia L - Rysa/odprysk 1

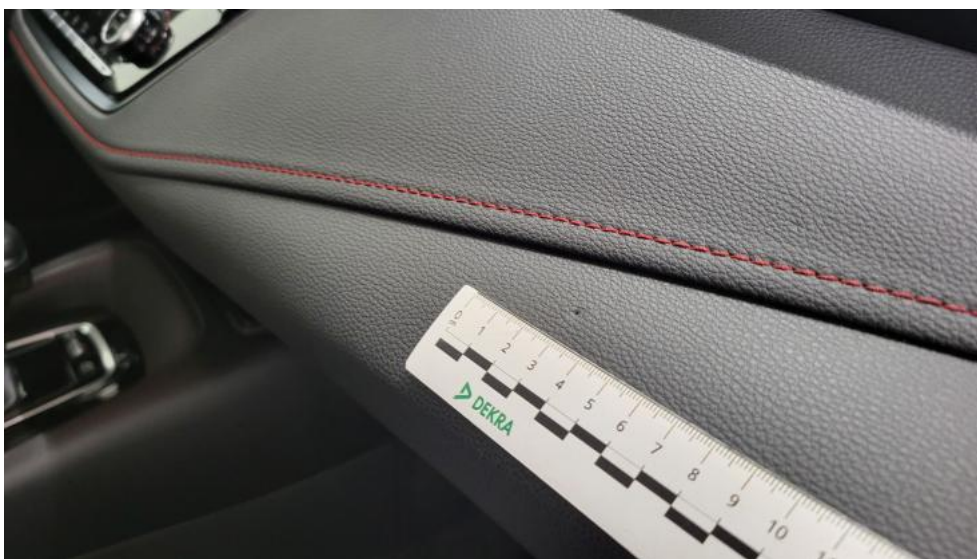
Deska rozdzielcza - Wgniecenie/odkształcenie 1

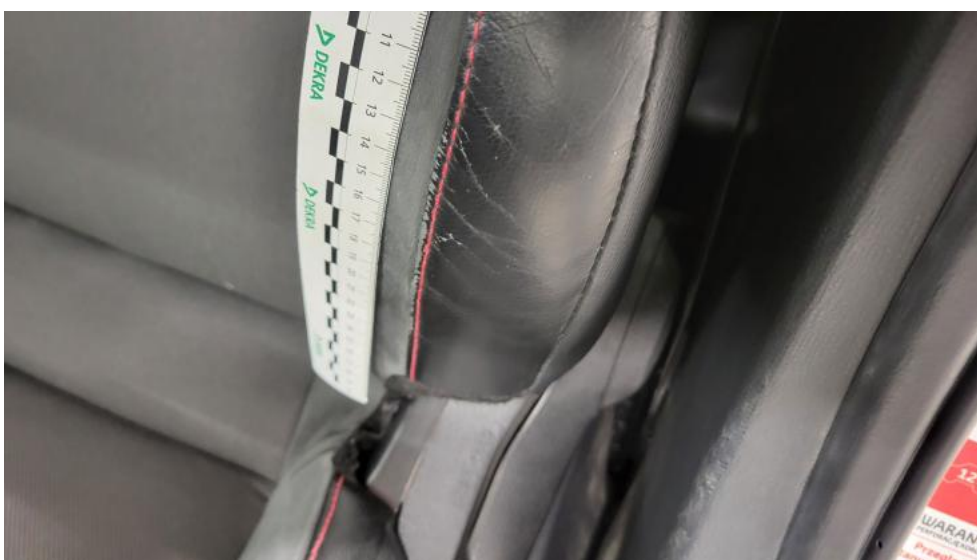
Fotel prz. lew. - Rysa/odprysk 1

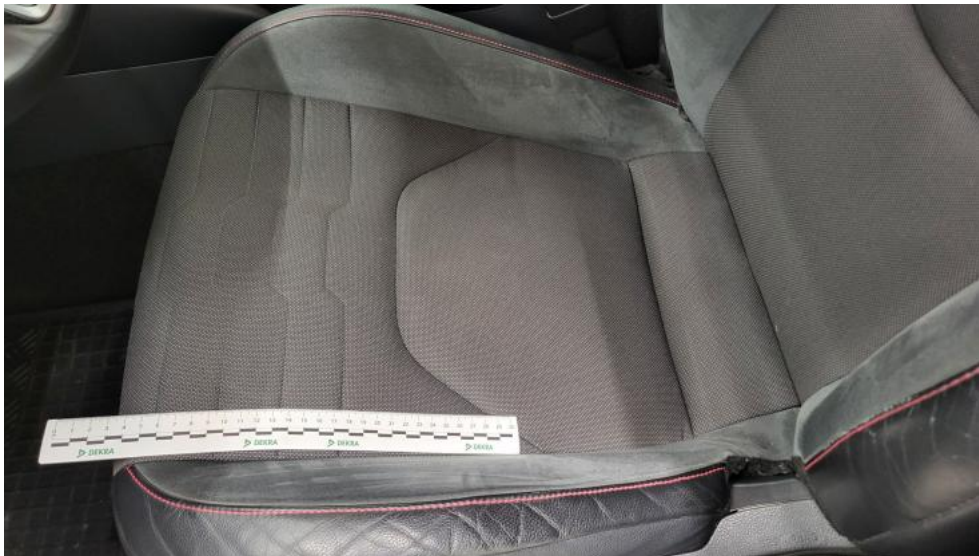
Fotel prz. lew. - Inne 1

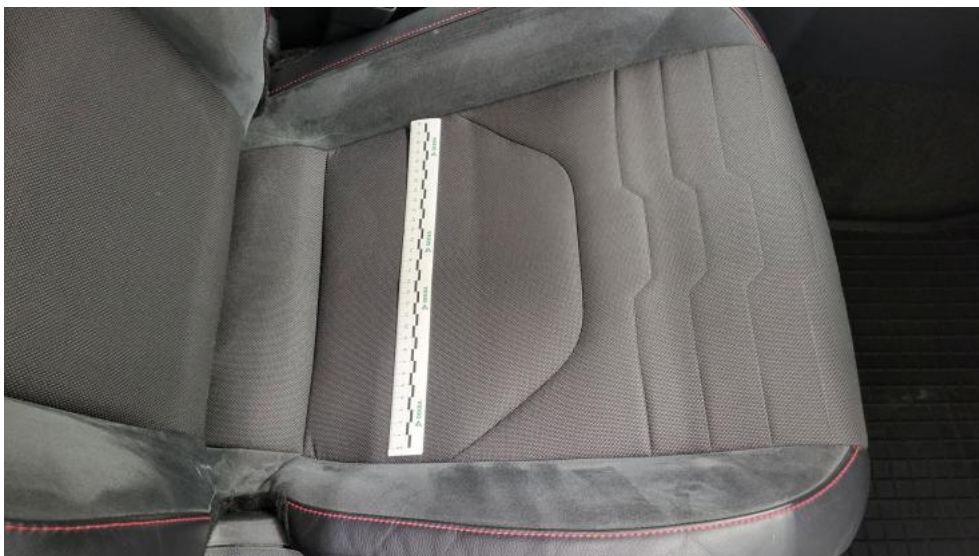
Fotel prz. praw. - Inne 1

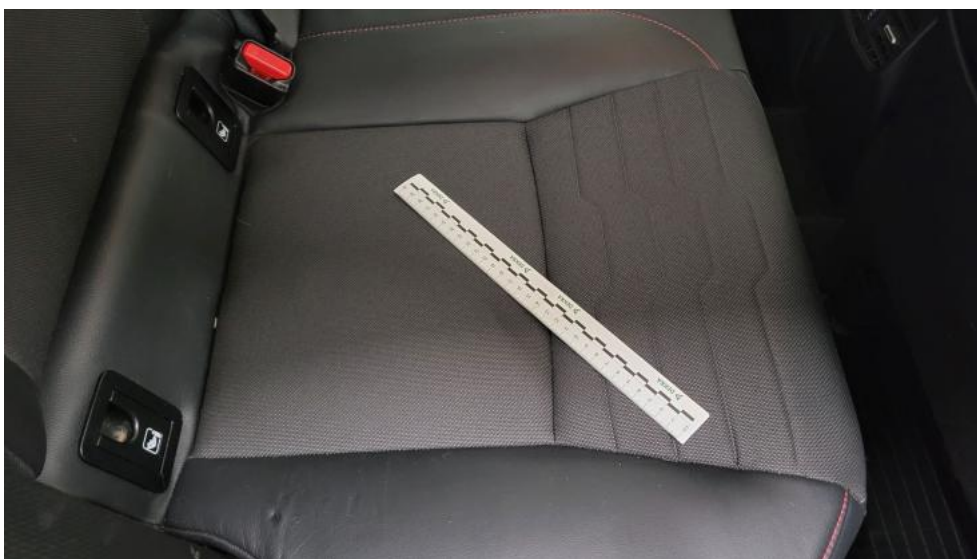
Kanapa tyl. - Inne 1

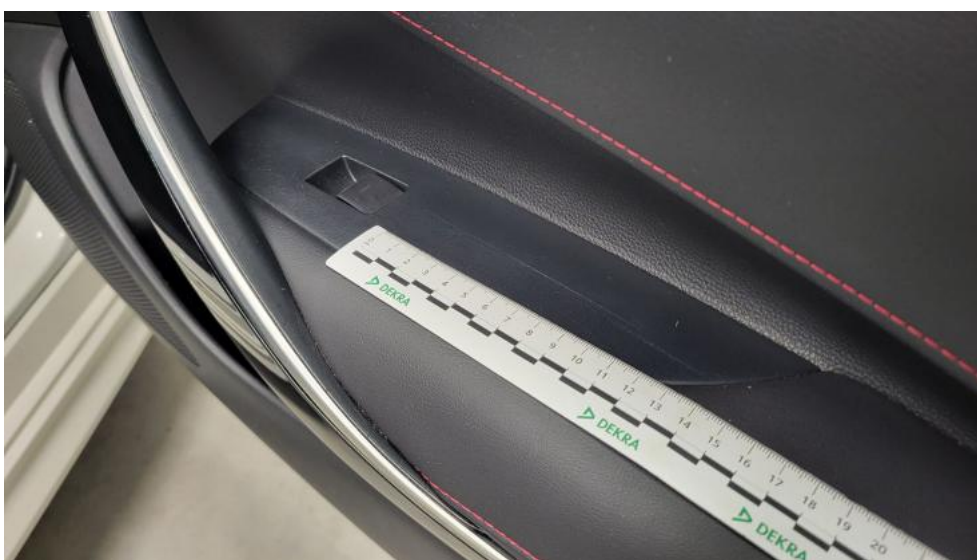
Tapicerka drzwi przednich P - Rysa/odprysk 1

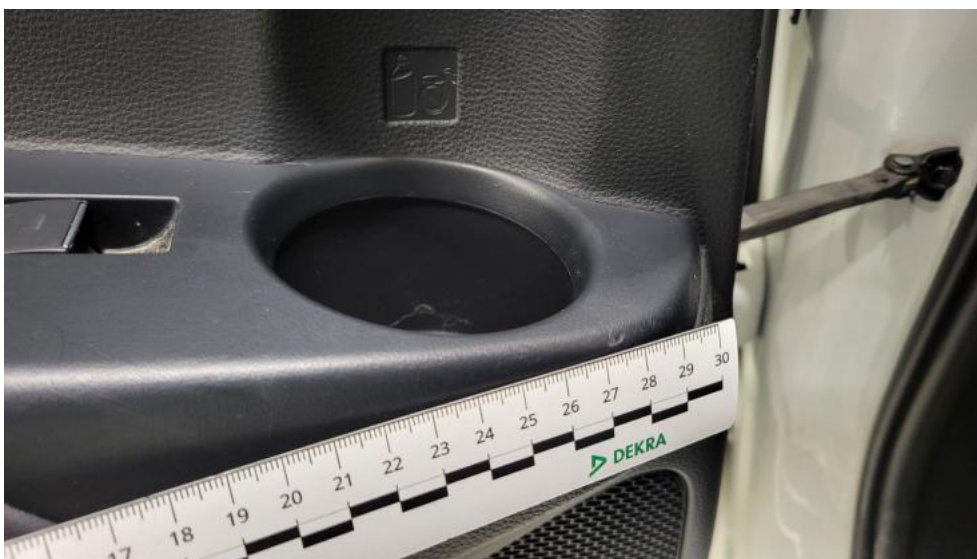
Tapicerka drzwi tylnych L - Rysa/odprysk 1

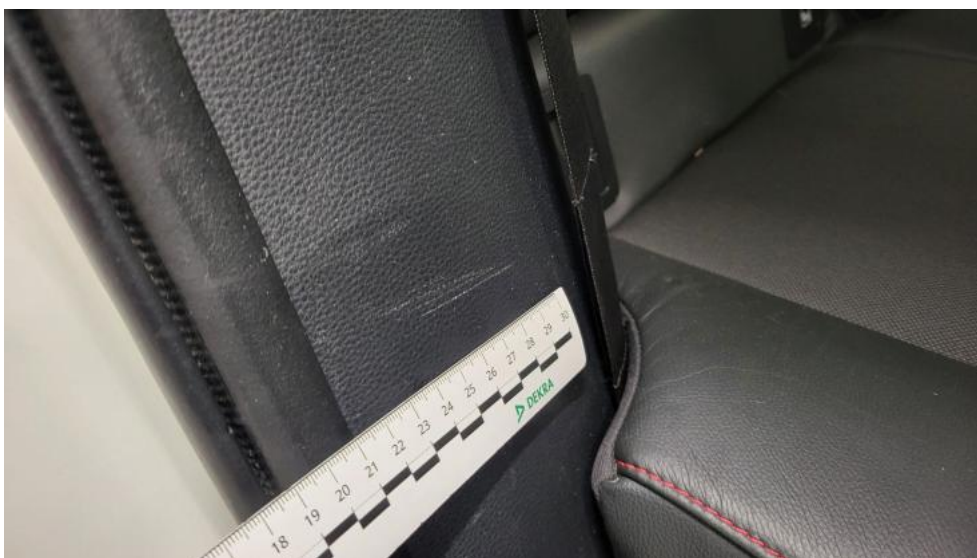
Wykładzina(y) słupka tylnego P - Rysa/odprysk 1
