DEKRA's commission No. : PKOL(W)/LODZ/13260/26/02/18
commission/ damage No. : 24/001574
Date of commission: 18-02-2026

Group of objects (Eurotax)	jeeps
EC code (Eurotax)	0159256
Manufacturer	PORSCHE
Model	Cayenne III Coupe 23-
Type / version	Cayenne Coupe E-Hybrid PHEV
Body type	KOM
Number of doors / seats	5/5
Curb weight [kg]	2550
Gross vehicle weight [kg]	3110
Wheelbase 1/2	2895
Engine type	spark ignition
Pollution reduction system	three-way catalytic converter
Engine capacity [ccm]	2995
Engine Power [hp/kW]	304/224
Gearbox	automatic
Registration /record No.	FG6642R
VIN / serial number	WP1ZZZ9Y7RDA65541
Date of first registration	16-05-2024
Date of next. tech. test	16-05-2027
Year of manufacture	2024 (year has been verified with the manufacturer's base)
Readout [km]	50 930 (read)
Body color / type of coating	beżowy/UNI

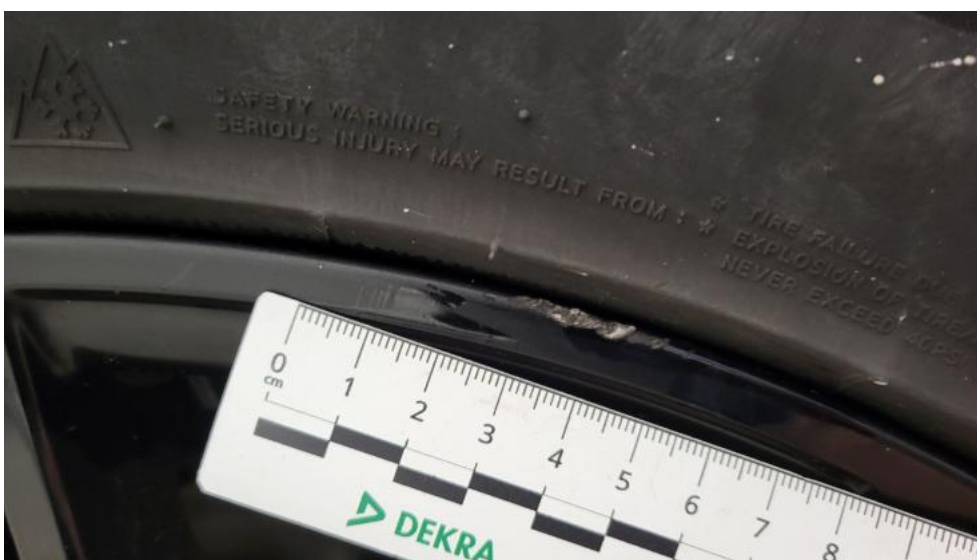
Photo 56.
Felga aluminiowa przednia P - Rysa/odprysk 1

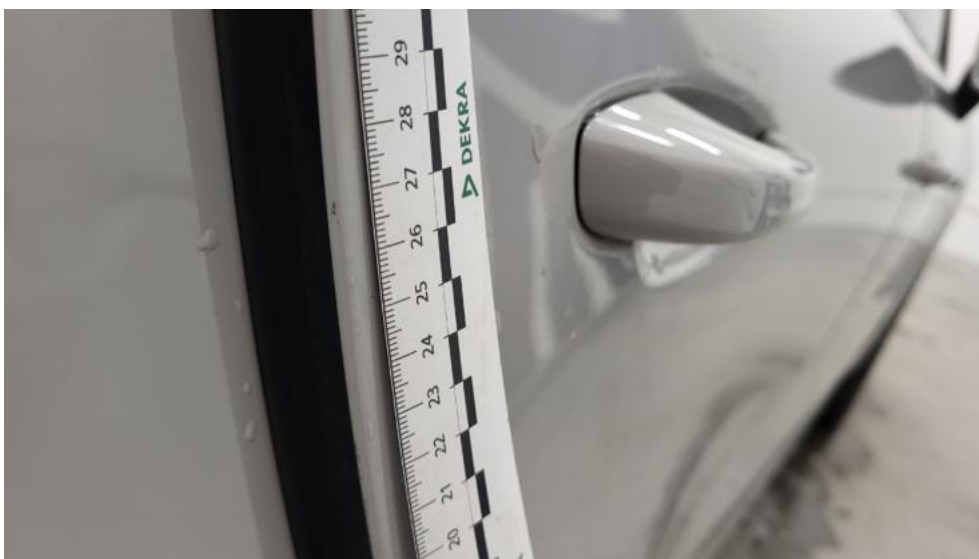
Photo 59.

Drzwi tylne P - Rysa/odprysk 1

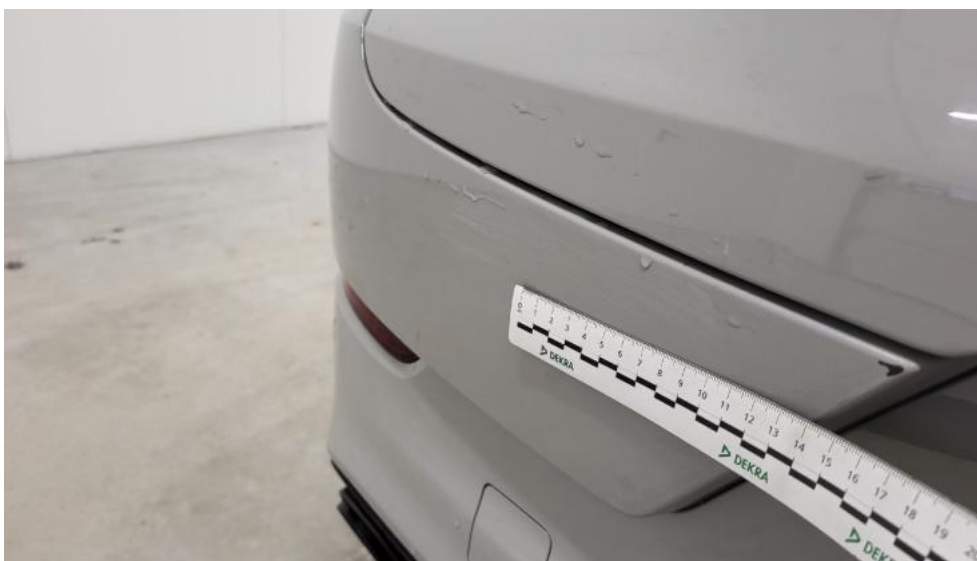
Photo 67.
Zderzak tylny cz L - Rysa/odprysk 1

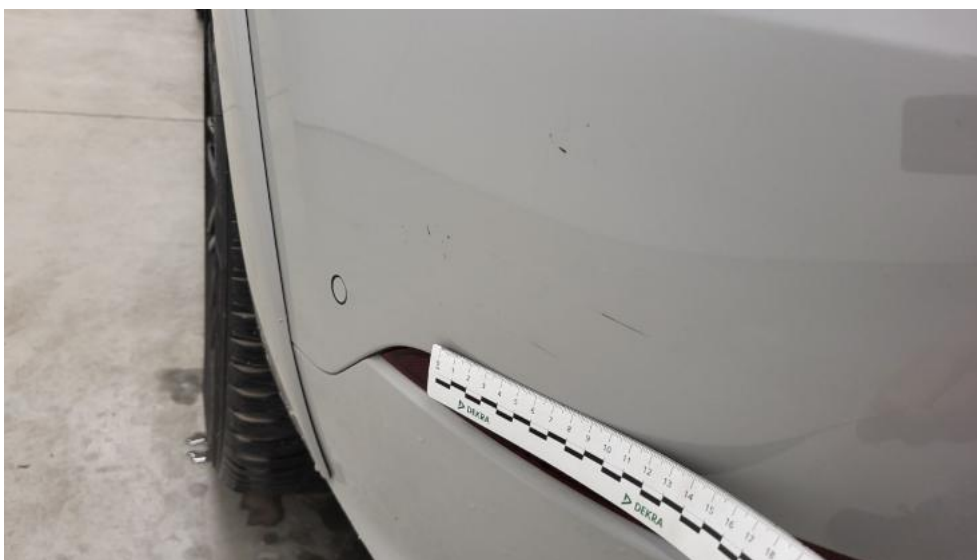
Photo 68.
Zderzak tylny cz L - Rysa/odprysk 2

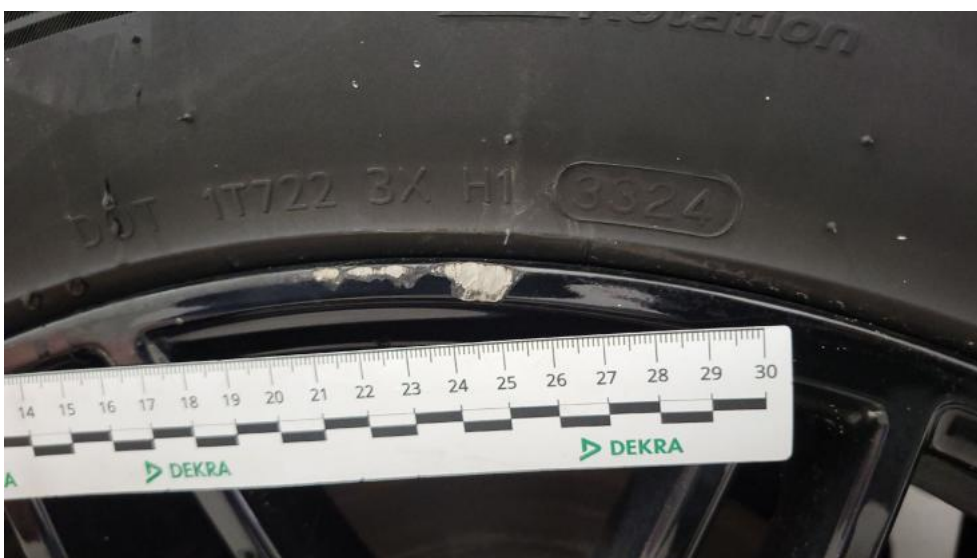
Photo 70.

Felga aluminiowa tylna L - Rysa/odprysk 1

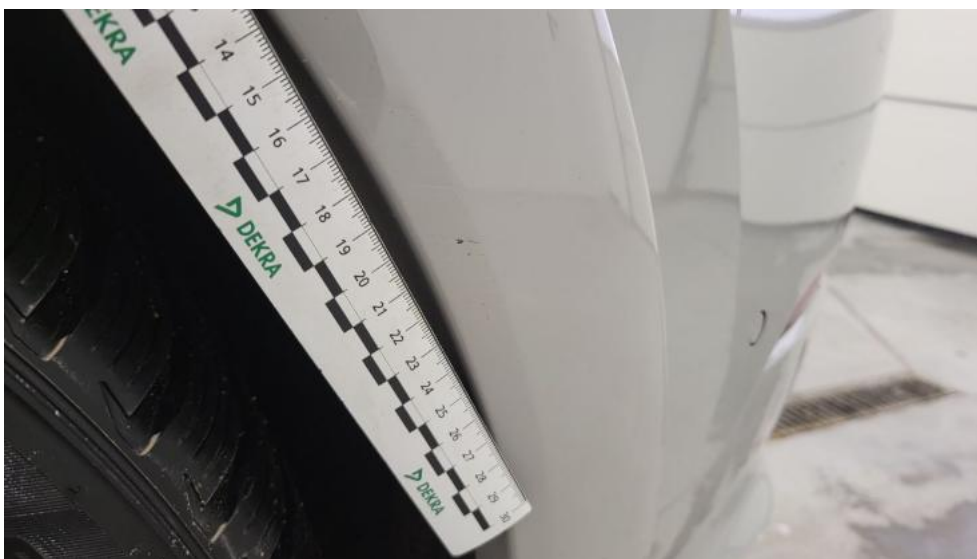
Photo 71.

Listwa krawędzi błotnika tył L - Rysa/odprysk 1

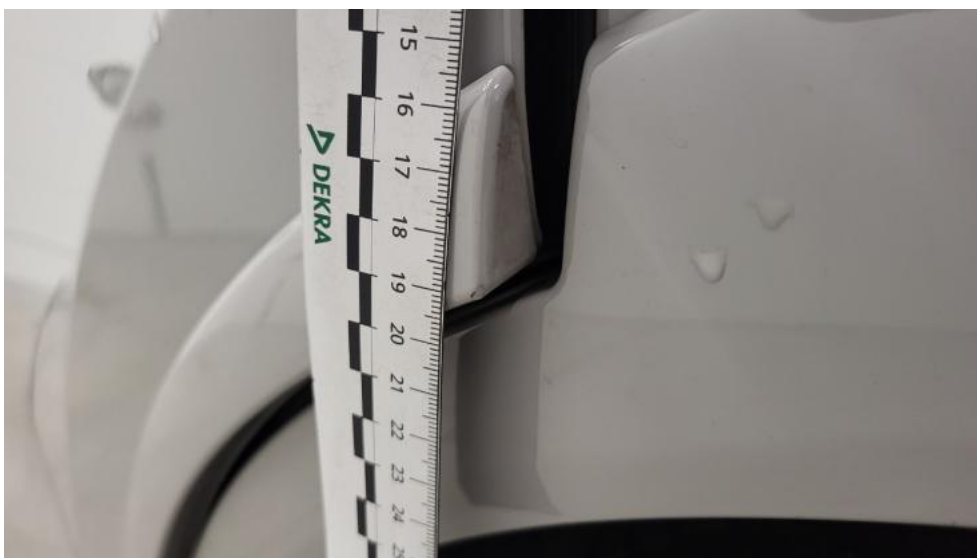
Photo 72.

Listwa drzwi tylnych L - Rysa/odprysk 1

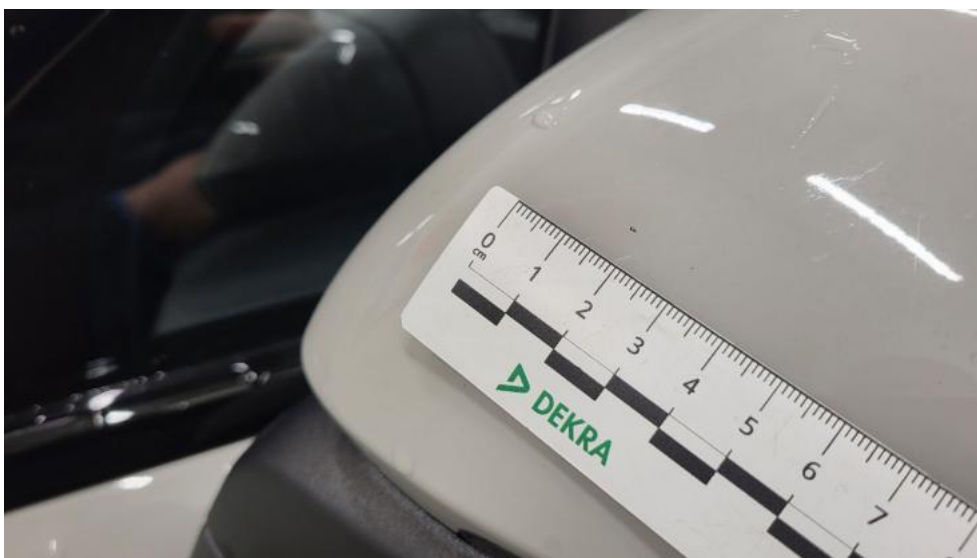
Photo 74.

Lusterko zew L - Rysa/odprysk 1
