DEKRA's commission No. : PKOL(W)/LODZ/74993/24/09/27
commission/ damage No. : 21/014059
Date of commission: 27-09-2024

Vehicle data

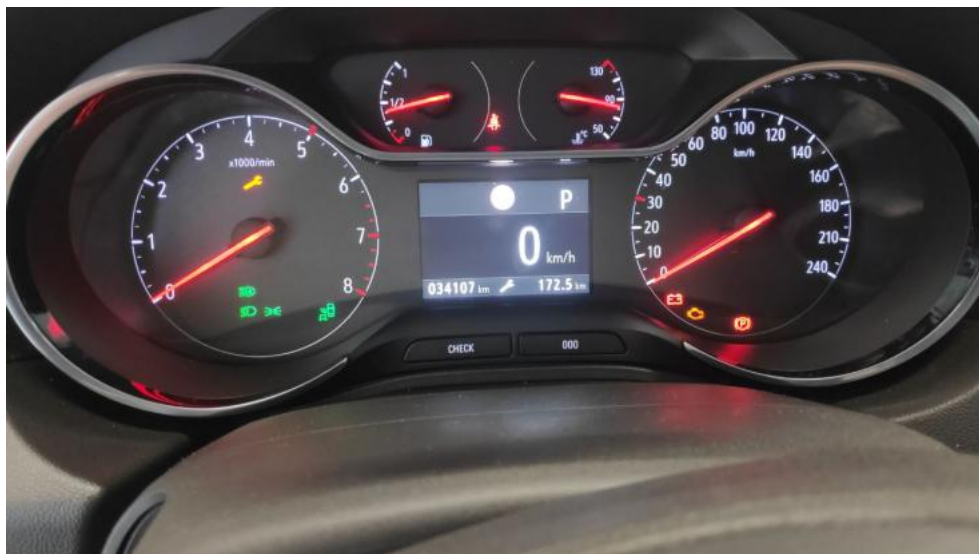
Aktywna kontrolka serwisu. Ikona wymaganego serwisu.

Photo 25.
Zestaw wskaźników - serwis

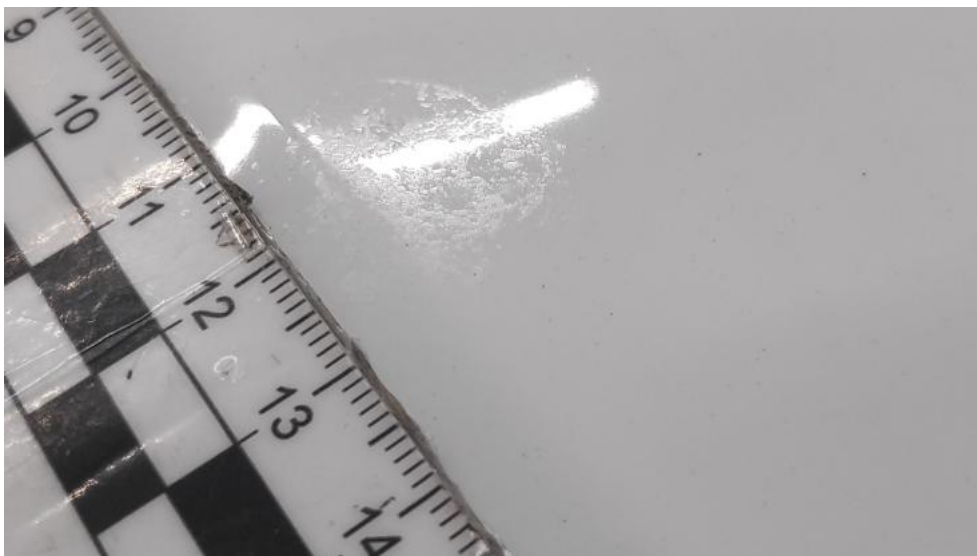
Photo 39.

Pokrywa komory silnika - Inne 1

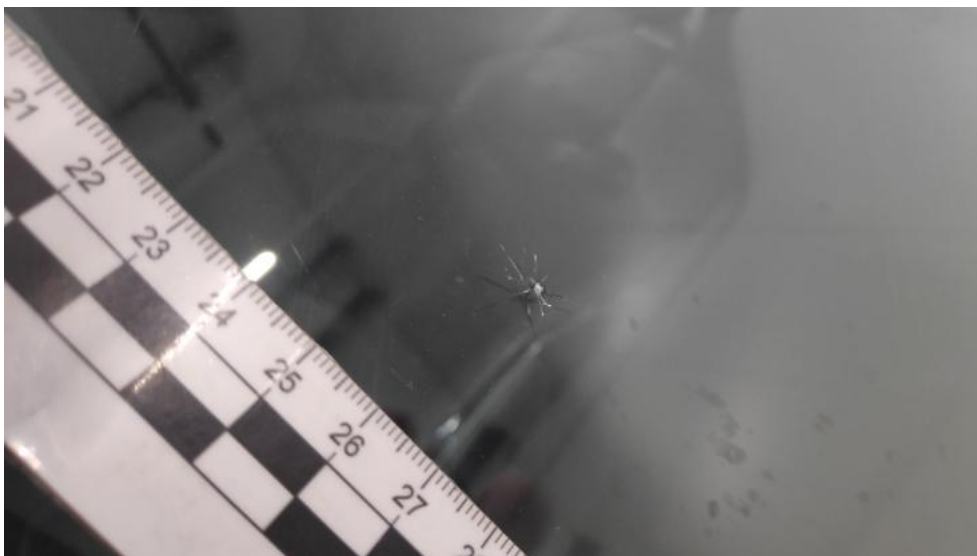
Photo 41.
Szyba czołowa - Pęknięcie/rozerwanie 1

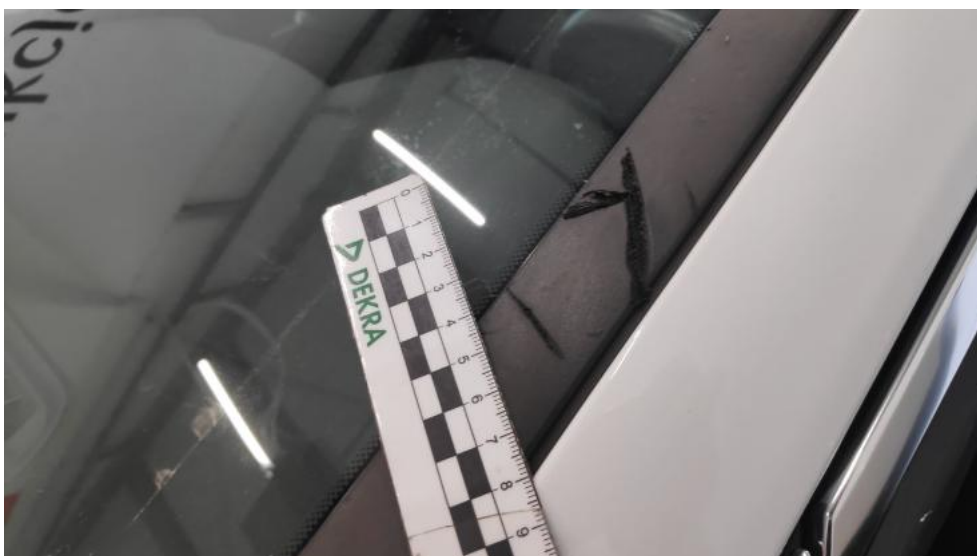
Photo 42.
Uszczelka/listwa szyby czołowej - Rysa/odprysk 1

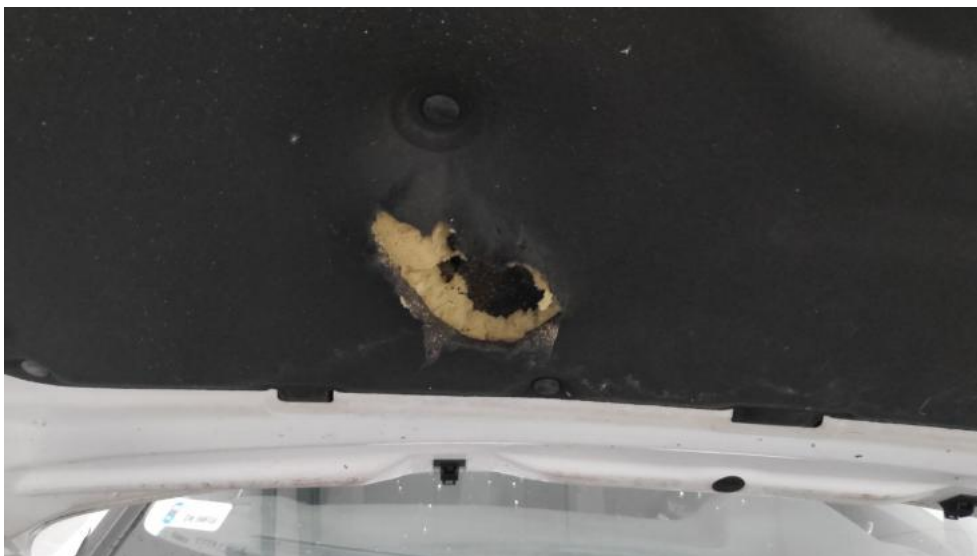
Photo 43.
Wykładzina pokrywy komory silnika - Pęknięcie/rozerwanie 1

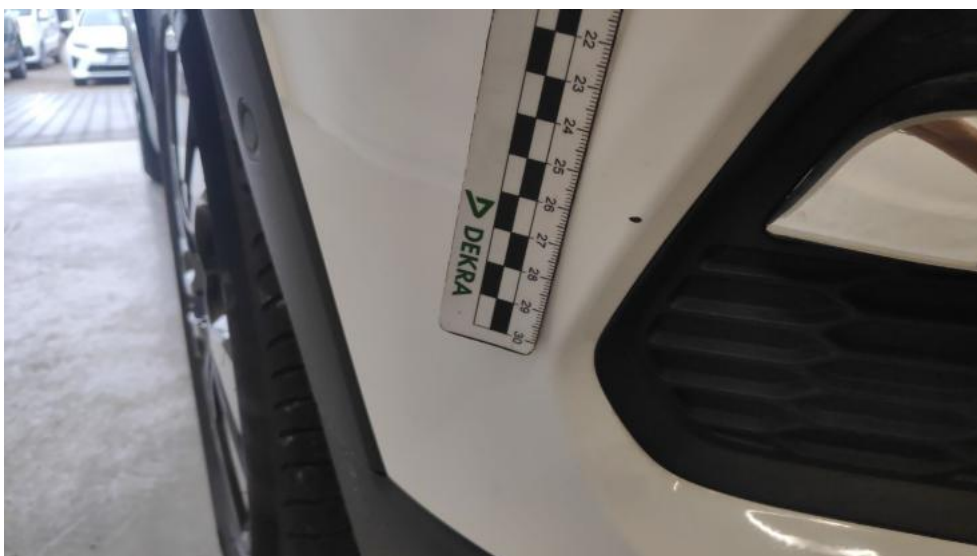
Photo 44.
Zderzak - Rysa/odprysk 1

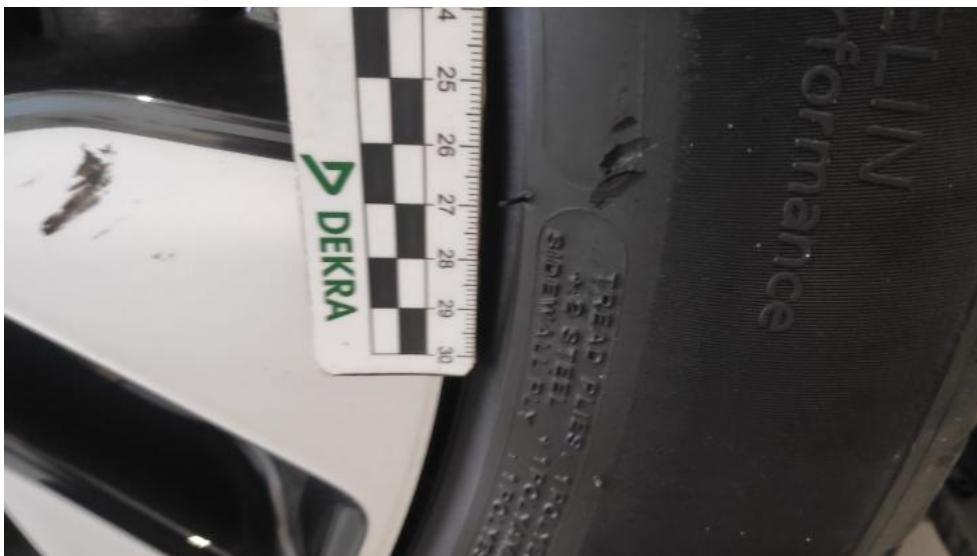
Photo 45.

Opona przednia P - Rysa/odprysk 1

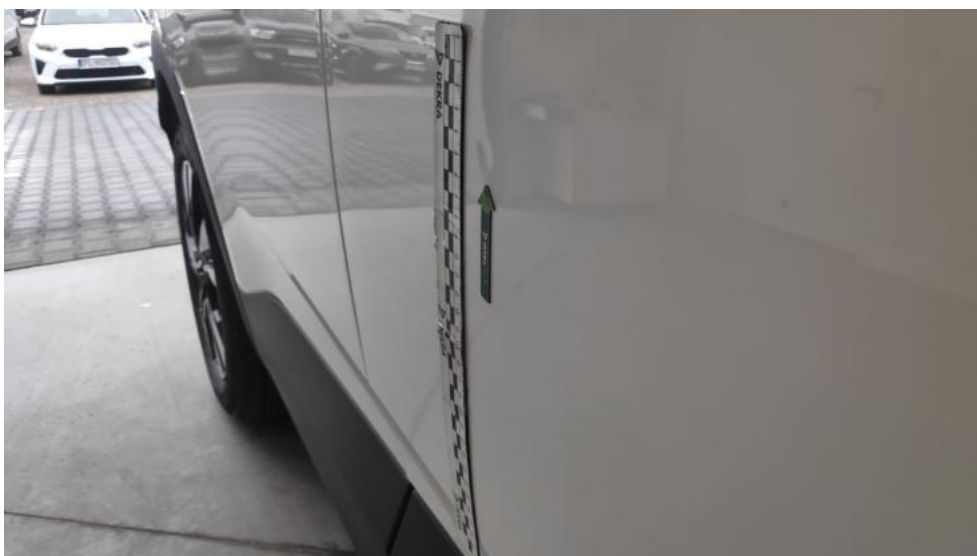
Photo 46.

Drzwi przednie P - Wgniecenie/odkształcenie 1

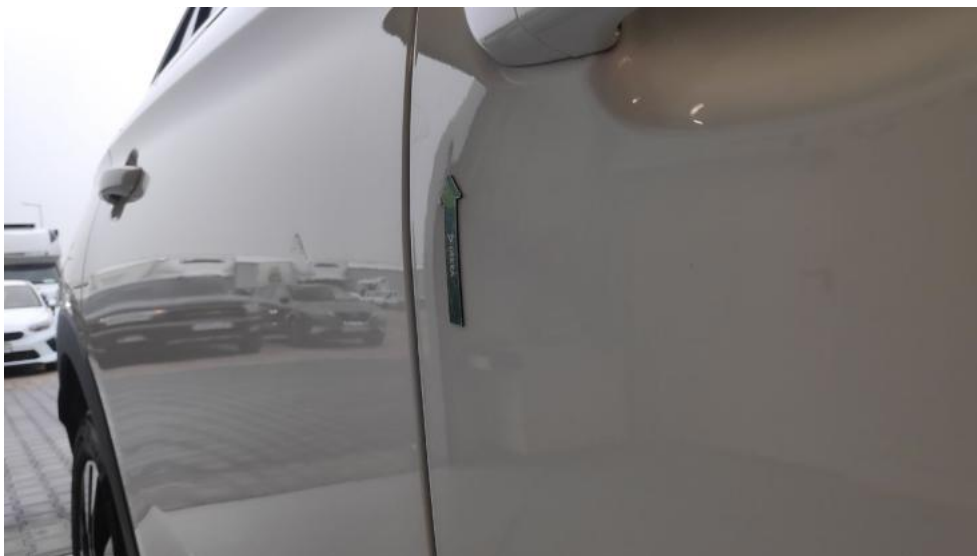
Photo 47.
Drzwi przednie P - Wgniecenie/odkształcenie 2

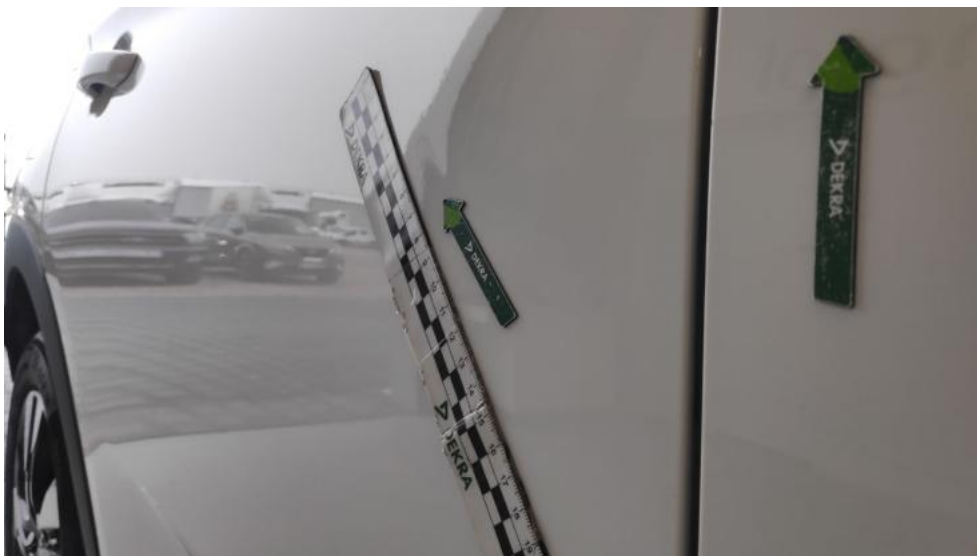
Photo 49.
Drzwi tylne P - Wgniecenie/odkształcenie 1

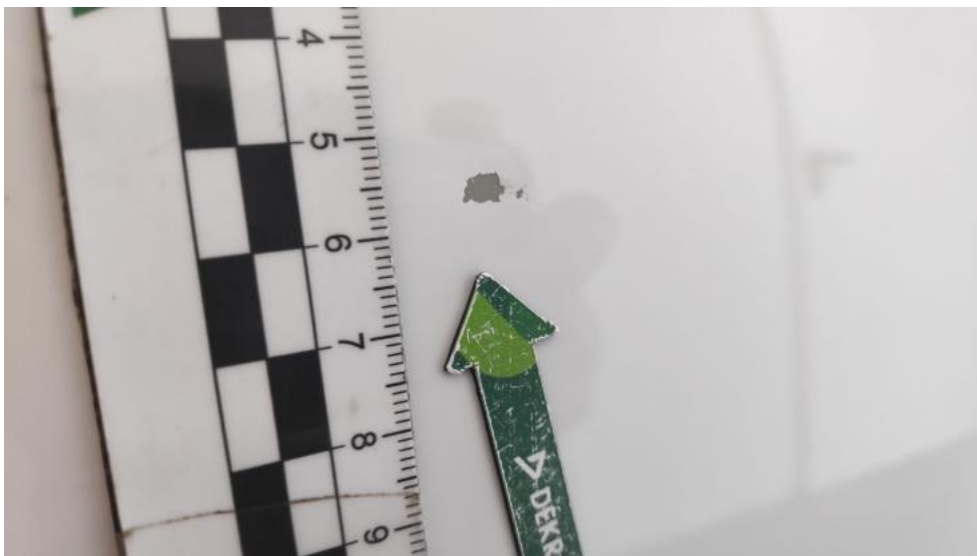
Photo 51.

Drzwi przed L - Rysa/odprysk 1

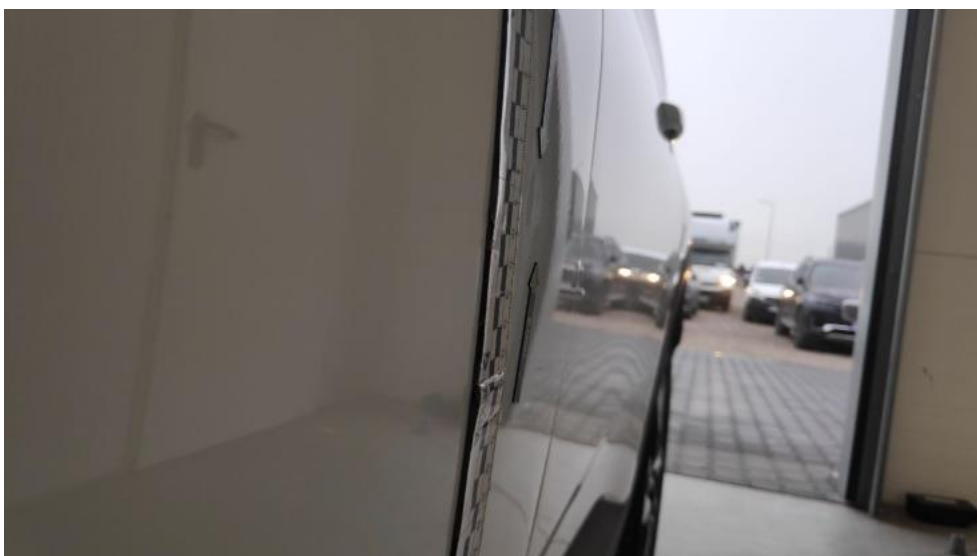
Photo 52.

Drzwi przed L - Wgniecenie/odkształcenie 1

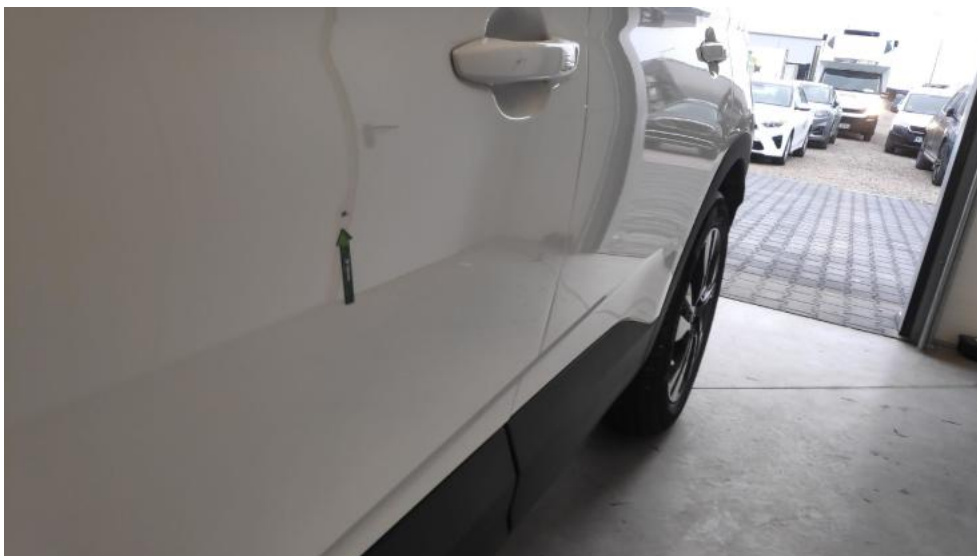
Photo 53.
Drzwi przed L - Wgniecenie/odkształcenie 2

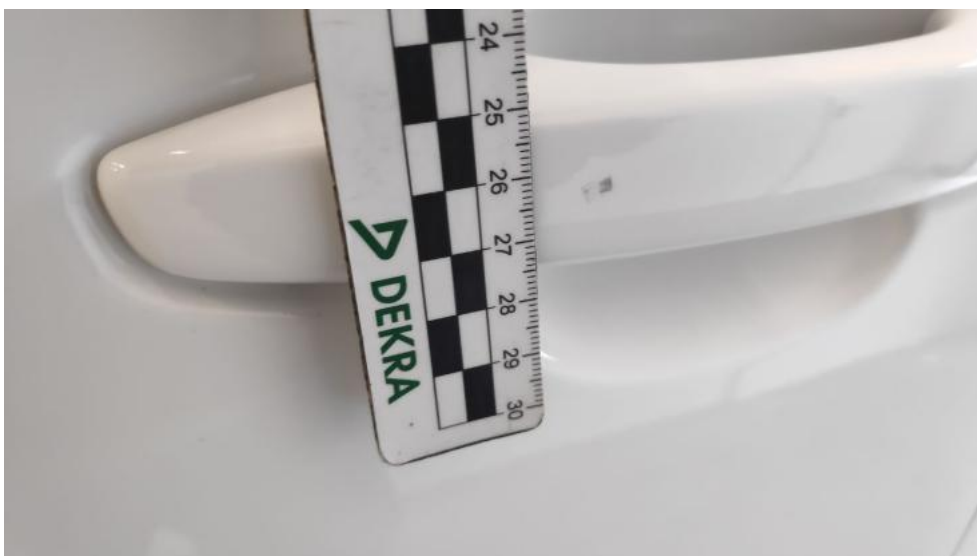
Photo 54.
Klamka drzwi prz L - Rysa/odprysk 1
