DEKRA's commission No. : PKOL(W)/LODZ/63830/24/08/21  
commission/ damage No. : 49501  
Date of commission: 21-08-2024

**Vehicle data**

| Model | Jumper 35 BlueHDi Euro 6 1997ccm - 130KM 3,5t<br>16-19 |
| Registration /record No. | DW2EG12 |

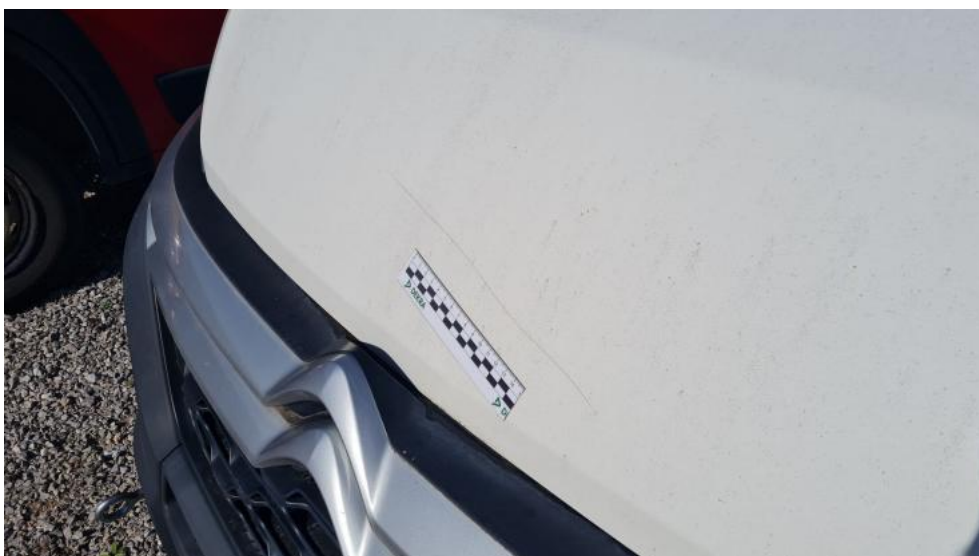
**Photo 30.**  
Pokrywa komory silnika - Rysa/odprysk 1

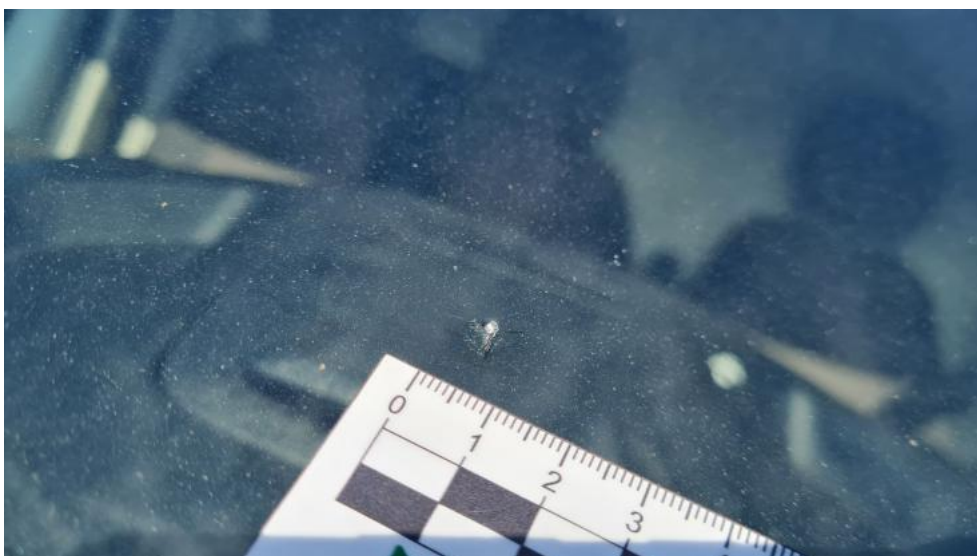
**Photo 32.**  
Szyba czołowa - Pęknięcie/rozerwanie 1

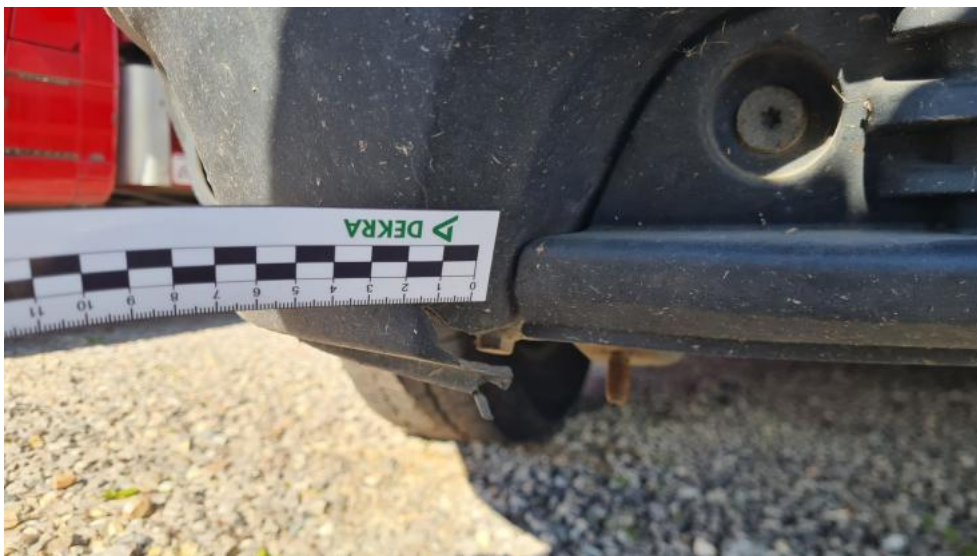
**Photo 33.**  
Zderzak - Pęknięcie/rozerwanie 1

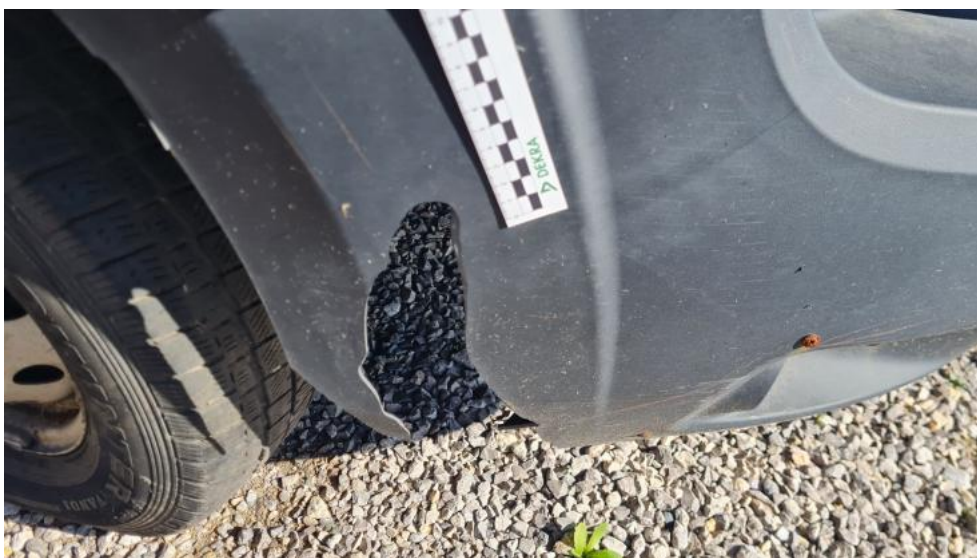
**Photo 34.**  
Zderzak - Pęknięcie/rozerwanie 2

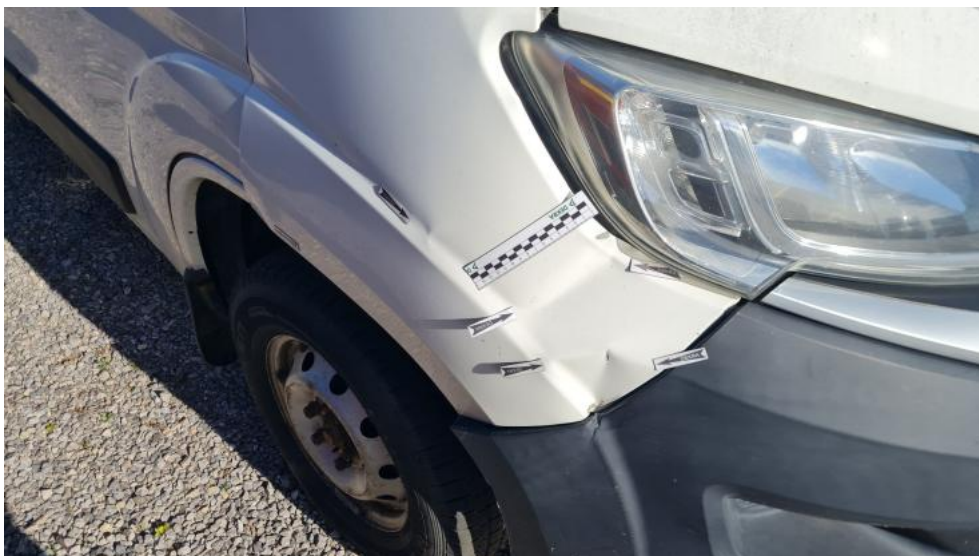
**Photo 35.**  
Błotnik przedni P - Wgniecenie/odkształcenie 1

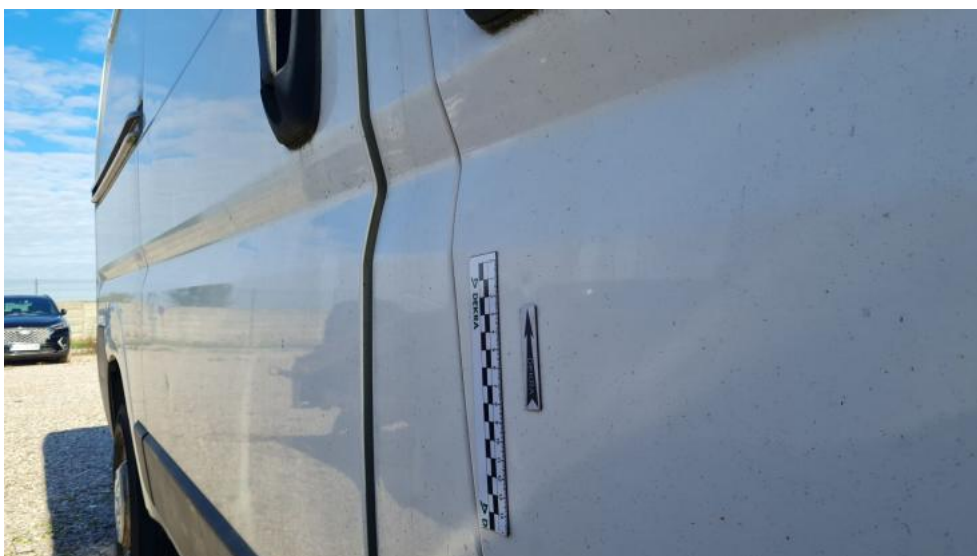
**Photo 38.**

Drzwi przednie P - Wgniecenie/odkształcenie 1

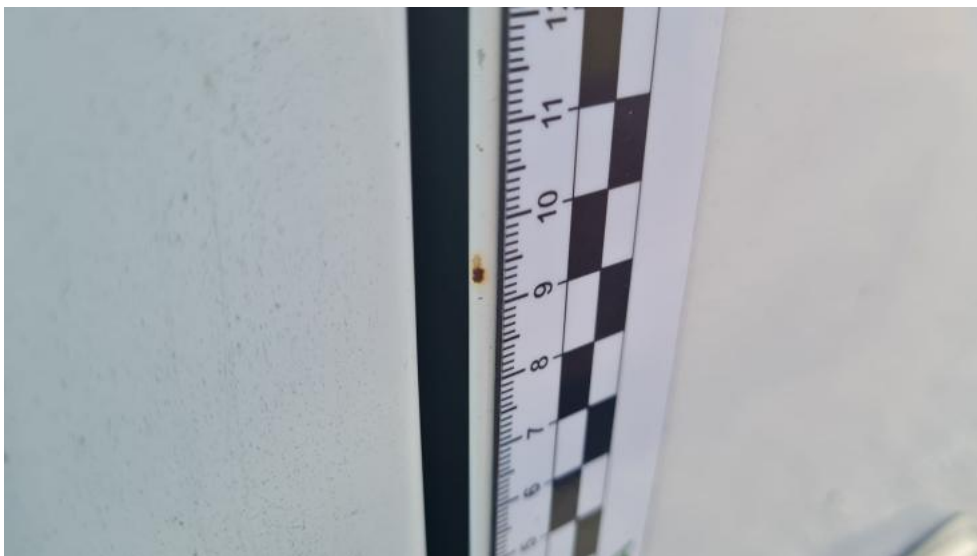
Drzwi przednie P - Inne 1

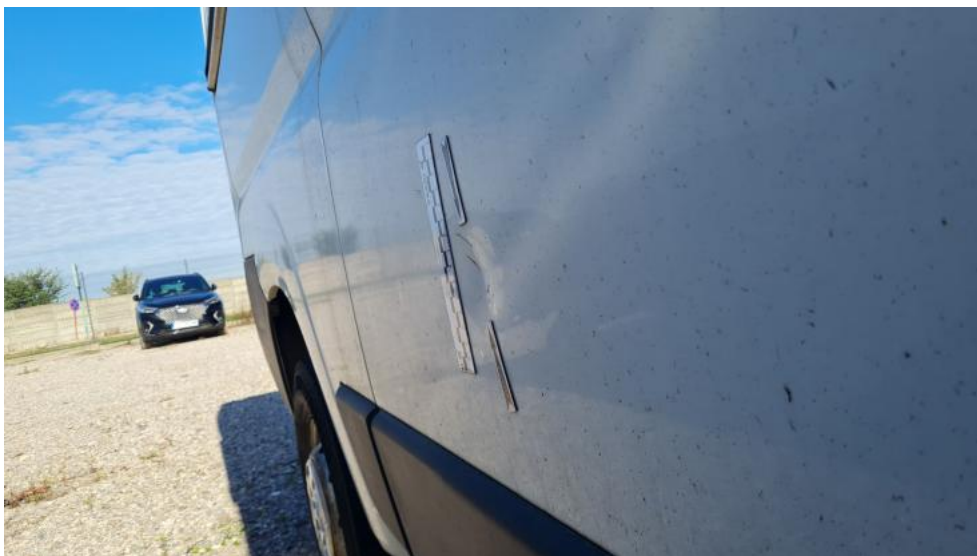
**Photo 41.**  
Drzwi tylne P - Wgniecenie/odkształcenie 1

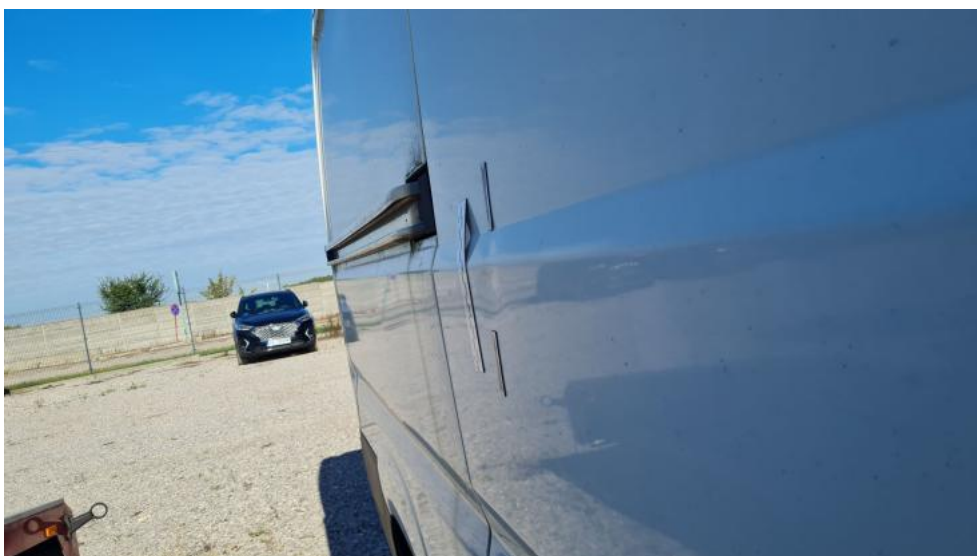
**Photo 42.**  
Drzwi tylne P - Wgniecenie/odkształcenie 2

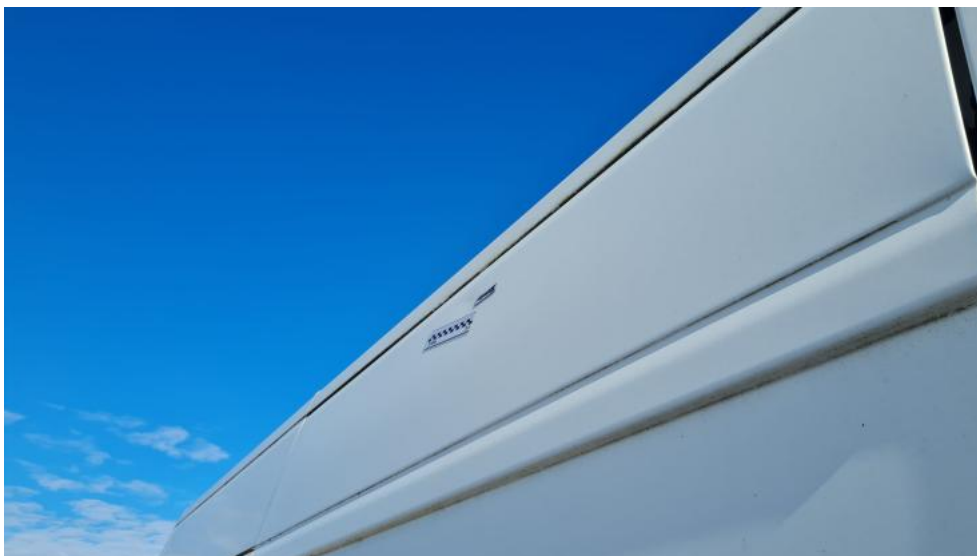
**Photo 43.**  
Drzwi tylne P() - Wgniecenie/odkształcenie 3

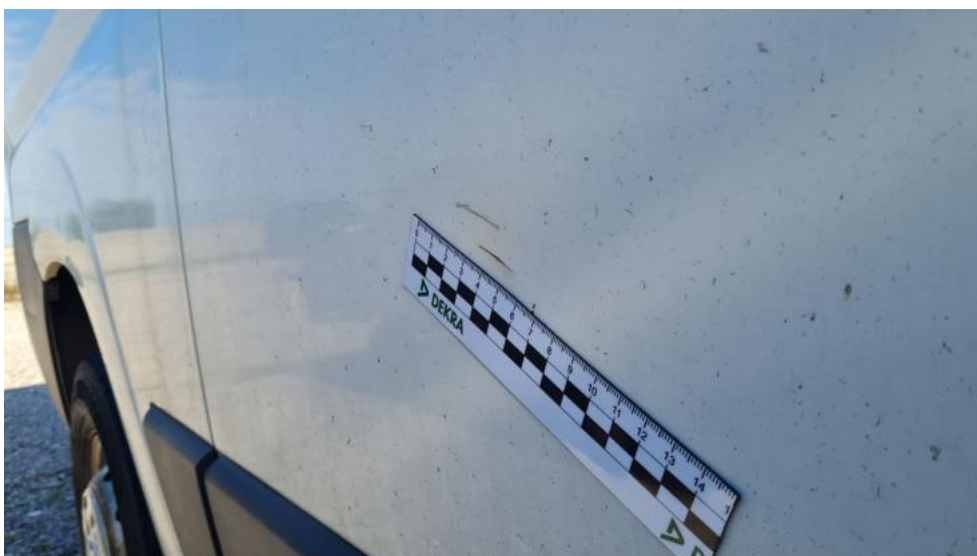
**Photo 44.**  
Drzwi tylne P - Inne 1

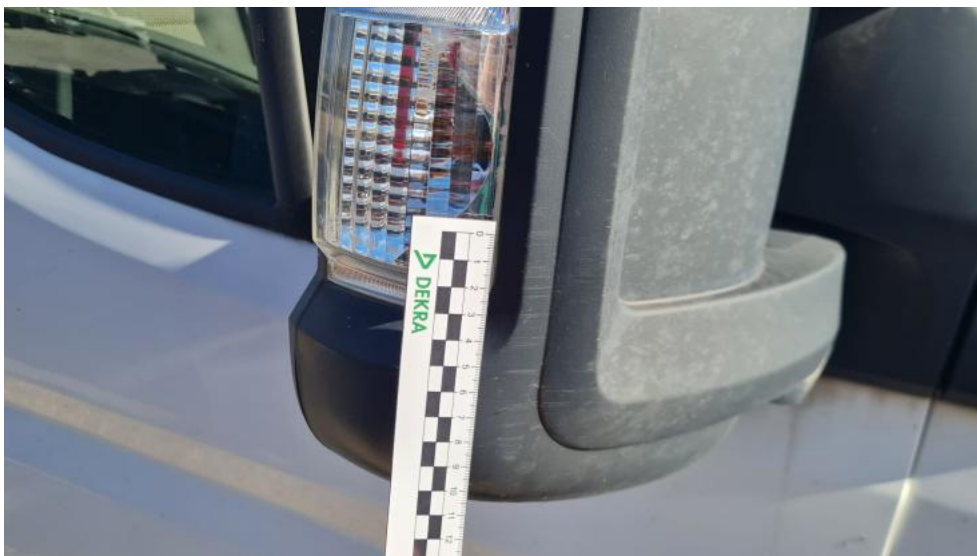
**Photo 45.**

Lusterko zew P - Rysa/odprysk 1

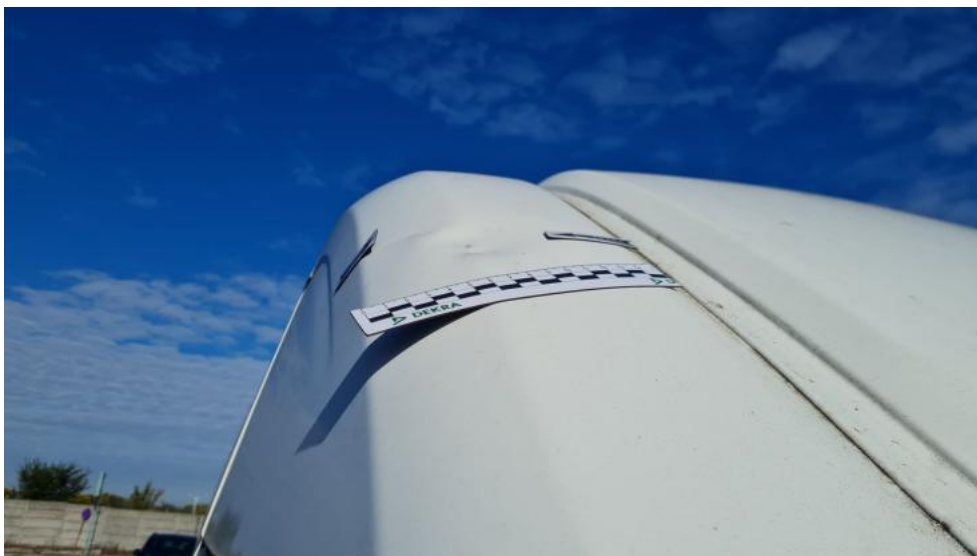
**Photo 47.**  
Stupek przedni P - Wgniecenie/odkształcenie 1

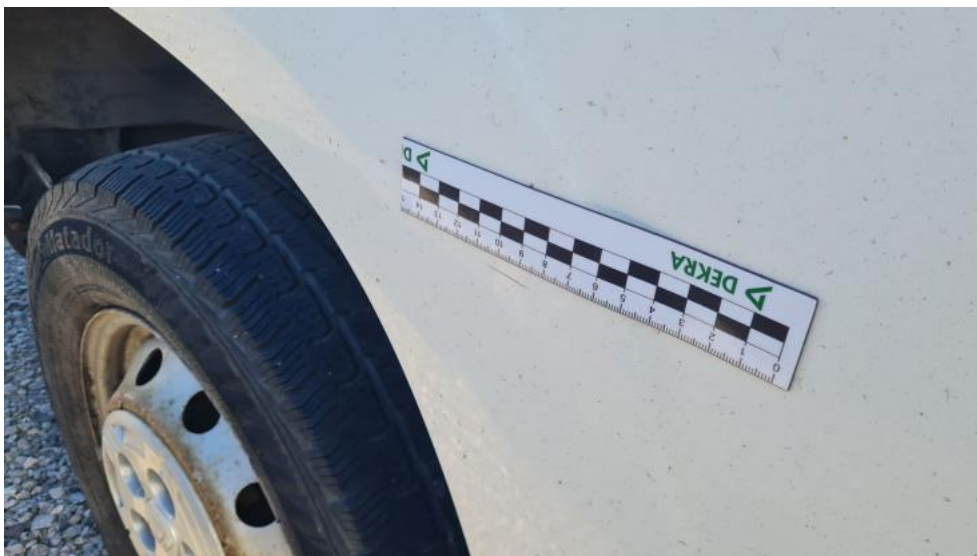
**Photo 49.**

Błotnik tylny P / Ściana boczna P - Rysa/odprysk 1

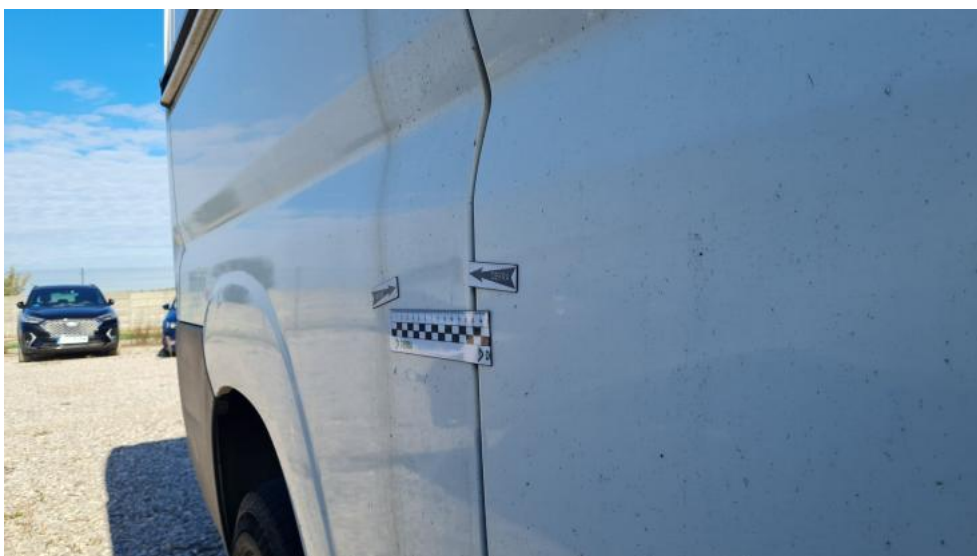
**Photo 50.**

Błotnik tylny P / Ściana boczna P - Wgniecenie/odkształcenie 1

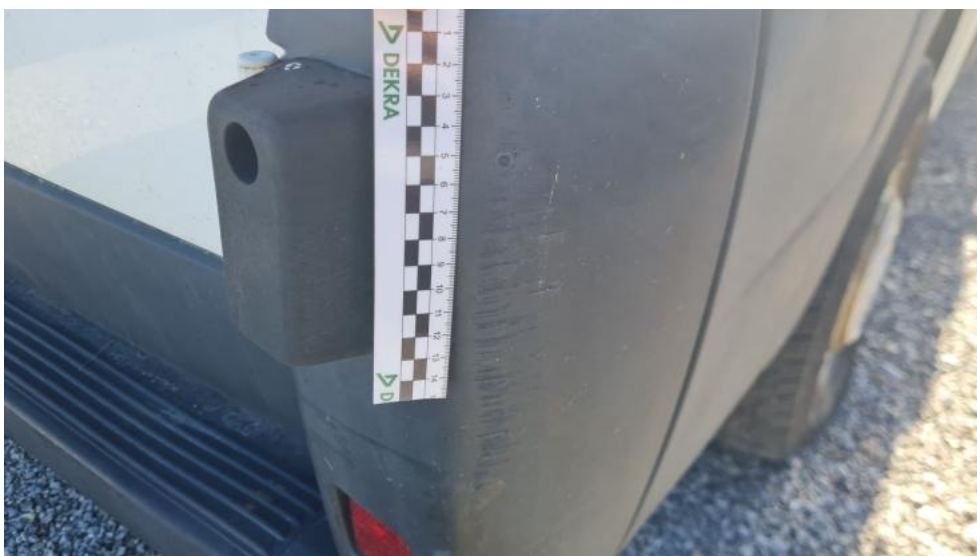
**Photo 52.**  
Zderzak tylny - Rysa/odprysk 1

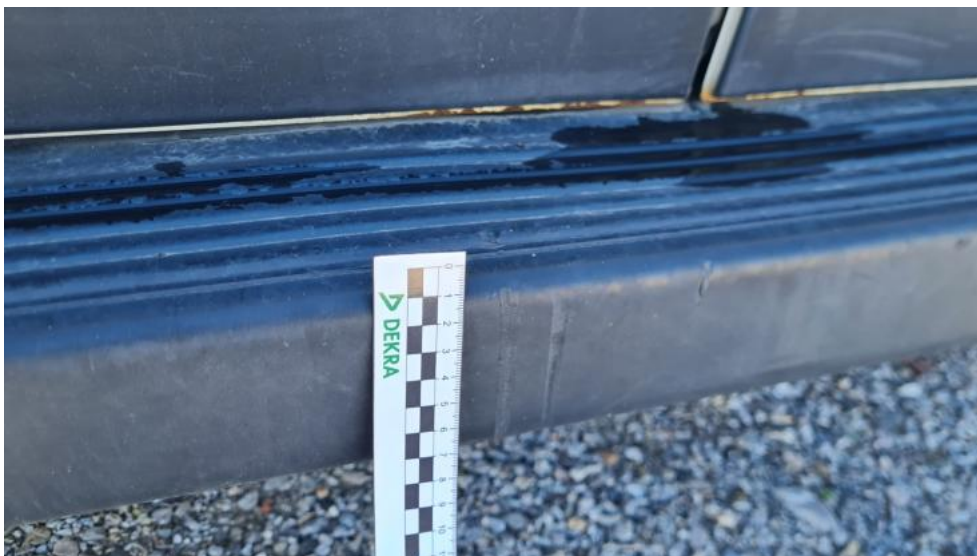
**Photo 53.**  
Zderzak tylny - Rysa/odprysk 2

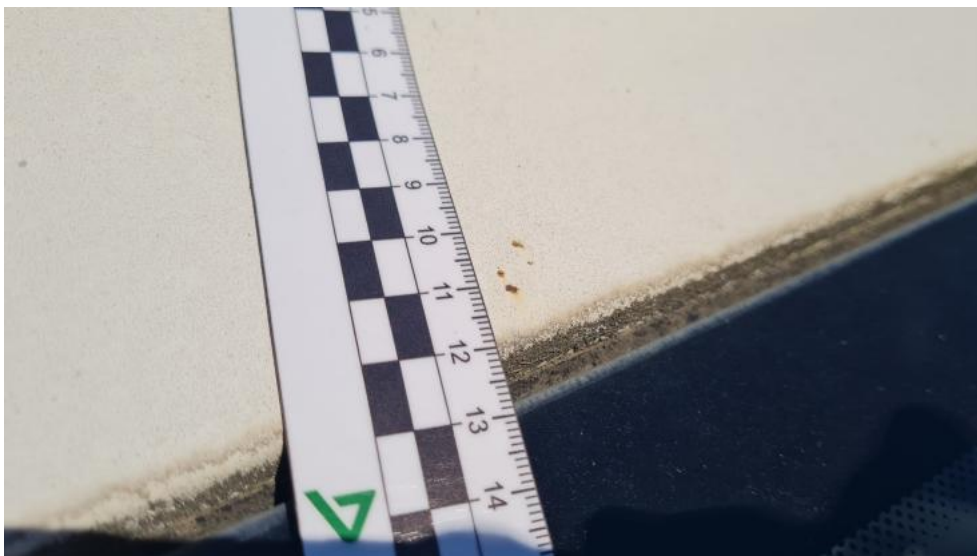
**Photo 55.**  
Dach - Inne 1

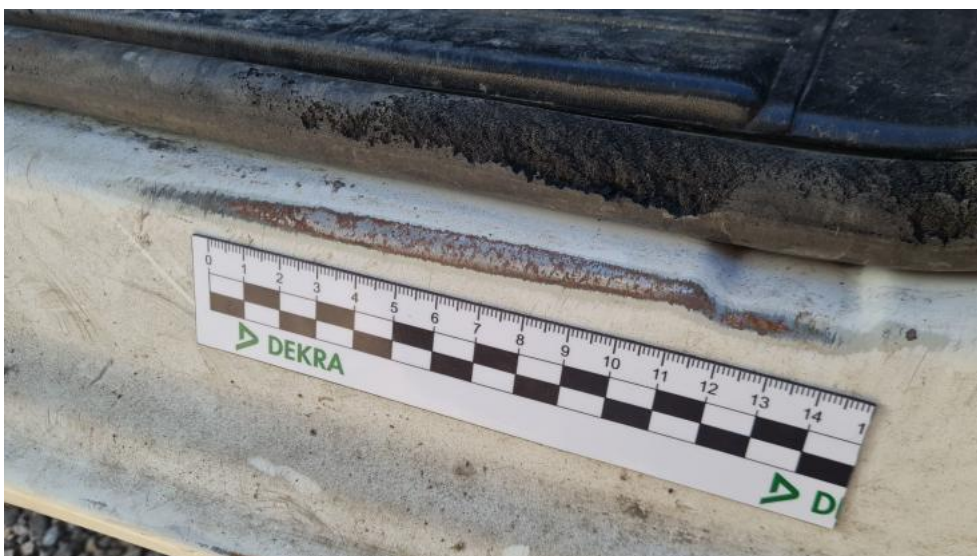
**Photo 60.**  
Próg L - Inne 1

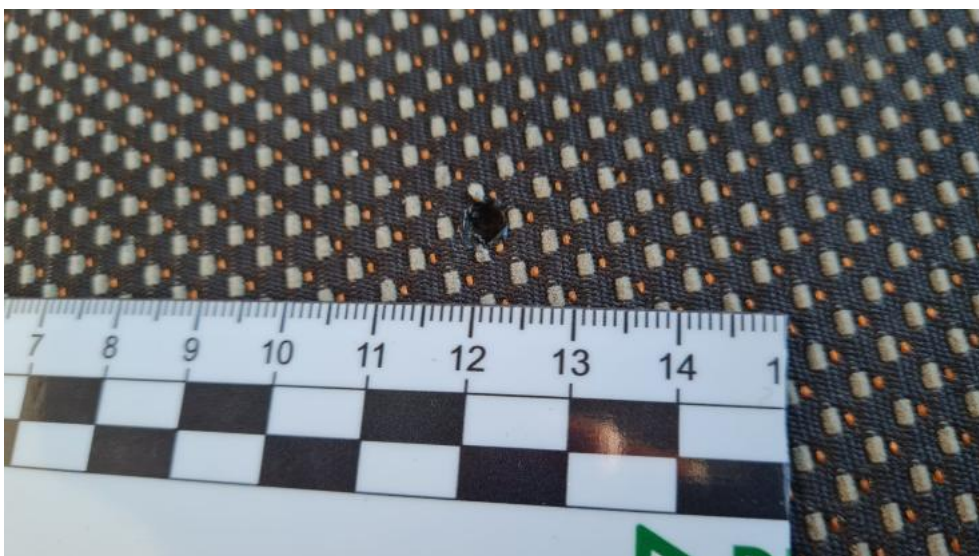
**Photo 62.**

Fotel prz. praw. - Inne 1

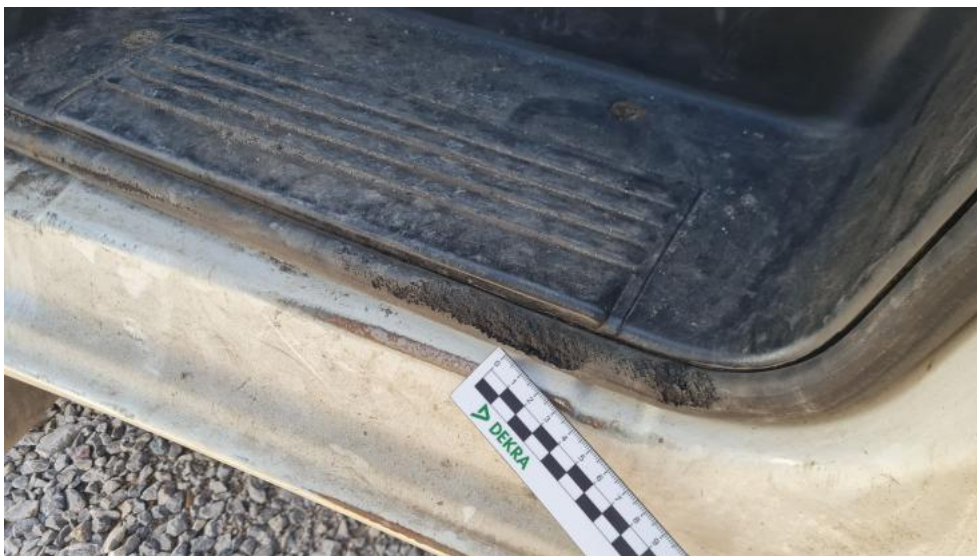
**Photo 63.**  
Uszczelka drzwi przednich L - Pęknięcie/rozerwanie 1

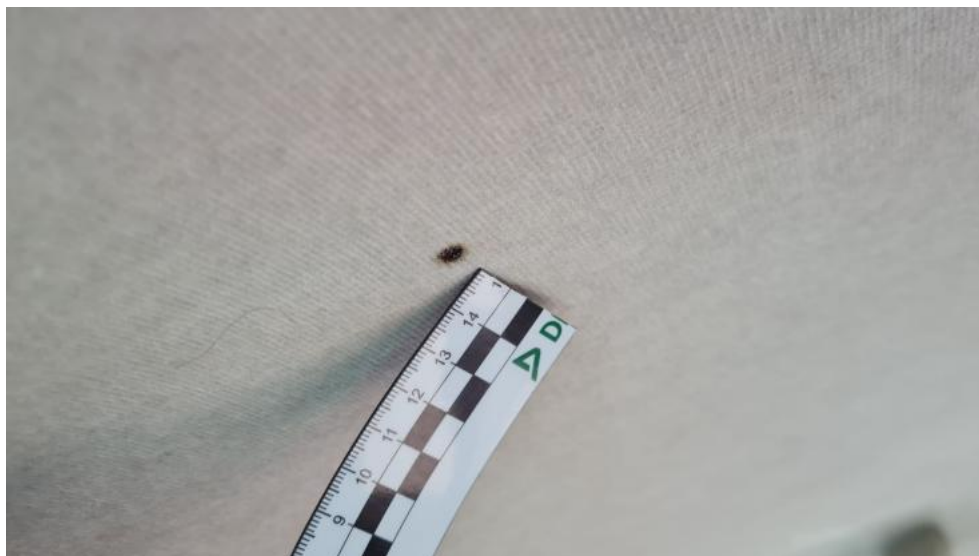
**Photo 65.**  
Podsufitka - Inne 1

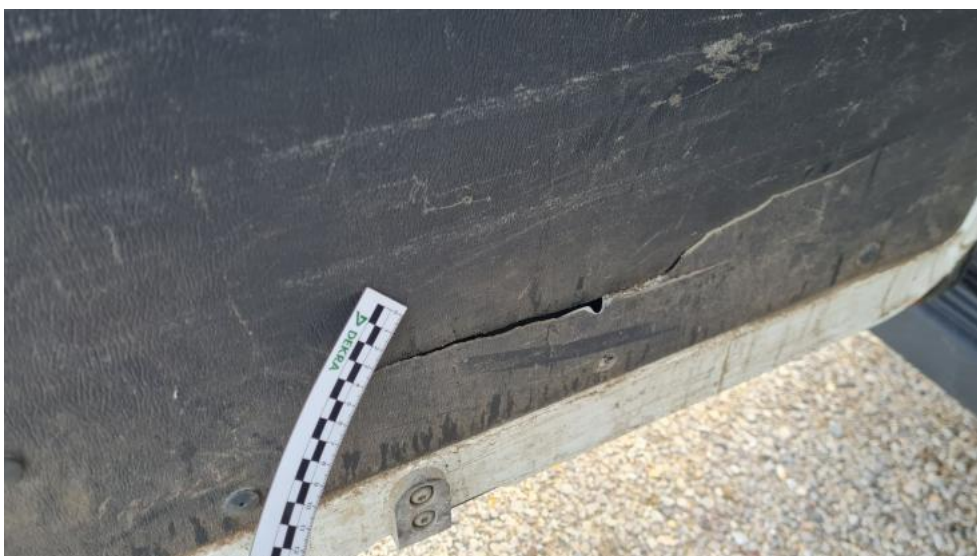
**Photo 68.**  
Drzwi tyłu lewe - Pęknięcie/rozerwanie 1

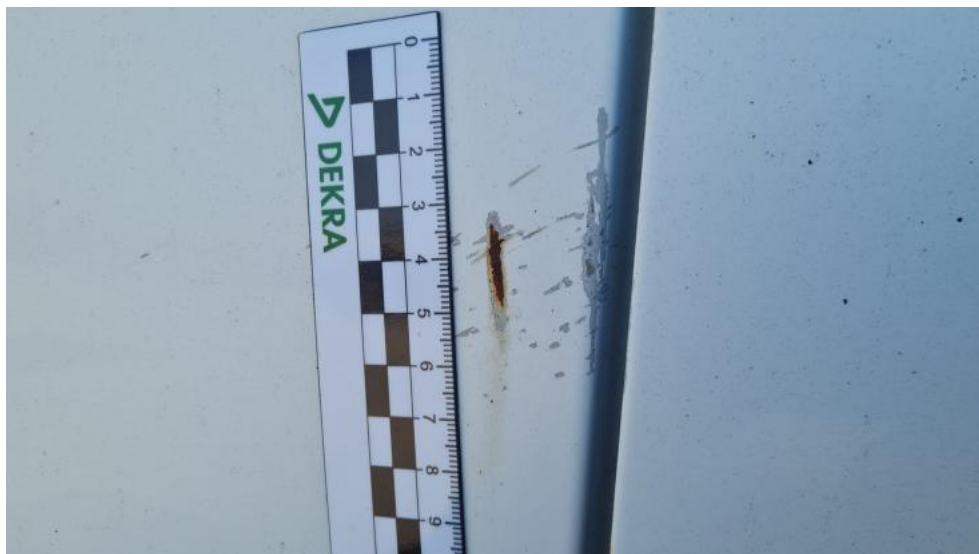
**Photo 69.**  
Drzwi tyłu lewe - Inne 1

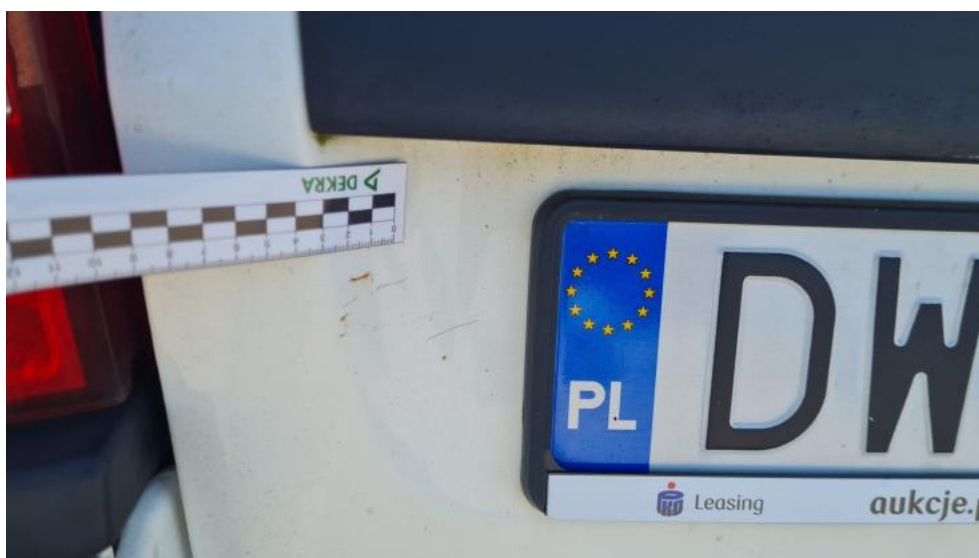
**Photo 70.**  
Drzwi tyłu lewe - Inne 2

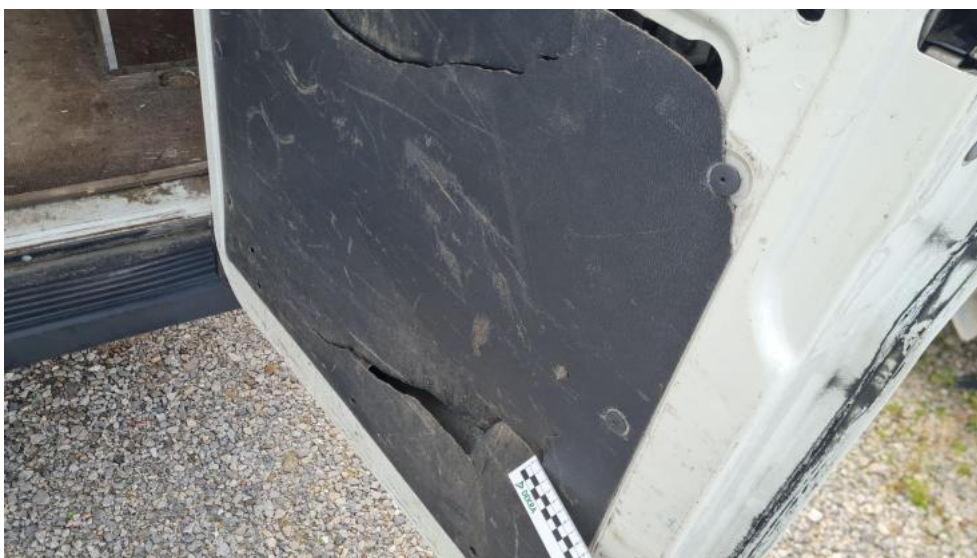
**Photo 72.**

Drzwi tyłu prawe - Pęknięcie/rozerwanie 1
