DEKRA's commission No. : PKOL(W)/LODZ/36429/25/05/20  
commission/ damage No. : FUTURA  
Date of commission: 20-05-2025

| Model | Qashqai 17-21 |
| Type / version | Qashqai 1.3 DIG-T Acenta |
| Registration /record No. | EL4JU98 |

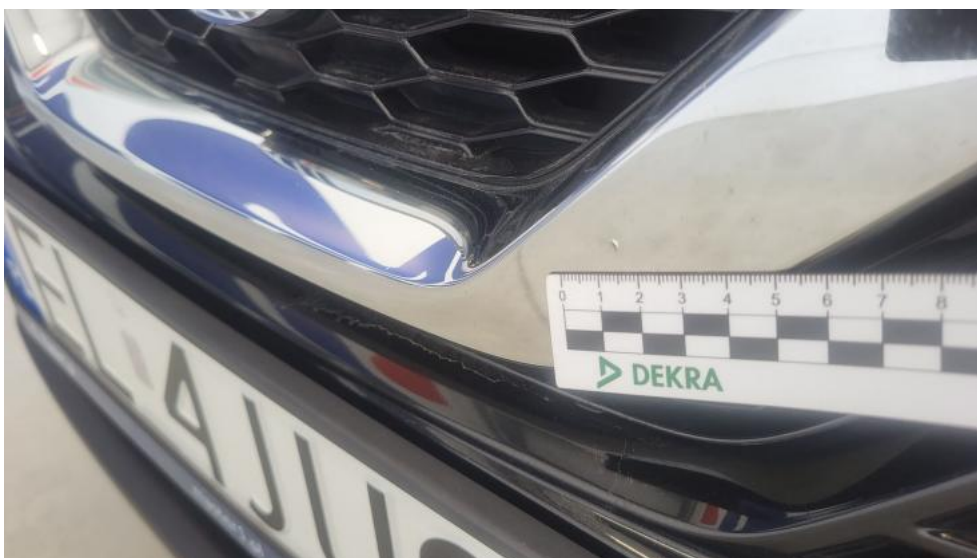
**Photo 34.**

Atrapa przednia - Rysa/odprysk 1

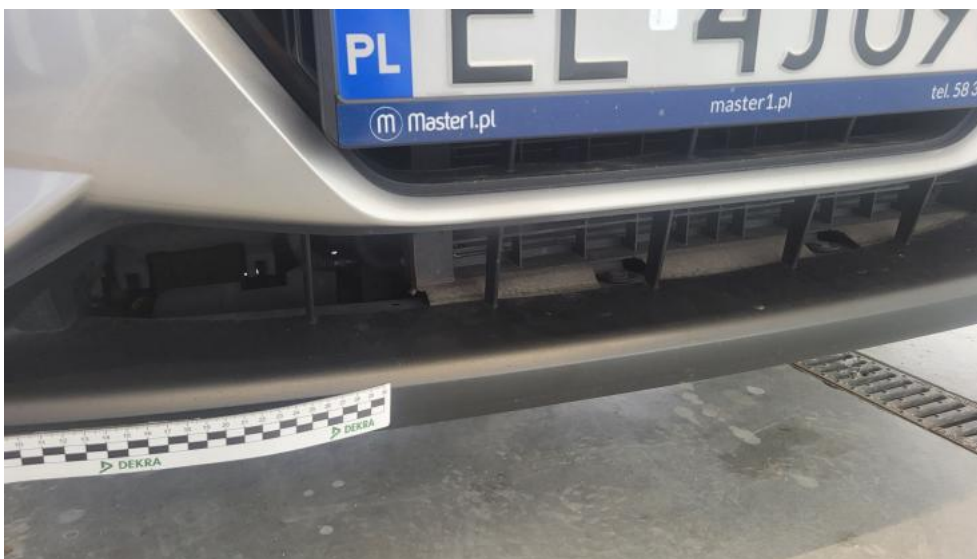
**Photo 35.**

Krata zderzaka prz. - Inne 1

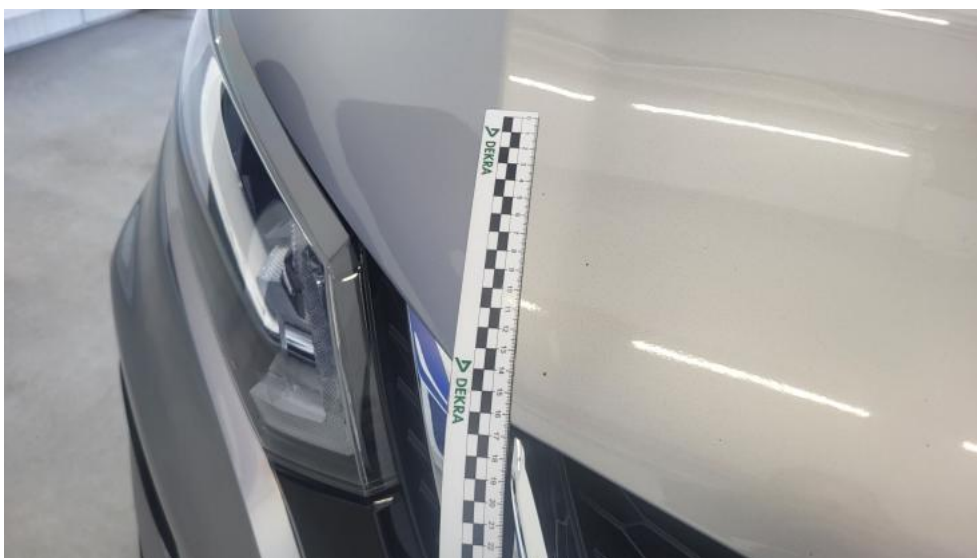
**Photo 36.**

Pokrywa komory silnika - Rysa/odprysk 1

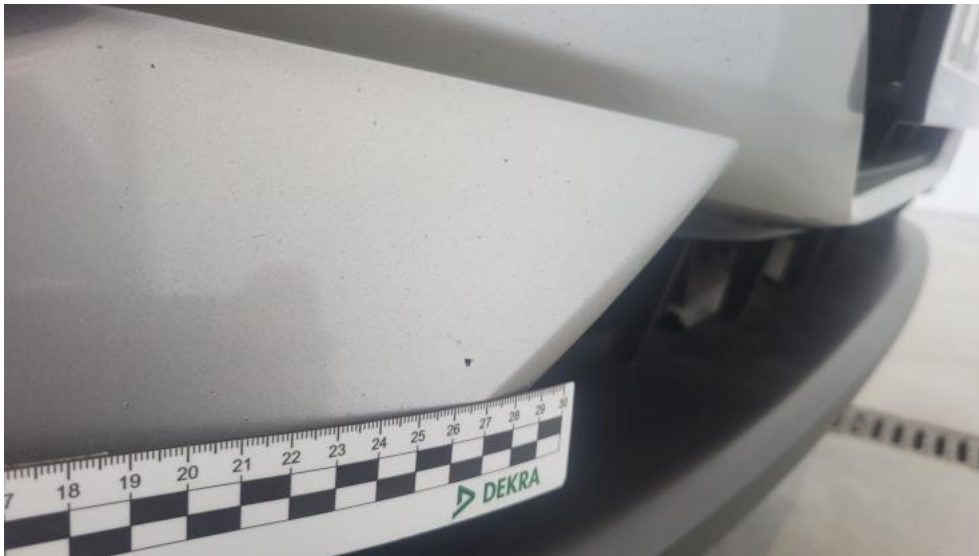
**Photo 39.**

Zderzak - Rysa/odprysk 2

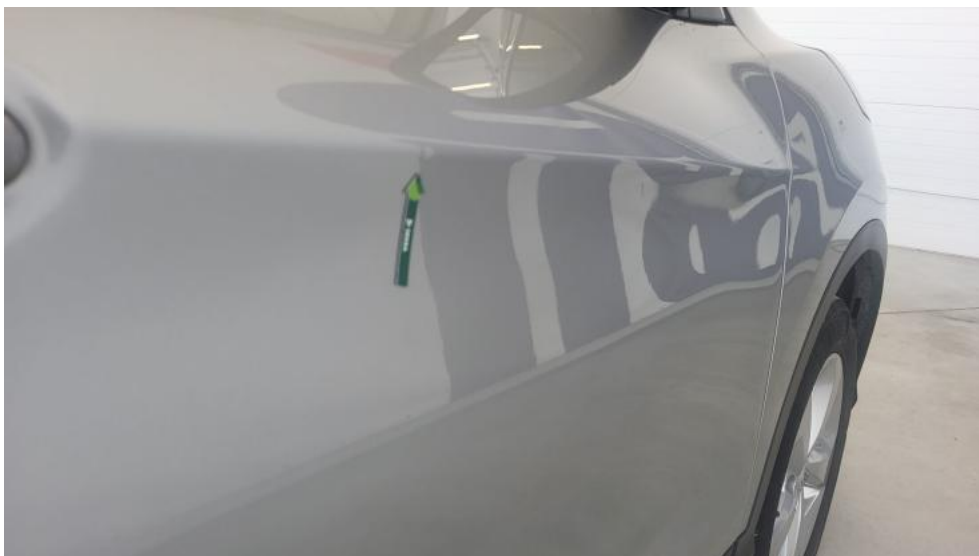
**Photo 40.**

Drzwi przednie P - Wgniecenie/odkształcenie 1

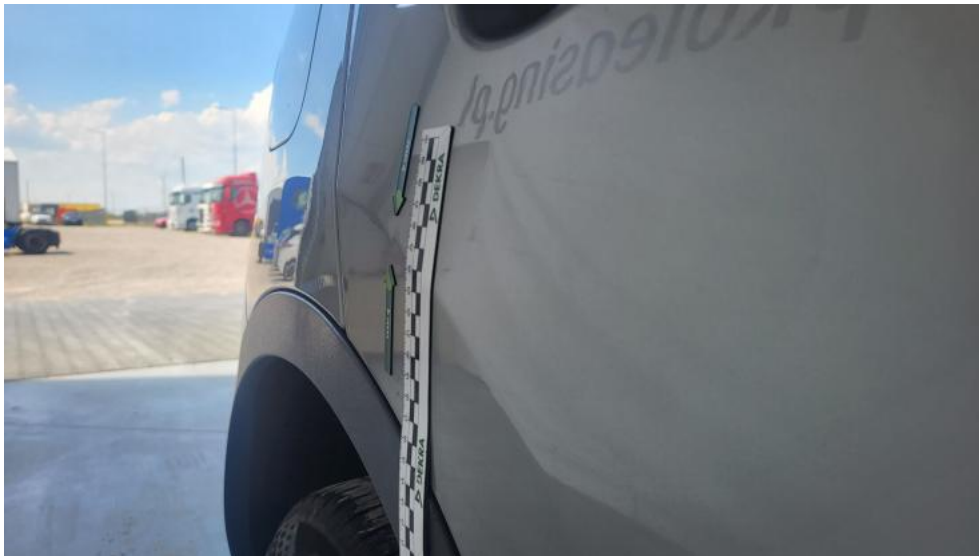
**Photo 41.**

Drzwi tylne P - Wgniecenie/odkształcenie 1

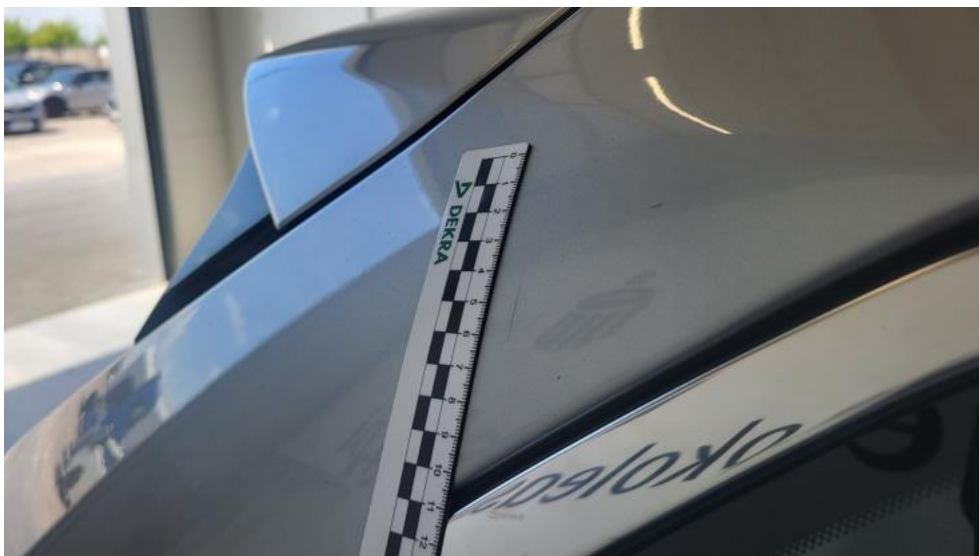
**Photo 42.**

Łotnik tylny P / Ściana boczna P - Rysa/odprysk 1

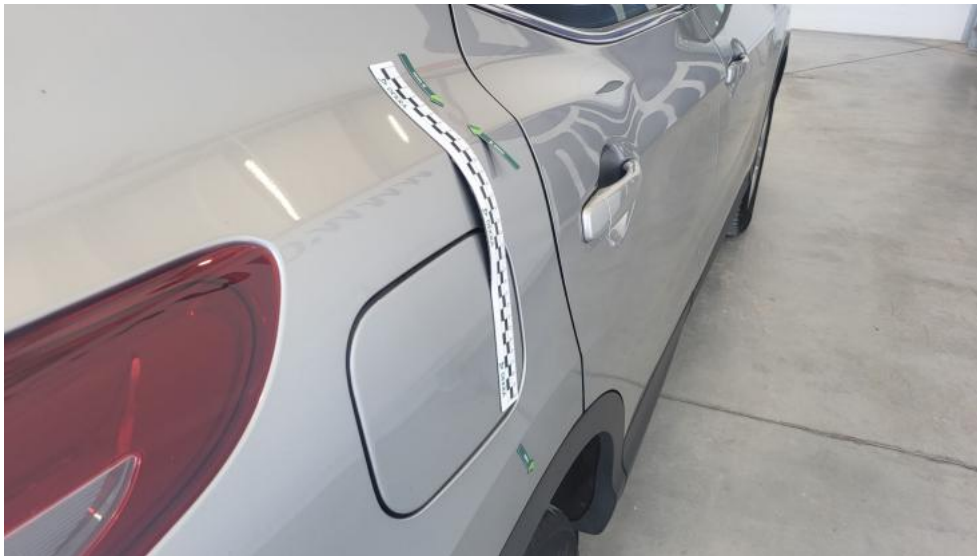
**Photo 43.**

Błotnik tylny P / Ściana boczna P - Wgniecenie/odkształcenie 1

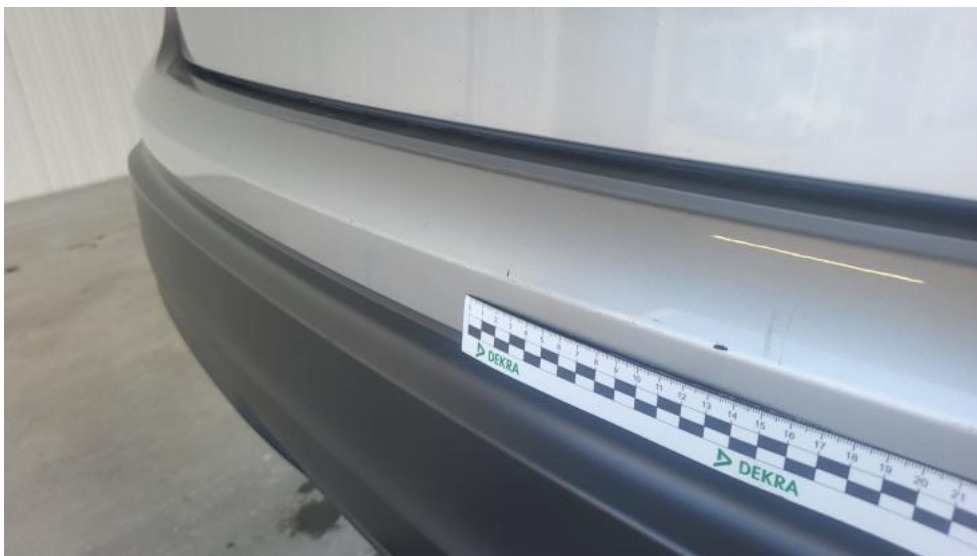
**Photo 44.**

Zderzak tylny - Rysa/odprysk 1

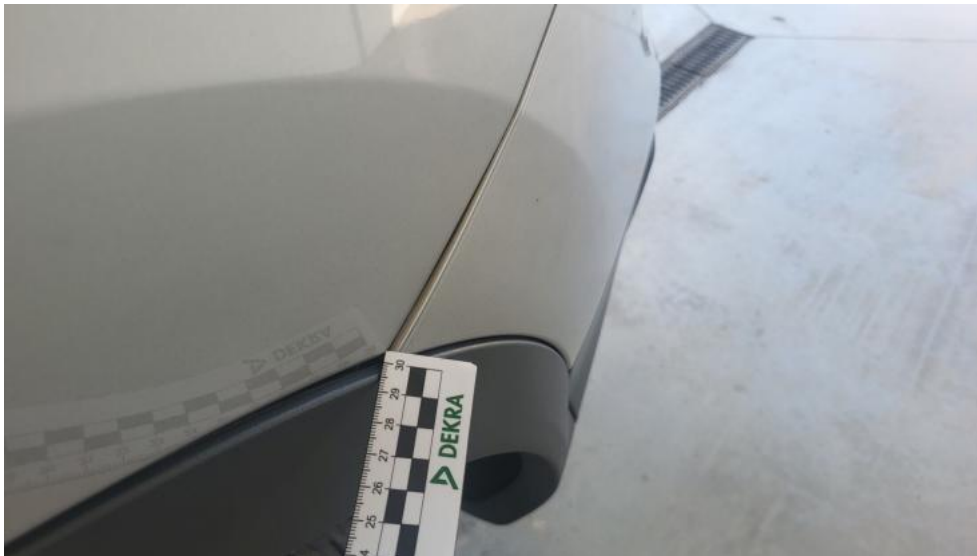
**Photo 45.**

Zderzak tylny - Inne 1

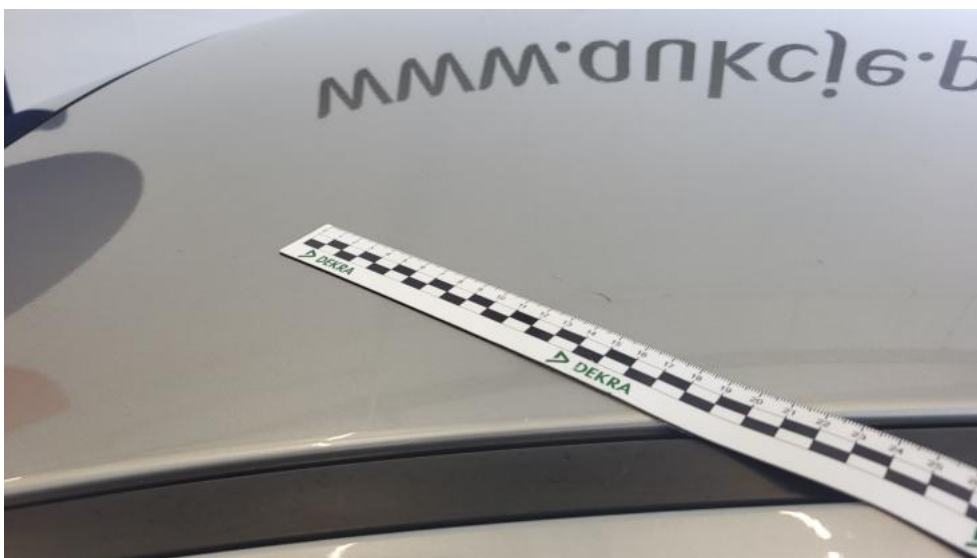
**Photo 46.**

Dach - Rysa/odprysk 1

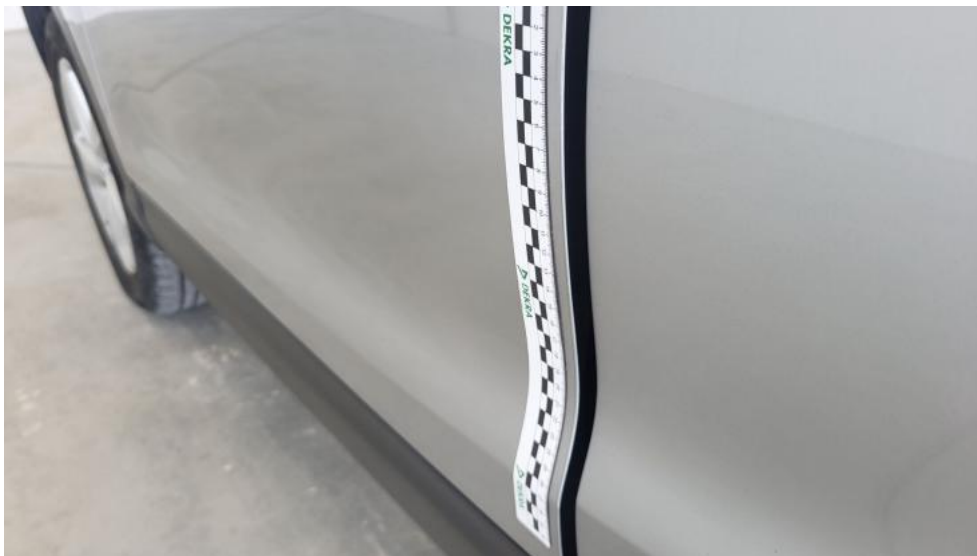
**Photo 47.**

Drzwi przed L - Rysa/odprysk 1

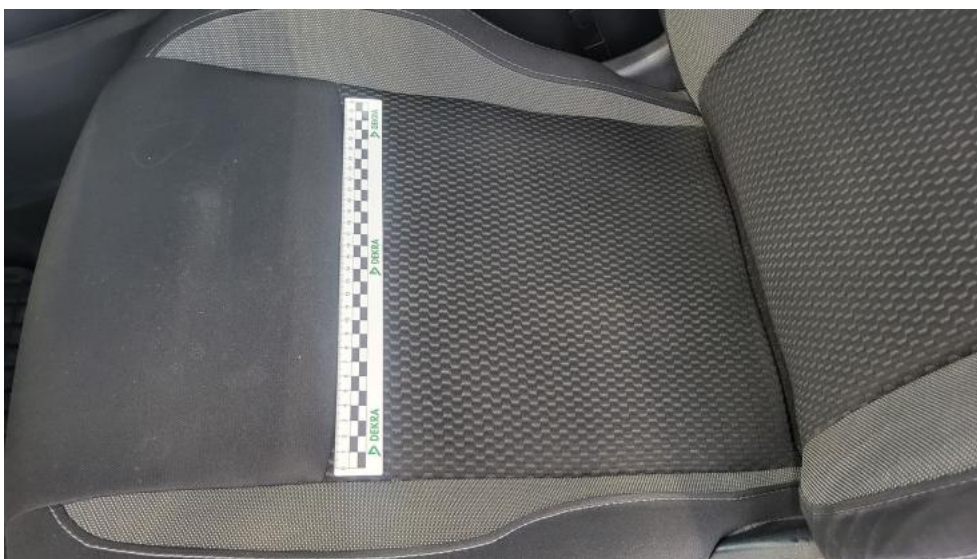
**Photo 51.**

Fotel prz. lew. - Inne 1

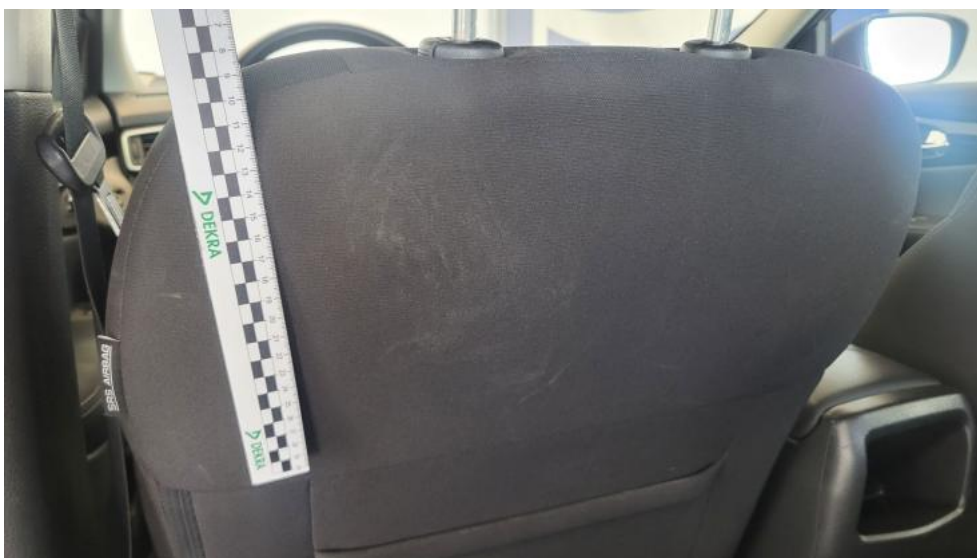
**Photo 52.**

Fotel prz. lew. - Inne 2

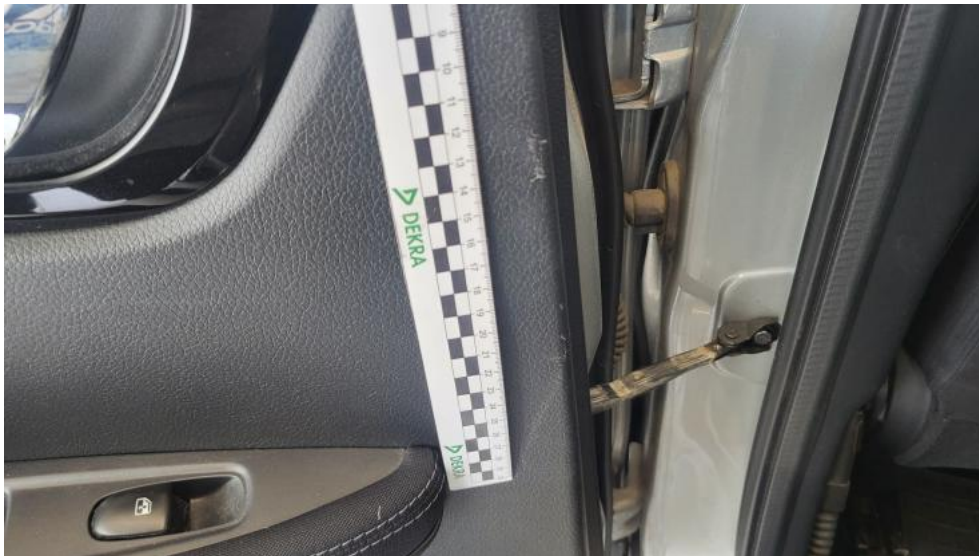
**Photo 57.**

Tapicerka drzwi tylnych L - Rysa/odprysk 1

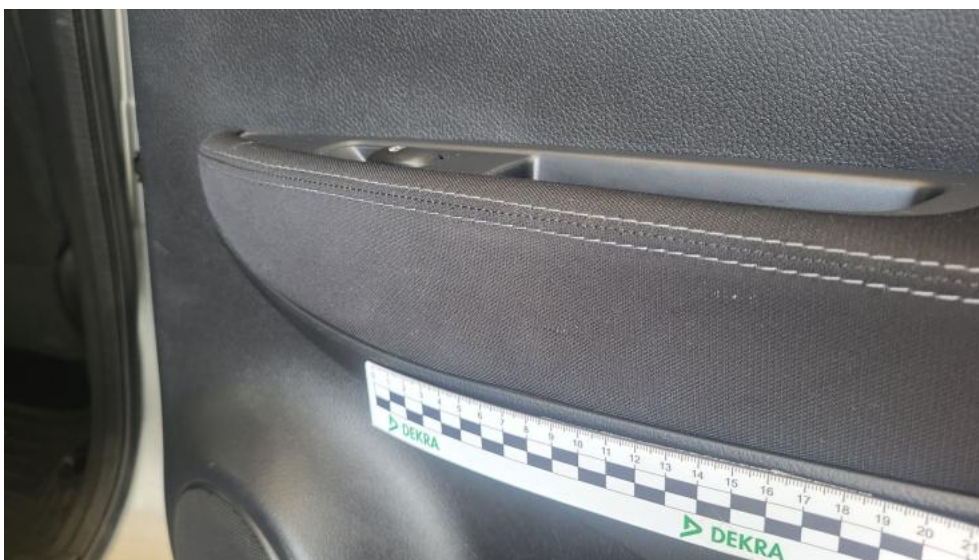
**Photo 58.**

Tapicerka drzwi tylnych P - Inne 1

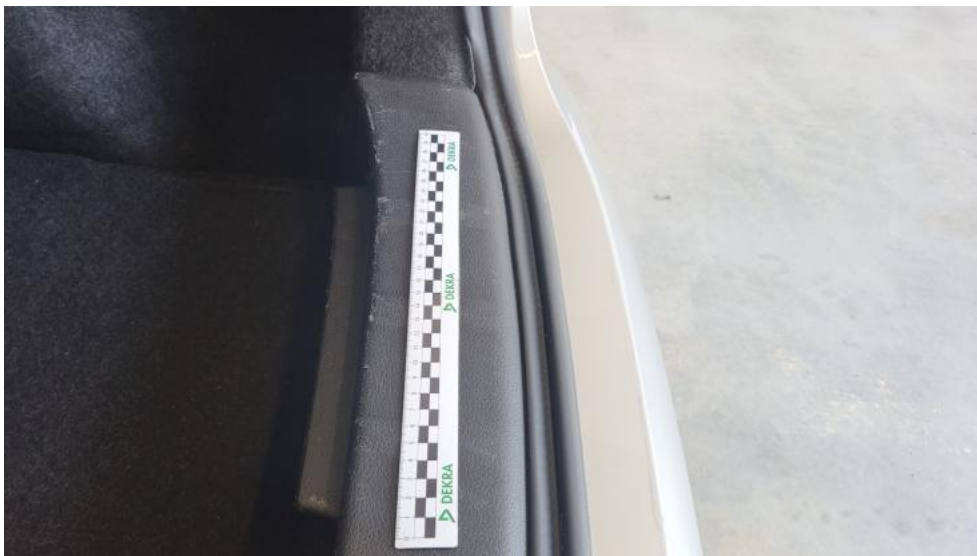
**Photo 63.**

Wykładzina przestrzeni bagażowej - Rysa/odprysk 1
