DEKRA's commission No. : PKOL(W)/LODZ/19189/25/03/17
 commission/ damage No. : FUTURA
 Date of commission: 17-03-2025

Vehicle data

Measurement of thickness of the vehicle lacquer coating

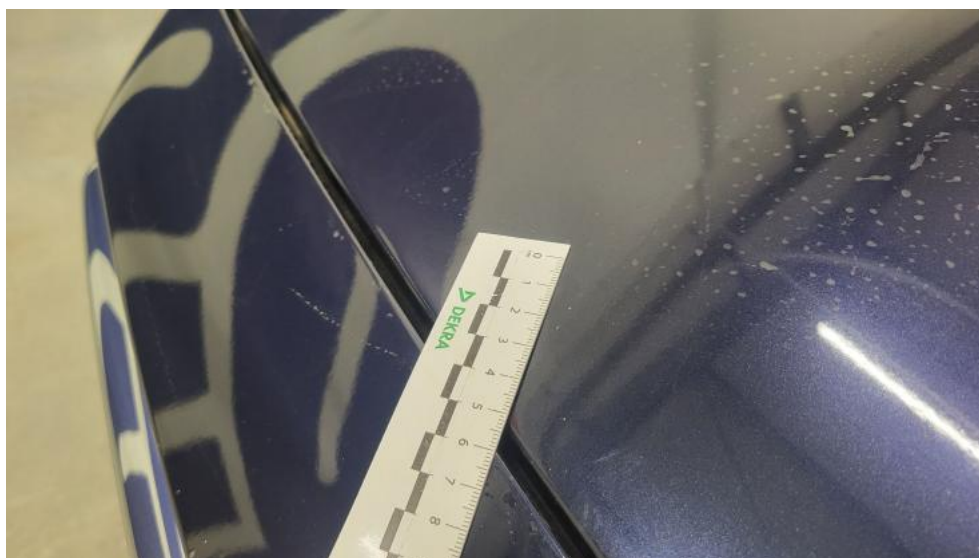
Photo 42.
Pokrywa komory silnika - Rysa/odprysk 1

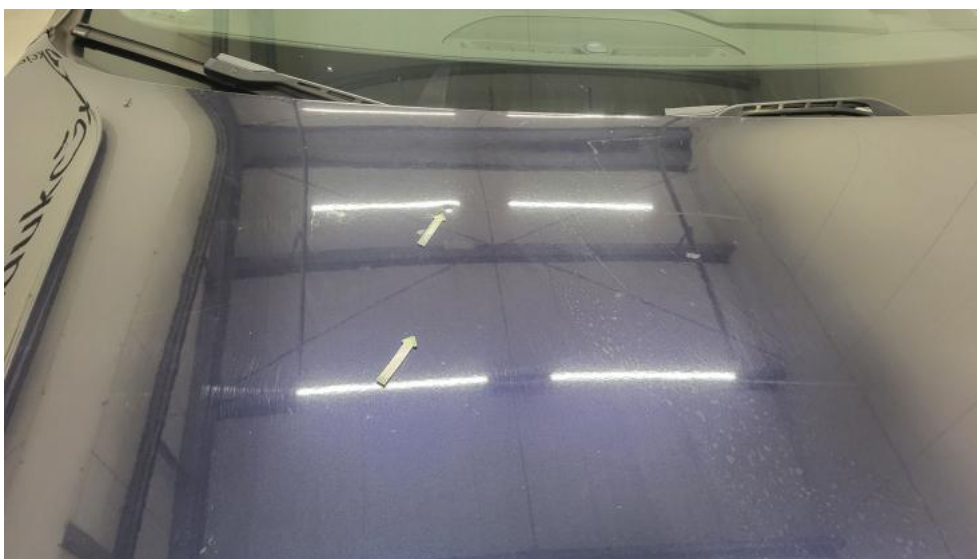
Photo 43.
Pokrywa komory silnika - Wgniecenie/odkształcenie 1

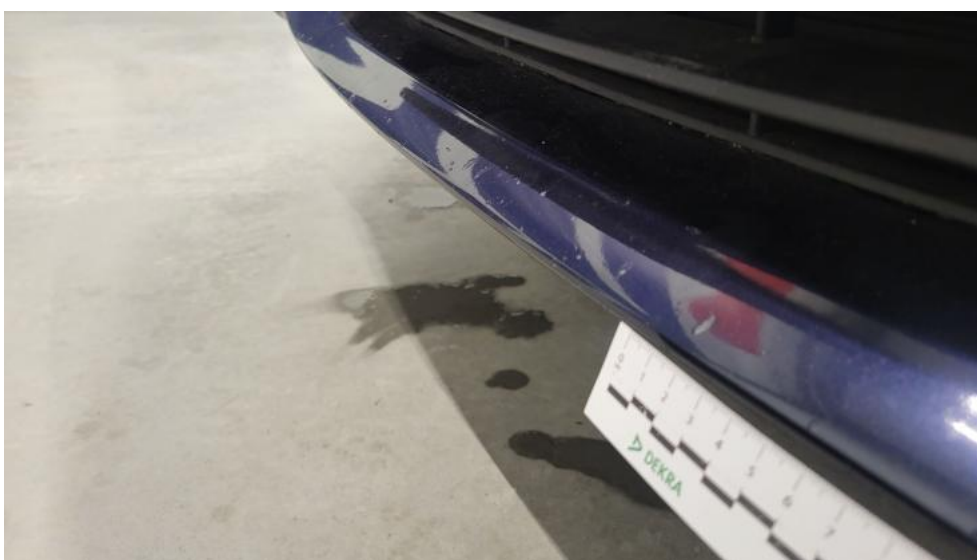
Photo 46.
Zderzak przedni cz dolna - Rysa/odprysk 1

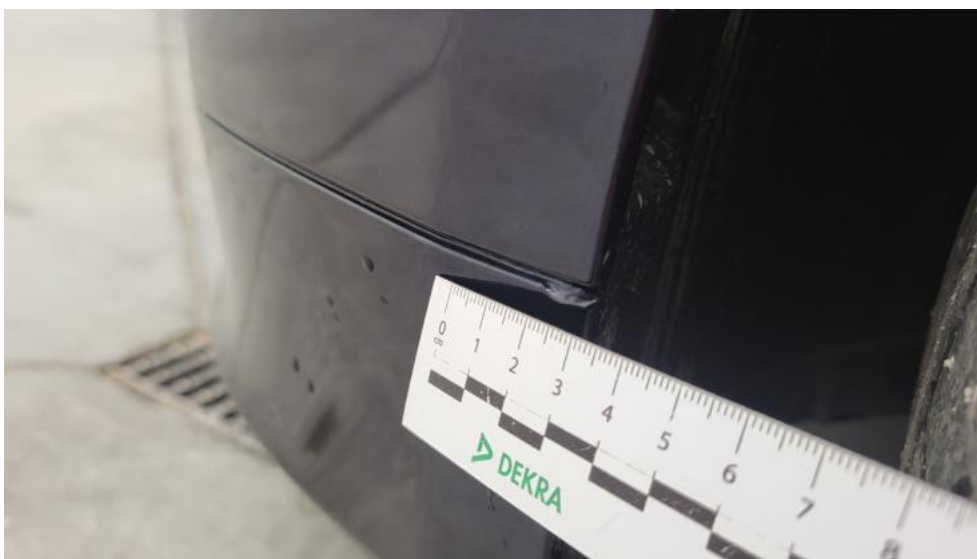
Photo 47.
Zderzak przedni cz dolna - Wgniecenie/odkształcenie 1

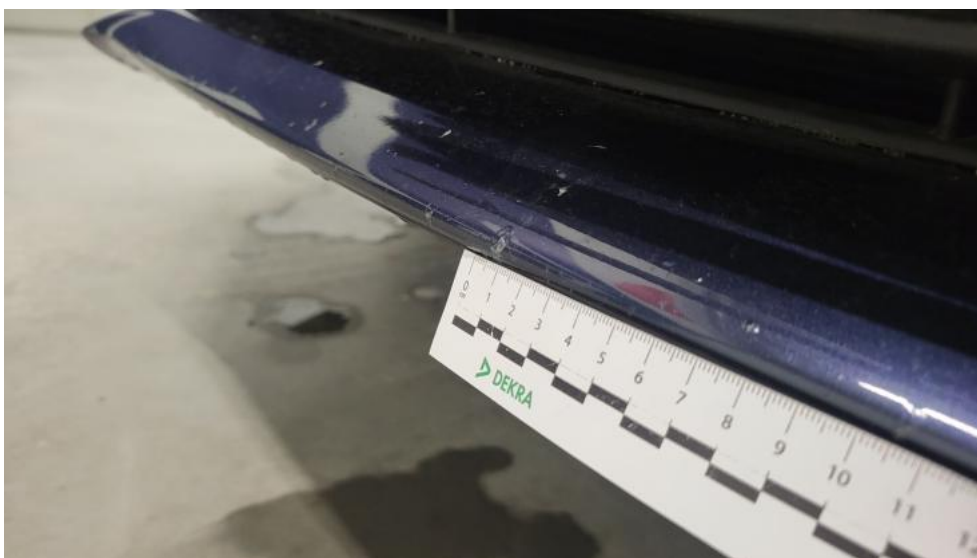
Photo 48.
Zderzak przedni cz dolna - Wgniecenie/odkształcenie 2

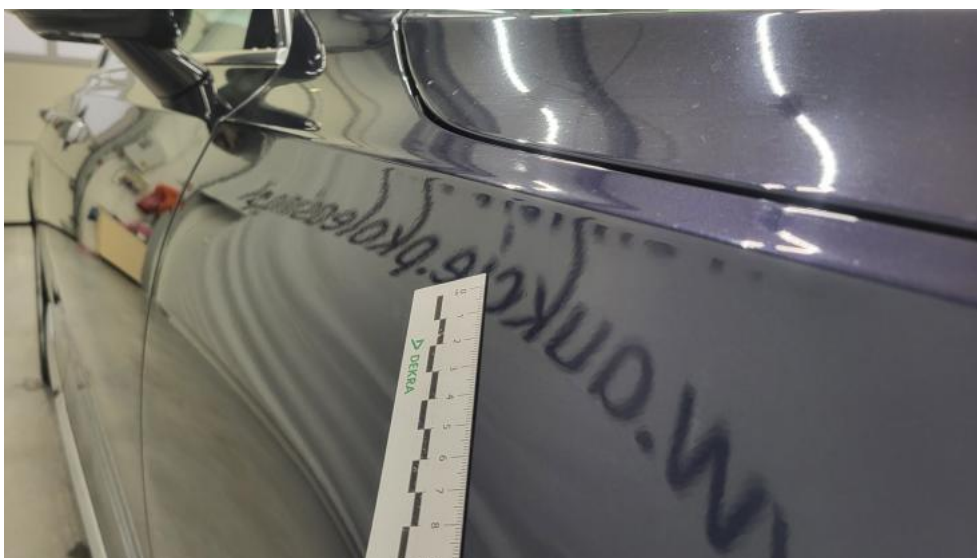
Photo 50.
Błotnik przedni P - Wgniecenie/odkształcenie 1

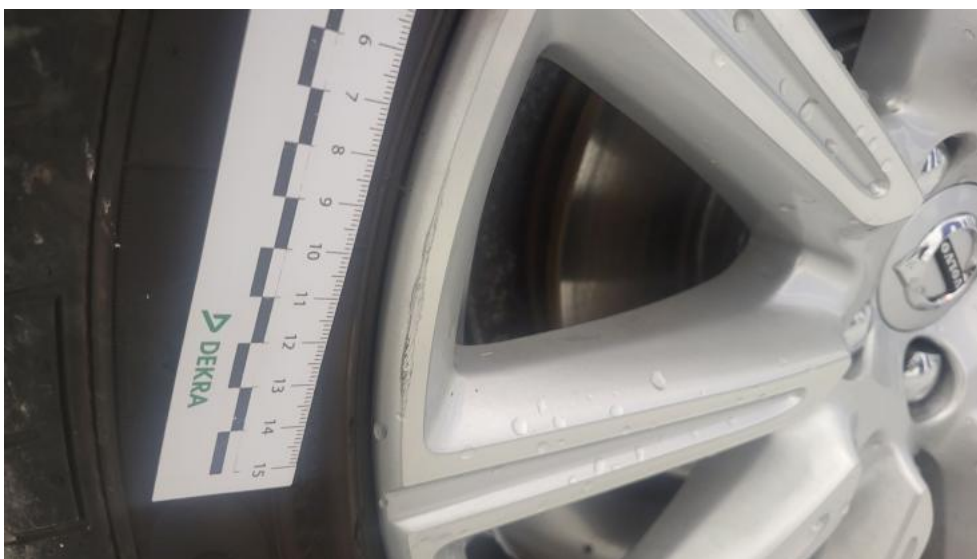
Photo 51.
Felga aluminiowa przednia P - Rysa/odprysk 1

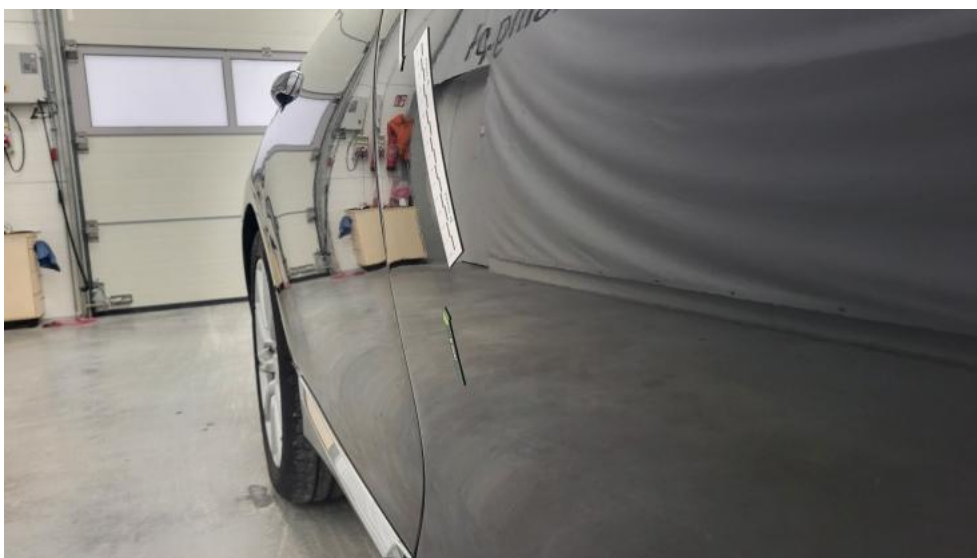
Photo 52.
Drzwi przednie P - Wgniecenie/odkształcenie 1

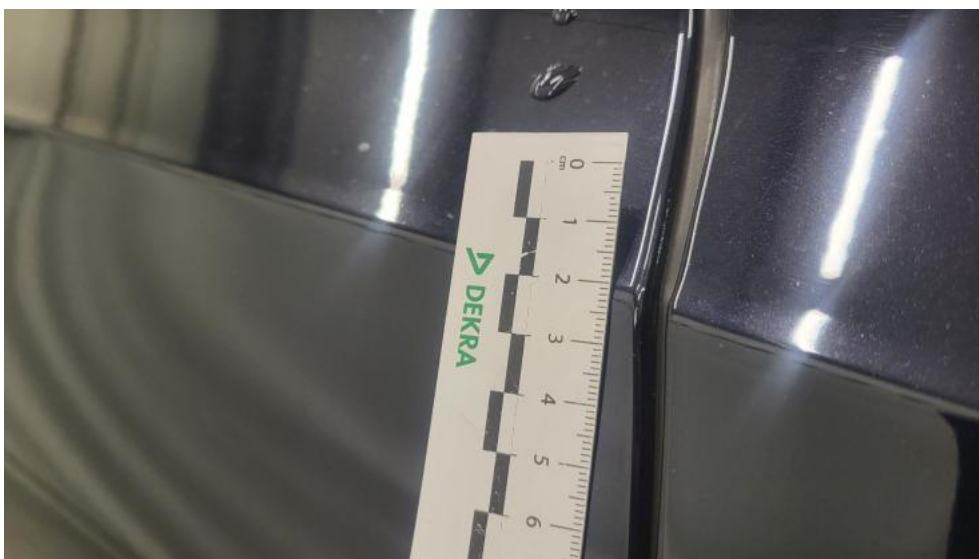
Photo 53.

Drzwi tylne P - Rysa/odprysk 1

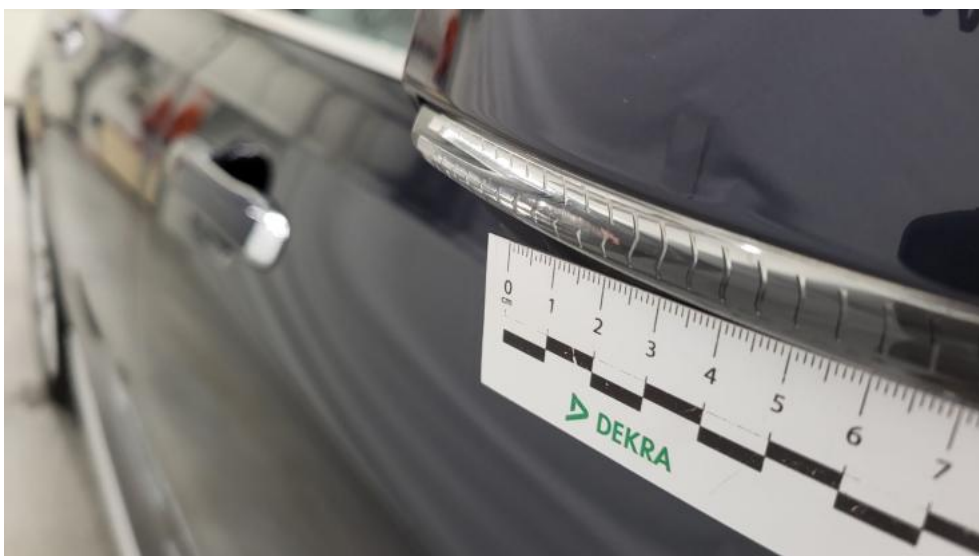
Photo 54.

Lusterko zew P - Rysa/odprysk 1

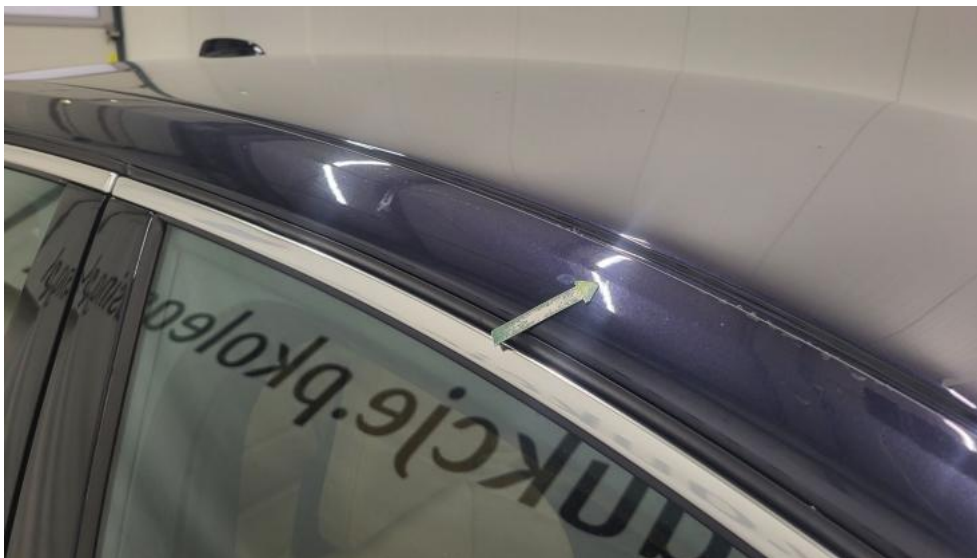
Photo 55.
Stupek przedni P - Wgniecenie/odkształcenie 1

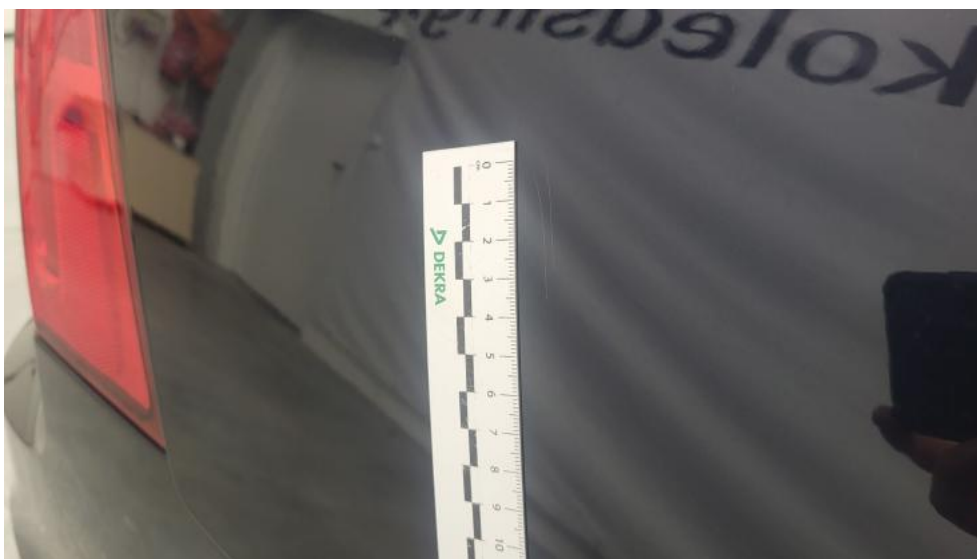
Photo 57.

Błotnik tylny P / Ściana boczna P - Rysa/odprysk 1

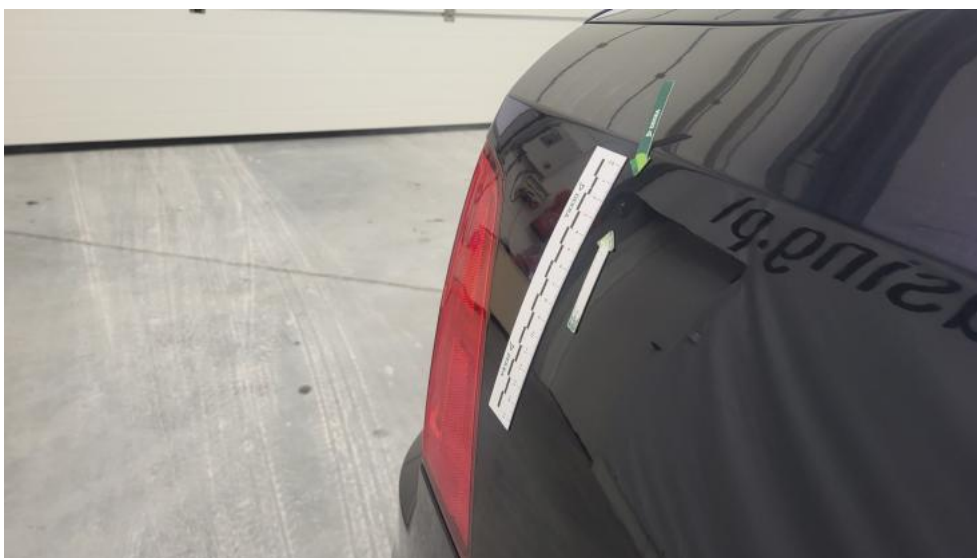
Photo 58.

Błotnik tylny P / Ściana boczna P - Wgniecenie/odkształcenie 1

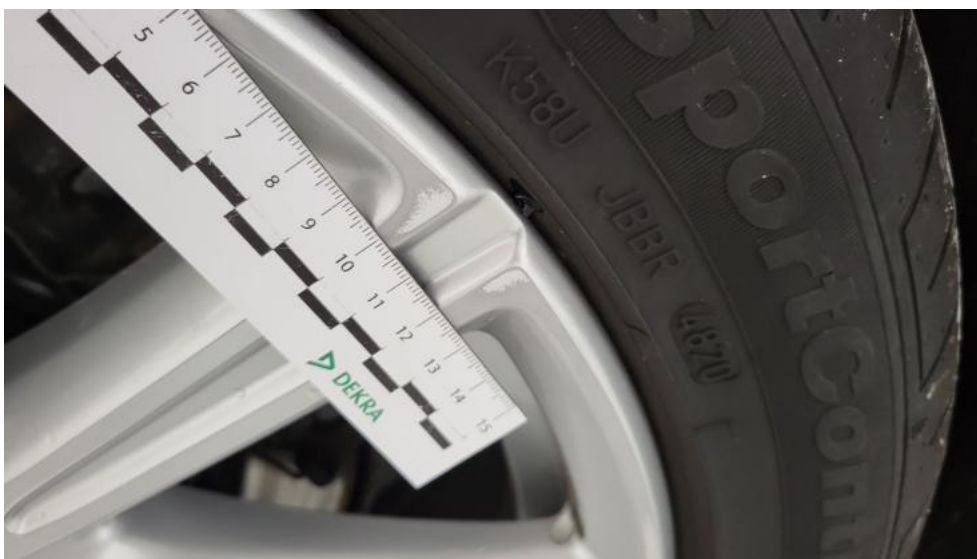
Photo 59.

Felga aluminiowa tylna P - Rysa/odprysk 1

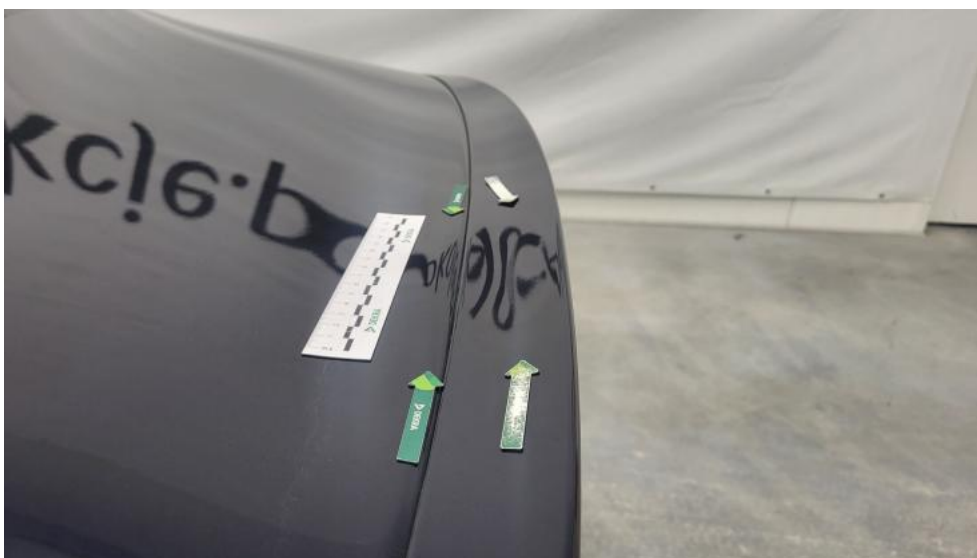
Photo 60.

Pokrywy bagażnika - Wgniecenie/odkształcenie 1

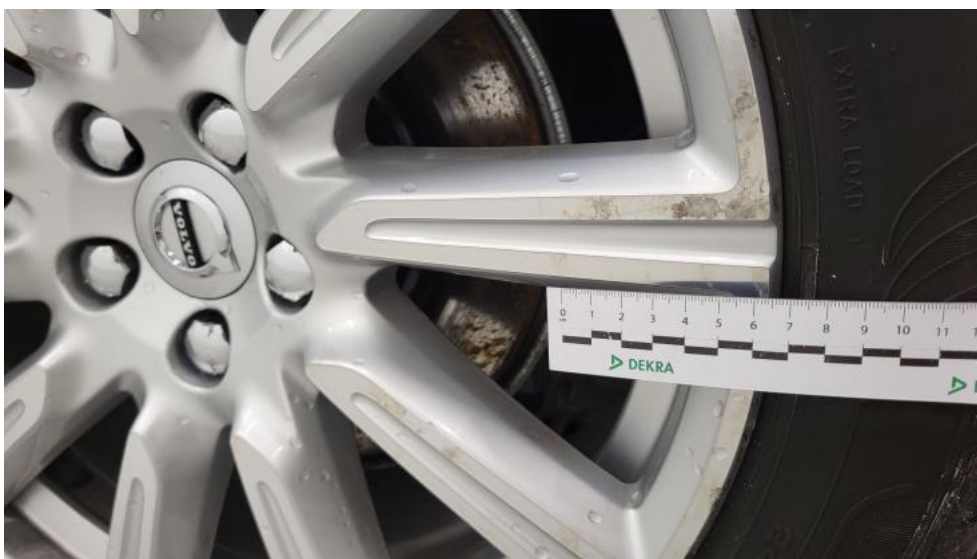
Photo 61.
Felga aluminiowa tylna L - Rysa/odprysk 1

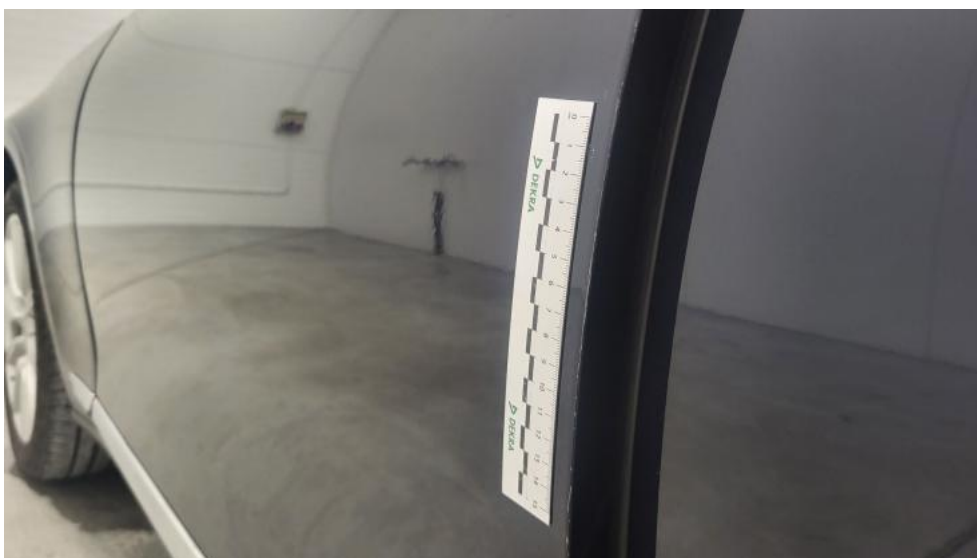
Photo 62.
Drzwi przed L - Rysa/odprysk 1

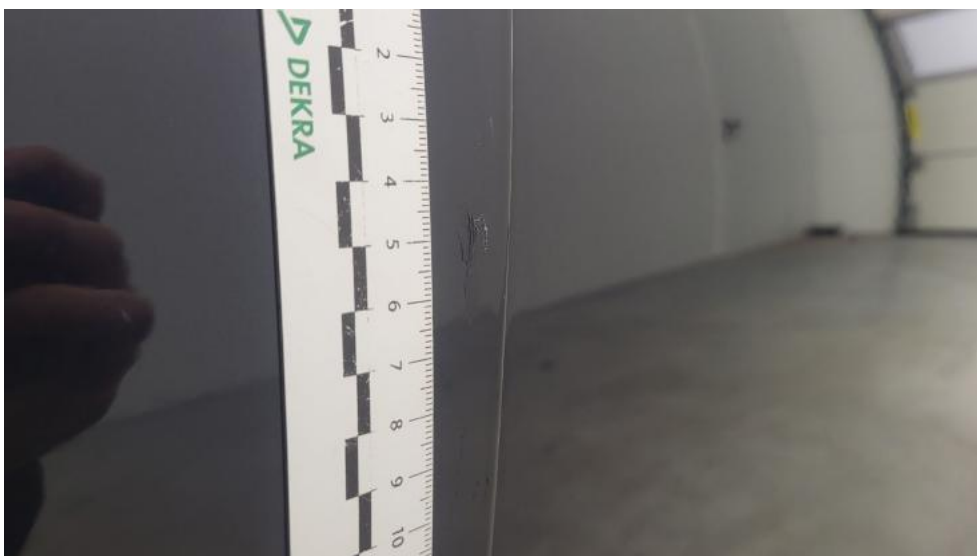
Photo 64.
Drzwi przed L - Inne 1

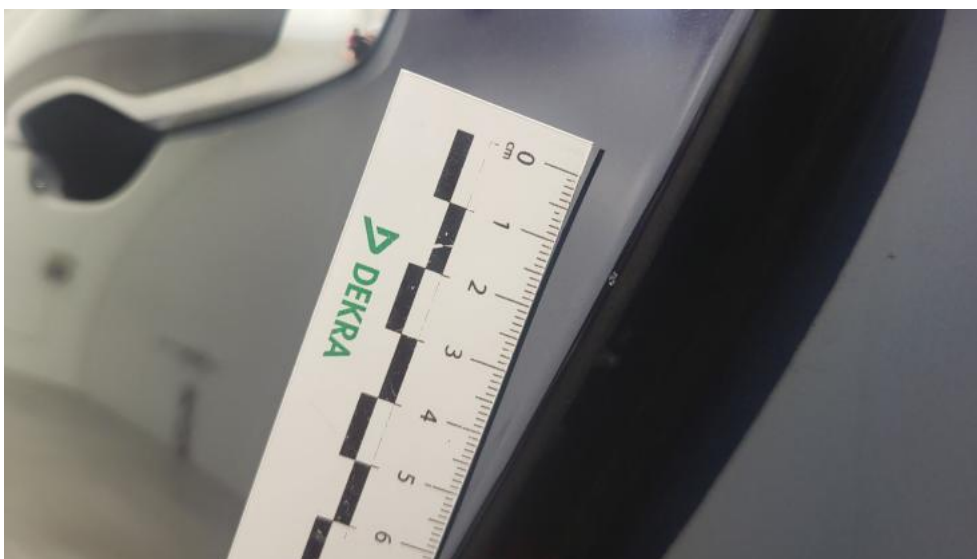
Photo 65.
Drzwi tylne L - Rysa/odprysk 1

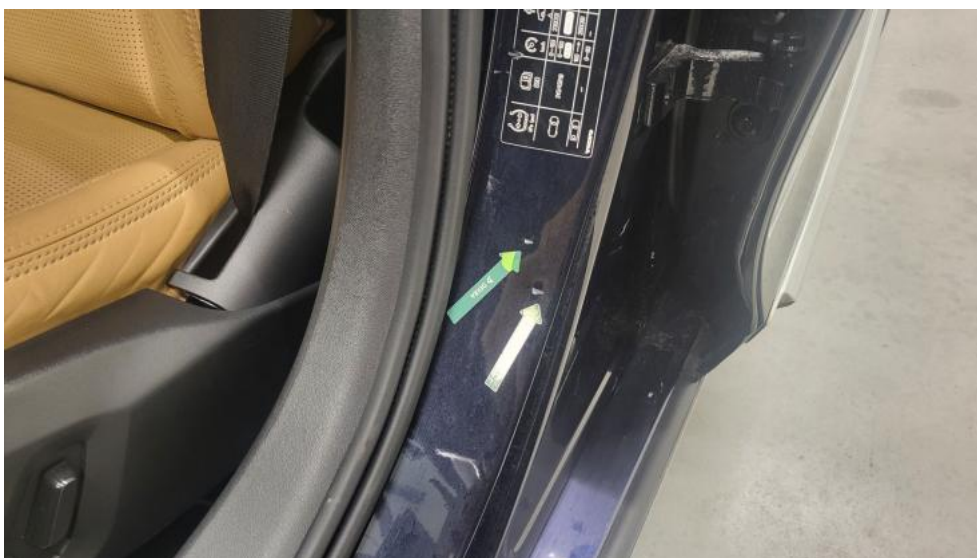
Photo 66.
Słupek środkowy L - Wgniecenie/odkształcenie 1

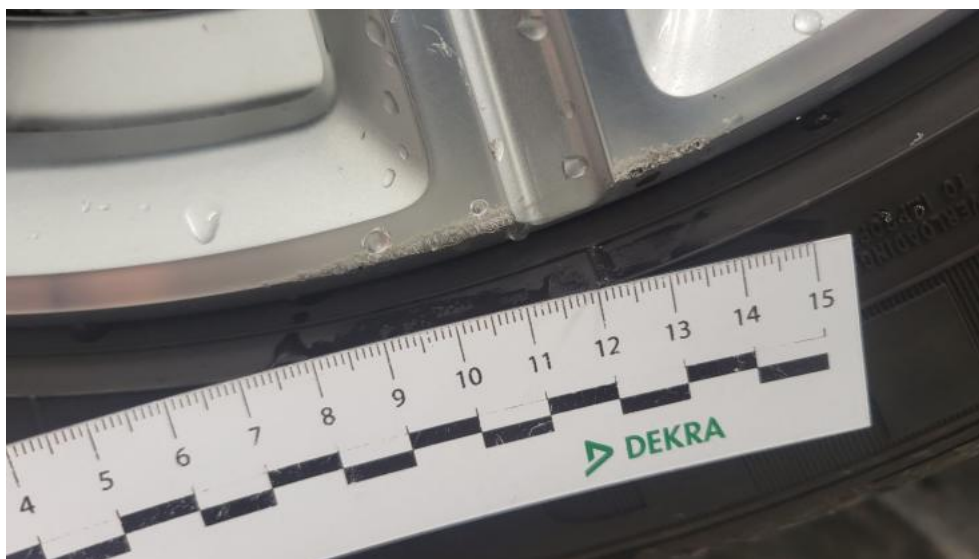
Photo 67.

Felga Aluminiowa przednia L - Rysa/odprysk 1

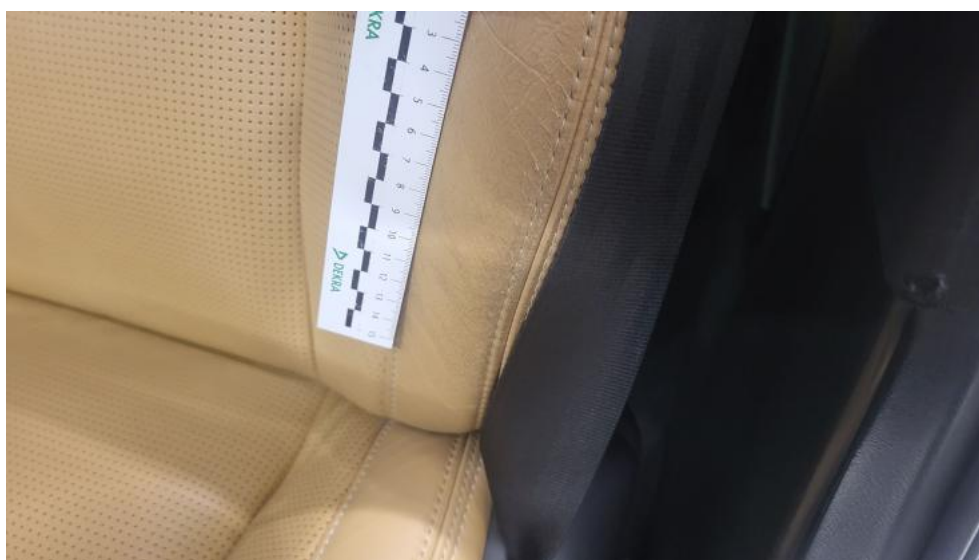
Photo 68.

Fotel prz. lew. - Inne 1

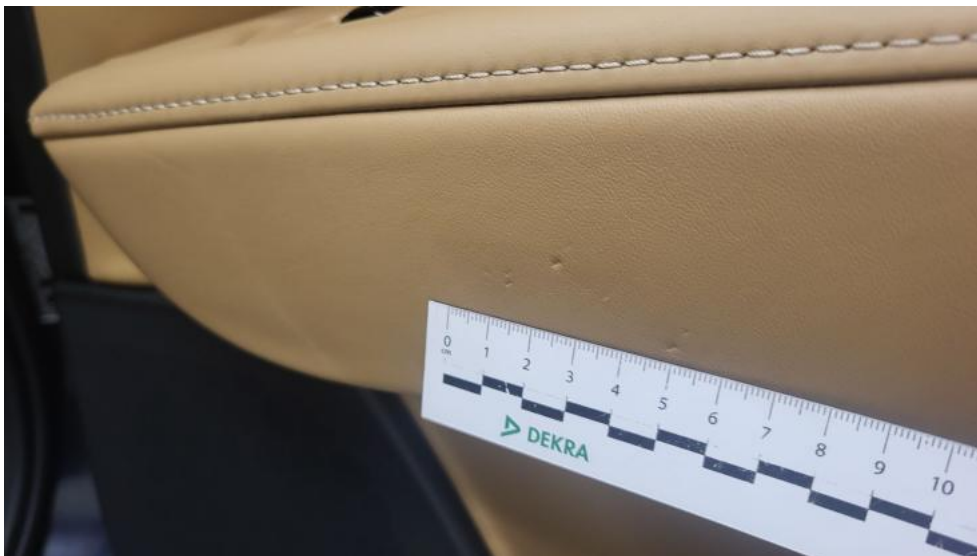
Photo 69.

Tapicerka drzwi tylnych P - Wgniecenie/odkształcenie 1
