DEKRA's commission No. : PKOL(W)/LODZ/79250/24/10/14(64465)
commission/ damage No. : 21/009023
Date of commission: 14-10-2024 10:31:10

Group of objects (Eurotax)	cars
EC code (Eurotax)	0145543
Manufacturer	AUDI
Model	A3 Sportback 20-24
Type / version	S3 TFSI Quattro S tronic
Body type	hatchback
Number of doors / seats	5/5
Curb weight [kg]	1544
Gross vehicle weight [kg]	2020
Wheelbase 1/2	2630
Engine type	spark ignition
Pollution reduction system	GPF
Emission standard	EURO 6
Engine capacity [ccm]	1984
Engine Power [hp/kW]	310/228
Gearbox	automatic 7- gear
Registration /record No.	L6SIWYY
VIN / serial number	WAUZZZGYXMA043951
Date of first registration	03-03-2021
Date of next. tech. test	03-03-2024
Year of manufacture	2020 (year has been verified with the manufacturer's base)
Readout [km]	35 986 (read)
Body color / type of coating	blue/2-warstwowy metalik

Measurement of thickness of the vehicle lacquer coating

PHOTOGRAPHIC DOCUMENTATION

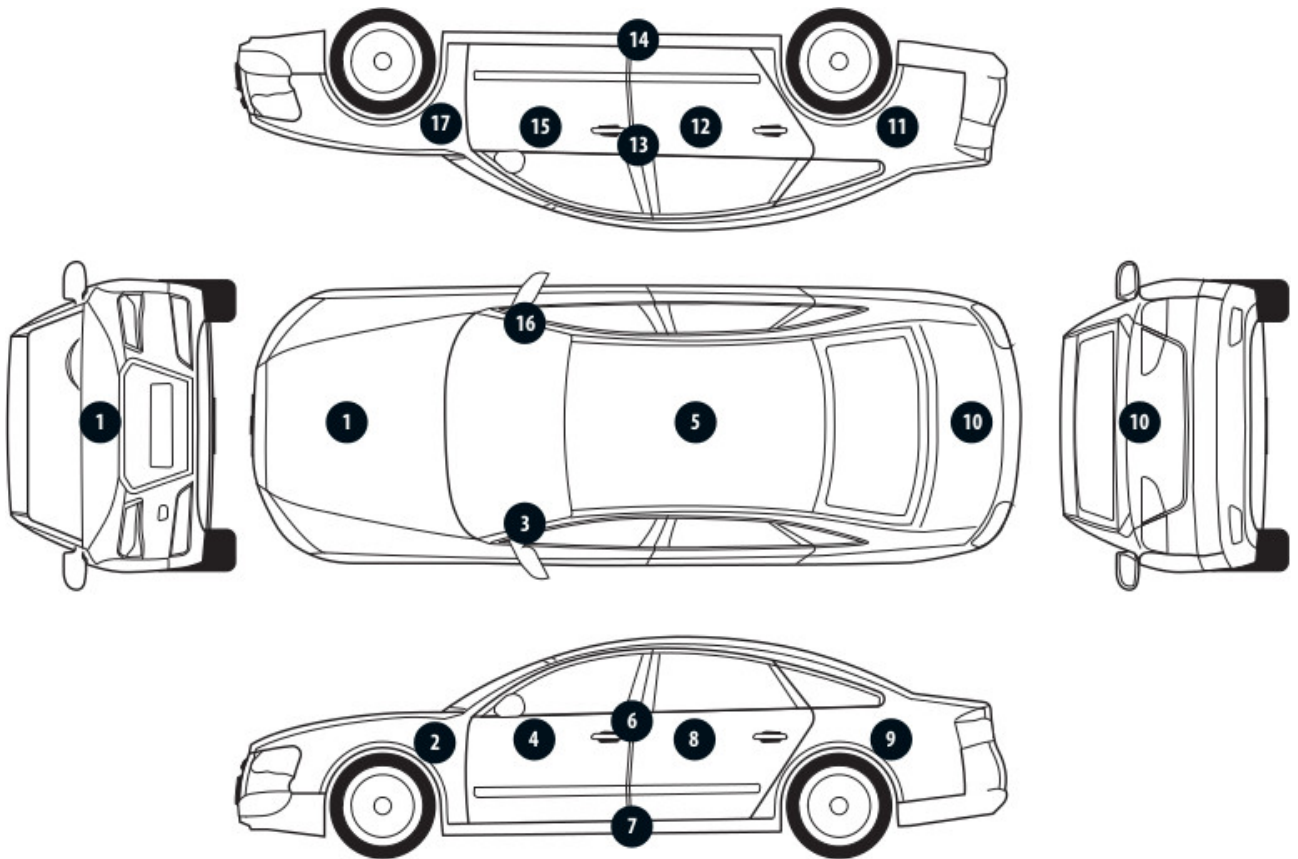
No. of controlled item	Controlled item	Measured range of thickness of the lacquer coat [μm]
1	Front cover	to 150
2	Front left fender	150 - 200
3	Left front pillar	to 150
4	Front left door	150 - 200
5	Roof	to 150
6	Left middle pillar	to 150
7	Right side sill	to 150
8	Left rear door	to 150
9	Rear left fender	to 150
10	Cover/lid	to 150
11	Right rear fender	to 150
12	Right rear door	to 150
13	Right middle pillar	to 150
14	Right side sill	to 150
15	Front right door	to 150
16	Right front pillar	to 150
17	Front right fender	to 150

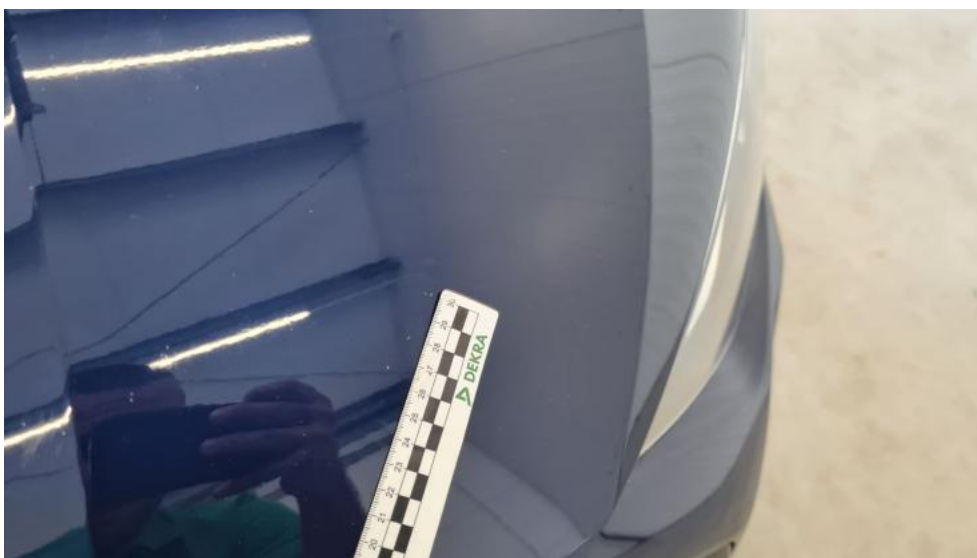
Photo 34.
Pokrywa komory silnika - Rysa/odprysk 1

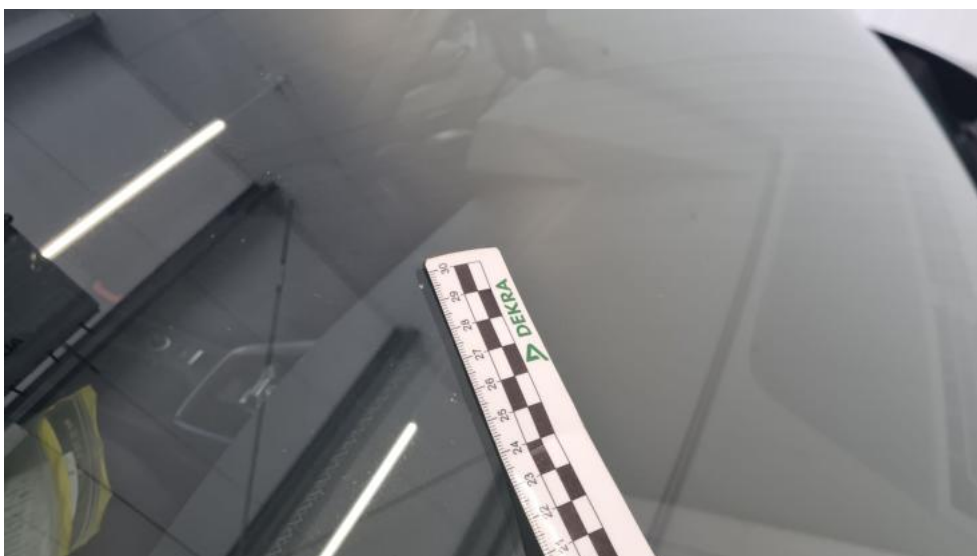
Photo 36.
Szyba czołowa - Rysa/odprysk 1

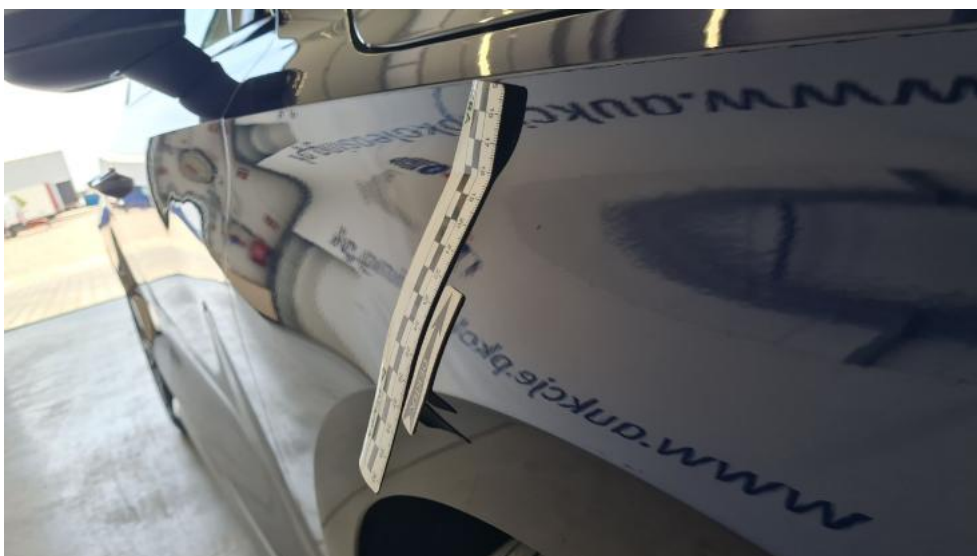
Photo 40.
Błotnik przedni P - Wgniecenie/odkształcenie 1

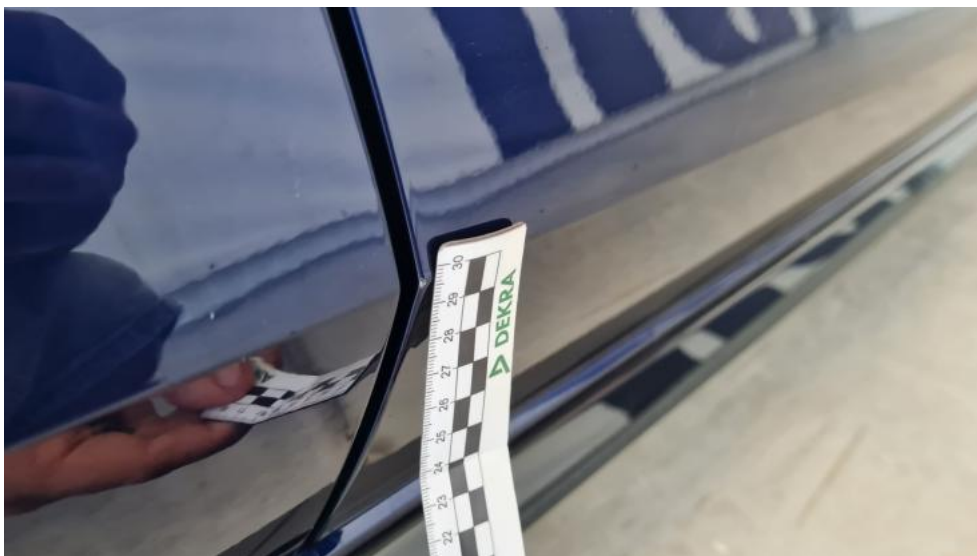
Photo 41.
Drzwi przednie P - Rysa/odprysk 1

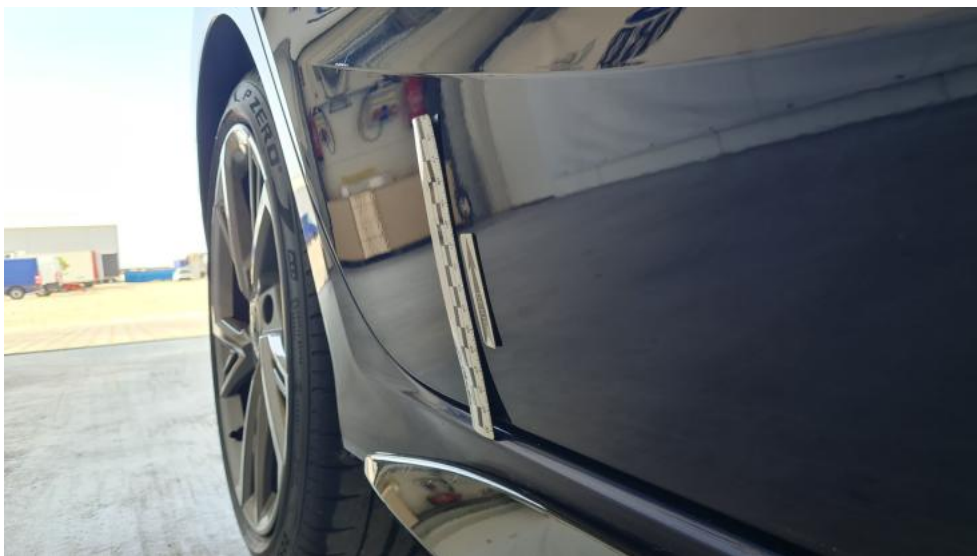
Photo 43.
Drzwi tylne P - Wgniecenie/odkształcenie 1

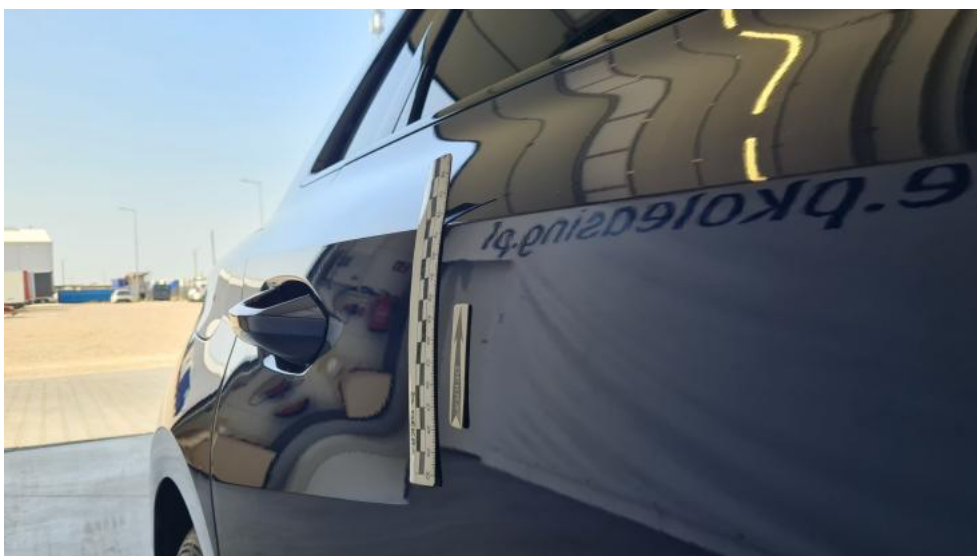
Photo 44.
Drzwi tylne P - Wgniecenie/odkształcenie 2

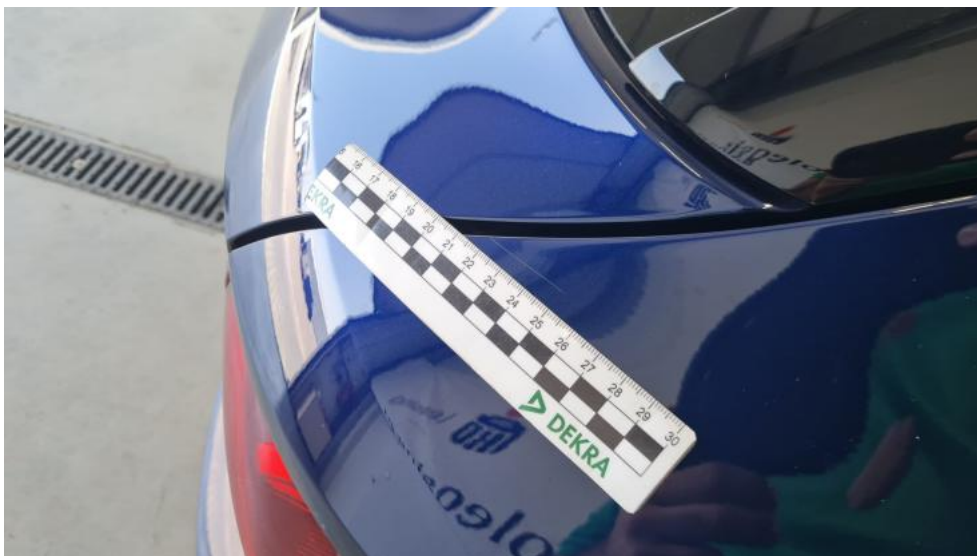
Photo 45.

Błotnik tylny P / Ściana boczna P - Rysa/odprysk 1

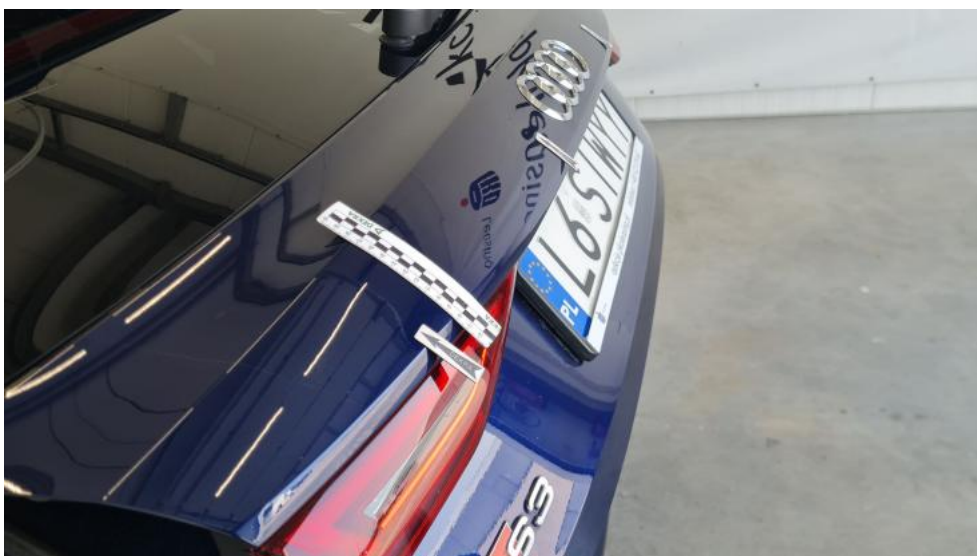
Photo 46.

Pokrywy bagażnika - Wgniecenie/odkształcenie 1

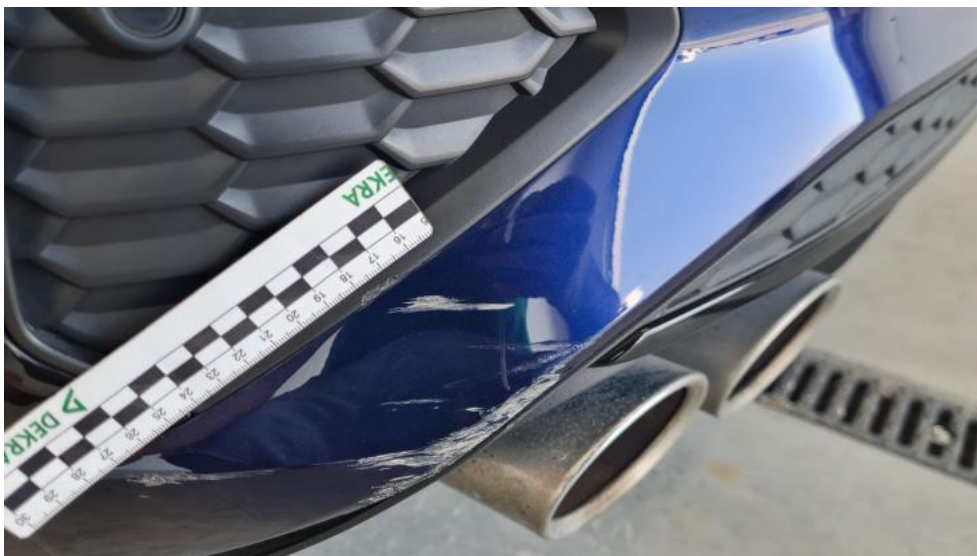
Photo 47.
Zderzak tylny - Rysa/odprysk 1

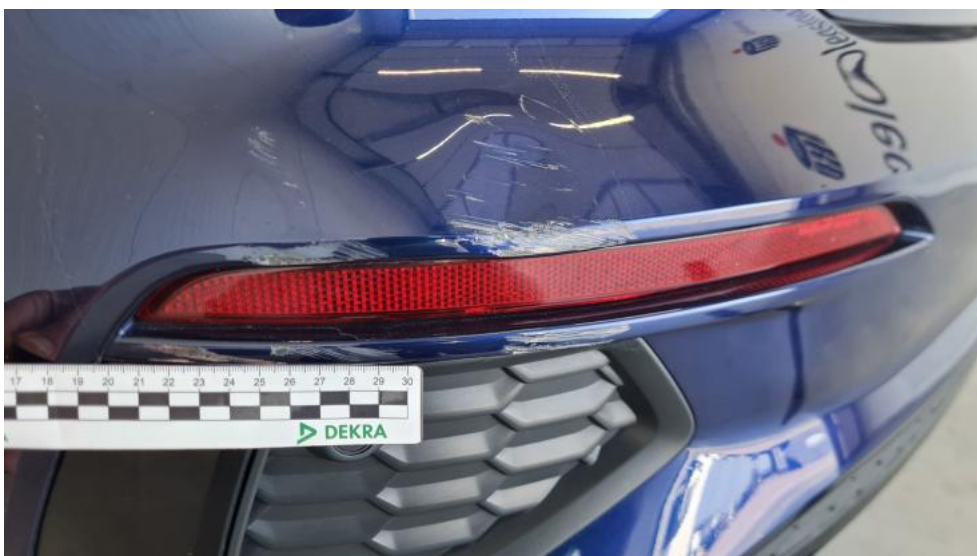
Photo 48.
Zderzak tylny - Rysa/odprysk 2

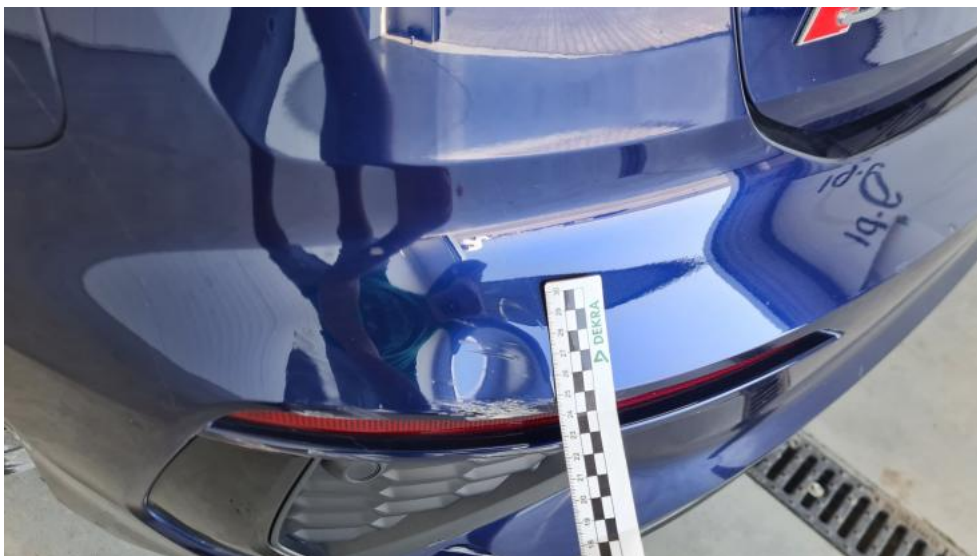
Photo 49.
Zderzak tylny - Wgniecenie/odkształcenie 1

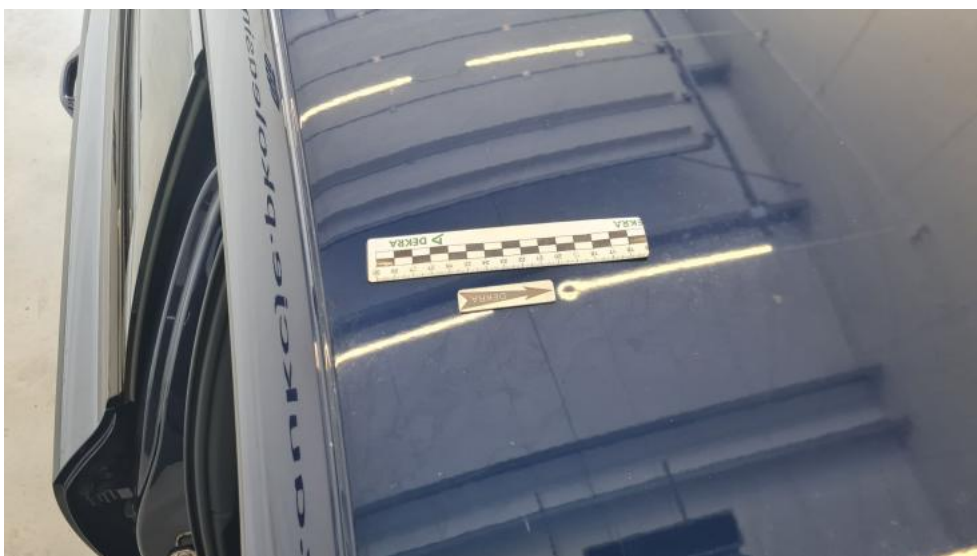
Photo 52.
Dach - Wgniecenie/odkształcenie 1

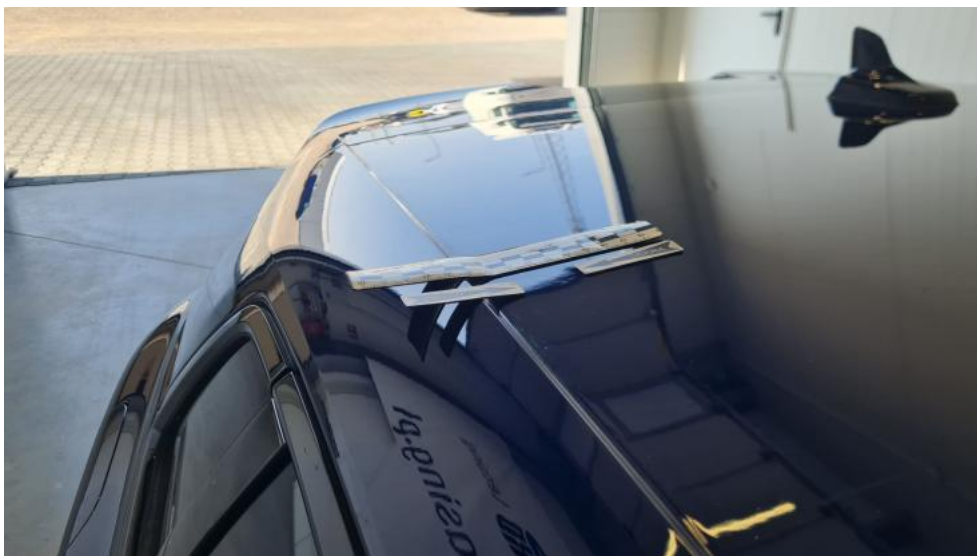
Photo 53.
Dach - Wgniecenie/odkształcenie 2

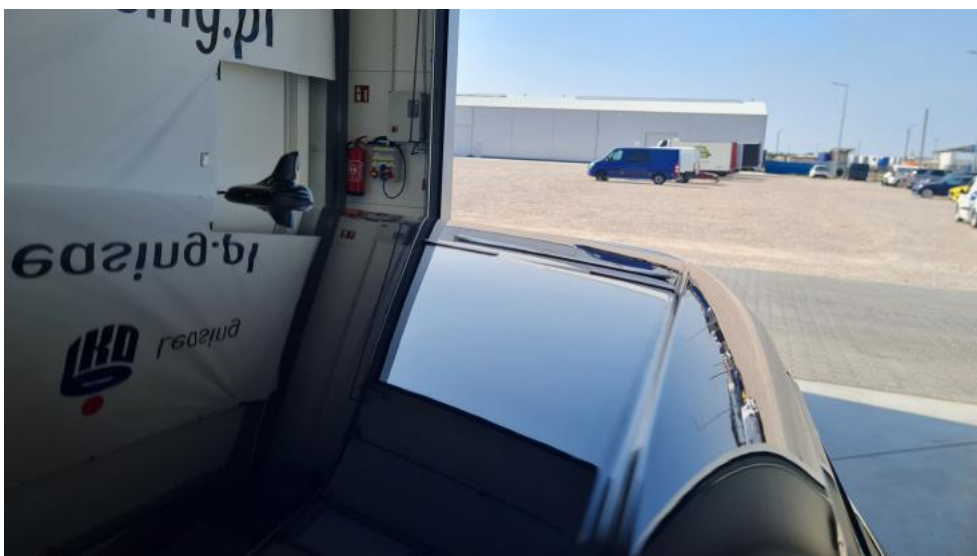
Photo 54.
Dach() - Wgniecenie/odkształcenie 3

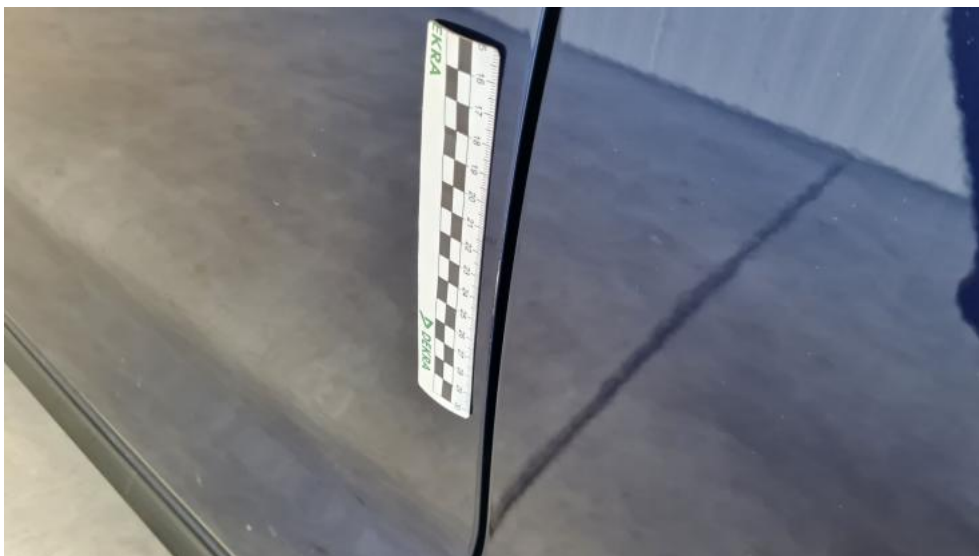
Photo 55.
Drzwi przed L - Rysa/odprysk 1

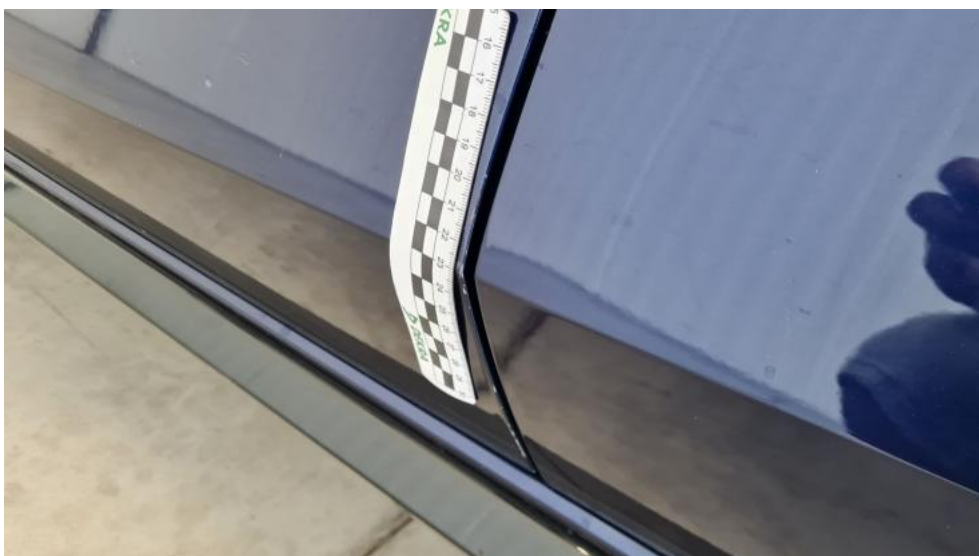
Photo 56.
Drzwi przed L - Rysa/odprysk 2

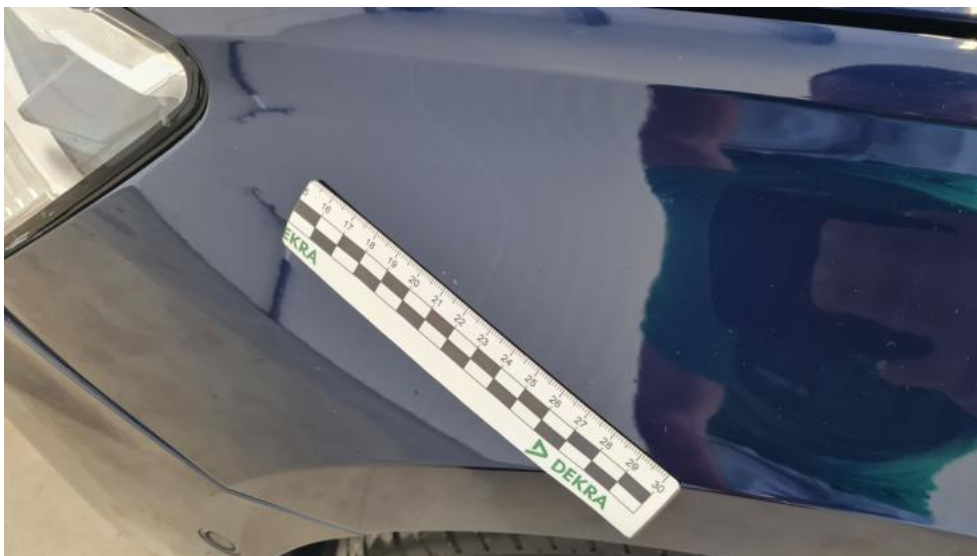
Photo 57.
Błotnik przedni L - Rysa/odprysk 1

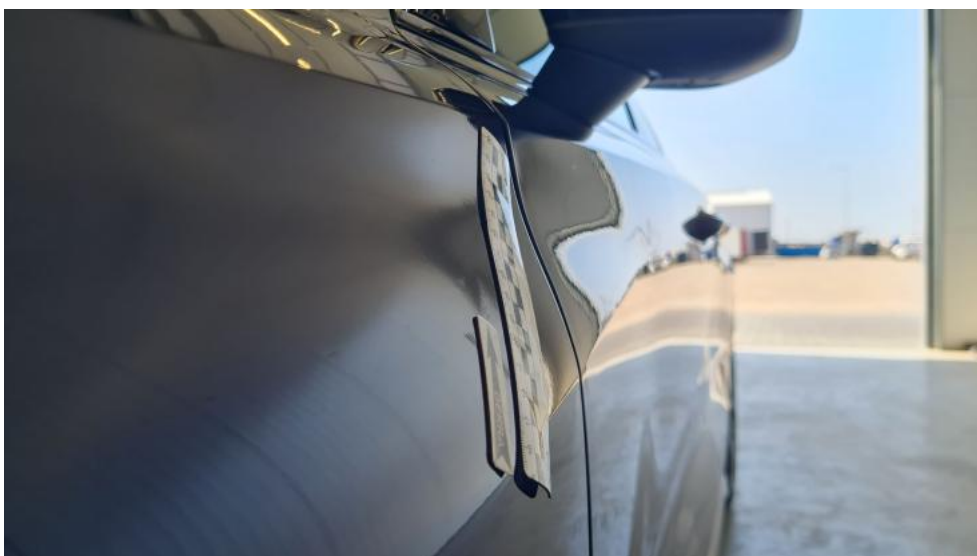
Photo 58.
Błotnik przedni L - Wgniecenie/odkształcenie 1

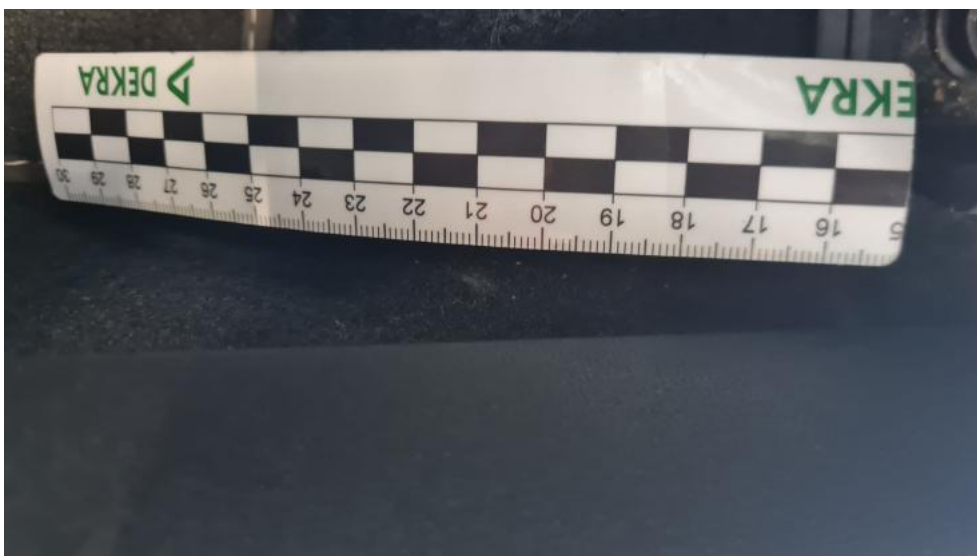
Photo 60.

Wykładzina podłogi - Inne 1
