DEKRA's commission No. : PKOL(W)/LODZ/10364/25/02/11  
commission/ damage No. : 22/012696  
Date of commission: 11-02-2025

**Vehicle data**

Measurement of thickness of the vehicle lacquer coating

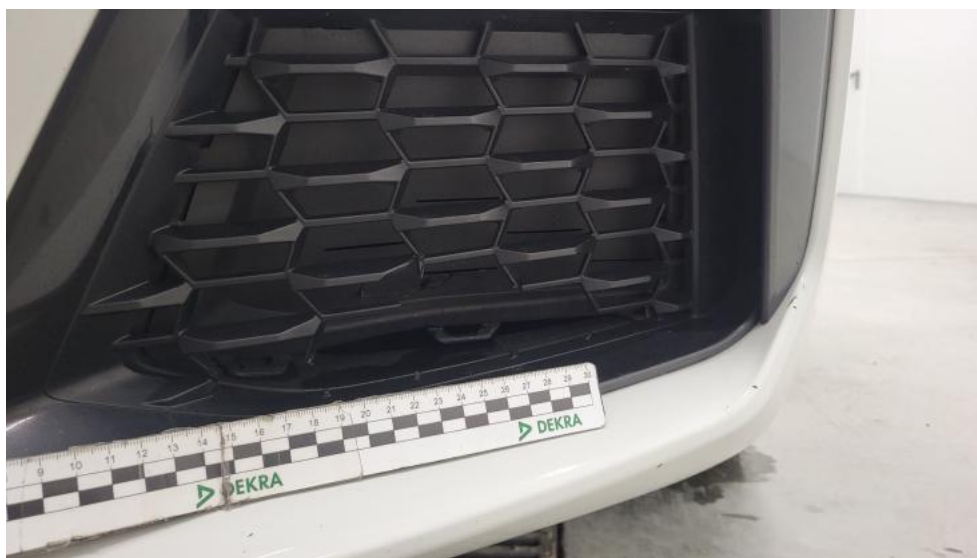
**Photo 40.**  
Kratka zderzaka prz. - Pęknięcie/rozerwanie 1

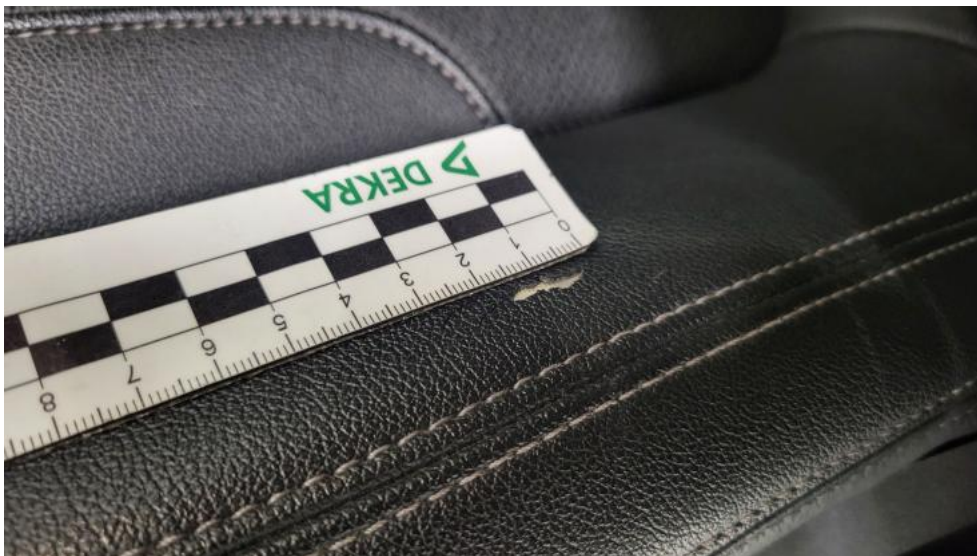
**Photo 47.**

Fotel prz. lew. - Pęknięcie/rozerwanie 1
