DEKRA's commission No. : PKOL(W)/LODZ/17211/25/03/07
 commission/ damage No. : 23/033957
 Date of commission: 07-03-2025

Vehicle data

Group of objects (Eurotax)	jeeps
EC code (Eurotax)	0109187
Manufacturer	VOLVO
Model	XC90 14-19
Type / version	XC90 T8 AWD Plug-In Hybrid Inscription 7os
Body type	KOM
Number of doors / seats	5/7
Curb weight [kg]	2244
Gross vehicle weight [kg]	3010
Wheelbase 1/2	2984
Engine type	spark ignition
Pollution reduction system	three-way catalytic converter
Engine capacity [ccm]	1969
Engine Power [hp/kW]	320/236
Gearbox	automatic
Registration /record No.	RZ288EY
VIN / serial number	YV1LFBABDH1131575
Date of first registration	05-10-2016
Date of next. tech. test	28-03-2024
Year of manufacture	2016 (year has been verified with the manufacturer's base)
Readout [km]	255 828 (read)
Body color / type of coating	white/double-layered, metallized

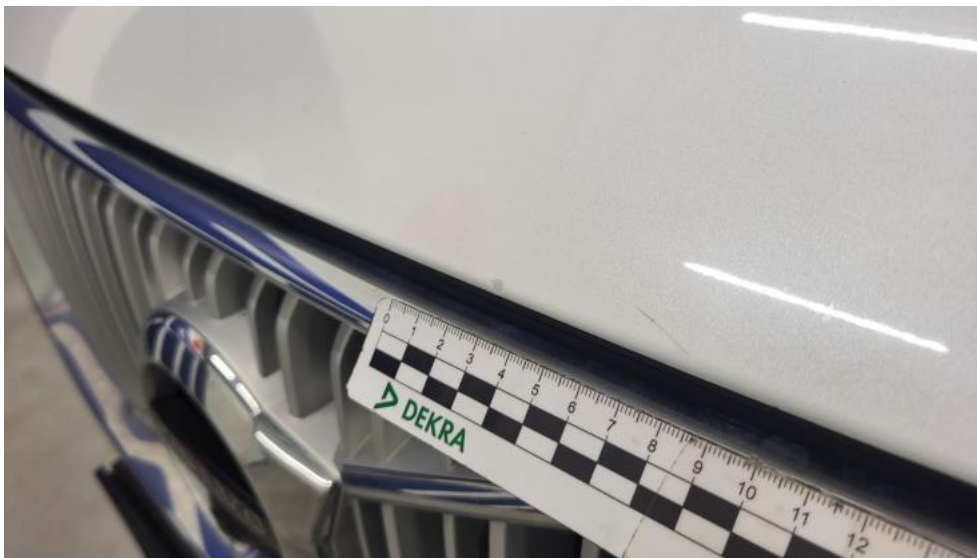
Photo 49.
Pokrywa komory silnika - Rysa/odprysk 1

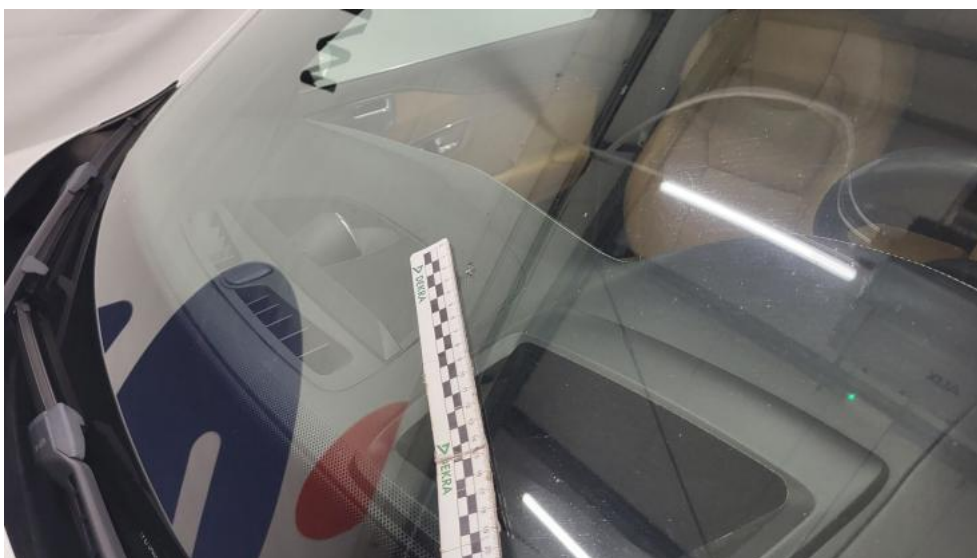
Photo 50.
Szyba czołowa - zdjęcie poglądowe 1

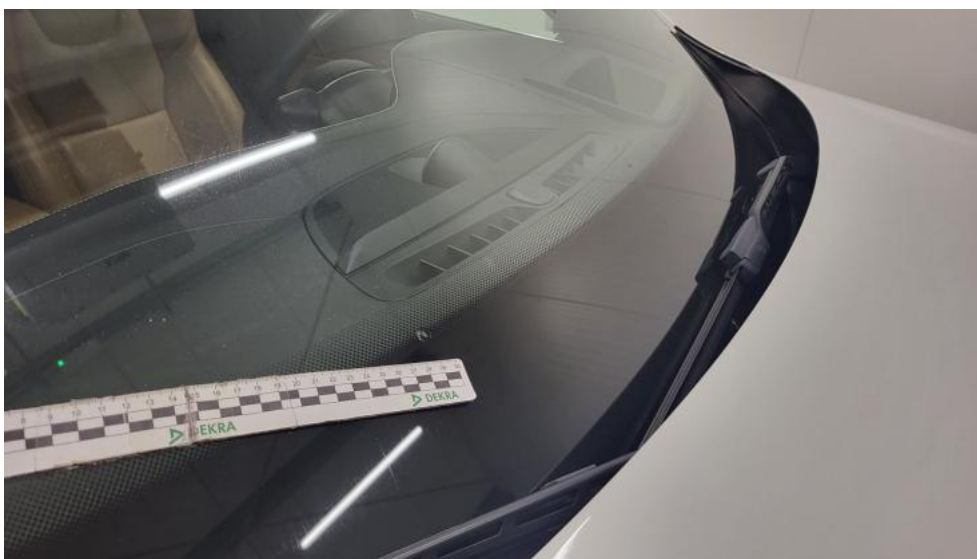
Photo 51.
Szyba czołowa - zdjęcie pogłądowe 2

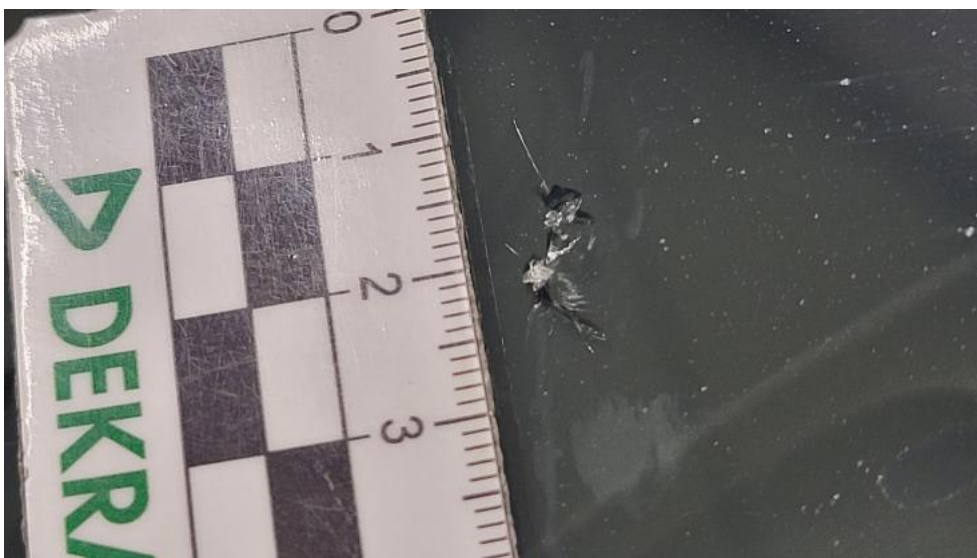
Photo 52.
Szyba czołowa - Pęknięcie/rozerwanie 1

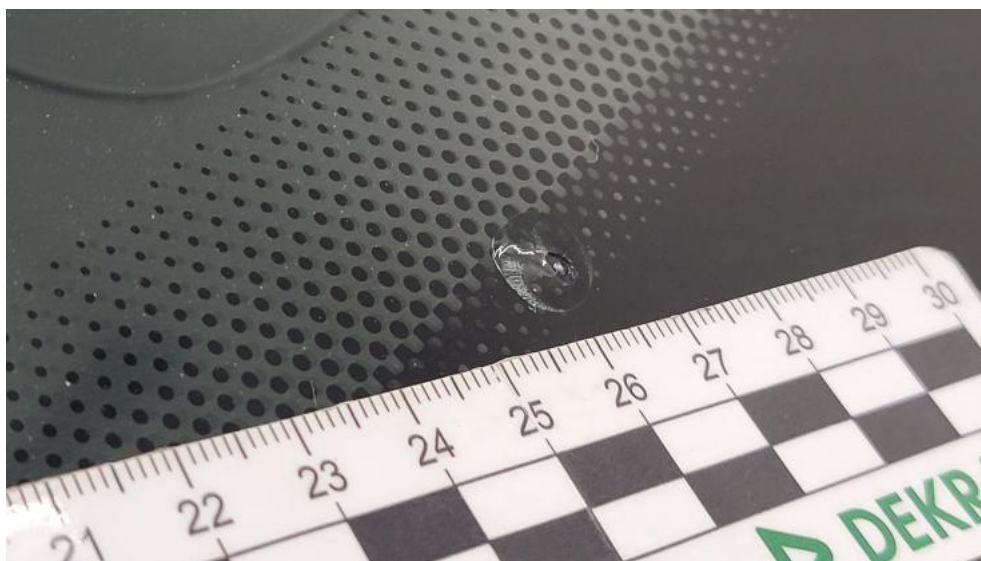
Photo 53.

Szyba czołowa - Pęknięcie/rozerwanie 2

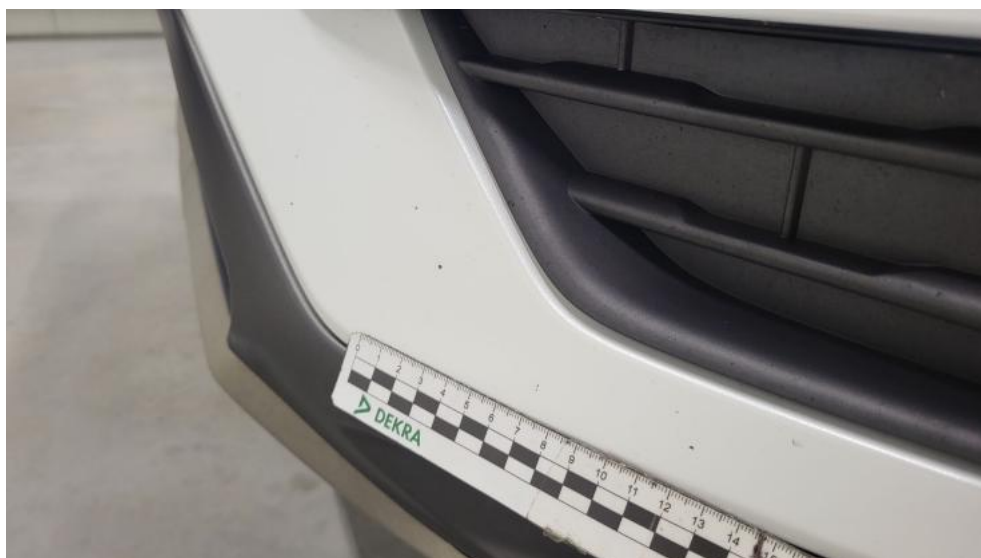
Photo 54.

Zderzak - Rysa/odprysk 1

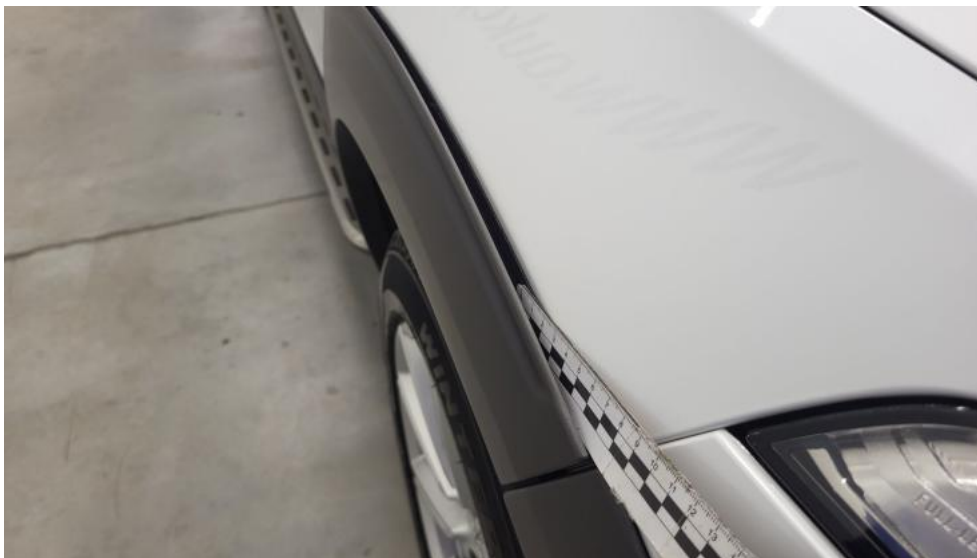
Photo 55.

Listwa błotnika przedniego P - Inne 1

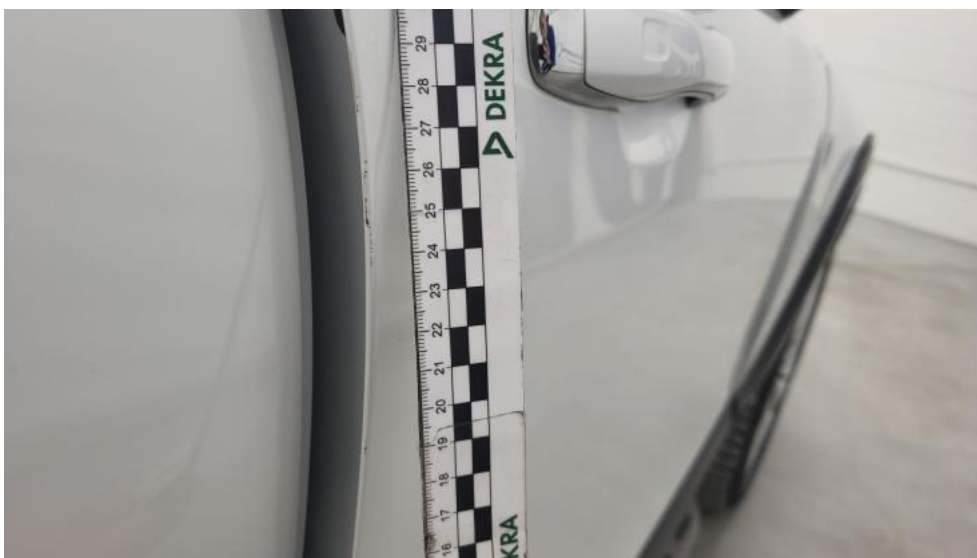
Photo 56.

Drzwi przednie P - Rysa/odprysk 1

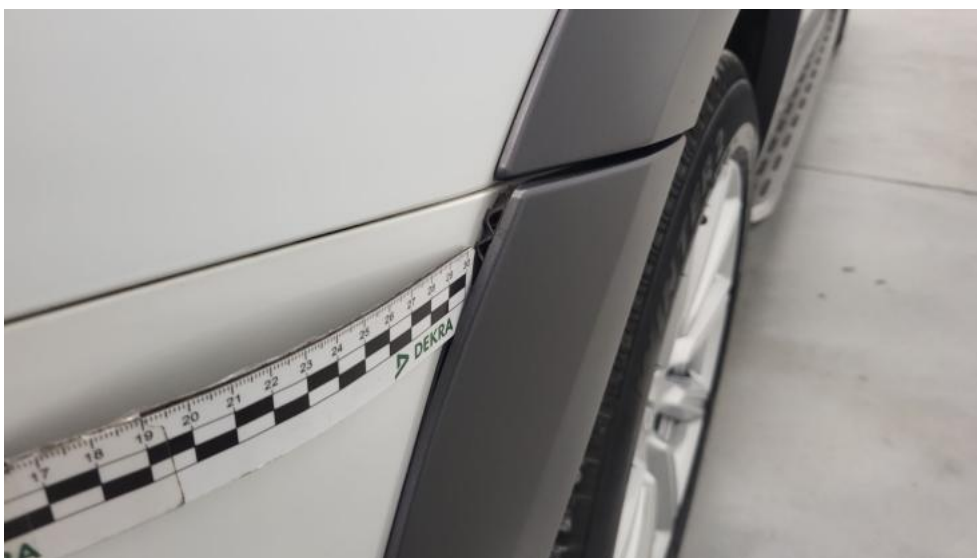
Photo 60.
Listwa zderzaka tylnego P - Inne 1

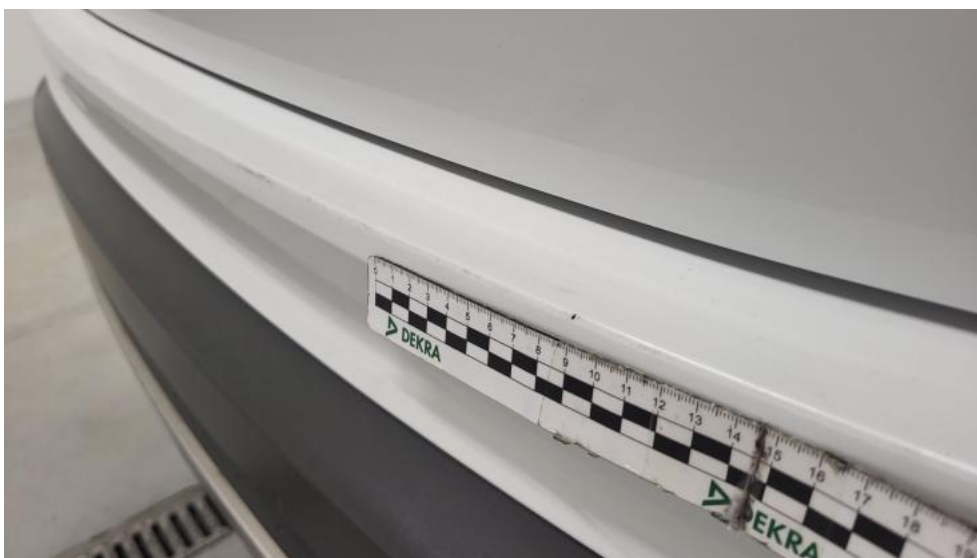
Photo 62.

Zderzak tylny - Rysa/odprysk 1

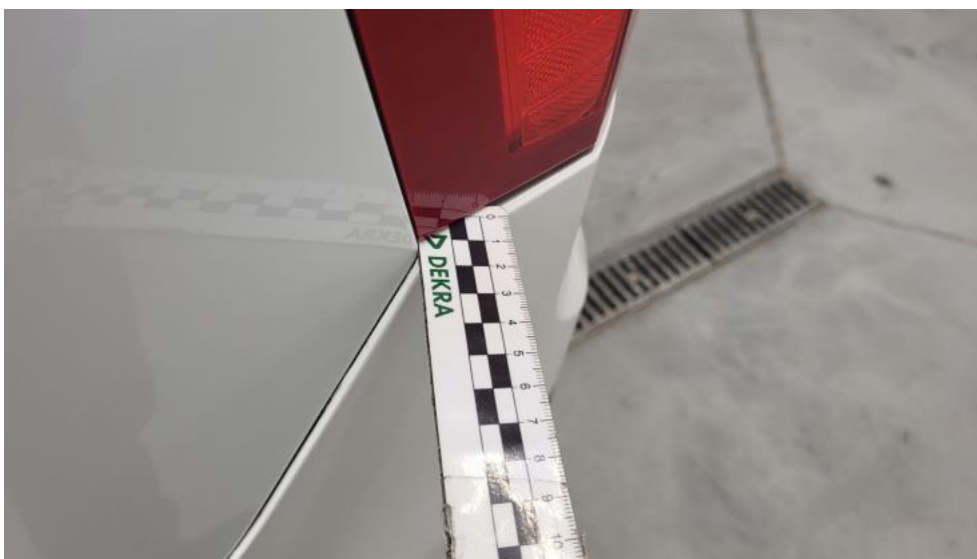
Photo 63.
Zderzak tylny - Inne 1

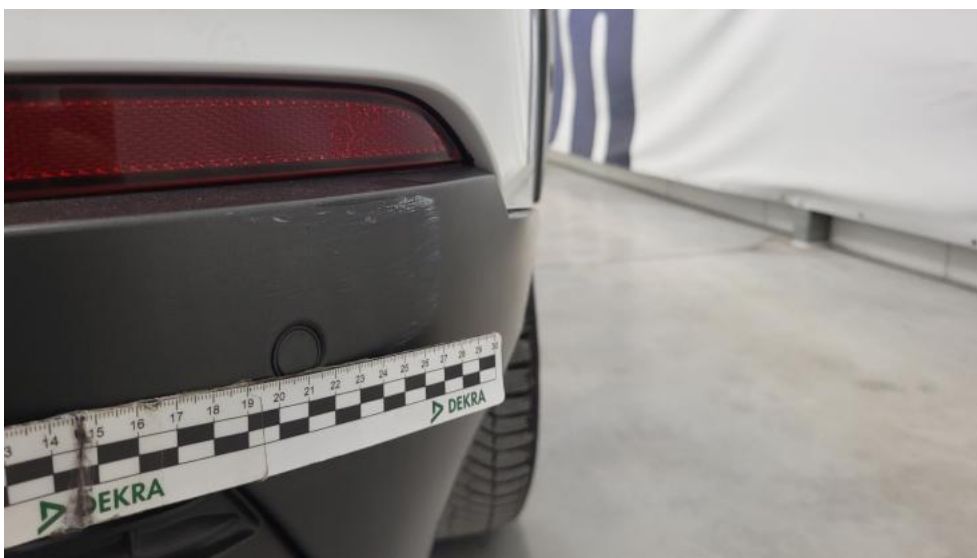
Photo 64.
Zderzak tylny cz dolna - Rysa/odprysk 1

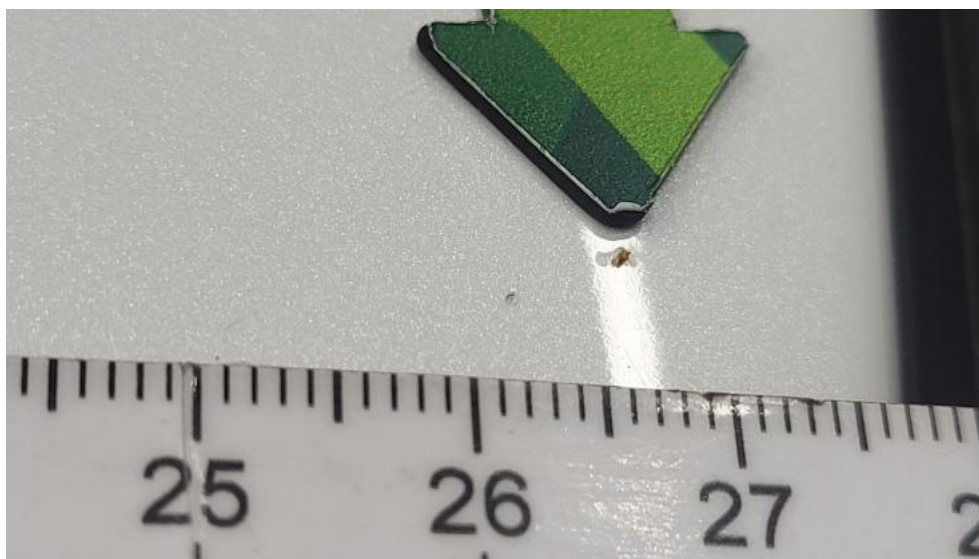
Photo 67.
Dach - Inne 1

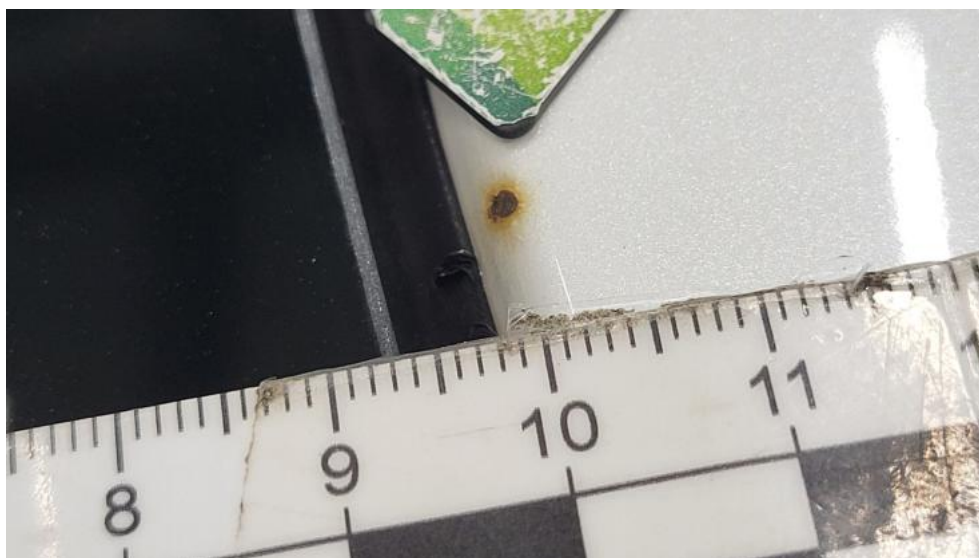
Photo 68.
Dach - Inne 2

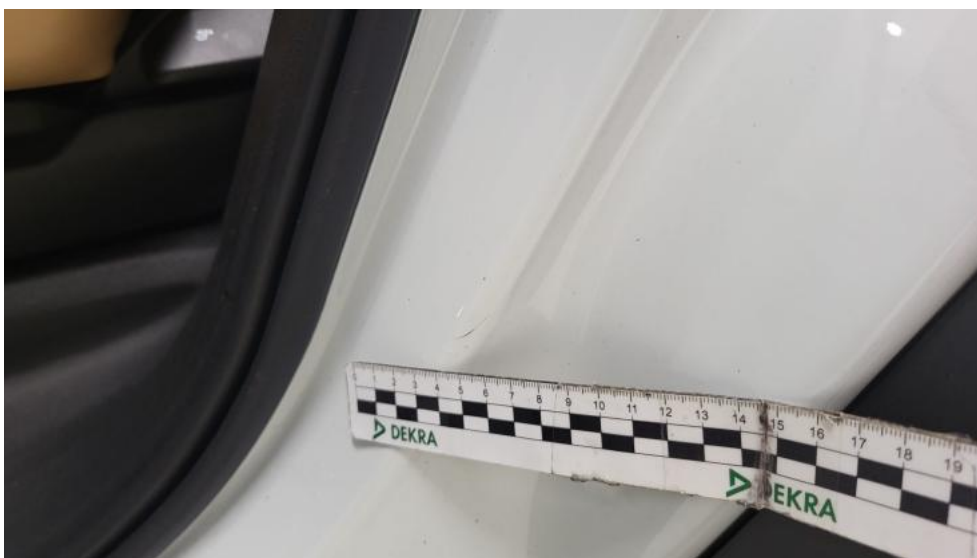
Photo 70.

Błotnik tylny L / Ściana boczna L - Rysa/odprysk 2

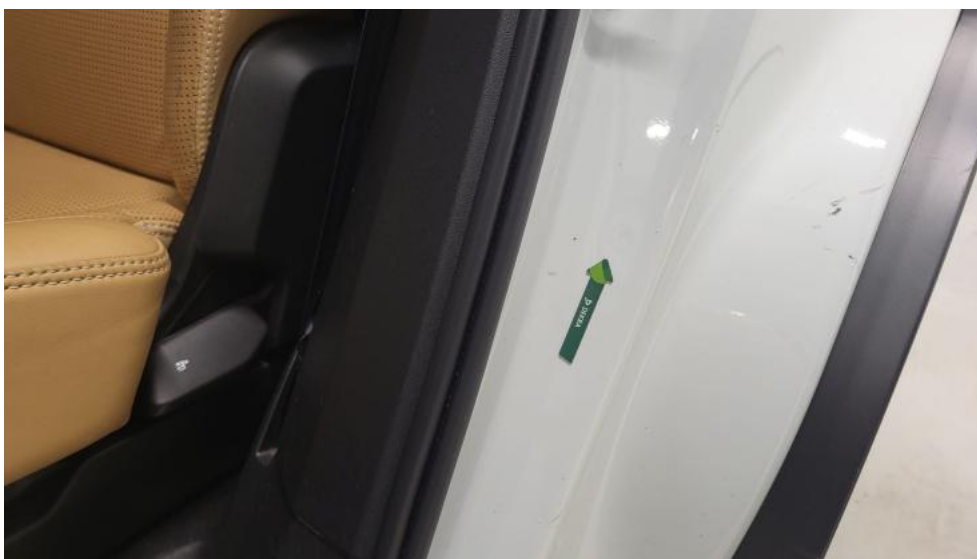
Photo 71.
Błotnik tylny L / Ściana boczna L - Wgniecenie/odkształcenie 1

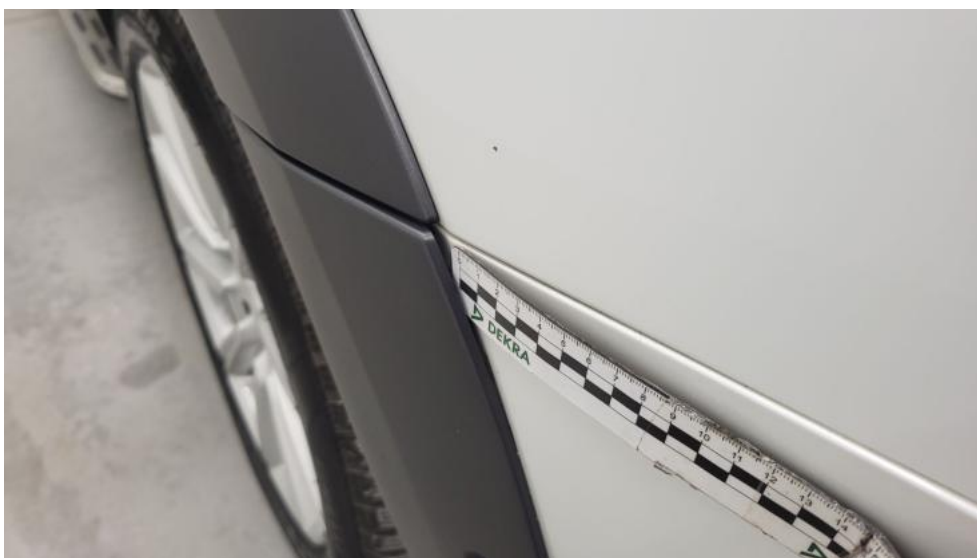
Photo 72.
Listwa zderzaka tylnego L - Inne 1

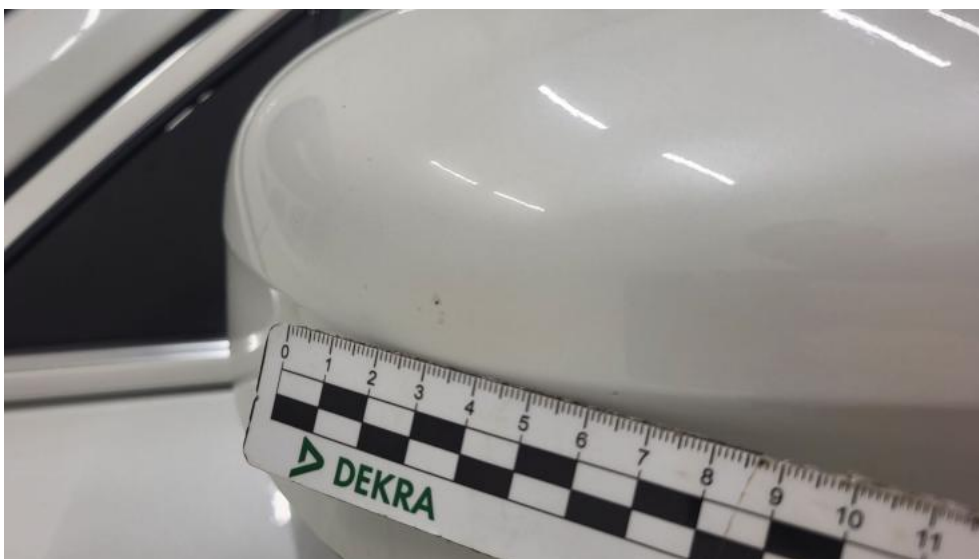
Photo 77.
Lusterko zew L - Rysa/odprysk 1

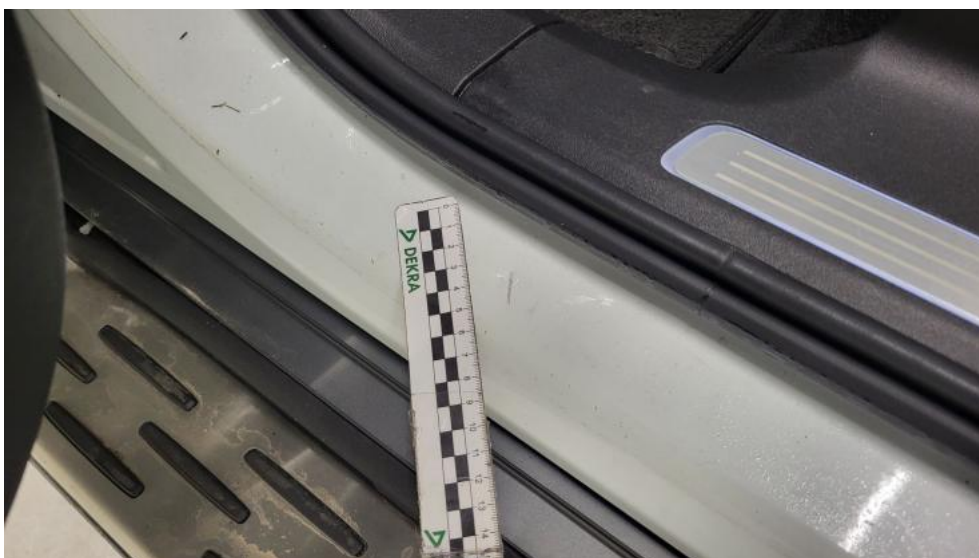
Photo 78.
Próg L - Rysa/odprysk 1

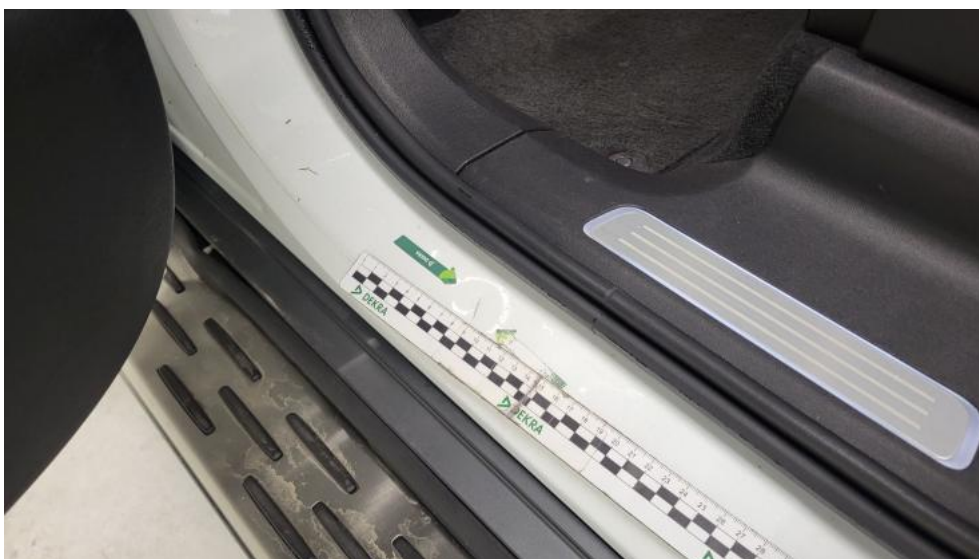
Photo 79.
Próg L - Wgniecenie/odkształcenie 1

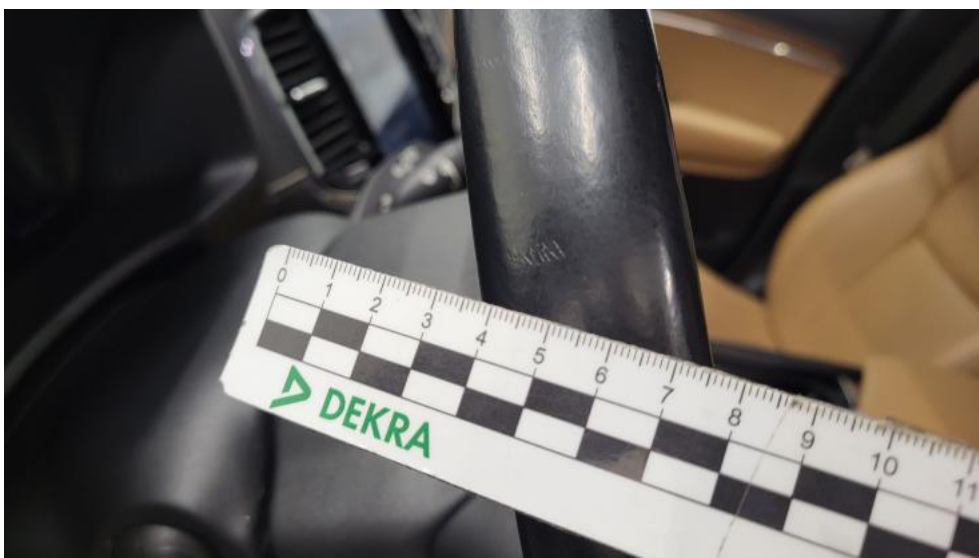
Photo 80.
Koło kierownicy - Rysa/odprysk 1

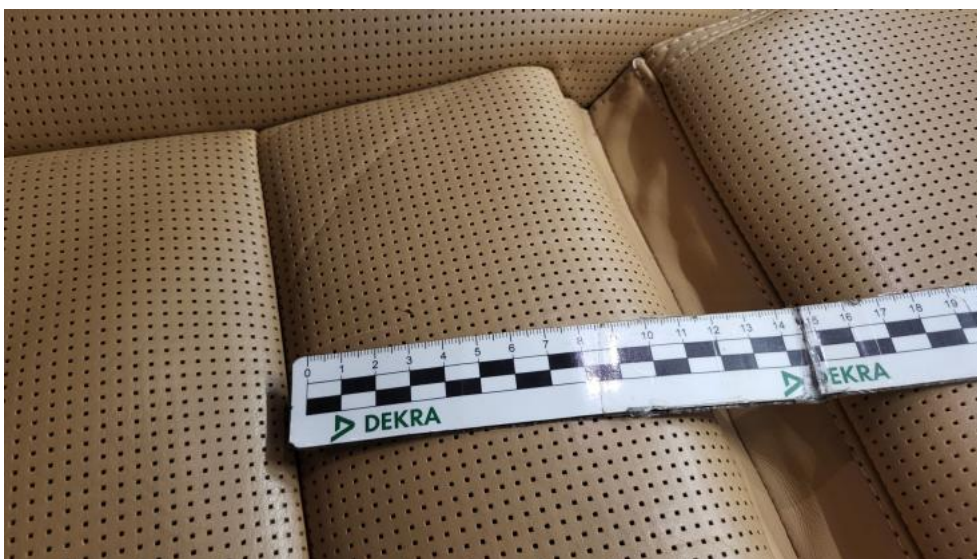
Photo 81.
Fotel prz. praw. - Rysa/odprysk 1

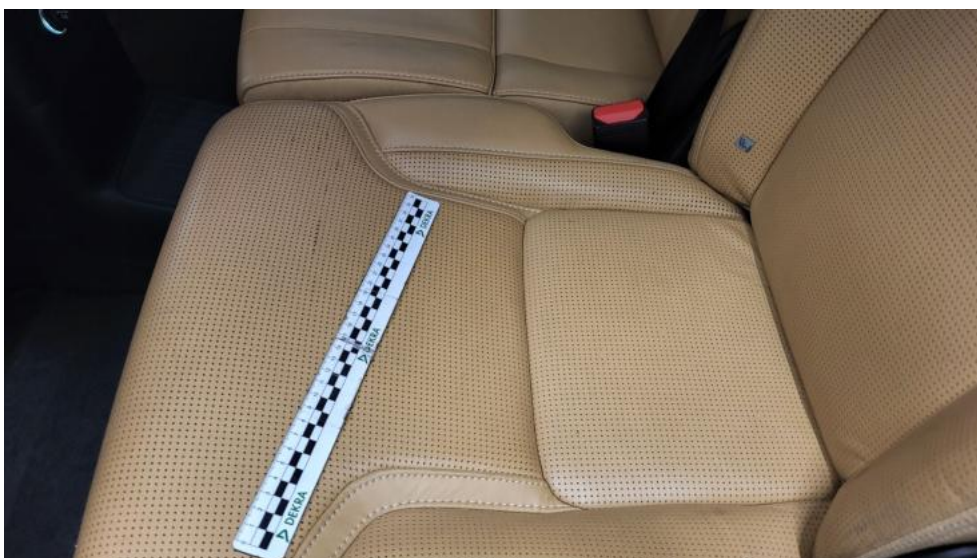
Photo 82.
Kanapa tyl. - Inne 1

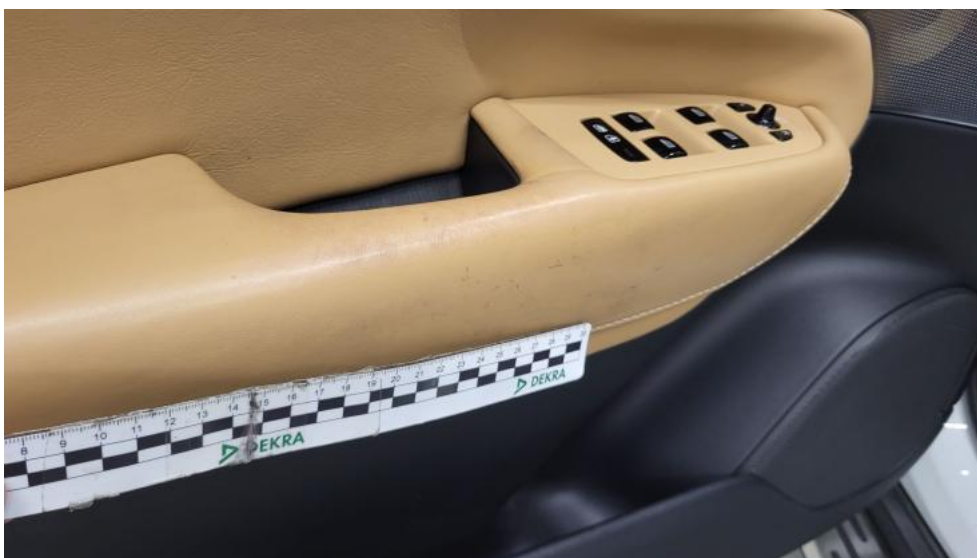
Photo 84.
Tapicerka drzwi przednich L - Inne 1
