DEKRA's commission No. : PKOL(W)/LODZ/19180/25/03/17  
commission/ damage No. : Futura  
Date of commission: 17-03-2025

| Manufacturer | BMW |
| Model | Seria 3 Touring [F31] 15-19 |
| Registration /record No. | WD1520P |

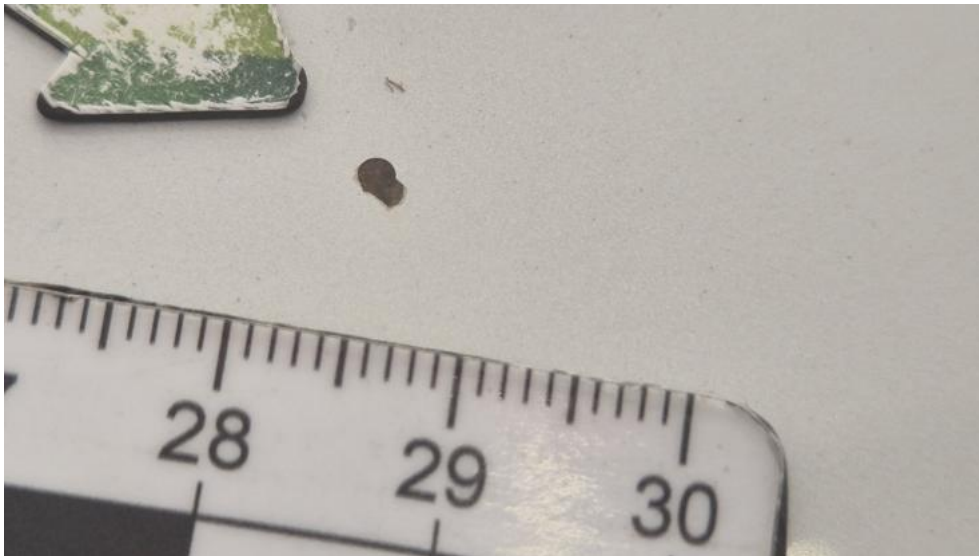
**Photo 39.**

Pokrywa komory silnika - Inne 1

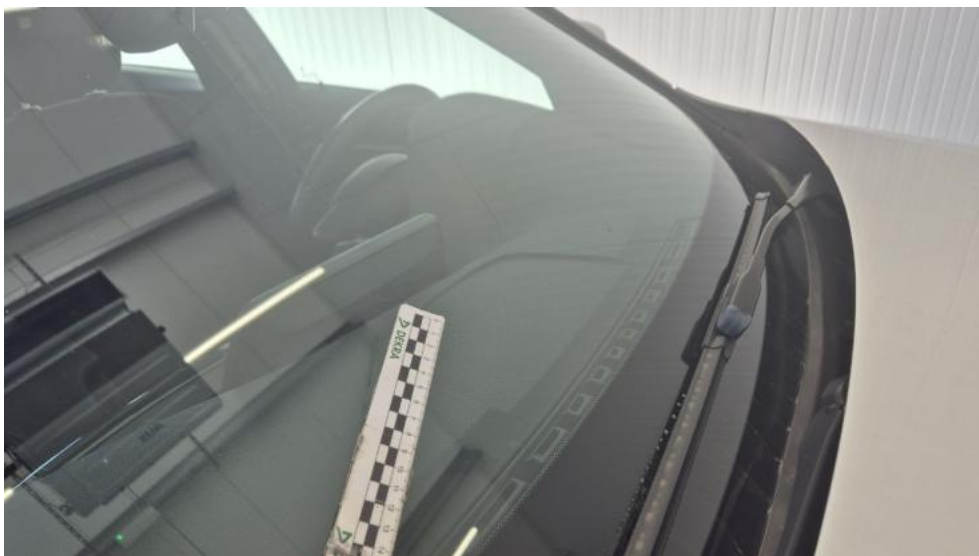
**Photo 40.**

Rysy na samochodzie. Aktywna kontrolka ciśnienia w kołach. Odpryski na szybie czołowej.

Szyba czołowa - zdjęcie poglądowe 1

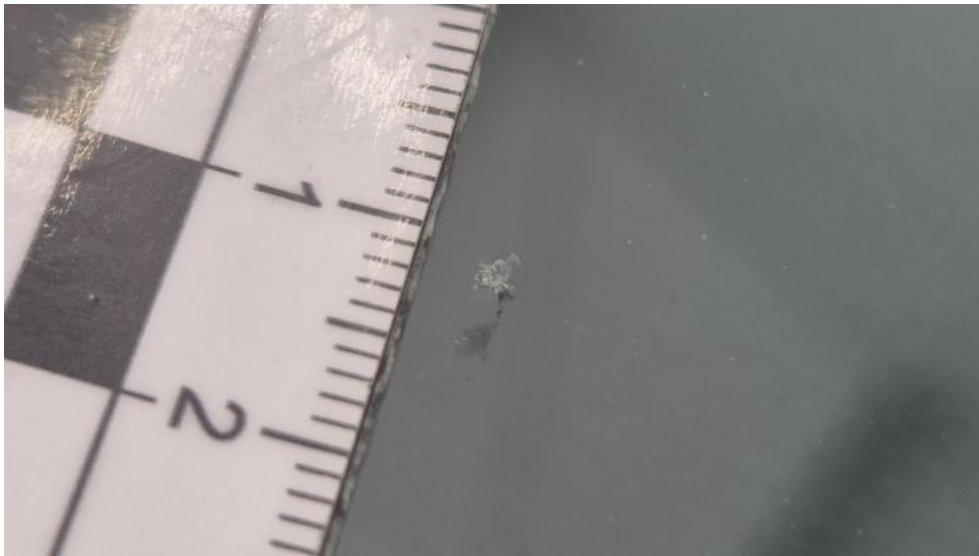
**Photo 41.**

Szyba czołowa - Pęknięcie/rozerwanie 1

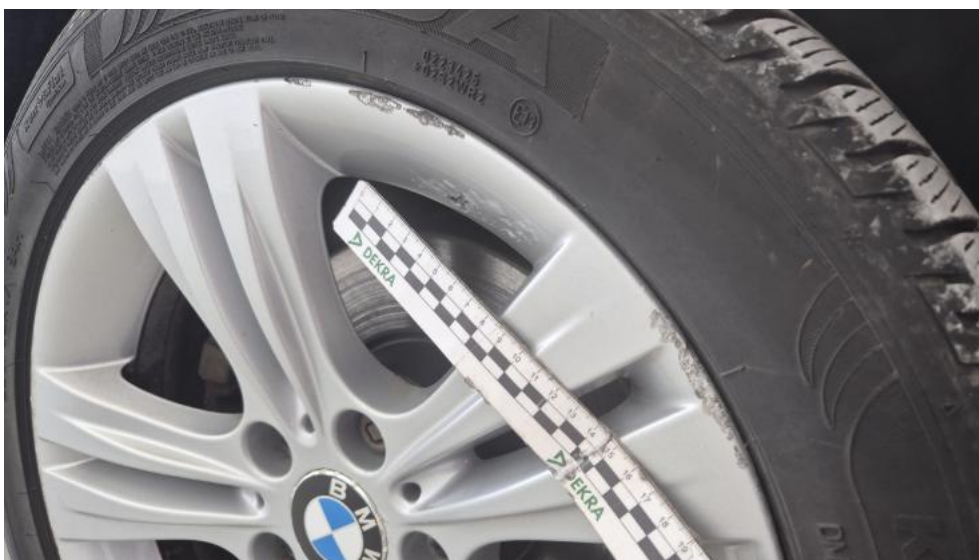
**Photo 42.**

Felga aluminiowa przednia P - Rysa/odprysk 1

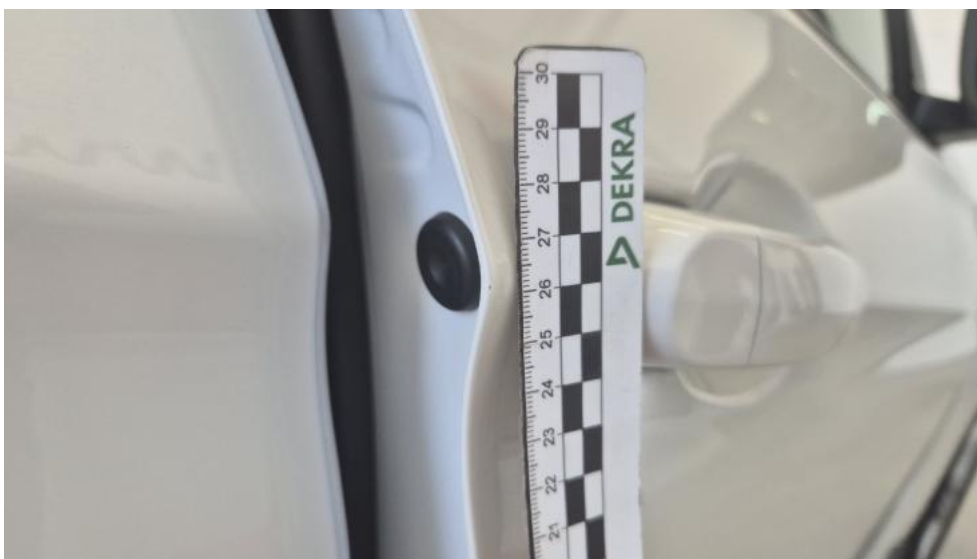
**Photo 43.**

Drzwi przednie P - Rysa/odprysk 1

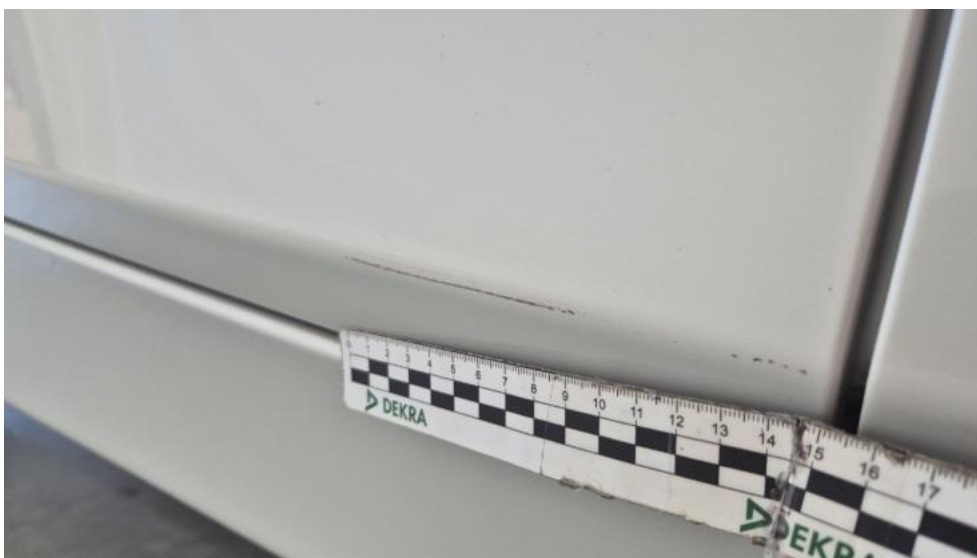
**Photo 44.**

Drzwi tylne P - Rysa/odprysk 1

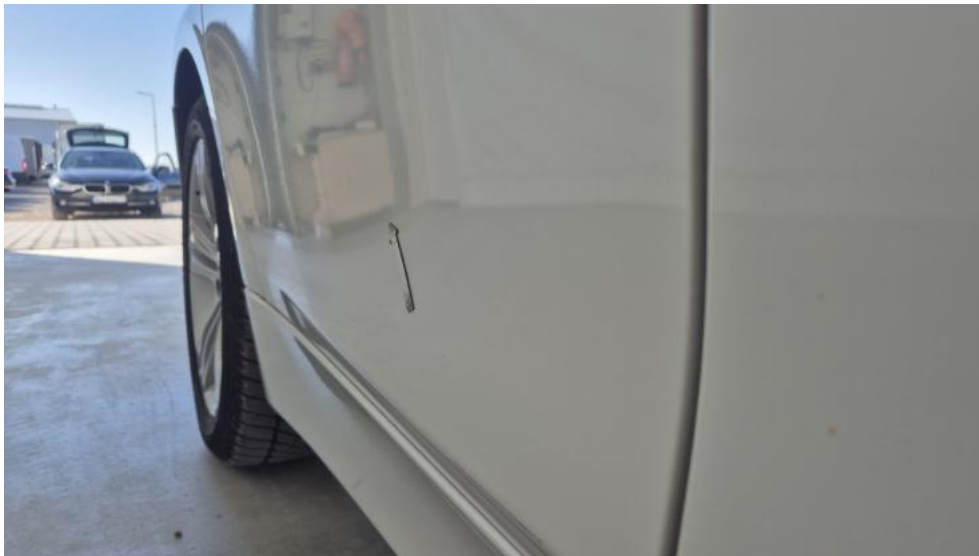
**Photo 45.**

Drzwi tylne P - Wgniecenie/odkształcenie 1

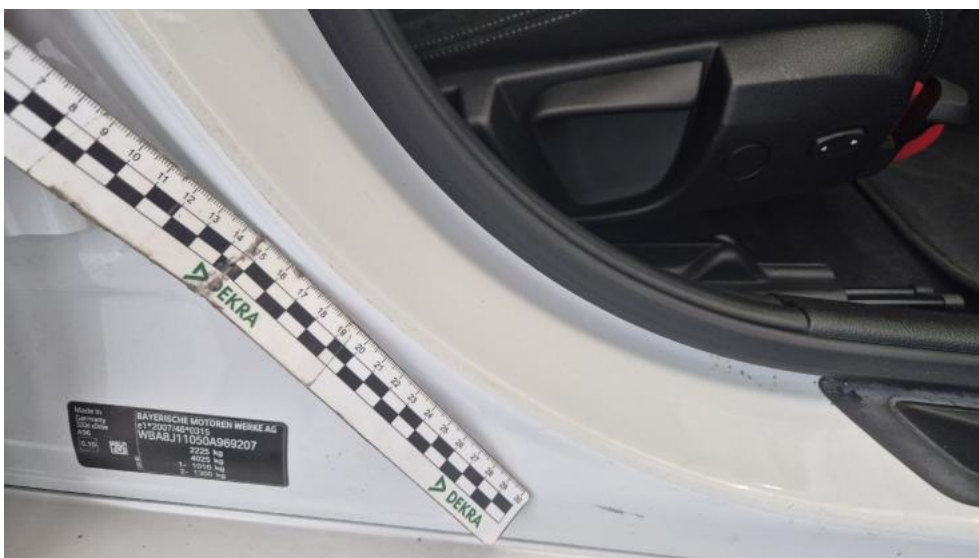
**Photo 46.**

Próg P - Rysa/odprysk 1

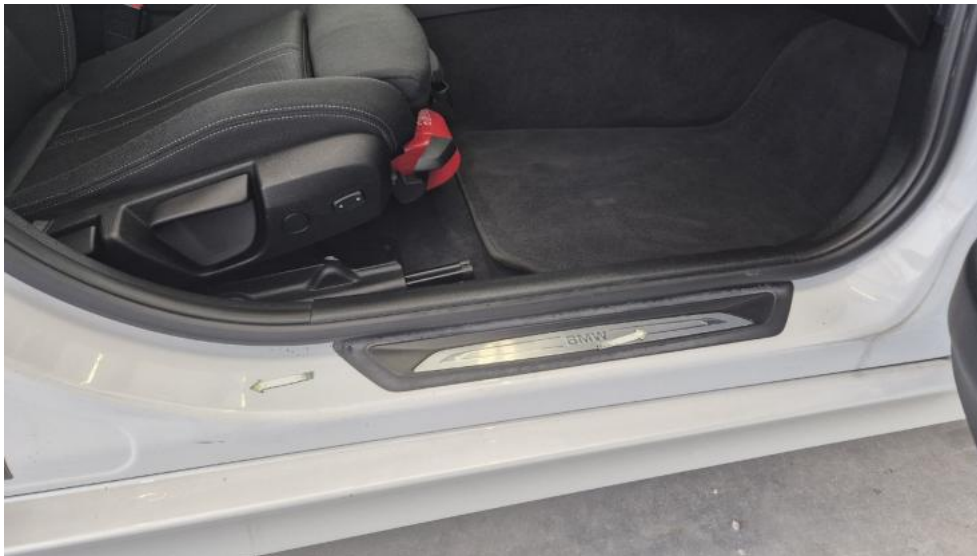
**Photo 47.**

Próg P - Wgniecenie/odkształcenie 1

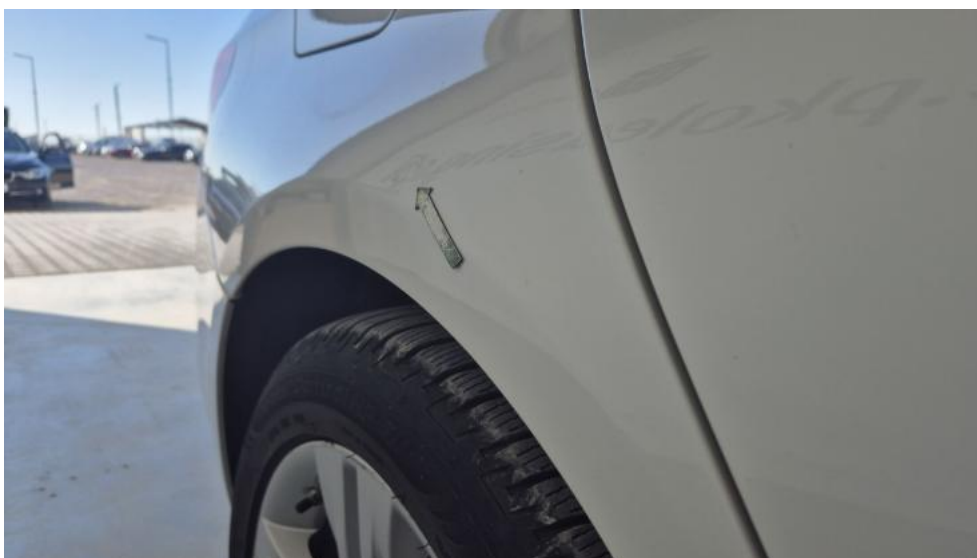
**Photo 48.**

Łotnik tylny P / Ściana boczna P - Wgniecenie/odkształcenie 1

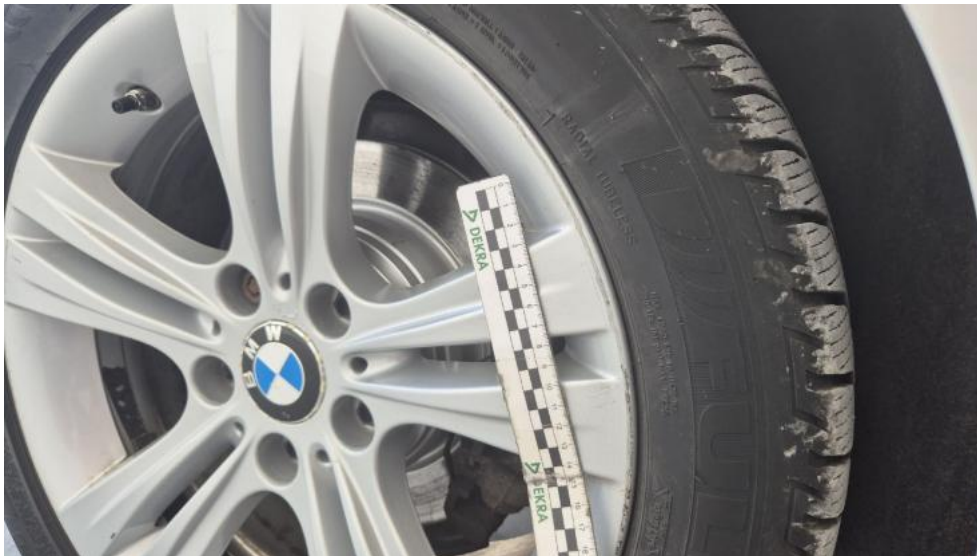
**Photo 49.**

Felga aluminiowa tylna P - Rysa/odprysk 1

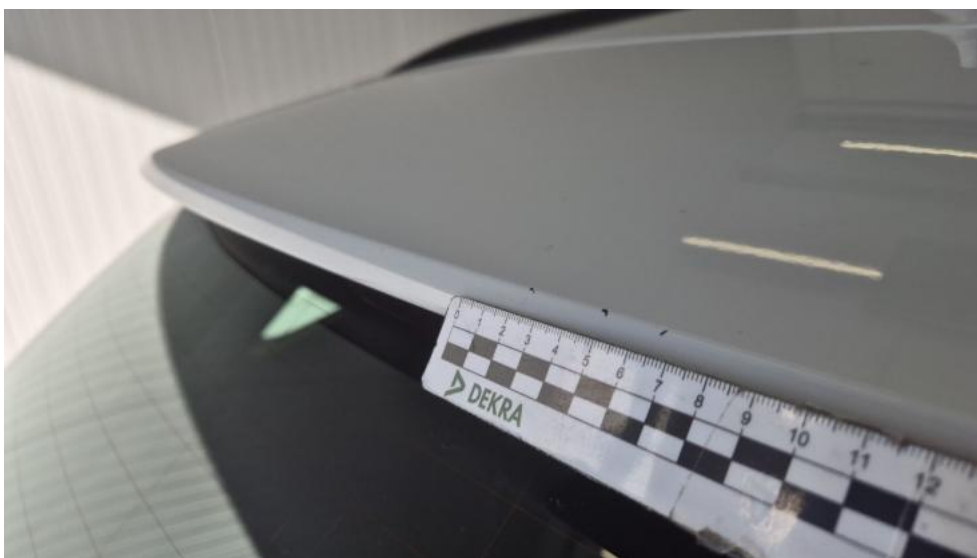
**Photo 50.**

Pokrywy bagażnika - Rysa/odprysk 1

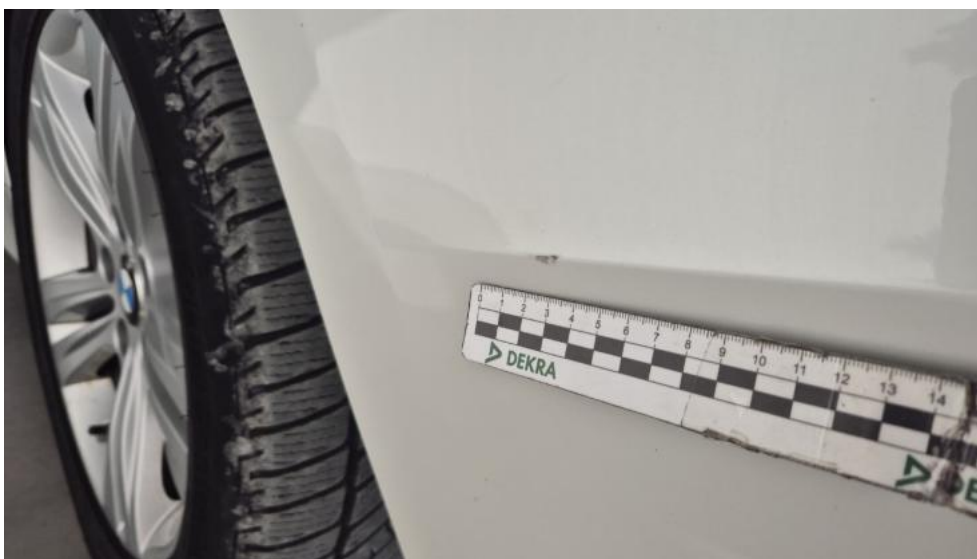
**Photo 51.**

Zderzak tylny - Rysa/odprysk 1

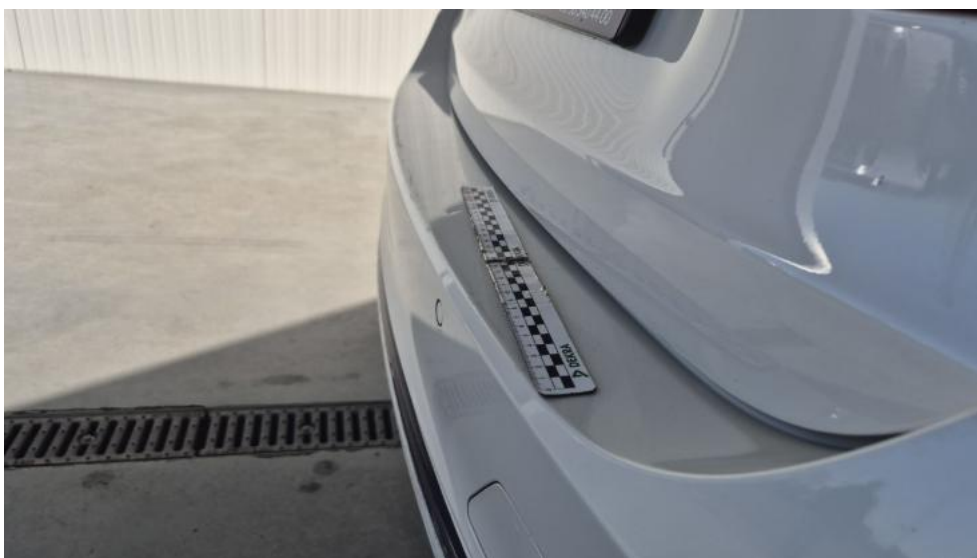
**Photo 52.**

Zderzak tylny - Wgniecenie/odkształcenie 1

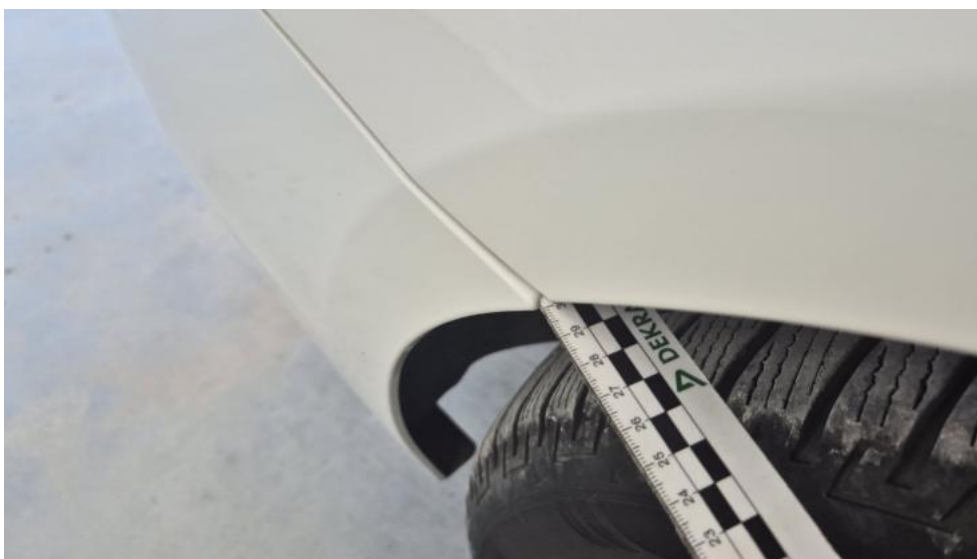
**Photo 53.**

Zderzak tylny - Inne 1

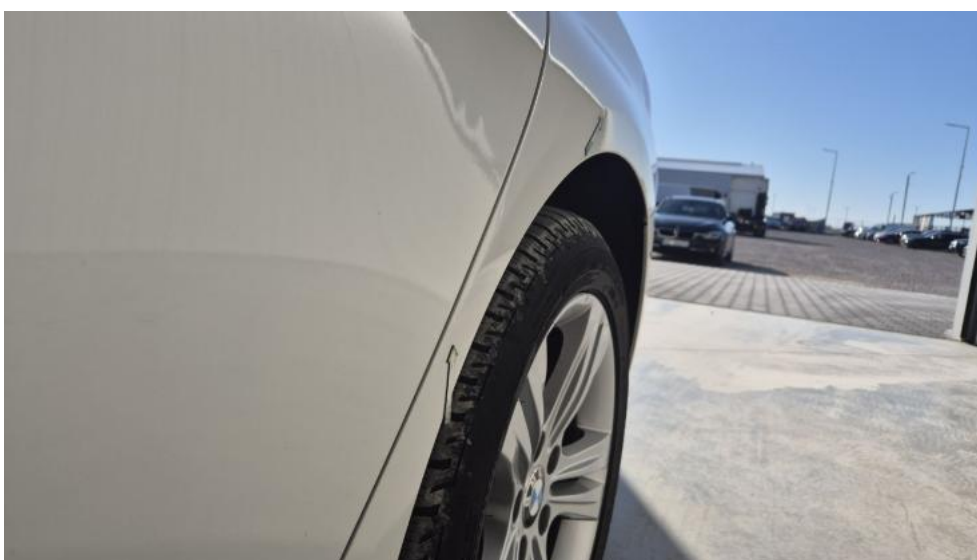
**Photo 54.**

Błotnik tylny L / Ściana boczna L - Wgniecenie/odkształcenie 1

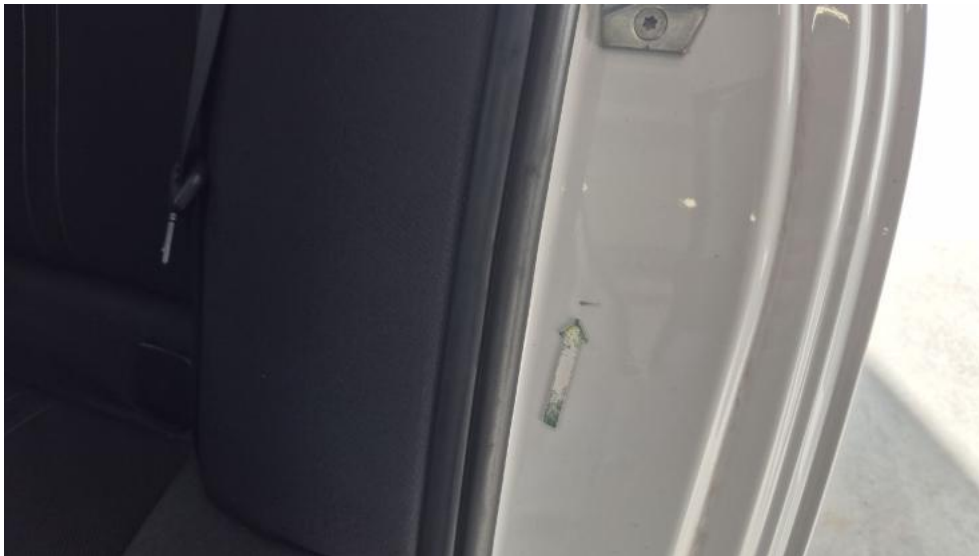
**Photo 55.**

Błotnik tylny L / Ściana boczna L - Wgniecenie/odkształcenie 2

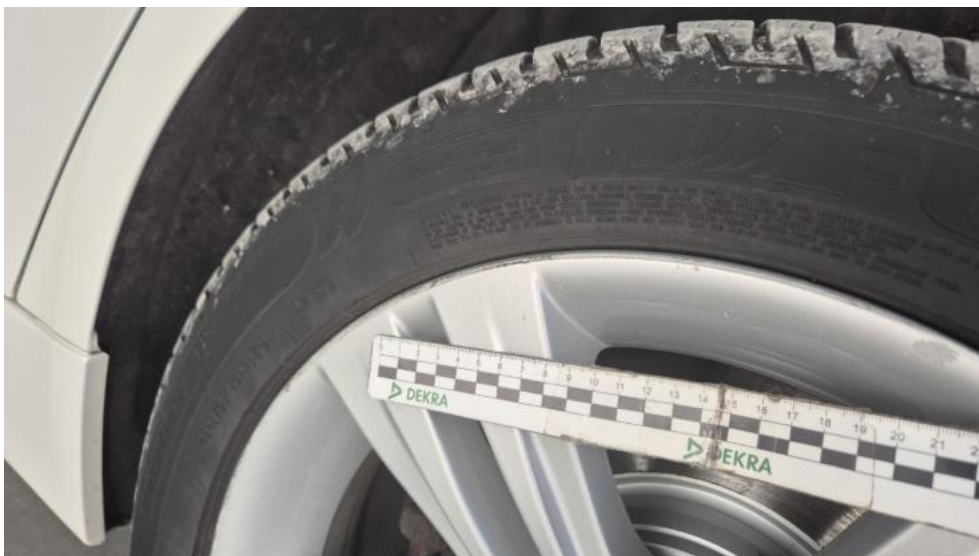
**Photo 56.**

Felga aluminiowa tylna L - Rysa/odprysk 1

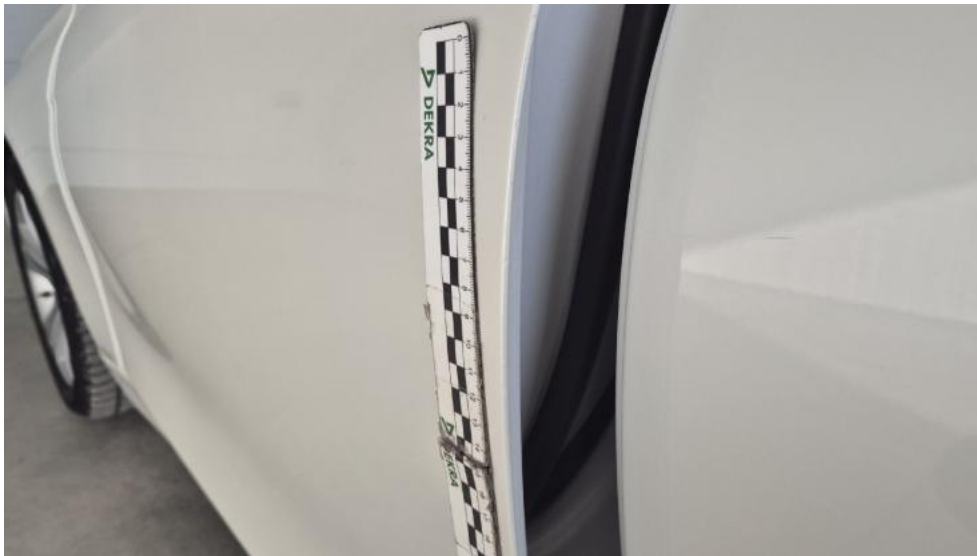
**Photo 57.**

Drzwi przed L - Rysa/odprysk 1

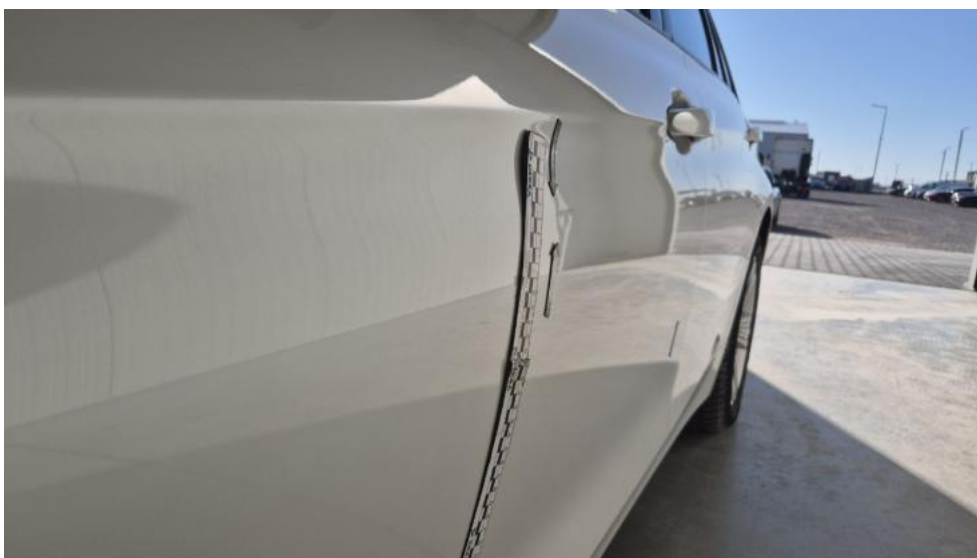
**Photo 58.**

Drzwi przed L - Wgniecenie/odkształcenie 1

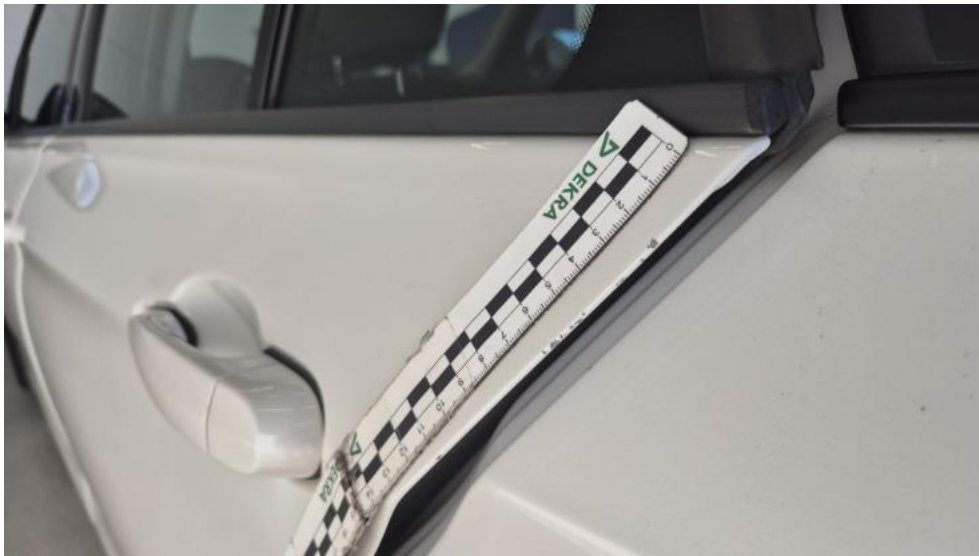
**Photo 59.**

Drzwi tylne L - Rysa/odprysk 1

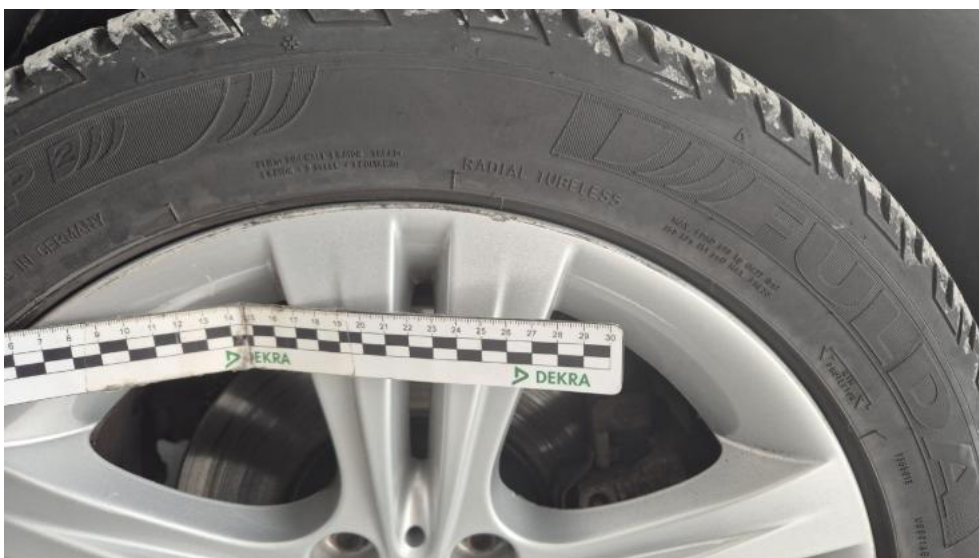
**Photo 60.**

Felga Aluminiowa przednia L - Rysa/odprysk 1

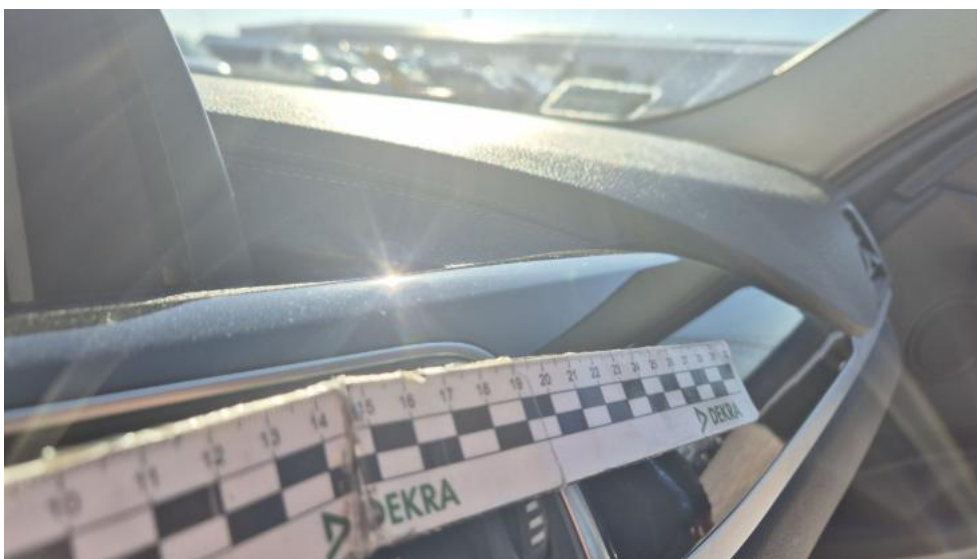
**Photo 61.**

Deska rozdzielcza - Rysa/odprysk 1

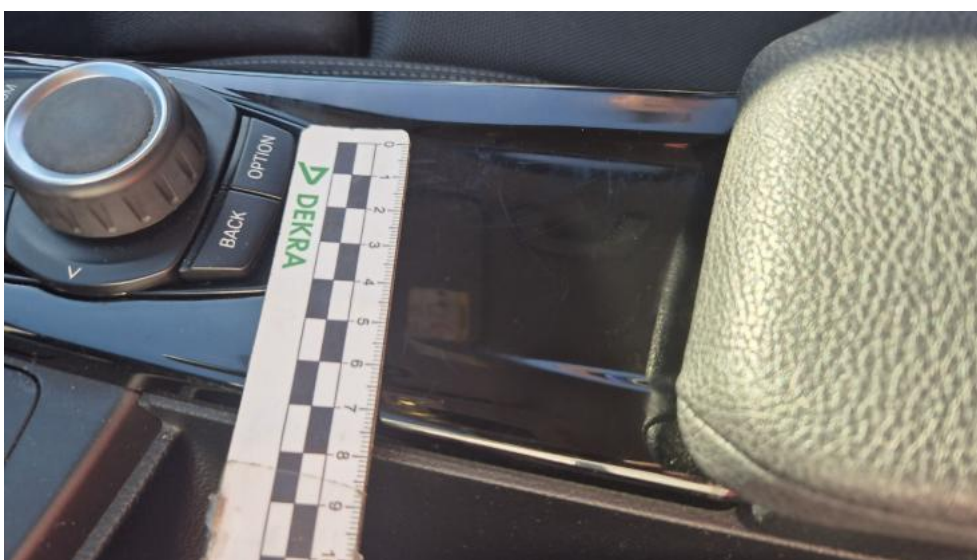
**Photo 62.**

Konsola tunelu śr. - Rysa/odprysk 1

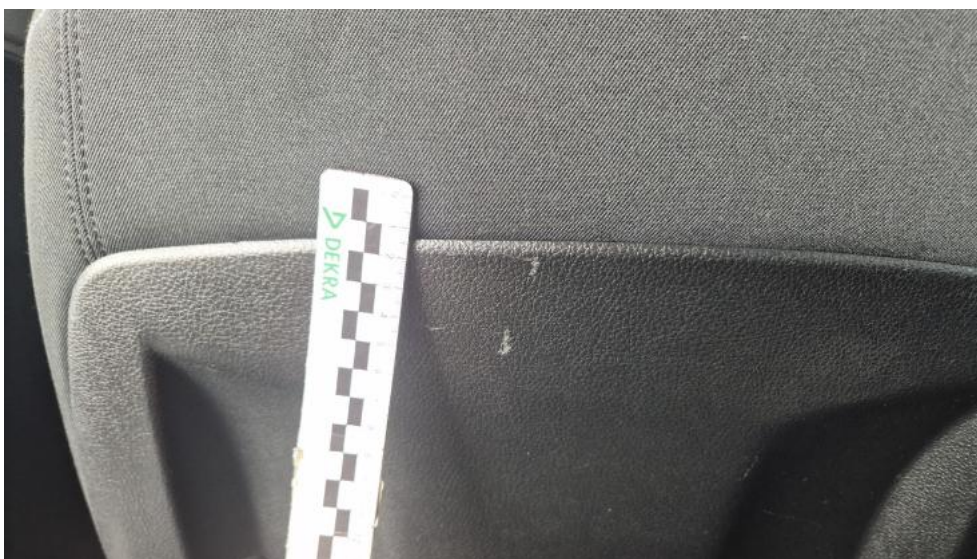
**Photo 63.**

Fotel prz. lew. - Rysa/odprysk 1

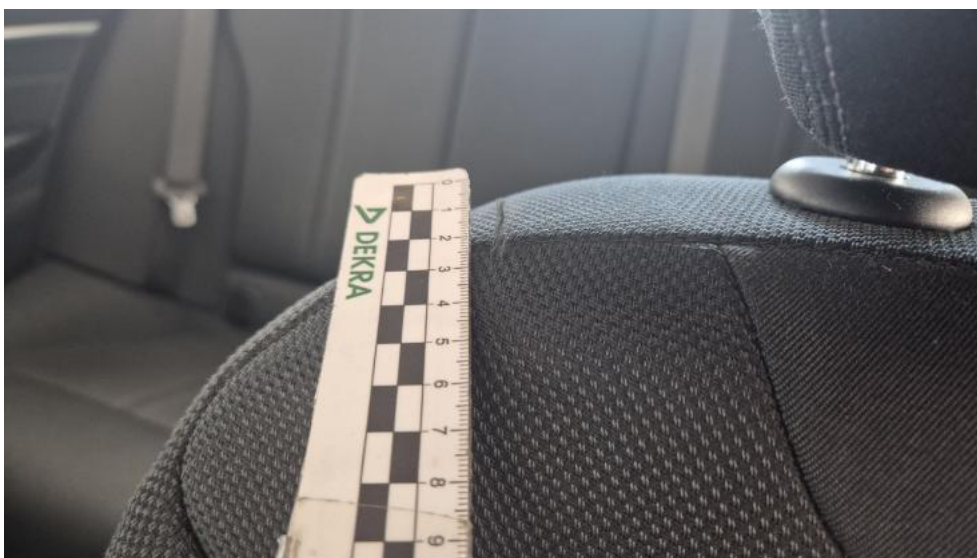
**Photo 64.**

Fotel prz. lew. - Inne 1

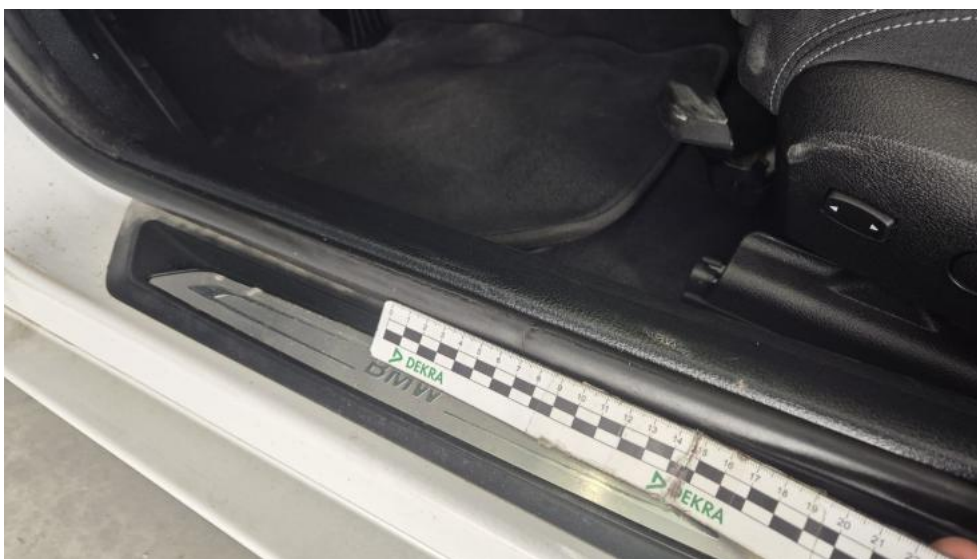
**Photo 65.**

Uszczelka drzwi przednich L - Inne 1
