DEKRA's commission No. : PKOL(W)/LODZ/19196/25/03/17
 commission/ damage No. : Futura
 Date of commission: 17-03-2025

PKO Leasing SA
 Świętokrzyska 36
 00-116 Warszawa

Group of objects (Eurotax)	cars
EC code (Eurotax)	0118536
Manufacturer	VOLVO
Model	V90 16-20
Type / version	V90 D5 AWD Inscription aut
Body type	KOM
Number of doors / seats	5/5
Curb weight [kg]	1884
Gross vehicle weight [kg]	2400
Wheelbase 1/2	2941
Engine type	Automatic ignition
Pollution reduction system	DPF
Emission standard	EURO 6
Engine capacity [ccm]	1969
Engine Power [hp/kW]	235/173
Gearbox	automatic 8- gear
Registration /record No.	WD3155H
VIN / serial number	YV1PW68BCJ1055145
Date of first registration	09-02-2018
Date of next. tech. test	21-01-2026
Year of manufacture	2018 (year has been verified with the manufacturer's base)
Readout [km]	141 953 (read)
Body color / type of coating	black/2-warstwowy metalik

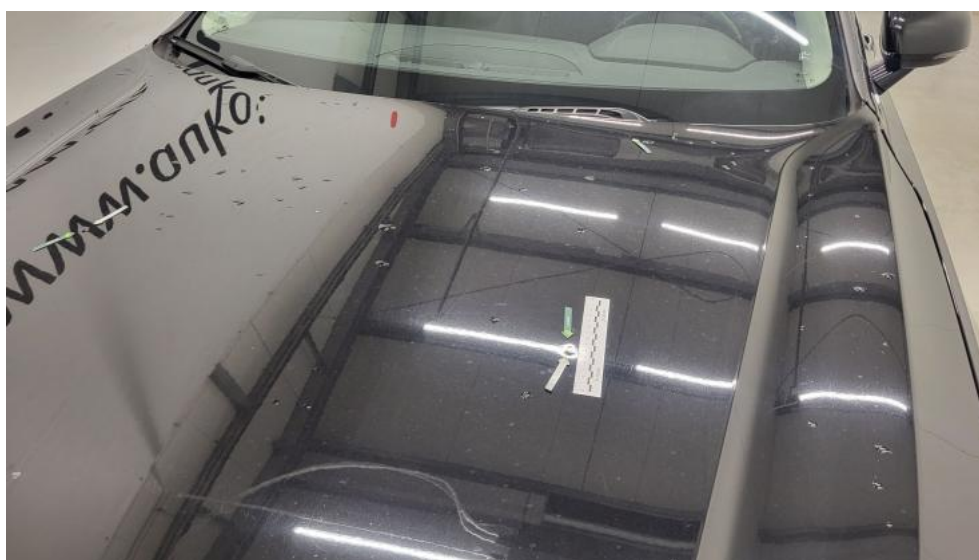
Photo 42.
Pokrywa komory silnika - Wgniecenie/odkształcenie 1

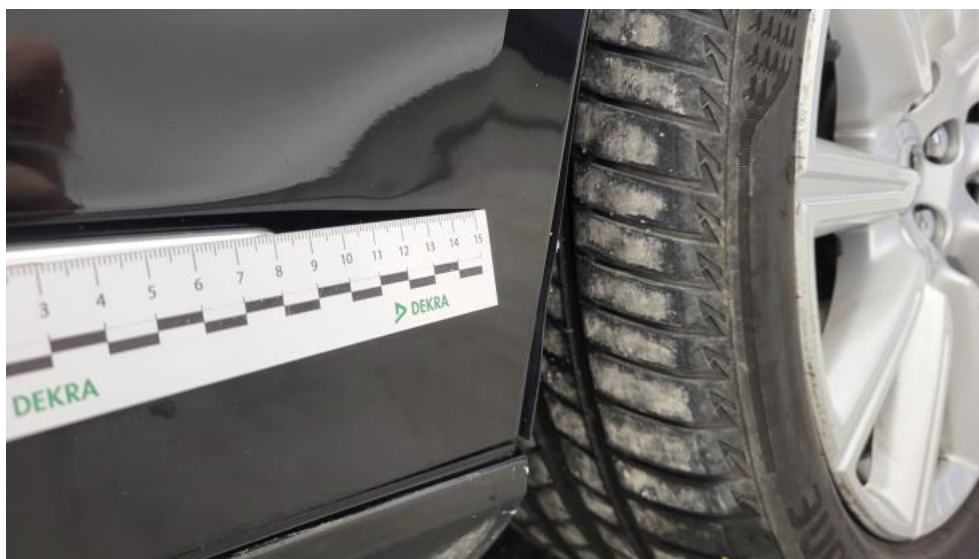
Photo 43.
Błotnik przedni P - Wgniecenie/odkształcenie 1

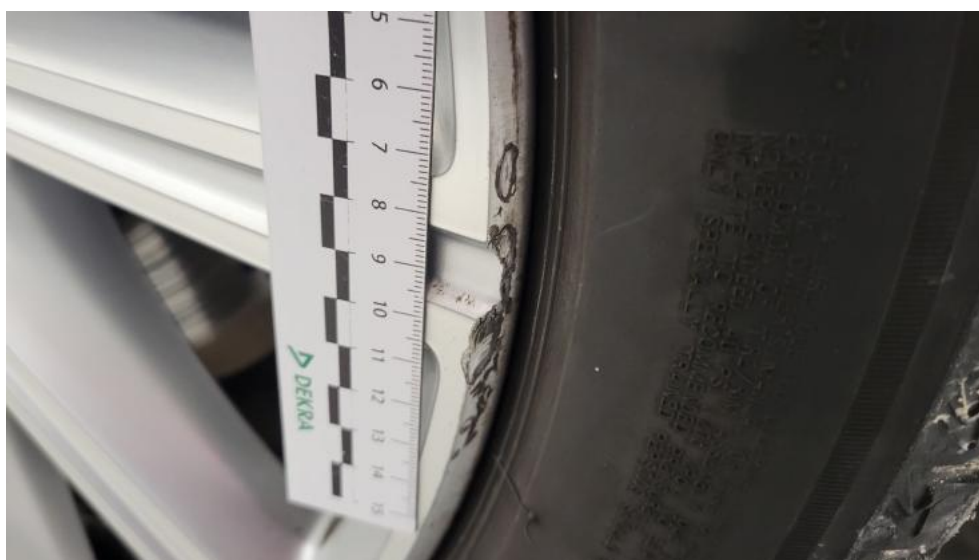
Photo 44.
Felga aluminiowa przednia P - Rysa/odprysk 1

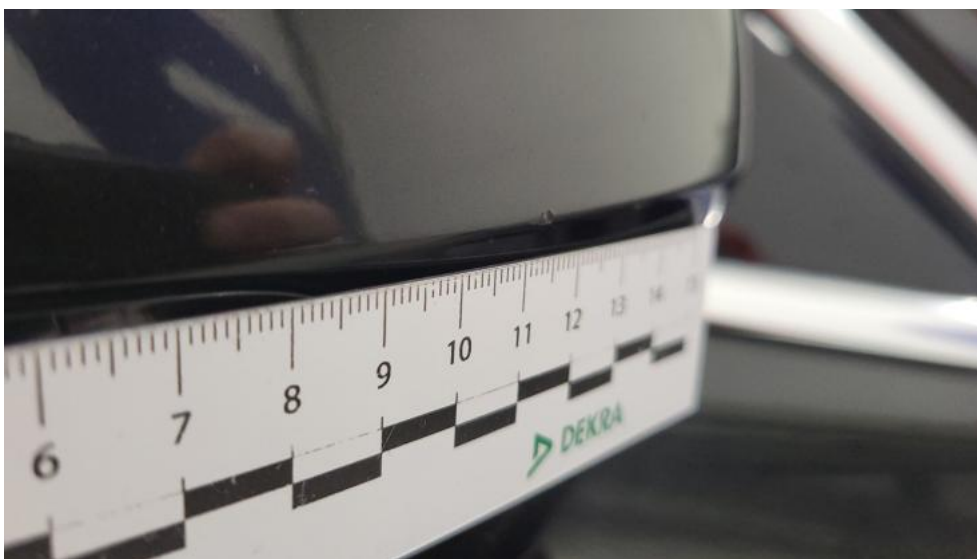
Photo 47.
Lusterko zew P - Rysa/odprysk 1

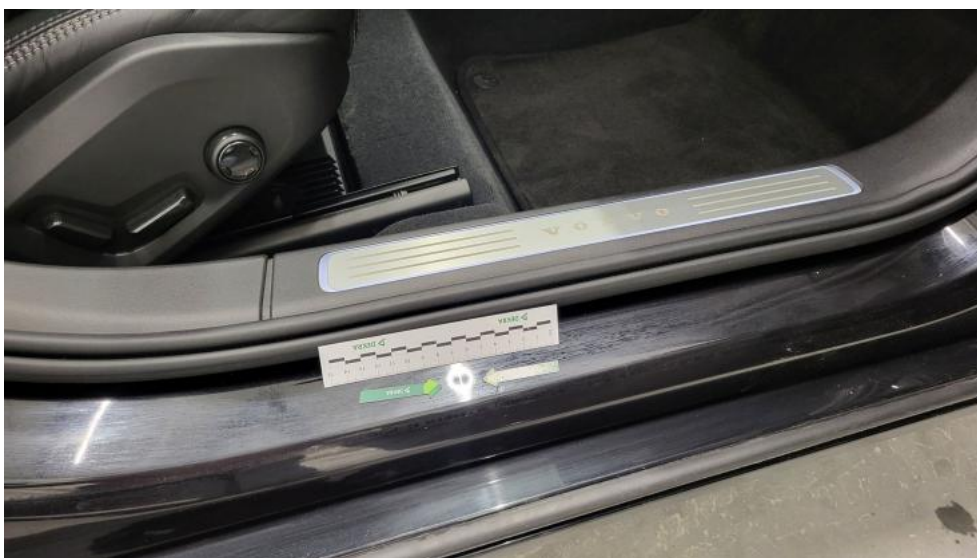
Photo 48.
Próg P - Wgniecenie/odkształcenie 1

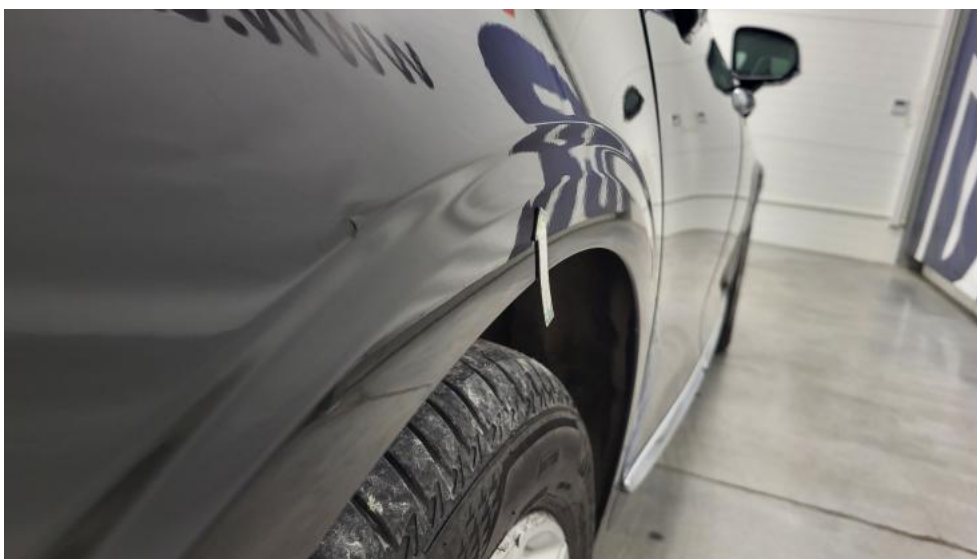
Photo 51.
Błotnik tylny P / Ściana boczna P - Wgniecenie/odkształcenie 2

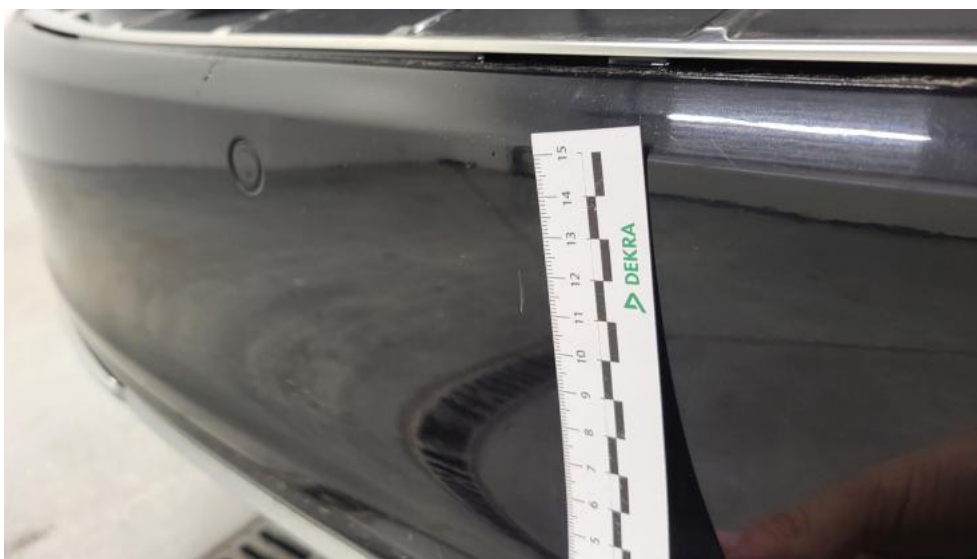
Photo 53.
Zderzak tylny - Rysa/odprysk 1

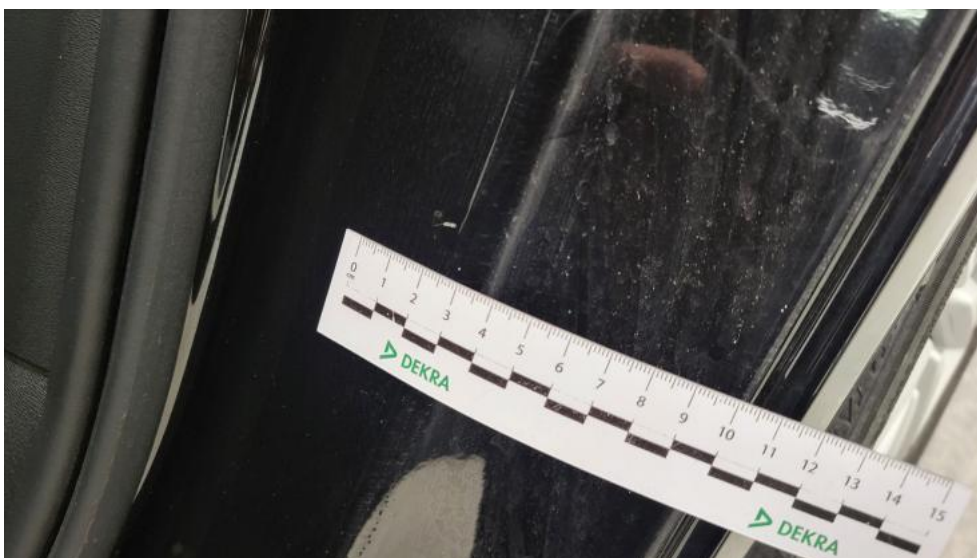
Photo 54.
Błotnik tylny L / Ściana boczna L - Rysa/odprysk 1

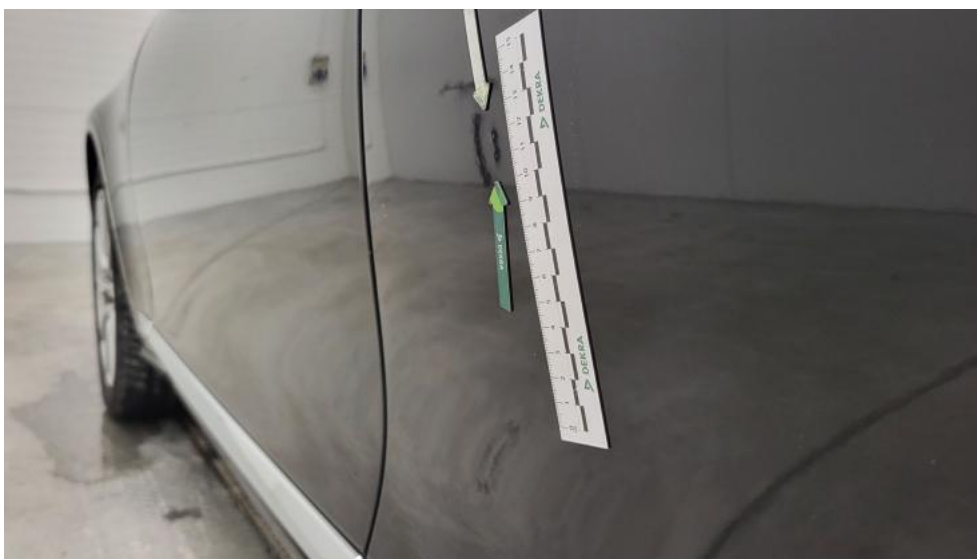
Photo 59.
Drzwi tylne L - Wgniecenie/odkształcenie 1

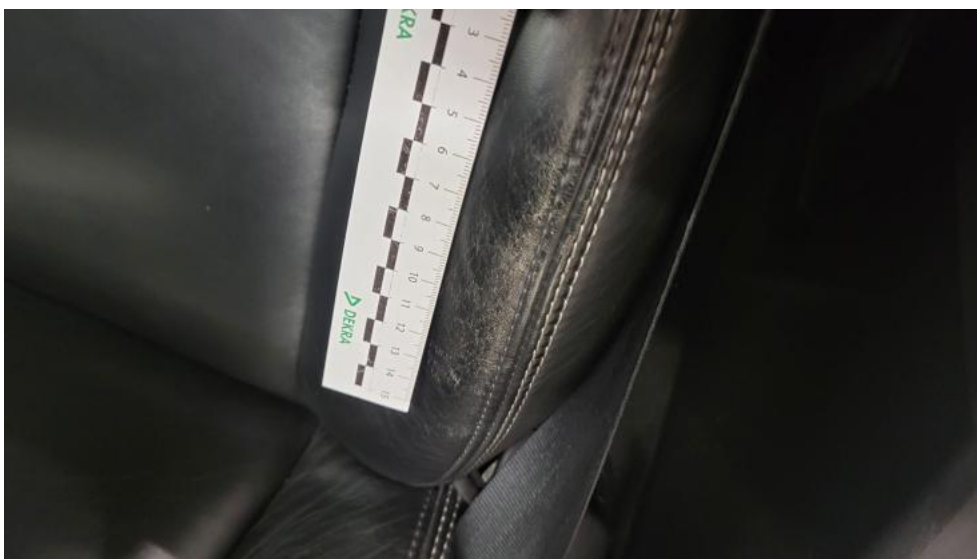
Photo 63.
Fotel prz. lew. - Inne 1

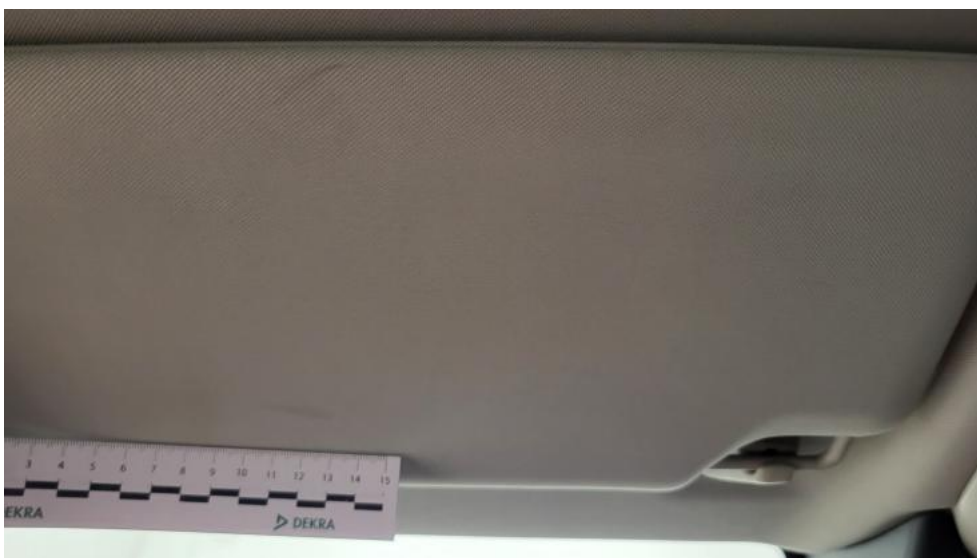
Photo 64.
Osłona p/słoneczna lewa - Inne 1

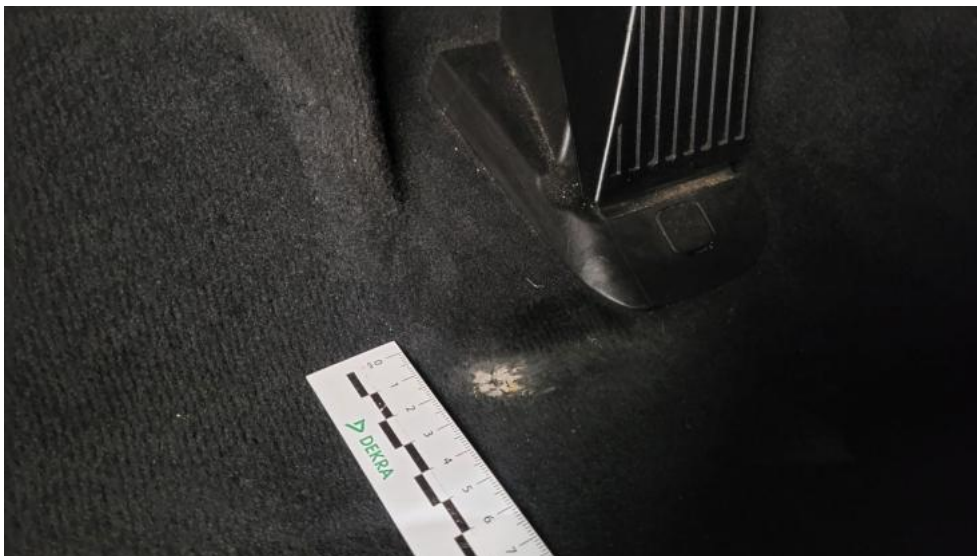
Photo 65.

Wykładzina podłogi - Inne 1
