DEKRA's commission No. : PKOL(W)/LODZ/27075/25/04/14  
commission/ damage No. : FUTURA  
Date of commission: 14-04-2025

| Manufacturer | HYUNDAI |
| Model | i30 20-24 |
| Registration /record No. | WJ1253L |

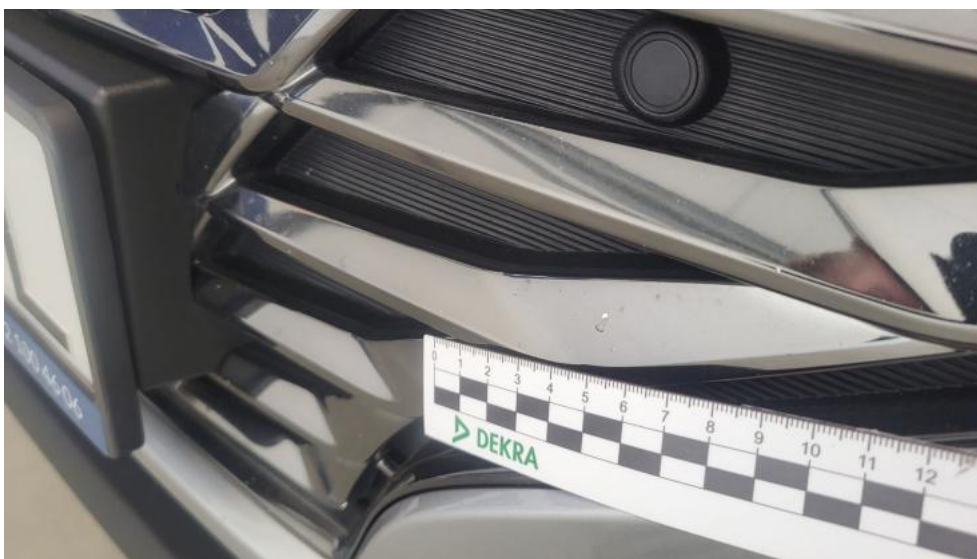
**Photo 37.**

Atrapa przednia - Rysa/odprysk 1

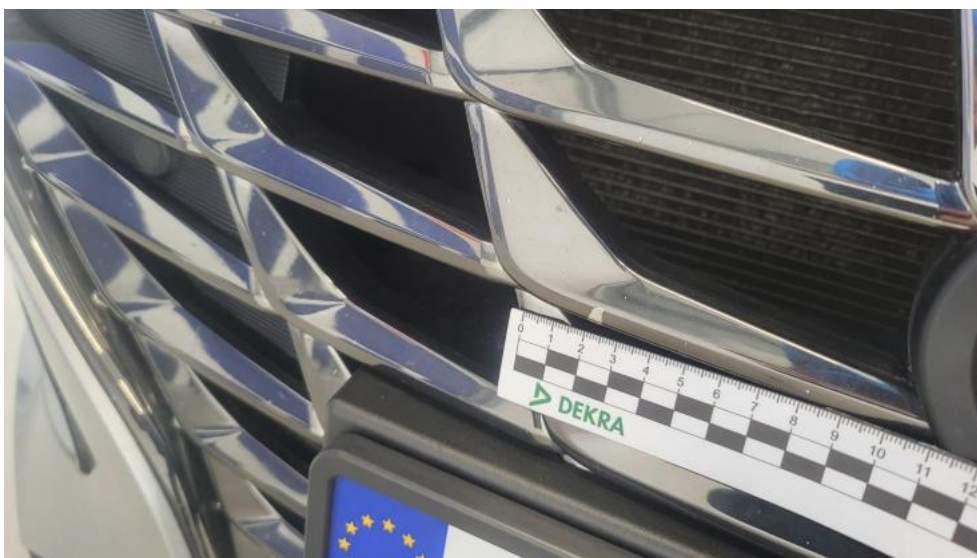
**Photo 38.**

Atrapa przednia - Rysa/odprysk 2

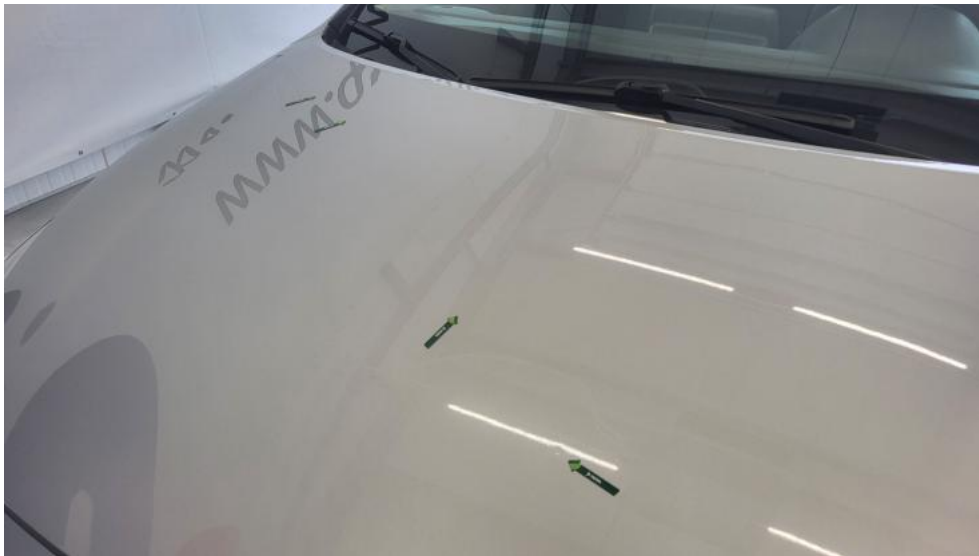
**Photo 39.**

Pokrywa komory silnika - Wgniecenie/odkształcenie 1

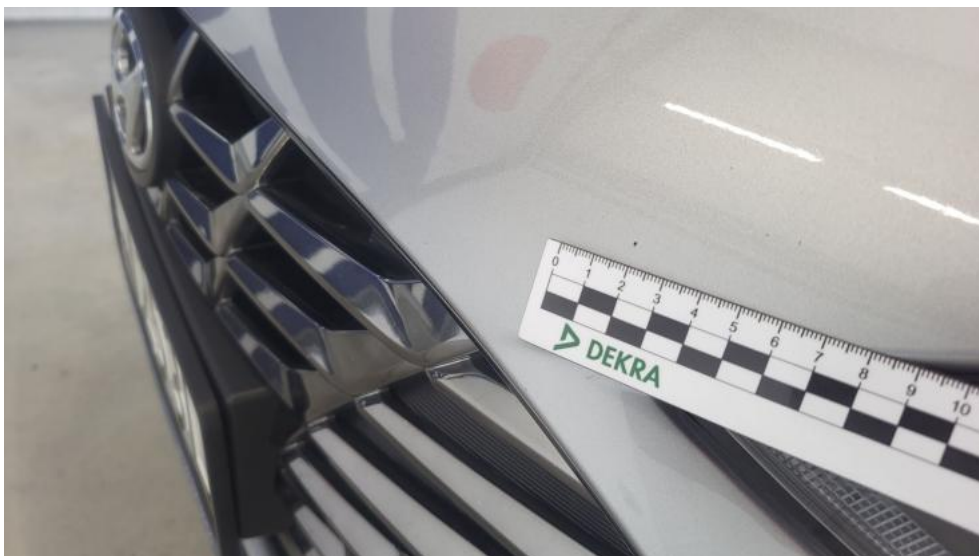
**Photo 40.**

Zderzak - Rysa/odprysk 1

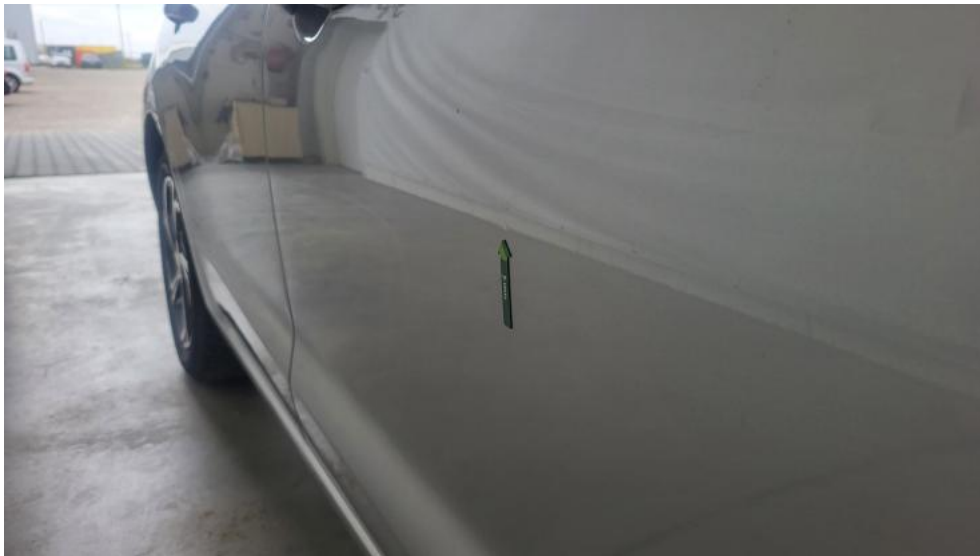
**Photo 41.**

Drzwi przednie P - Wgniecenie/odkształcenie 1

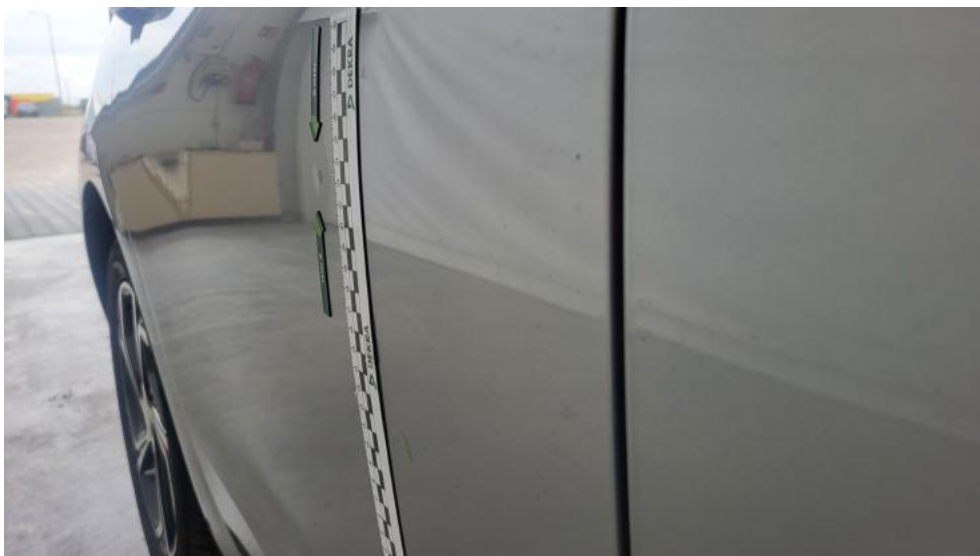
**Photo 42.**

Drzwi tylne P - Wgniecenie/odkształcenie 1

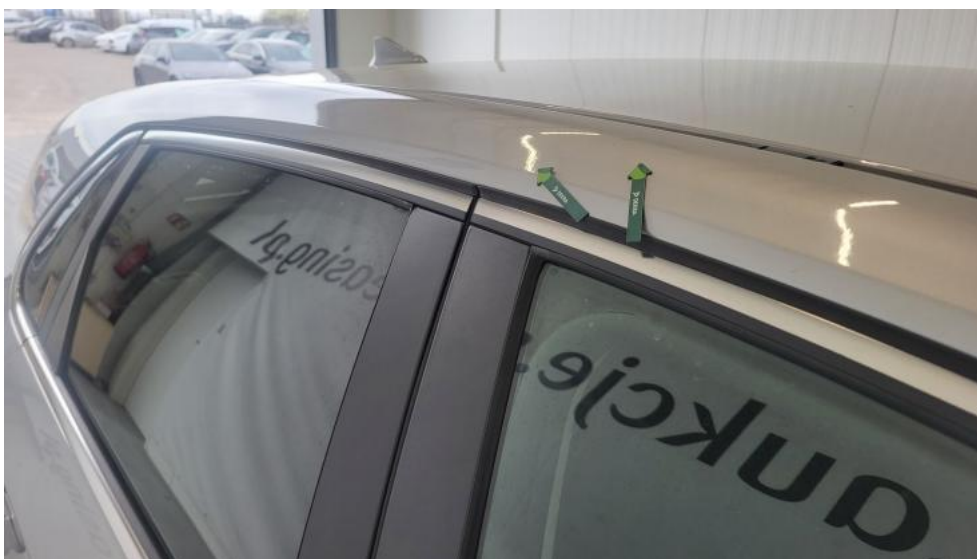
**Photo 43.**

Słupek przedni P - Wgniecenie/odkształcenie 1

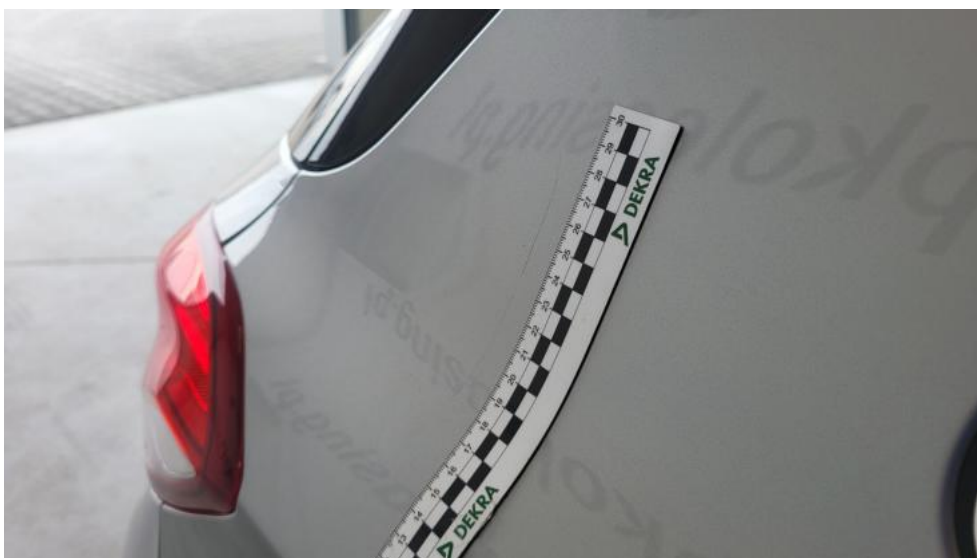
**Photo 44.**

Ścianka tylna P / Ścianka boczna P - Rysa/odprysk 1

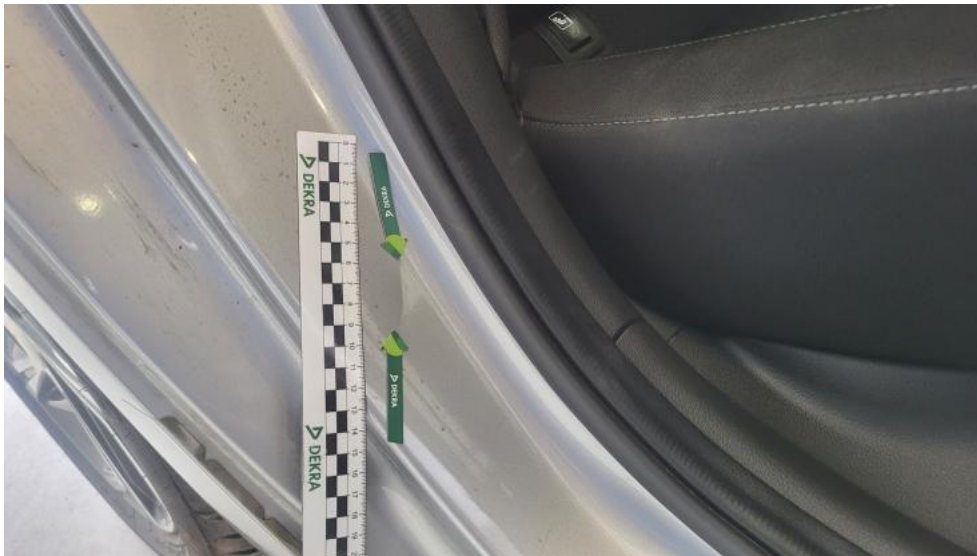
**Photo 45.**

Błotnik tylny P / Ściana boczna P - Wgniecenie/odkształcenie 1

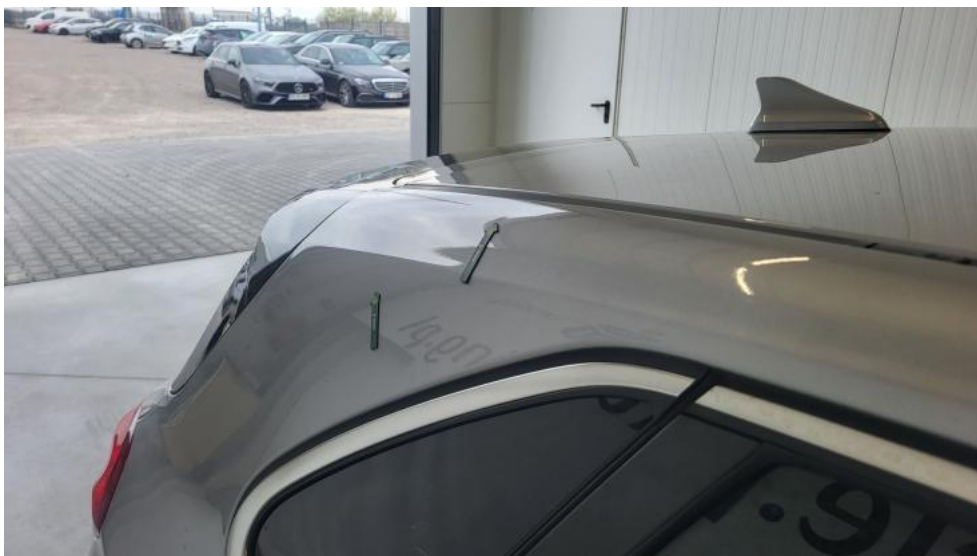
**Photo 46.**

Błotnik tylny P / Ściana boczna P - Wgniecenie/odkształcenie 2

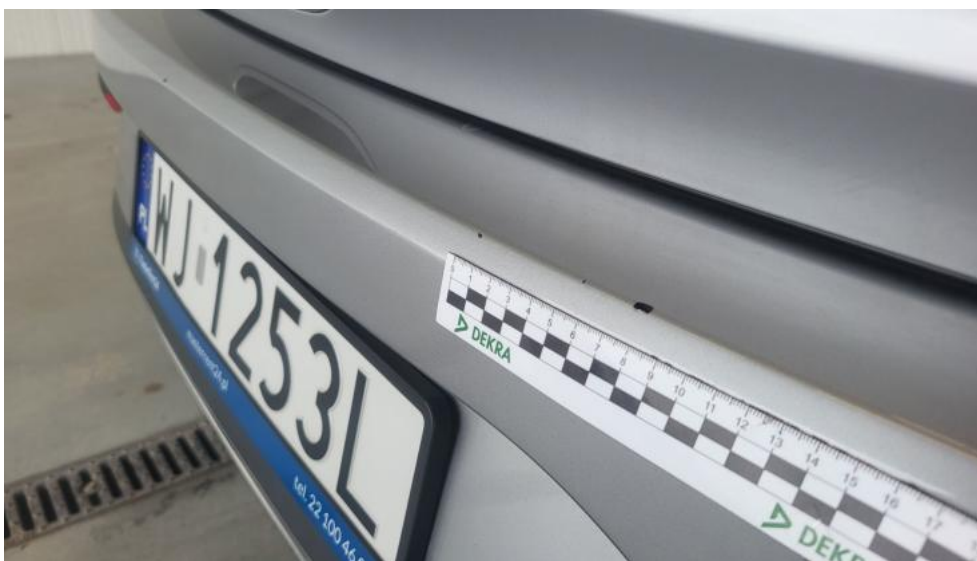
**Photo 47.**

Zderzak tylny - Rysa/odprysk 1

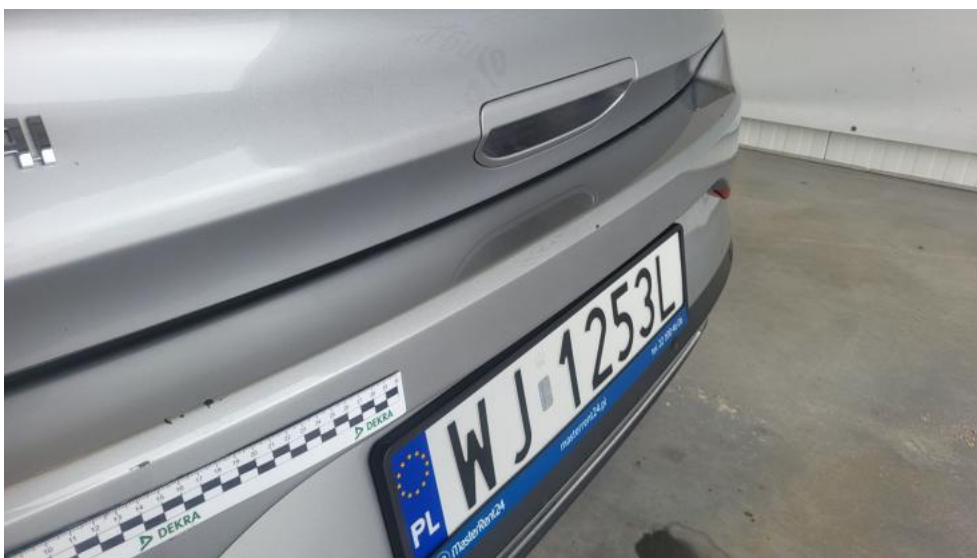
**Photo 48.**

Zderzak tylny - Rysa/odprysk 2

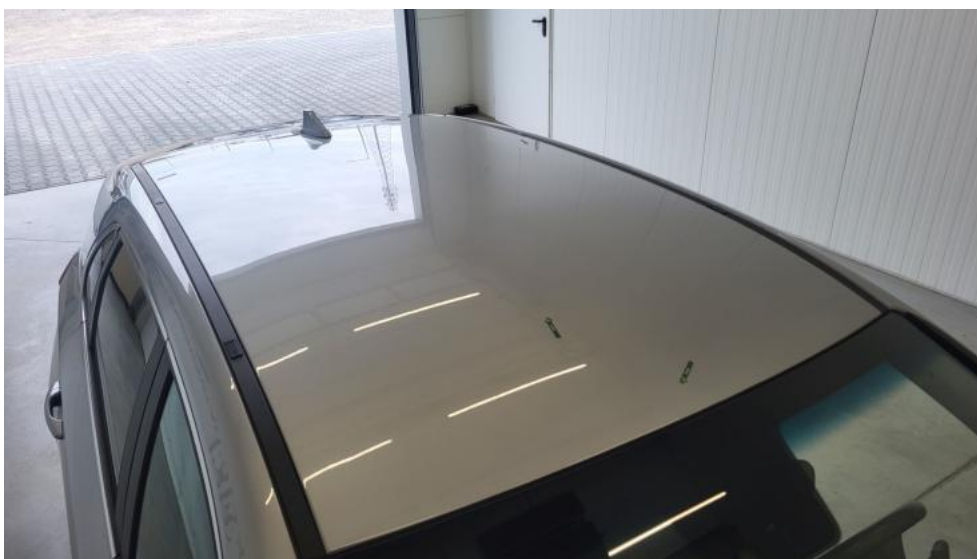
**Photo 49.**

Dach - Wgniecenie/odkształcenie 1

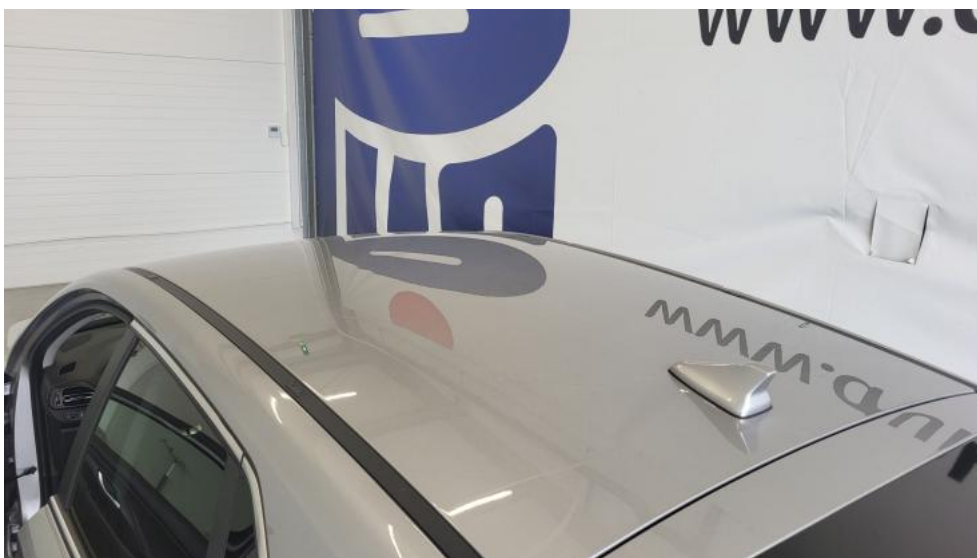
**Photo 50.**

Dach - Wgniecenie/odkształcenie 2

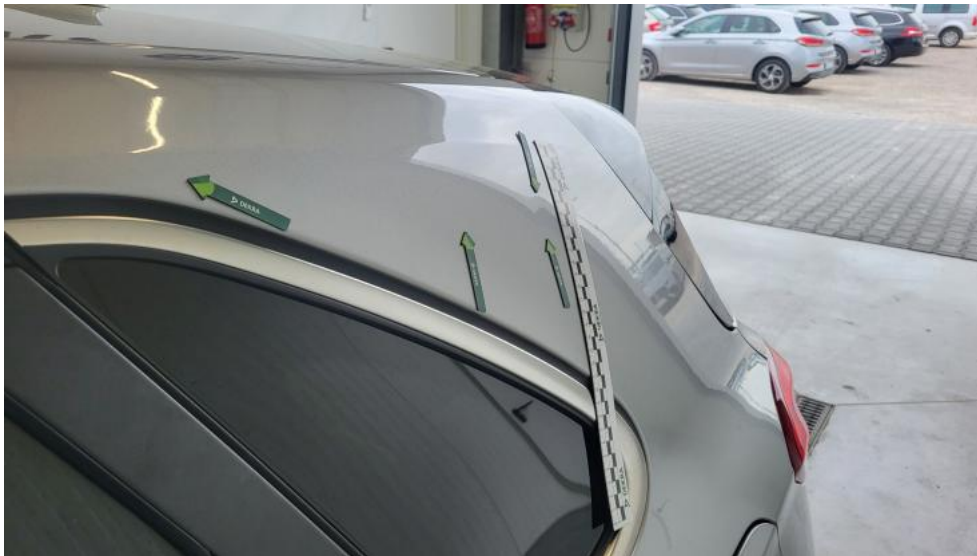
**Photo 51.**

Błotnik tylny L / Ściana boczna L - Wgniecenie/odkształcenie 1

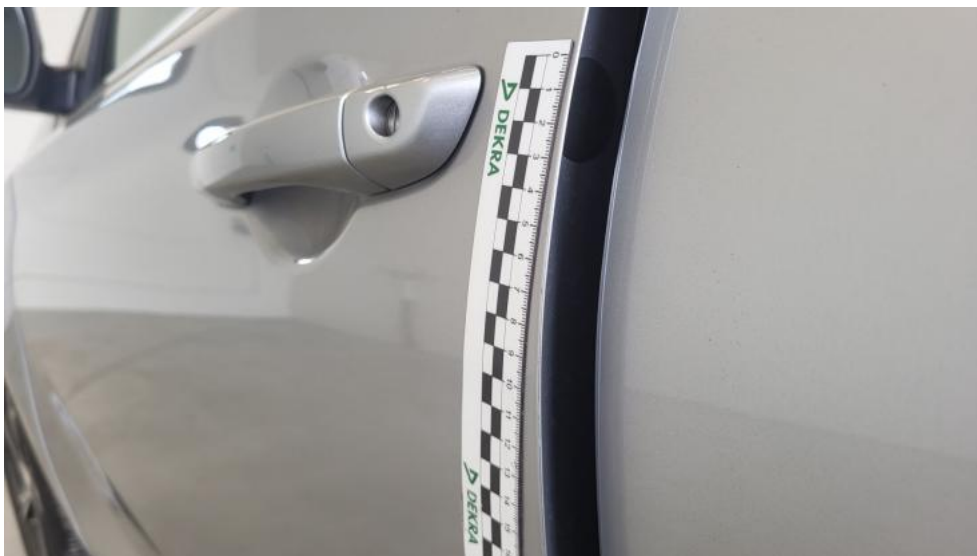
**Photo 52.**

Drzwi przed L - Rysa/odprysk 1

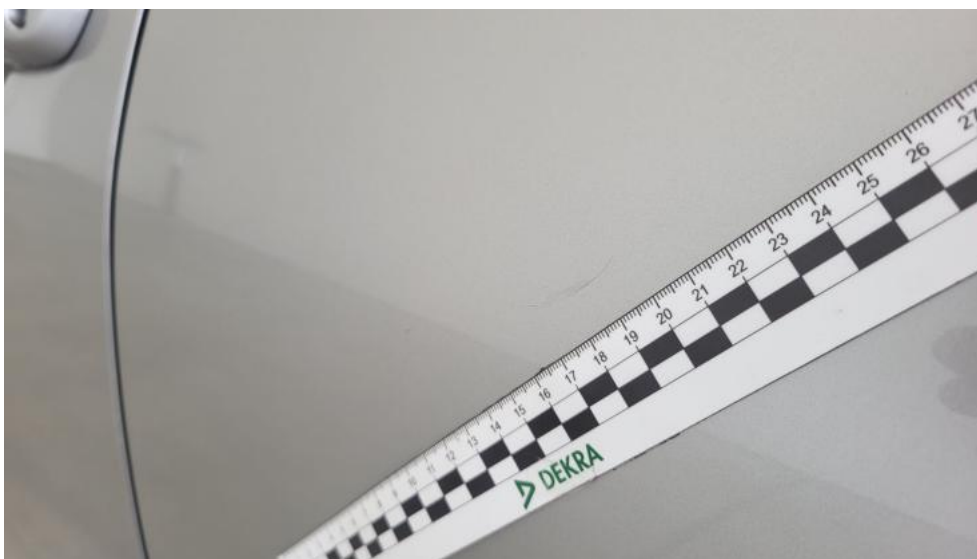
**Photo 53.**

Drzwi tylne L - Rysa/odprysk 1

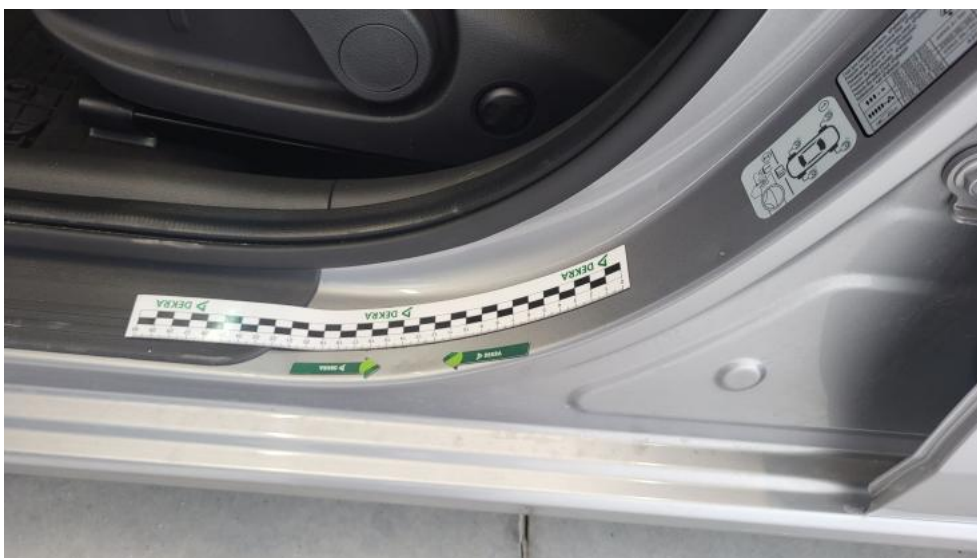
**Photo 54.**

Próg L - Wgniecenie/odkształcenie 1

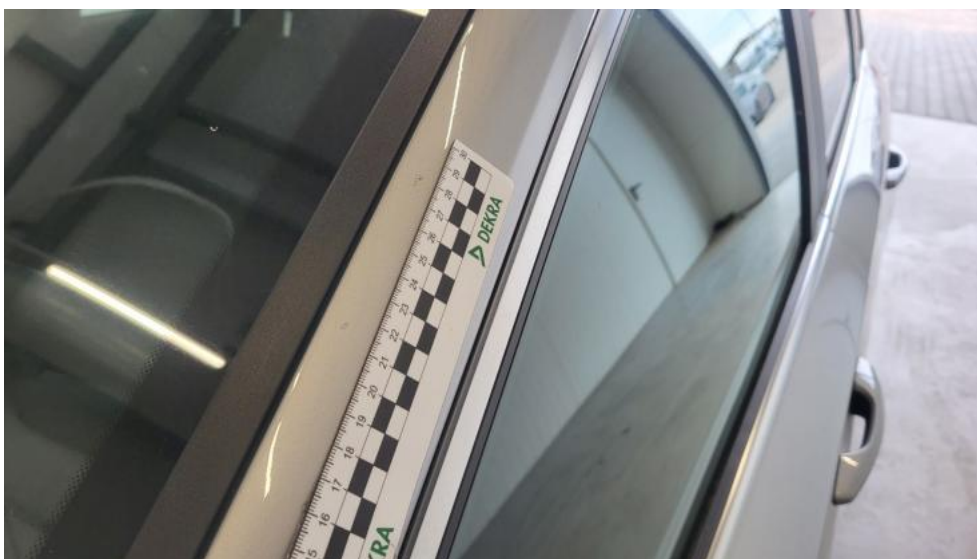
**Photo 55.**

Słupek przedni L - Rysa/odprysk 1

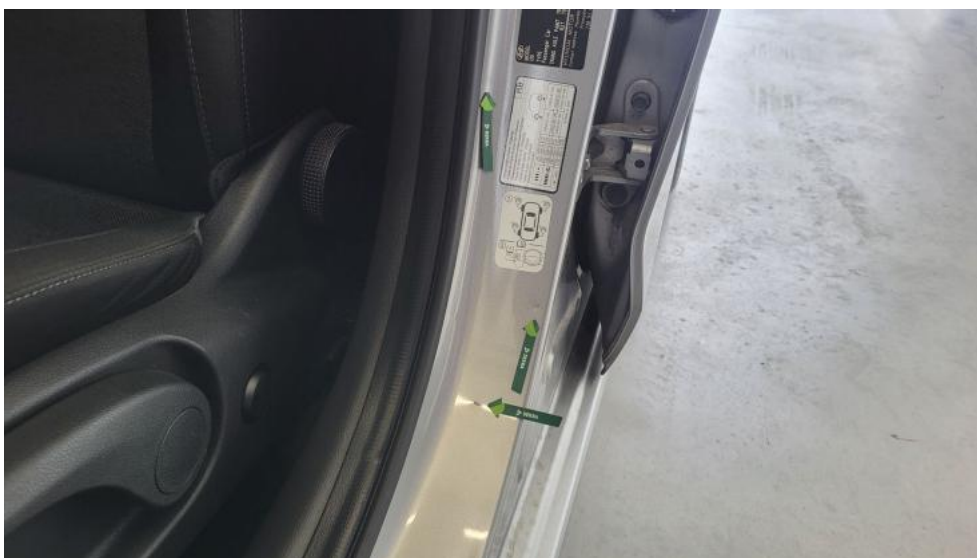
**Photo 56.**

Słupek środkowy L - Wgniecenie/odkształcenie 1

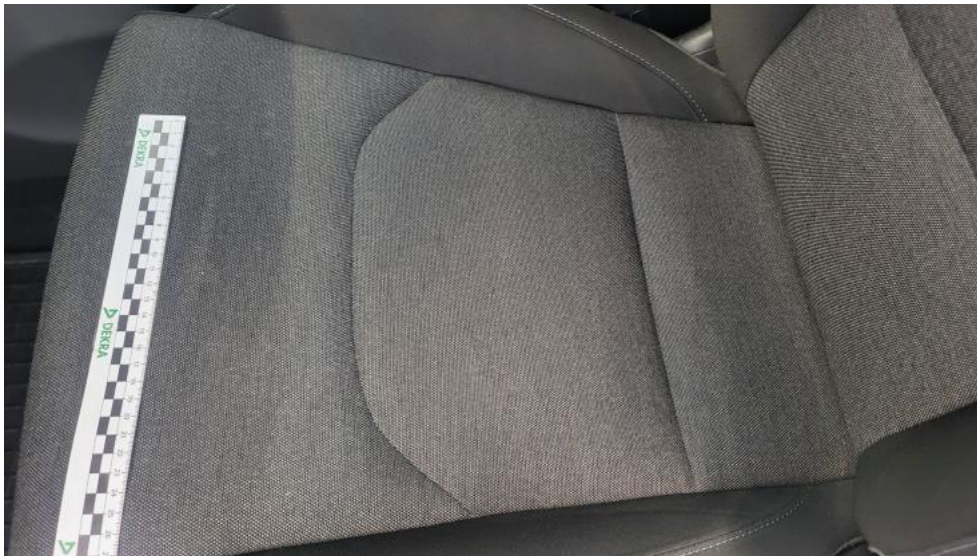
**Photo 57.**

Fotel prz. lew. - Inne 1

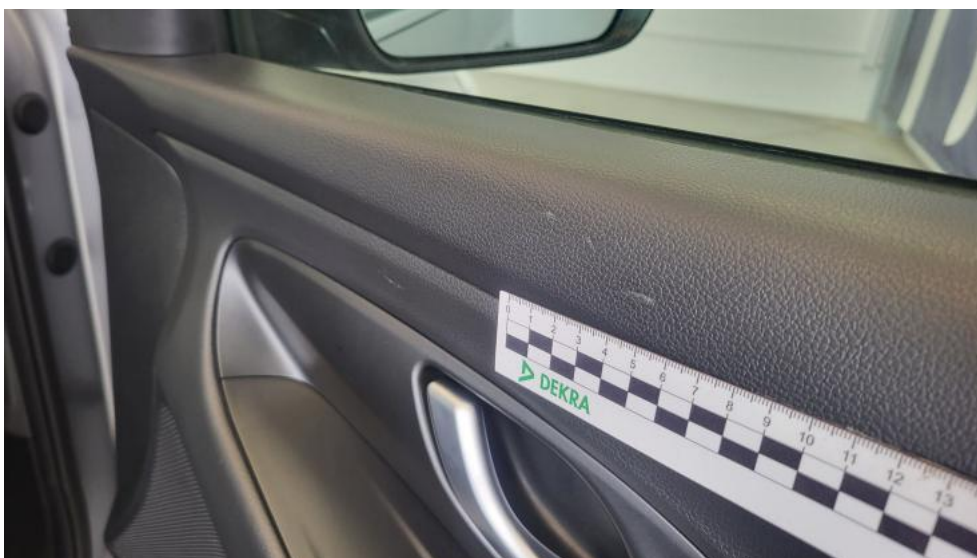
**Photo 58.**

Tapicerka drzwi przednich P - Wgniecenie/odkształcenie 1

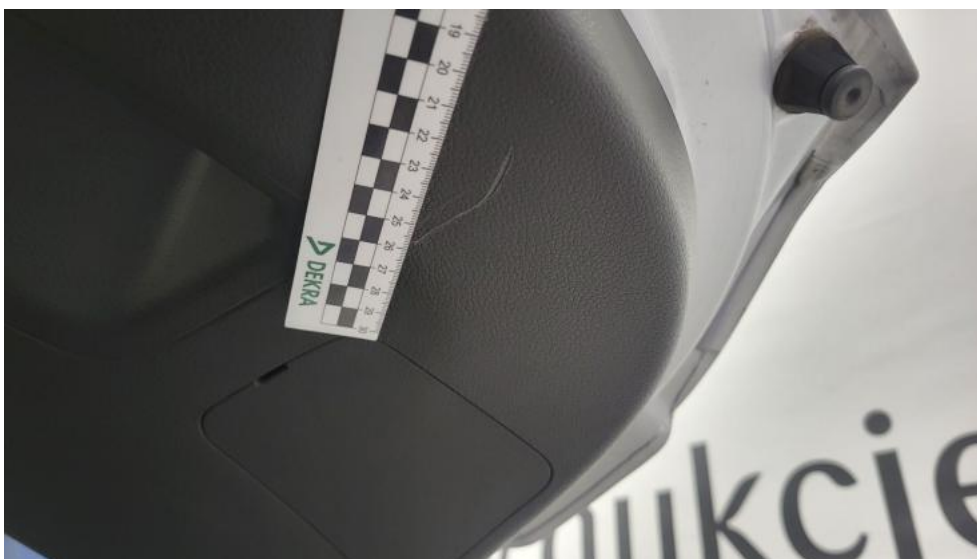
**Photo 59.**

Wykładzina pokrywy tylnej - Rysa/odprysk 1
