DEKRA's commission No. : PKOL(W)/LODZ/73945/24/09/25
 commission/ damage No. : 22/020322
 Date of commission: 25-09-2024

Vehicle data

Measurement of thickness of the vehicle lacquer coating

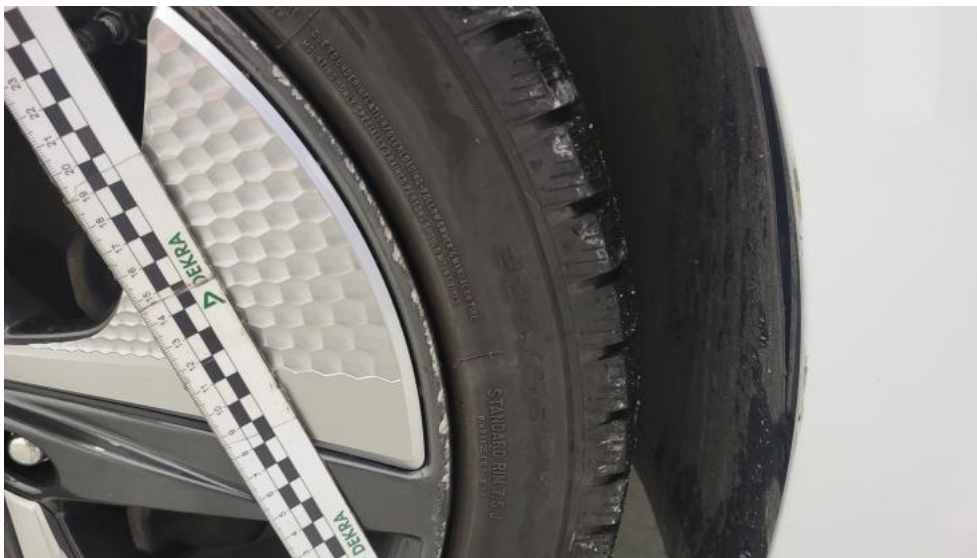
Photo 37.
Felga aluminiowa przednia P - Rysa/odprysk 1

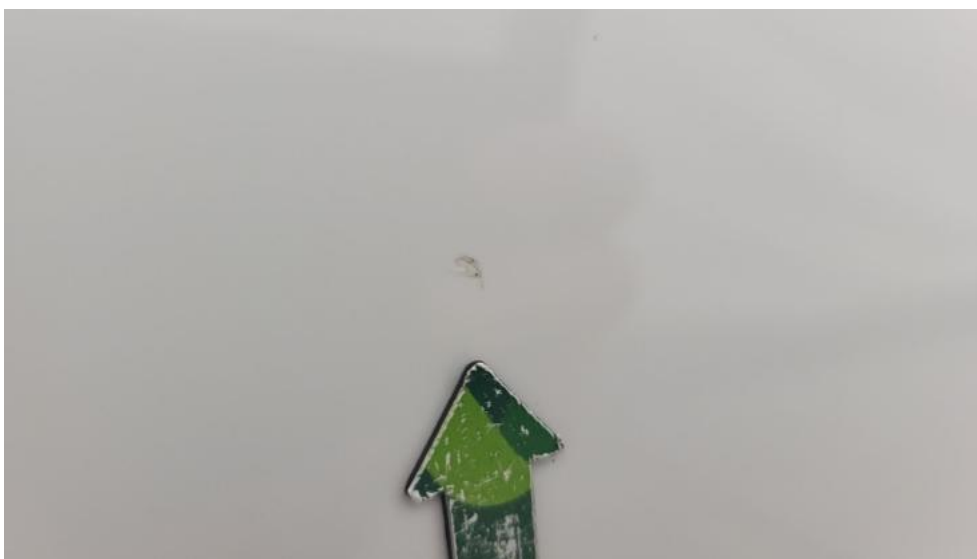
Photo 39.

Drzwi tylne P - Rysa/odprysk 1

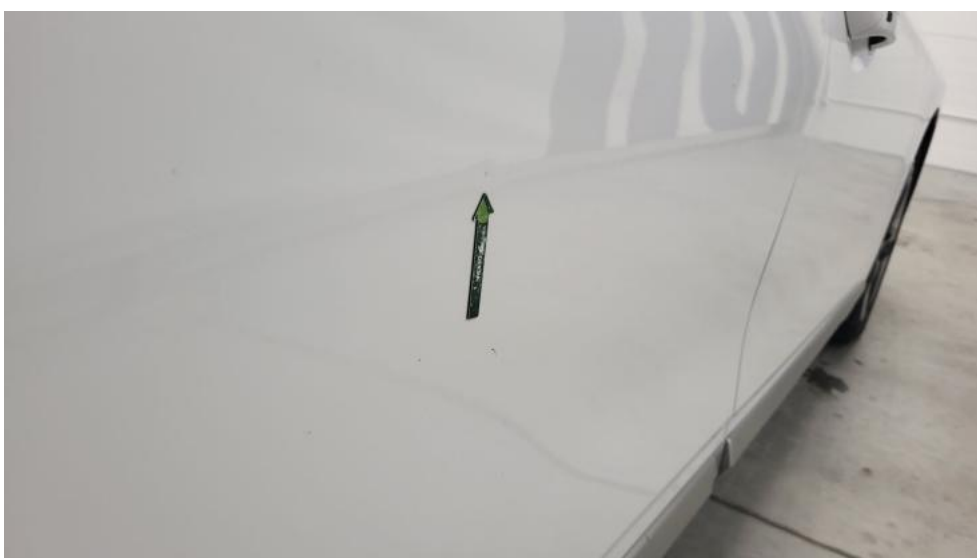
Photo 40.

Drzwi tylne P - Wgniecenie/odkształcenie 1

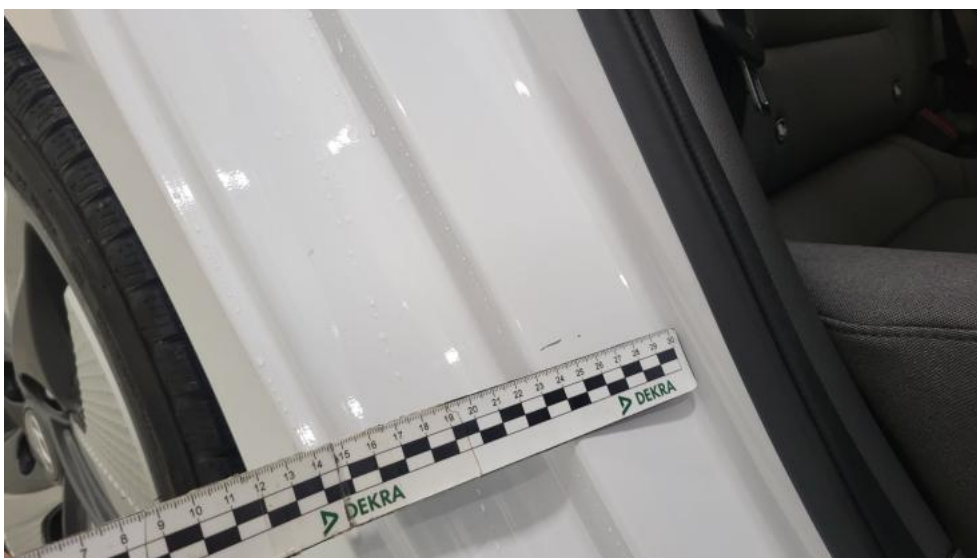
Photo 42.
Błotnik tylny P / Ściana boczna P - Rysa/odprysk 2

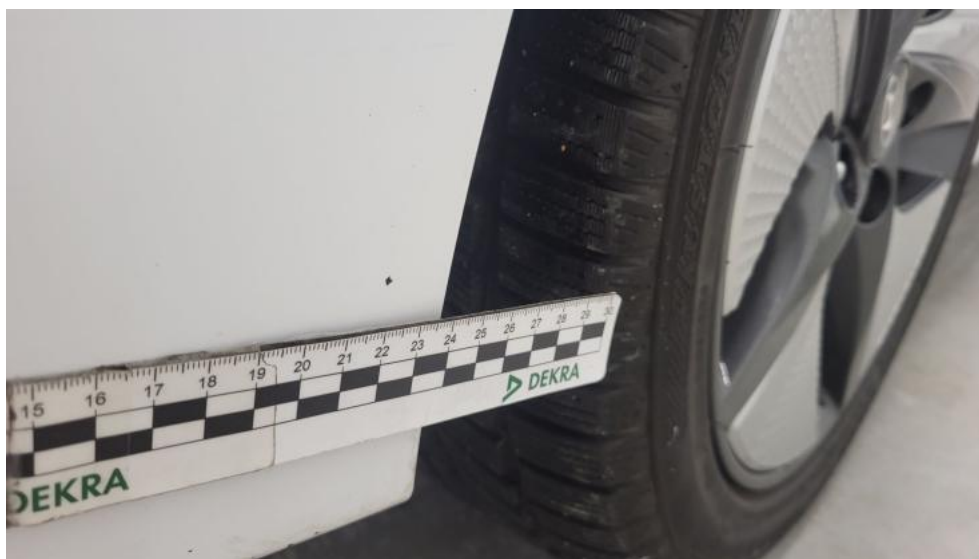
Photo 47.

Zderzak tylny() - Rysa/odprysk 3

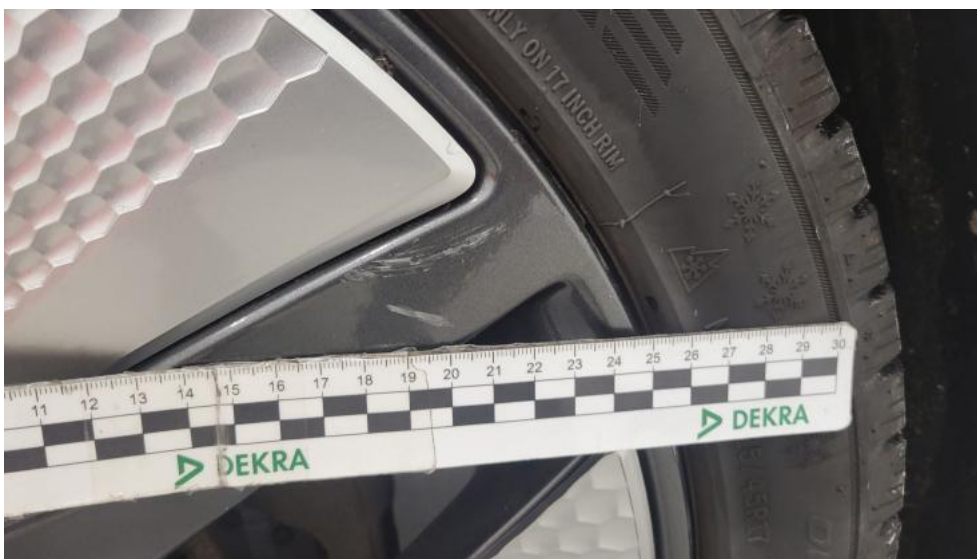
Photo 49.
Felga aluminiowa tylna L - Rysa/odprysk 1

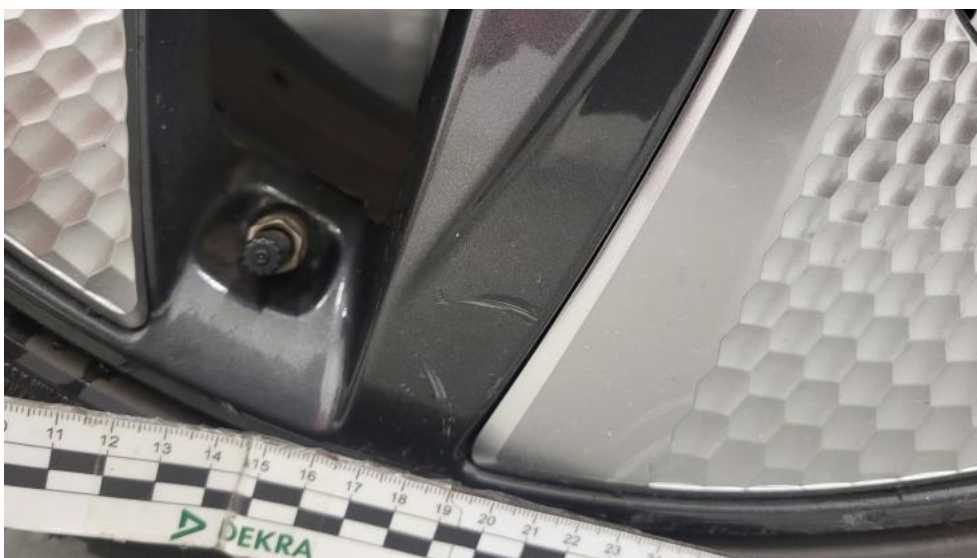
Photo 50.
Felga aluminiowa tylna L - Rysa/odprysk 2

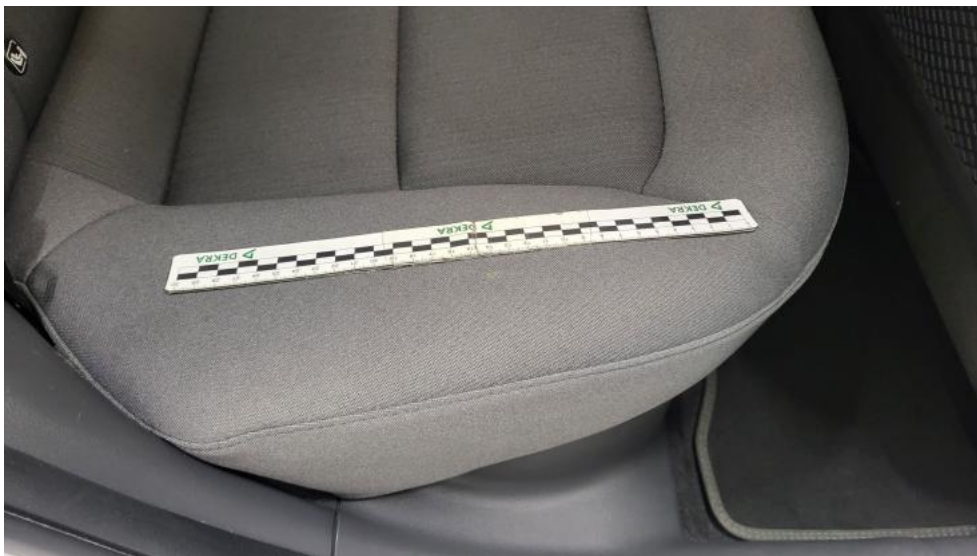
Photo 53.
Kanapa tyl. - Inne 1

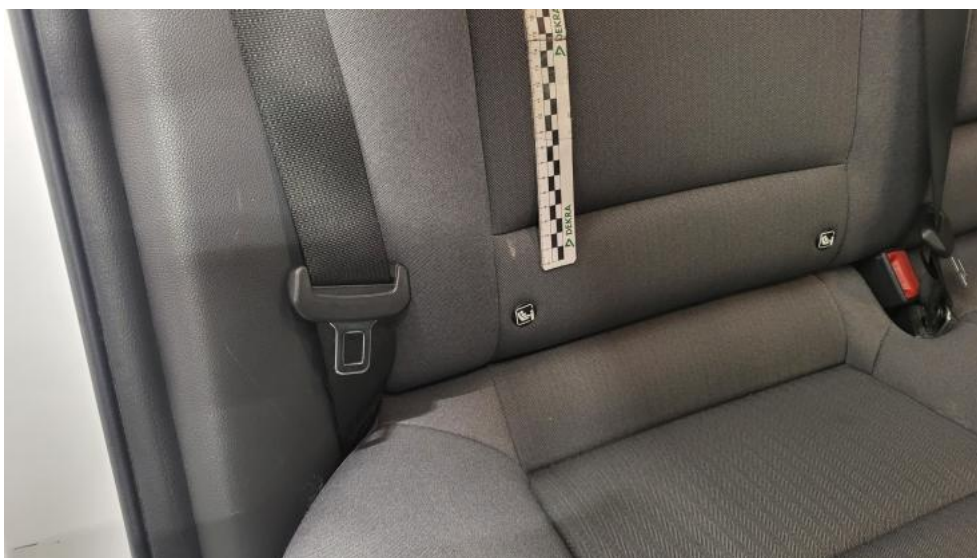
Photo 54.
Kanapa tyl. - Inne 2
