DEKRA's commission No. : PKOL(W)/LODZ/82841/24/10/25  
 commission/ damage No. : 21/048549  
 Date of commission: 25-10-2024

Group of objects (Eurotax)	cars
EC code (Eurotax)	0149193
Manufacturer	FORD
Model	Mondeo Kombi 19-21
Type / version	Mondeo 2.0 EcoBlue Executive Plus aut
Body type	KOM
Number of doors / seats	5/5
Curb weight [kg]	1677
Gross vehicle weight [kg]	2330
Wheelbase 1/2	2850
Engine type	Automatic ignition
Supercompression	turbocompressor with intercooler
Pollution reduction system	KSC
Emission standard	EURO 6
Engine capacity [ccm]	1995
Engine Power [hp/kW]	190/140
Gearbox	automatic 8- gear
Registration /record No.	GA558HL
VIN / serial number	WF0FXXWPCFMJ44676
Date of first registration	28-05-2021
Date of next. tech. test	22-05-2026
Year of manufacture	2021 (year has been verified with the manufacturer's base)
Readout [km]	124 603 (read)
Body color / type of coating	blue/METALIK

Date: 04-11-2024

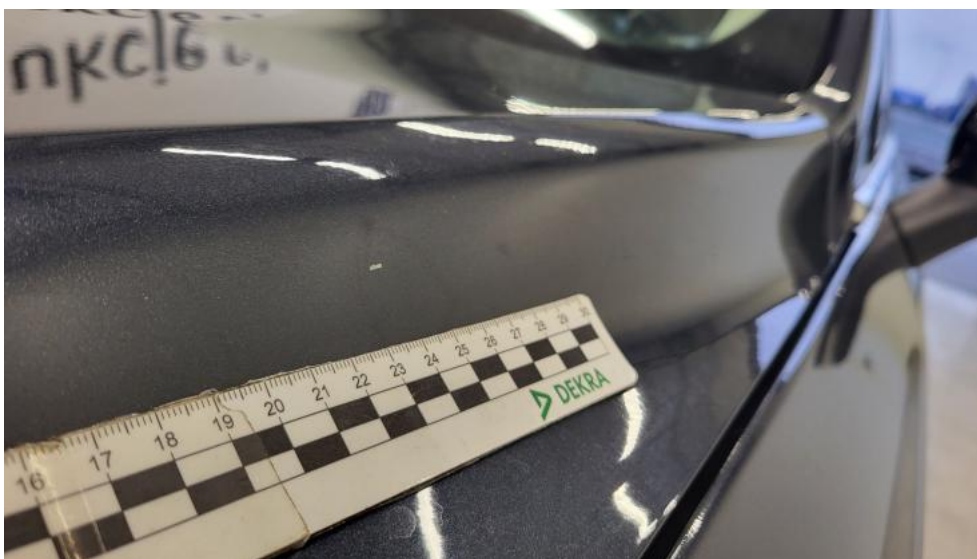
**Photo 45.**  
Pokrywa komory silnika - Rysa/odprysk 1

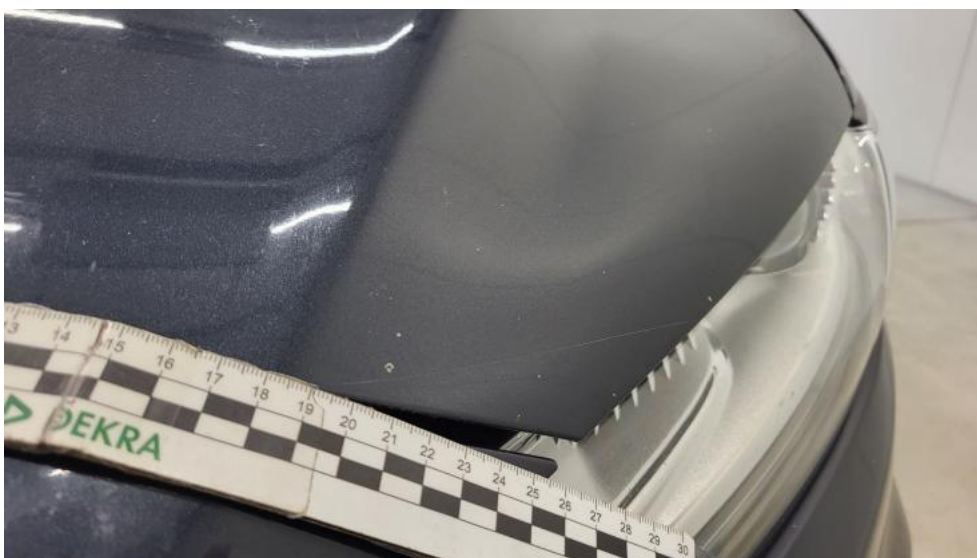
**Photo 46.**  
Pokrywa komory silnika - Rysa/odprysk 2

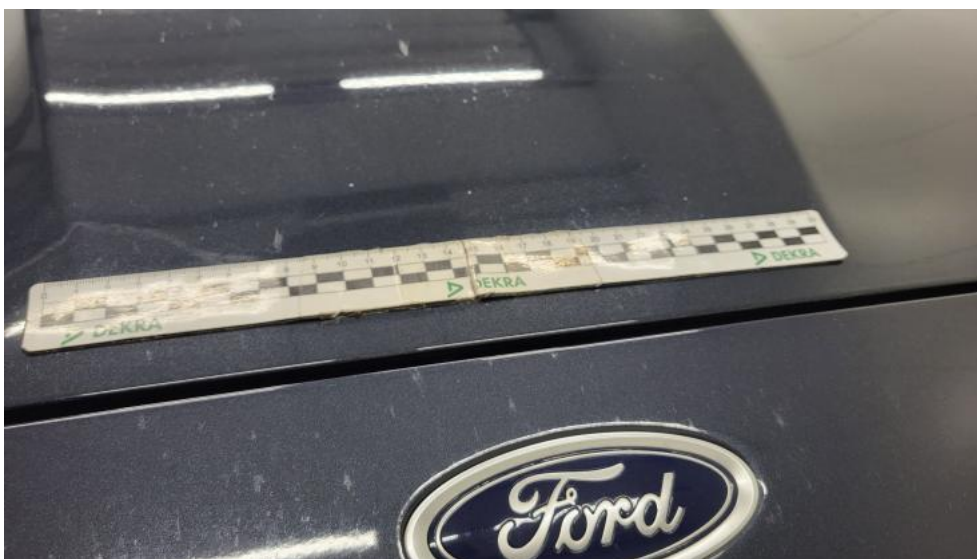
**Photo 47.**

Pokrywa komory silnika() - Rysa/odprysk 3

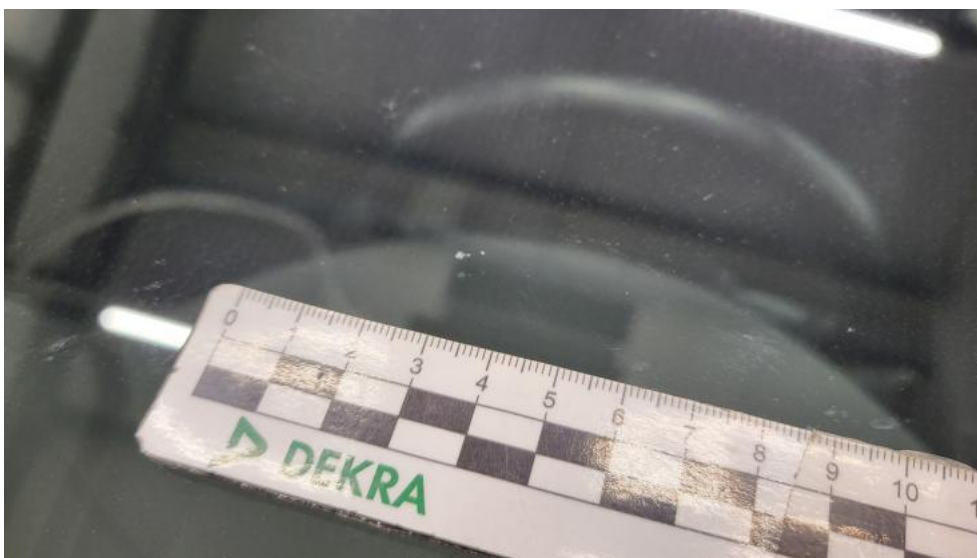
**Photo 48.**

Szyba czołowa ogrzewana - Rysa/odprysk 1

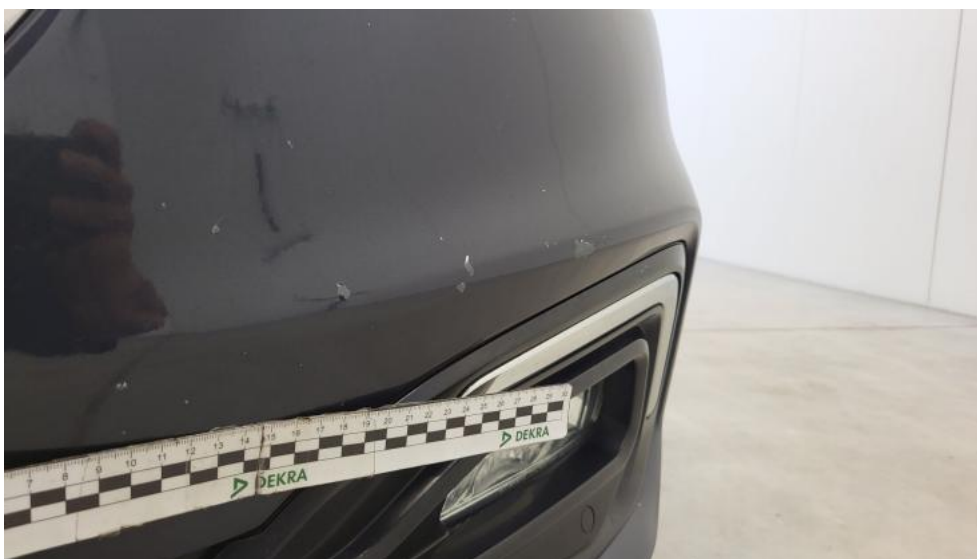
**Photo 49.**

Zderzak - Rysa/odprysk 1

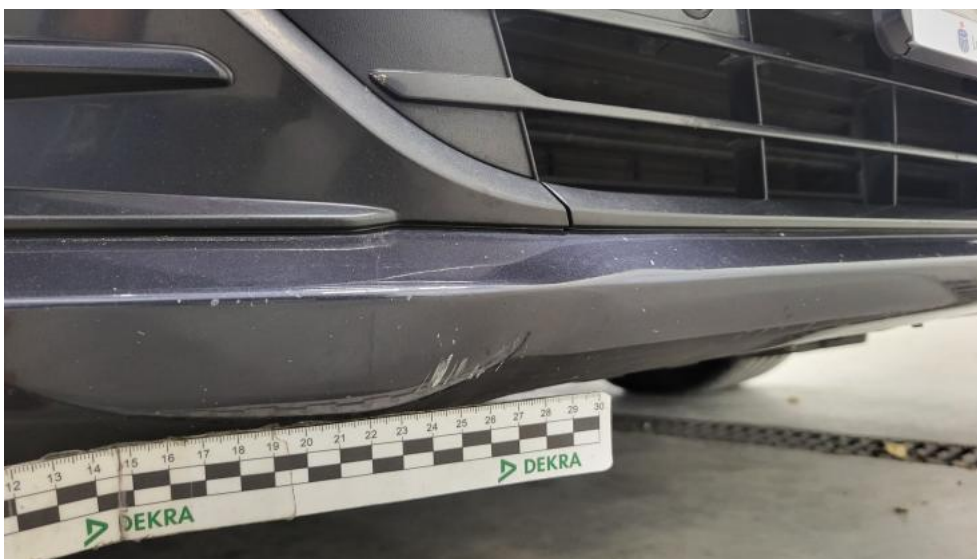
**Photo 51.**  
Zderzak() - Rysa/odprysk 3

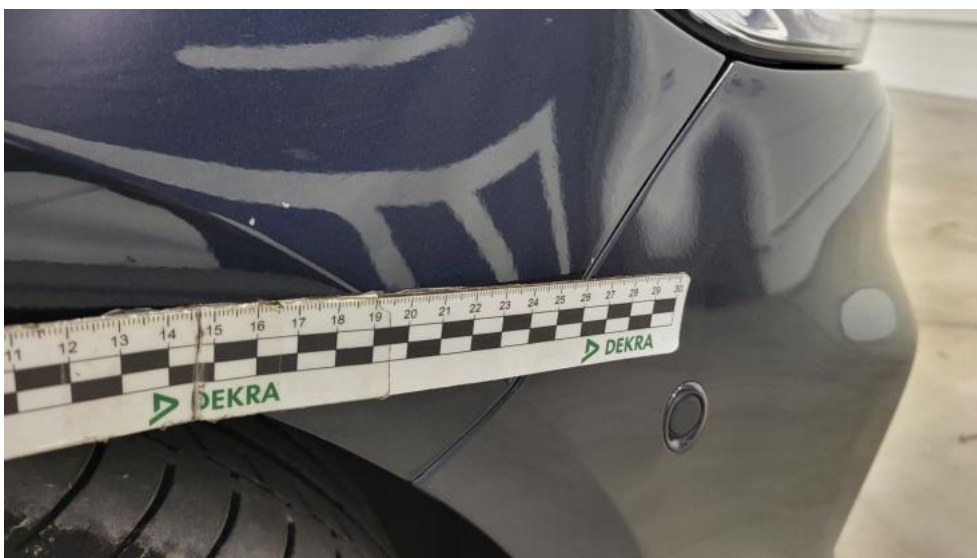
**Photo 52.**  
Błotnik przedni P - Rysa/odprysk 1

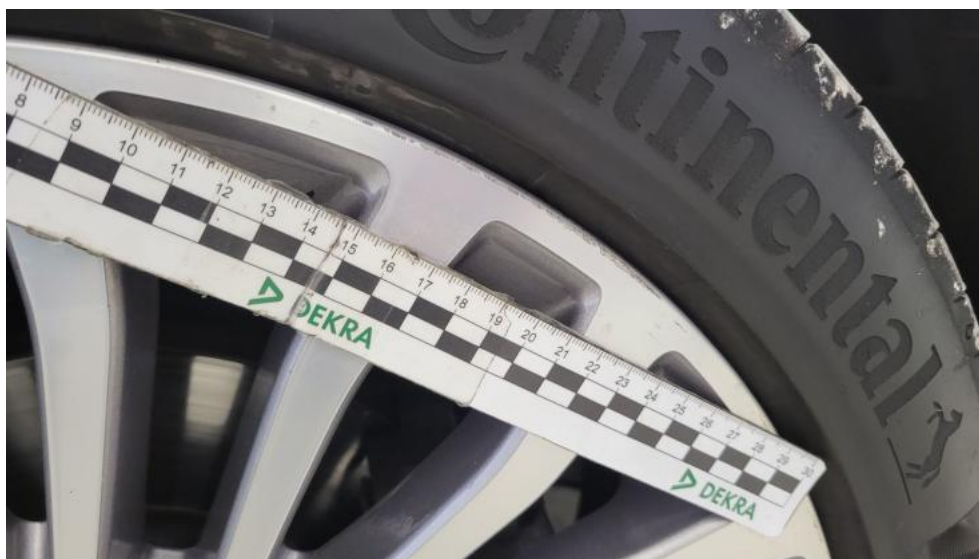
**Photo 53.**  
Felga aluminiowa przednia P - Rysa/odprysk 1

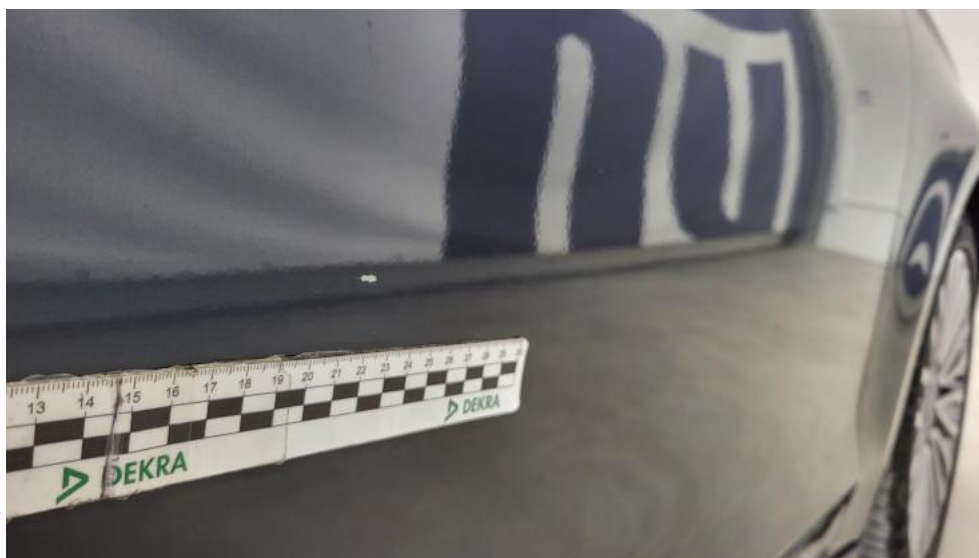
**Photo 54.**  
Drzwi przednie P - Rysa/odprysk 1

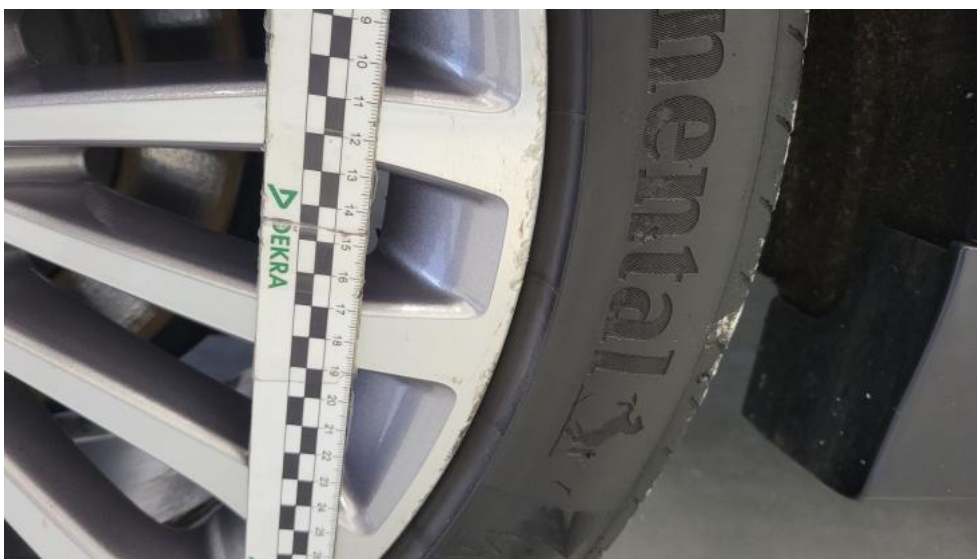
**Photo 59.**  
Felga aluminiowa tylna P - Rysa/odprysk 1

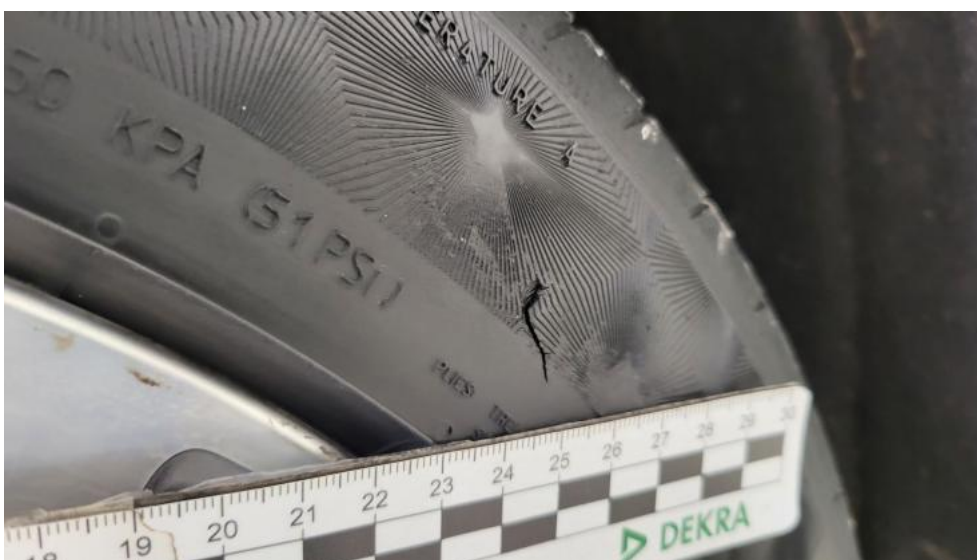
**Photo 60.**  
Opona tylna P - Pęknięcie/rozerwanie 1

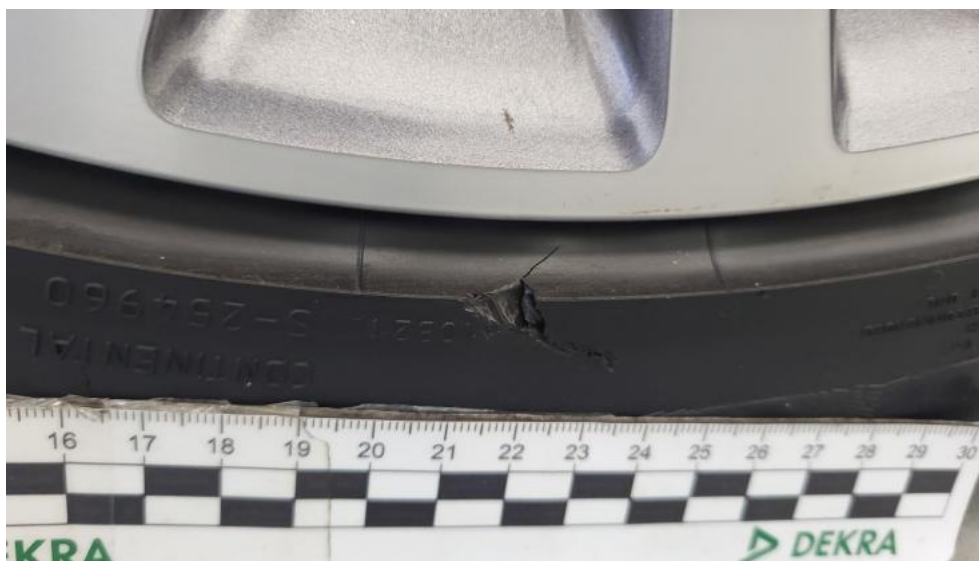
**Photo 61.**

Opona tylna P - Pęknięcie/rozerwanie 2

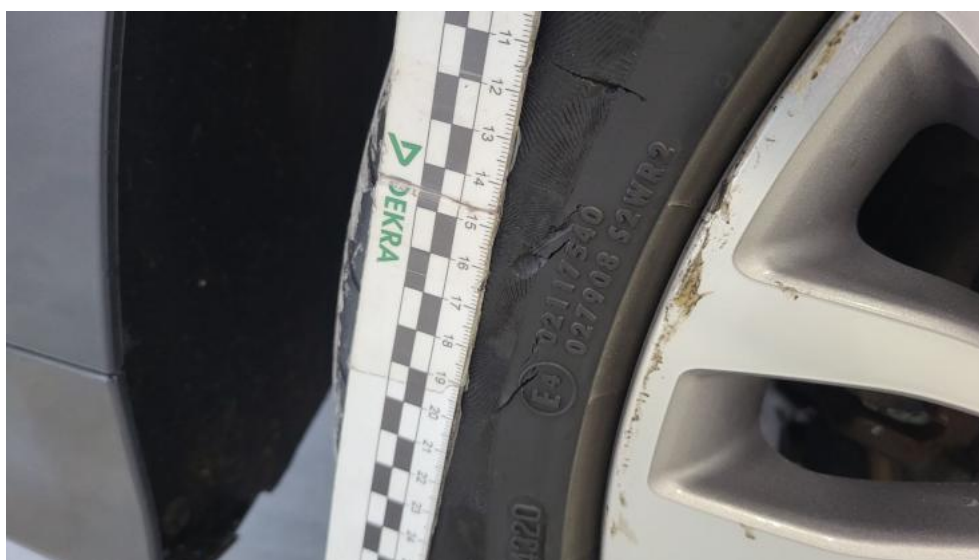
**Photo 62.**

Opona tylna P() - Pęknięcie/rozerwanie 3

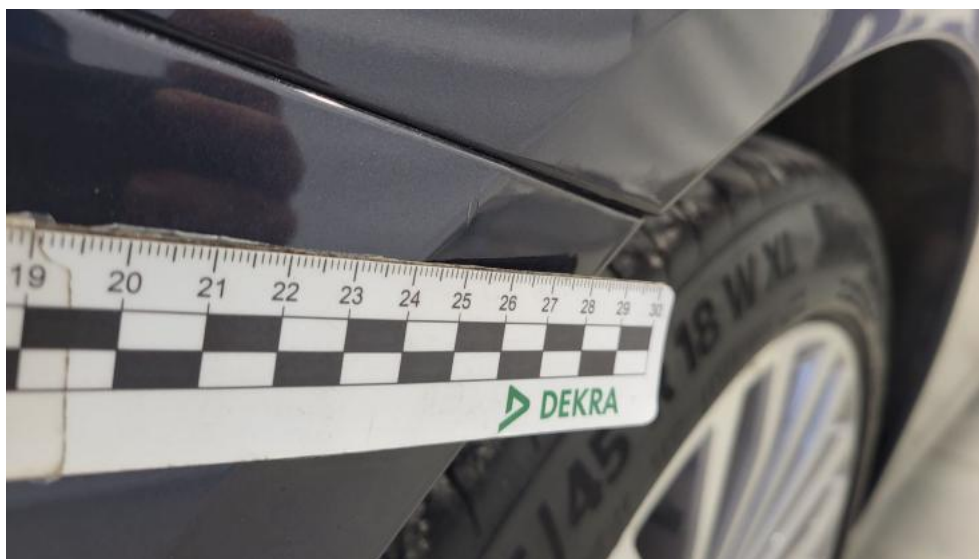
**Photo 65.**  
Zderzak tylny - Rysa/odprysk 1

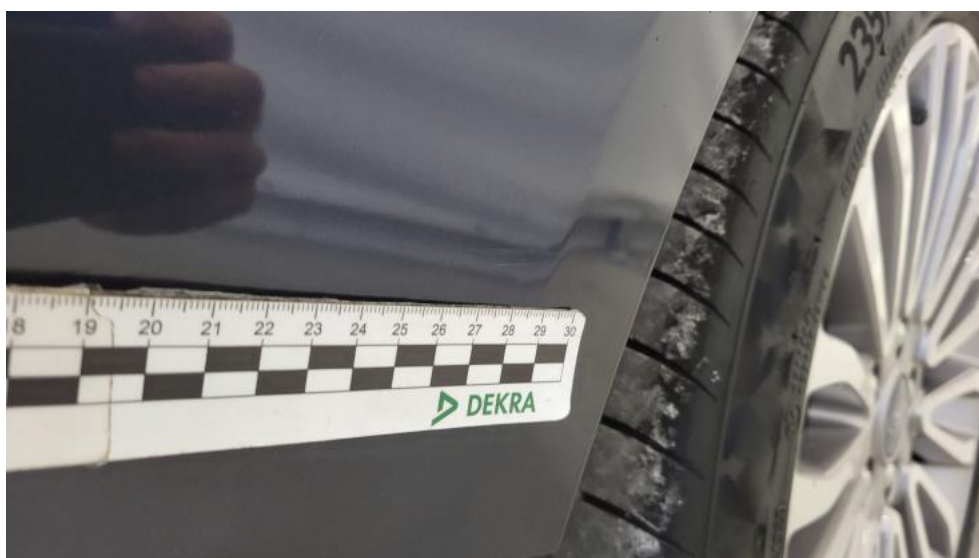
**Photo 66.**  
Zderzak tylny - Rysa/odprysk 2

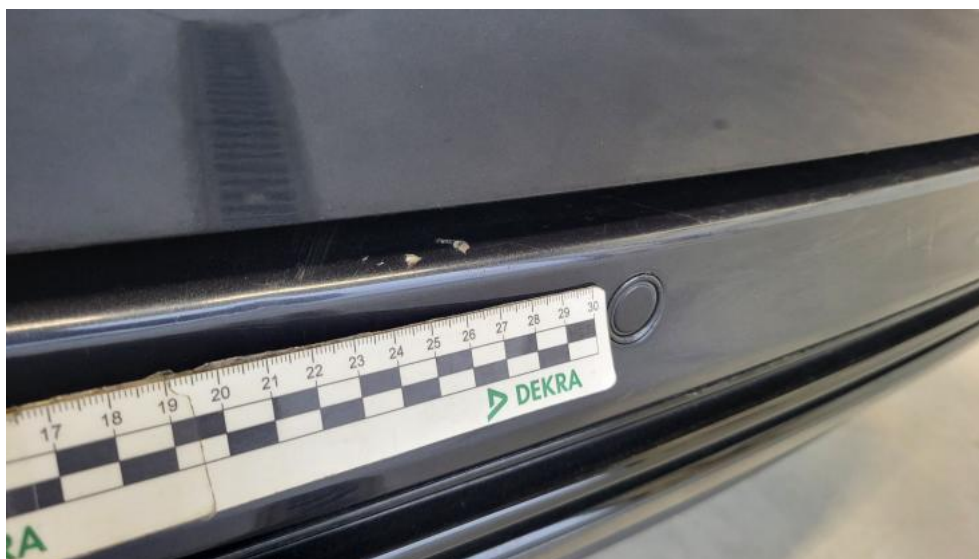
**Photo 67.**  
Zderzak tylny() - Rysa/odprysk 3

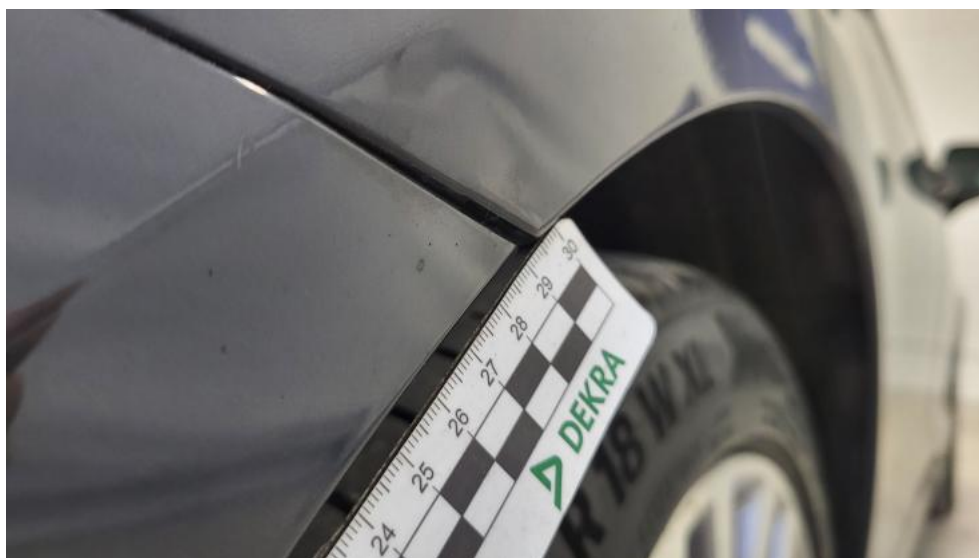
**Photo 68.**  
Zderzak tylny - Inne 1

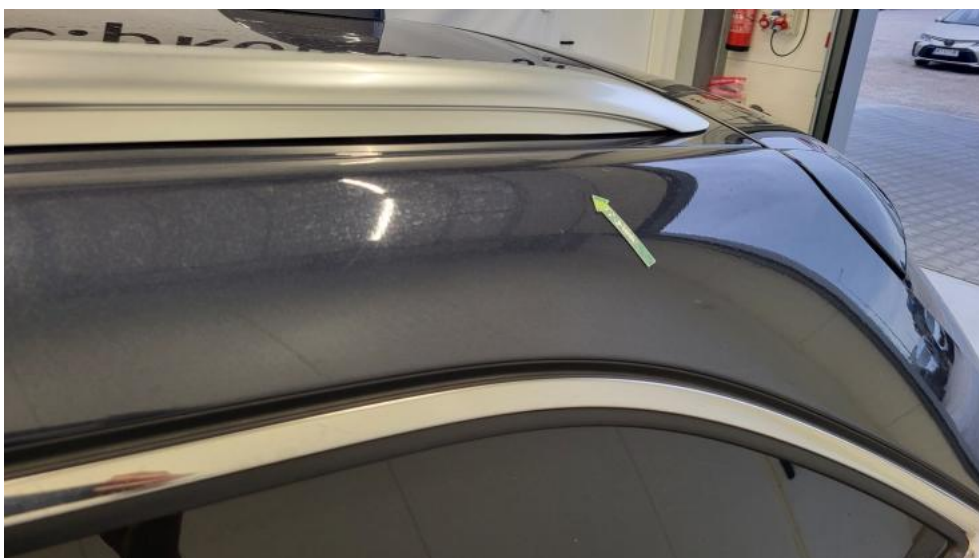
**Photo 70.**  
Błotnik tylny L / Ściana boczna L - Wgniecenie/odkształcenie 2

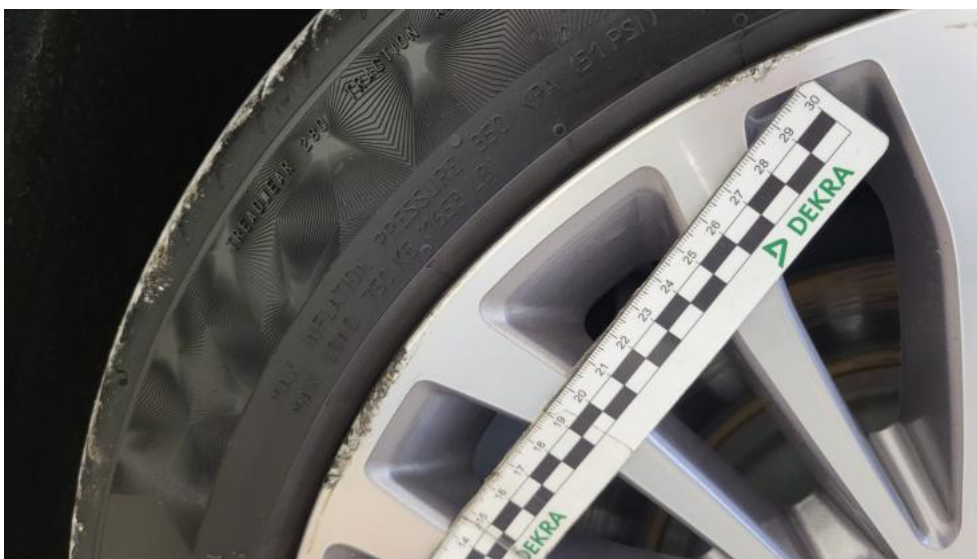
**Photo 71.**

Felga aluminiowa tylna L - Rysa/odprysk 1

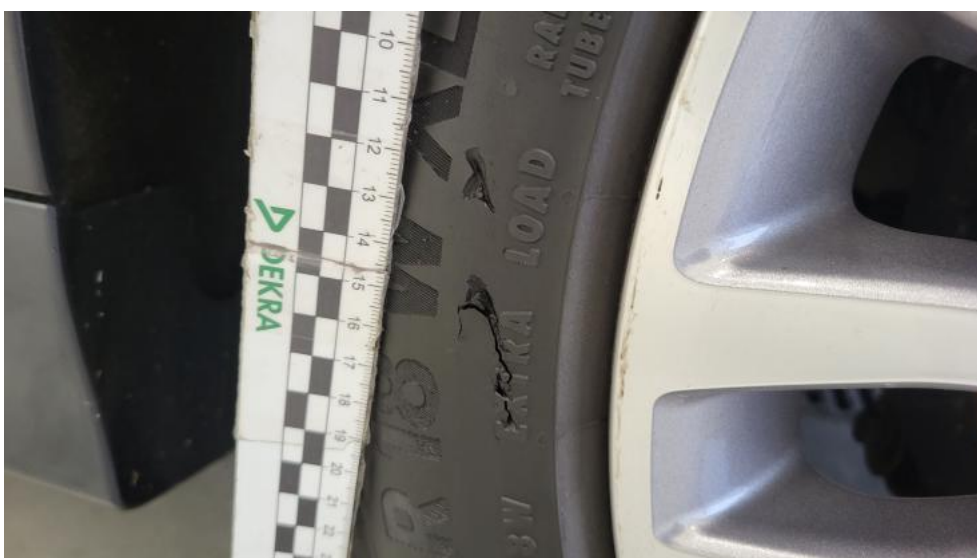
**Photo 72.**

Opona tylna L - Pęknięcie/rozerwanie 1

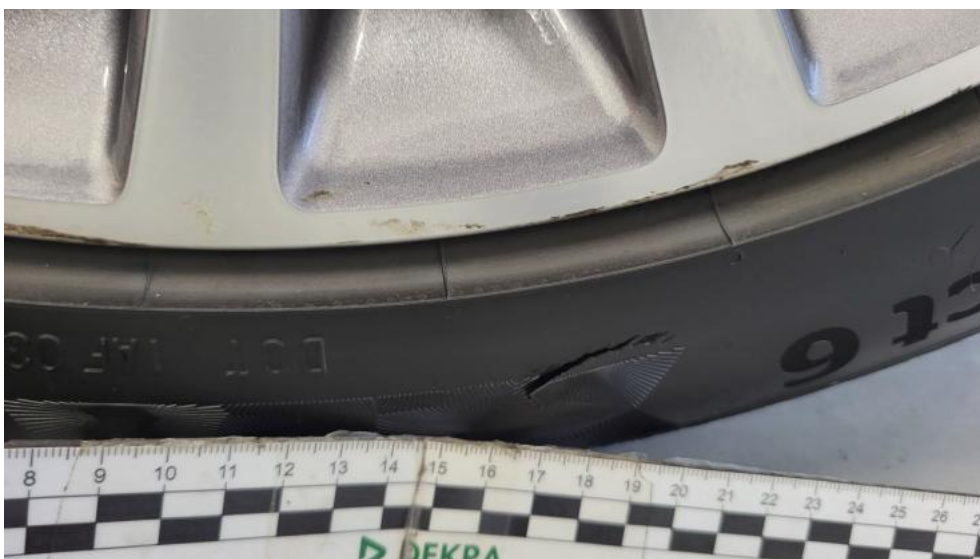
**Photo 73.**

Opona tylna L - Pęknięcie/rozerwanie 2

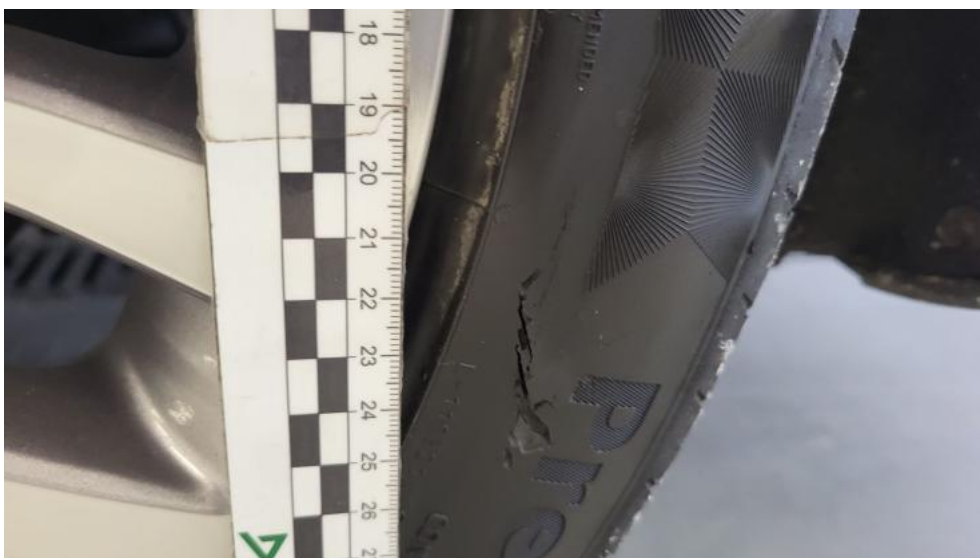
**Photo 74.**

Opona tylna L() - Pęknięcie/rozerwanie 3

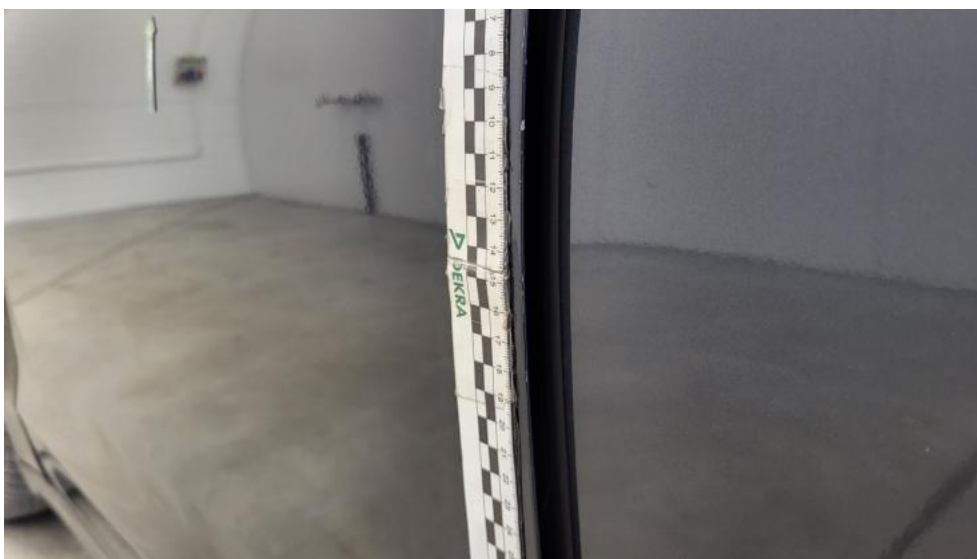
**Photo 77.**

Drzwi przed L - Rysa/odprysk 2

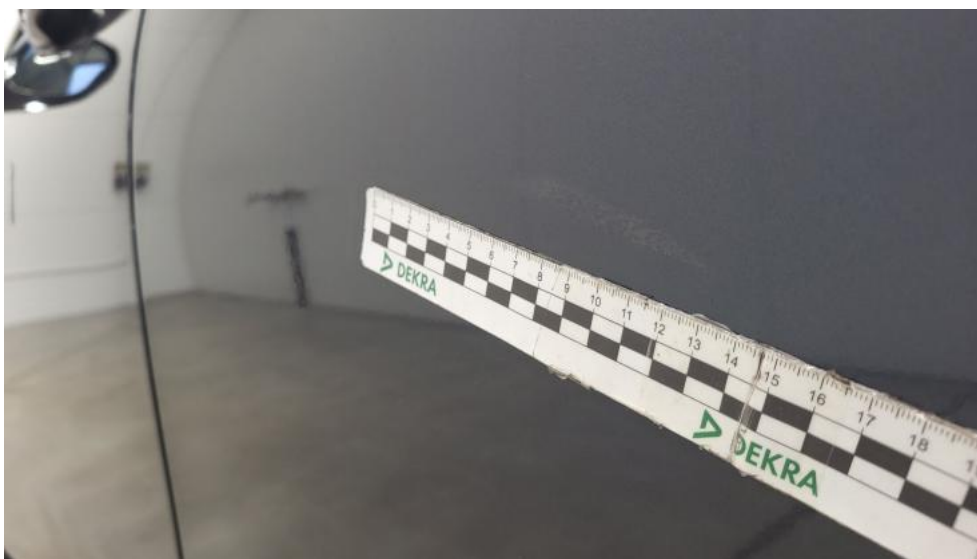
**Photo 81.**

Drzwi tylne L() - Rysa/odprysk 3

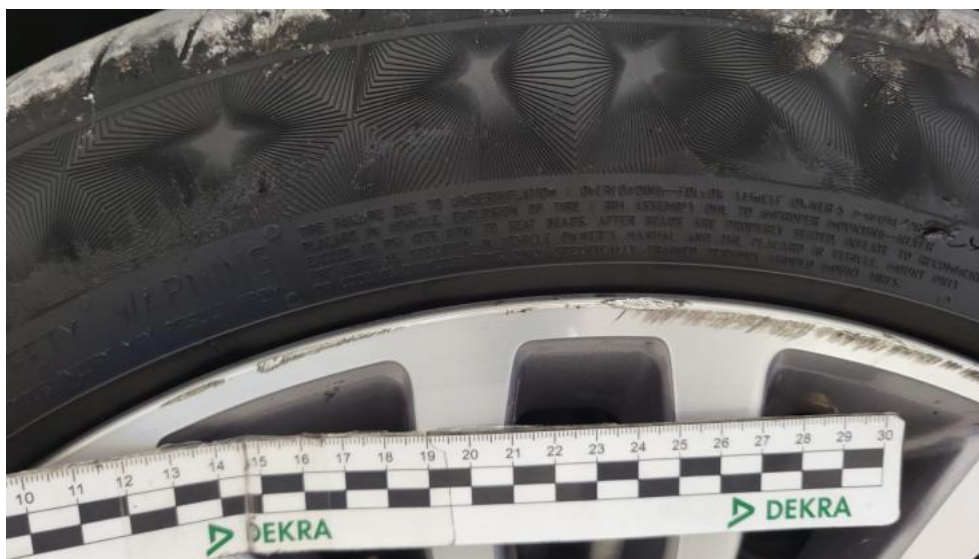
**Photo 83.**  
Felga Aluminiowa przednia L - Rysa/odprysk 1

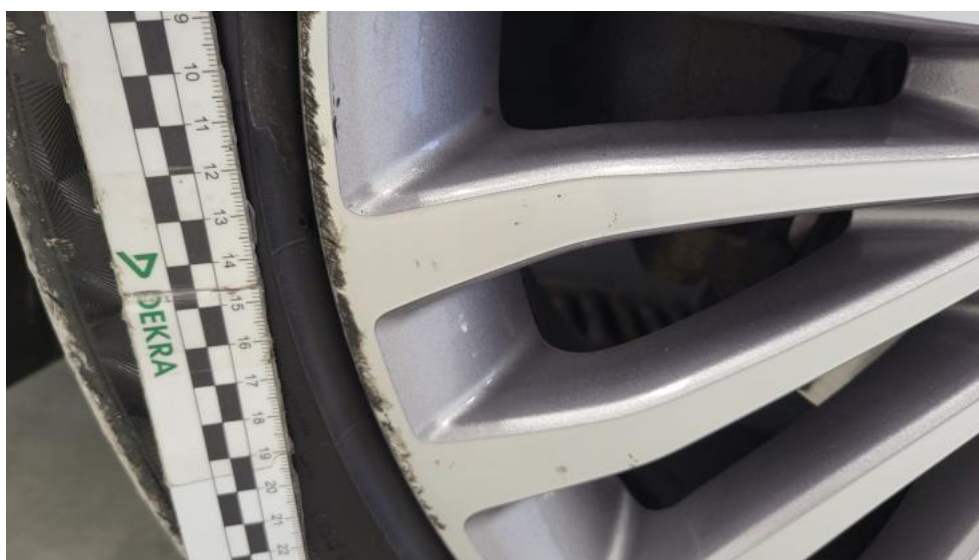
**Photo 84.**  
Felga Aluminiowa przednia L - Rysa/odprysk 2

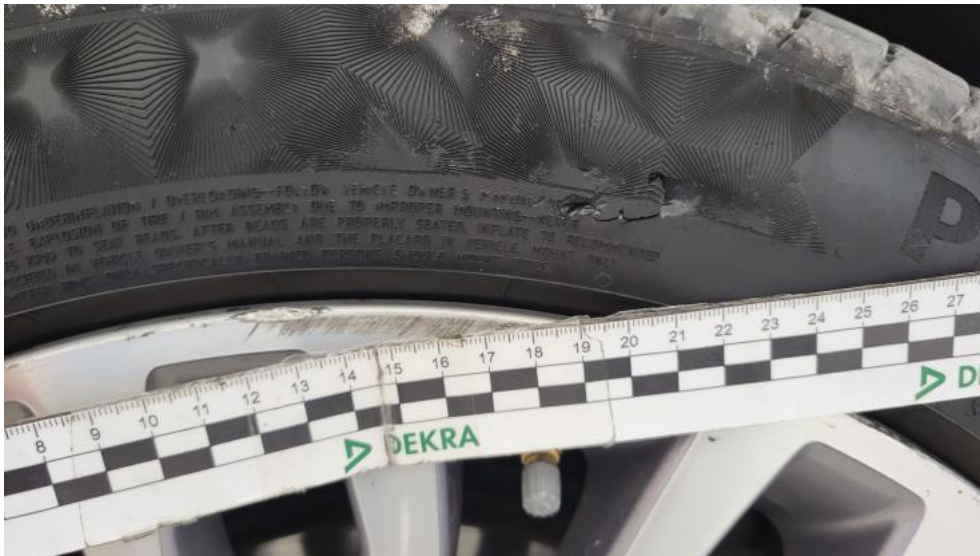
**Photo 85.**  
Opona przednia L - Pęknięcie/rozerwanie 1

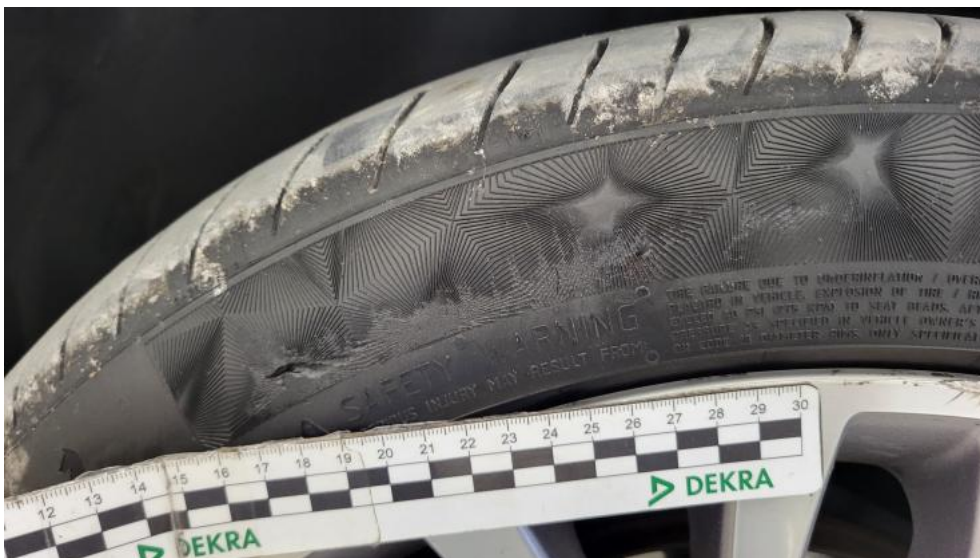
**Photo 86.**  
Opona przednia L - Pęknięcie/rozerwanie 2

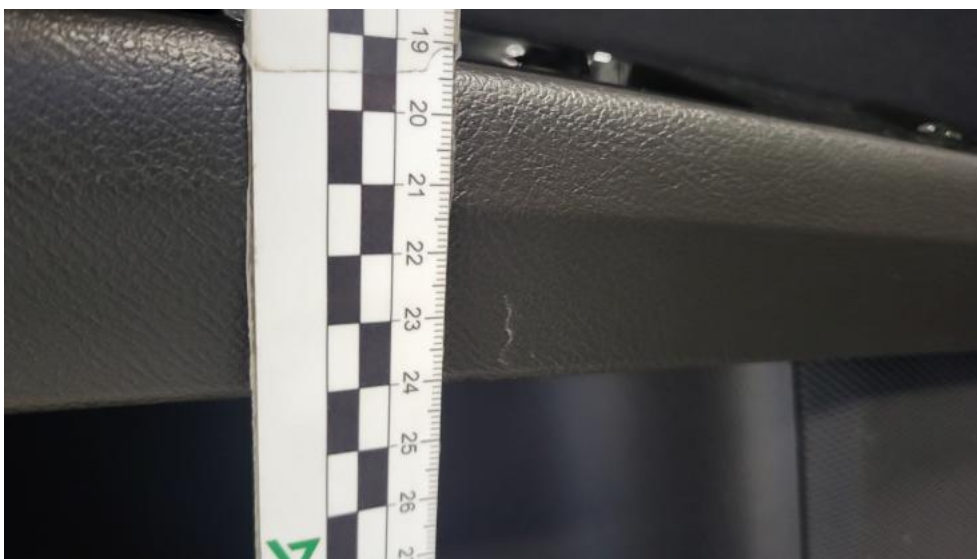
**Photo 87.**  
Tapicerka drzwi tylnych L - Rysa/odprysk 1

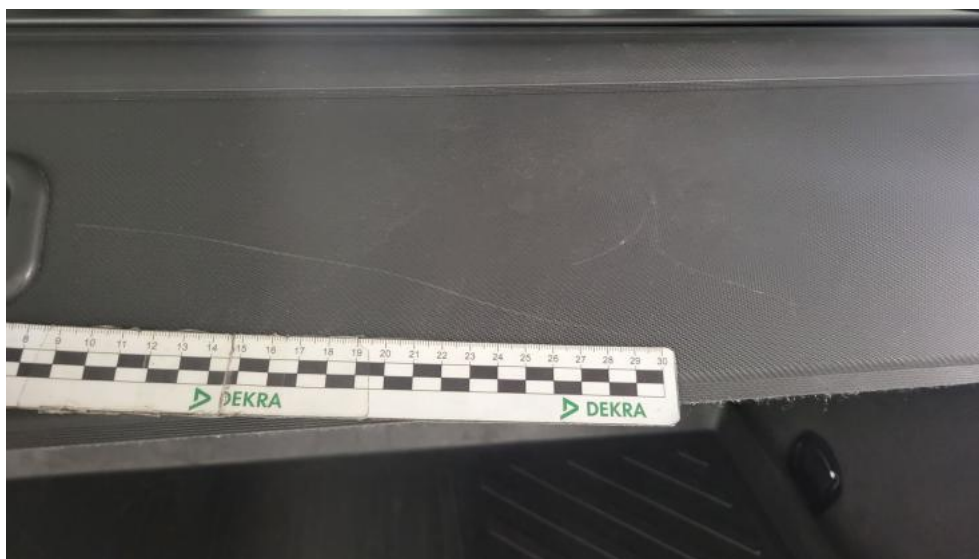
**Photo 89.**

Półka/roleta tylna - Rysa/odprysk 2
