DEKRA's commission No. : PKOL(W)/LODZ/82472/24/10/24
commission/ damage No. : 22/008145
Date of commission: 24-10-2024

| Manufacturer | AUDI |
| Model | A6 Allroad 14-19 |
| VIN / serial number | WAUZZZ4G0JN089806 |

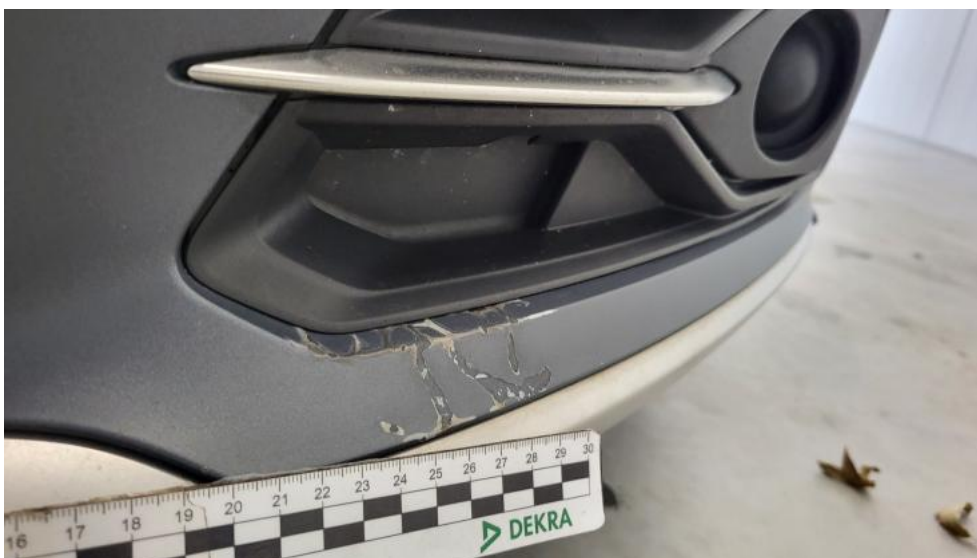
Photo 46.
Spoiler zderzaka przedniego - Rysa/odprysk 1

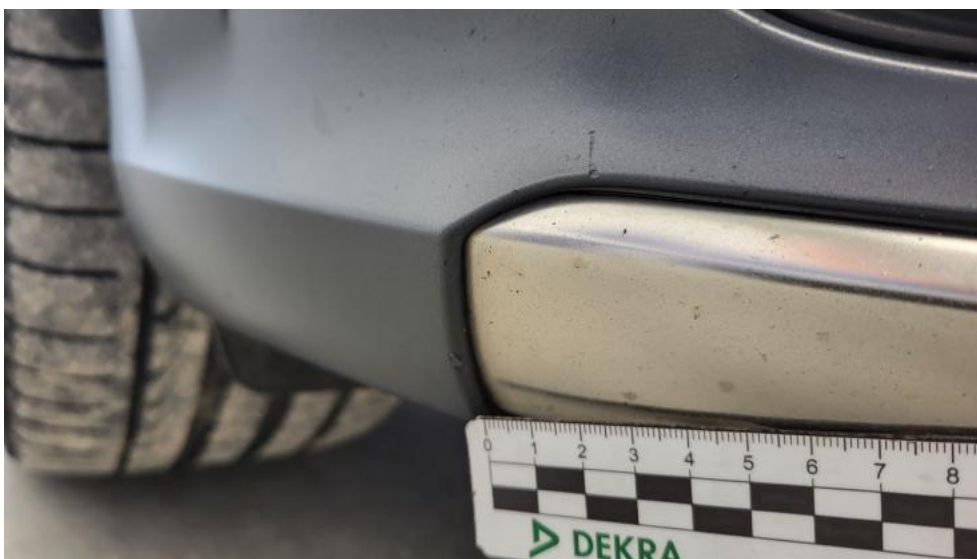
Photo 47.
Spoiler zderzaka przedniego - Rysa/odprysk 2

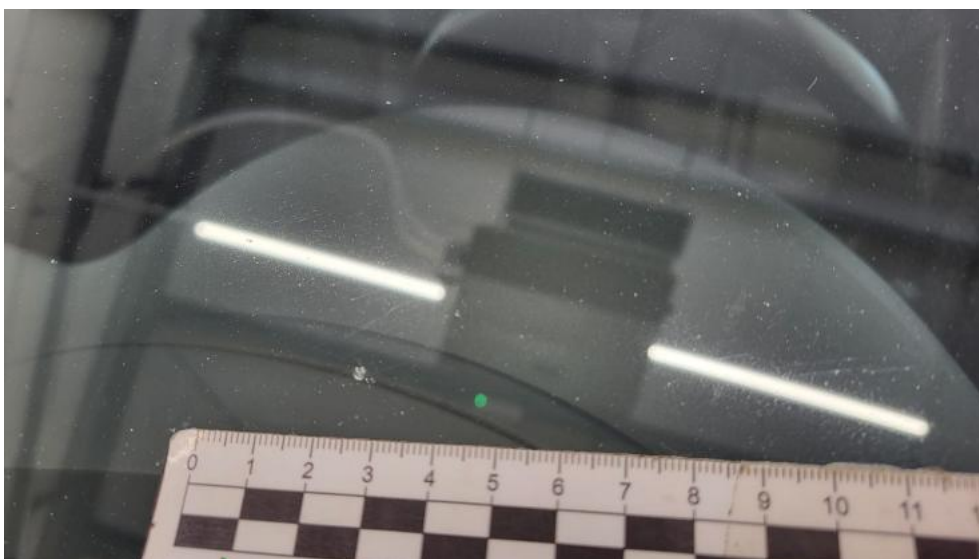
Photo 49.
Szyba czołowa - Rysa/odprysk 1

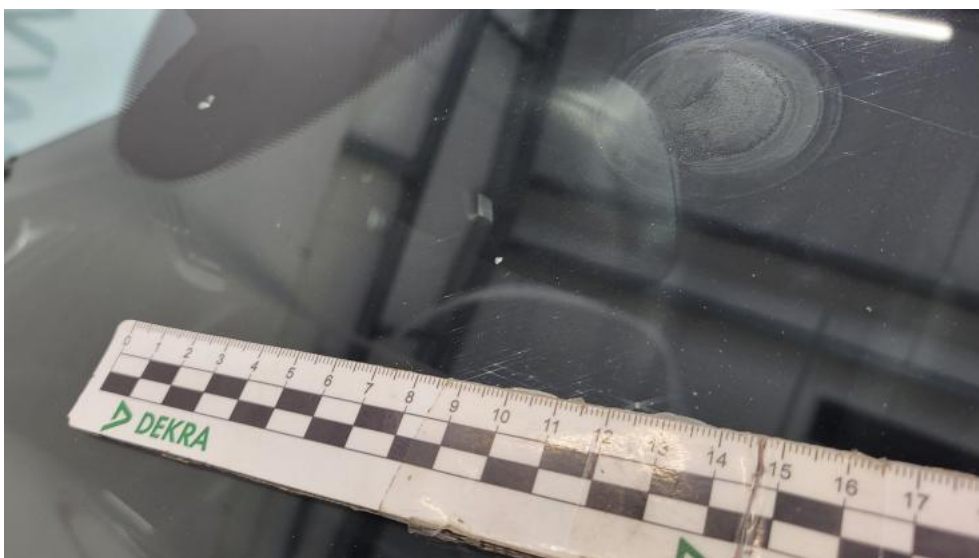
Photo 50.
Szyba czołowa - Rysa/odprysk 2

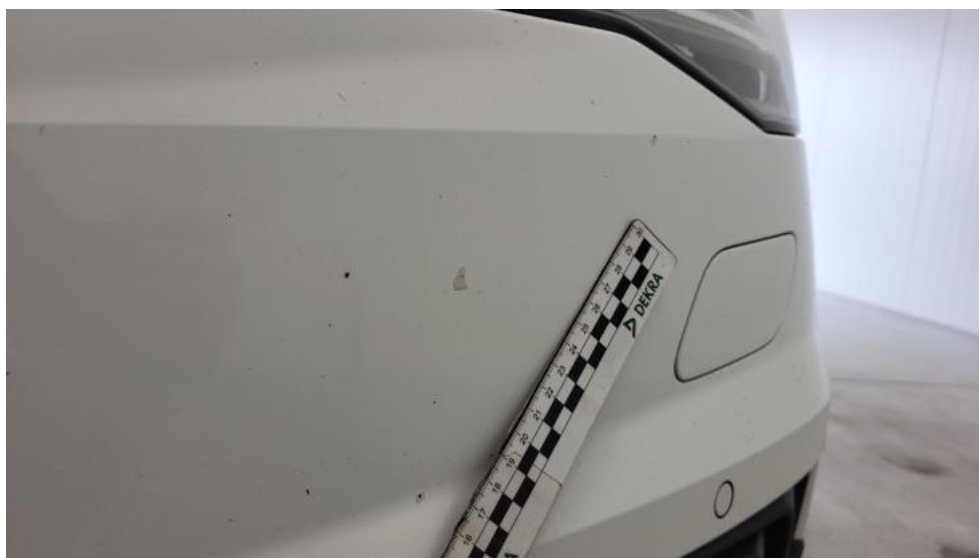
Photo 52.

Zderzak - Rysa/odprysk 1

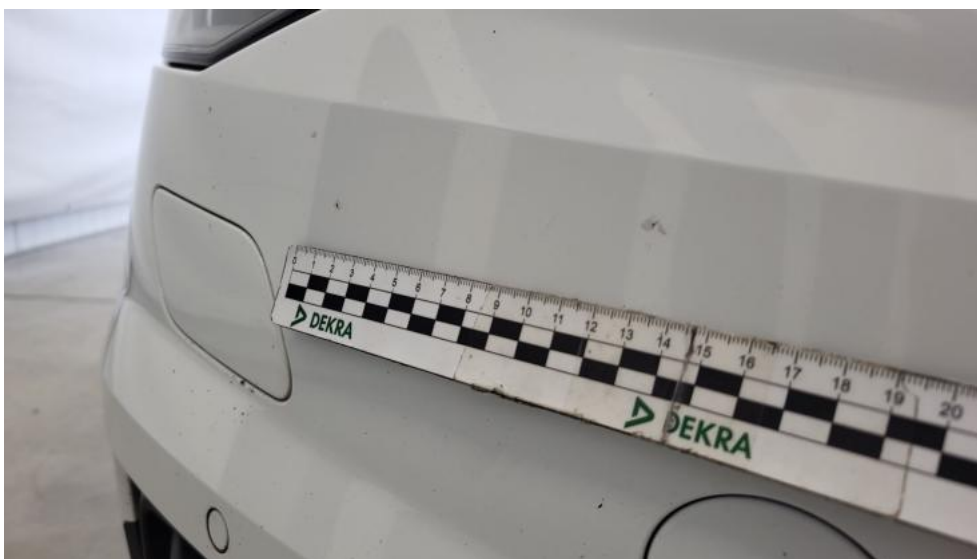
Photo 53.
Zderzak - Rysa/odprysk 2

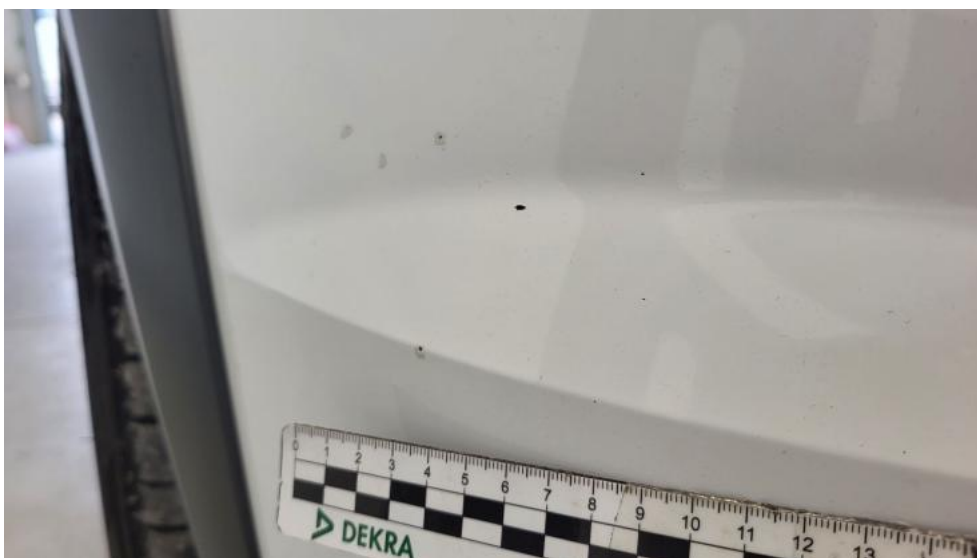
Photo 54.
Zderzak() - Rysa/odprysk 3

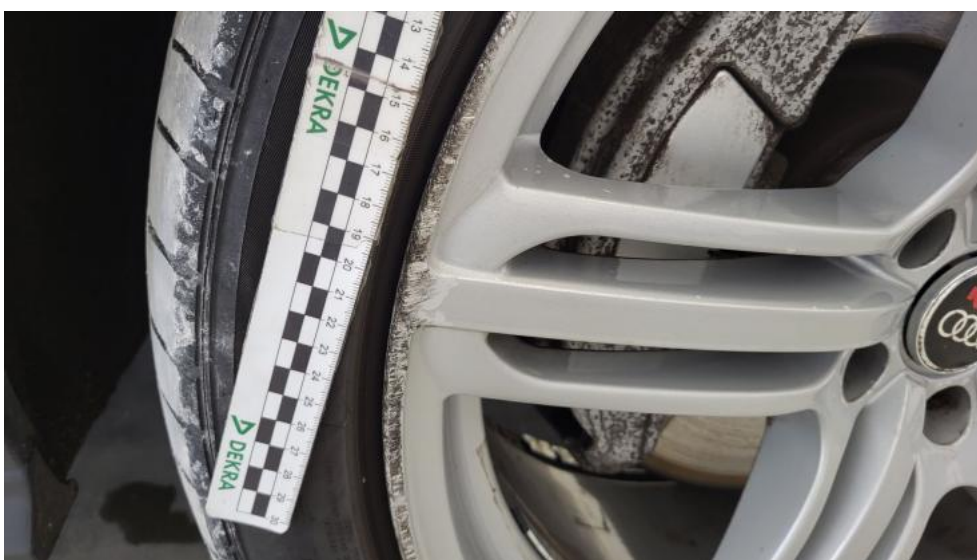
Photo 56.

Felga aluminiowa przednia P - Rysa/odprysk 1

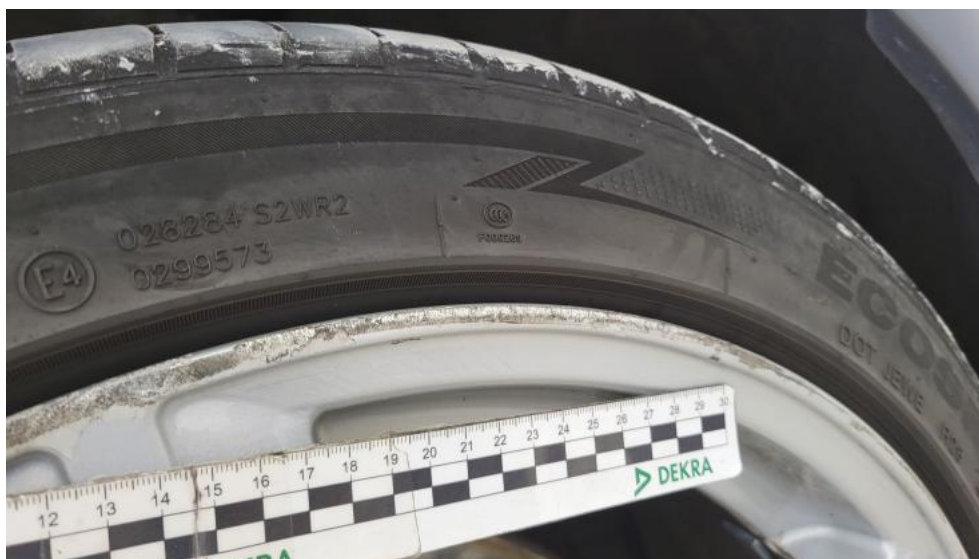
Photo 57.
Felga aluminiowa przednia P - Rysa/odprysk 2

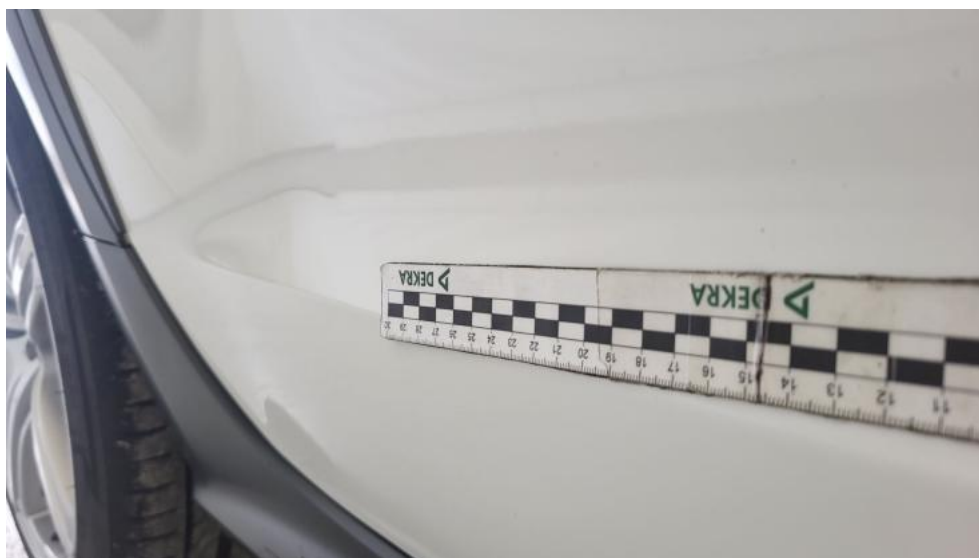
Photo 58.
Drzwi tylne P - Wgniecenie/odkształcenie 1

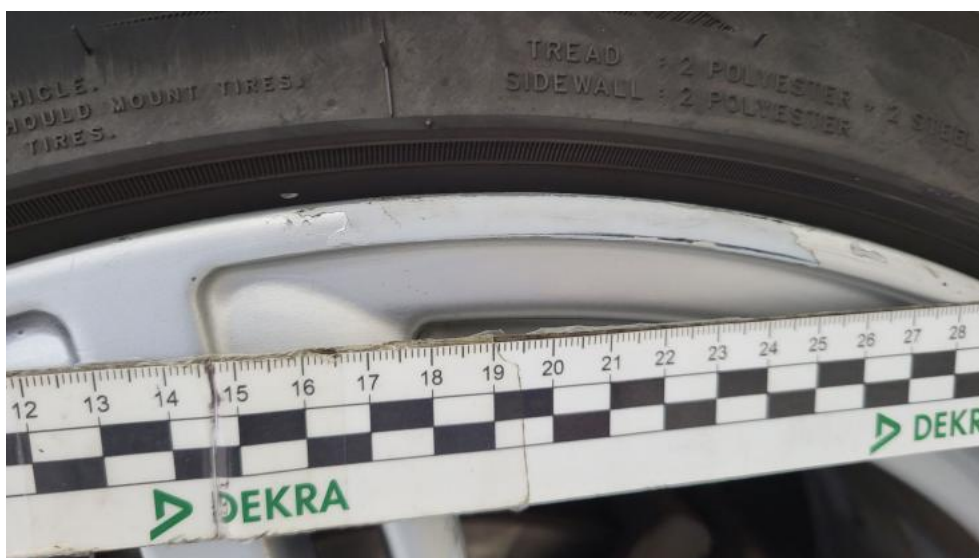
Photo 60.
Felga aluminiowa tylna P - Rysa/odprysk 1

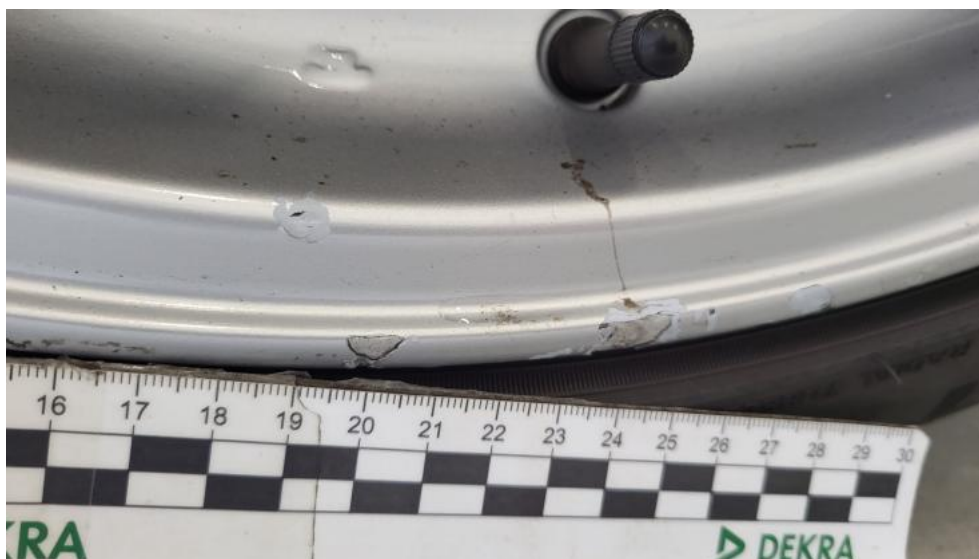
Photo 61.
Felga aluminiowa tylna P - Rysa/odprysk 2

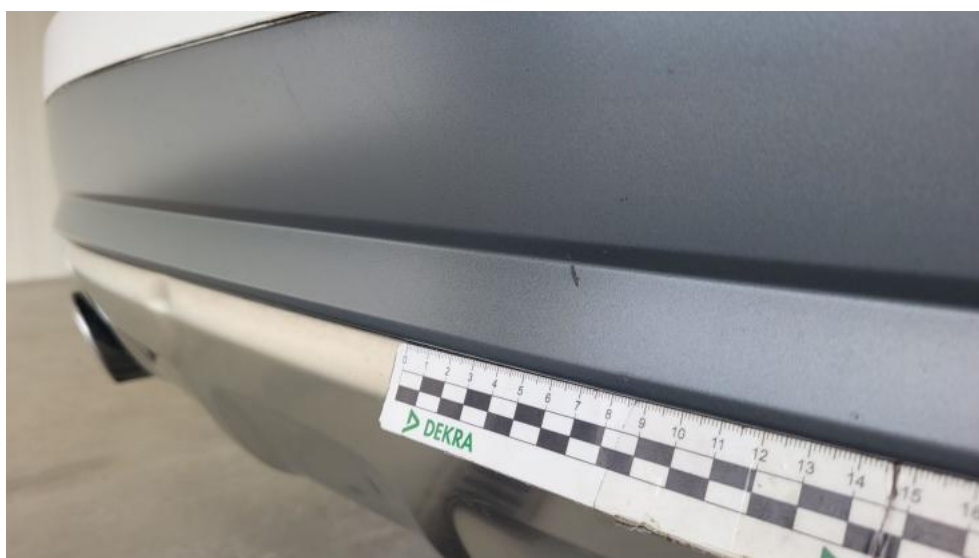
Photo 62.
Zderzak tylny - Rysa/odprysk 1

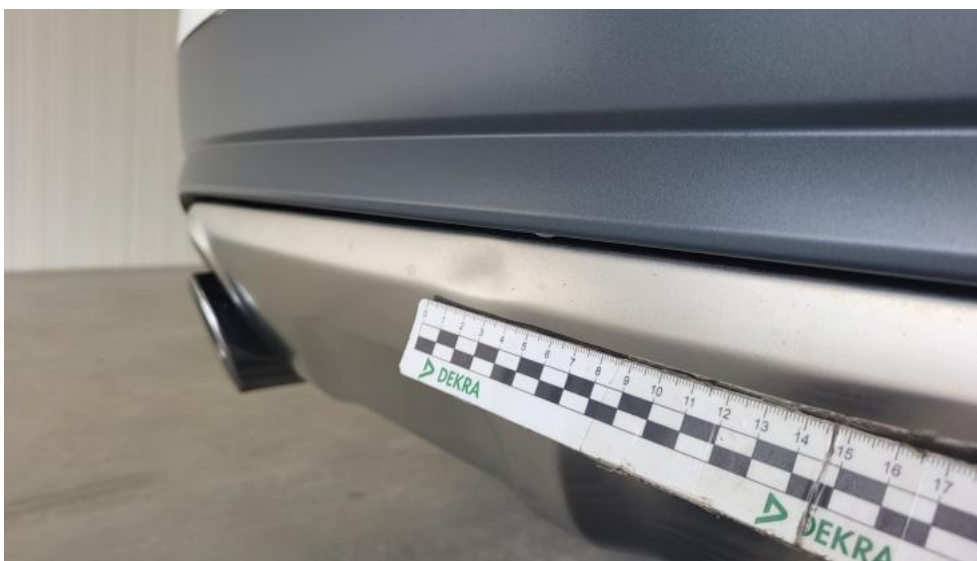
Photo 63.
Zderzak tylny - Wgniecenie/odkształcenie 1

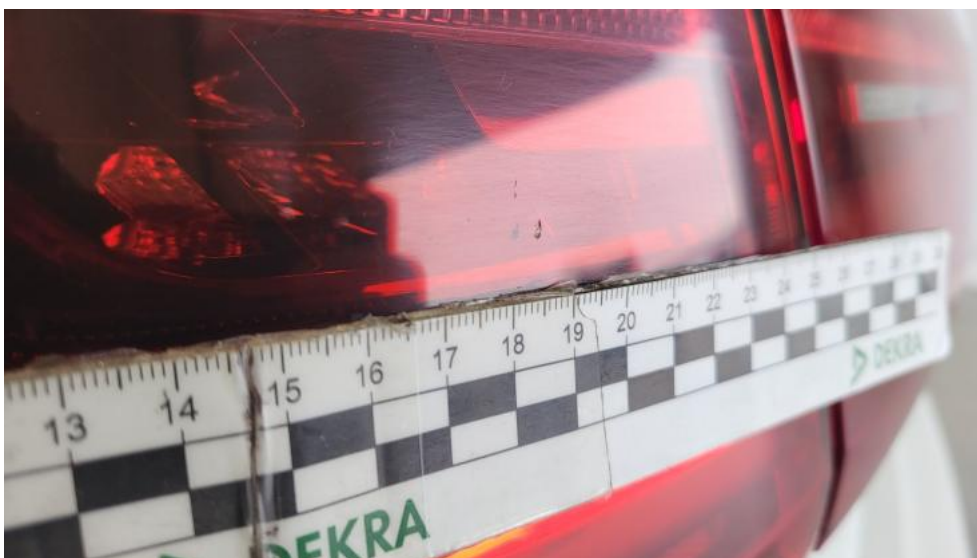
Photo 64.
Lampa tylna zew L - Rysa/odprysk 1

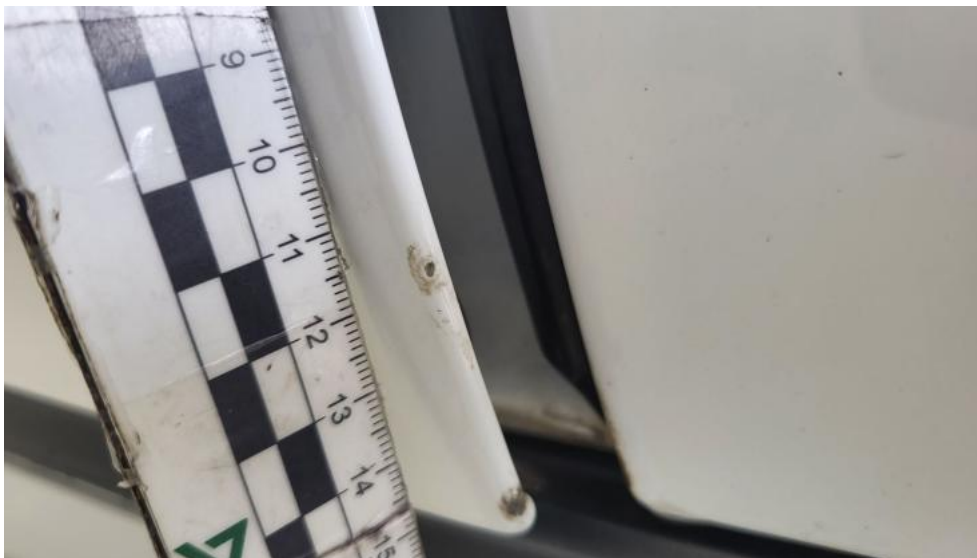
Photo 65.

Drzwi przed L - Rysa/odprysk 1

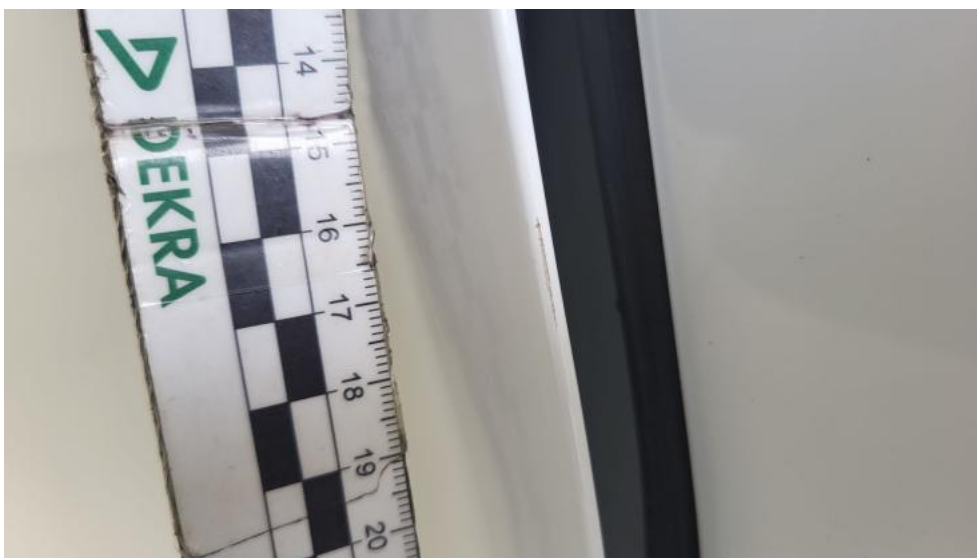
Photo 66.

Drzwi przed L - Rysa/odprysk 2

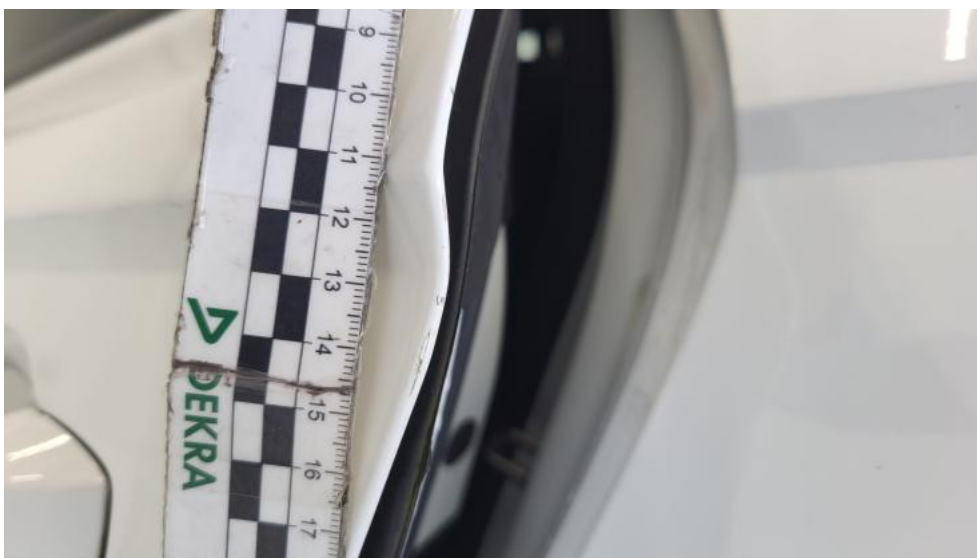
Photo 68.

Drzwi tylne L - Rysa/odprysk 1

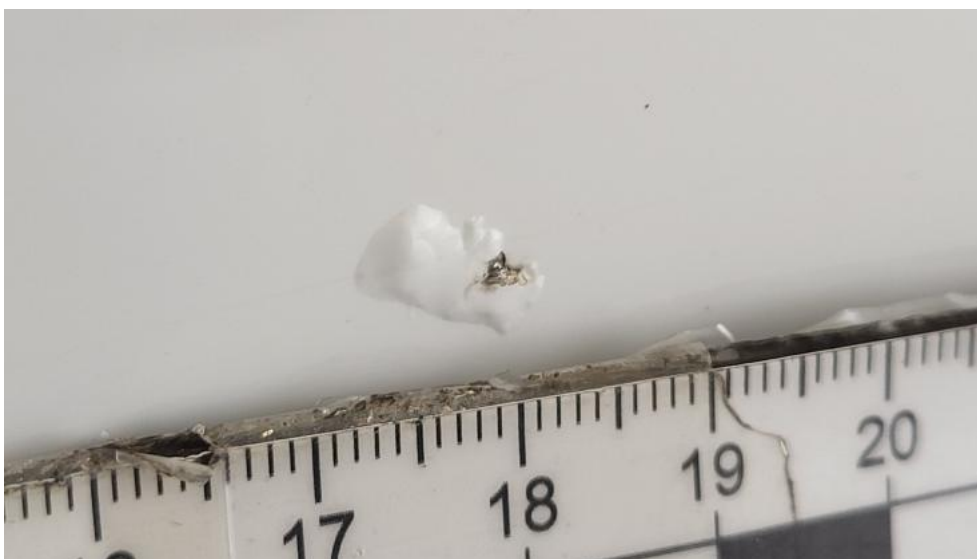
Photo 69.
Drzwi tylne L - Inne 1

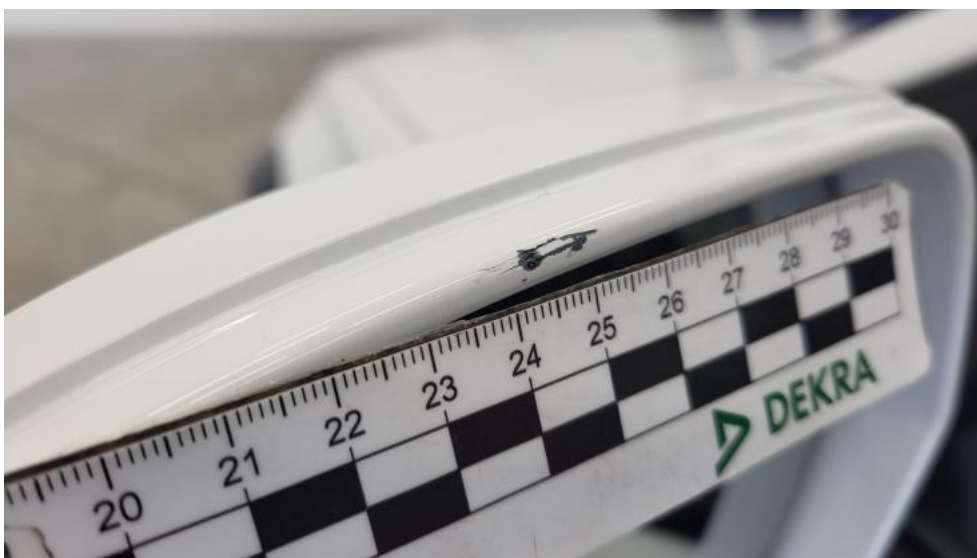
Photo 70.
Lusterko zew L - Rysa/odprysk 1

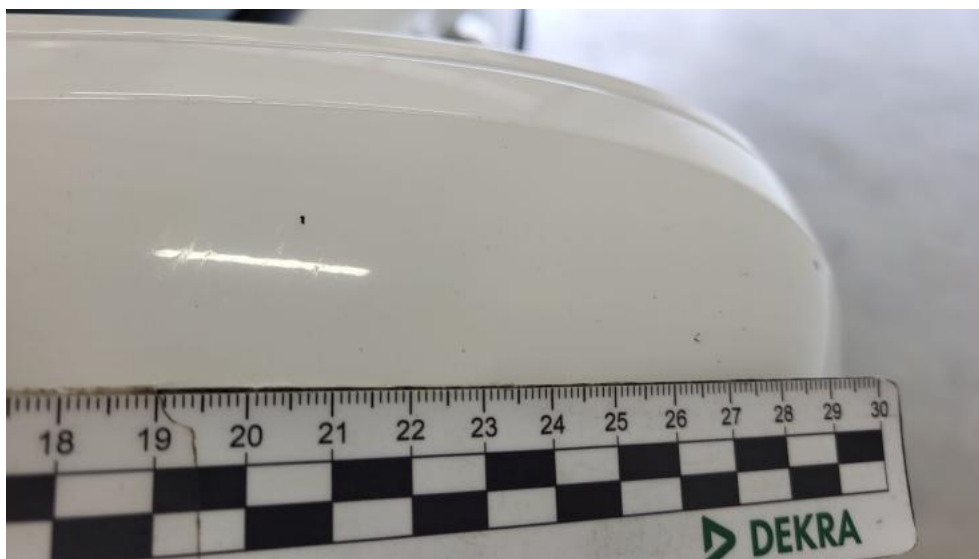
Photo 71.

Lusterko zew L - Rysa/odprysk 2

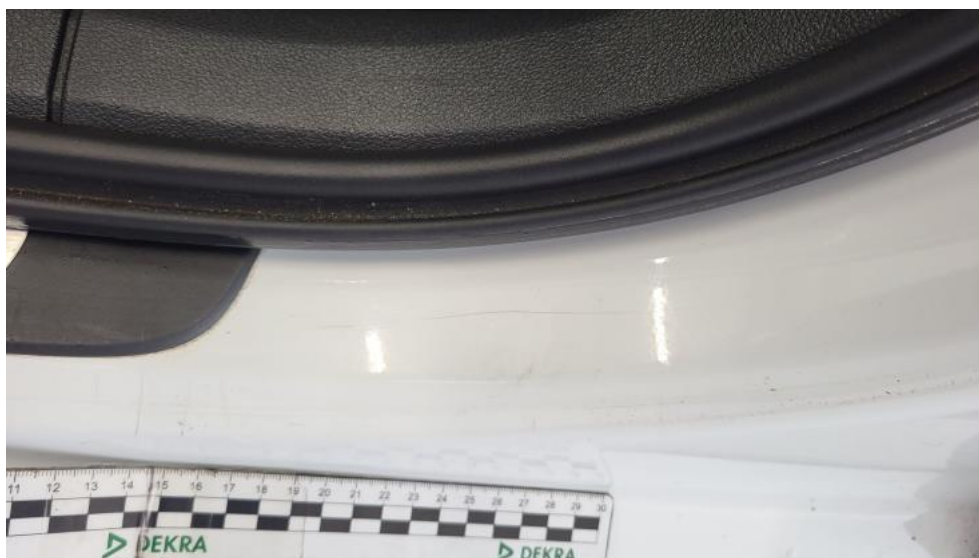
Photo 72.

Próg L - Rysa/odprysk 1

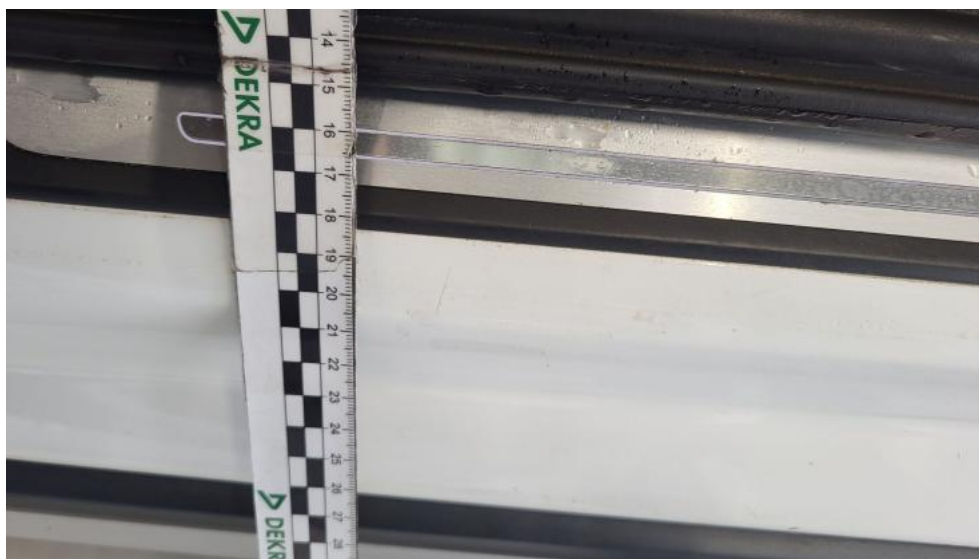
Photo 73.
Próg L - Rysa/odprysk 2

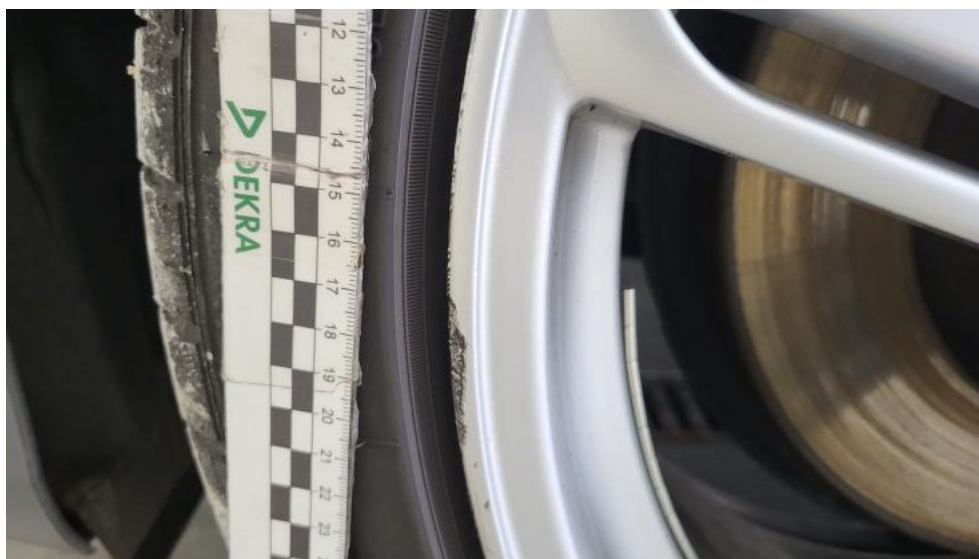
Photo 75.

Felga Aluminiowa przednia L - Rysa/odprysk 1

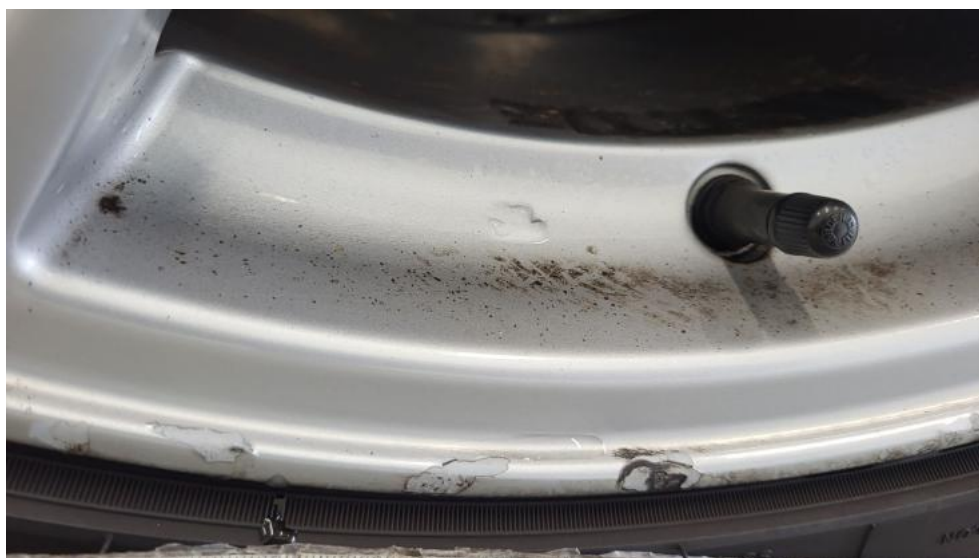
Photo 76.

Felga Aluminiowa przednia L - Rysa/odprysk 2

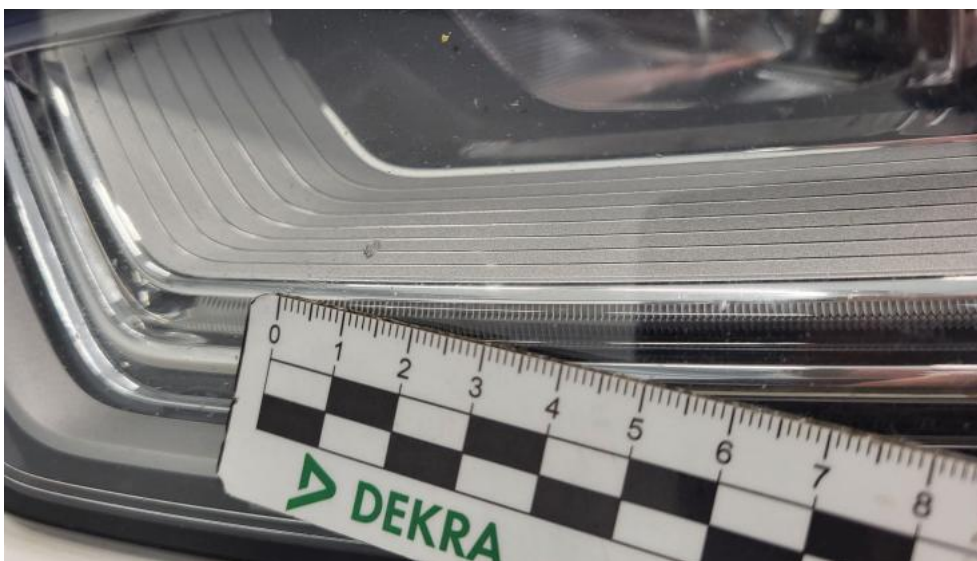
Photo 77.
Reflektor L - Rysa/odprysk 1

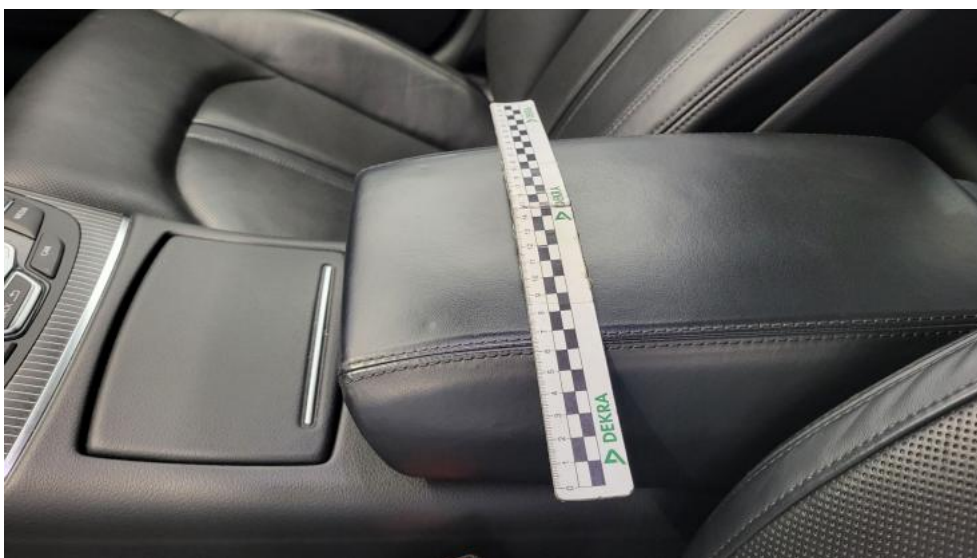
Photo 78.
Podłokietnik środkowy przedni - Wgniecenie/odkształcenie 1

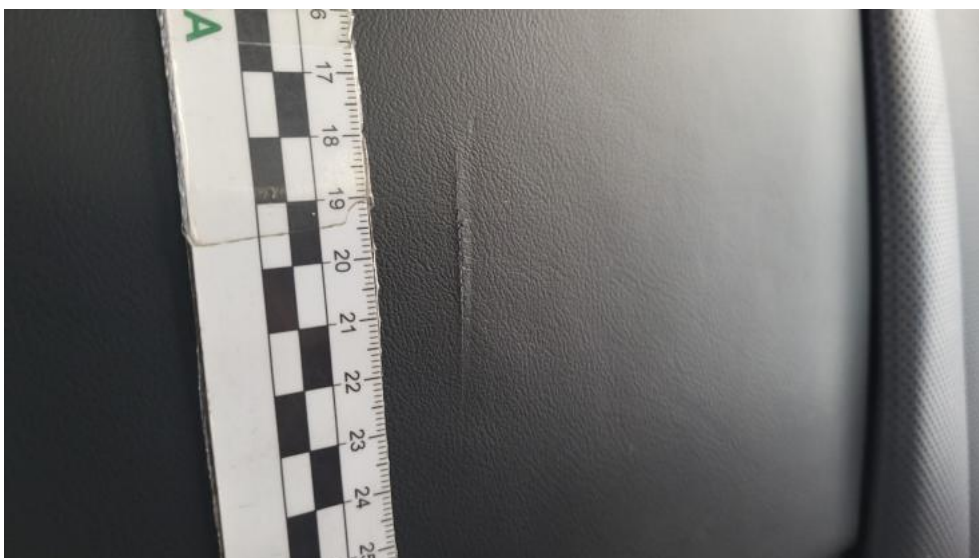
Photo 80.

Kanapa tyl. - Rysa/odprysk 1

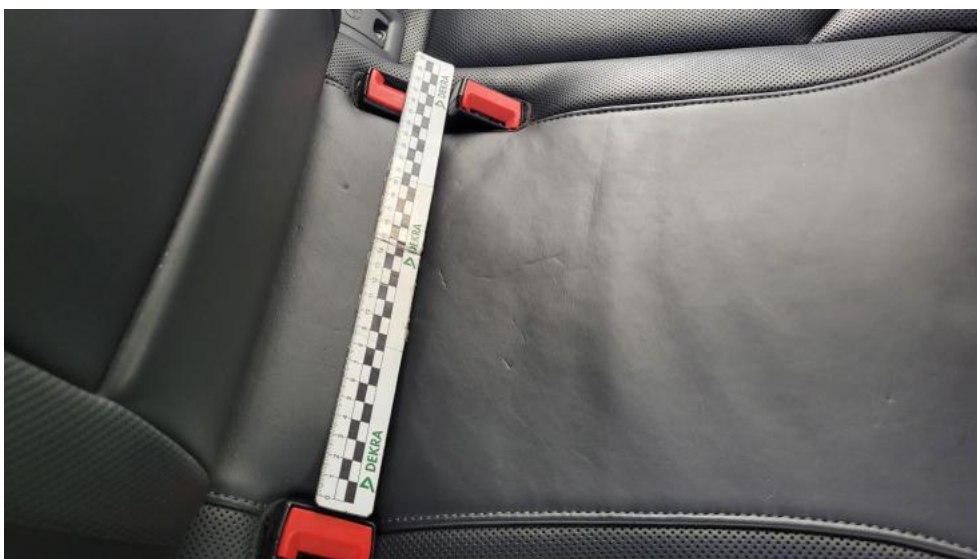
Photo 81.

Kanapa tyl. - Wgniecenie/odkształcenie 1
