DEKRA's commission No. : PKOL(W)/LODZ/67053/26/07/20  
commission/ damage No. : 23/001673  
Date of commission: 20-07-2026

**Vehicle data**

| Manufacturer | MERCEDES-BENZ |
| Type / version | GLS 400 d 4-Matic |

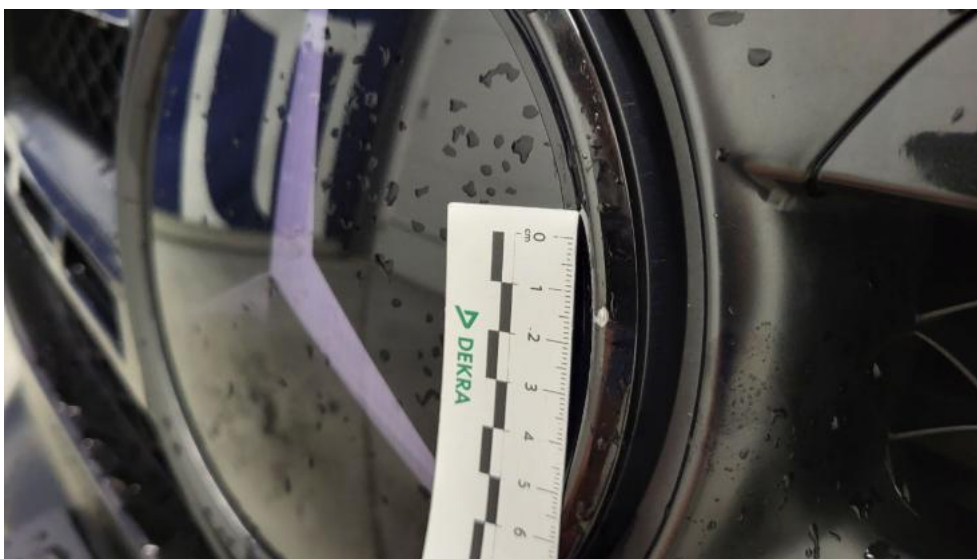
**Photo 53.**

Emblemat - Rysa/odprysk 1

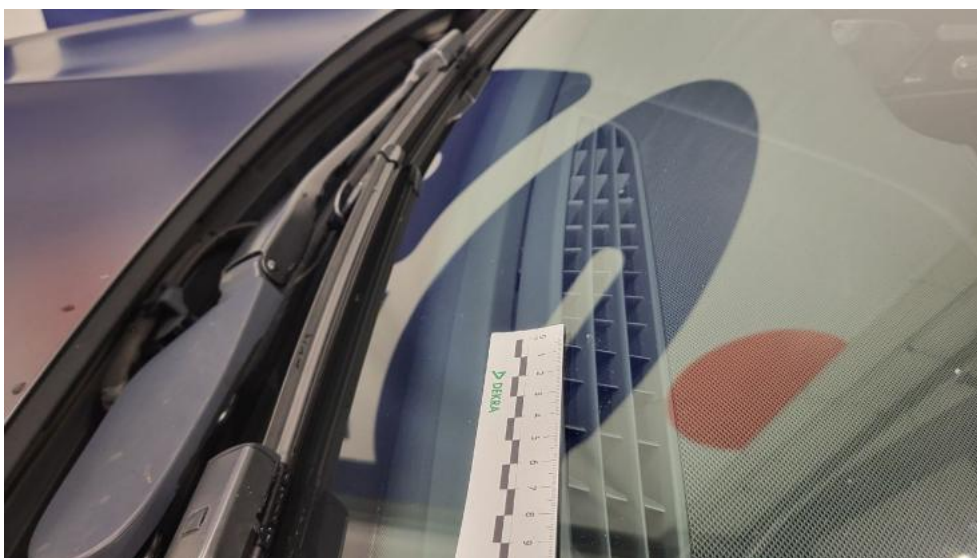
**Photo 54.**

Brak aktualnych badań technicznych. Pojazd białego koloru oklejony czarną folią, pomiar lakieru wykonany na folii. Lusterka i lampy tylne oklejone folią. Rysy na samochodzie. Odpryski na szybie czołowej.

Szyba czołowa - zdjęcie poglądowe 1

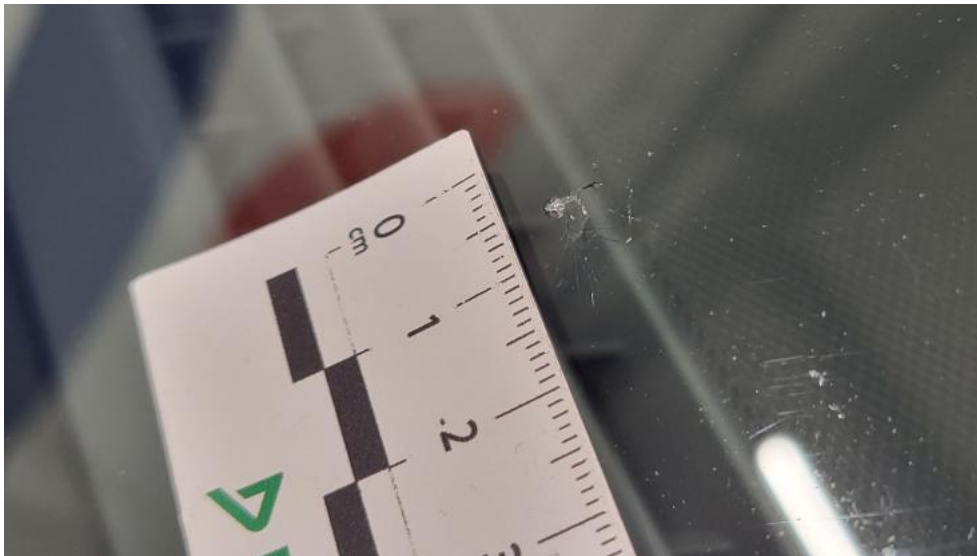
**Photo 55.**

Szyba czołowa - Pęknięcie/rozerwanie 1

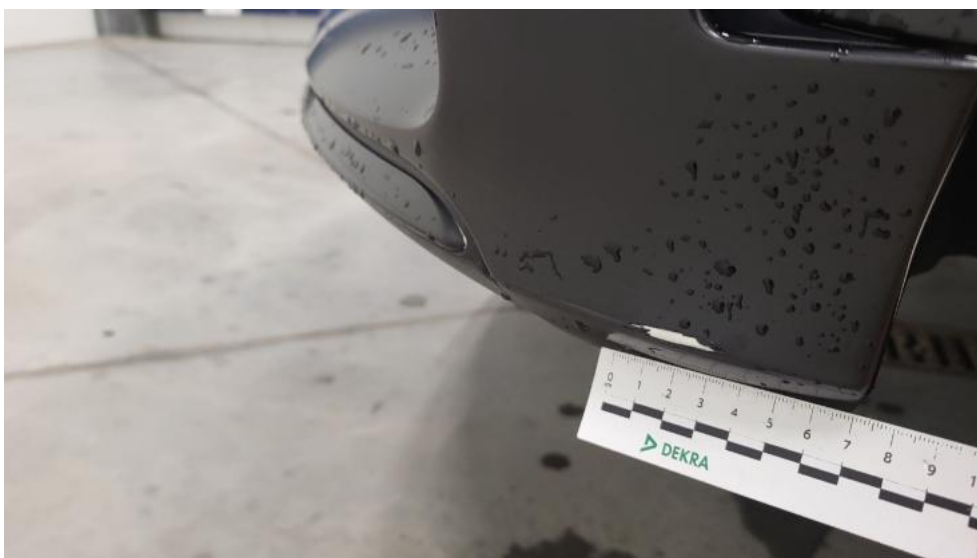
**Photo 56.**

Zderzak - Rysa/odprysk 1

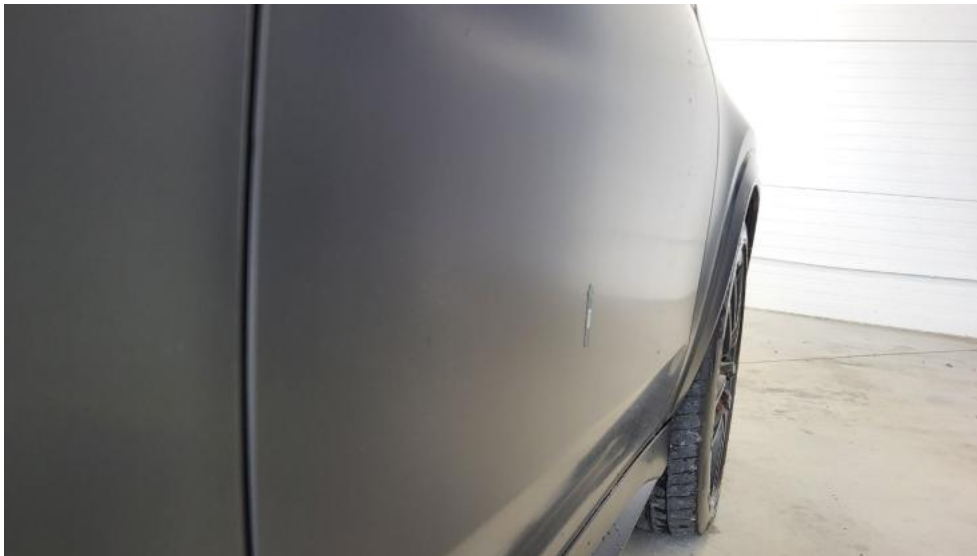
**Photo 57.**

Drzwi przednie P - Wgniecenie/odkształcenie 1

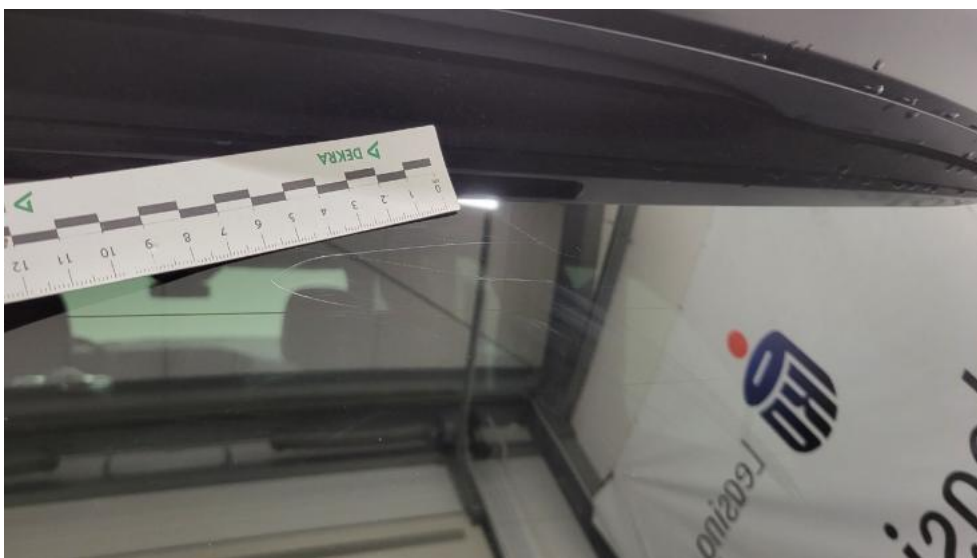
**Photo 58.**

Szyba tylna - Rysa/odprysk 1

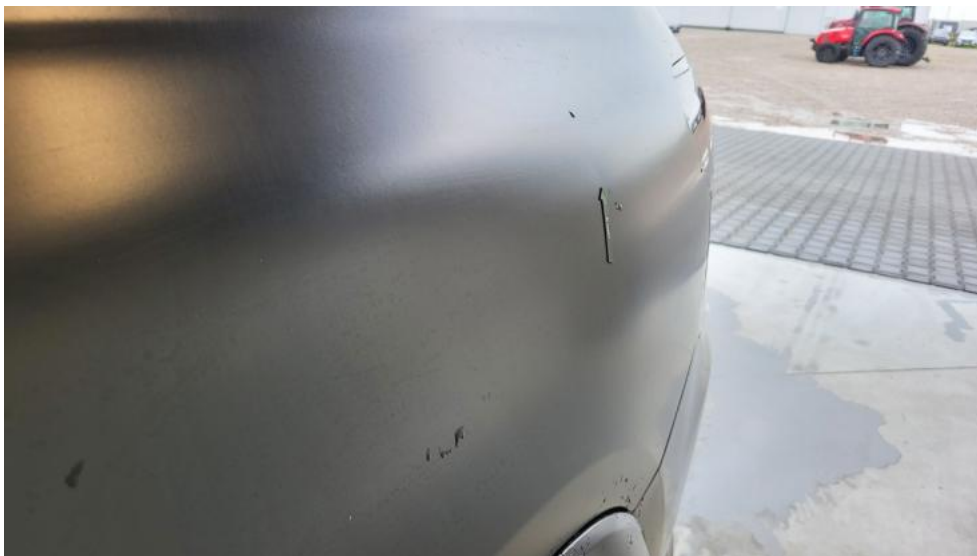
**Photo 59.**

Błotnik tylny L / Ściana boczna L - Wgniecenie/odkształcenie 1

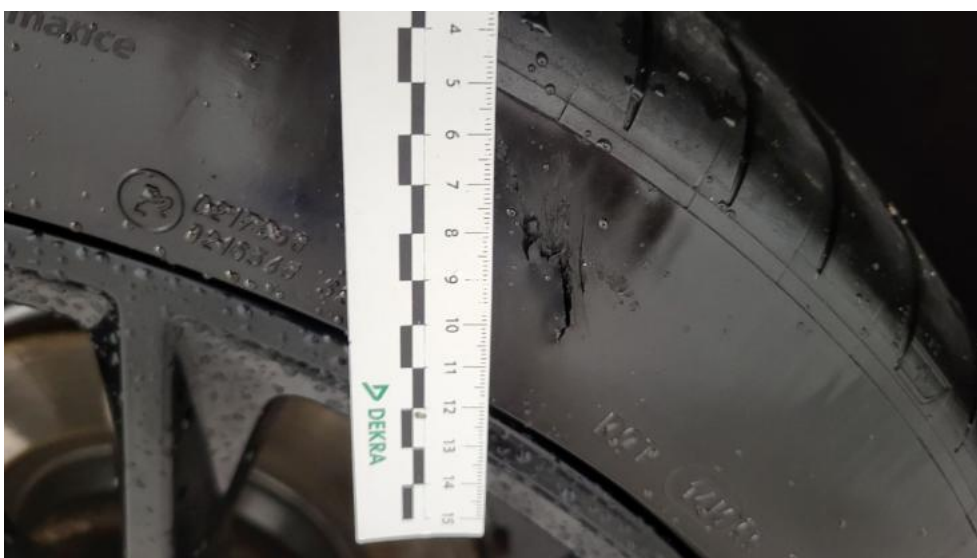
**Photo 60.**

Opona tylna L - Pęknięcie/rozerwanie 1

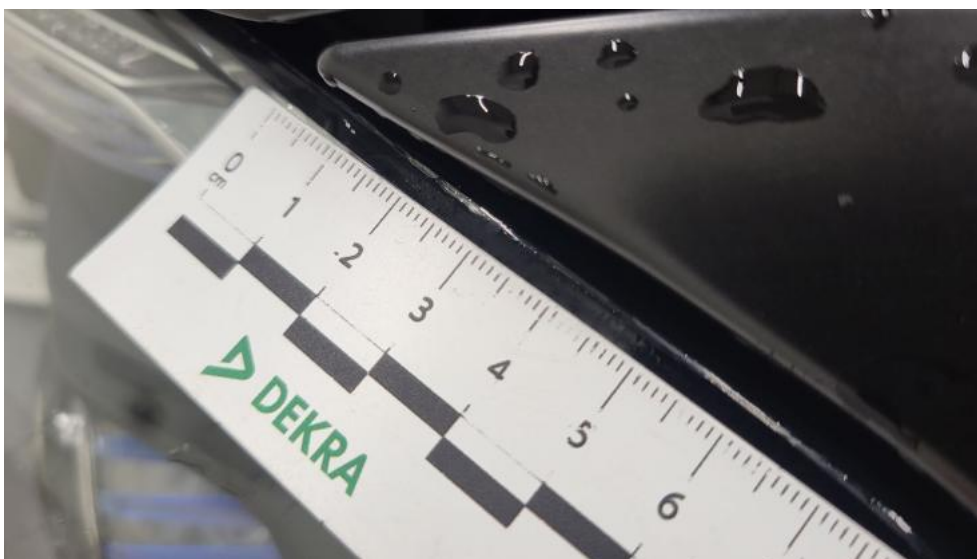
**Photo 61.**

Reflektor L - Rysa/odprysk 1

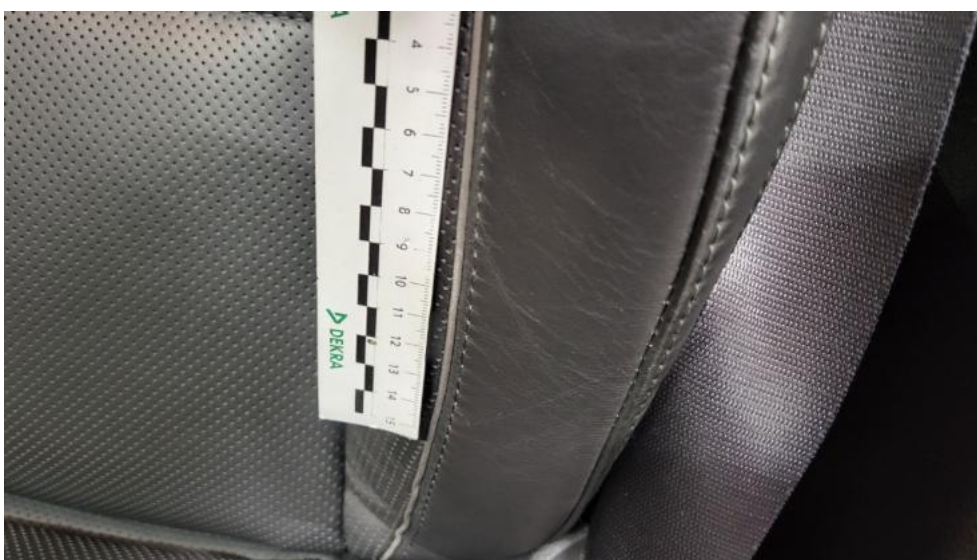
**Photo 62.**

Fotel prz. lew. - Rysa/odprysk 1
