DEKRA's commission No. : PKOL(W)/LODZ/99348/26/10/23  
commission/ damage No. : 22/026066  
Date of commission: 23-10-2026

**DEKRA Poland - Headquarters**  
02-673 Warszawa, ul. Konstruktorska 12A

**Vehicle data**

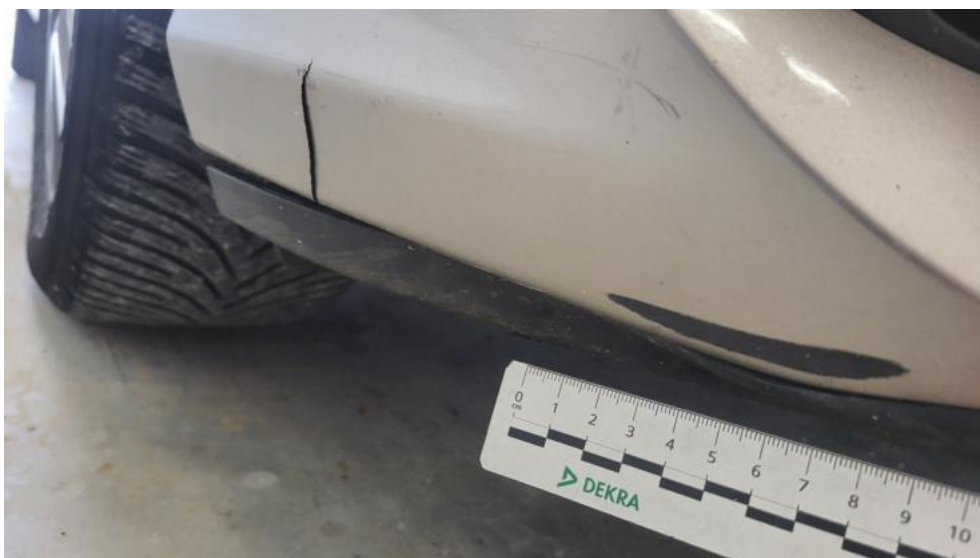
**Photo 44.**

Spoiler zderzaka przedniego - Wgniecenie/odkształcenie 1

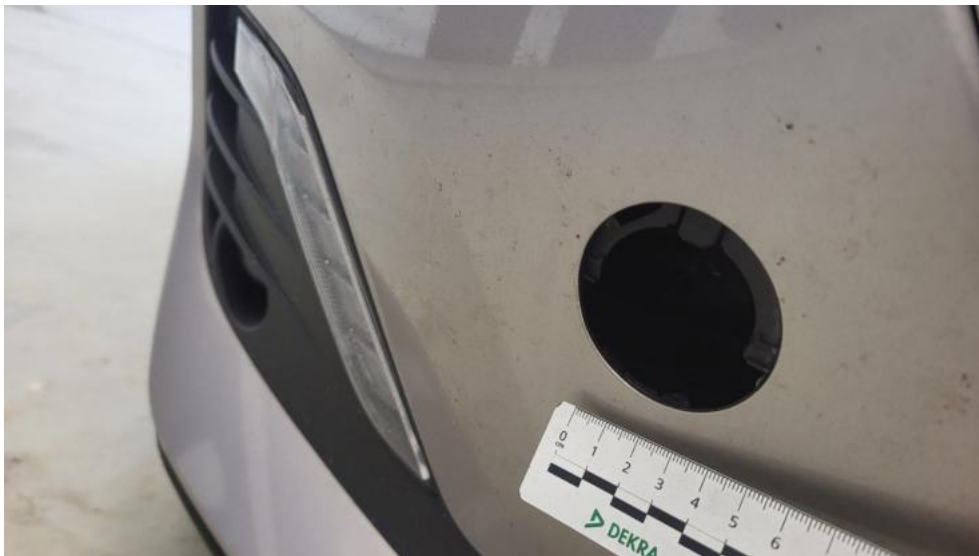
**Photo 45.**

Zaślepka prz haka hol. - Inne 1

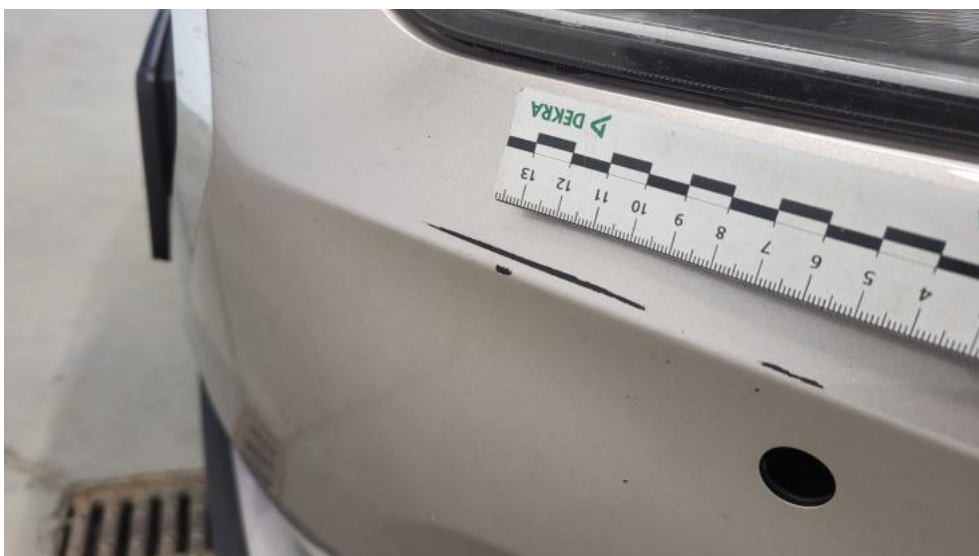
**Photo 46.**

Zderzak - Rysa/odprysk 1

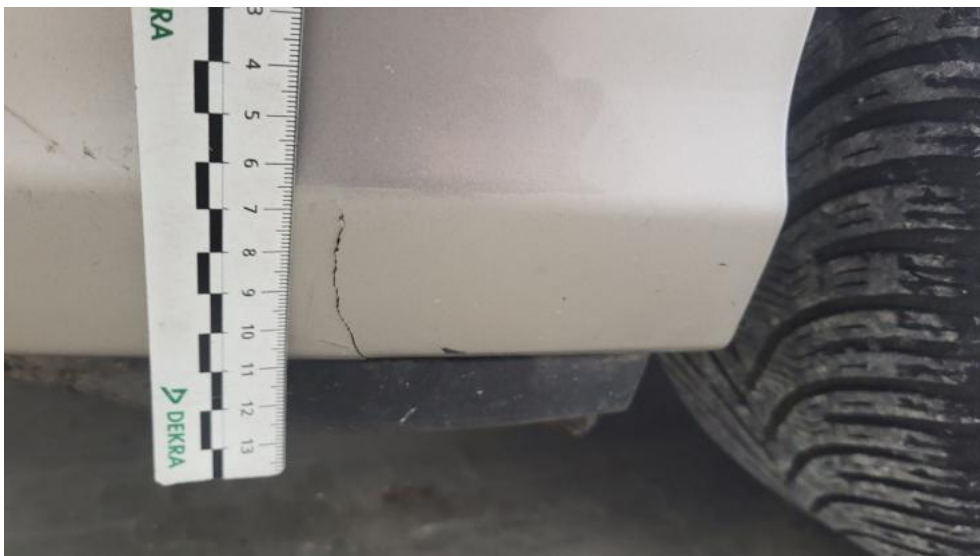
**Photo 48.**

Zderzak - Pęknięcie/rozerwanie 1

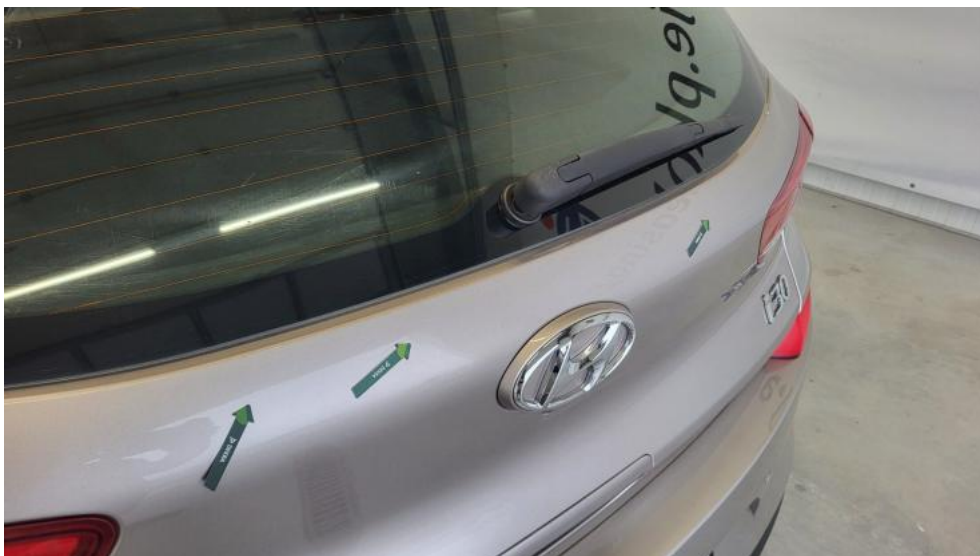
**Photo 62.**

Pokrywy bagażnika - Wgniecenie/odkształcenie 1

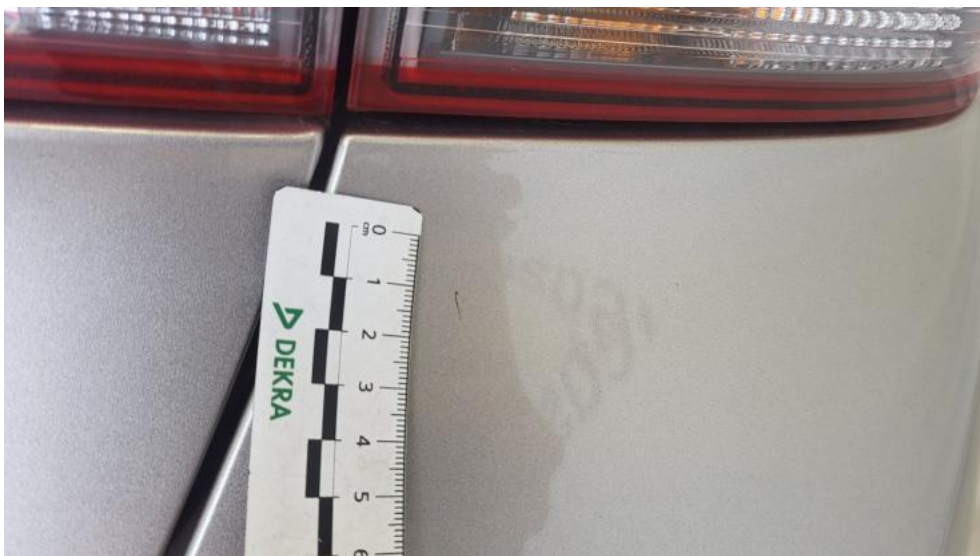
**Photo 64.**

Zderzak tylny - Rysa/odprysk 1

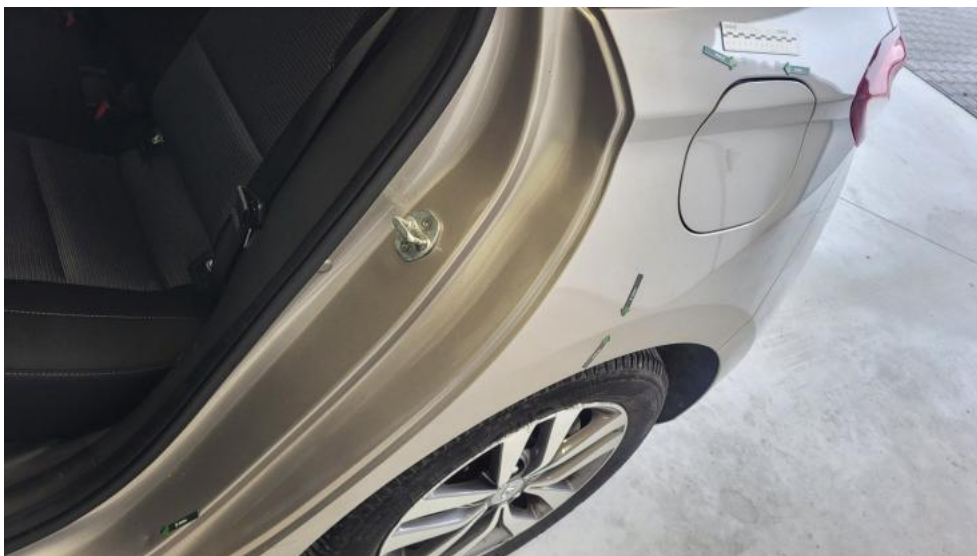
**Photo 67.**

Błotnik tylny L / Ściana boczna L - Wgniecenie/odkształcenie 1

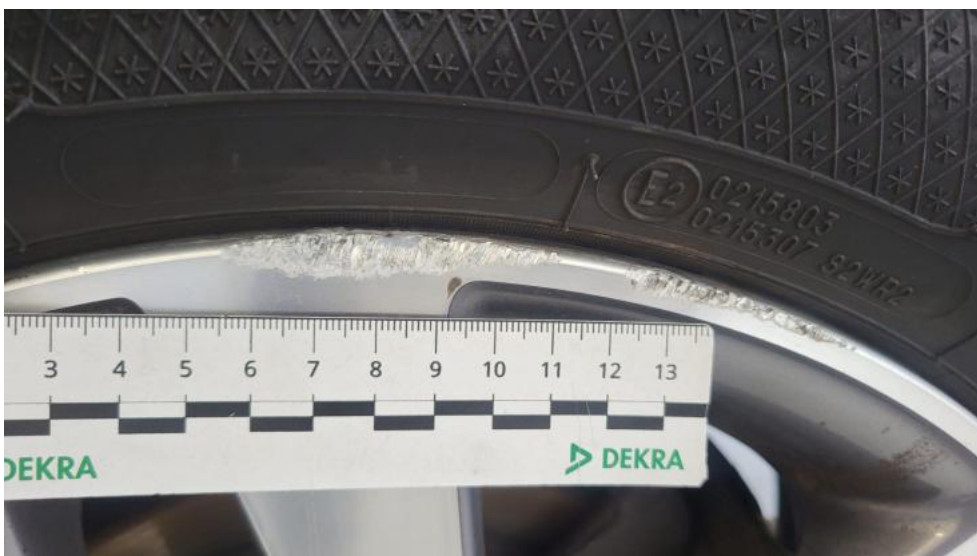
**Photo 68.**

Felga aluminiowa tylna L - Rysa/odprysk 1

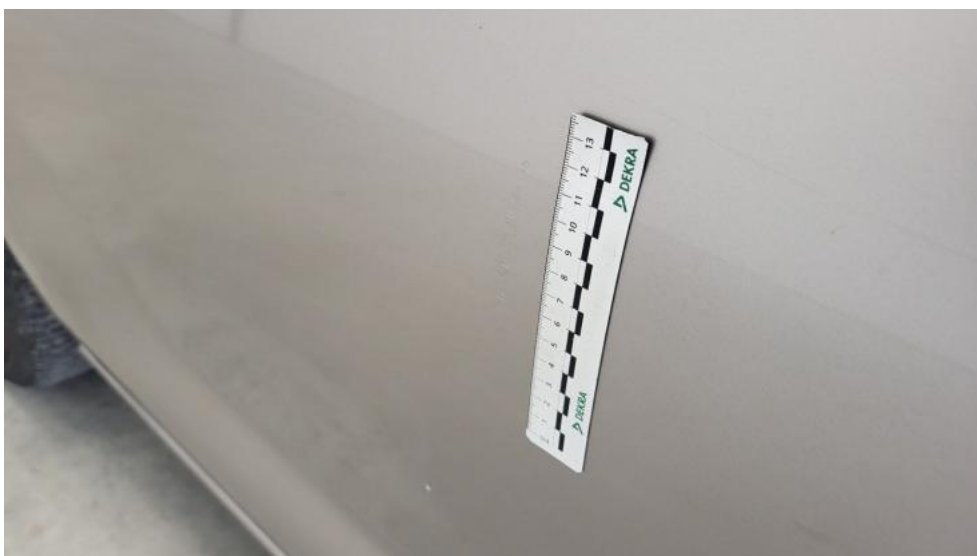
**Photo 70.**

Drzwi przed L - Rysa/odprysk 2

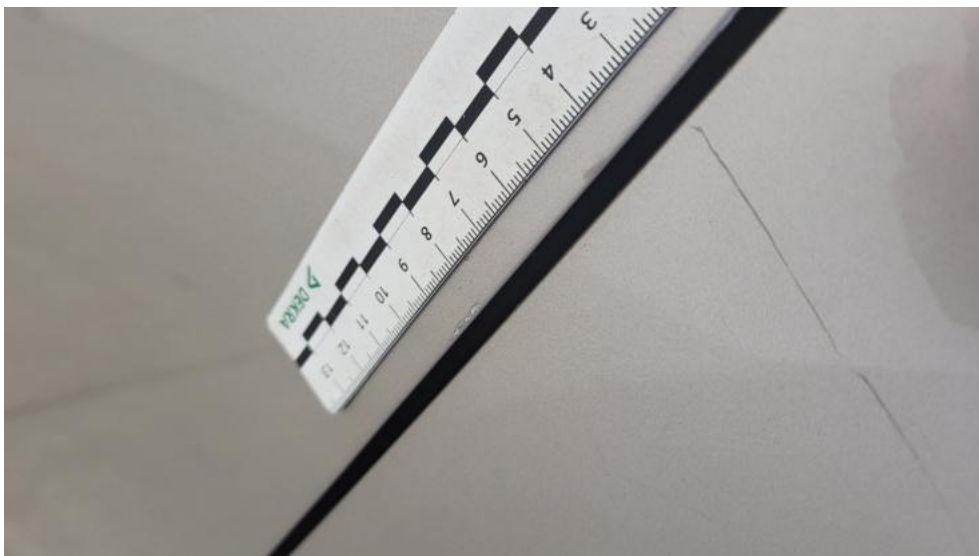
**Photo 72.**

Drzwi tylne L - Rysa/odprysk 1

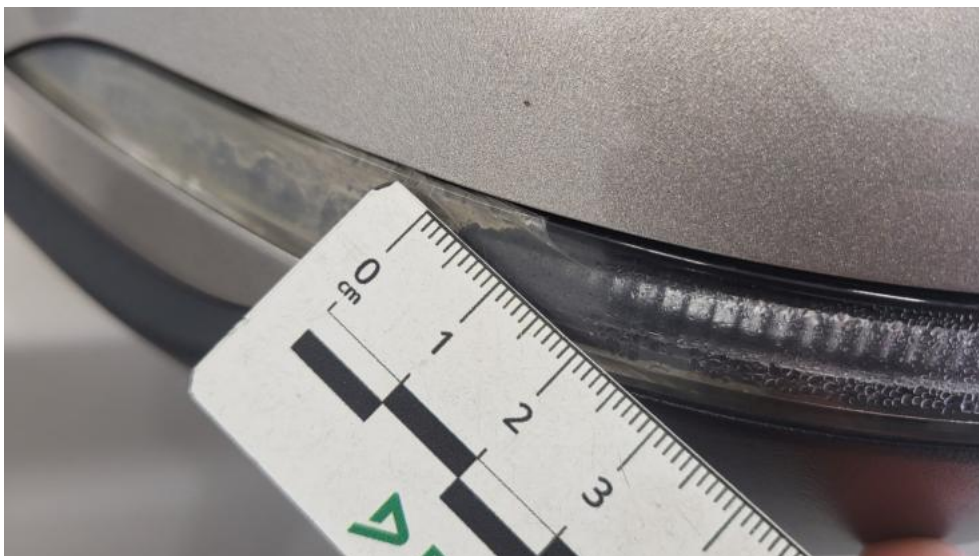
**Photo 74.**

Lusterko zew L - Pęknięcie/rozerwanie 1

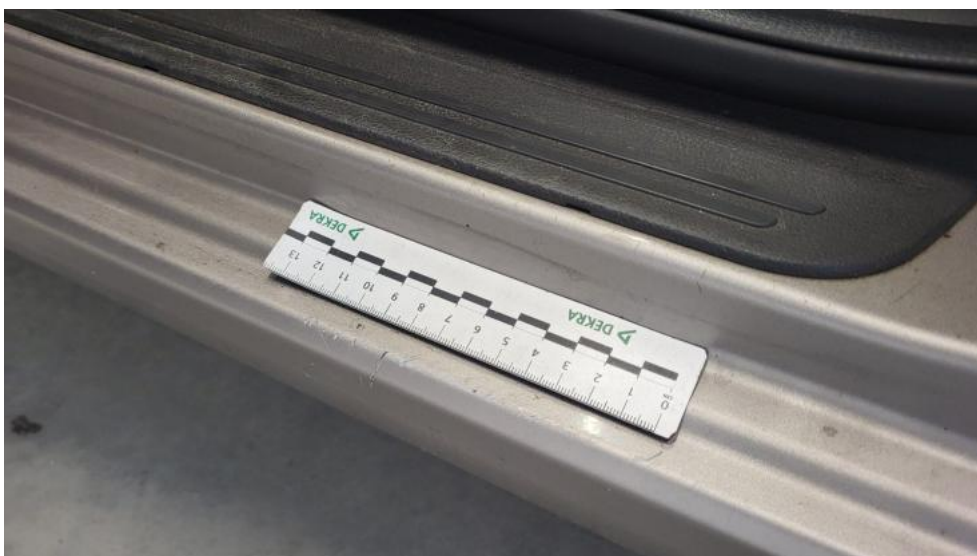
**Photo 76.**

Próg L - Rysa/odprysk 1

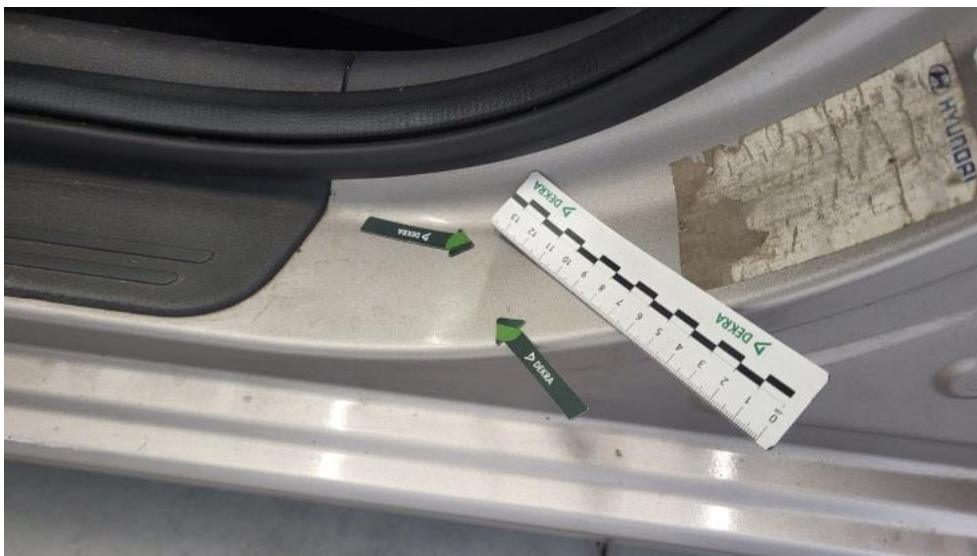
**Photo 77.**

Próg L - Wgniecenie/odkształcenie 1

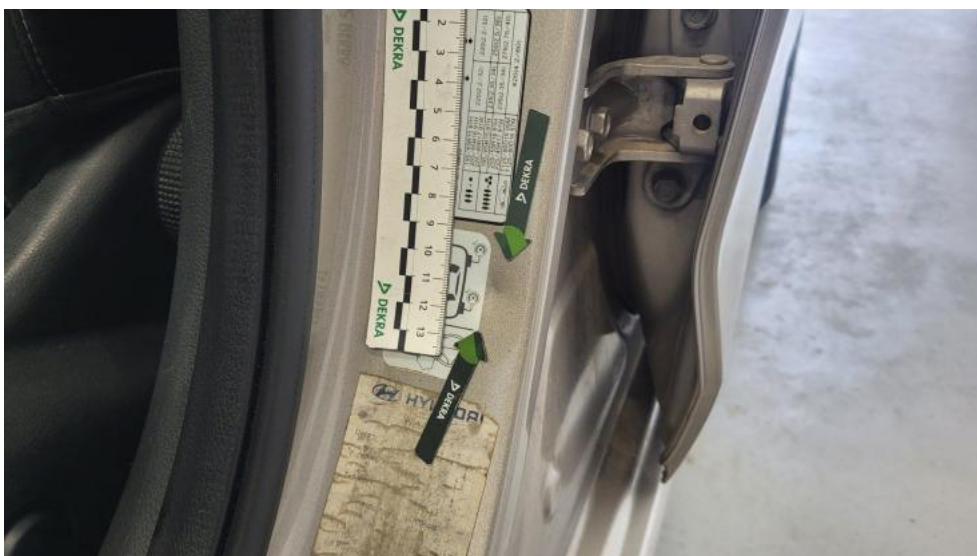
**Photo 78.**

Słupek środkowy L - Wgniecenie/odkształcenie 1

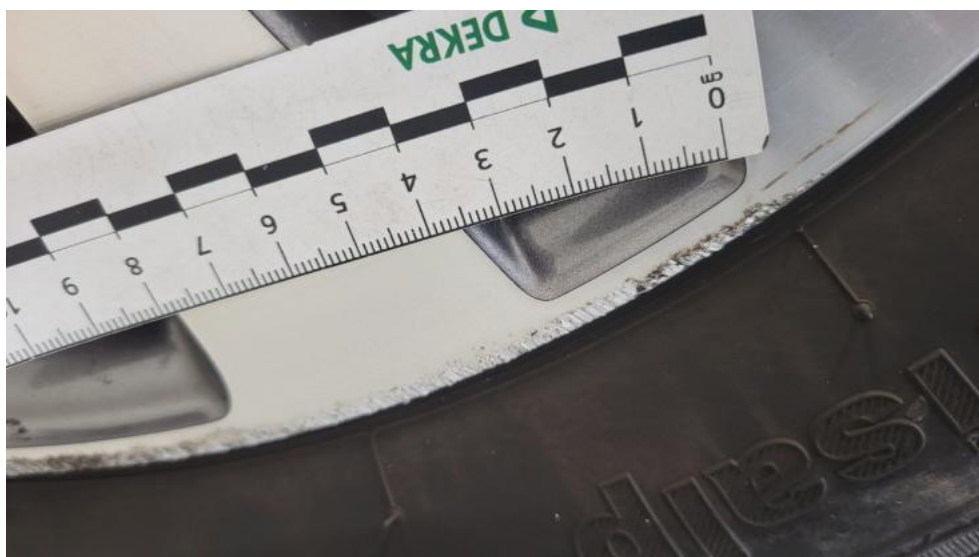
**Photo 79.**

Felga Aluminiowa przednia L - Rysa/odprysk 1

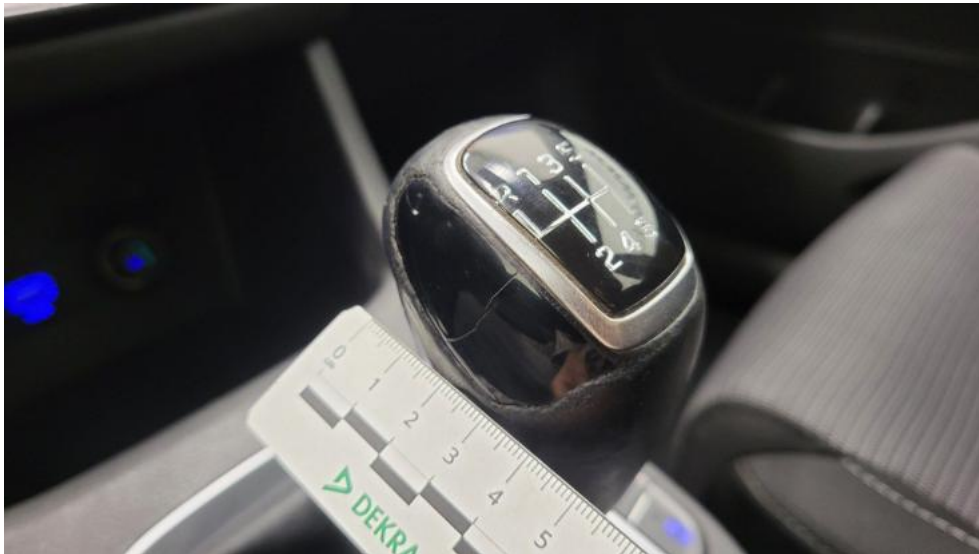
**Photo 81.**

Gałka dźwigni zmiany biegów - Pęknięcie/rozerwanie 1

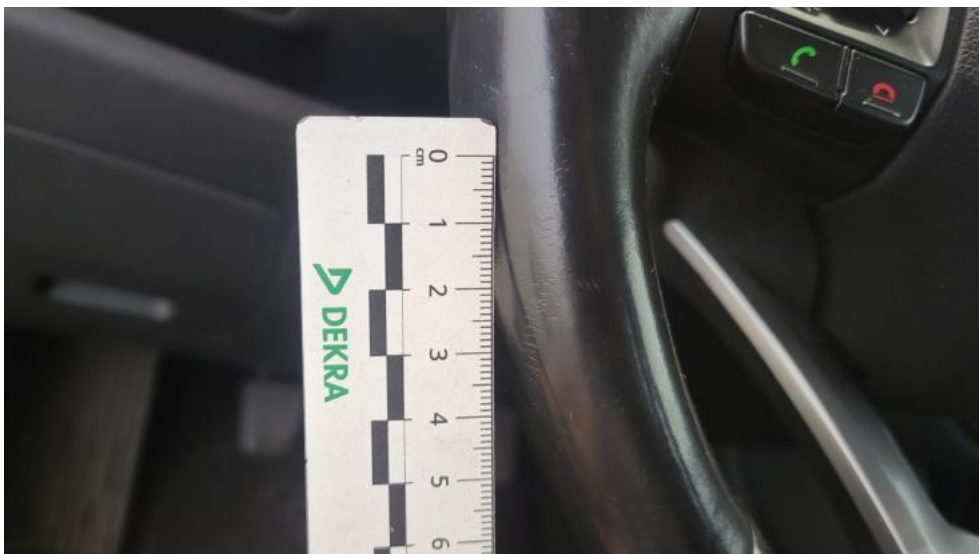
**Photo 82.**

Koło kierownicy - Rysa/odprysk 1

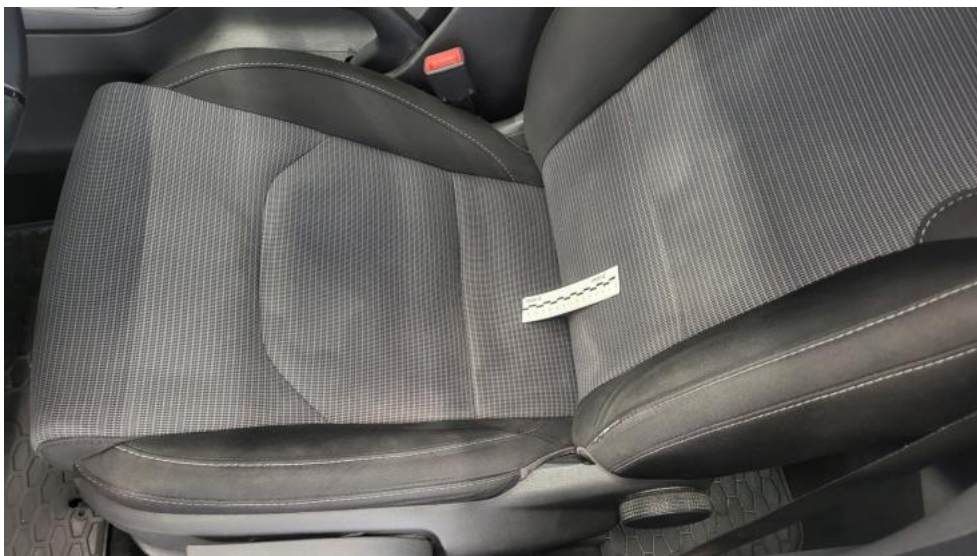
**Photo 83.**

Fotel prz. lew. - Inne 1

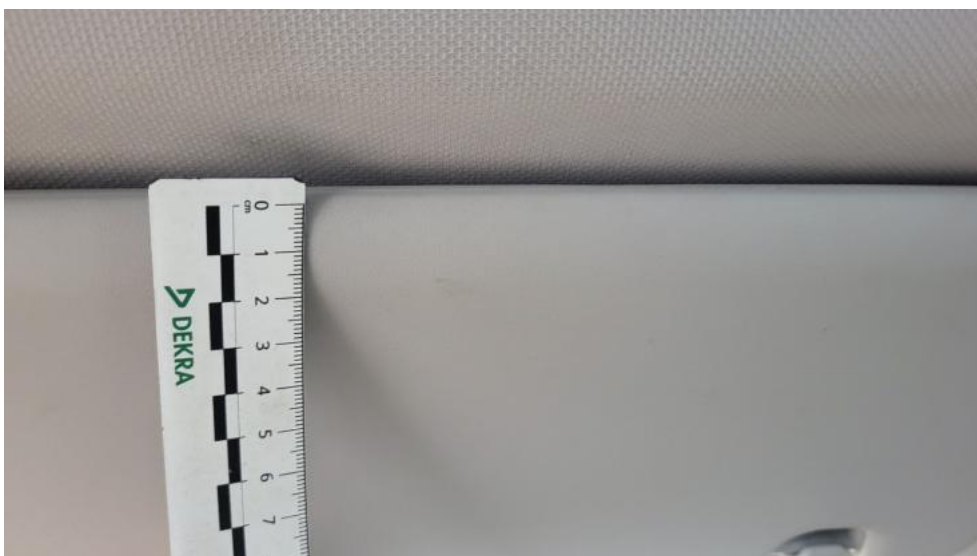
**Photo 84.**

Osłona p/słoneczna lewa - Inne 1

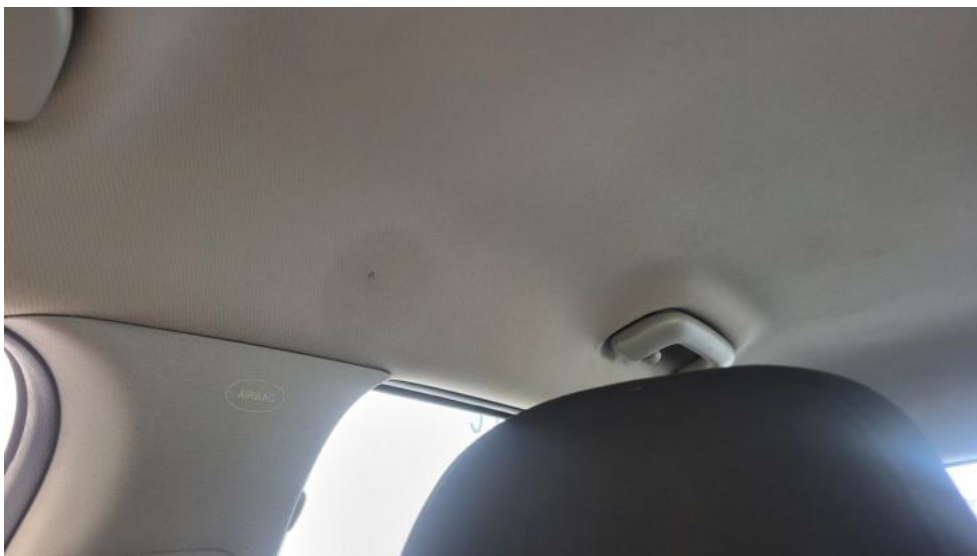
**Photo 85.**

Podsufitka - Inne 1

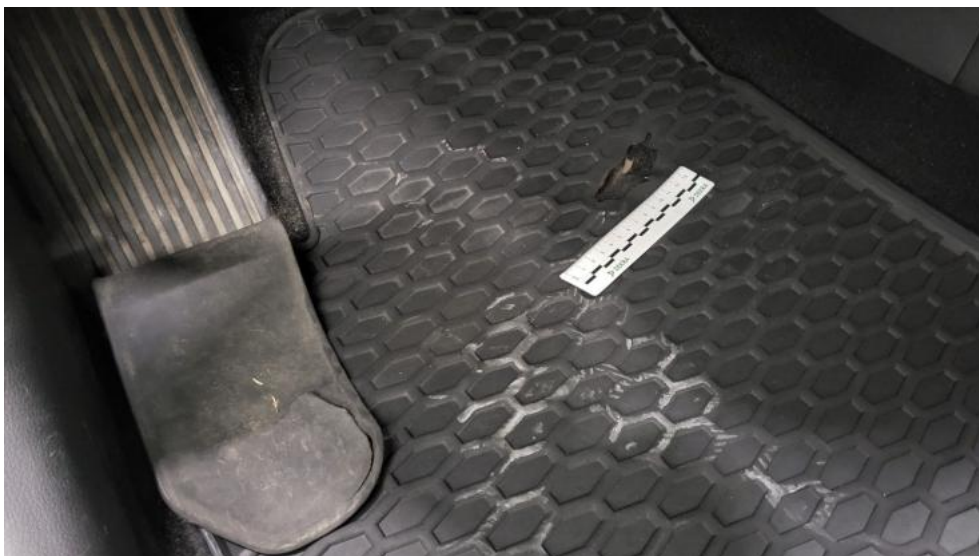
**Photo 88.**

Dywanik prze L - Pęknięcie/rozerwanie 1

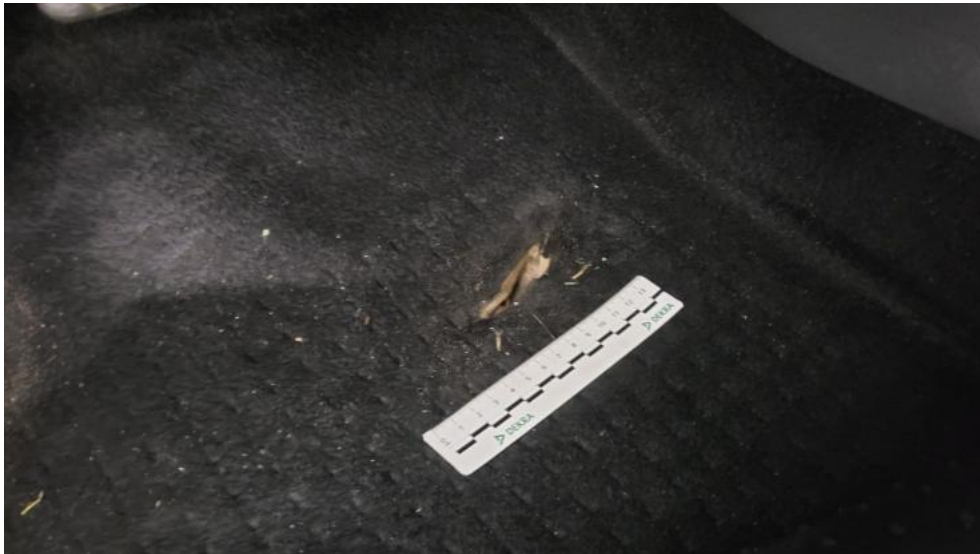
**Photo 89.**

Wykładzina podłogi - Pęknięcie/rozerwanie 1

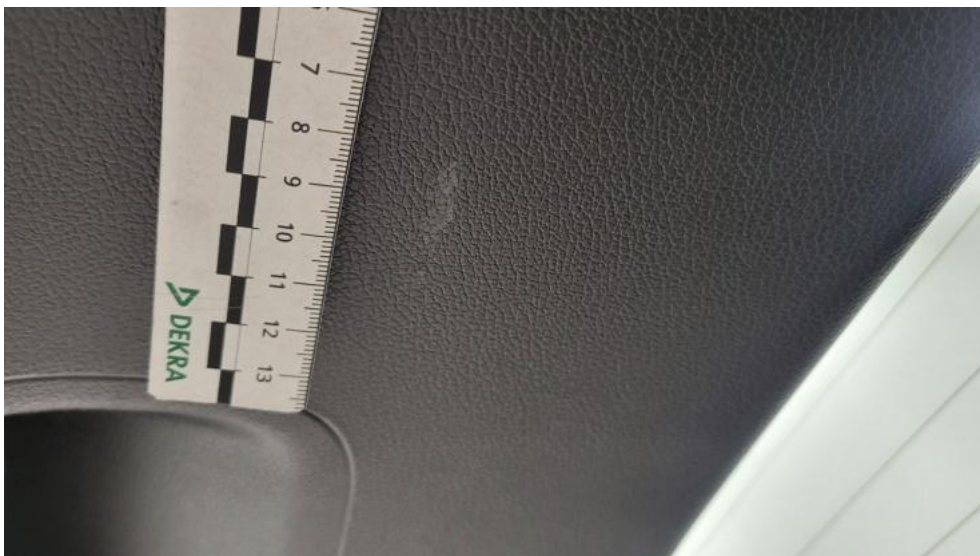
**Photo 90.**

Wykładzina pokrywy tylnej - Rysa/odprysk 1
