DEKRA's commission No. : PKOL(W)/LODZ/73095/25/09/26  
commission/ damage No. : 22/013693  
Date of commission: 26-09-2025

| Manufacturer | NISSAN |
| Type / version | Leaf 40kWh Acenta |
| Registration /record No. | GD188YR |

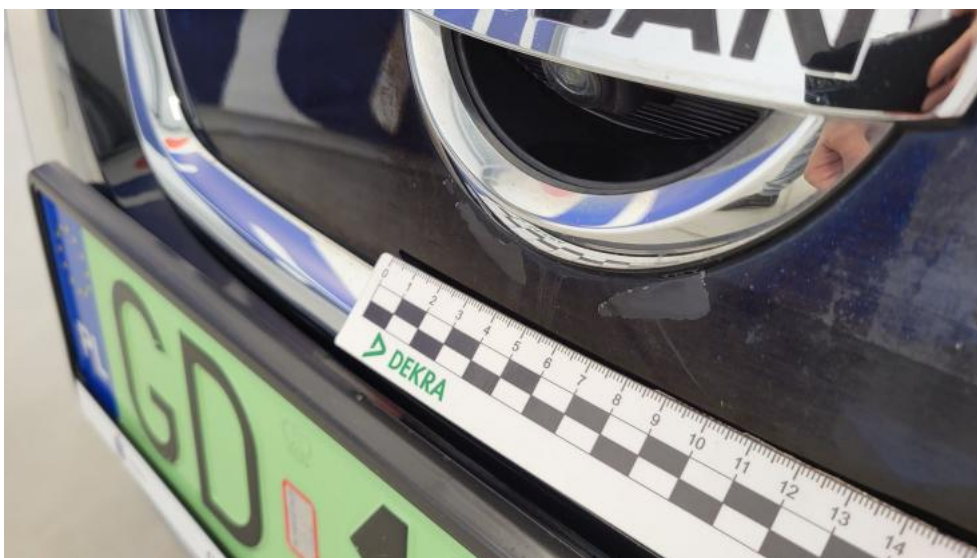
**Photo 44.**

Atrapa przednia - Rysa/odprysk 1

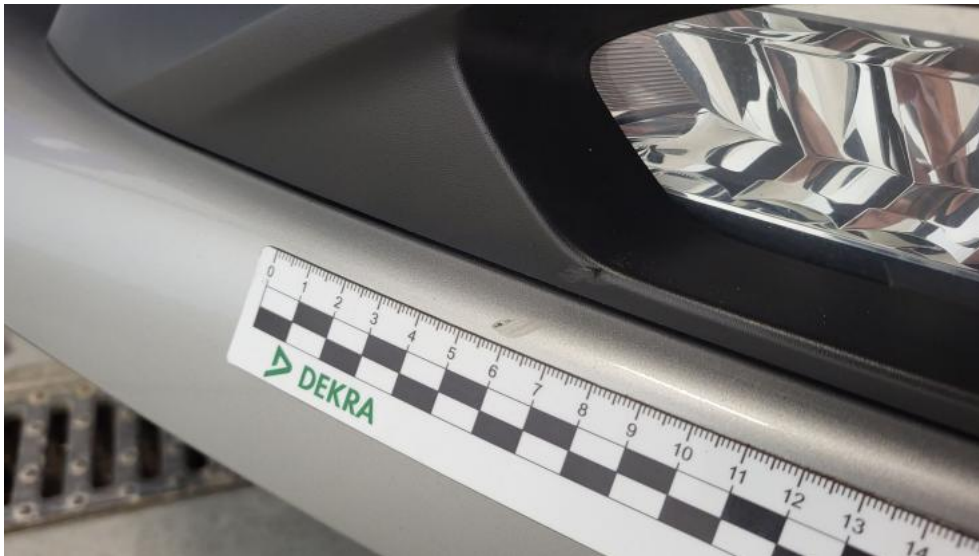
**Photo 45.**

Kratka/zaślepka halogenu L - Rysa/odprysk 1

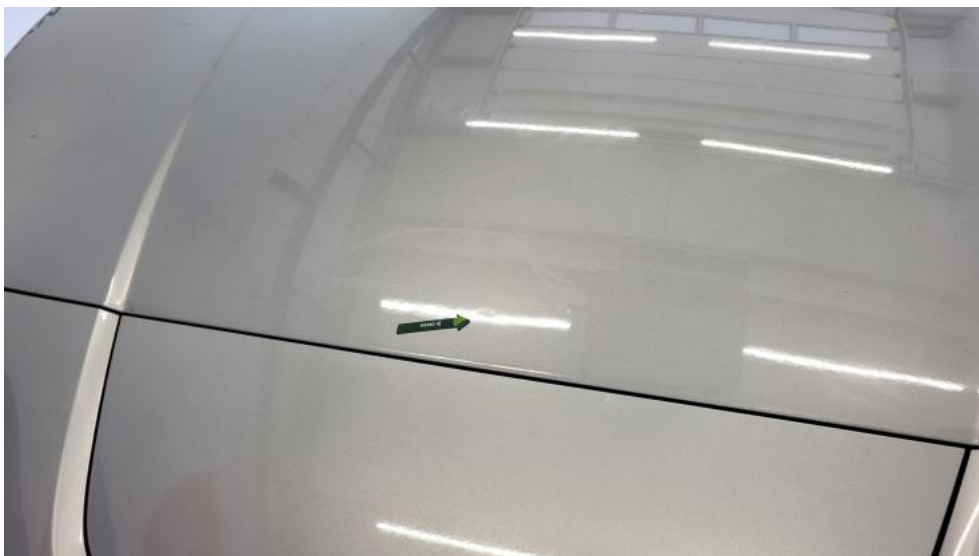
**Photo 46.**

Pokrywa komory silnika - Wgniecenie/odkształcenie 1

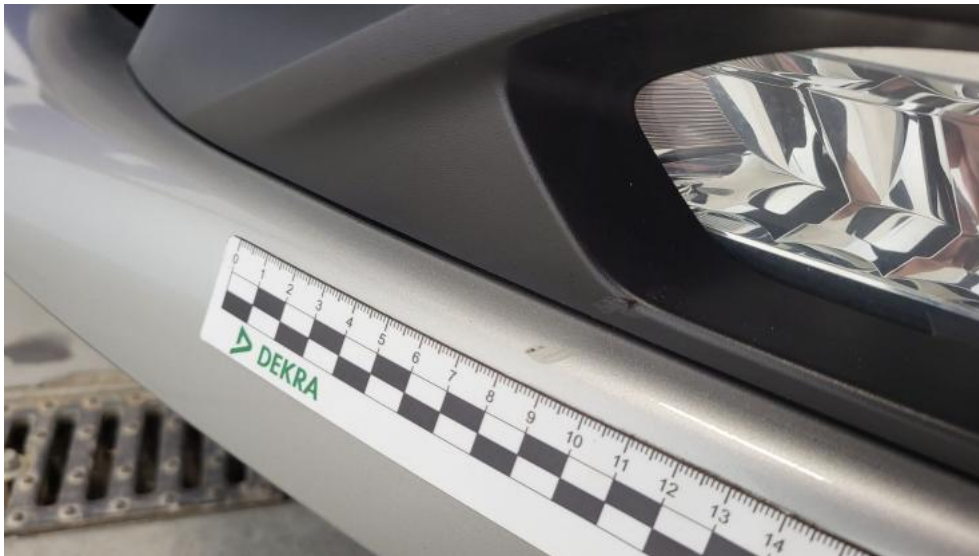
**Photo 49.**

Zderzak - Rysa/odprysk 2

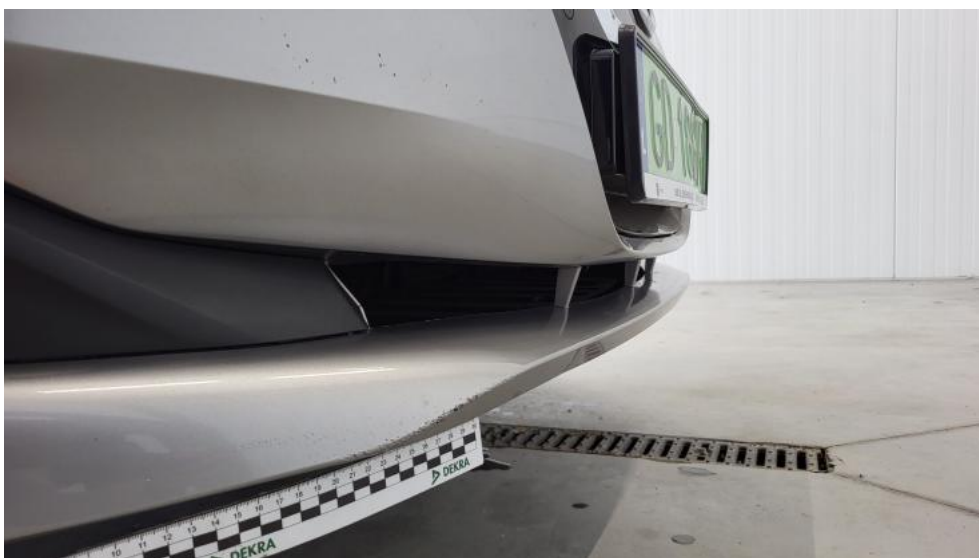
**Photo 50.**

Zderzak() - Rysa/odprysk 3

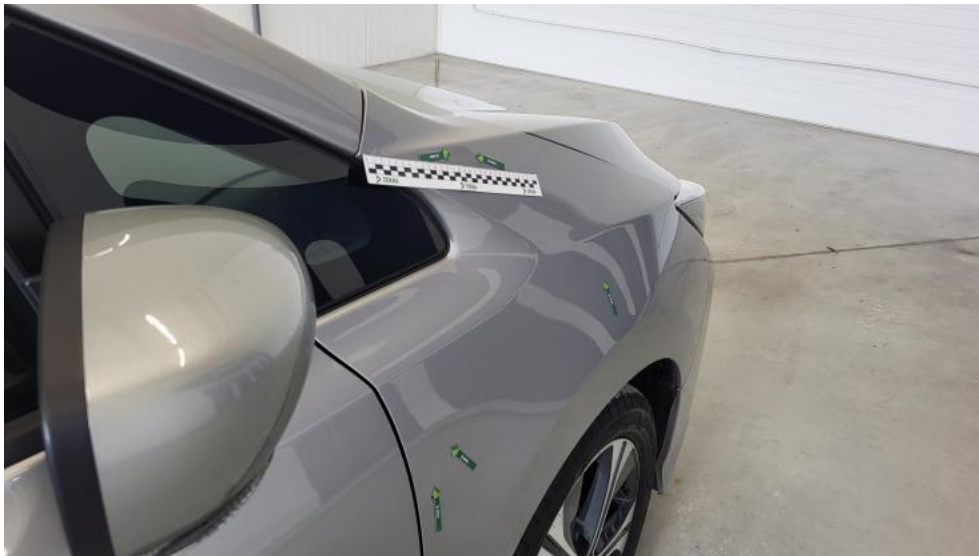
**Photo 51.**

Błotnik przedni P - Wgniecenie/odkształcenie 1

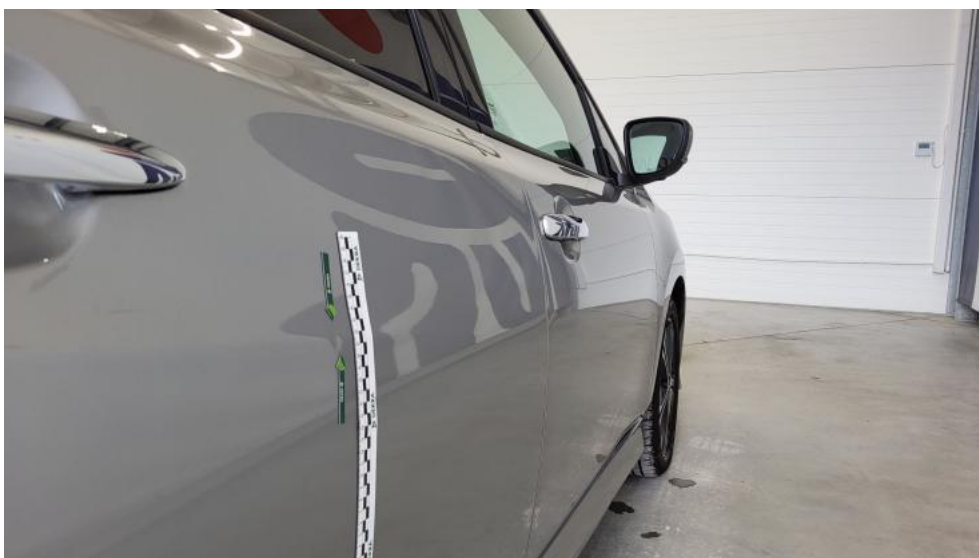
**Photo 52.**

Drzwi tylne P - Wgniecenie/odkształcenie 1

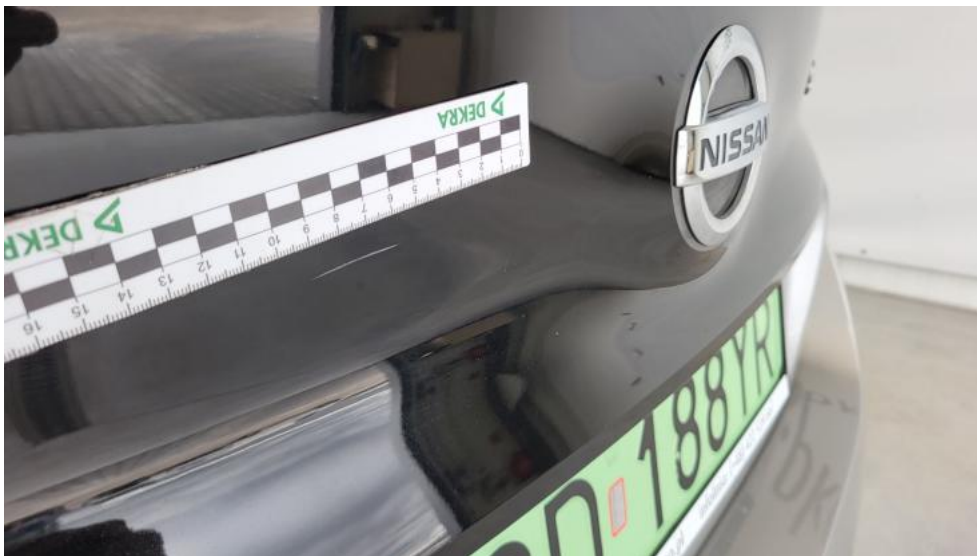
**Photo 57.**

Pokrywy bagażnika - Rysa/odprysk 1

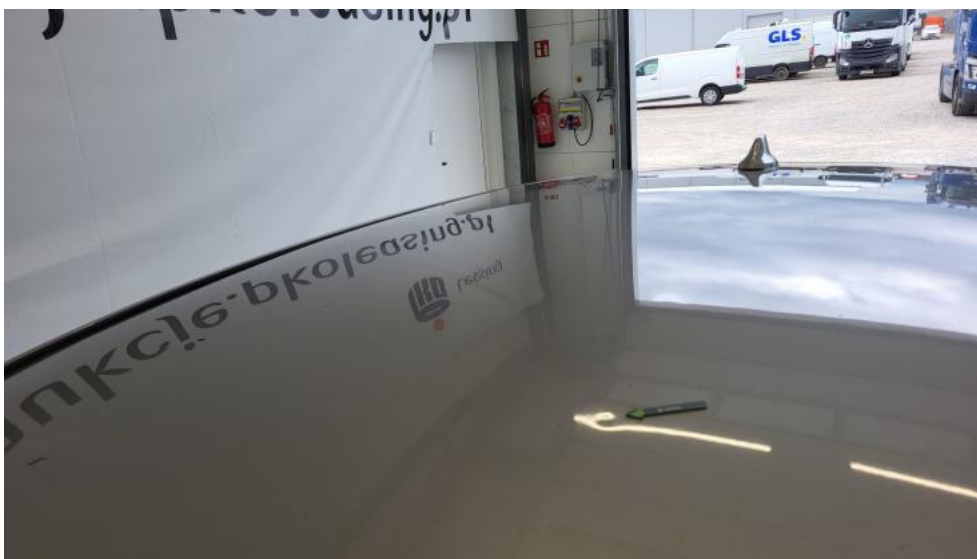
**Photo 61.**

Dach - Wgniecenie/odkształcenie 1

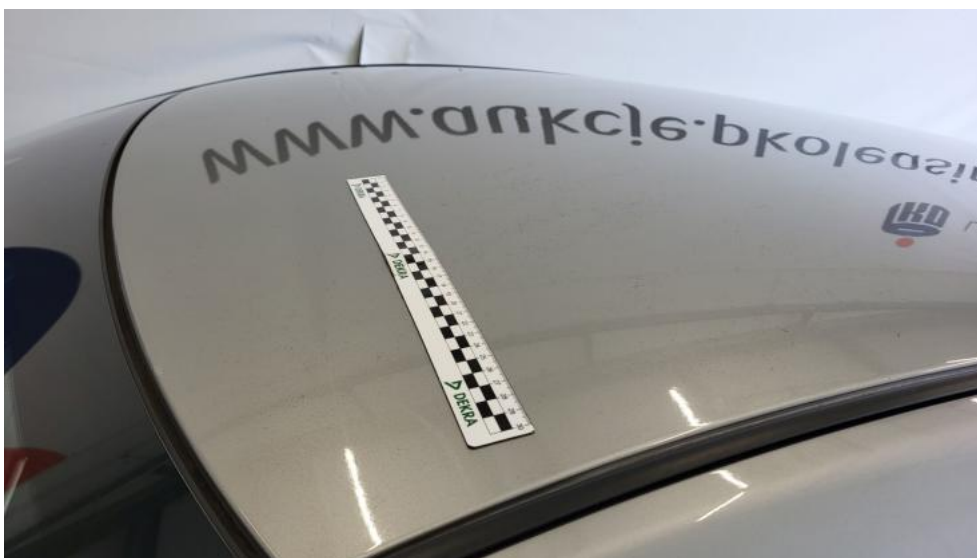
**Photo 62.**

Dach - Inne 1

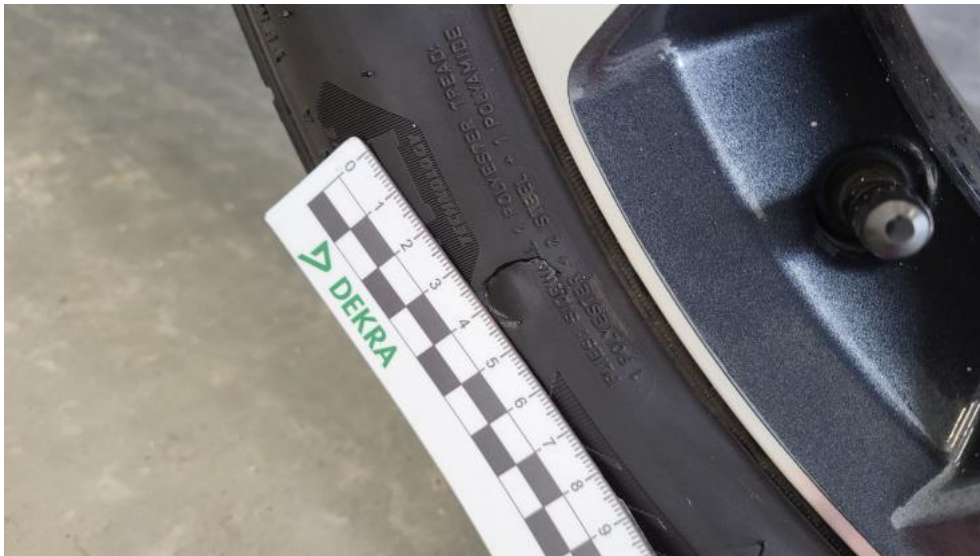
**Photo 65.**

Opona tylna L - Pęknięcie/rozerwanie 1

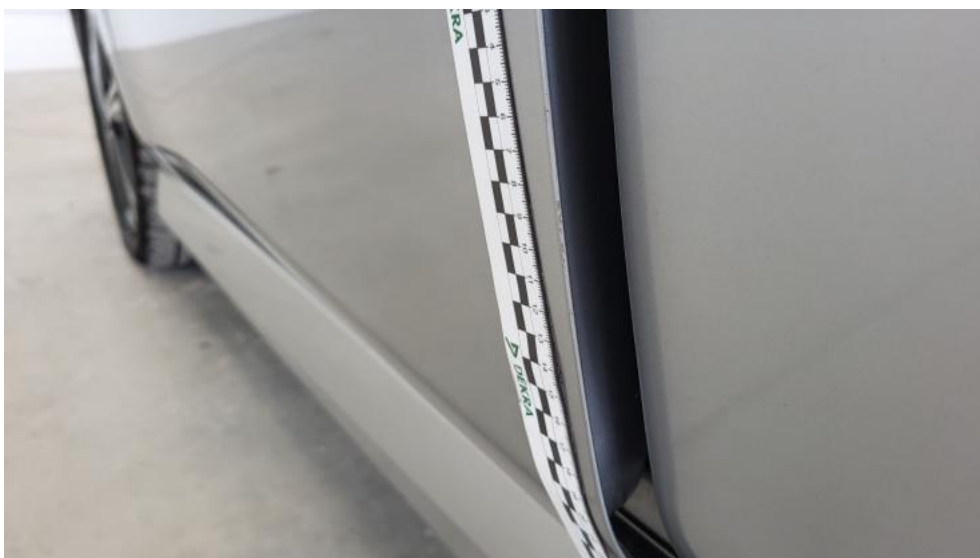
**Photo 66.**

Drzwi przed L - Rysa/odprysk 1

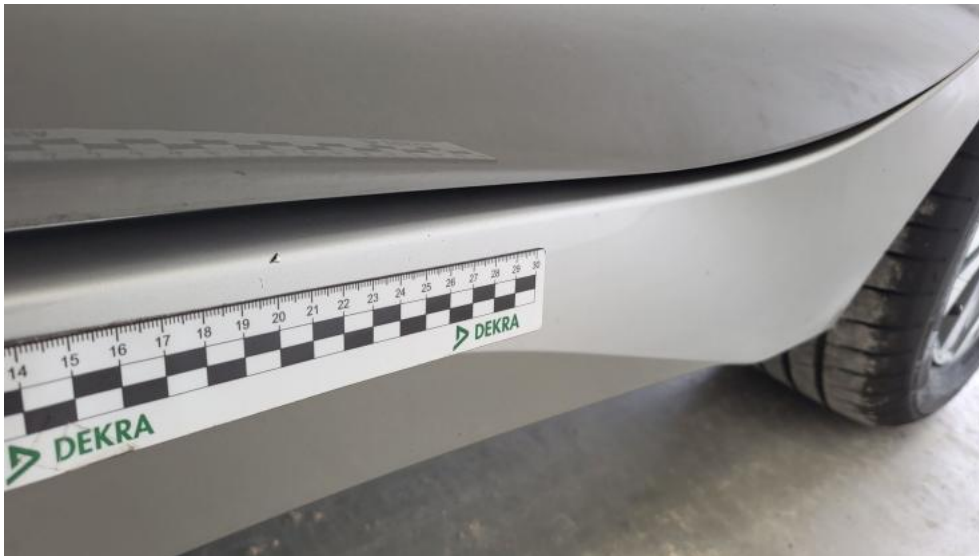
**Photo 67.**  
Próg L - Rysa/odprysk 1

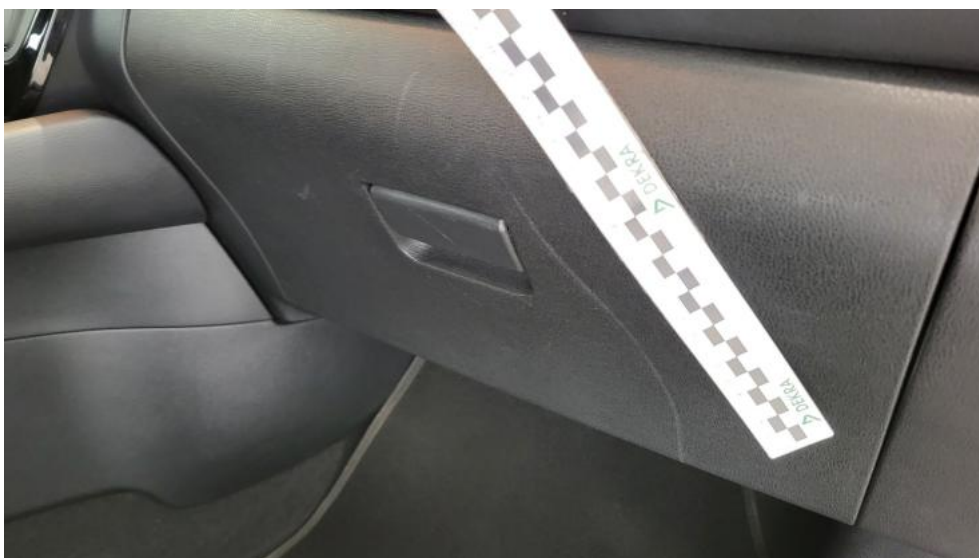
**Photo 68.**  
Deska rozdzielcza - Rysa/odprysk 1

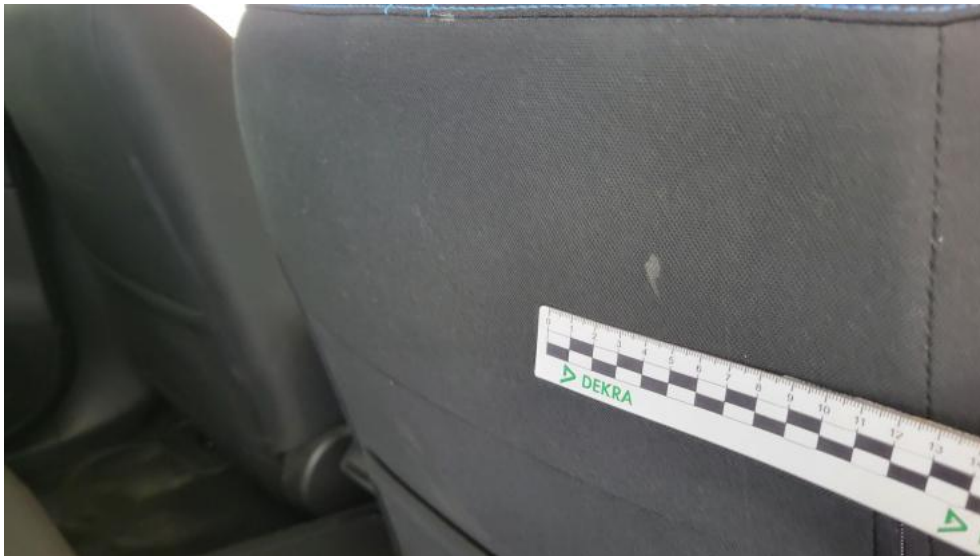
**Photo 69.**

Fotel prz. praw. - Inne 1

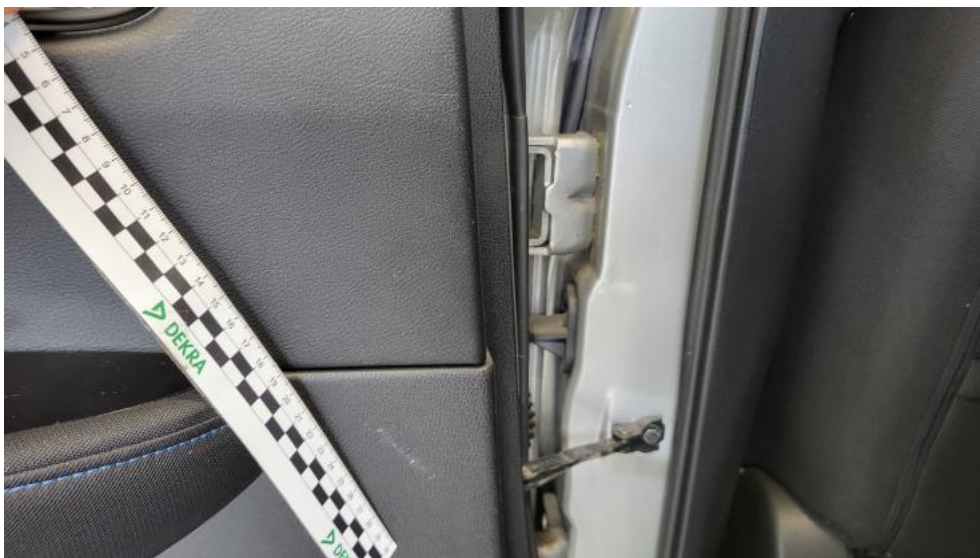
**Photo 70.**

Tapicerka drzwi tylnych L - Rysa/odprysk 1
