DEKRA's commission No. : PKOL(W)/LODZ/01388/26/01/08  
commission/ damage No. : 00747/EO/22  
Date of commission: 08-01-2026

| Manufacturer | JAGUAR |
| Type / version | F-Pace 5.0 V8 P550 AWD SVR |
| Registration /record No. | ZS657PU |

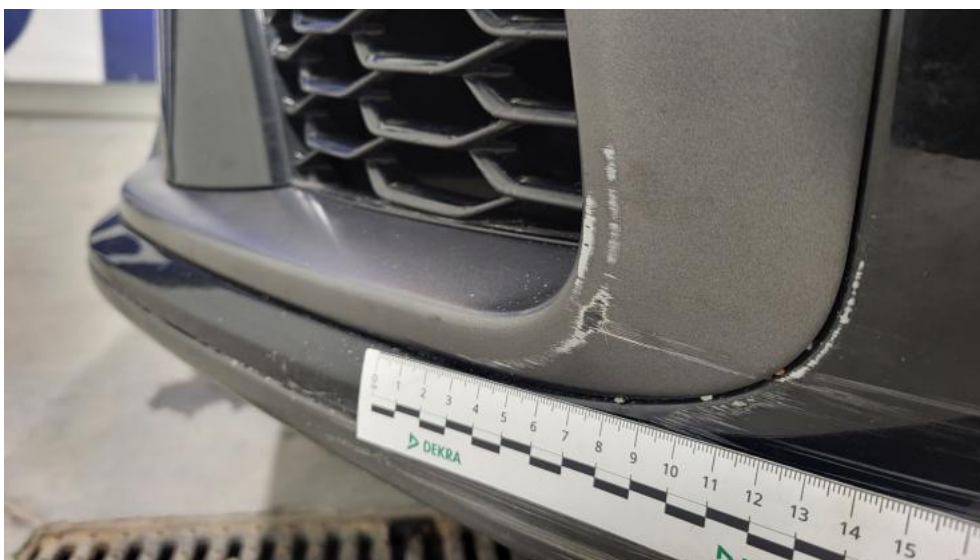
**Photo 42.**

Kratka/zaślepka halogenu L - Rysa/odprysk 1

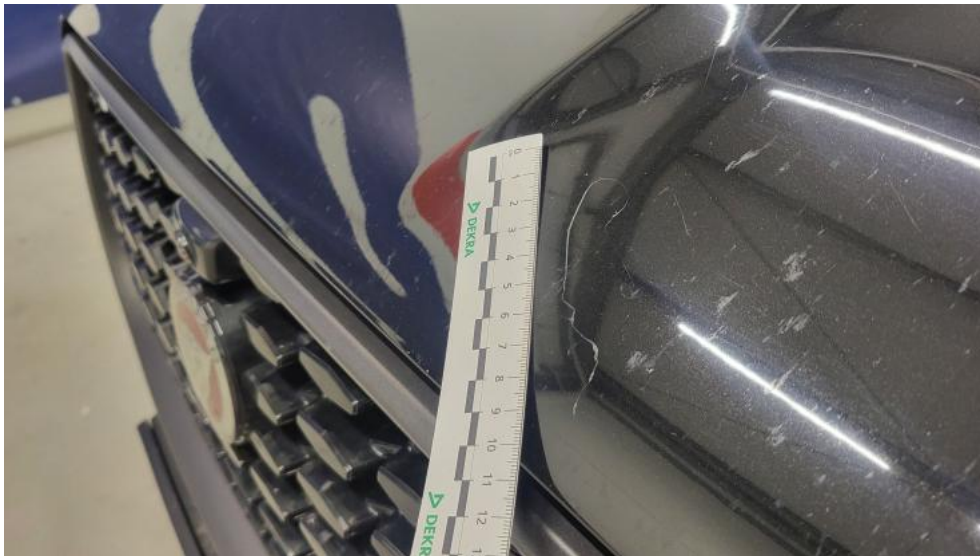
**Photo 43.**

Pokrywa komory silnika - Rysa/odprysk 1

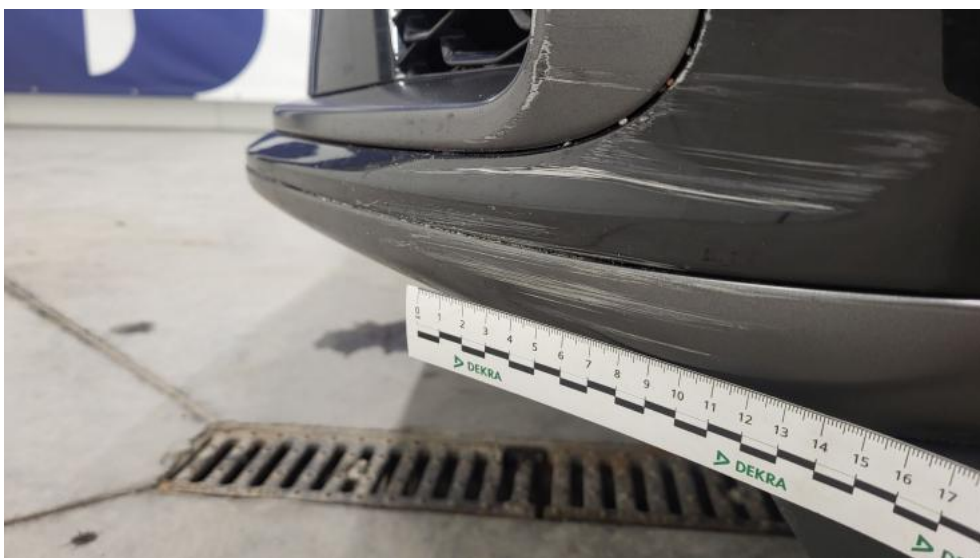
**Photo 44.**

Spoiler zderzaka przedniego - Rysa/odprysk 1

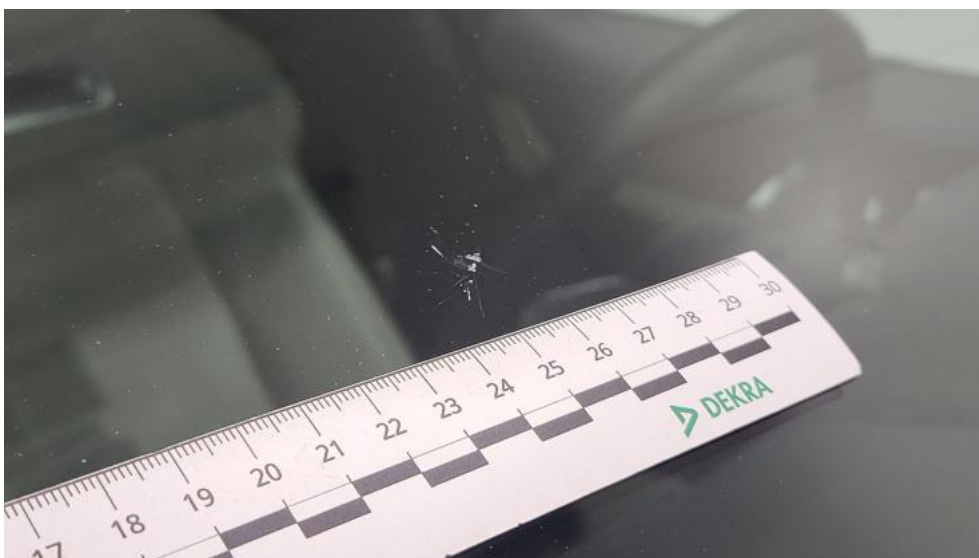
**Photo 46.**

Szyba czołowa - Pęknięcie/rozerwanie 1

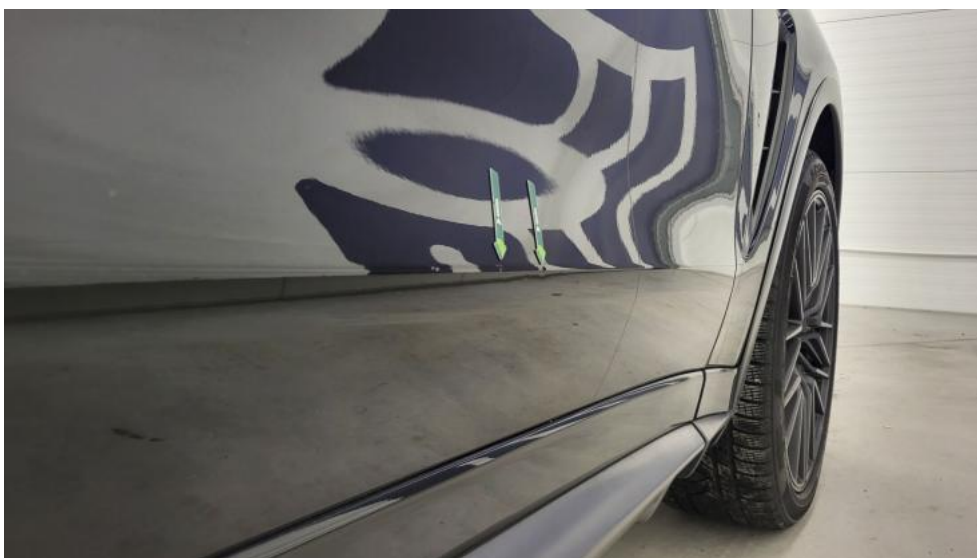
**Photo 50.**

Drzwi przednie P - Wgniecenie/odkształcenie 1

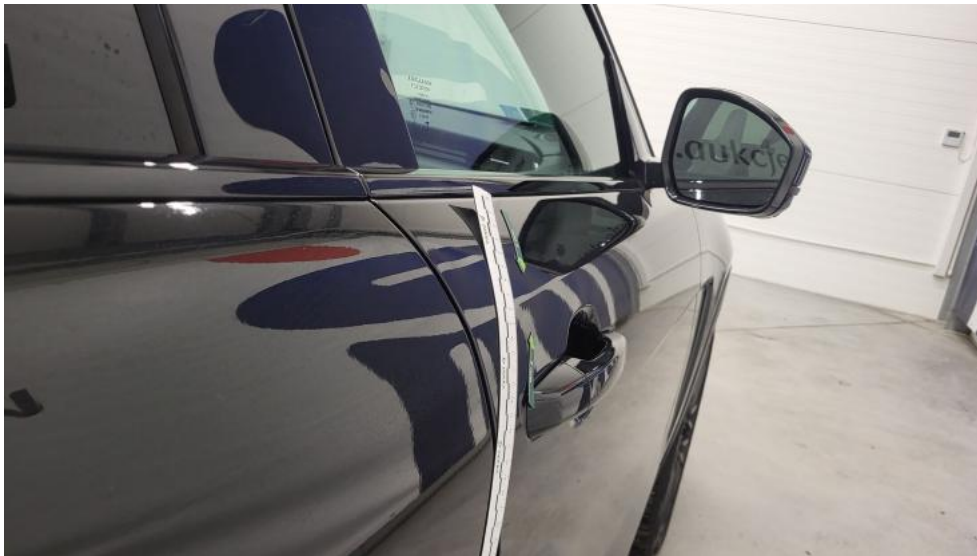
**Photo 51.**

Drzwi przednie P - Wgniecenie/odkształcenie 2

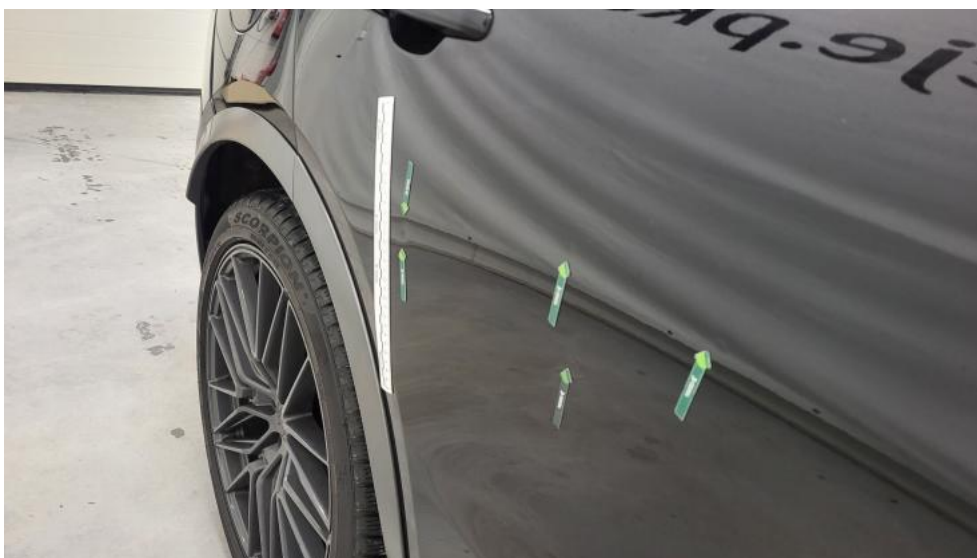
**Photo 52.**

Drzwi tylne P - Wgniecenie/odkształcenie 1

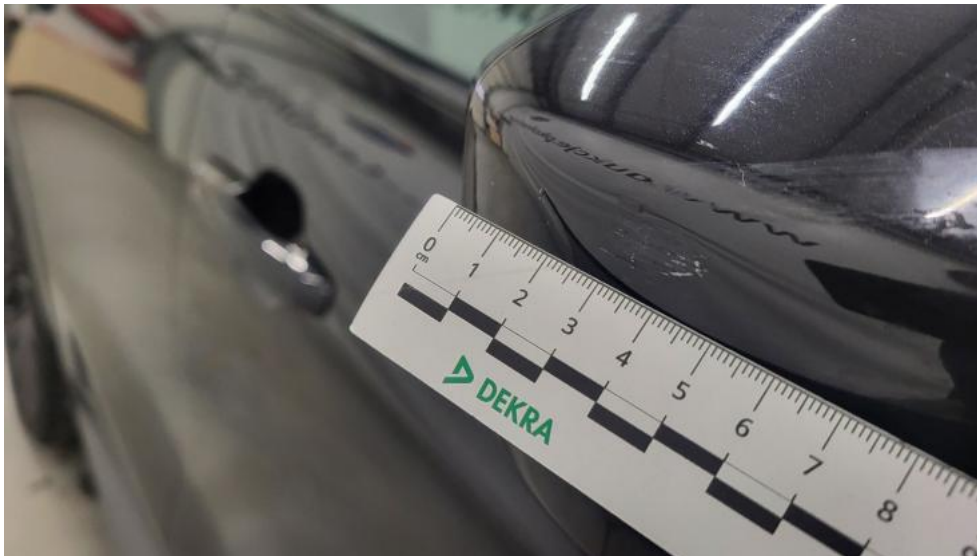
**Photo 53.**

Lusterko zew P - Rysa/odprysk 1

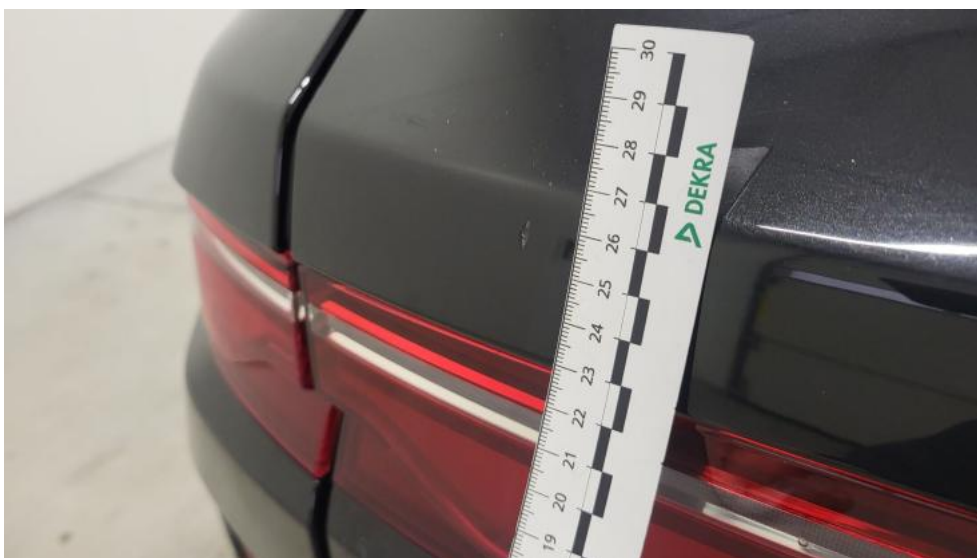
**Photo 54.**

Pokrywy bagażnika - Rysa/odprysk 1

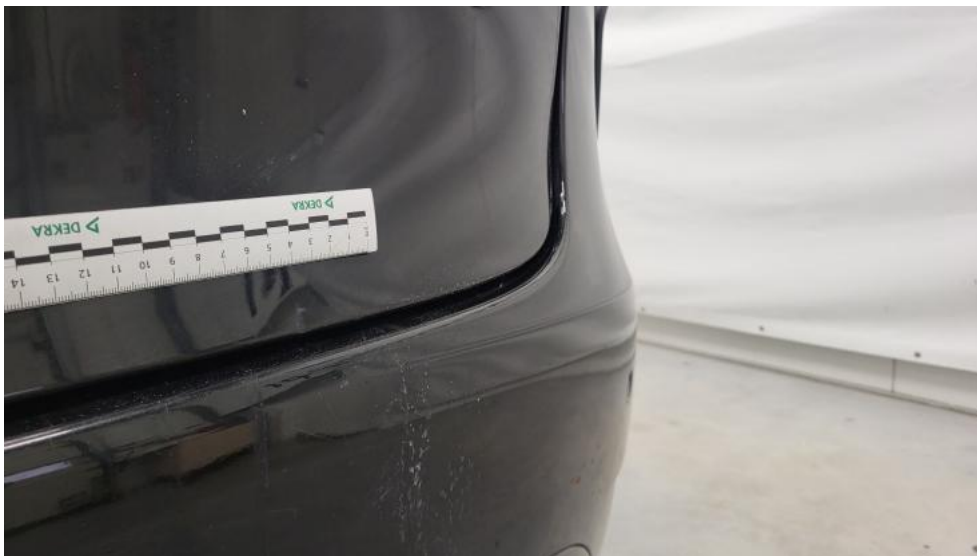
**Photo 55.**

Pokrywy bagażnika - Wgniecenie/odkształcenie 1

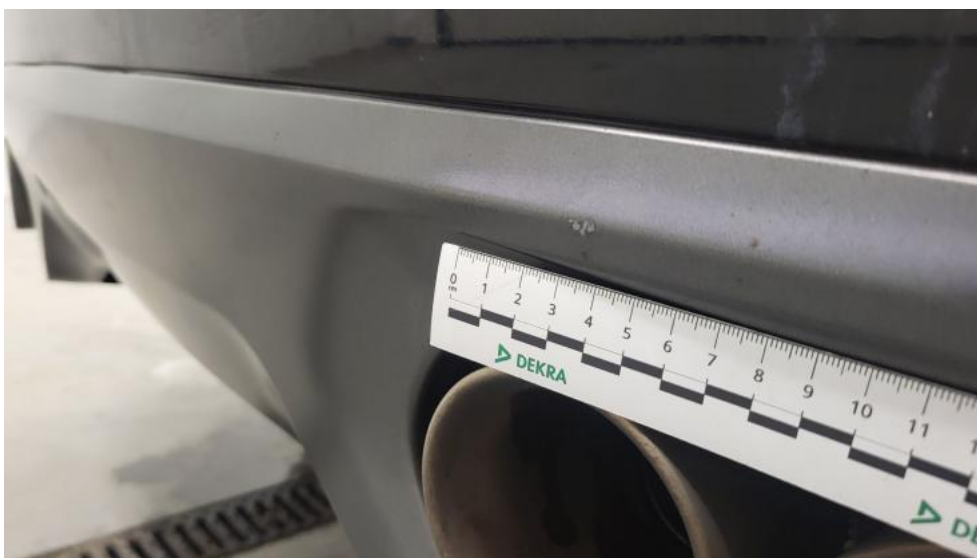
**Photo 56.**

Spojler zderzaka tylnego - Rysa/odprysk 1

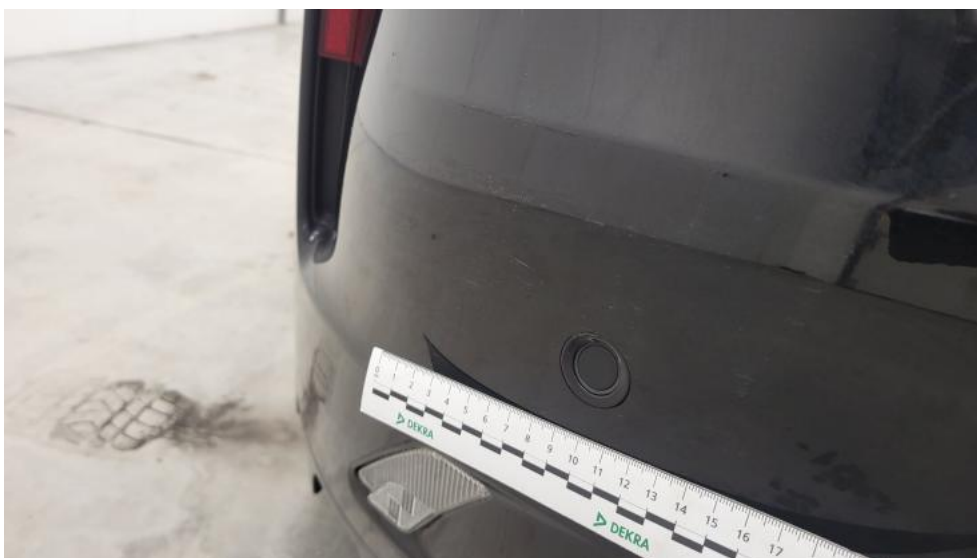
**Photo 58.**

Zderzak tylny - Rysa/odprysk 1

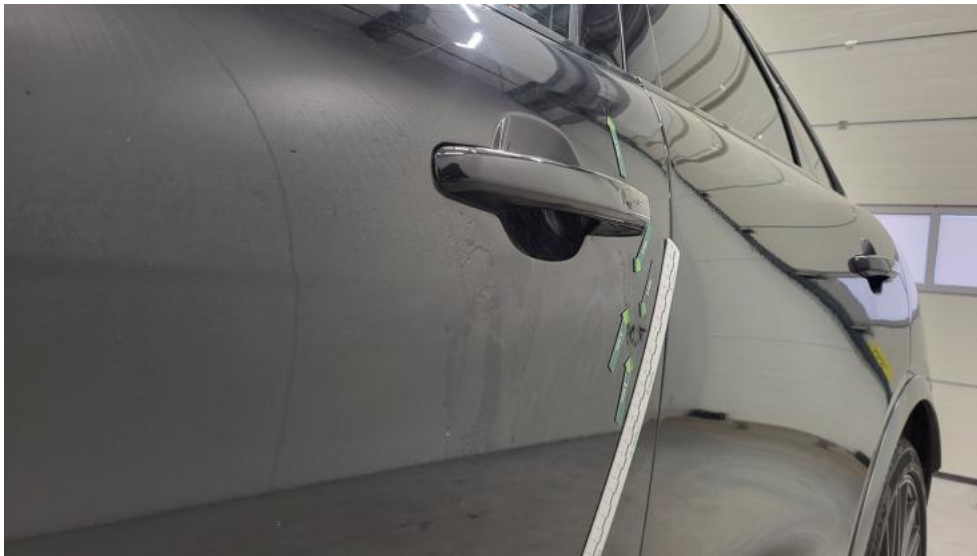
**Photo 61.**

Drzwi przed L - Wgniecenie/odkształcenie 1

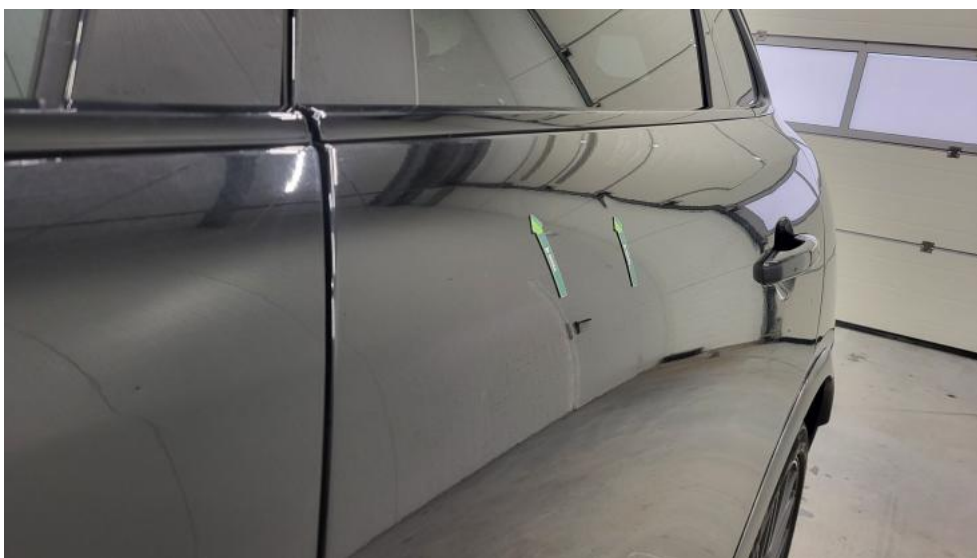
**Photo 62.**

Drzwi tylne L - Wgniecenie/odkształcenie 1

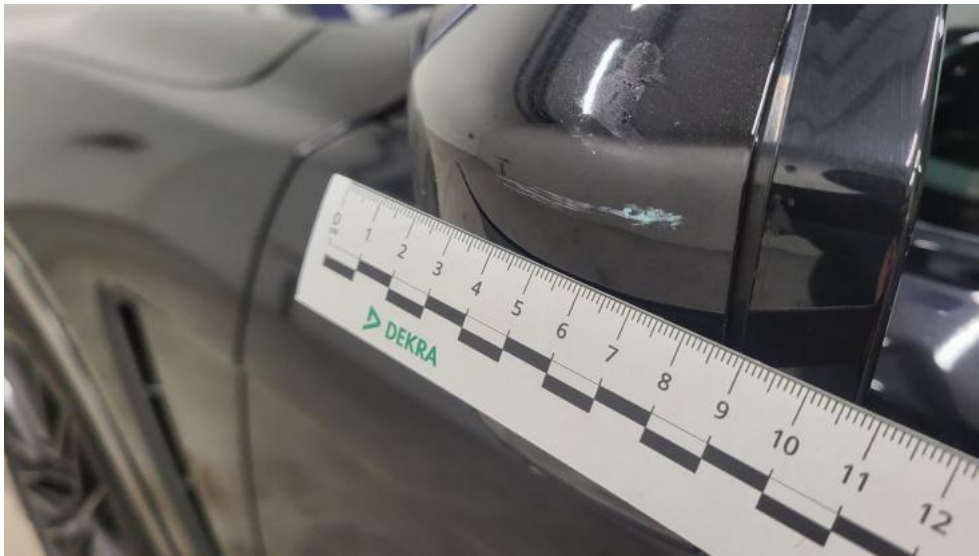
**Photo 63.**

Lusterko zew L - Rysa/odprysk 1

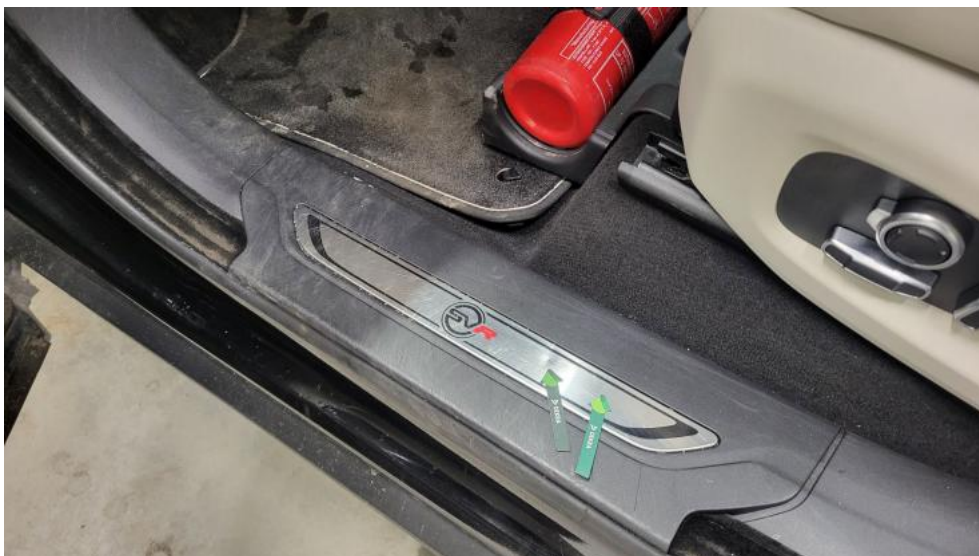
**Photo 64.**

Próg L - Wgniecenie/odkształcenie 1

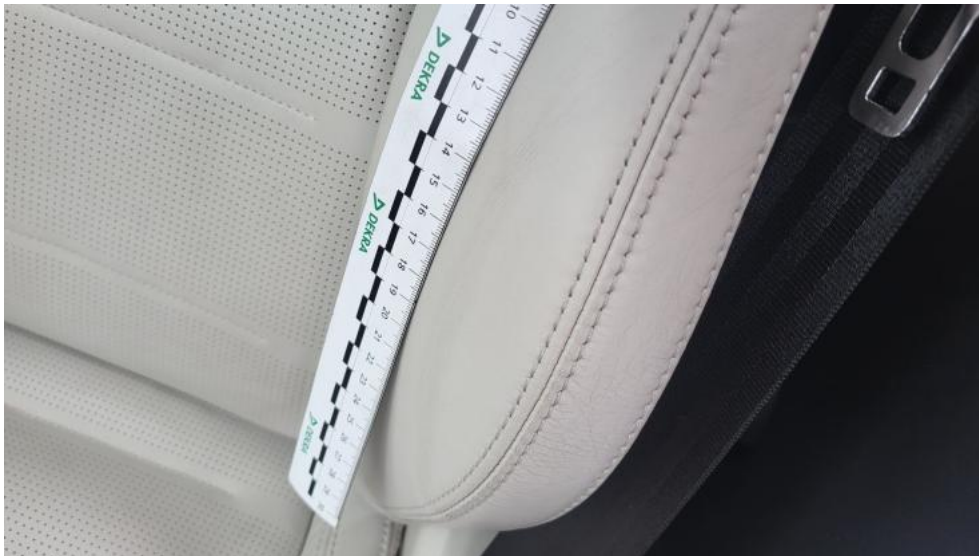
**Photo 65.**

Fotel prz. lew. - Rysa/odprysk 1

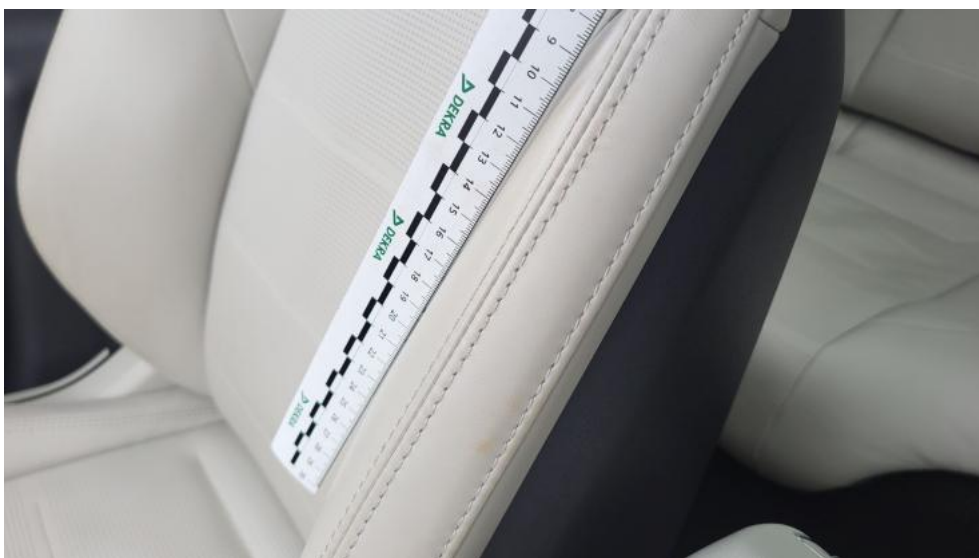
**Photo 66.**

Fotel prz. praw. - Inne 1
