DEKRA's commission No. : PKOL(W)/LODZ/90093/25/11/20  
commission/ damage No. : 22/035149  
Date of commission: 20-11-2025

| Manufacturer | MERCEDES-BENZ |
| Type / version | AMG GLC 63 S 4-Matic |
| VIN / serial number | WDC2539891F737426 |

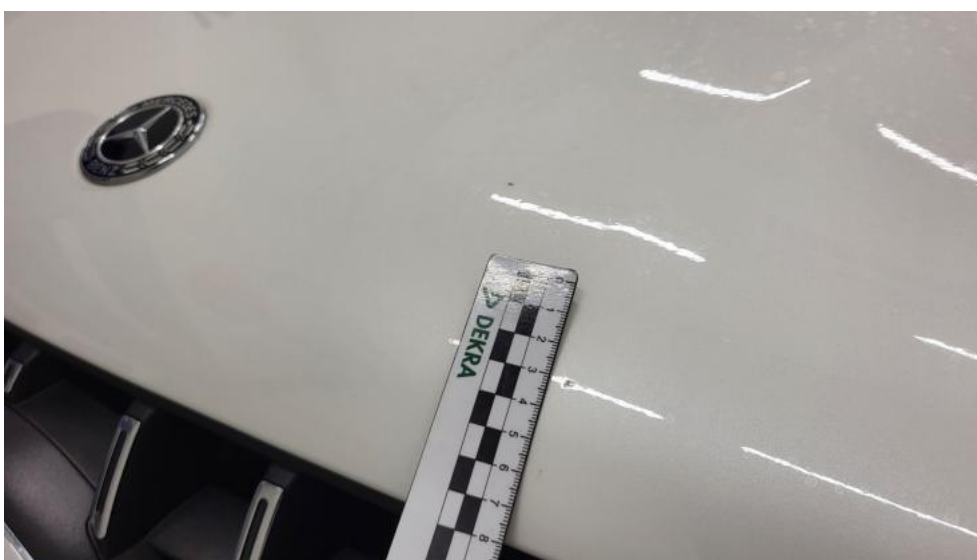
**Photo 46.**

Rysy na samochodzie. Brak płynu zestawu naprawczego. Brak zaślepek w tylnej kanapie. Przegląd B5 wymagany od 84 dni. Pokrywa przednia oklejona folią, pomiar lakieru wykonany na folii. Odpryski na szybie czołowej.

Pokrywa komory silnika - Wgniecenie/odkształcenie 1

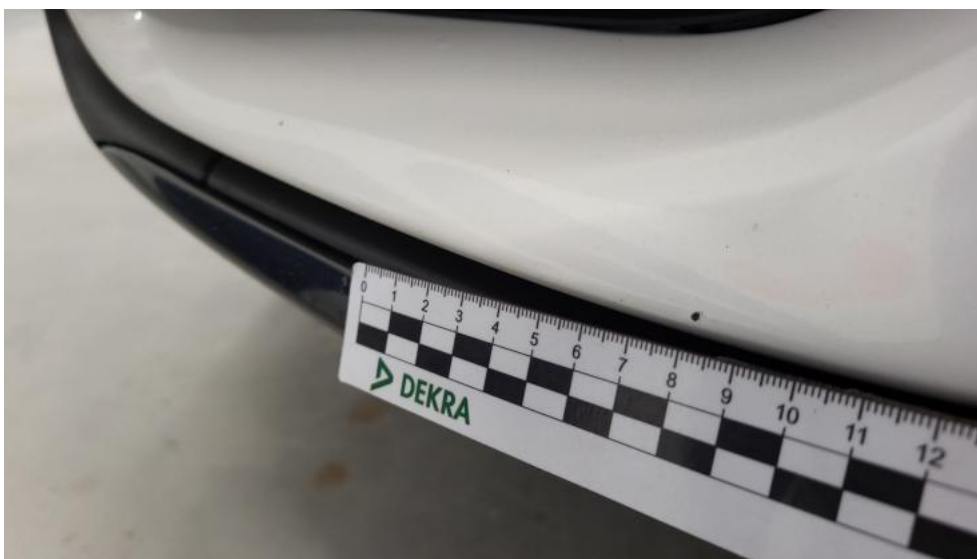
**Photo 47.**

Zderzak - Rysa/odprysk 1

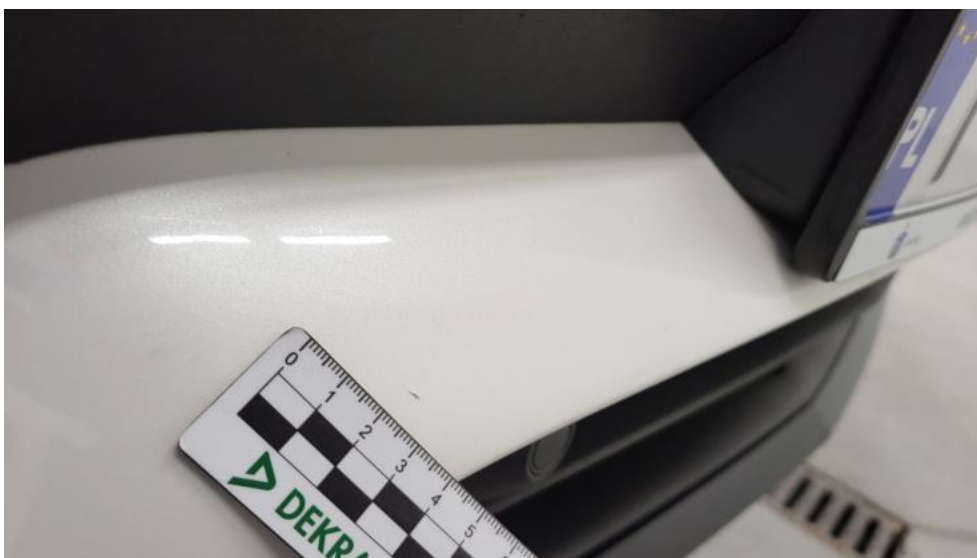
**Photo 48.**

Zderzak - Rysa/odprysk 2

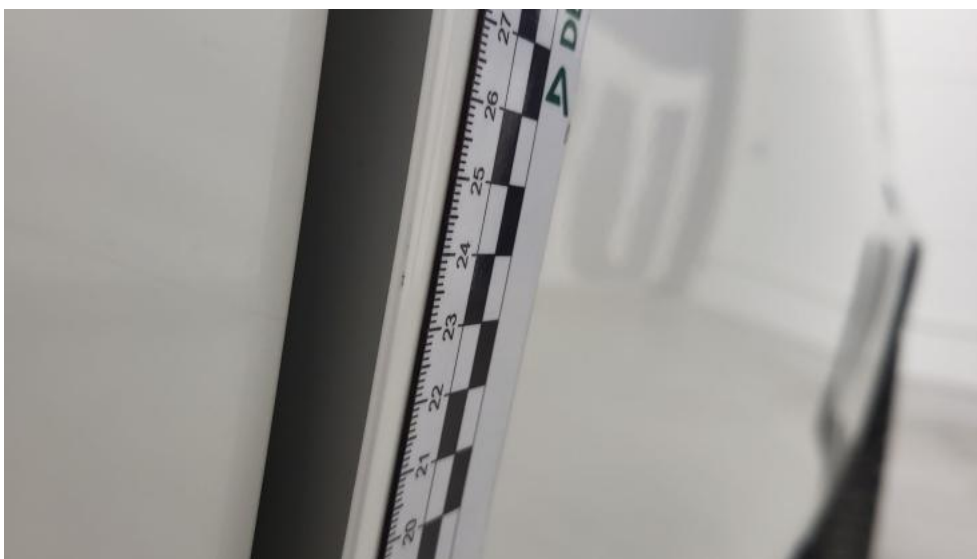
**Photo 49.**

Drzwi przednie P - Rysa/odprysk 1

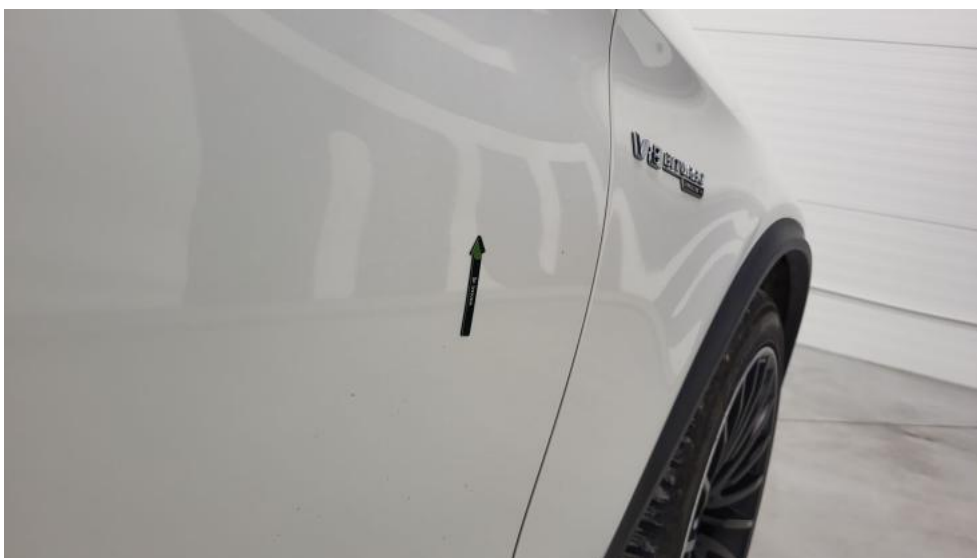
**Photo 50.**

Drzwi przednie P - Wgniecenie/odkształcenie 1

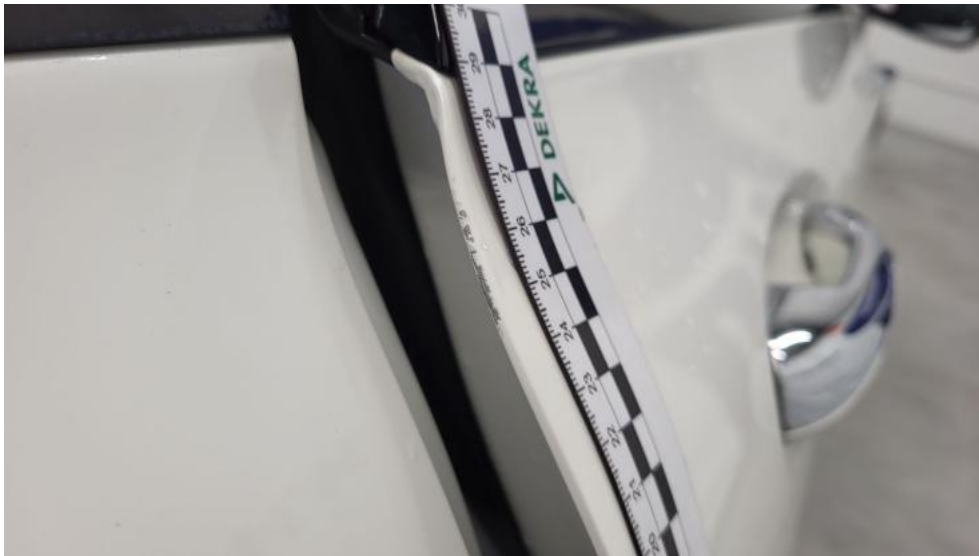
**Photo 51.**

Drzwi tylne P - Rysa/odprysk 1

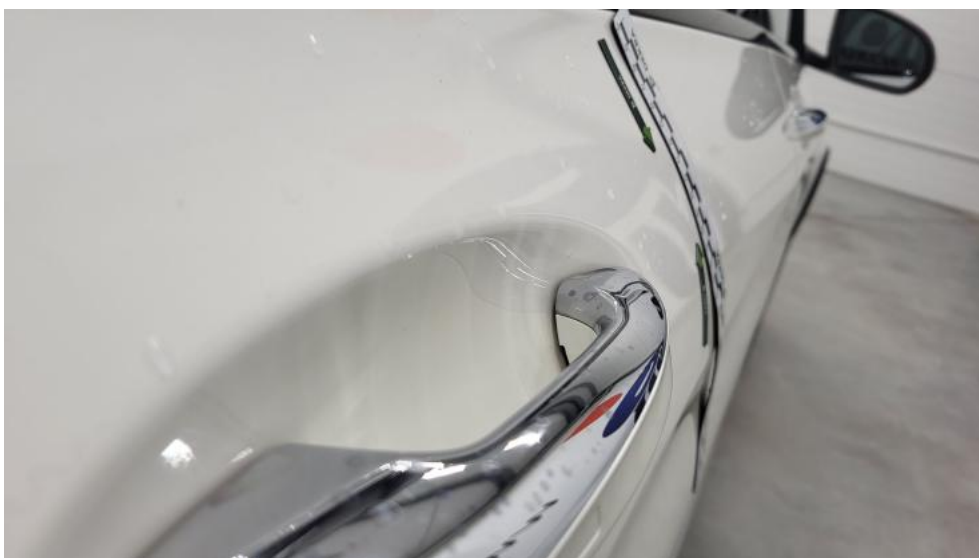
**Photo 52.**

Drzwi tylne P - Wgniecenie/odkształcenie 1

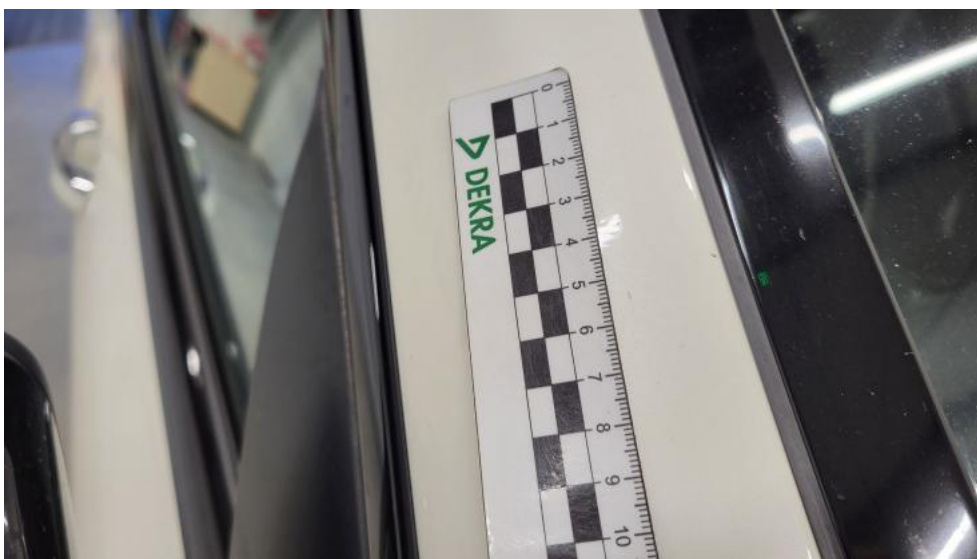
**Photo 53.**

Słupek przedni P - Rysa/odprysk 1

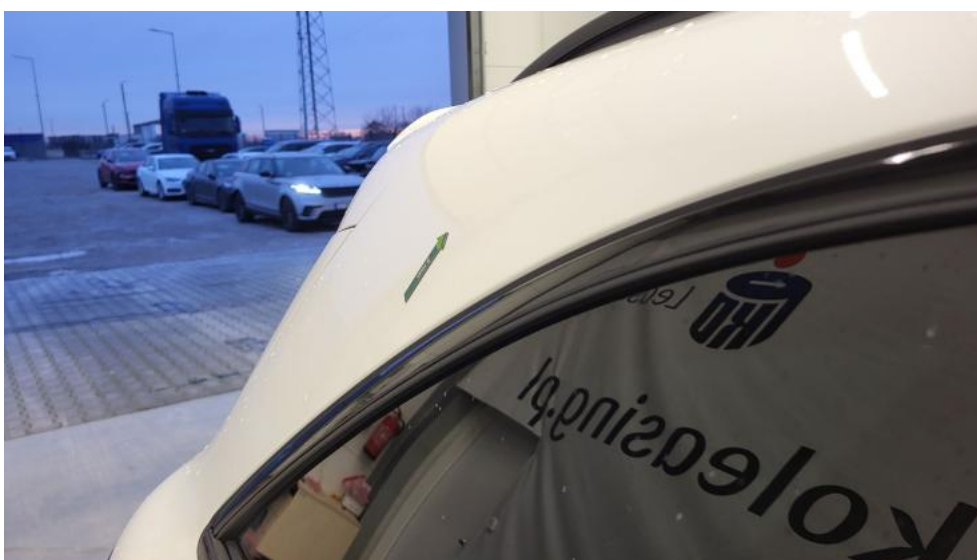
**Photo 54.**

Łotnik tylny P / Ściana boczna P - Wgniecenie/odkształcenie 1

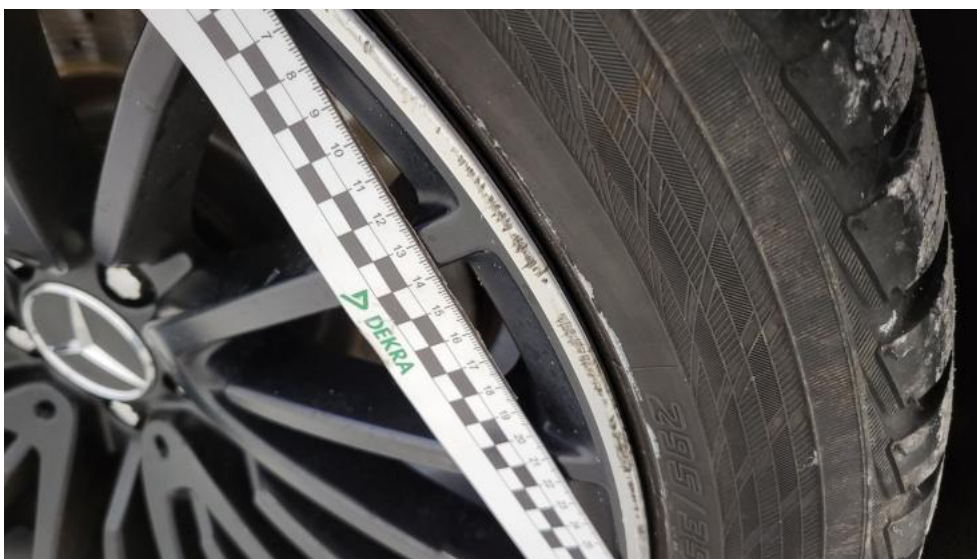
**Photo 55.**

Felga aluminiowa tylna P - Rysa/odprysk 1

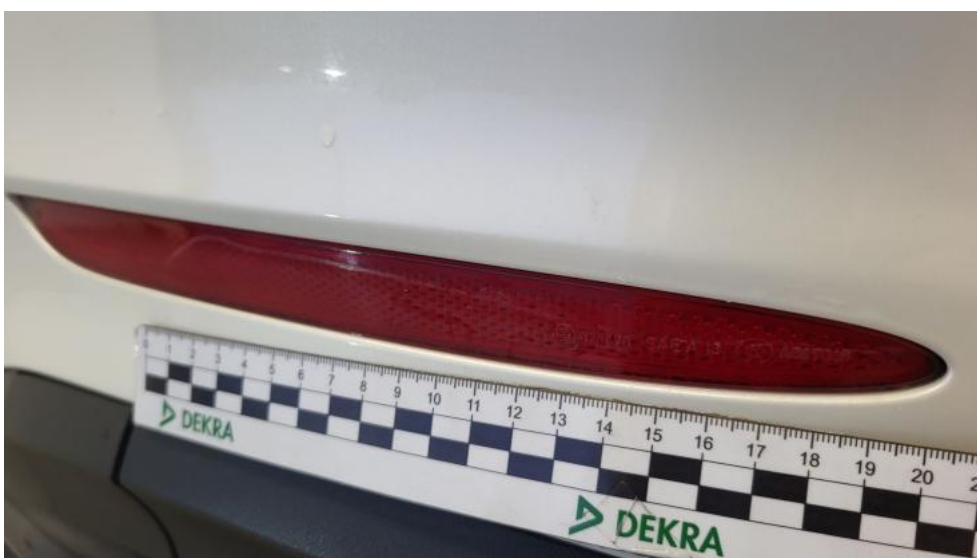
**Photo 56.**

Lampa przeciwmgielna tylna P - Rysa/odprysk 1

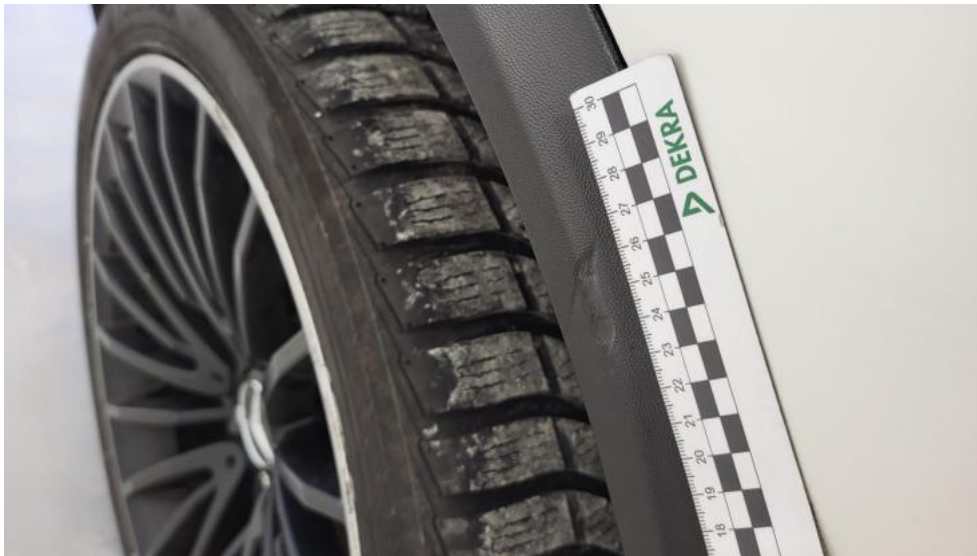
**Photo 57.**

Listwa krawędzi błotnika tyl P - Wgniecenie/odkształcenie 1

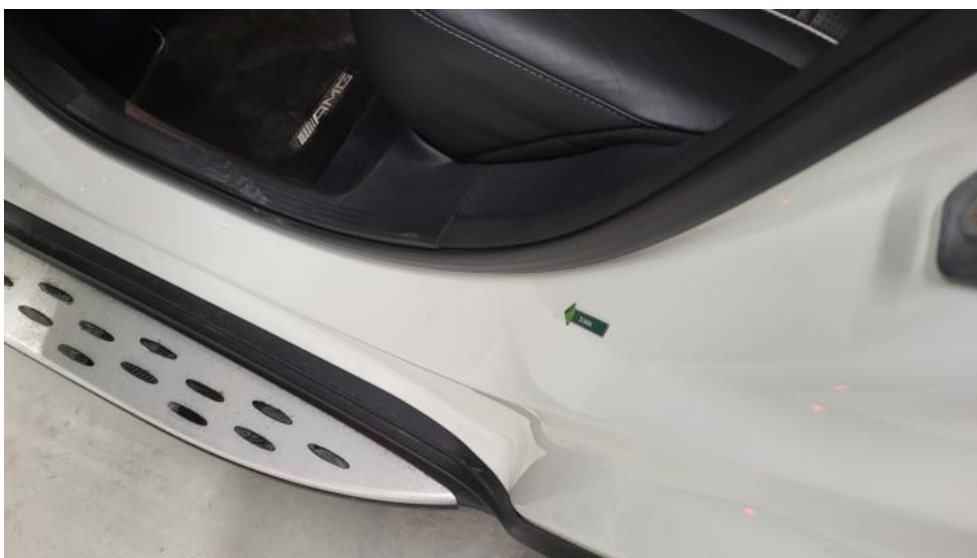
**Photo 58.**

Błotnik tylny L / Ściana boczna L - Wgniecenie/odkształcenie 1

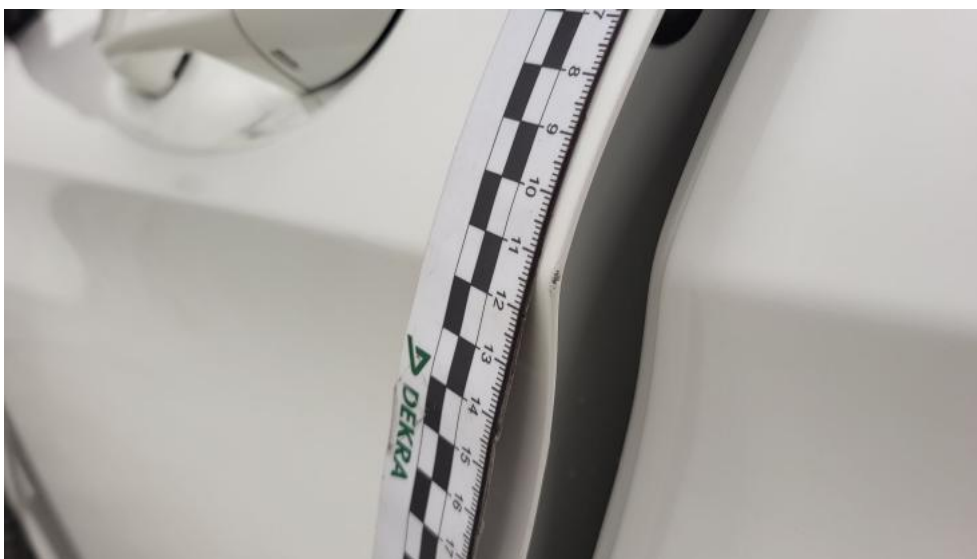
**Photo 59.**

Drzwi przed L - Rysa/odprysk 1

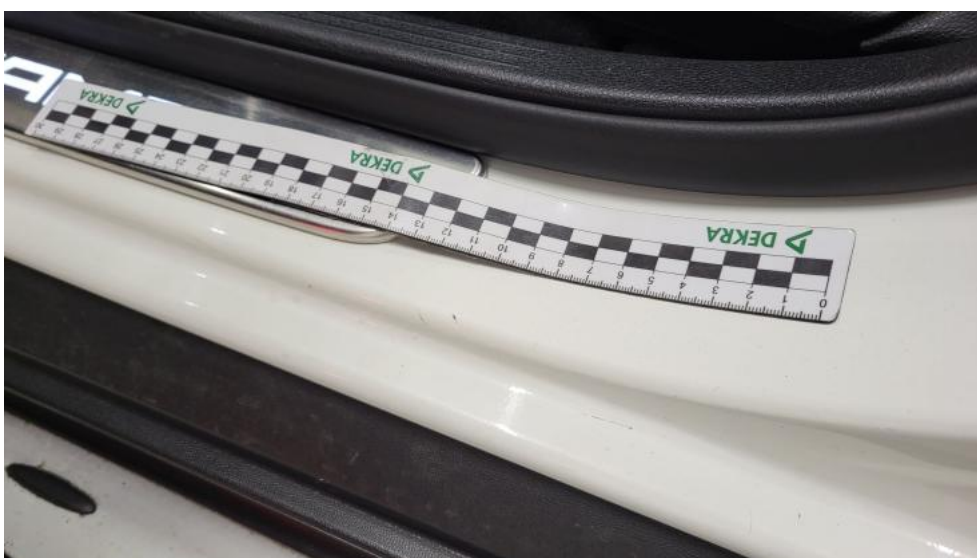
**Photo 60.**

Próg L - Rysa/odprysk 1

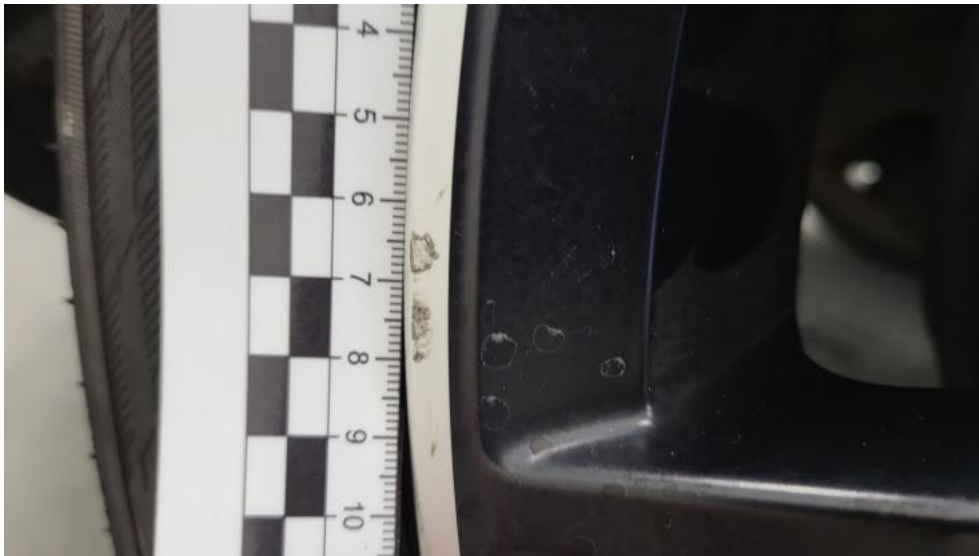
**Photo 61.**

Felga Aluminiowa przednia L - Rysa/odprysk 1

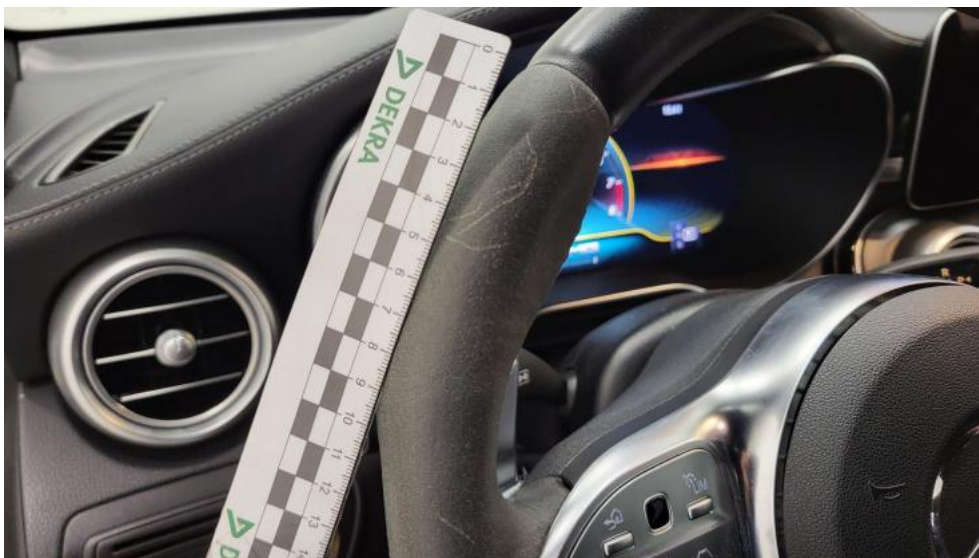
**Photo 62.**

Koło kierownicy - Rysa/odprysk 1

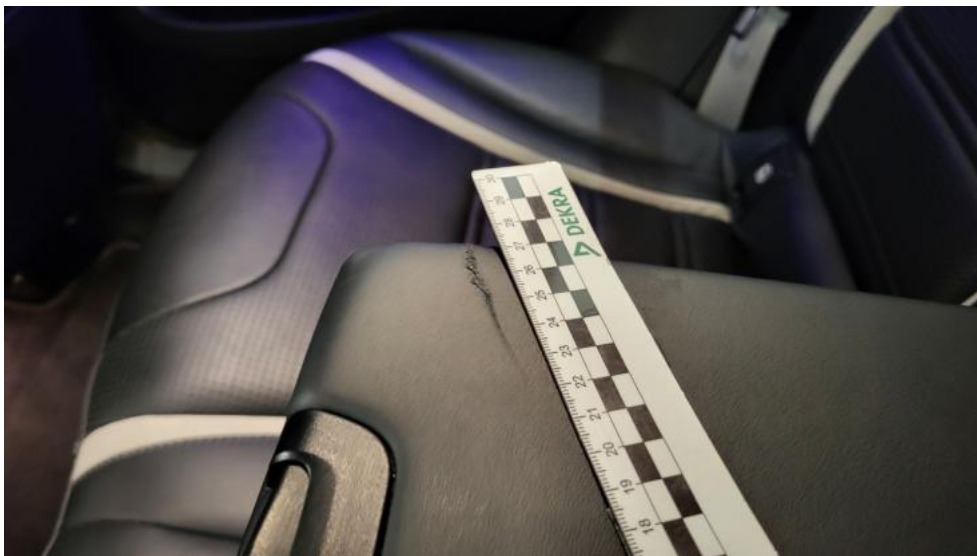
**Photo 63.**

Kanapa tyl. - Rysa/odprysk 1

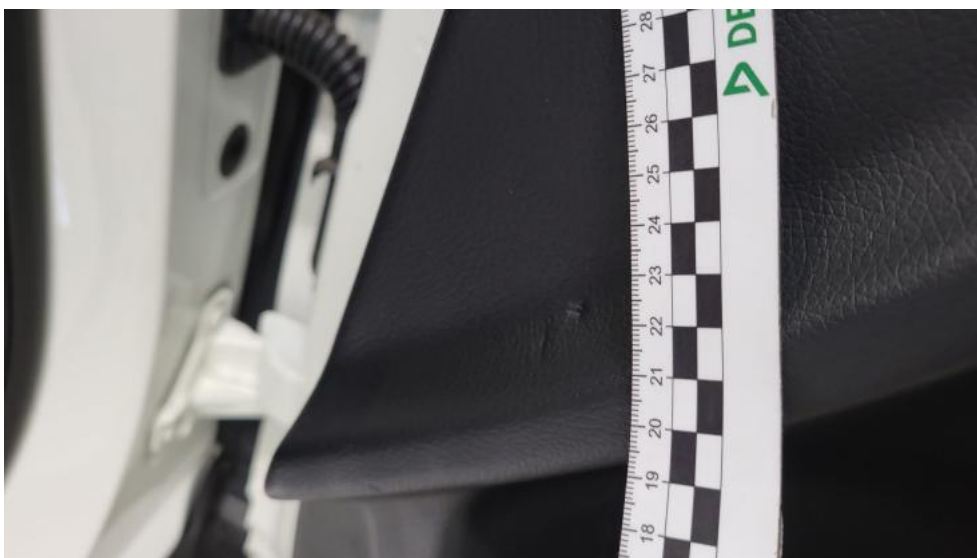
**Photo 64.**

Tapicerka drzwi przednich P - Wgniecenie/odkształcenie 1

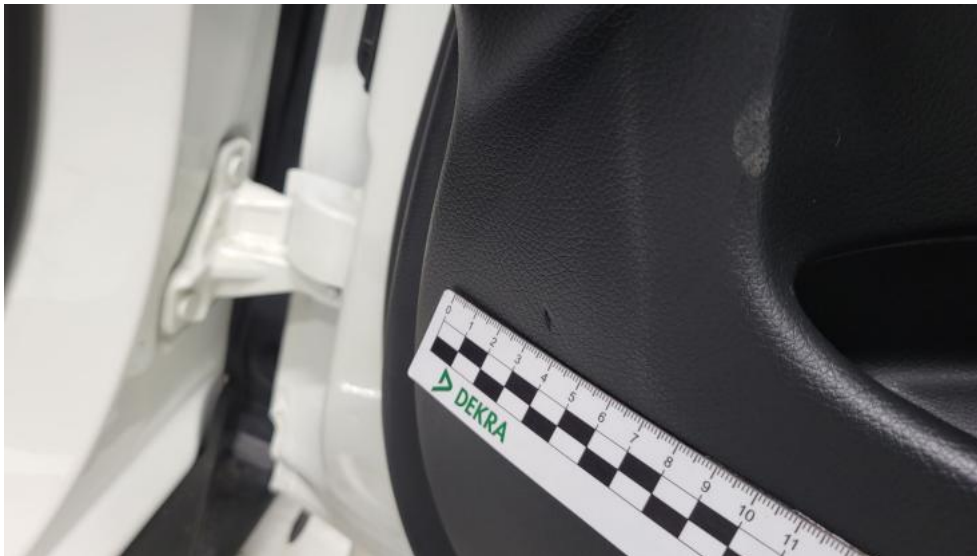
**Photo 65.**

Tapicerka drzwi przednich P - Wgniecenie/odkształcenie 2

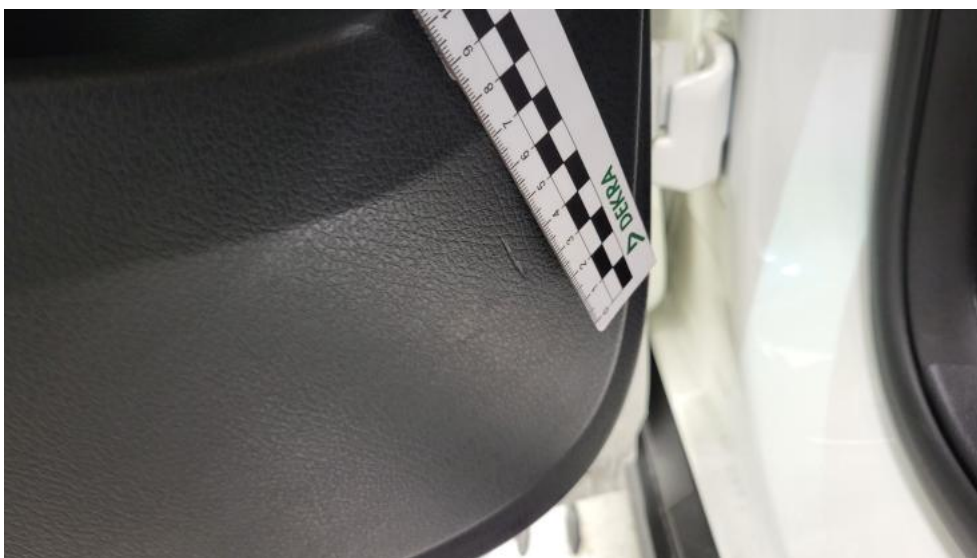
**Photo 66.**

Tapicerka drzwi tylnych L - Rysa/odprysk 1

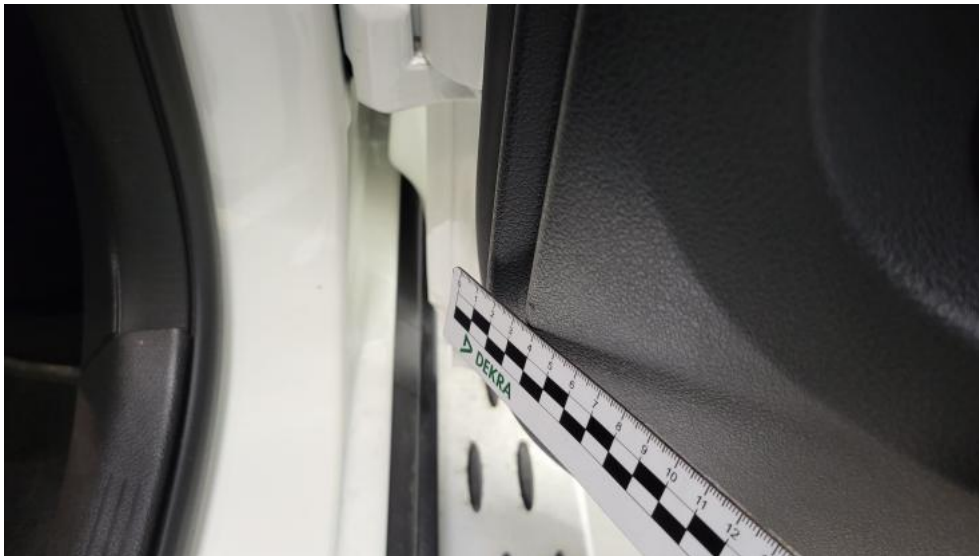
**Photo 67.**

Tapicerka drzwi tylnych P - Rysa/odprysk 1

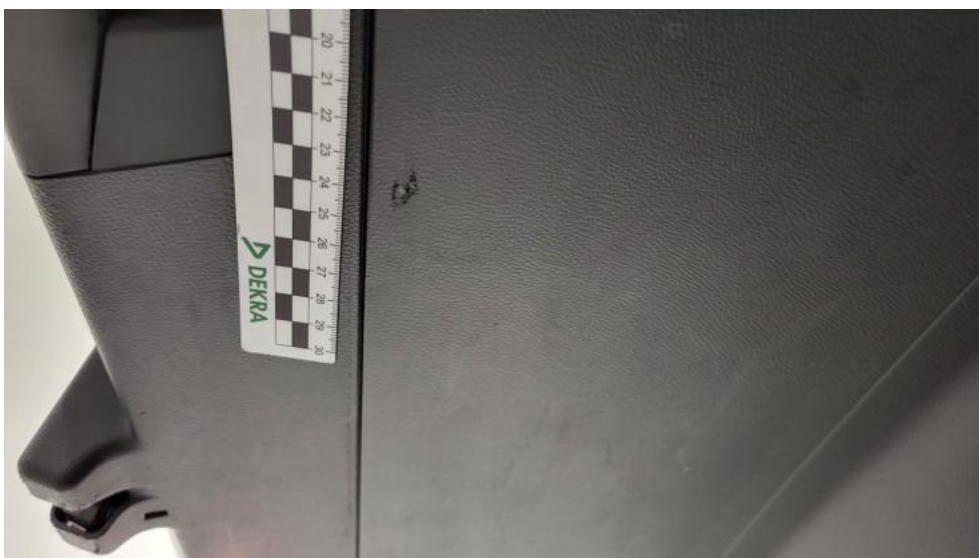
**Photo 68.**

Wykładzina pokrywy tylnej - Rysa/odprysk 1
