DEKRA's commission No. : PKOL(W)/LODZ/95169/25/12/04  
commission/ damage No. : 23/002317  
Date of commission: 04-12-2025

| Model | Captur 19-24 |
| Type / version | Captur 1.3 TCe mHEV Techno EDC |
| Registration /record No. | GD5F647 |

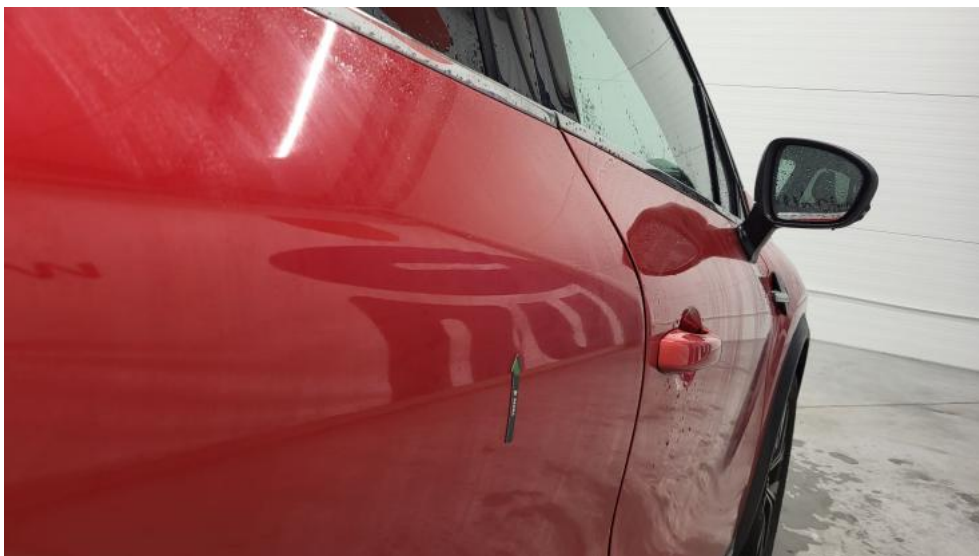
**Photo 38.**

Drzwi tylne P - Wgniecenie/odkształcenie 1

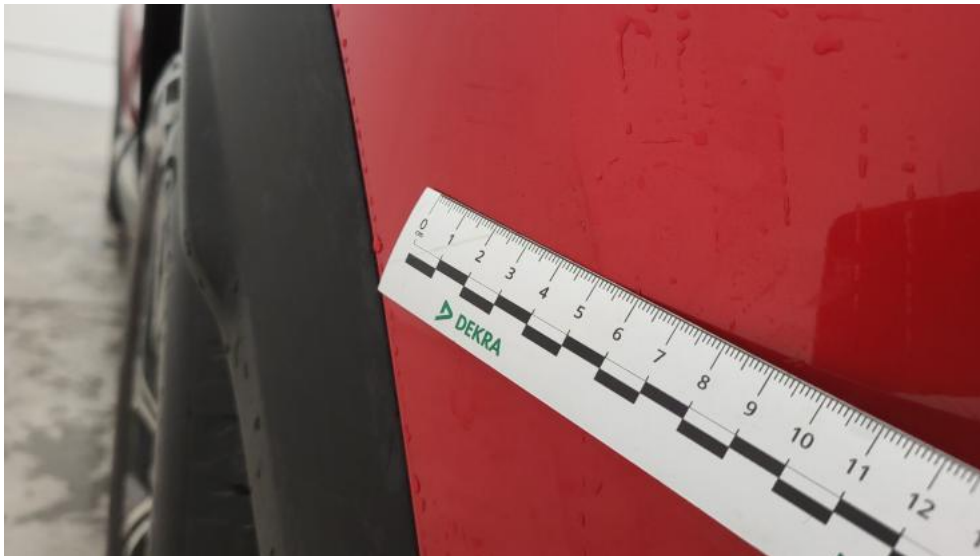
**Photo 39.**

Zderzak tylny cz L - Rysa/odprysk 1

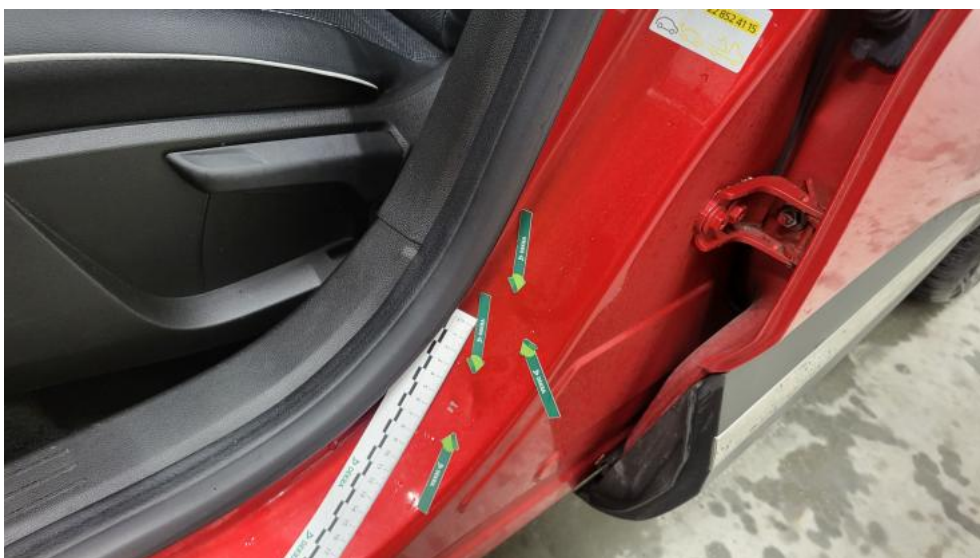
**Photo 40.**

Słupek środkowy L - Wgniecenie/odkształcenie 1

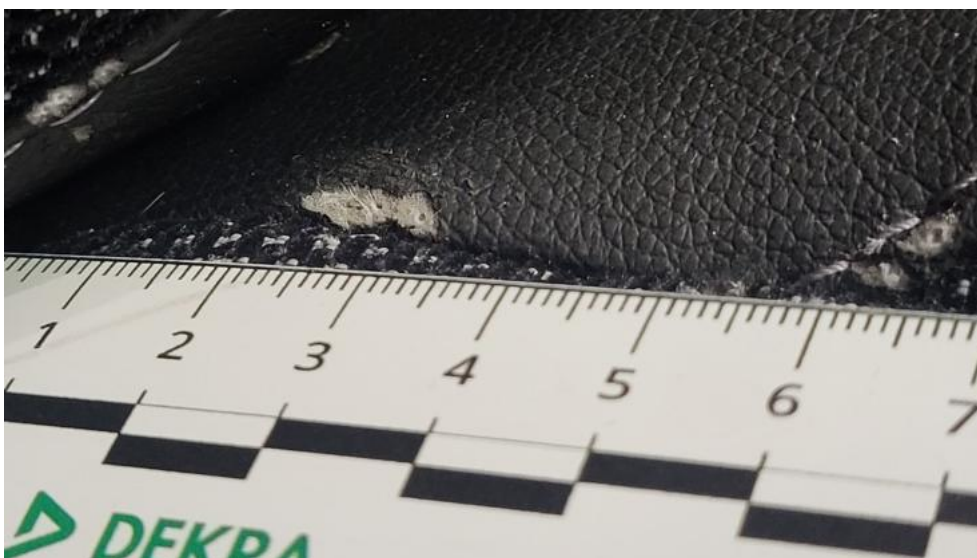
**Photo 42.**

Fotel prz. praw. - Pęknięcie/rozerwanie 1
