DEKRA's commission No. : PKOL(W)/LODZ/31403/26/04/10
 commission/ damage No. : 22/K00231
 Date of commission: 10-04-2026

Group of objects (Eurotax)	cars
EC code (Eurotax)	0000001
Manufacturer	CUPRA
Model	Formentor 2.0 TSI MR`20 E6
Type	4Drive DSG
Body type	SUV
Number of doors / seats	5/5
Curb weight [kg]	1552
Gross vehicle weight [kg]	2110
Engine type	ZAPŁON ISKROWY
Emission standard	EURO 6
Engine capacity [ccm]	1984
Engine Power [hp/kW]	190/140
Gearbox	automatic 7- gear
Registration /record No.	WZ438FP
VIN / serial number	VSSZZZKM7PR003399
Date of first registration	02-11-2022
Date of next. tech. test	20-06-2026
Year of manufacture	2022 (year has been verified with the manufacturer's base)
Readout [km]	123 234 (read)
Body color / type of coating	granatowy/metallized

Description of the technical condition

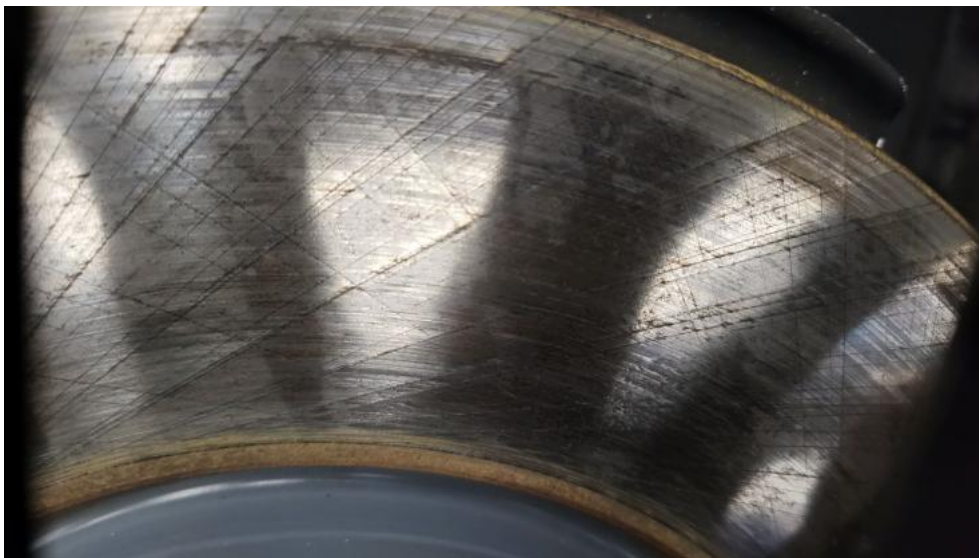
Photo 15.

Item name	Description of item	Damage type	Location / Size	Comments
Tarcze hamulcowe		scratch		- ślady korozji,

Tarcza hamulcowa przednia prawa

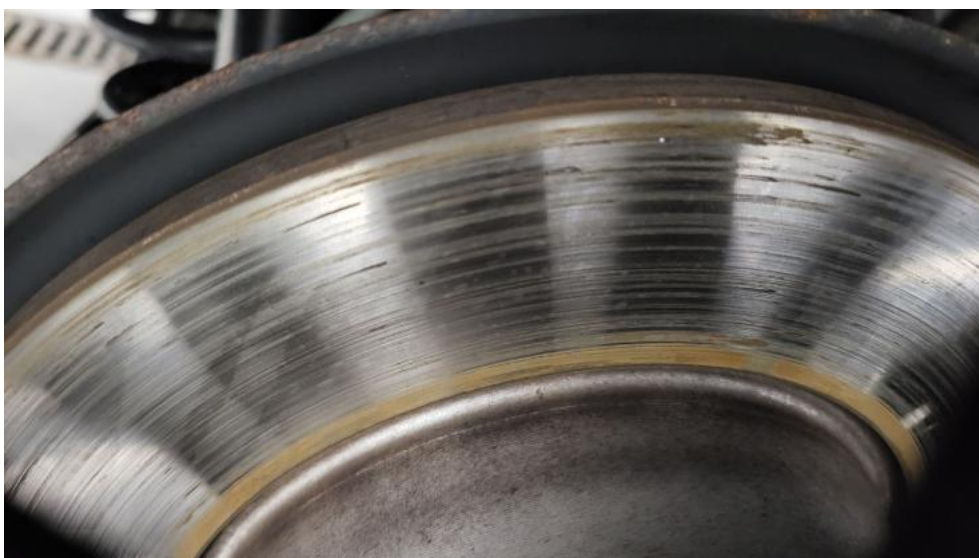
Photo 16.

Tarcza hamulcowa tylna prawa

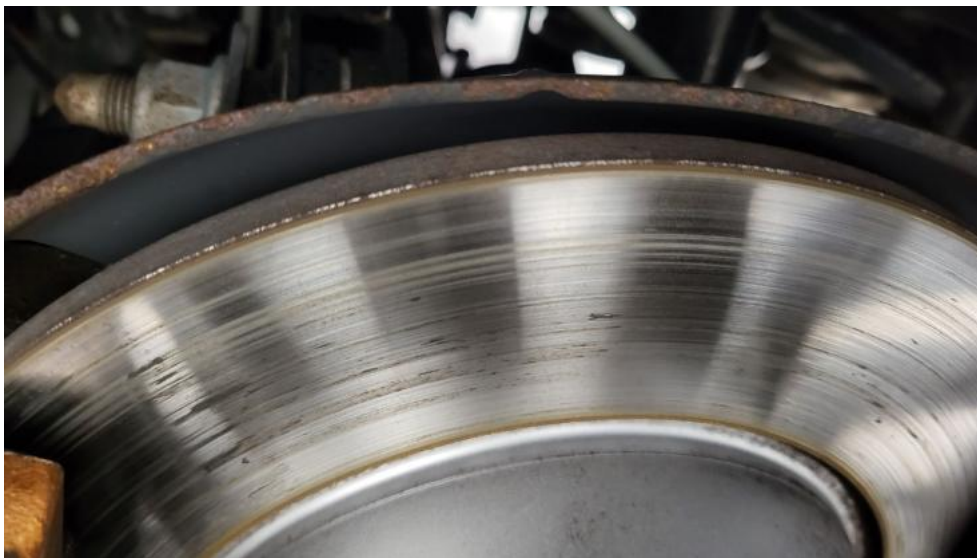
Photo 17.
Tarcza hamulcowa tylna lewa

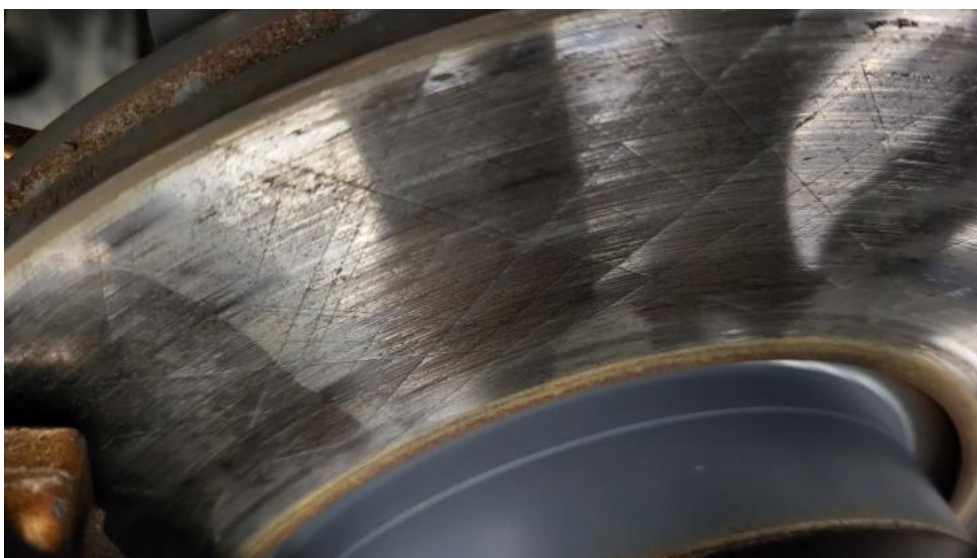
Photo 18.
Tarcza hamulcowa przednia lewa

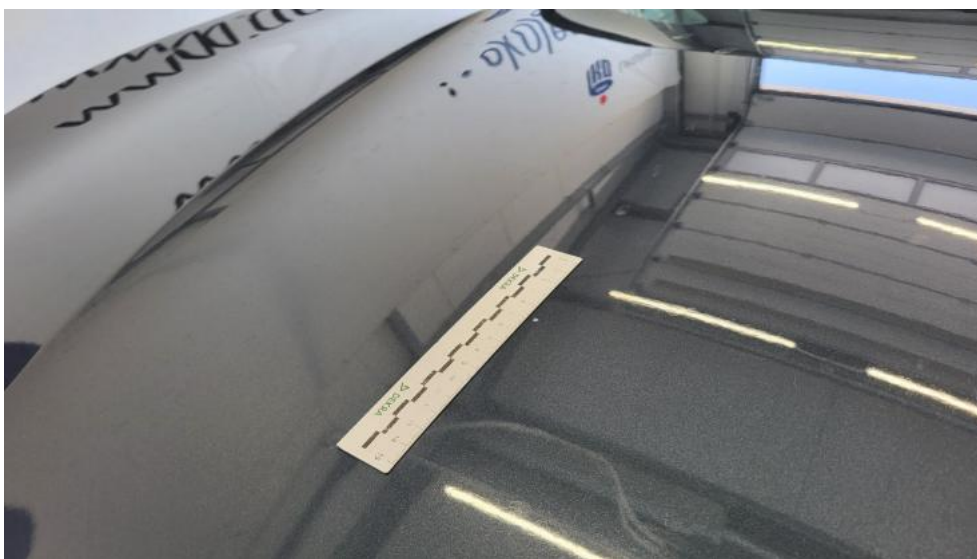
Photo 41.
Pokrywa komory silnika - Rysa/odprysk 1

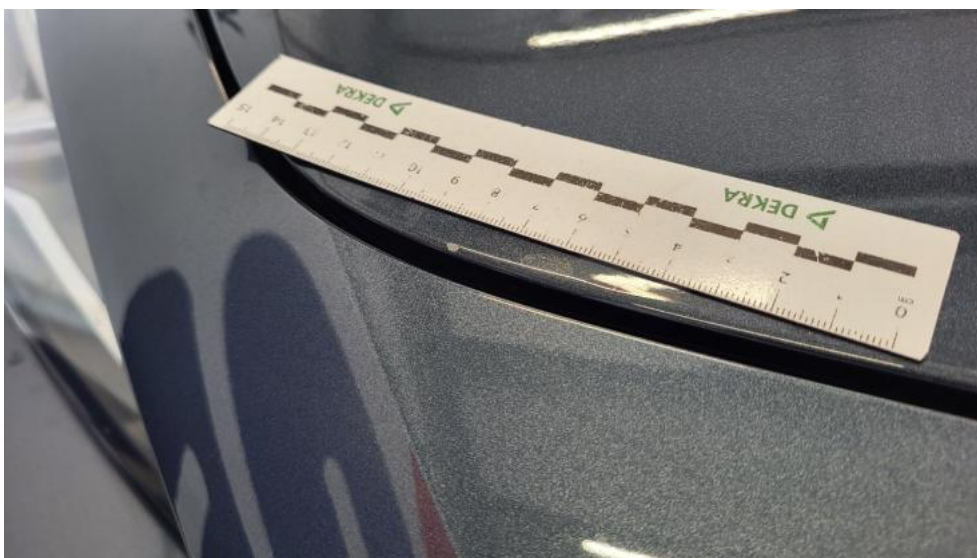
Photo 42.
Pokrywa komory silnika - Rysa/odprysk 2

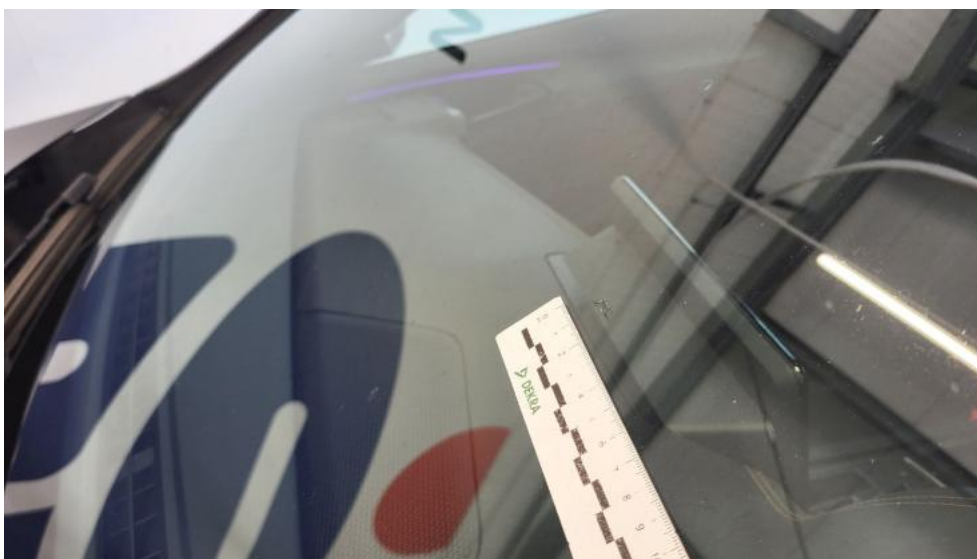
Photo 43.

Szyba czołowa - zdjęcie poglądowe 1

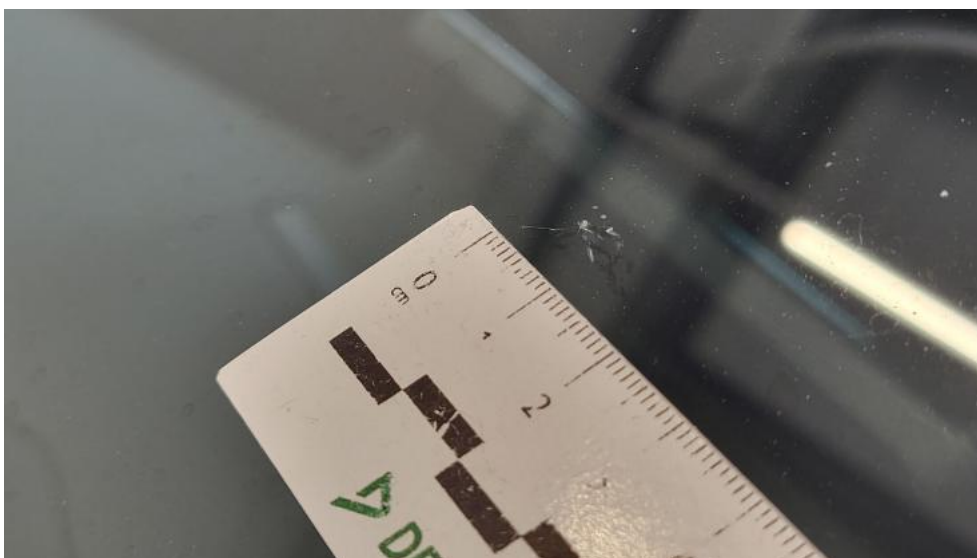
Photo 44.

Szyba czołowa - Pęknięcie/rozerwanie 1

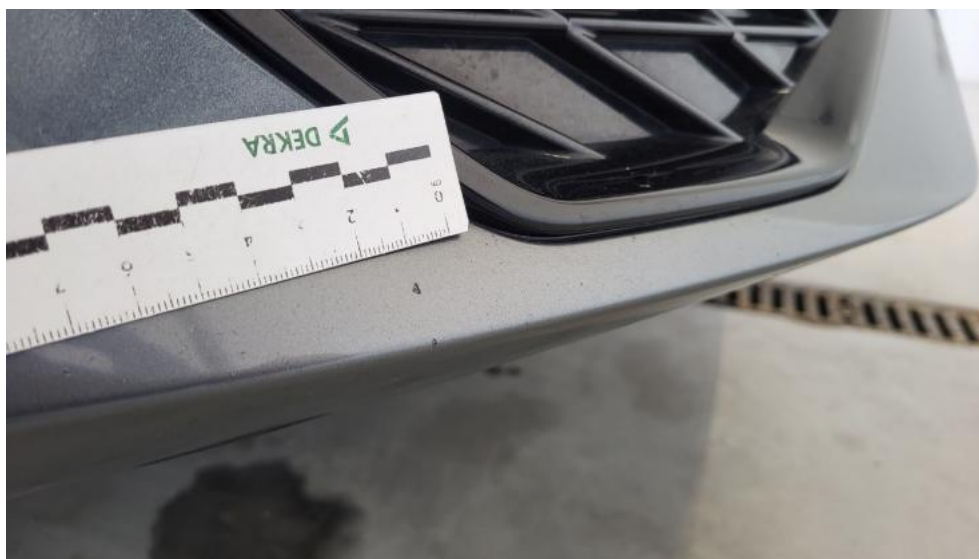
Photo 45.

Zderzak przedni cz P - Rysa/odprysk 1

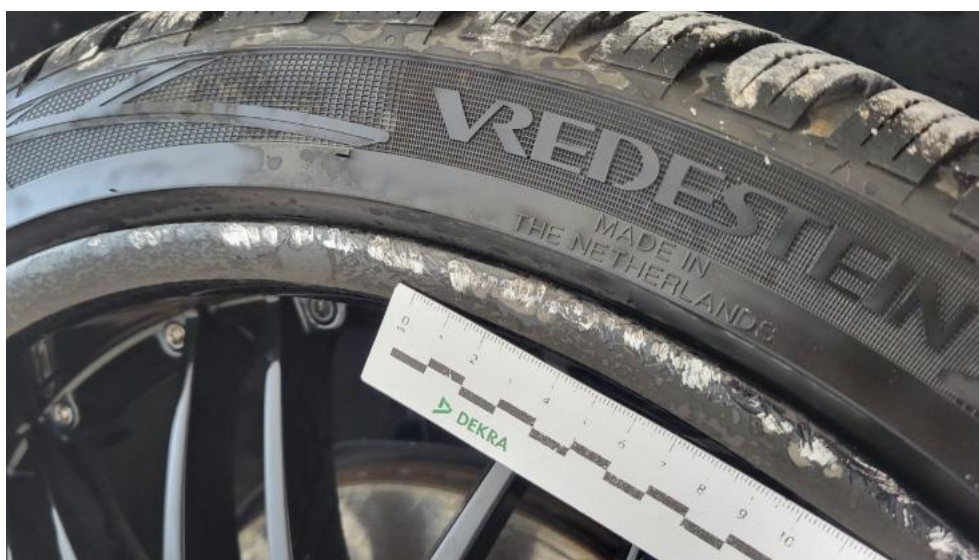
Photo 46.

Felga aluminiowa przednia P - Rysa/odprysk 1

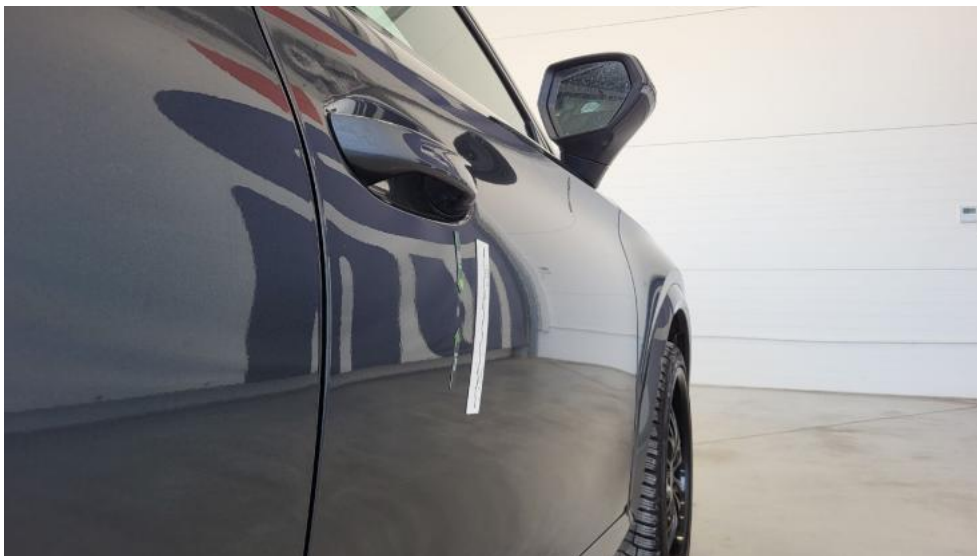
Photo 47.
Drzwi przednie P - Wgniecenie/odkształcenie 1

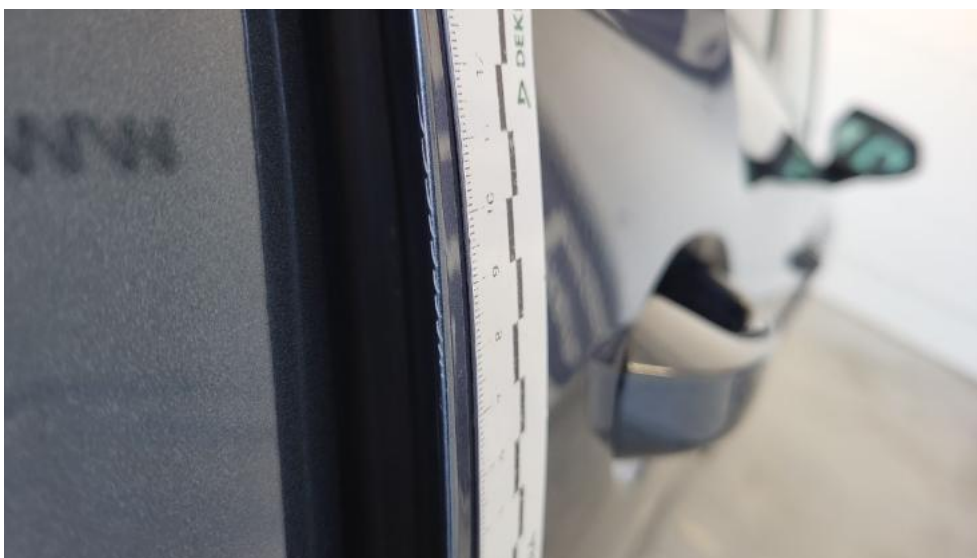
Photo 48.
Drzwi tylne P - Rysa/odprysk 1

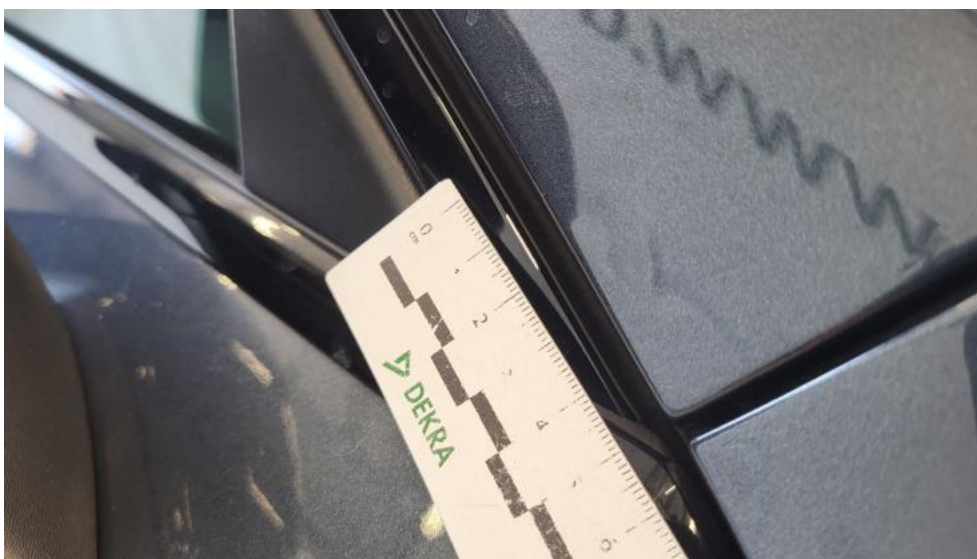
Photo 49.

Listwa drzwi przednich P - Rysa/odprysk 1

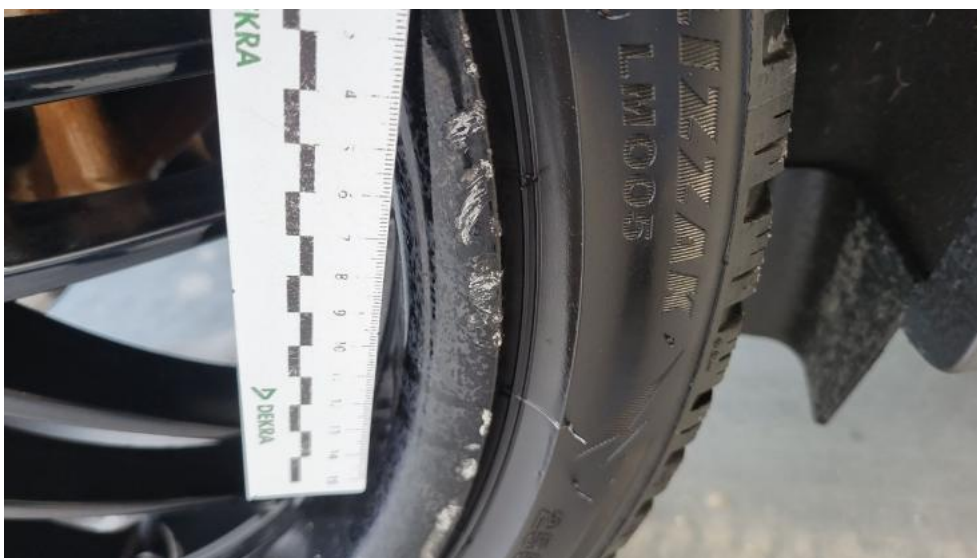
Photo 50.

Felga aluminiowa tylna P - Rysa/odprysk 1

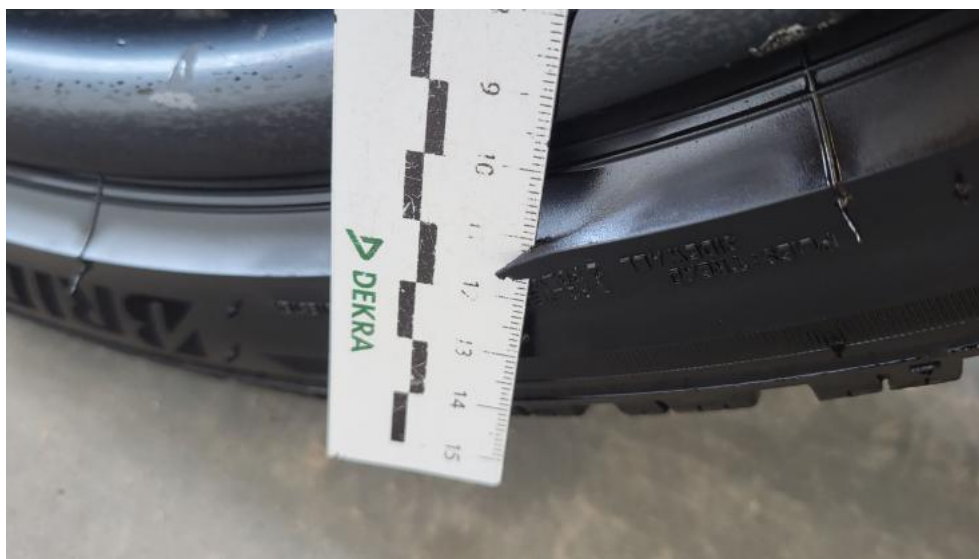
Photo 51.

Opona tylna P - Pęknięcie/rozerwanie 1

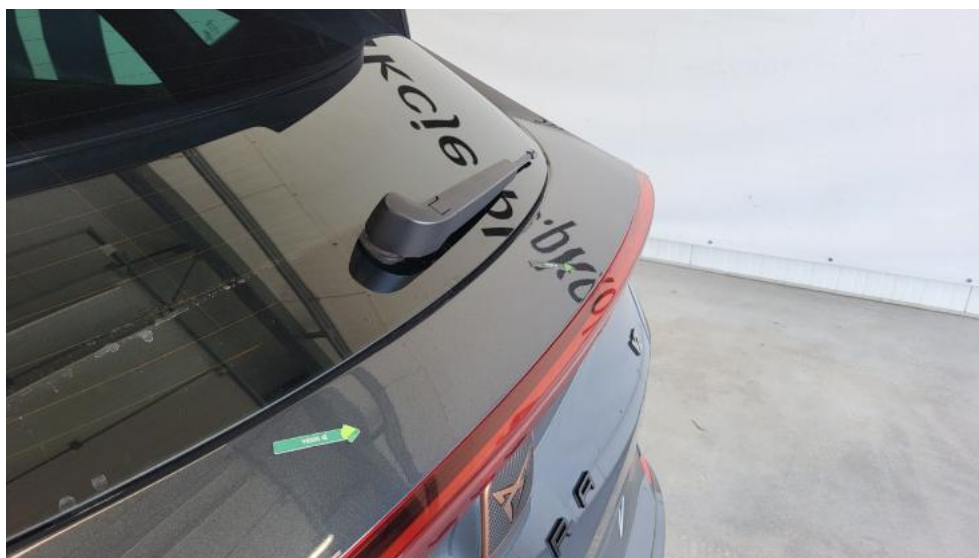
Photo 52.

Pokrywy bagażnika - Wgniecenie/odkształcenie 1

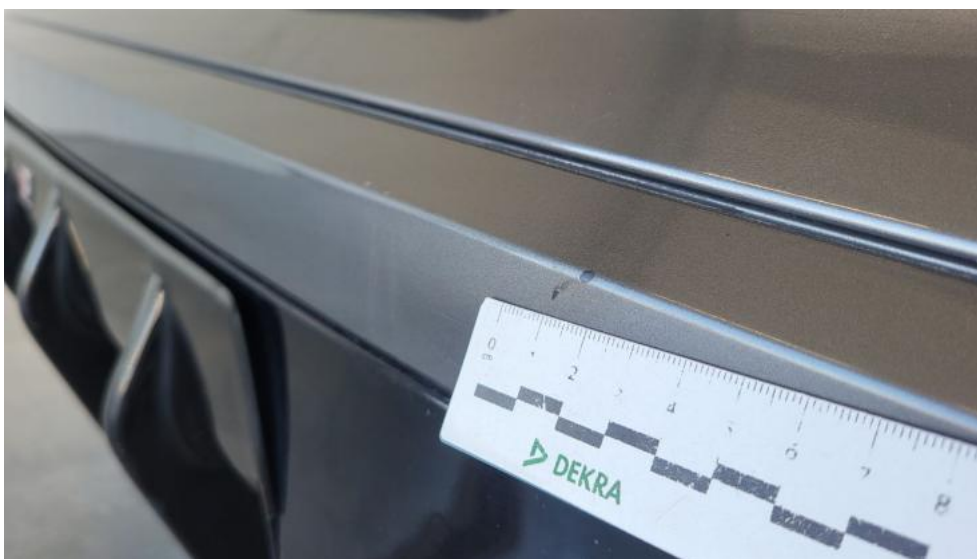
Photo 53.
Zderzak tylny - Rysa/odprysk 1

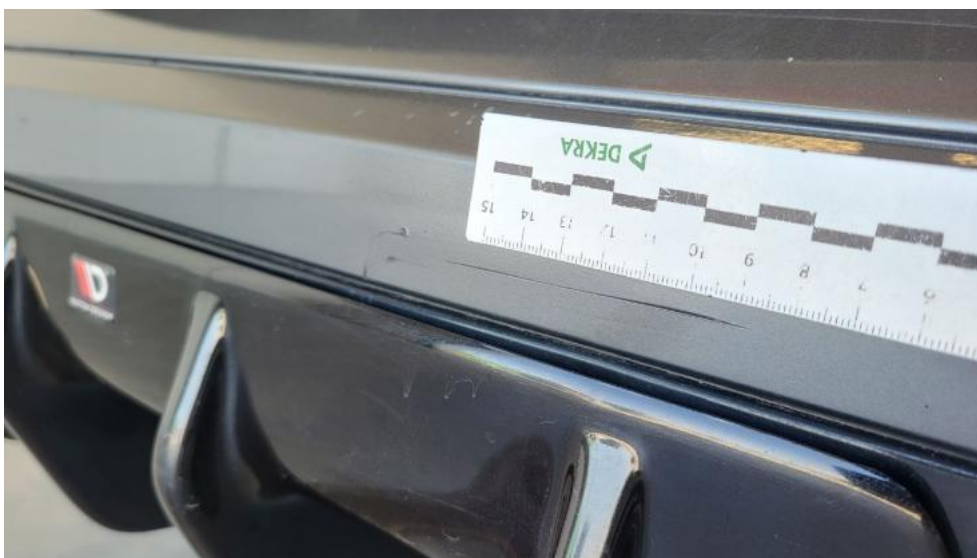
Photo 54.
Zderzak tylny - Rysa/odprysk 2

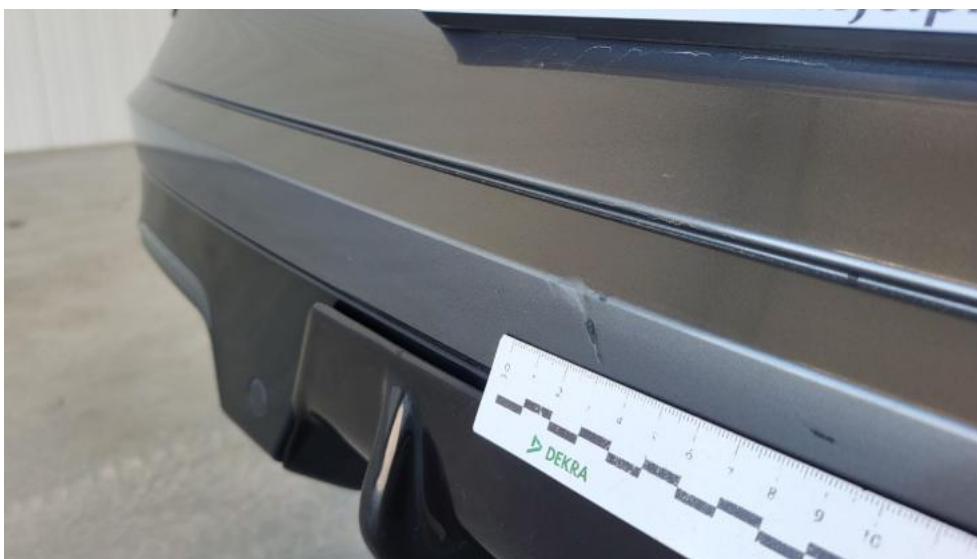
Photo 55.
Zderzak tylny - Wgniecenie/odkształcenie 1

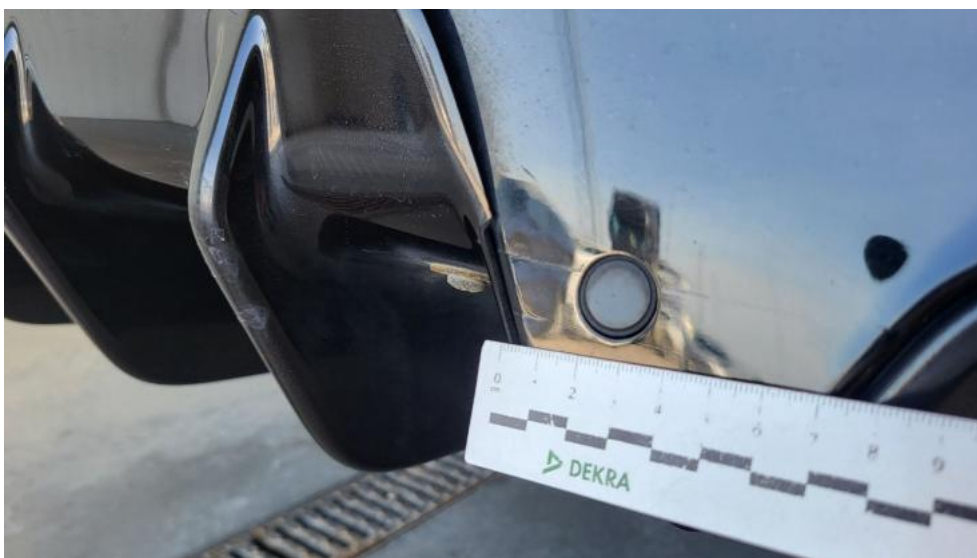
Photo 56.
Zderzak tylny cz dolna - Rysa/odprysk 1

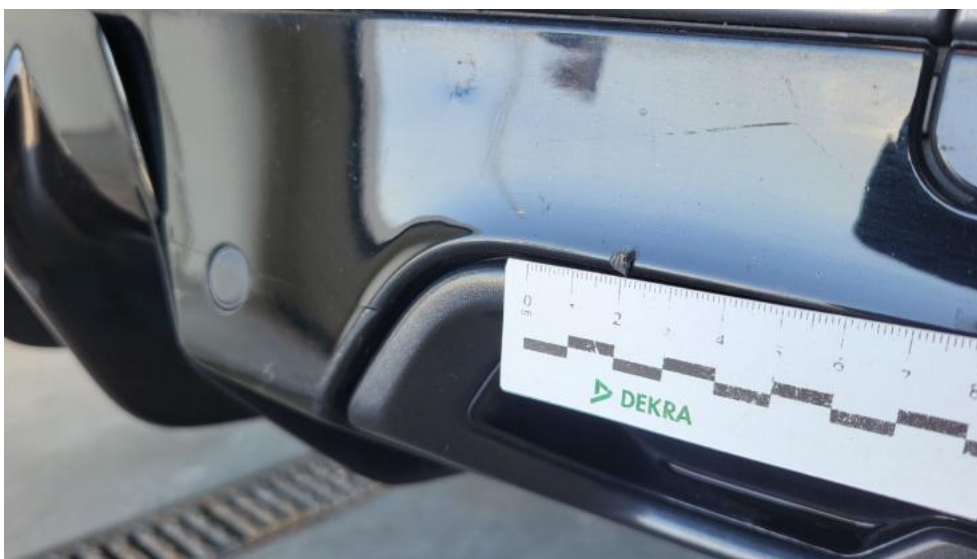
Photo 57.
Zderzak tylny cz dolna - Wgniecenie/odkształcenie 1

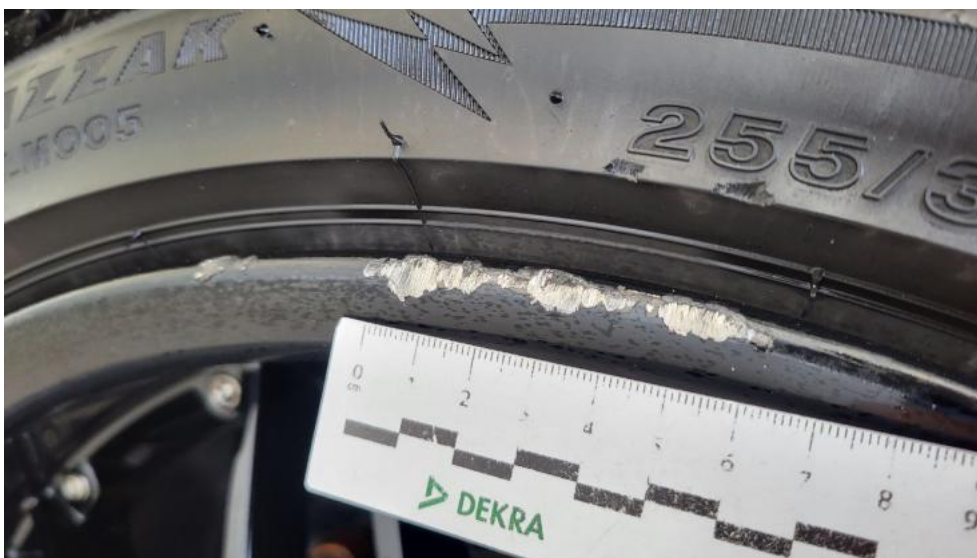
Photo 58.
Felga aluminiowa tylna L - Rysa/odprysk 1

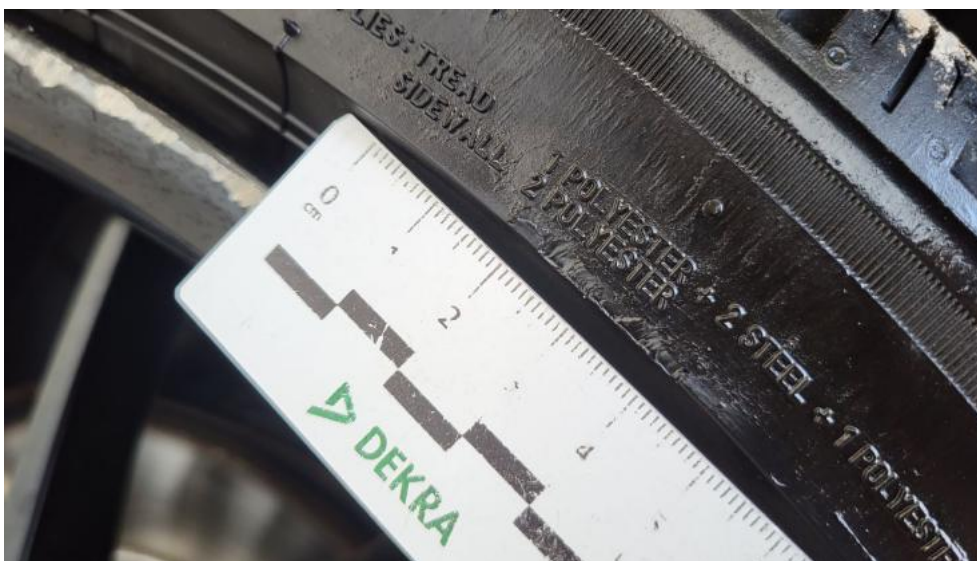
Photo 59.

Opona tylna L - Pęknięcie/rozerwanie 1

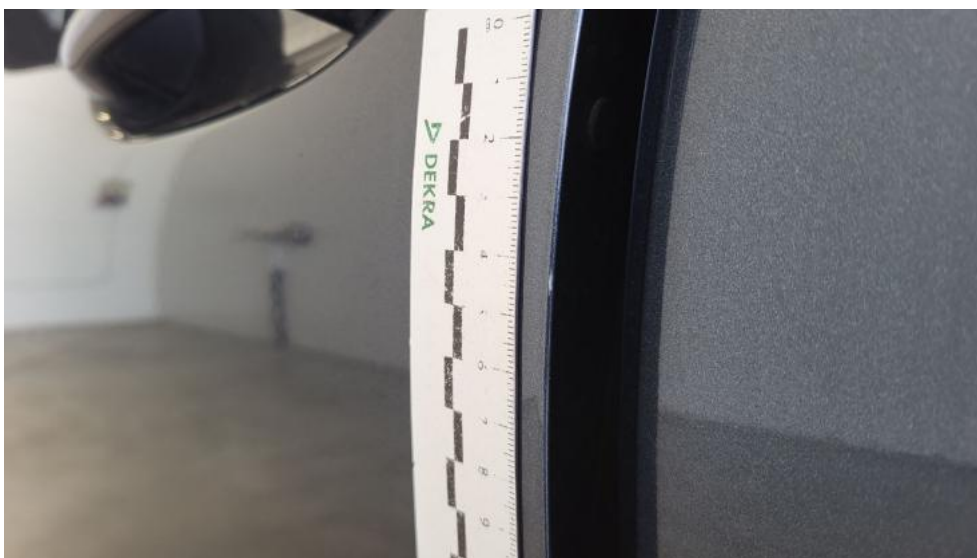
Photo 60.

Drzwi przed L - Rysa/odprysk 1

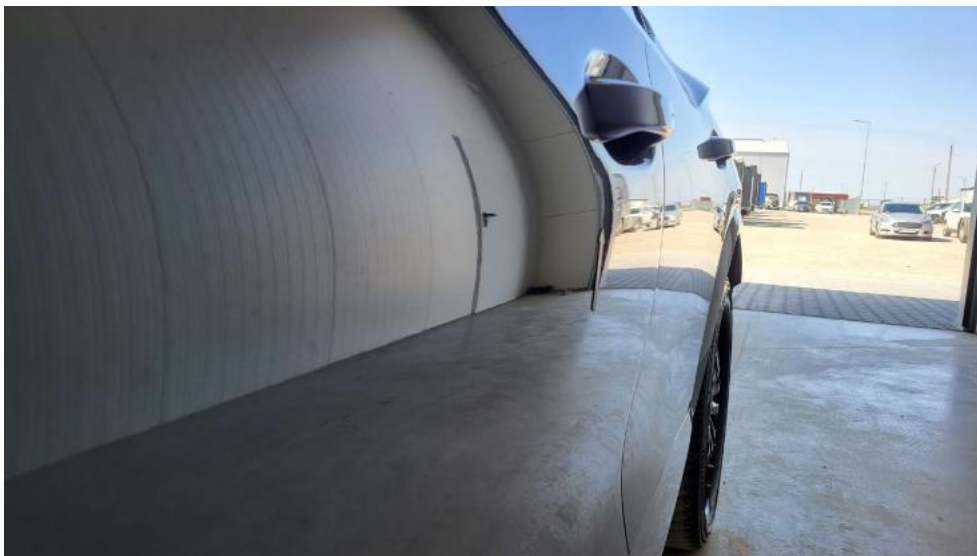
Photo 61.
Drzwi przed L - Wgniecenie/odkształcenie 1

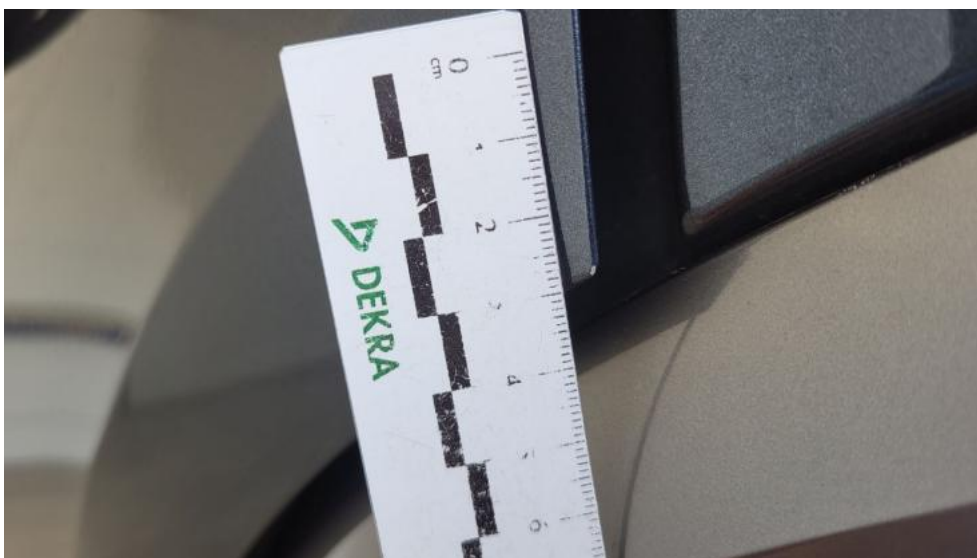
Photo 62.
Drzwi tylne L - Rysa/odprysk 1

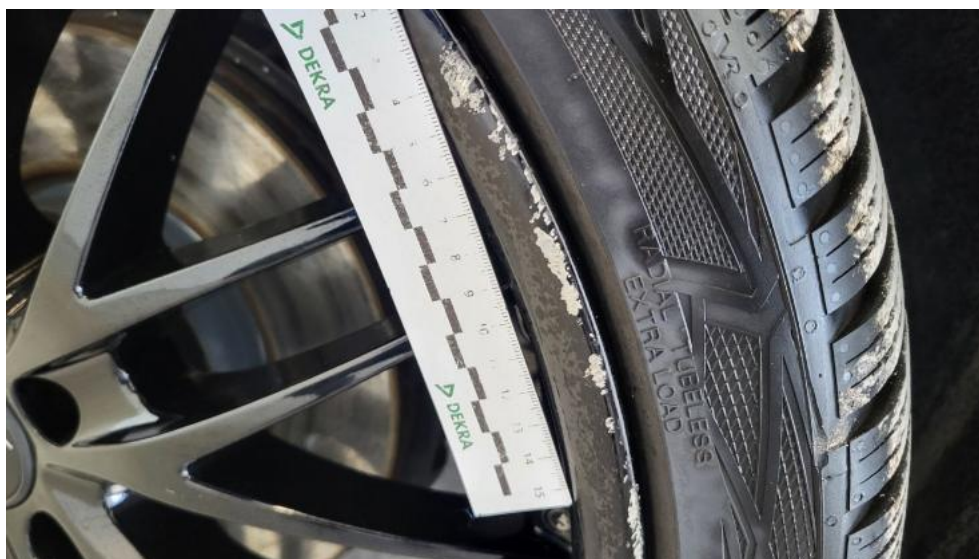
Photo 63.
Felga Aluminiowa przednia L - Rysa/odprysk 1

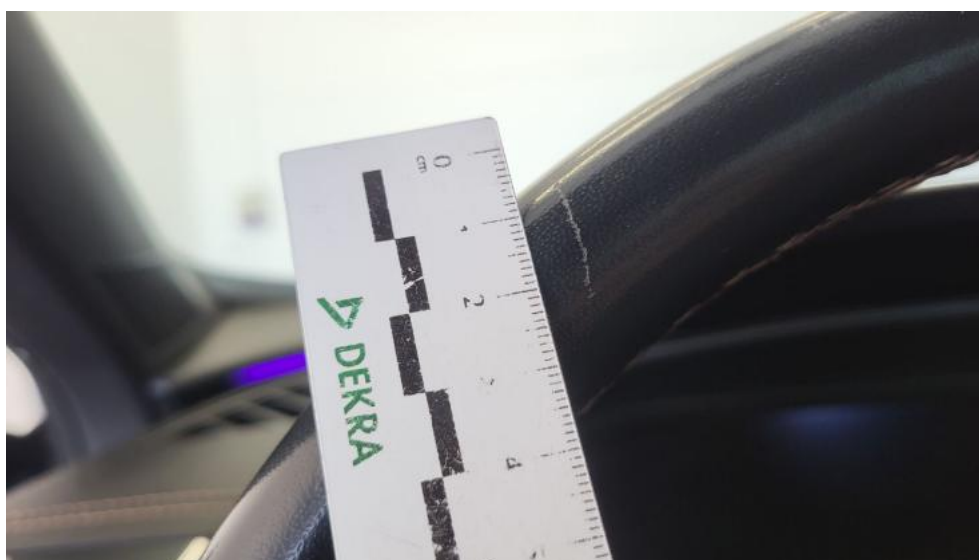
Photo 64.
Koło kierownicy - Rysa/odprysk 1

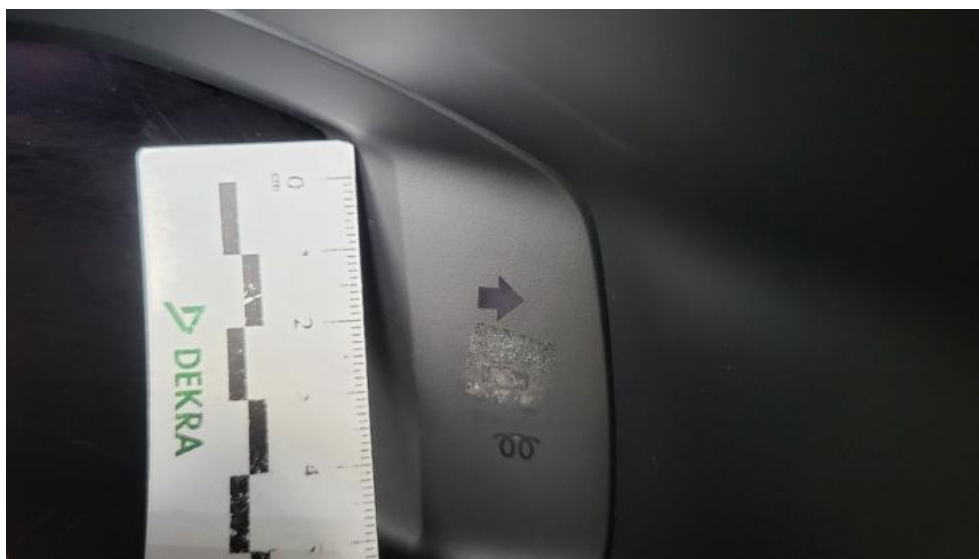
Photo 65.
Wyświetlacz - Inne 1

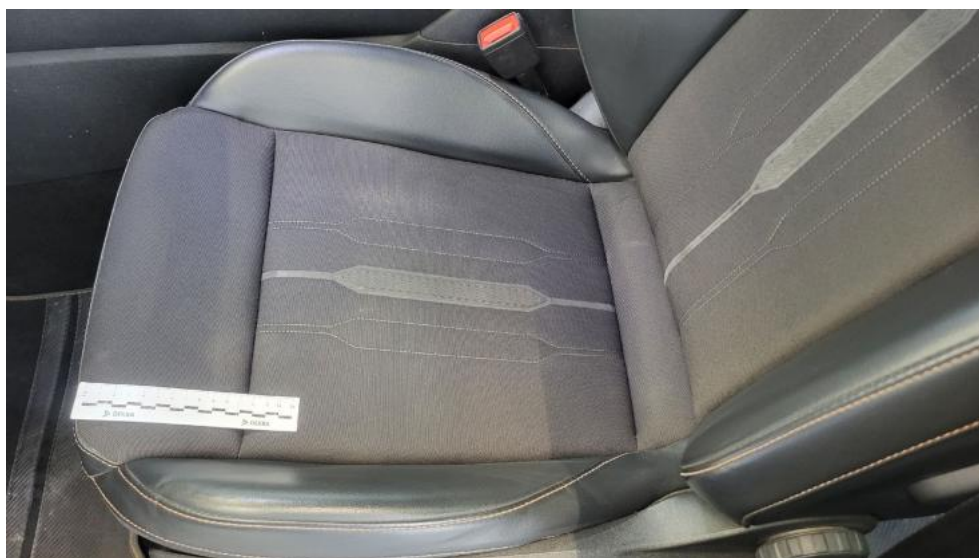
Photo 66.
Fotel prz. lew. - Inne 1

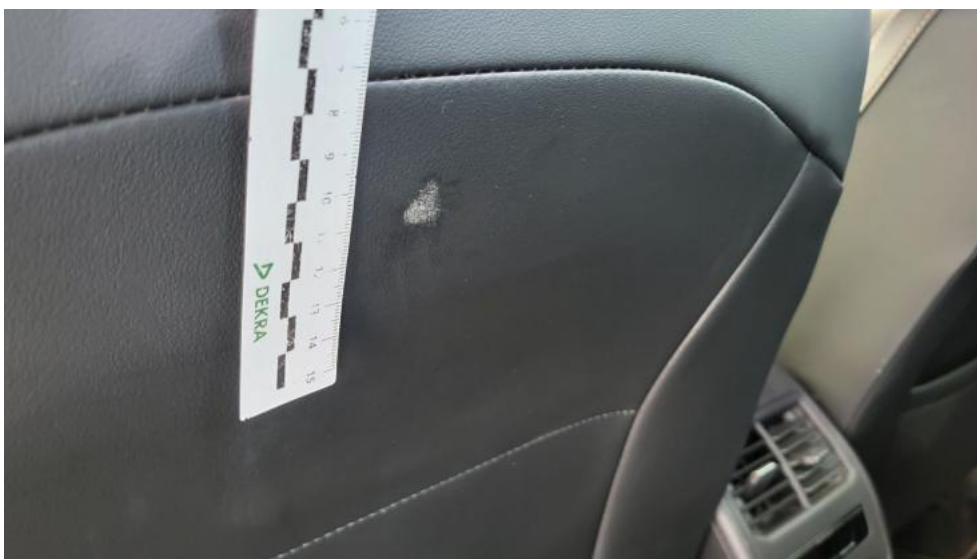
Photo 67.
Fotel prz. lew. - Inne 2

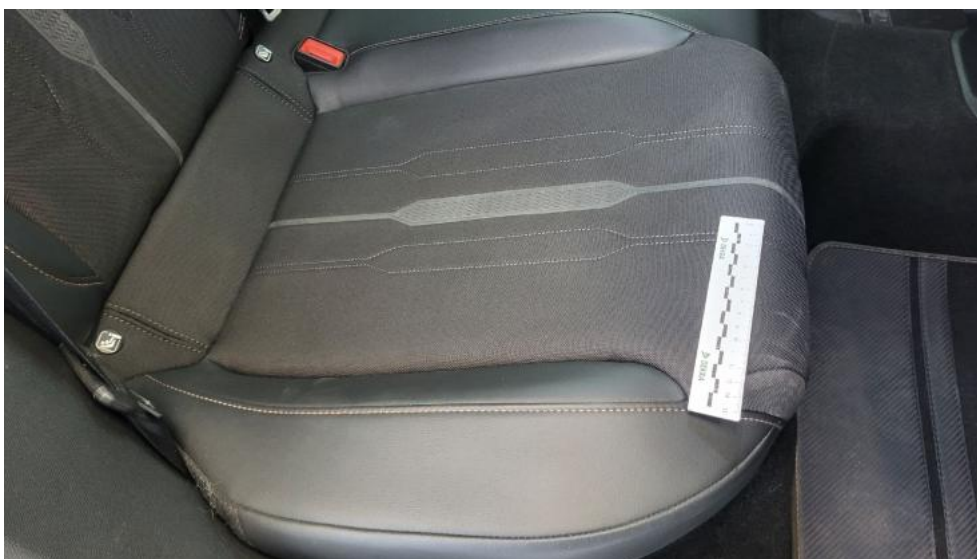
Photo 69.
Kanapa tyl. - Inne 1

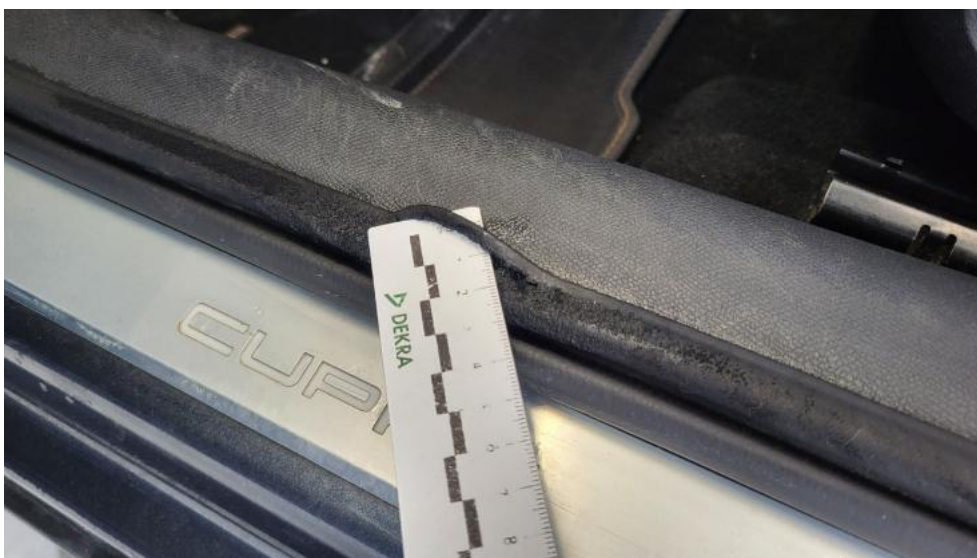
Photo 70.
Uszczelka drzwi przednich L - Pęknięcie/rozerwanie 1

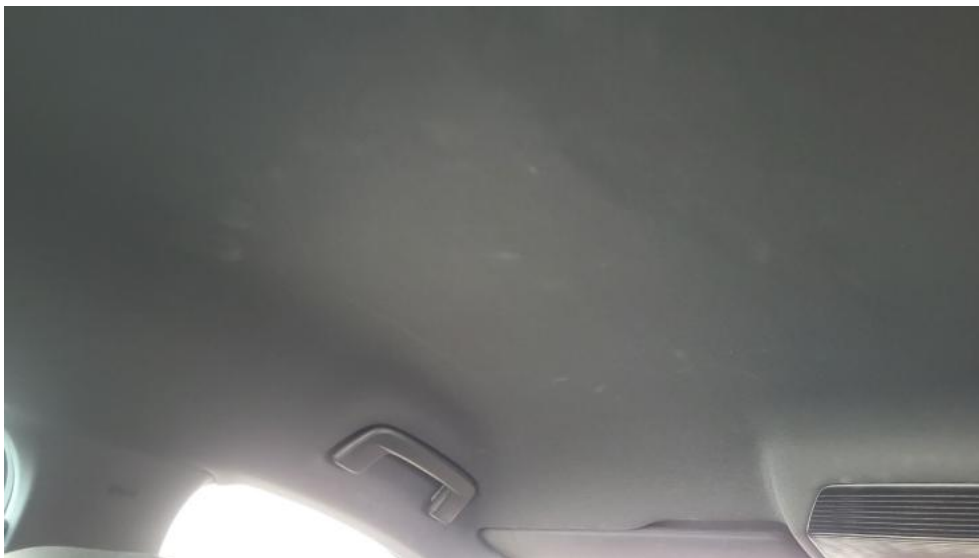
Photo 71.
Podsufitka - Inne 1
