DEKRA's commission No. : PKOL(W)/LODZ/17567/26/02/26  
commission/ damage No. : 23/044125  
Date of commission: 26-02-2026

| Manufacturer | BMW |
| Model | Seria 5 Touring [G31] 17-20 |
| Registration /record No. | WZ947HC |

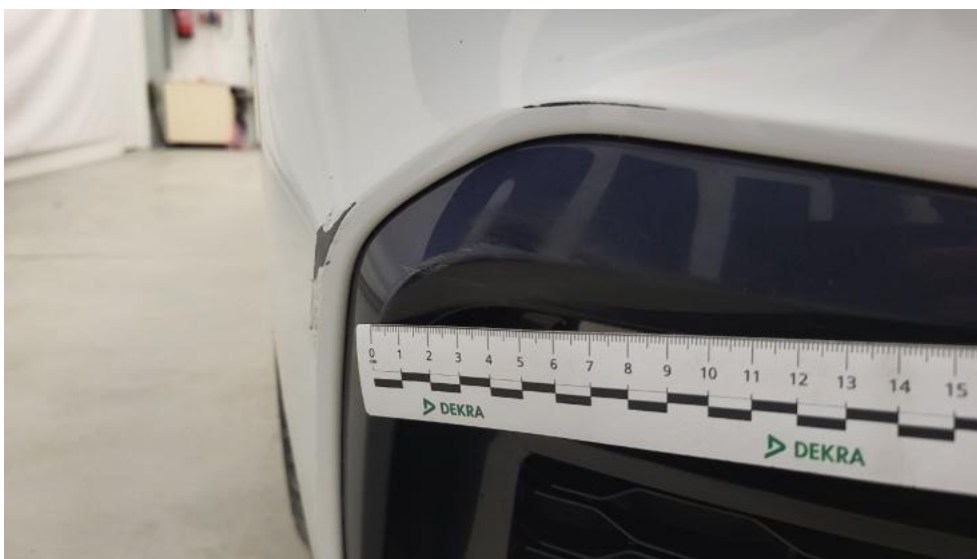
**Photo 41.**

Kratka/zaślepka halogenu P - Rysa/odprysk 1

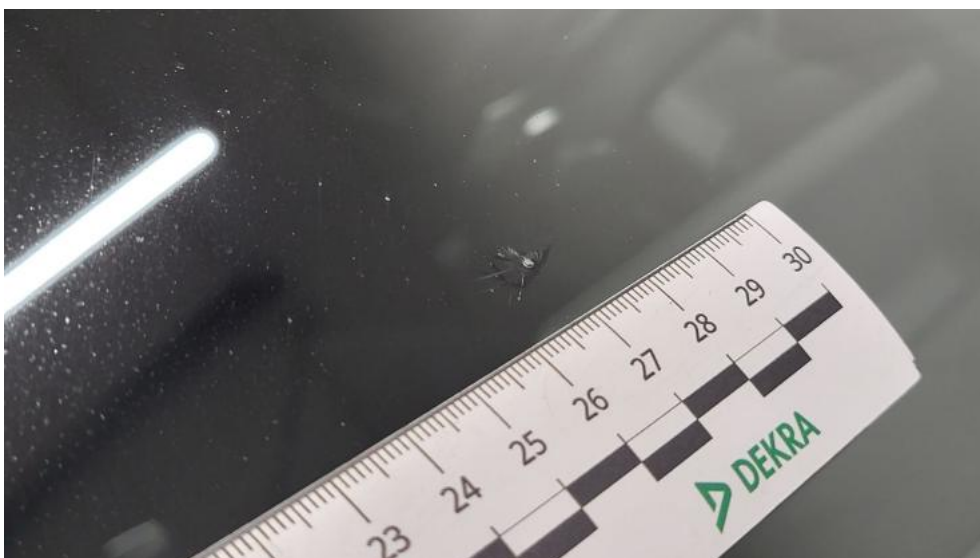
**Photo 44.**

Szyba czołowa - Pęknięcie/rozerwanie 1

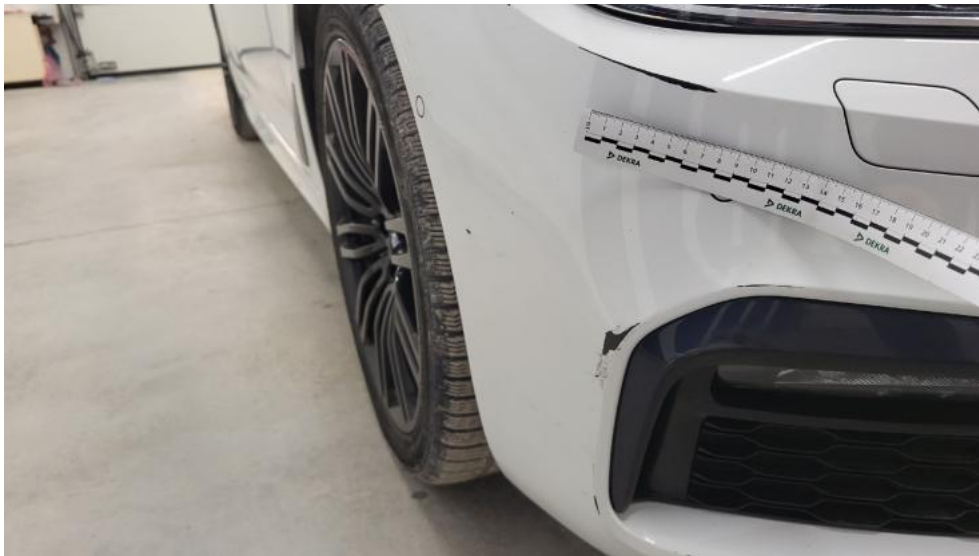
**Photo 47.**

Zderzak() - Rysa/odprysk 3

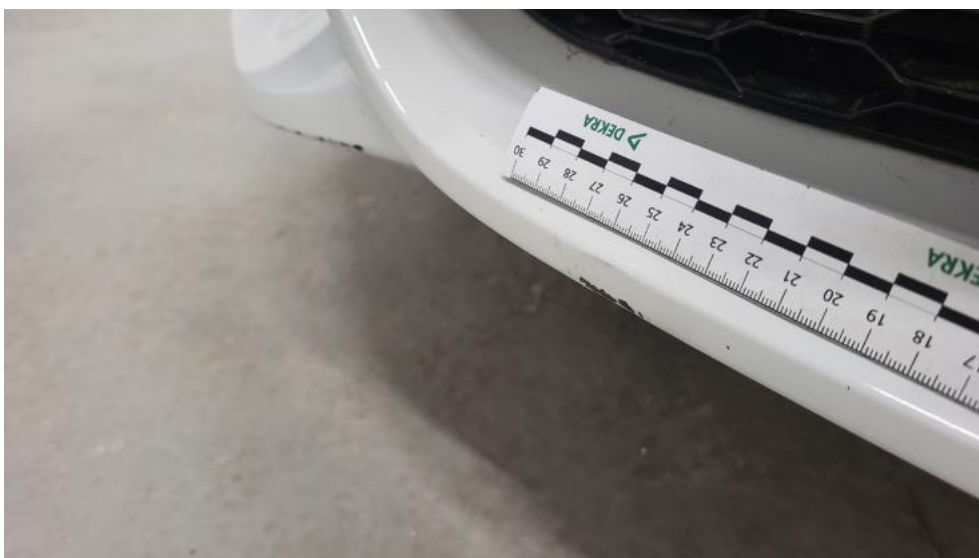
**Photo 48.**

Zderzak - Wgniecenie/odkształcenie 1

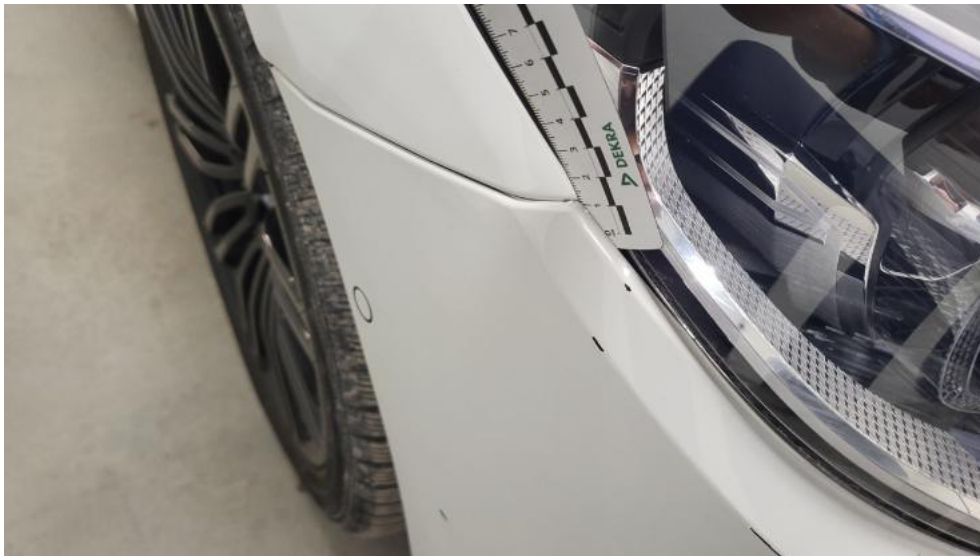
**Photo 49.**

Zderzak - Inne 1

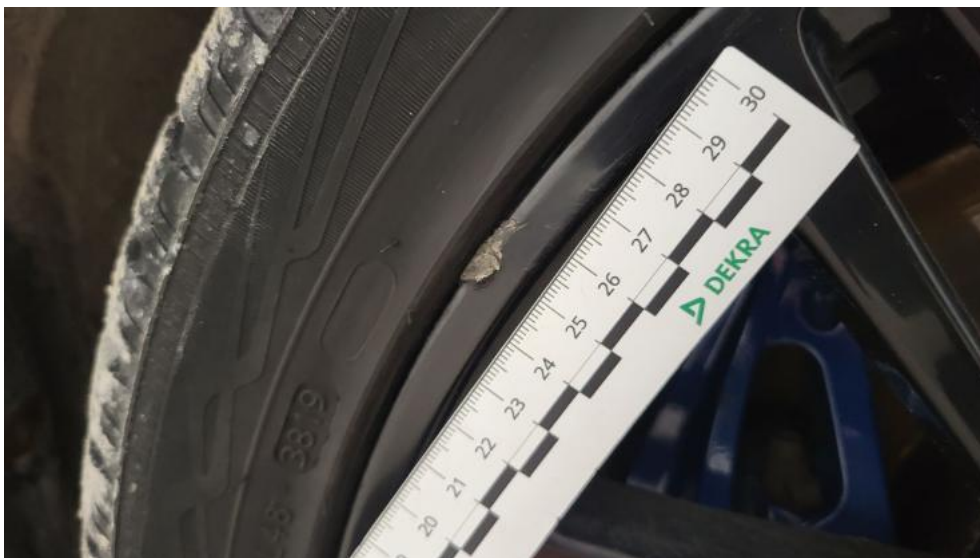
**Photo 50.**

Felga aluminiowa przednia P - Rysa/odprysk 1

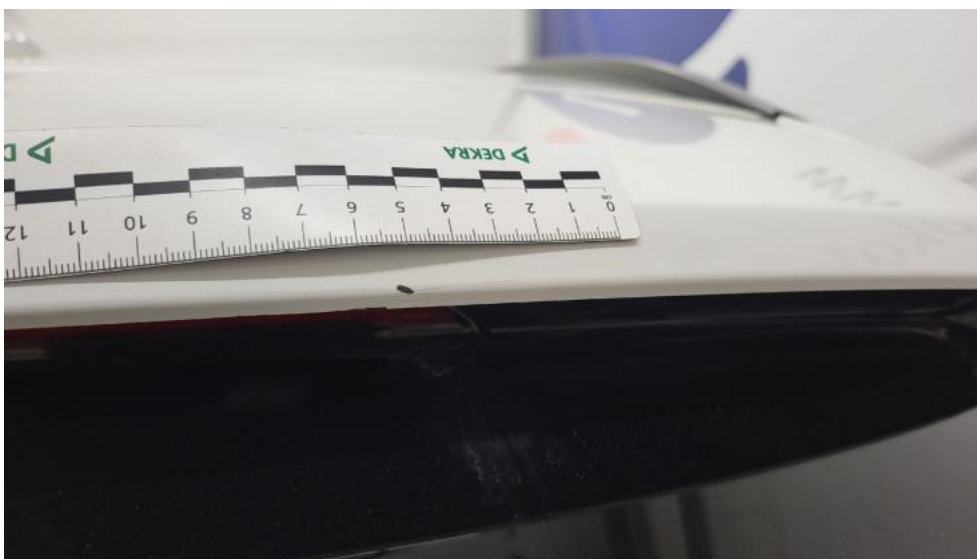
**Photo 57.**

Pokrywy bagażnika - Rysa/odprysk 1

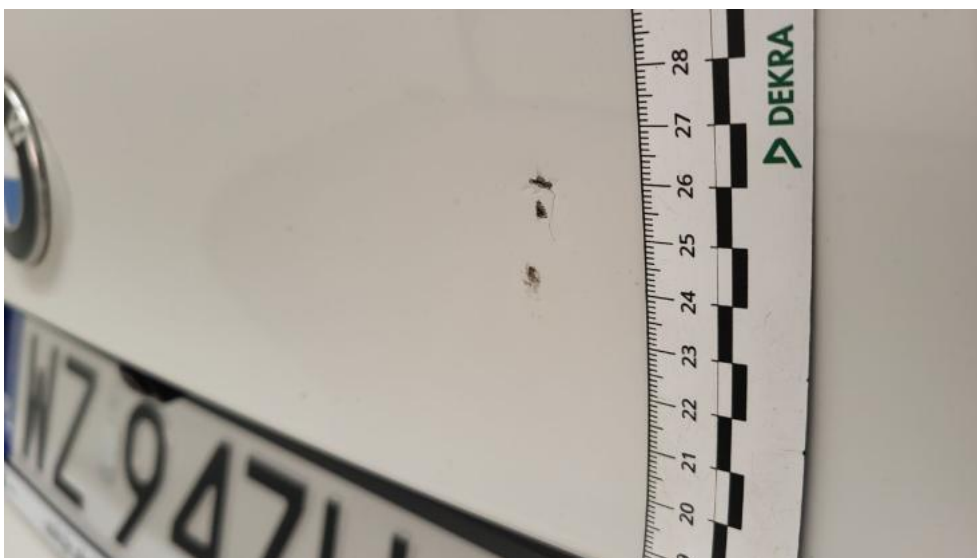
**Photo 58.**

Pokrywy bagażnika - Rysa/odprysk 2

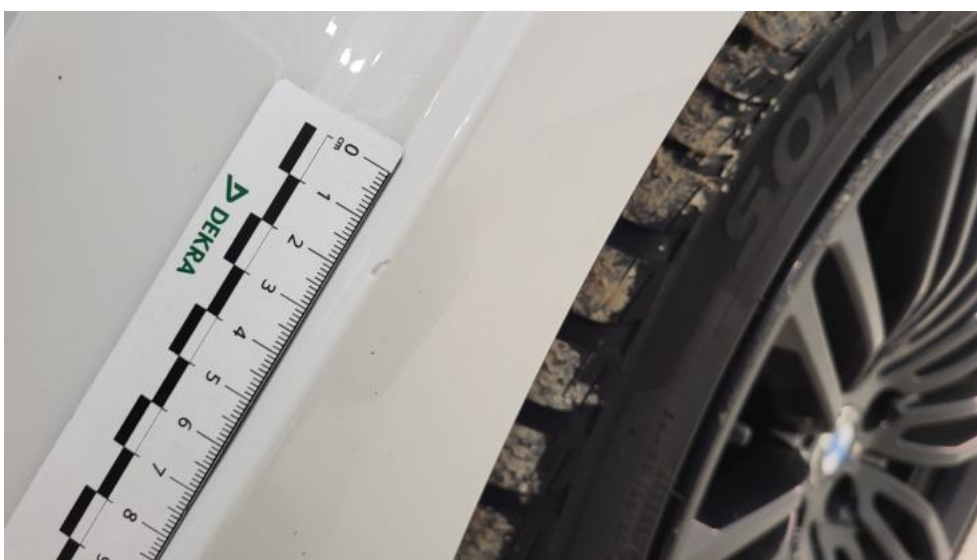
**Photo 60.**

Ścianka tylna L / Ścianka boczna L - Rysa/odprysk 1

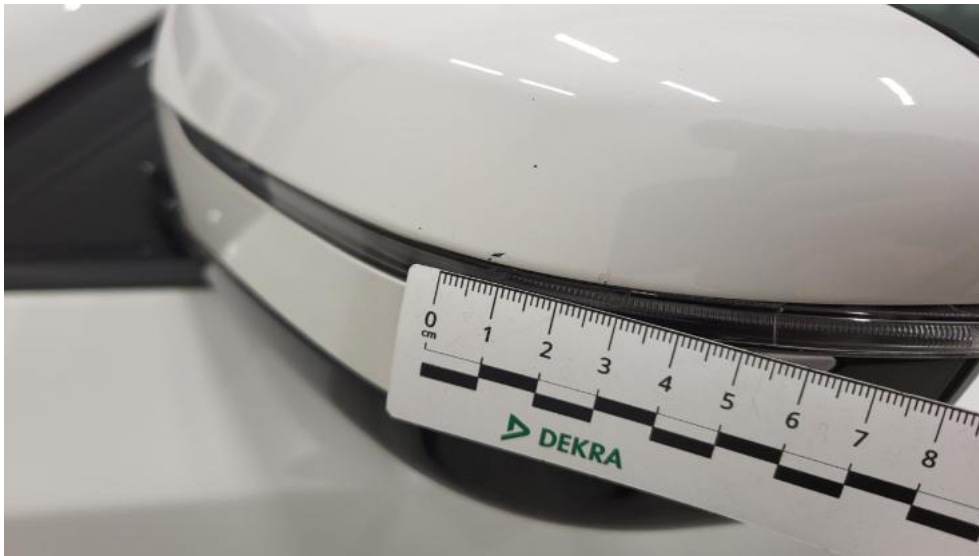
**Photo 65.**

Lusterko zew L - Rysa/odprysk 1

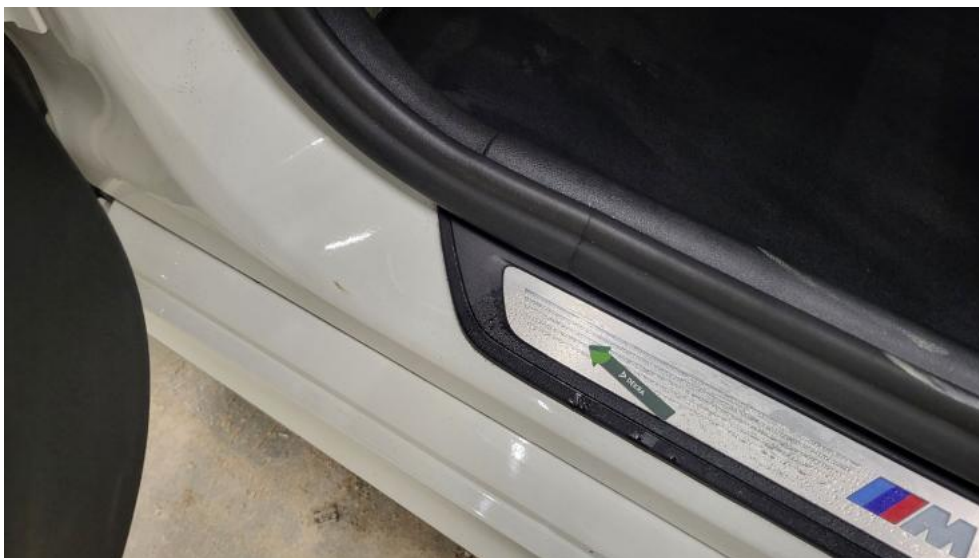
**Photo 66.**

Próg L - Wgniecenie/odkształcenie 1

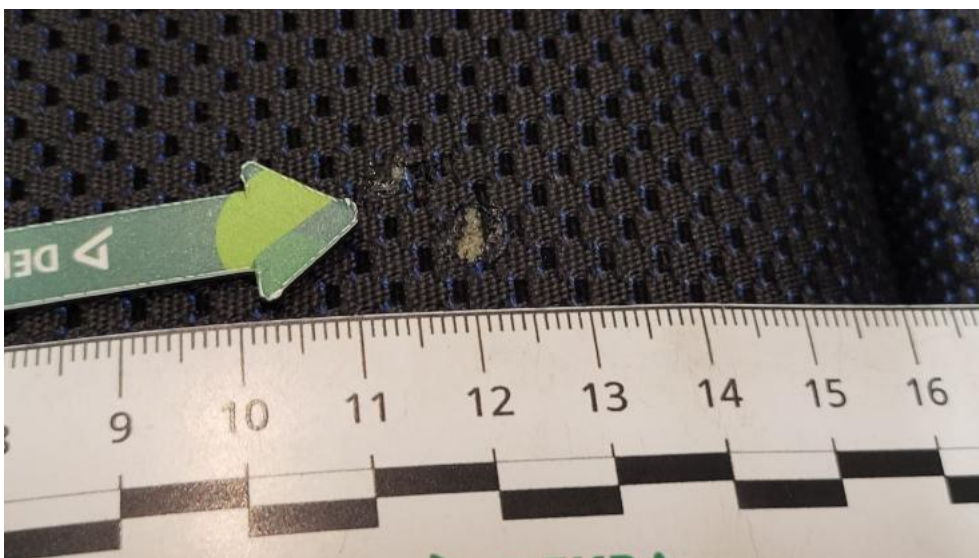
**Photo 70.**

Fotel prz. lew. - Inne 1

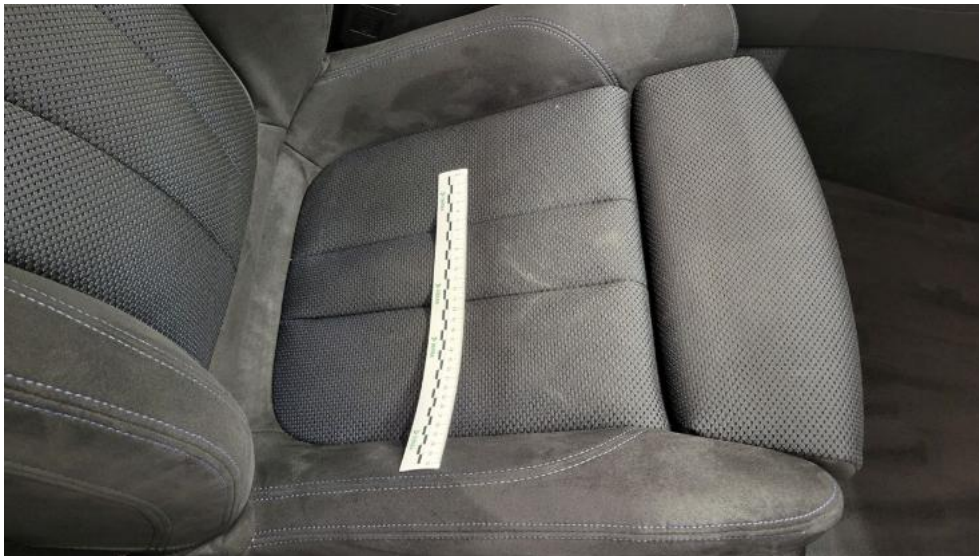
**Photo 71.**

Fotel prz. praw. - Inne 1

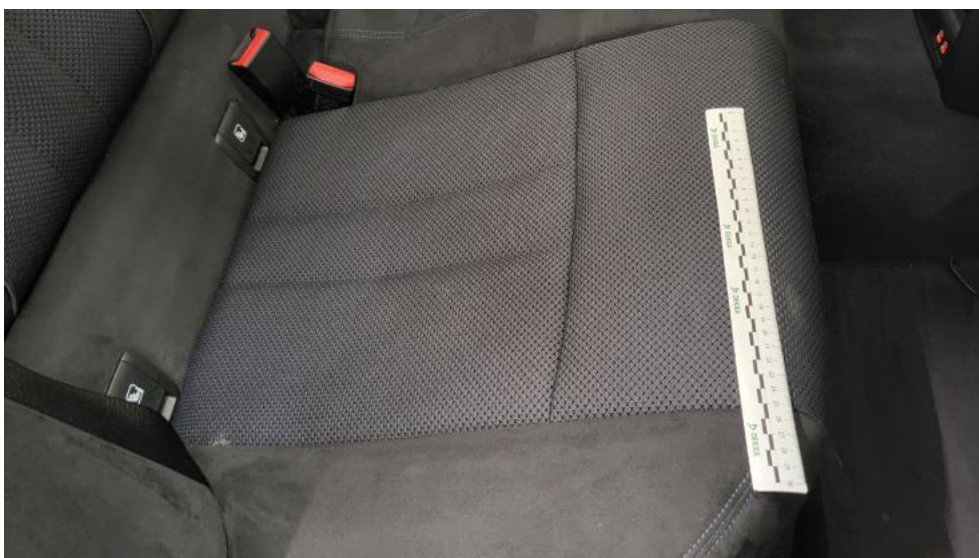
**Photo 72.**

Kanapa tyl. - Inne 1

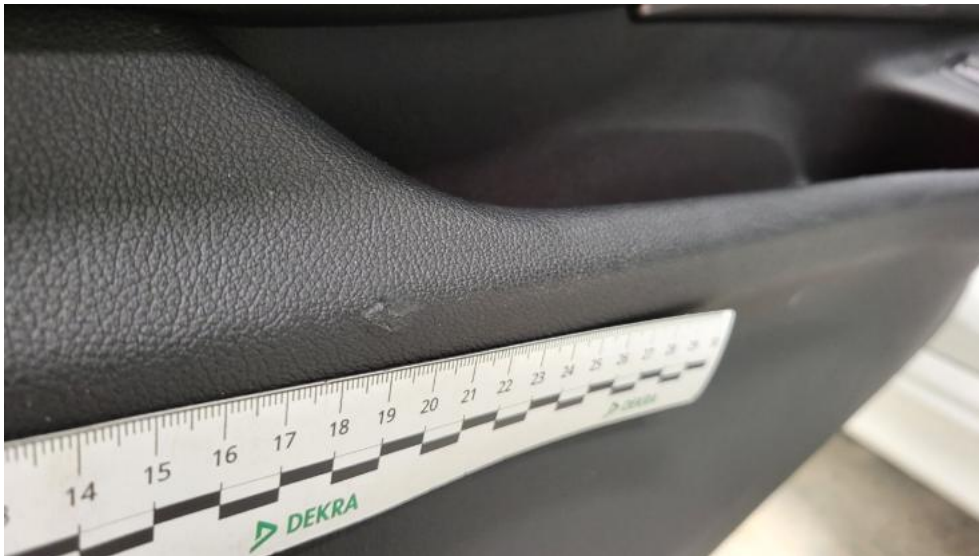
**Photo 73.**

Tapicerka drzwi przednich L - Rysa/odprysk 1

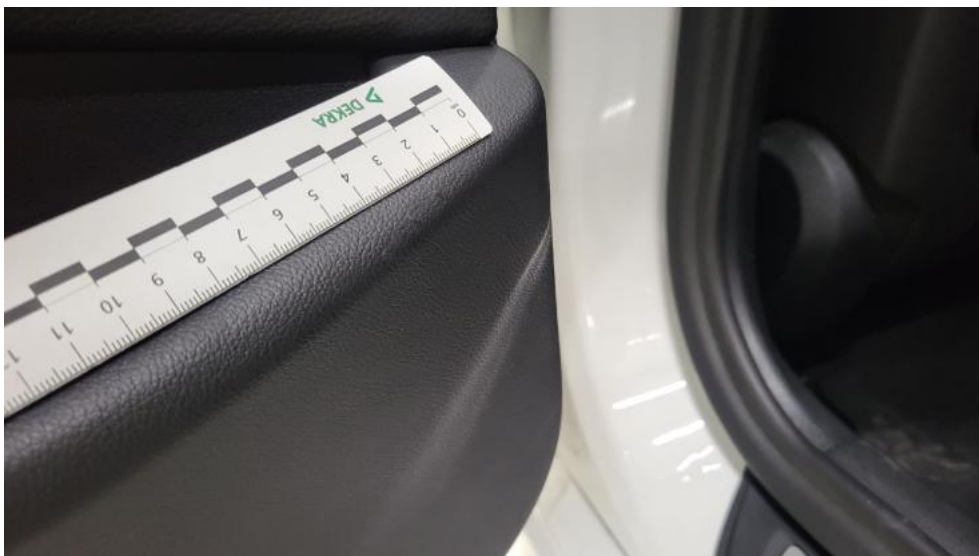
**Photo 74.**

Tapicerka drzwi tylnych L - Wgniecenie/odkształcenie 1

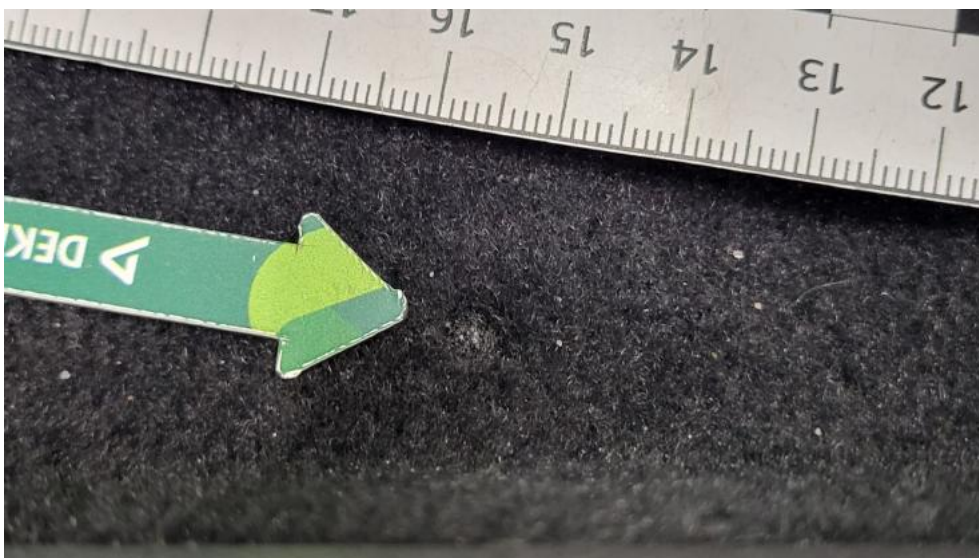
**Photo 76.**

Wykładzina podłogi - Inne 1
