DEKRA's commission No. : PKOL(W)/LODZ/93647/24/12/04
 commission/ damage No. : 22/006093
 Date of commission: 04-12-2024

Vehicle data

Measurement of thickness of the vehicle lacquer coating

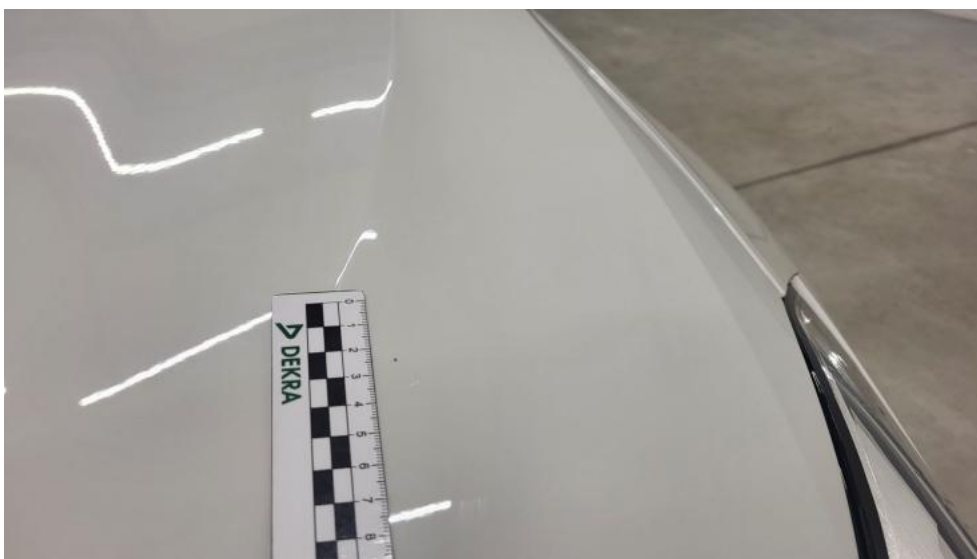
Photo 41.

Pokrywa komory silnika - Rysa/odprysk 2

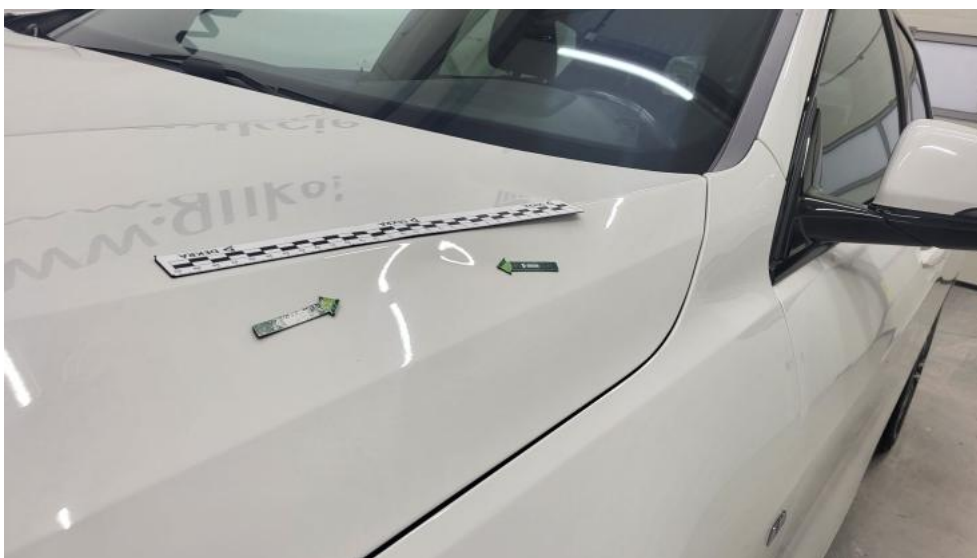
Photo 42.

Pokrywa komory silnika - Wgniecenie/odkształcenie 1

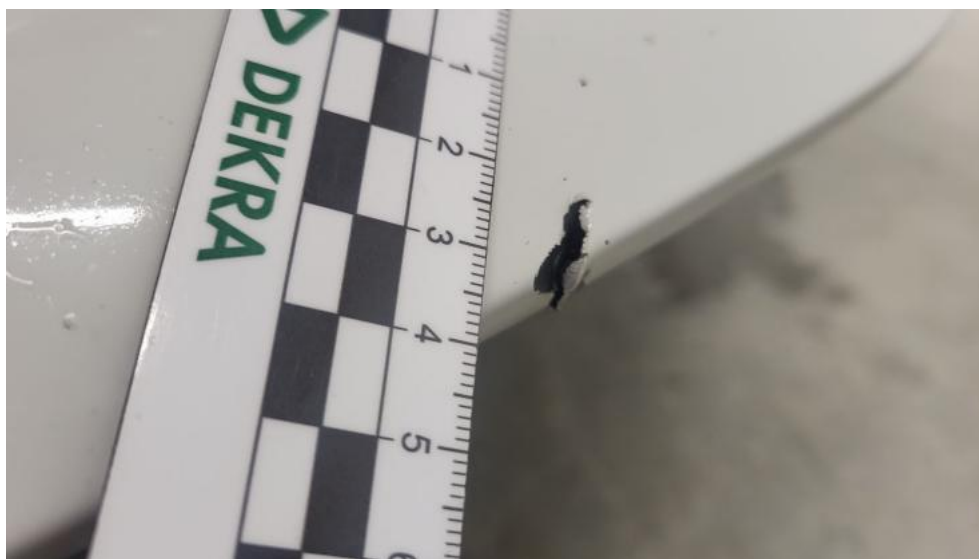
Photo 47.
Zderzak - Pęknięcie/rozerwanie 1

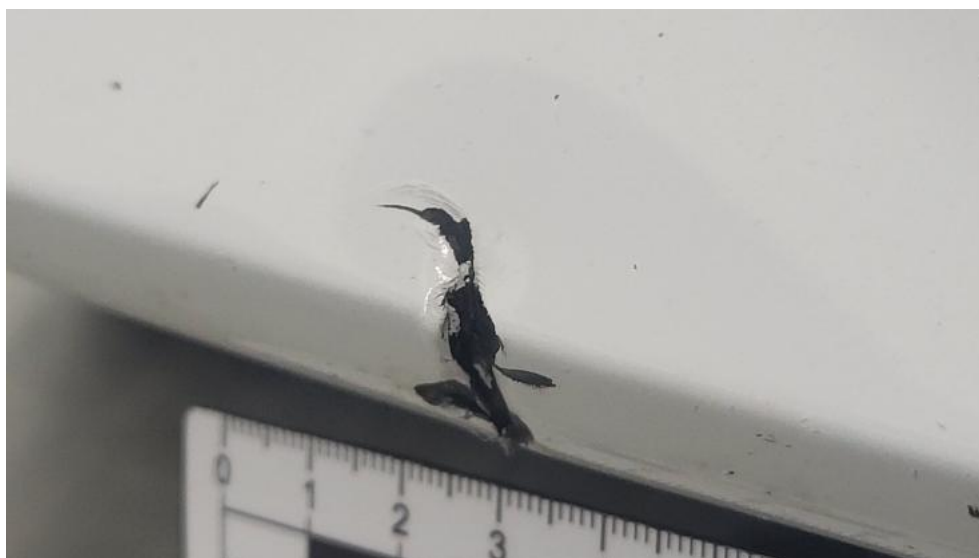
Photo 48.
Zderzak - Pęknięcie/rozerwanie 2

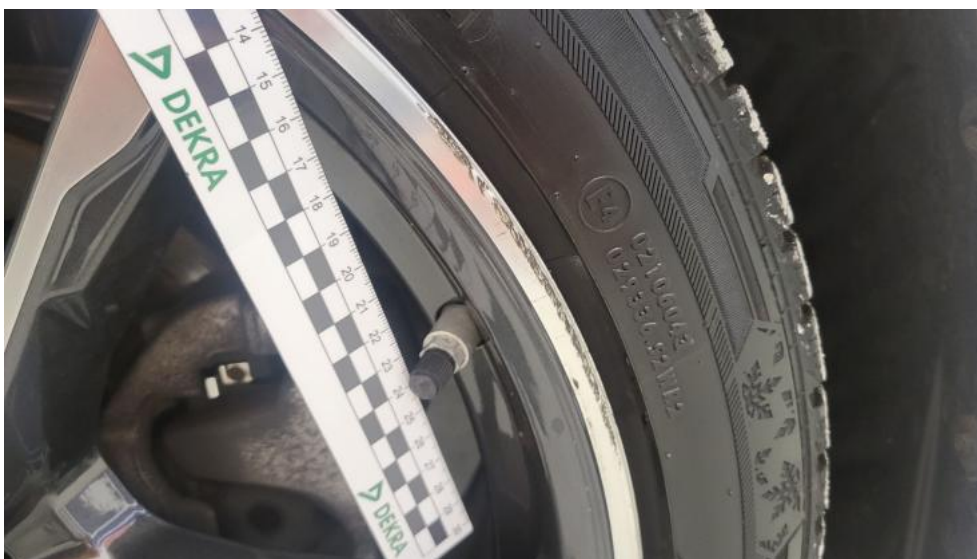
Photo 51.
Felga aluminiowa przednia P - Rysa/odprysk 2

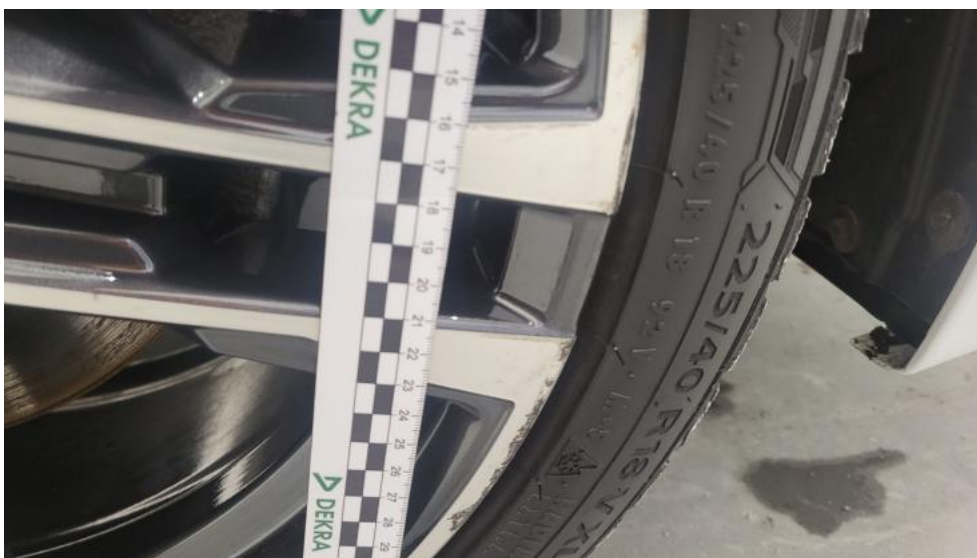
Photo 52.
Felga aluminiowa przednia P() - Rysa/odprysk 3

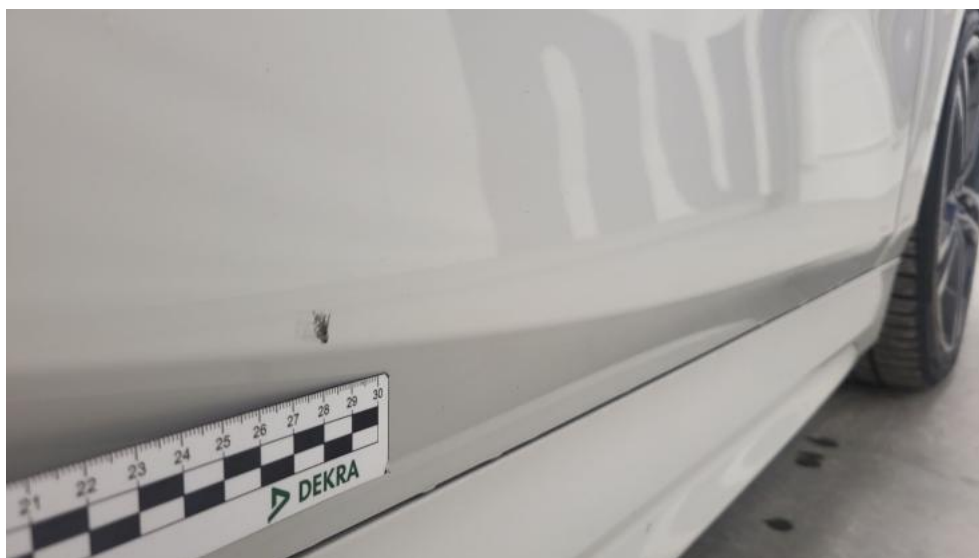
Photo 54.

Drzwi przednie P - Rysa/odprysk 1

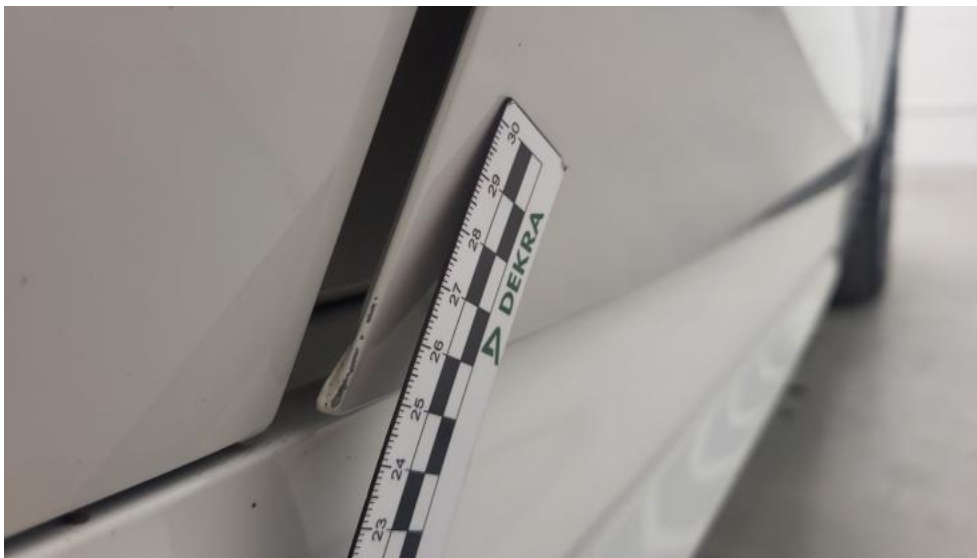
Photo 55.

Drzwi przednie P - Rysa/odprysk 2

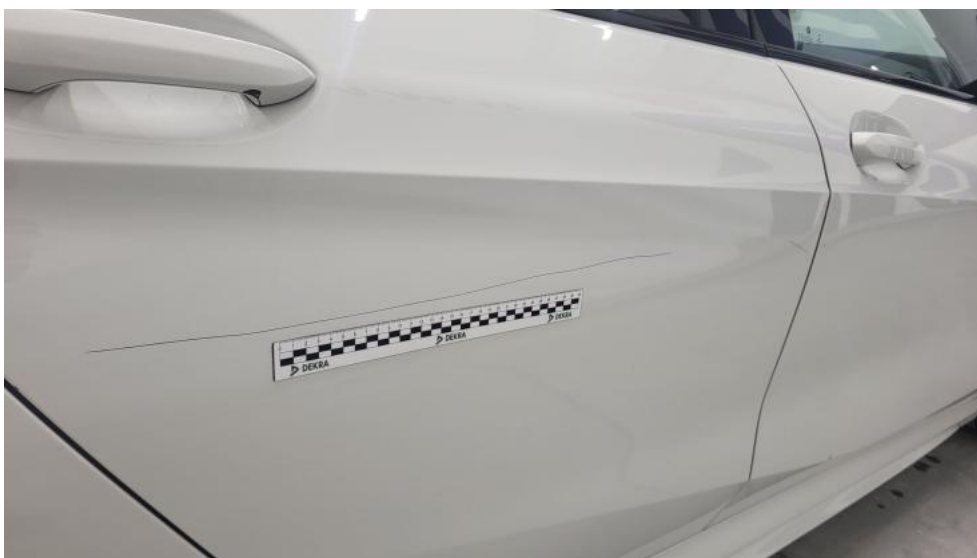
Photo 56.

Drzwi tylne P - Rysa/odprysk 1

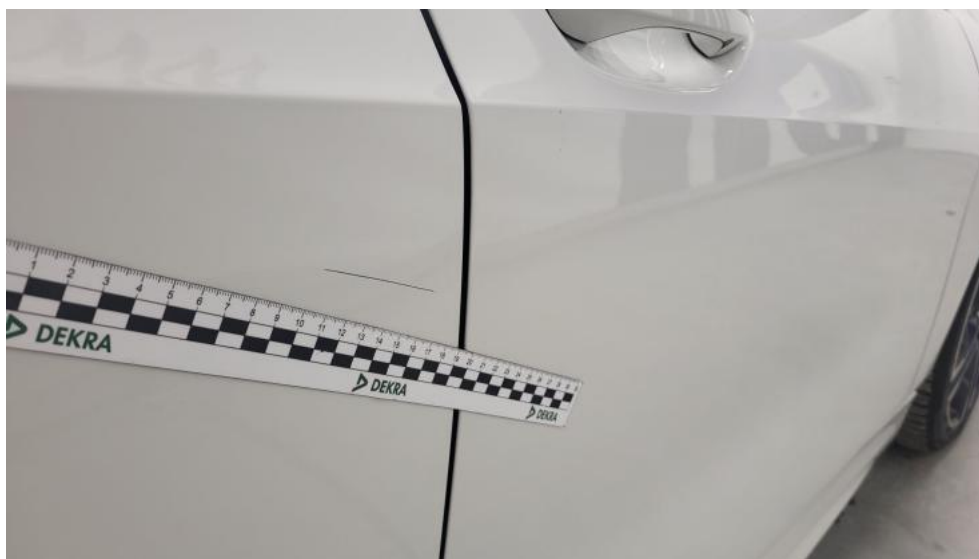
Photo 57.

Drzwi tylne P - Rysa/odprysk 2

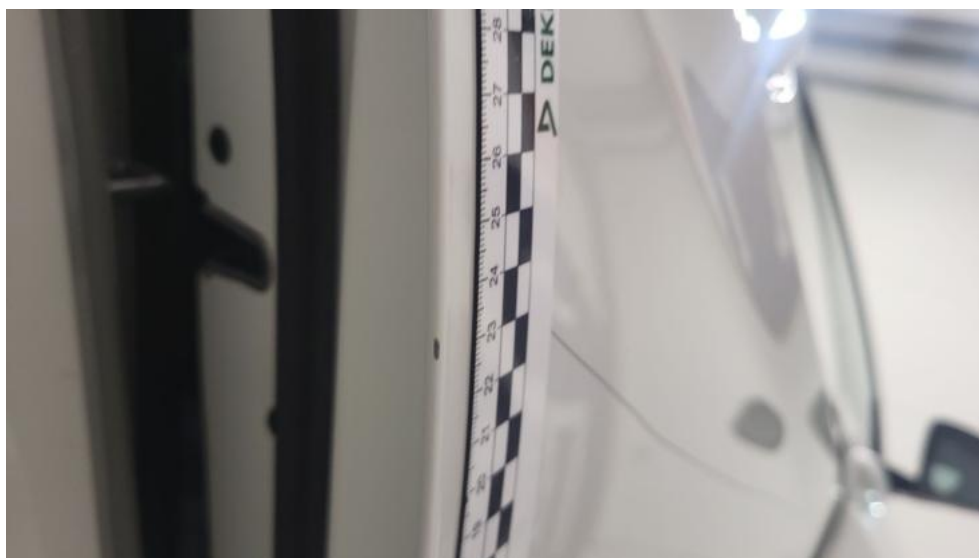
Photo 58.

Drzwi tylne P() - Rysa/odprysk 3

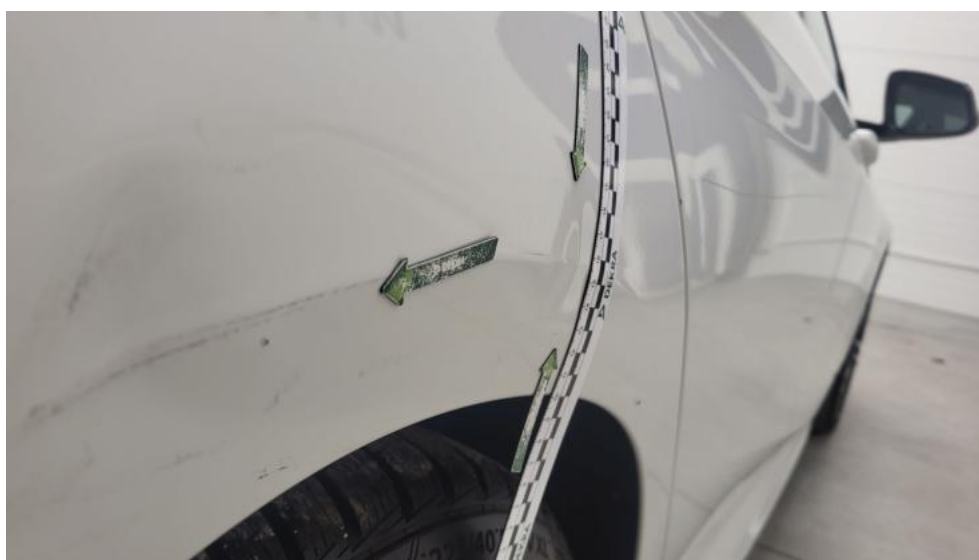
Photo 62.
Błotnik tylny P / Ściana boczna P - Wgniecenie/odkształcenie 2

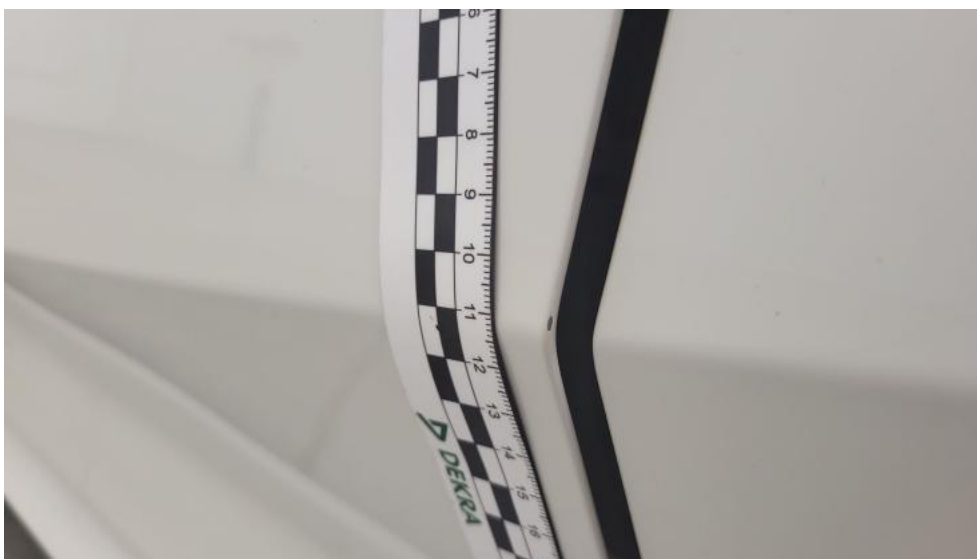
Photo 67.

Drzwi przed L - Rysa/odprysk 1

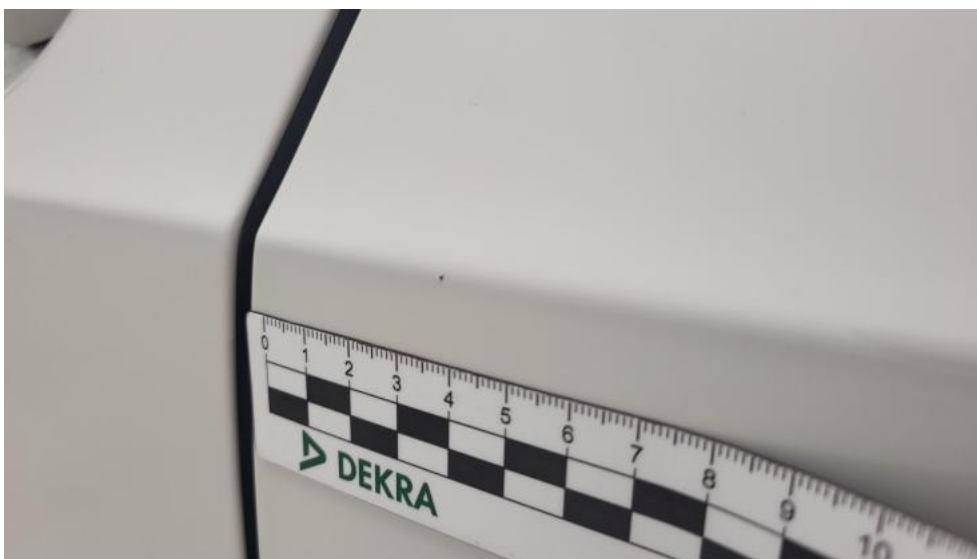
Photo 69.

Drzwi tylne L - Rysa/odprysk 2

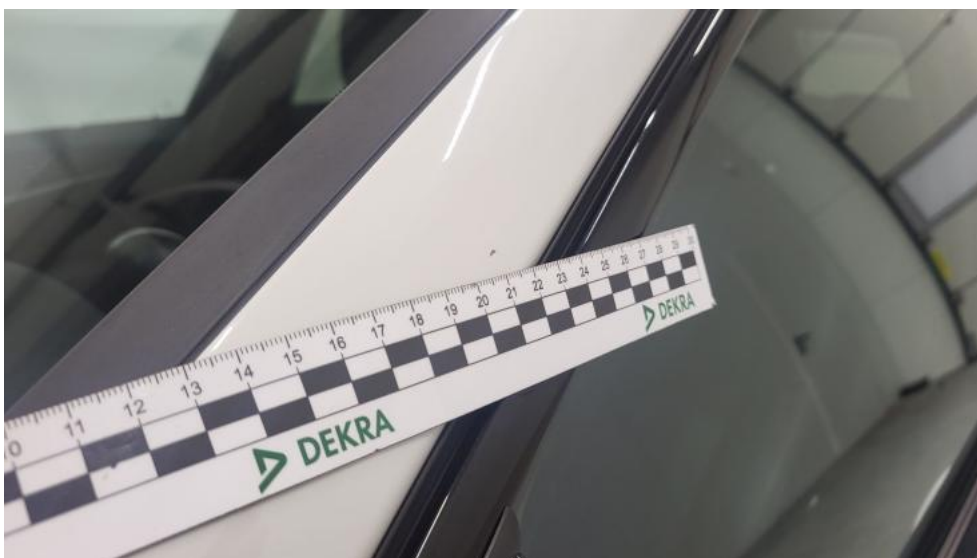
Photo 70.

Słupek przedni L - Rysa/odprysk 1

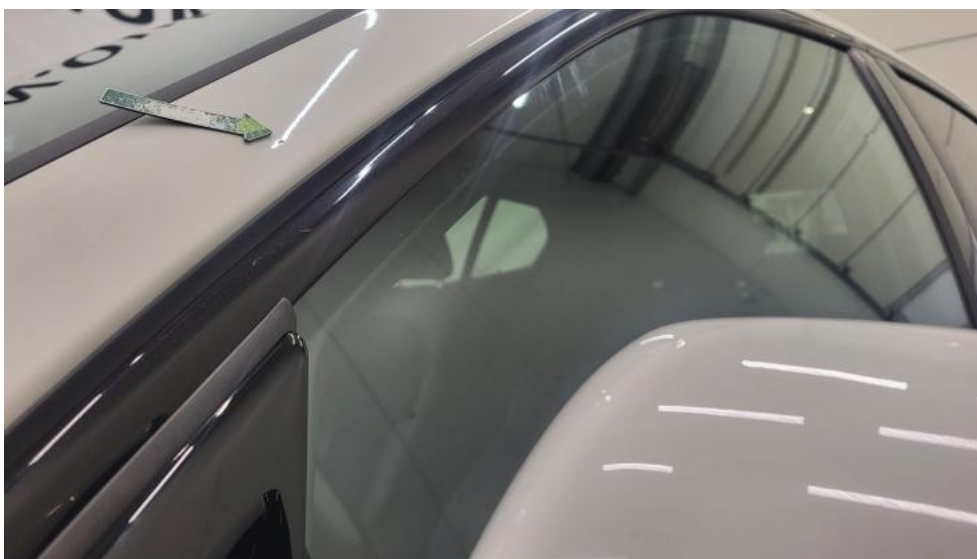
Photo 71.
Stupek przedni L - Wgniecenie/odkształcenie 1

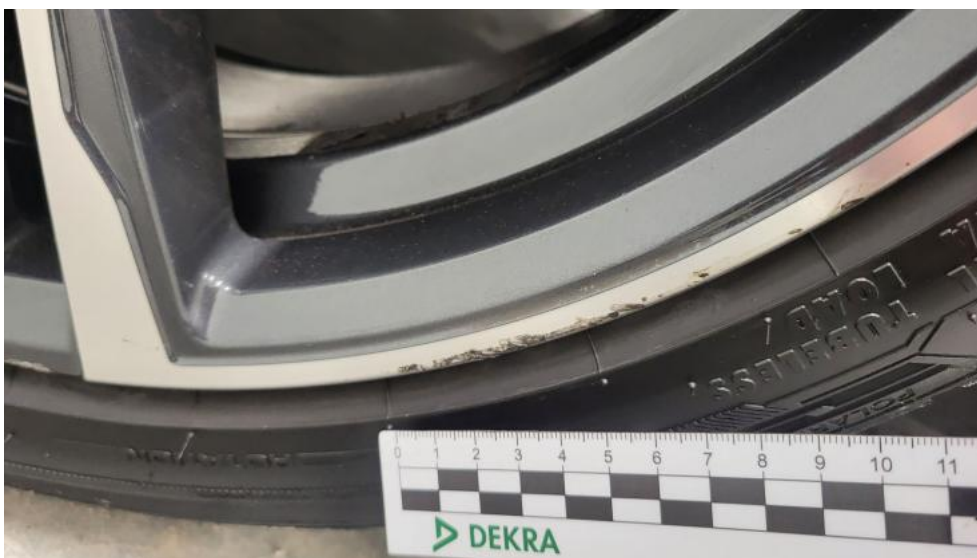
Photo 72.
Felga Aluminiowa przednia L - Rysa/odprysk 1
