DEKRA's commission No. : PKOL(W)/LODZ/12684/25/02/19
commission/ damage No. : 20/050074
Date of commission: 19-02-2025

Group of objects (Eurotax)	cars
EC code (Eurotax)	0116850
Manufacturer	JAGUAR
Model	XF 15-20
Type / version	XF 2.0 i4D R-Sport aut
Body type	sedan
Number of doors / seats	4/5
Curb weight [kg]	1734
Gross vehicle weight [kg]	2250
Wheelbase 1/2	2960
Engine type	Automatic ignition
Pollution reduction system	DPF
Engine capacity [ccm]	1999
Engine Power [hp/kW]	180/132
Gearbox	automatic 8- gear
Registration /record No.	WZ417GA
VIN / serial number	SAJBB4BN3KCY75904
Date of first registration	14-03-2019
Date of next. tech. test	04-01-2026
Year of manufacture	2019
Readout [km]	100 651 (read)
Body color / type of coating	black/METALIK

Measurement of thickness of the vehicle lacquer coating

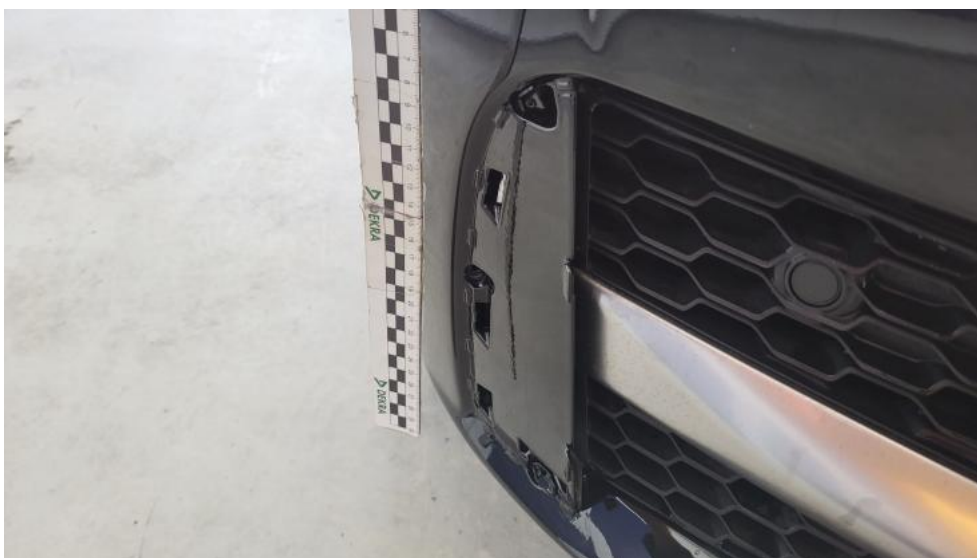
Photo 40.
Zderzak - Inne 1

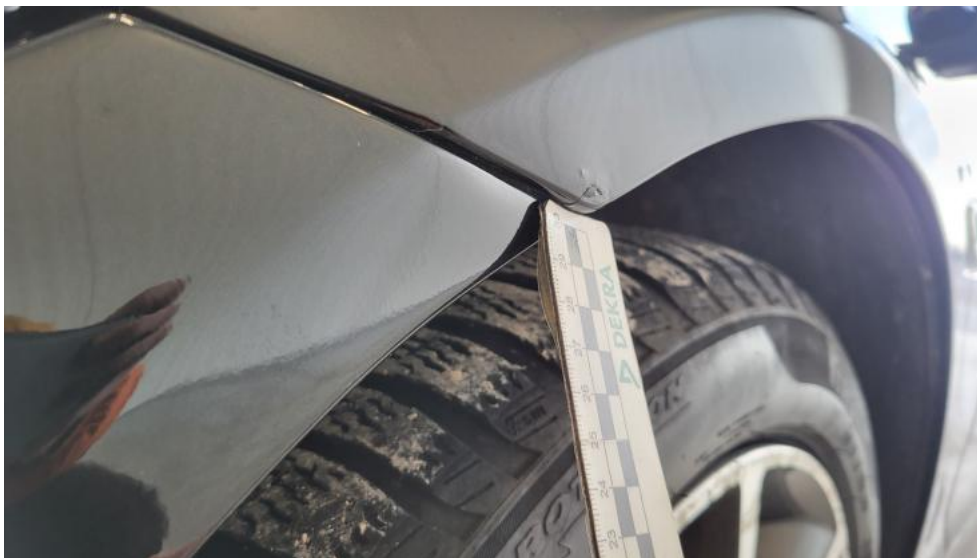
Photo 41.
Zderzak - Inne 2

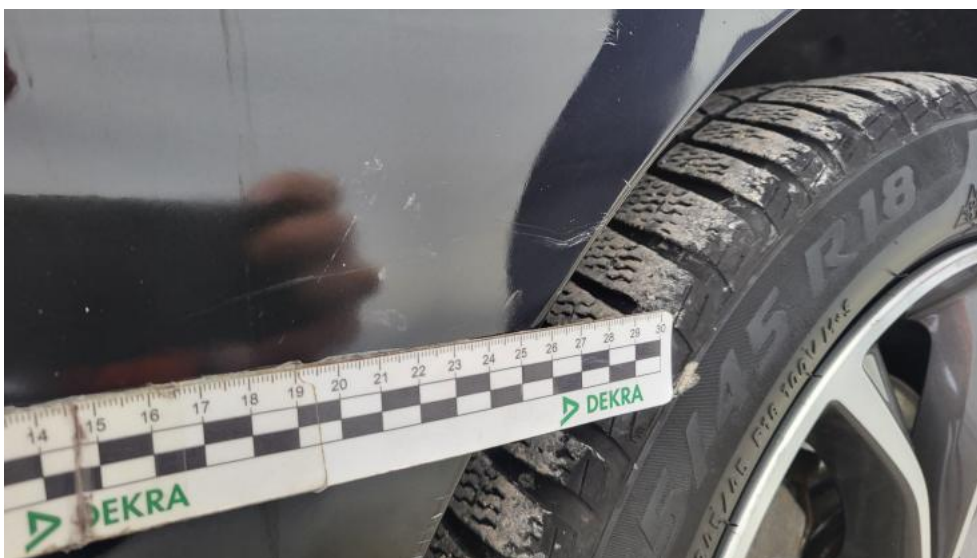
Photo 42.
Błotnik przedni P - Rysa/odprysk 1

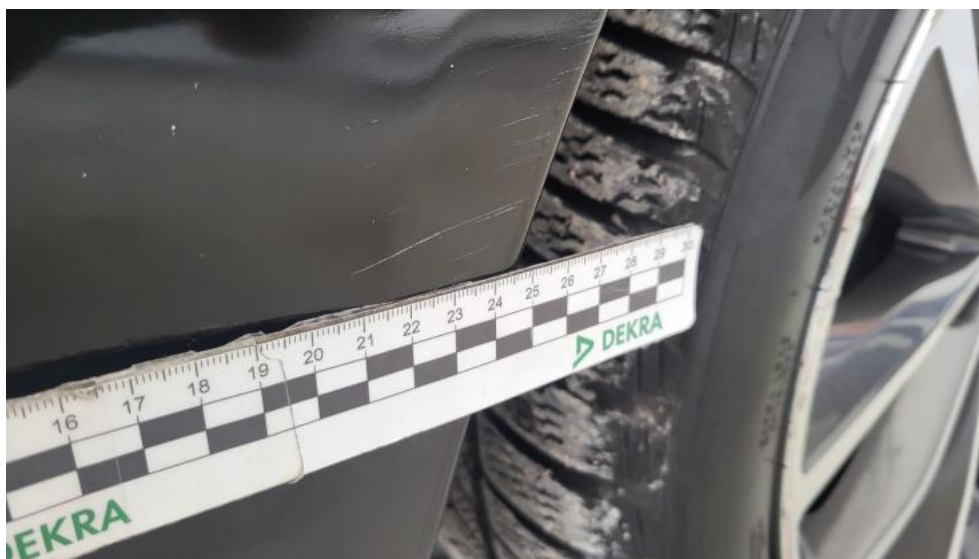
Photo 43.
Błotnik przedni P - Rysa/odprysk 2

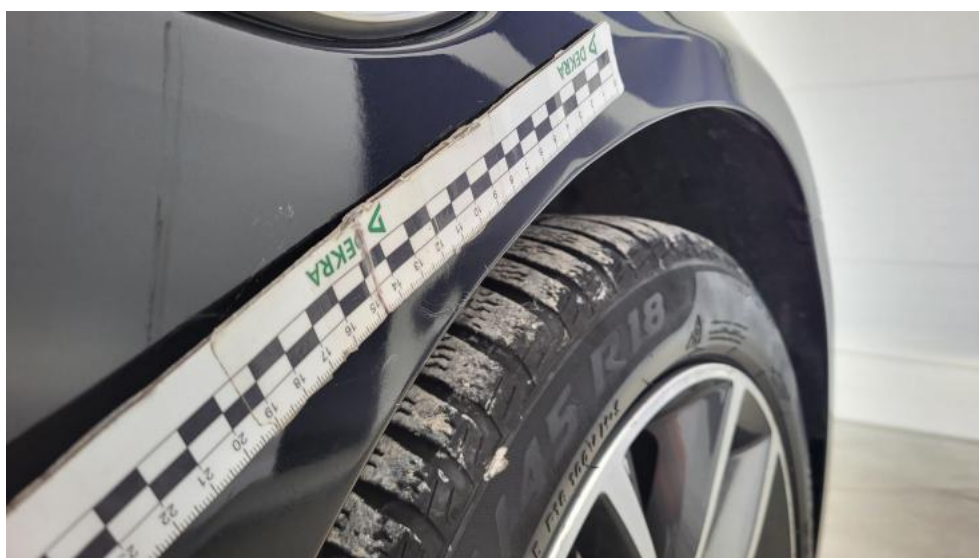
Photo 44.
Błotnik przedni P - Wgniecenie/odkształcenie 1

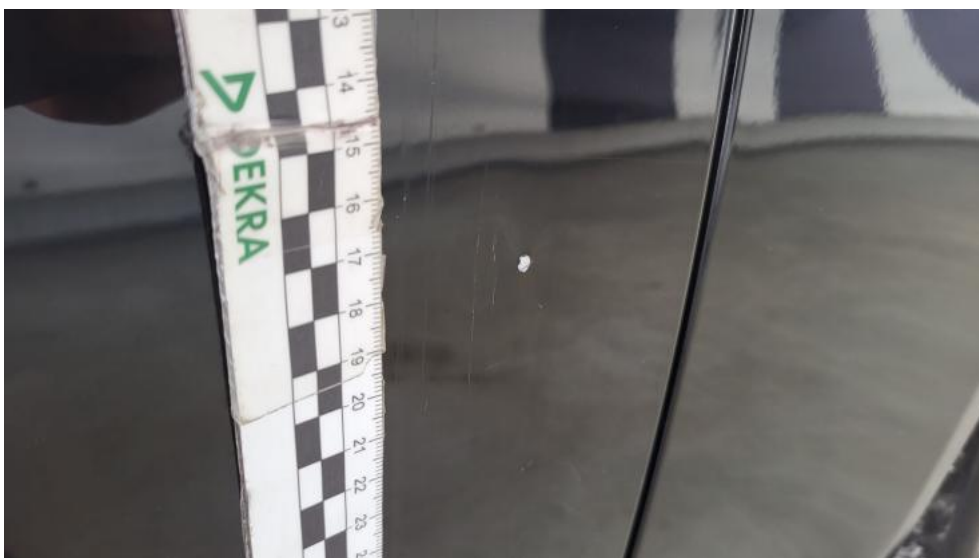
Photo 48.

Drzwi przednie P - Rysa/odprysk 1

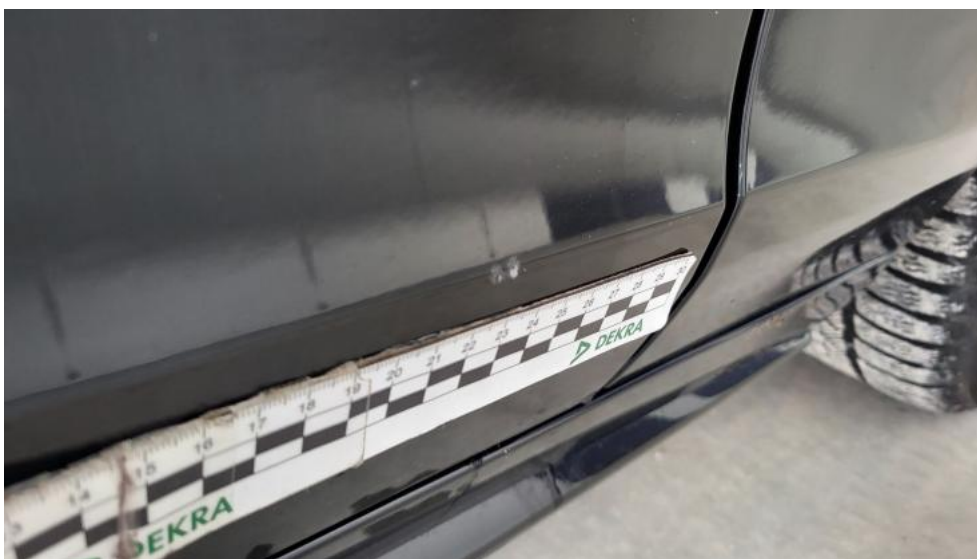
Photo 49.
Drzwi przednie P - Rysa/odprysk 2

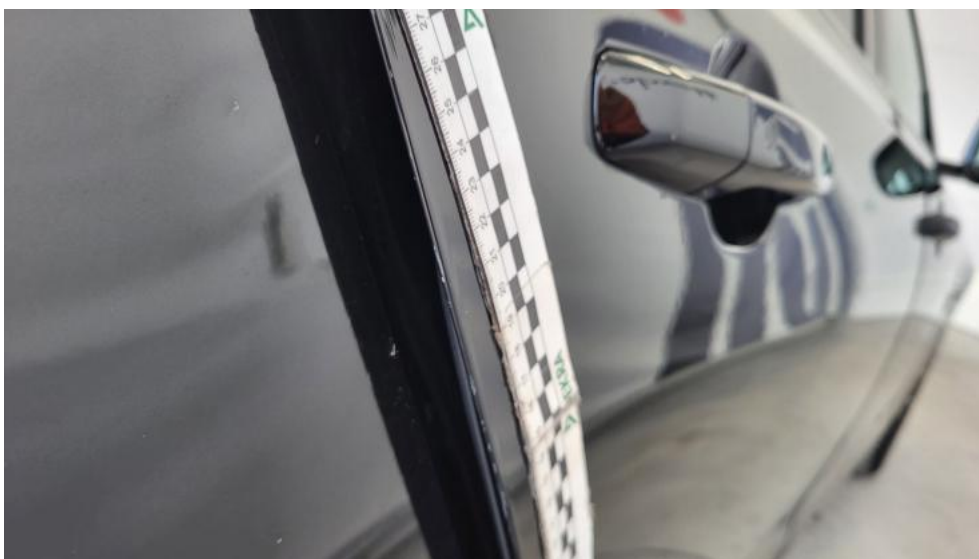
Photo 55.

Drzwi tylne P - Rysa/odprysk 2

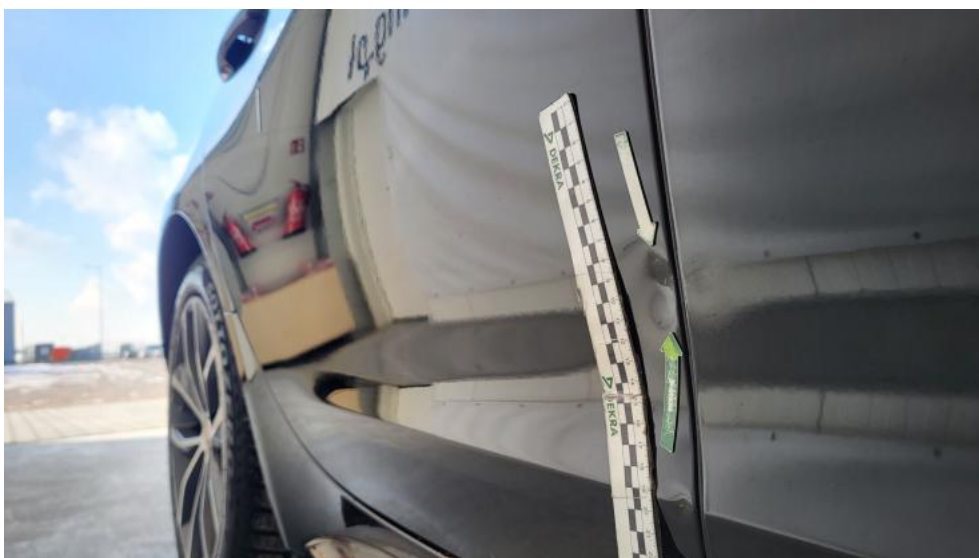
Photo 56.

Drzwi tylne P - Wgniecenie/odkształcenie 1

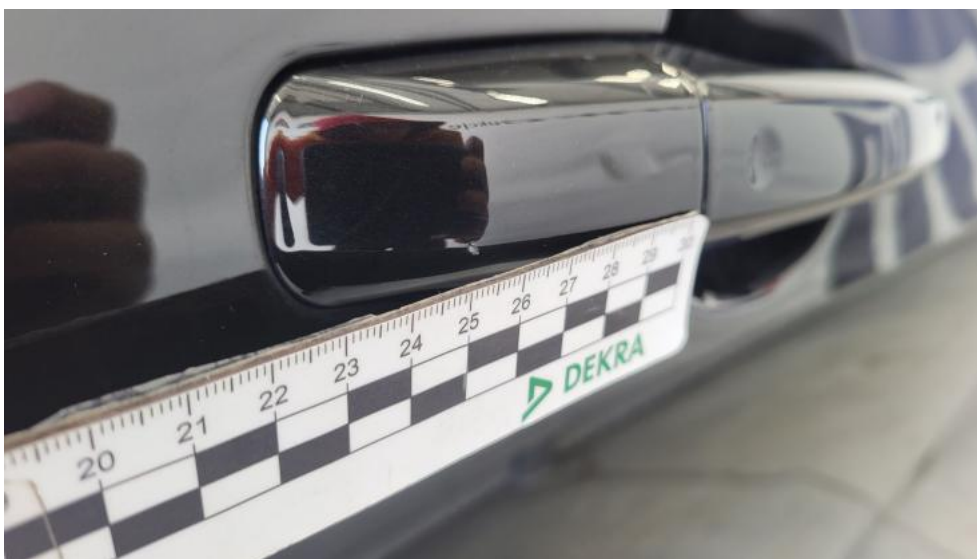
Photo 57.
Klamka drzwi tyl P - Rysa/odprysk 1

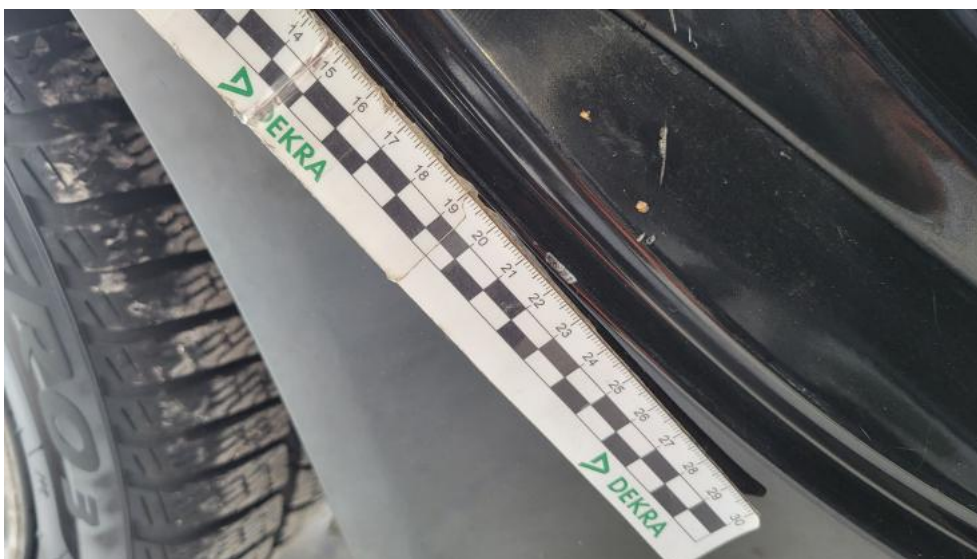
Photo 59.
Próg P - Rysa/odprysk 1

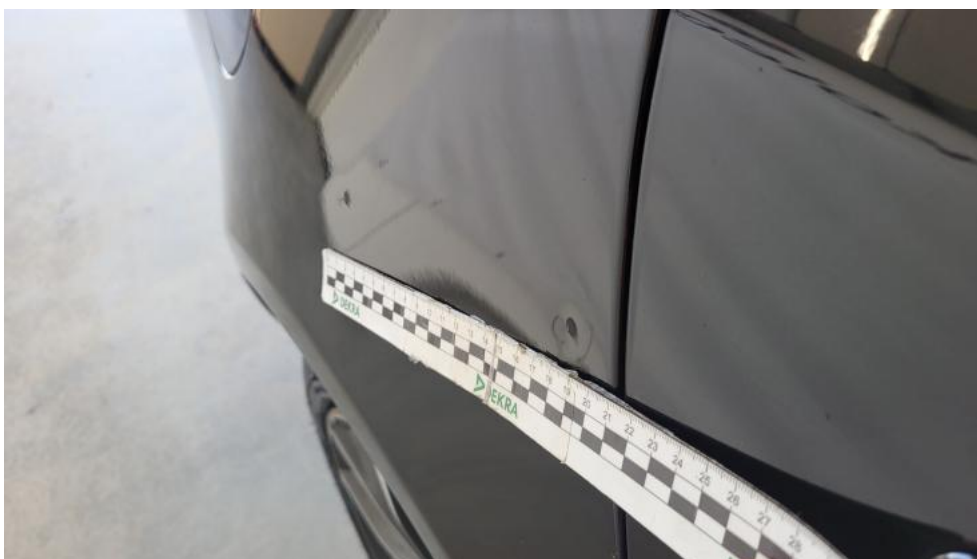
Photo 61.
Błotnik tylny P / Ściana boczna P - Wgniecenie/odkształcenie 1

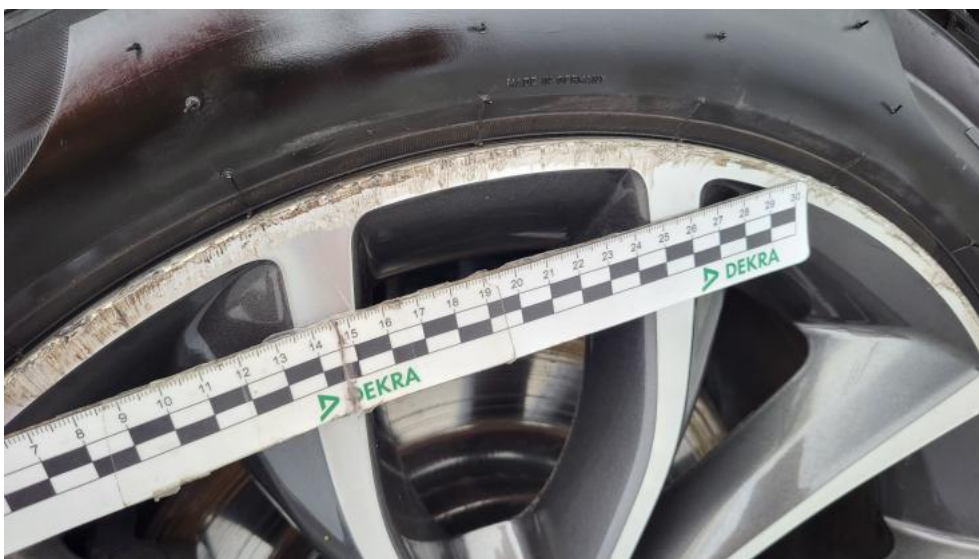
Photo 63.
Felga aluminiowa tylna P - Rysa/odprysk 1

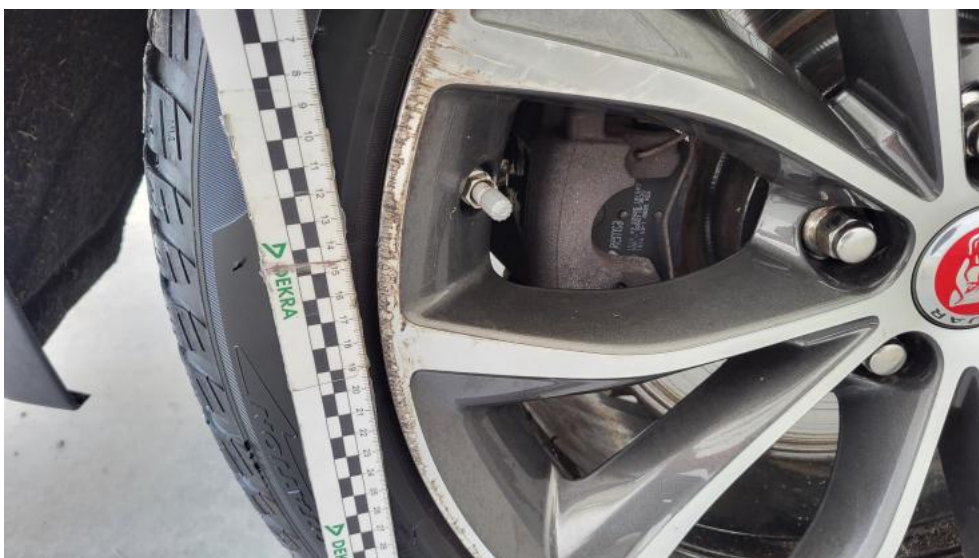
Photo 64.
Felga aluminiowa tylna P - Rysa/odprysk 2

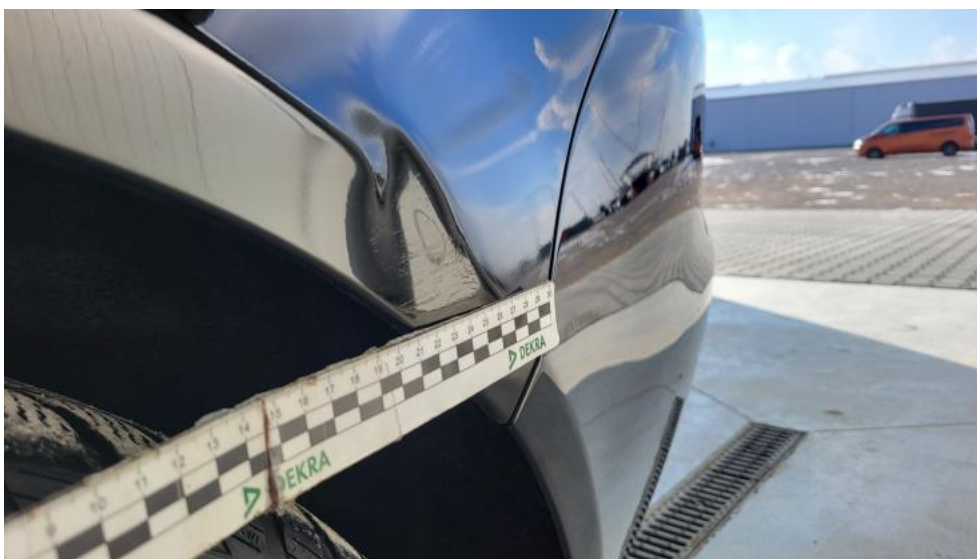
Photo 73.
Błotnik tylny L / Ściana boczna L - Wgniecenie/odkształcenie 1

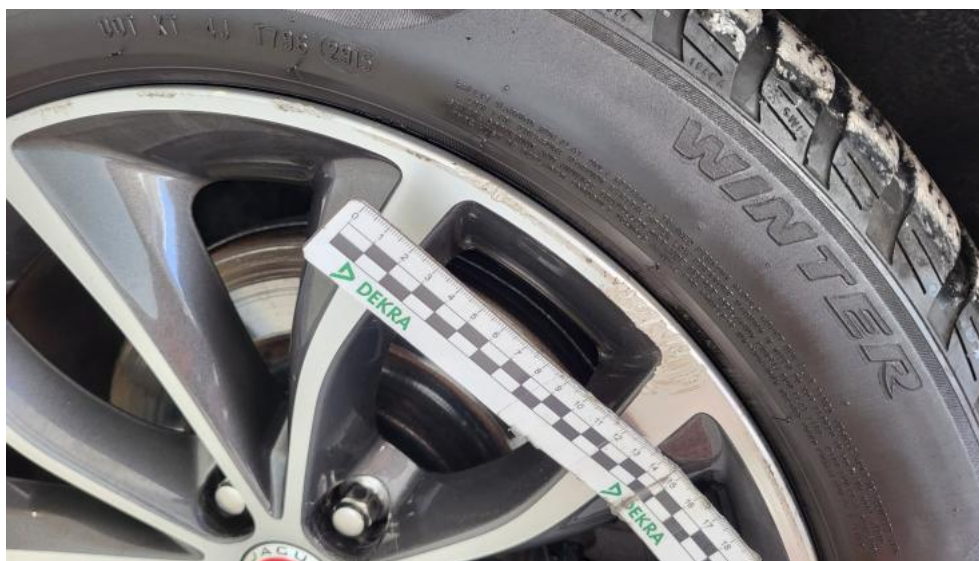
Photo 75.
Felga aluminiowa tylna L - Rysa/odprysk 1

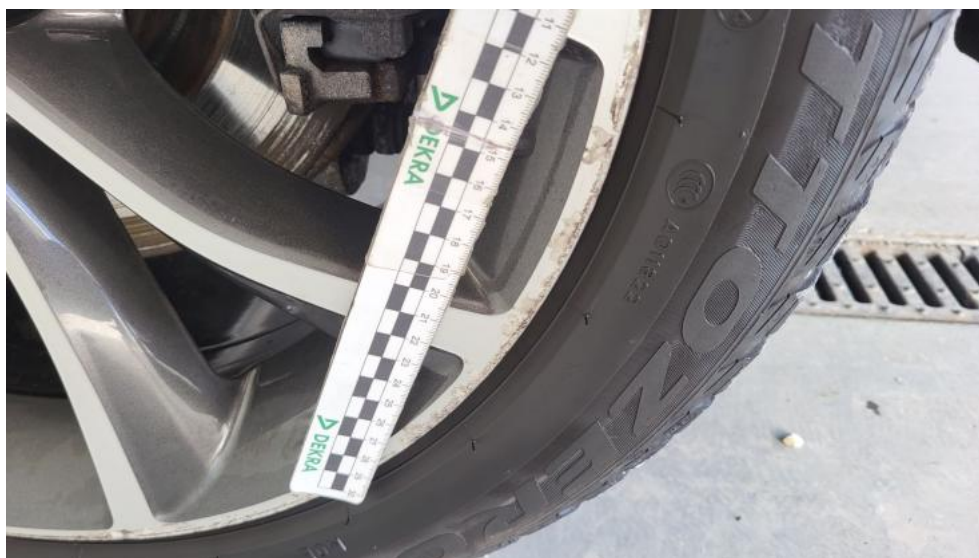
Photo 76.
Felga aluminiowa tylna L - Rysa/odprysk 2

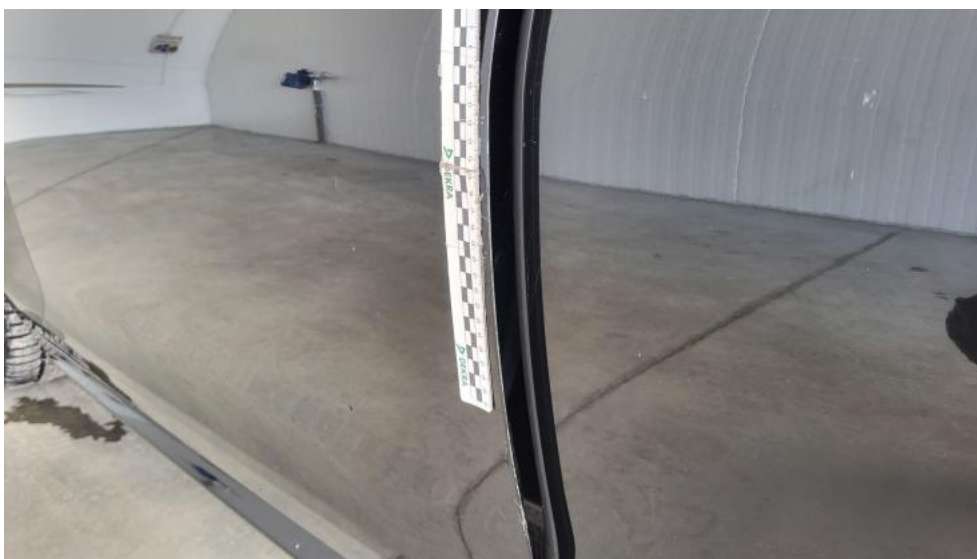
Photo 77.

Drzwi przed L - Rysa/odprysk 1

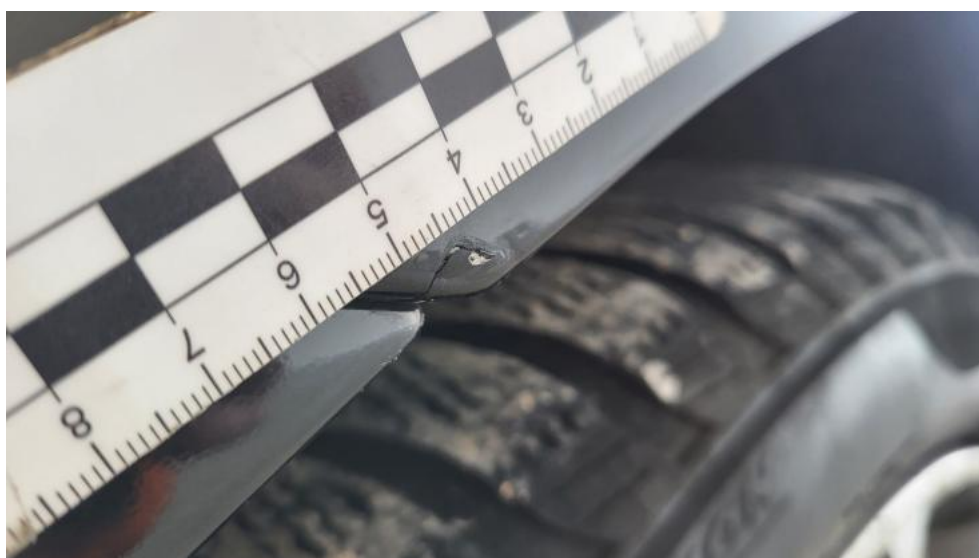
Photo 86.
Błotnik przedni L - Pęknięcie/rozerwanie 1

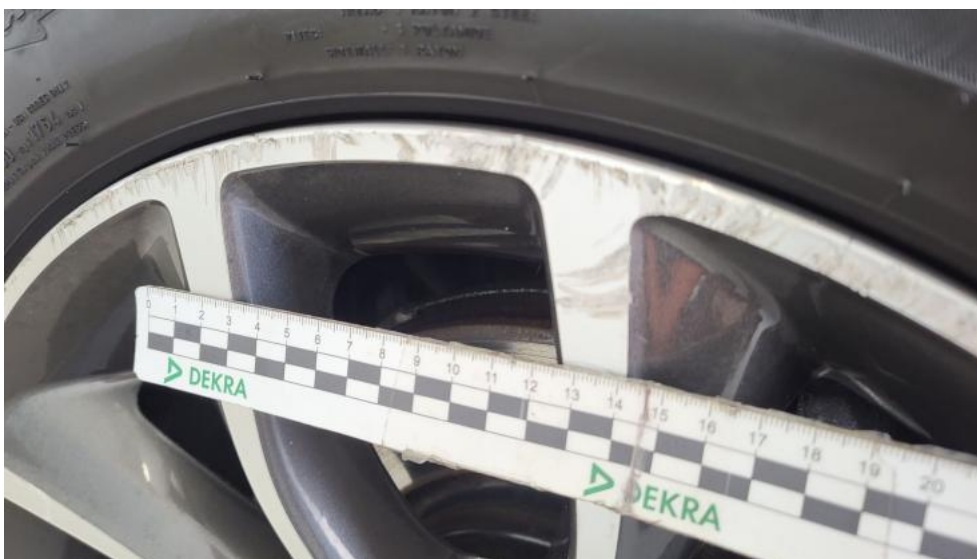
Photo 87.
Felga Aluminiowa przednia L - Rysa/odprysk 1

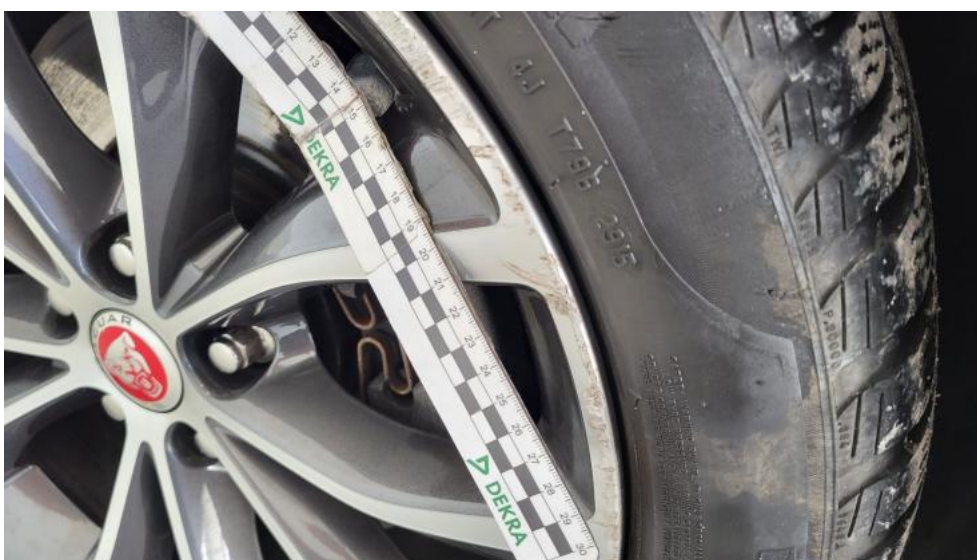
Photo 88.
Felga Aluminiowa przednia L - Rysa/odprysk 2

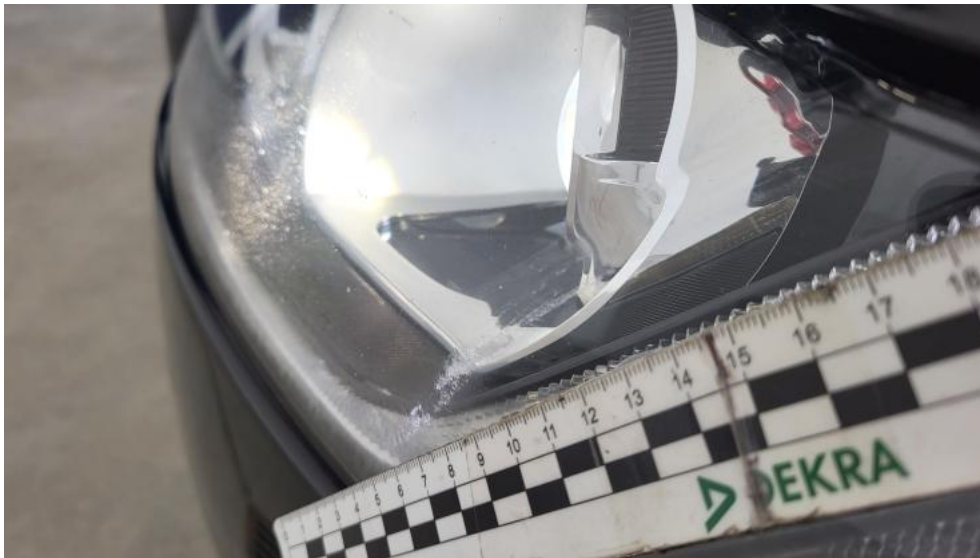
Photo 89.
Reflektor L - Rysa/odprysk 1

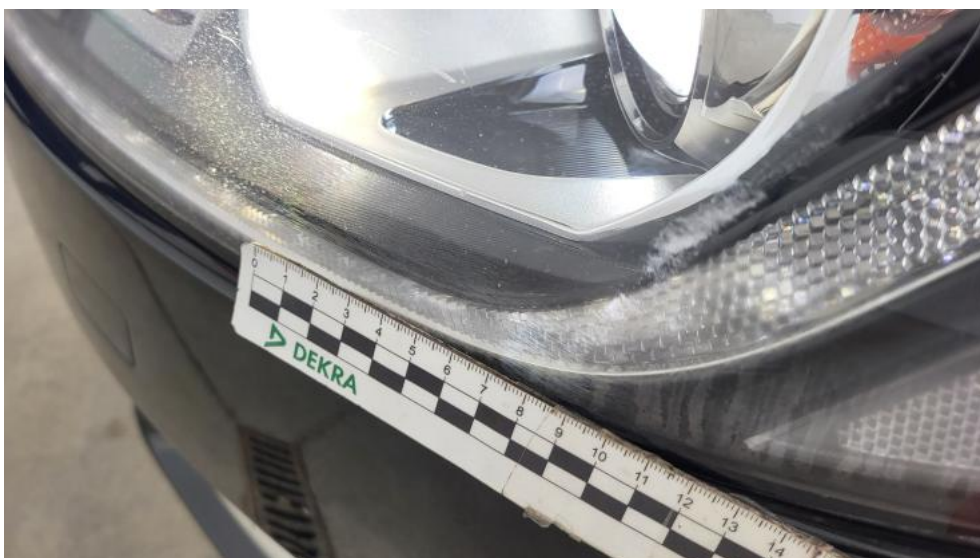
Photo 90.
Reflektor L - Rysa/odprysk 2

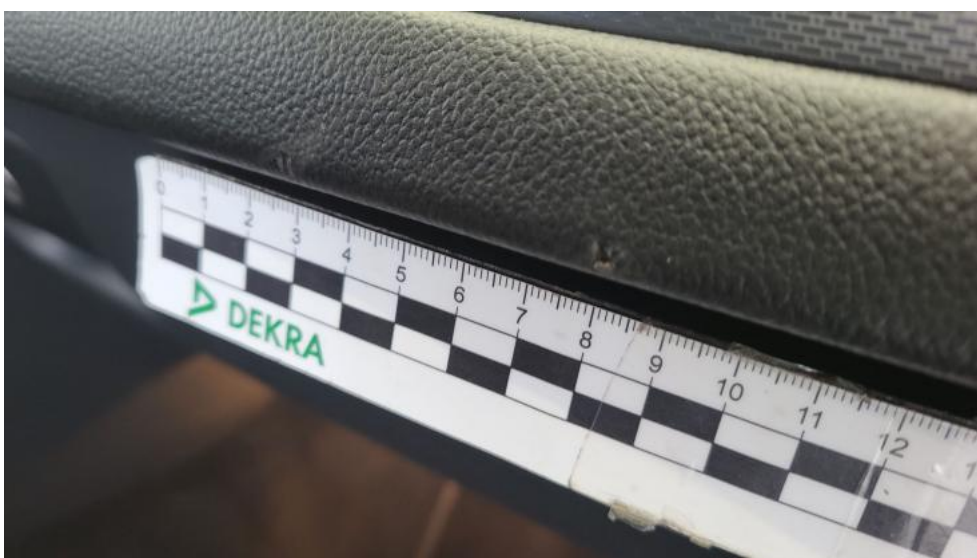
Photo 92.

Deska rozdzielcza - Pęknięcie/rozerwanie 1
