DEKRA's commission No. : PKOL(W)/LODZ/54289/26/06/12
commission/ damage No. : 24/025572
Date of commission: 12-06-2026

Vehicle data

Measurement of thickness of the vehicle lacquer coating

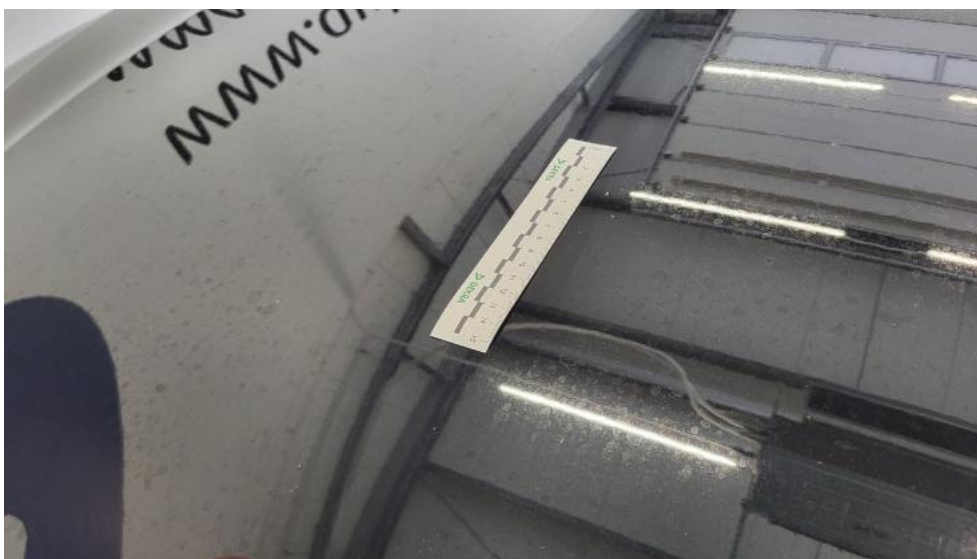
Photo 43.
Pokrywa komory silnika - Rysa/odprysk 1

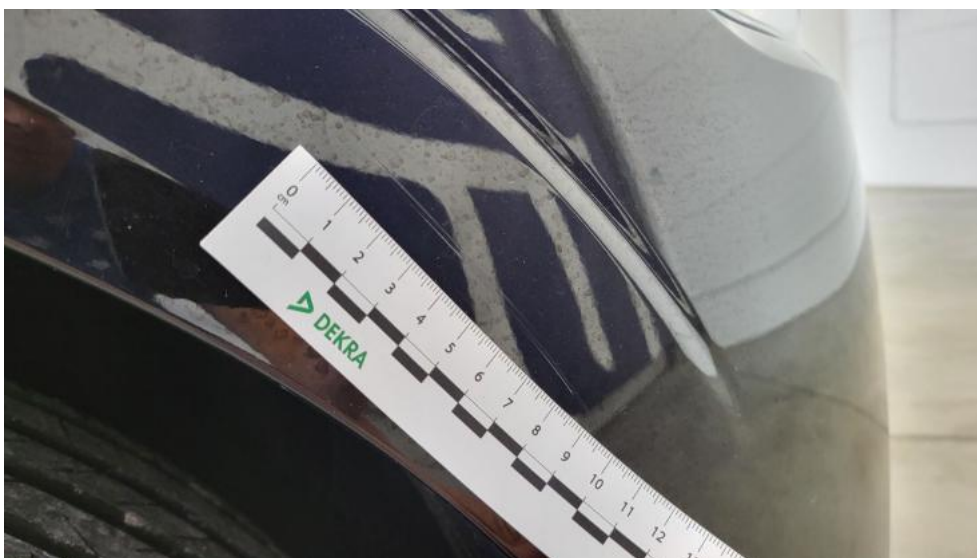
Photo 44.
Zderzak - Rysa/odprysk 1

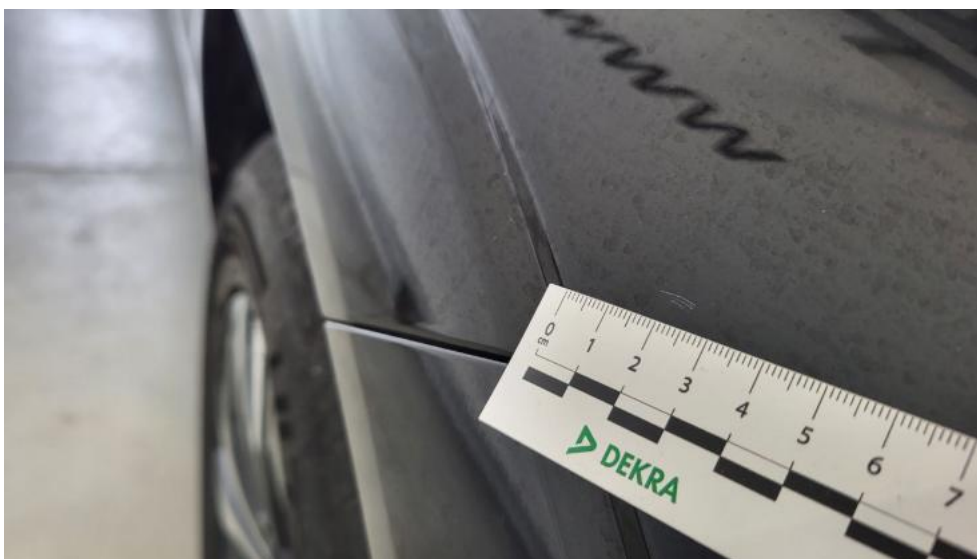
Photo 45.
Błotnik przedni P - Rysa/odprysk 1

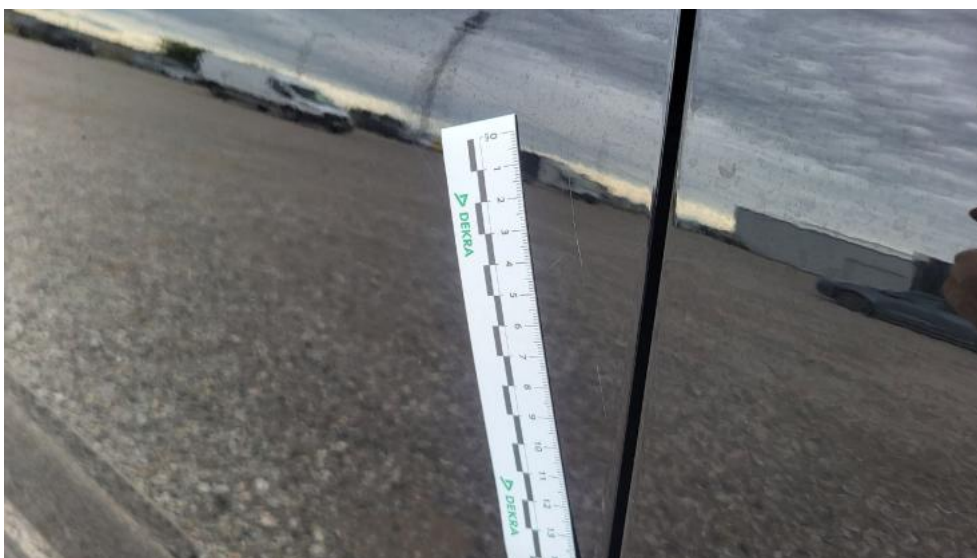
Photo 46.
Drzwi przednie P - Rysa/odprysk 1

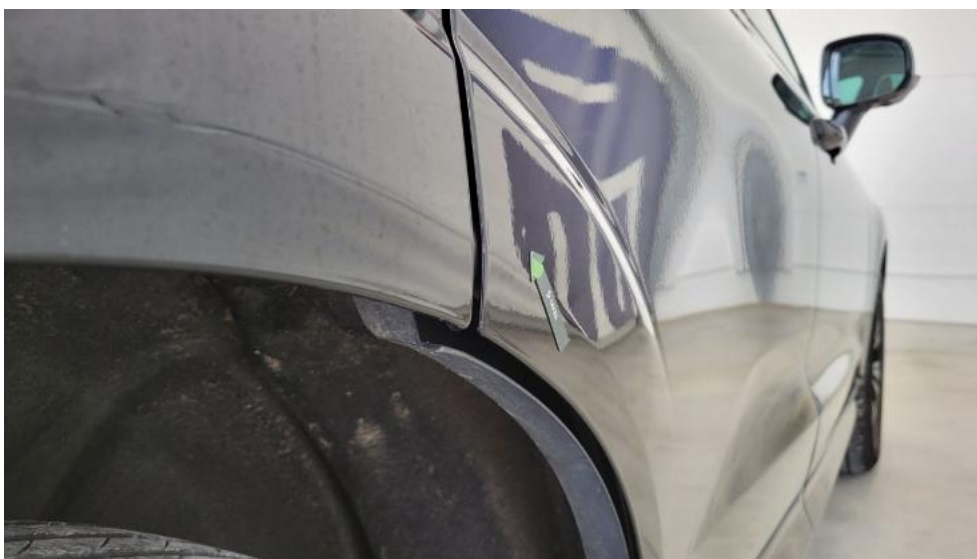
Photo 49.
Drzwi tylne P - Wgniecenie/odkształcenie 1

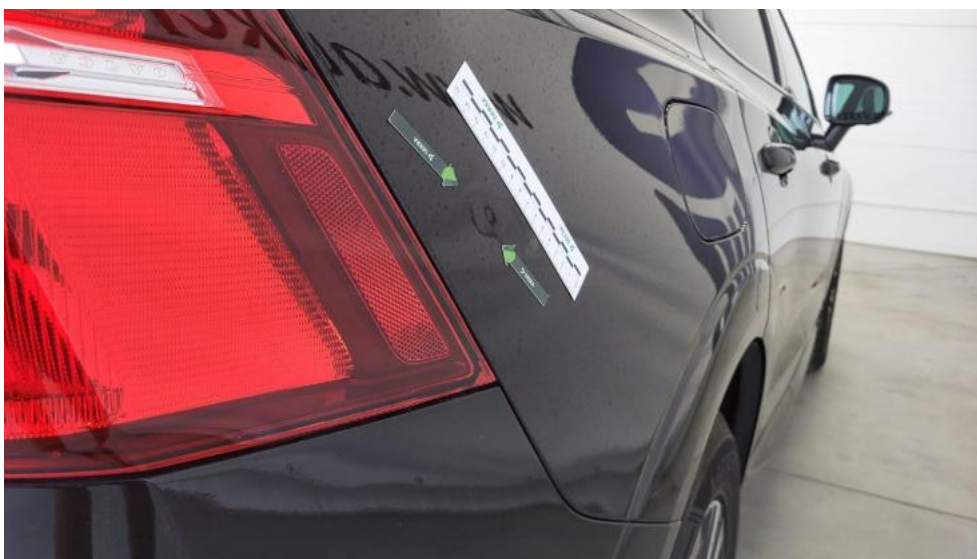
Photo 51.
Błotnik tylny P / Ściana boczna P - Wgniecenie/odkształcenie 1

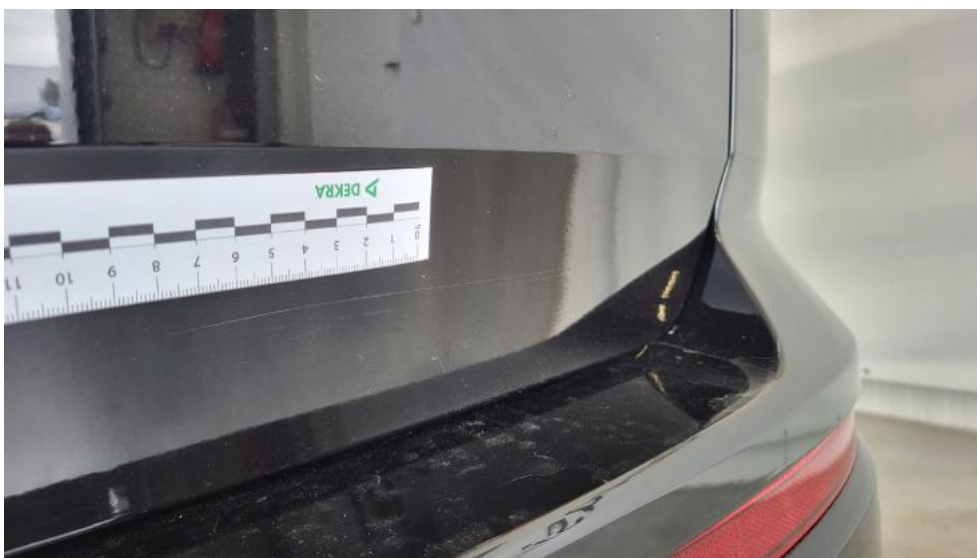
Photo 52.
Pokrywy bagażnika - Rysa/odprysk 1

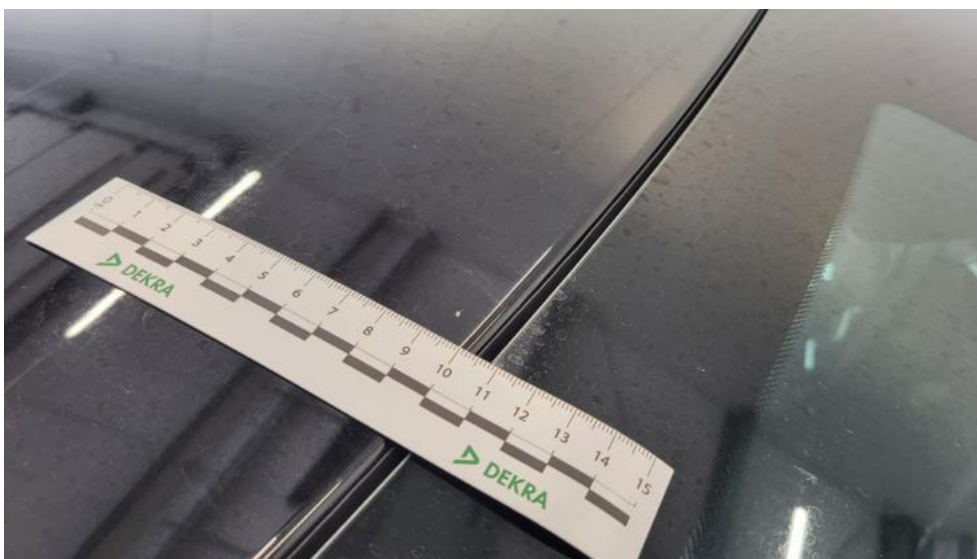
Photo 53.
Dach - Rysa/odprysk 1

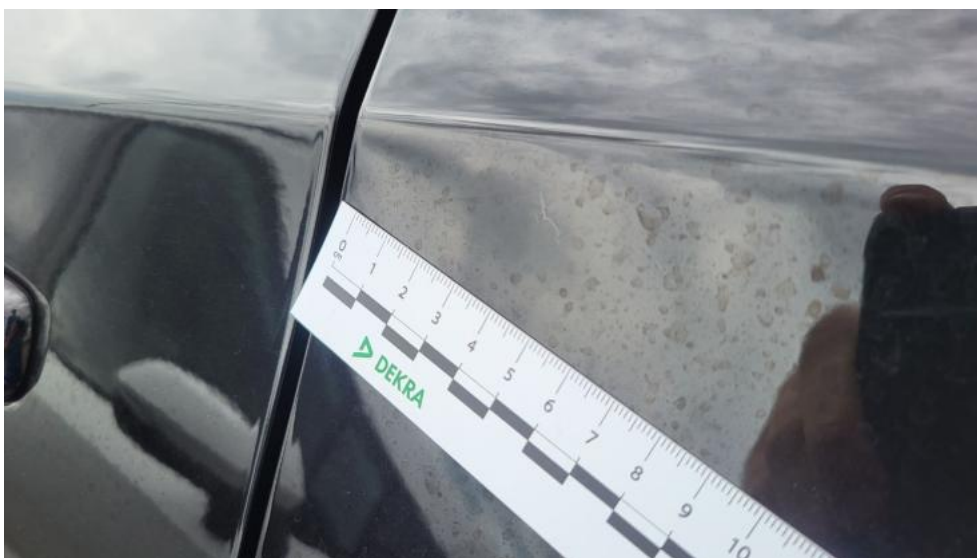
Photo 54.
Błotnik tylny L / Ściana boczna L - Rysa/odprysk 1

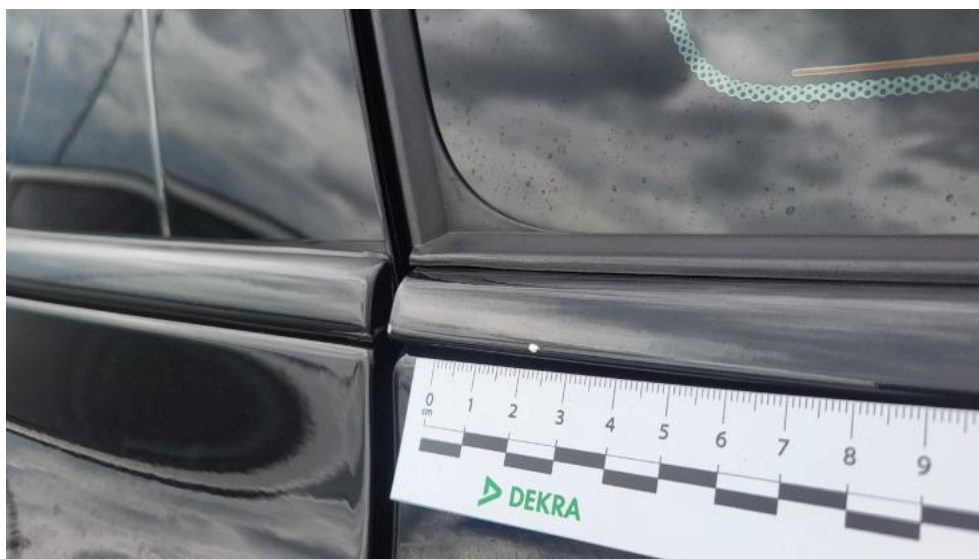
Photo 55.

Uszczelka szyby bocznej tyl L - Rysa/odprysk 1

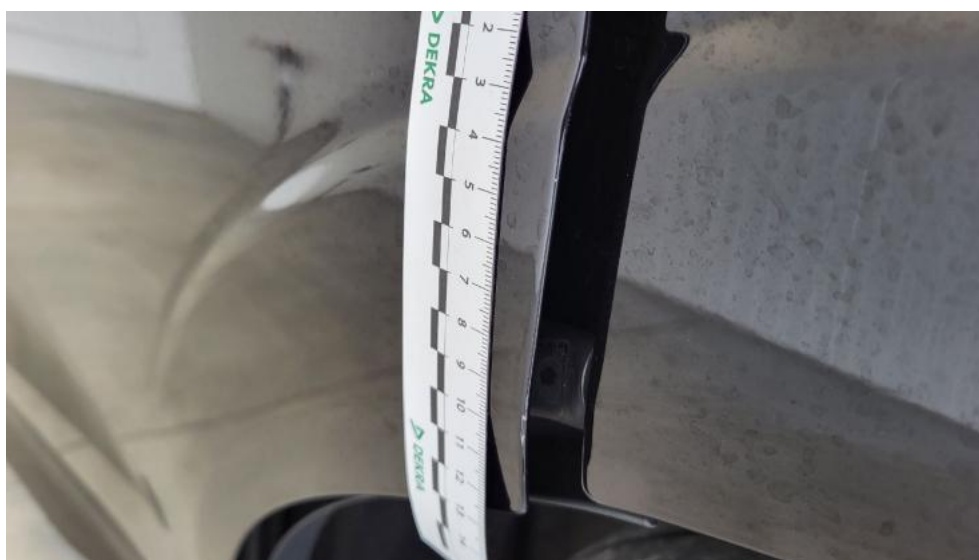
Photo 56.

Drzwi tylne L - Rysa/odprysk 1

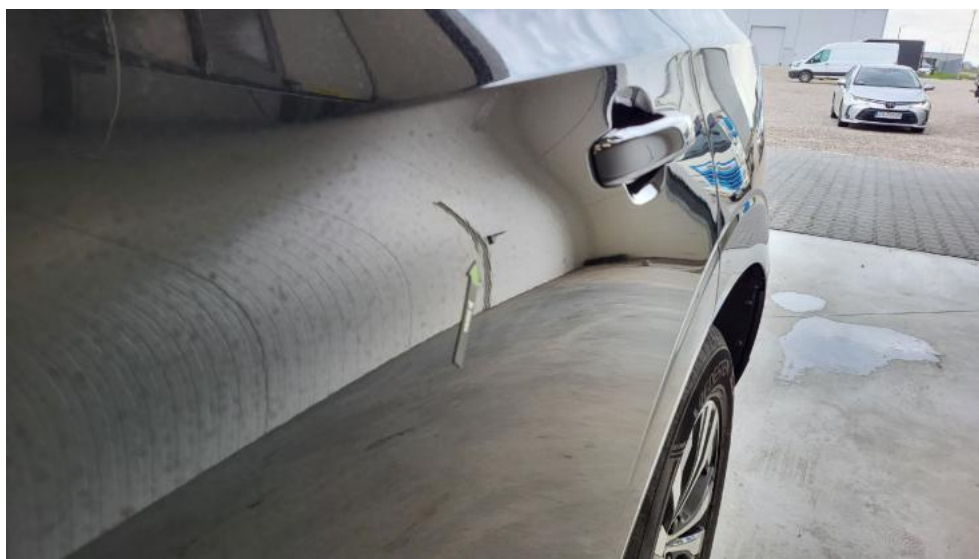
Photo 57.
Drzwi tylne L - Wgniecenie/odkształcenie 1

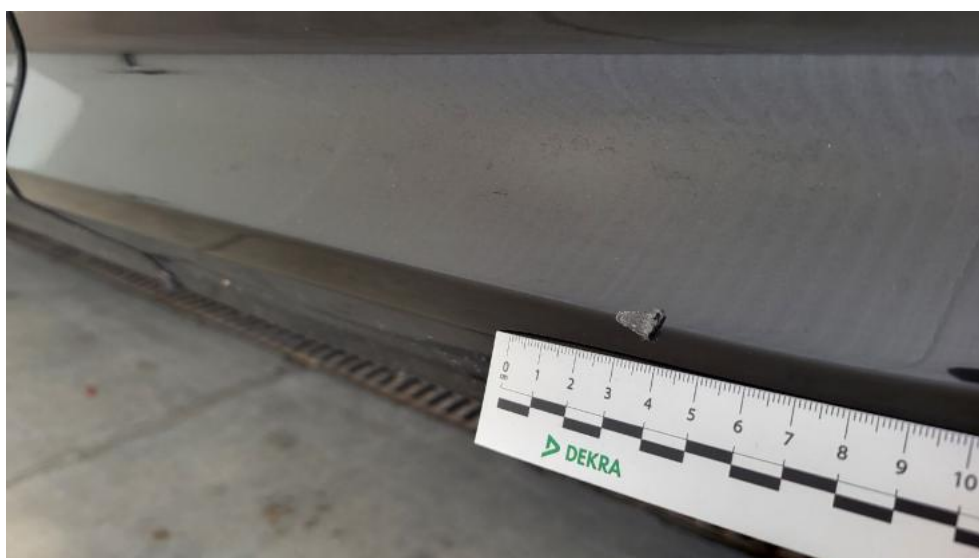
Photo 58.
Listwa drzwi tył L - Rysa/odprysk 1

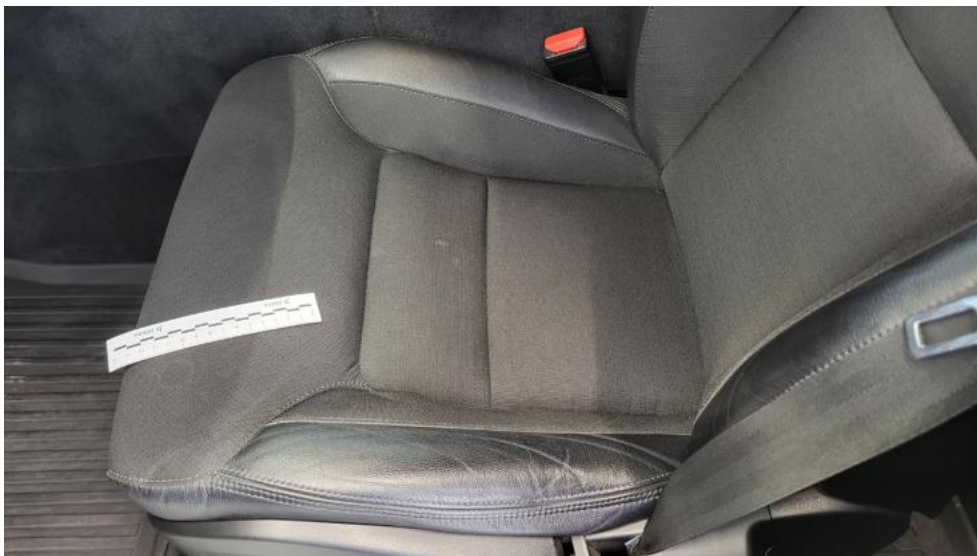
Photo 59.
Fotel prz. lew. - Inne 1

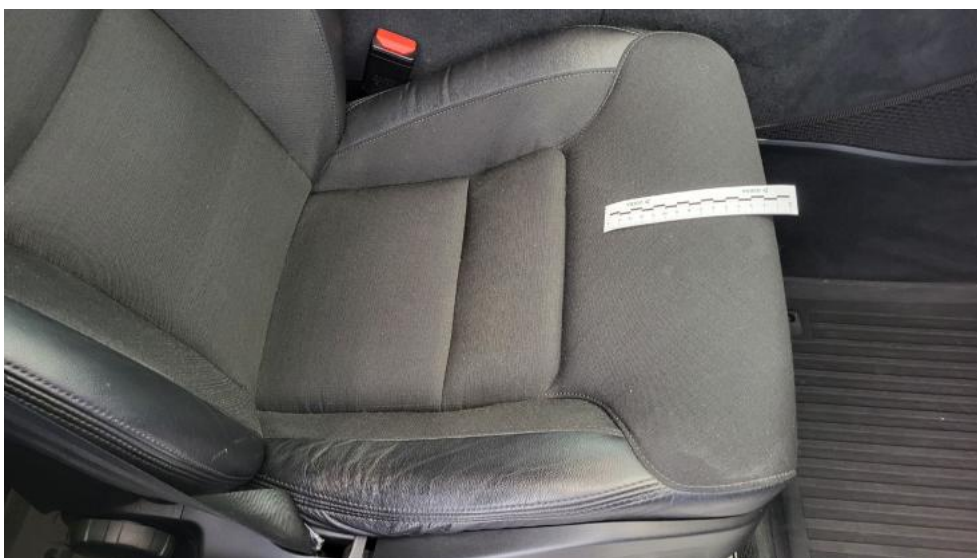
Photo 60.
Fotel prz. praw. - Inne 1

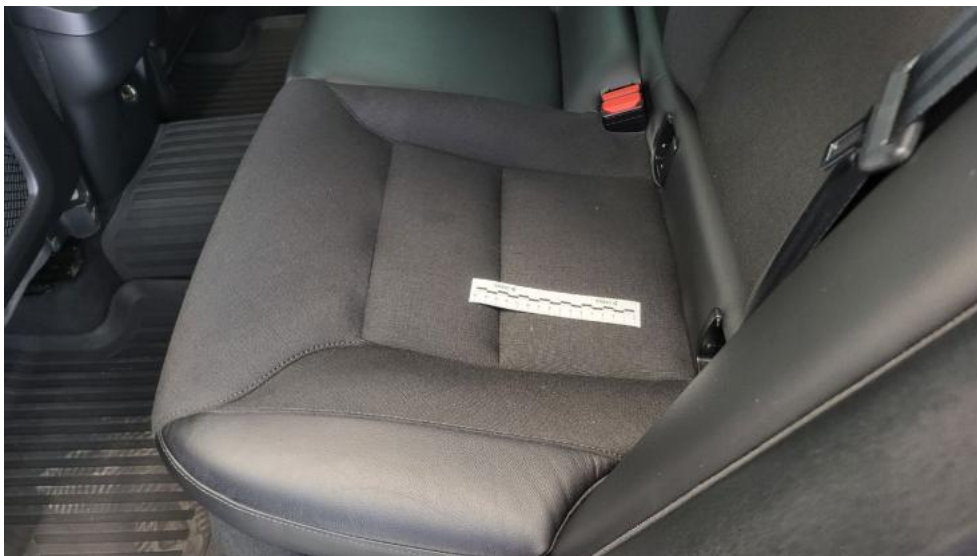
Rysy na samochodzie. Brak zaślepek w tylnej kanapie. Odpryski na szybie czołowej. Niesprawne przyciski funkcyjne w jednym z kluczyków grot prawidłowy

Photo 61.
Kanapa tyl. - Inne 1

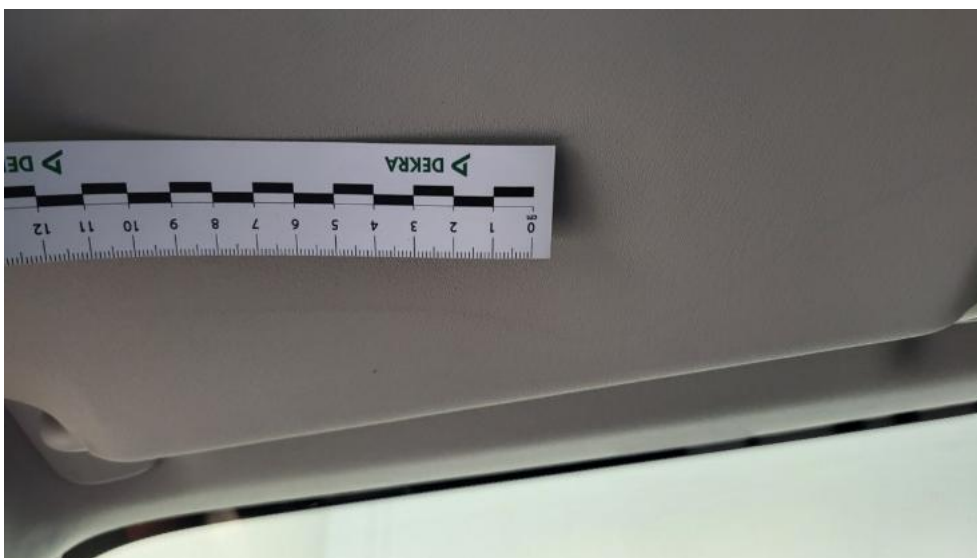
Photo 62.
Osłona p/słoneczna lewa - Inne 1
