DEKRA's commission No. : PKOL(W)/LODZ/22344/25/03/26  
commission/ damage No. : 23/000978  
Date of commission: 26-03-2025

**Vehicle data**

Measurement of thickness of the vehicle lacquer coating

PHOTOGRAPHIC DOCUMENTATION

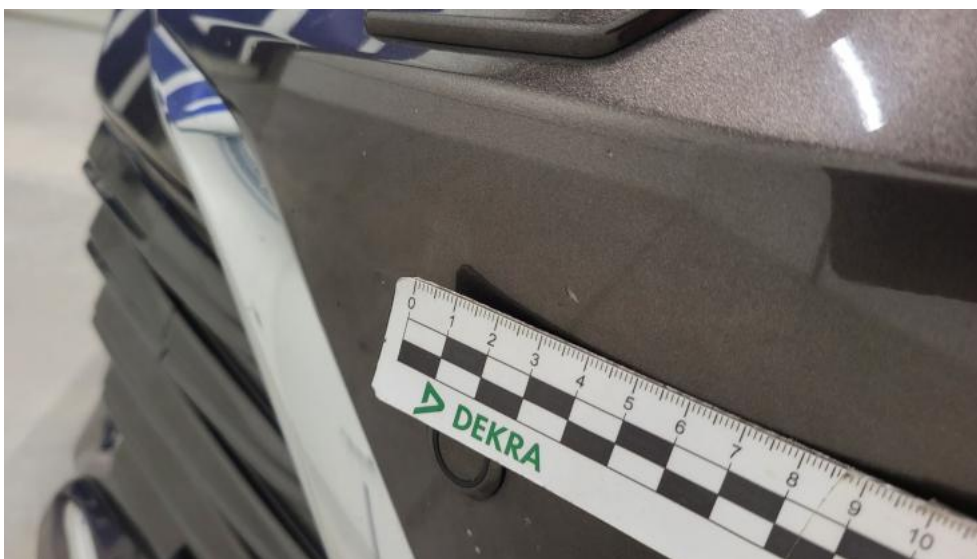
**Photo 39.**

Zderzak - Rysa/odprysk 1

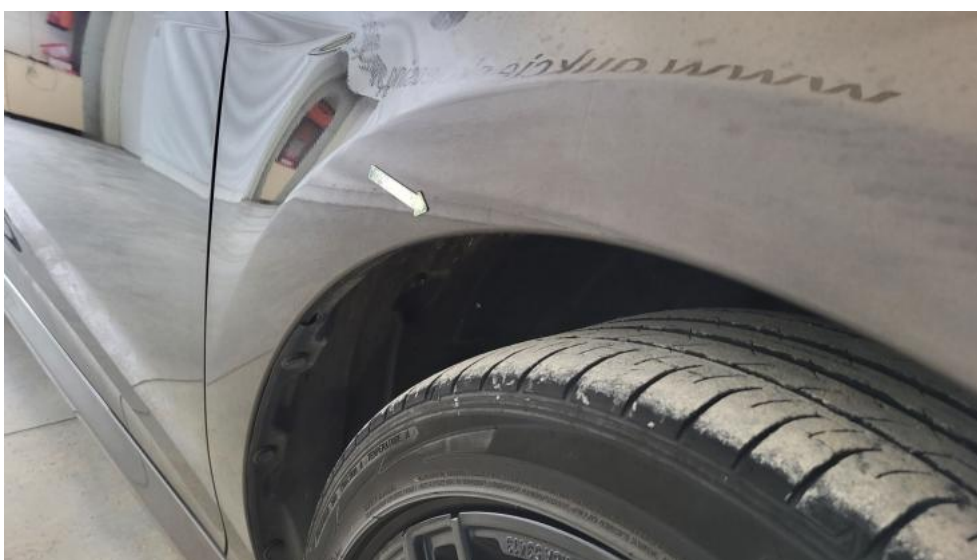
**Photo 40.**

Łotnik przedni P - Rysa/odprysk 1

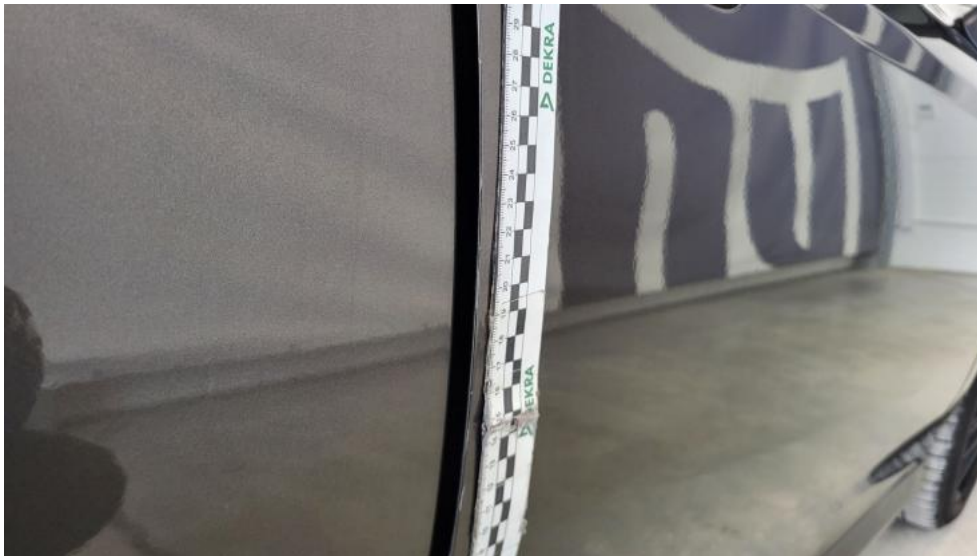
**Photo 41.**

Drzwi przednie P - Rysa/odprysk 1

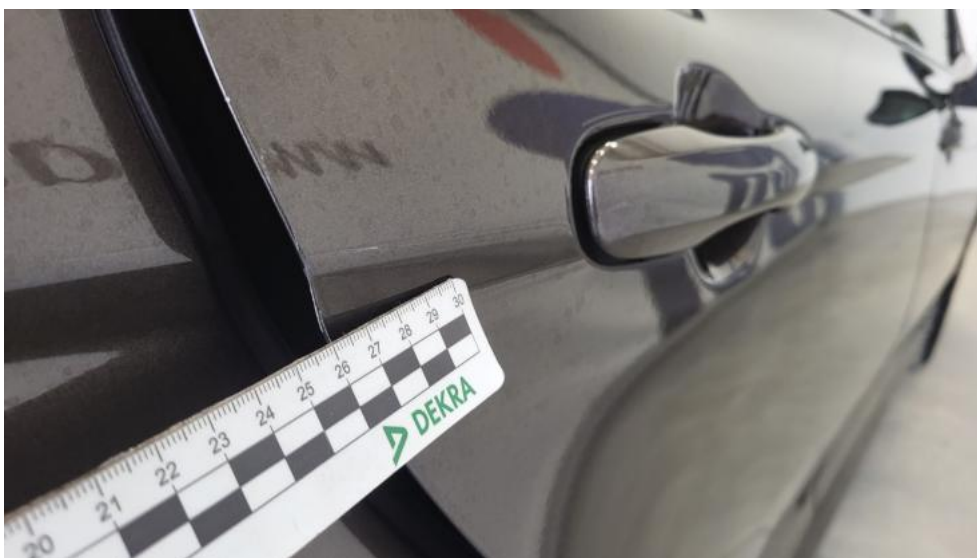
**Photo 42.**

Drzwi tylne P - Rysa/odprysk 1

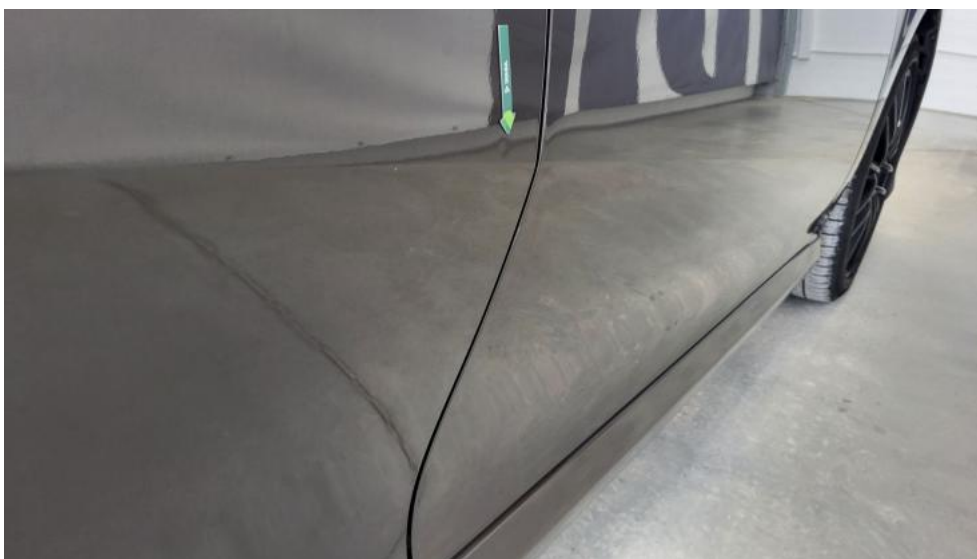
**Photo 43.**

Drzwi tylne P - Wgniecenie/odkształcenie 1

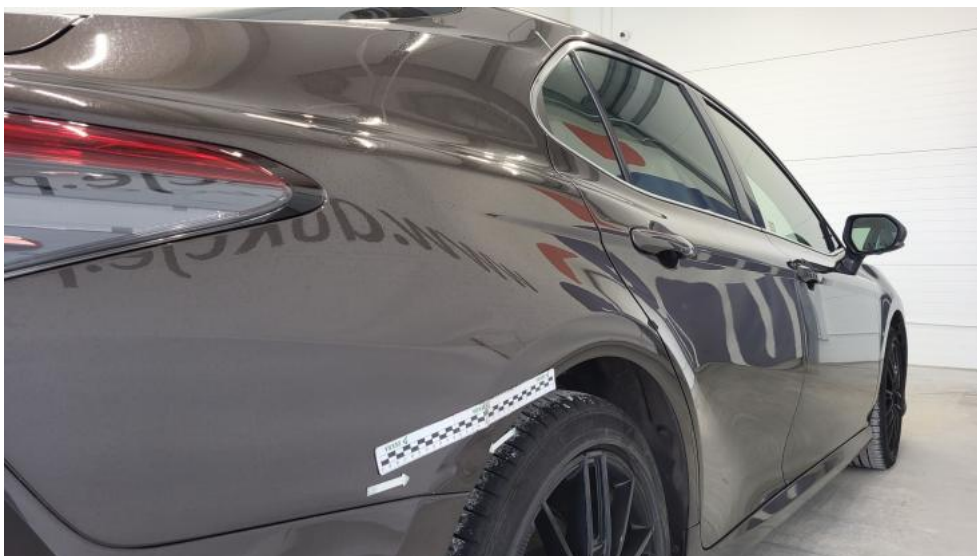
**Photo 44.**

Łotnik tylny P / Ściana boczna P - Wgniecenie/odkształcenie 1

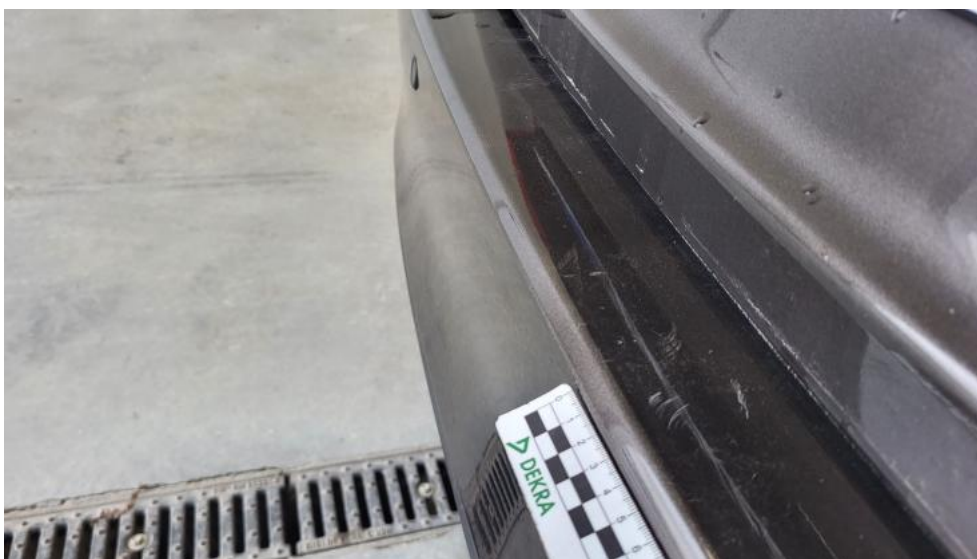
**Photo 45.**

Zderzak tylny - Rysa/odprysk 1

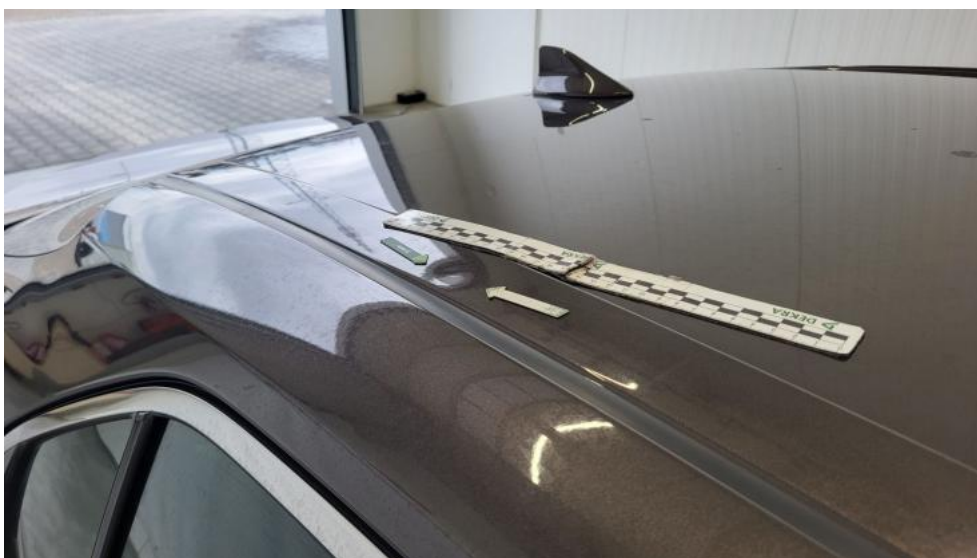
**Photo 46.**

Dach - Wgniecenie/odkształcenie 1

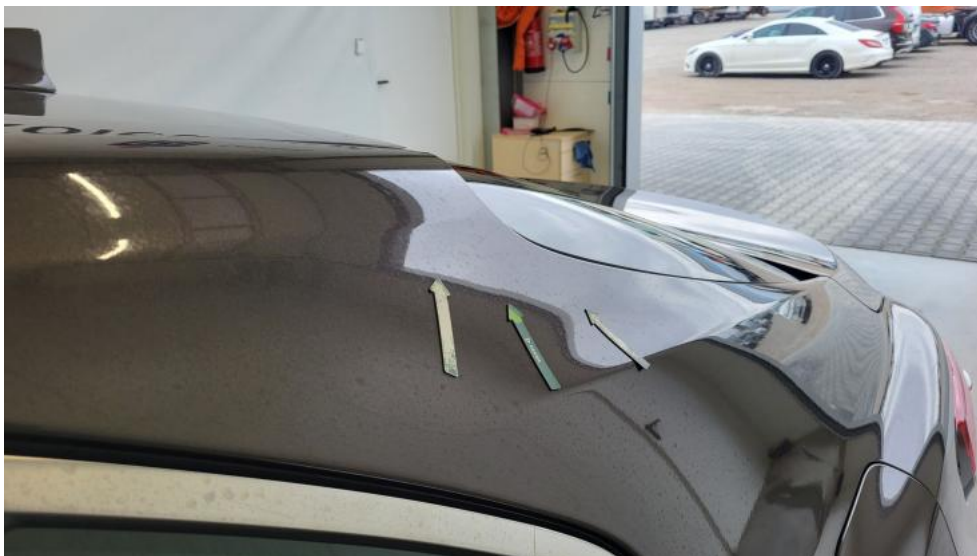
**Photo 47.**

Błotnik tylny L / Ściana boczna L - Wgniecenie/odkształcenie 1

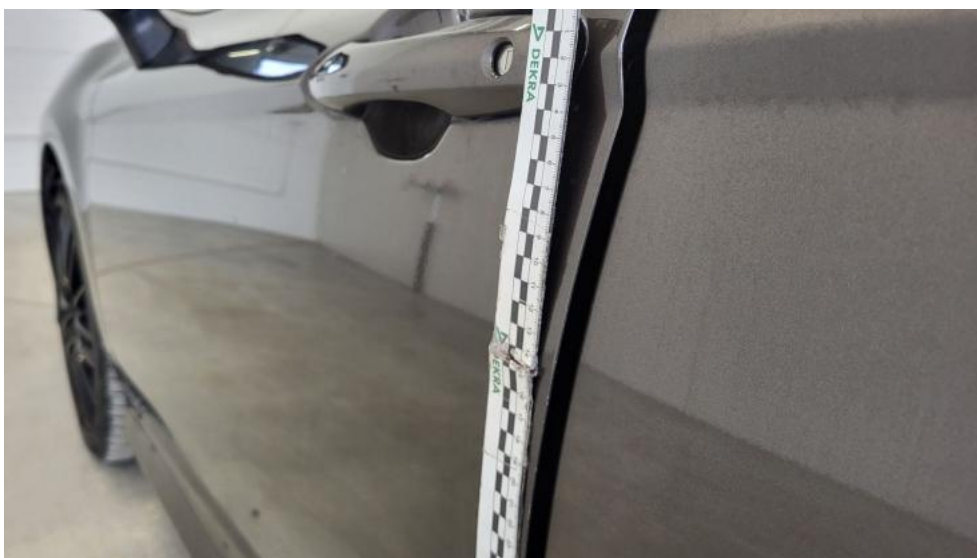
**Photo 48.**

Drzwi przed L - Rysa/odprysk 1

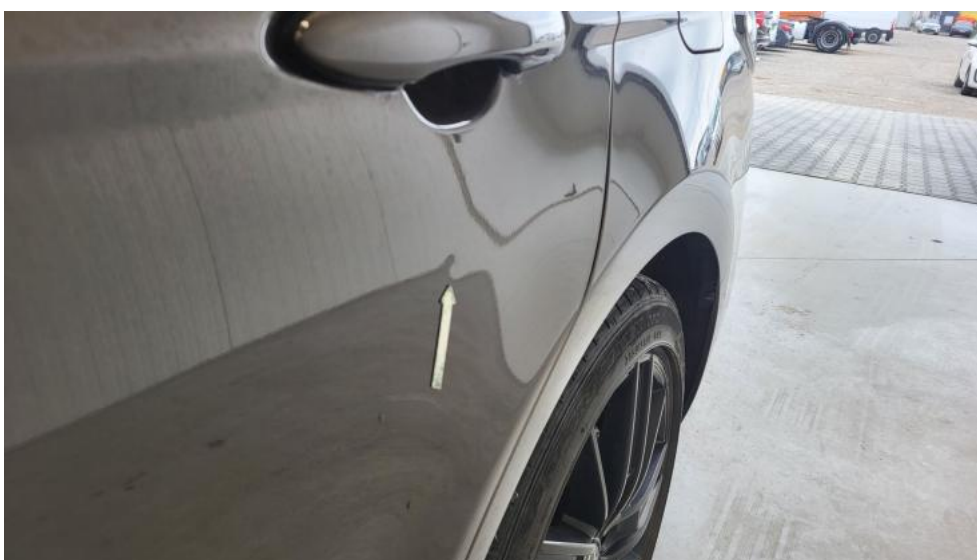
**Photo 50.**

Drzwi tylne L - Wgniecenie/odkształcenie 1

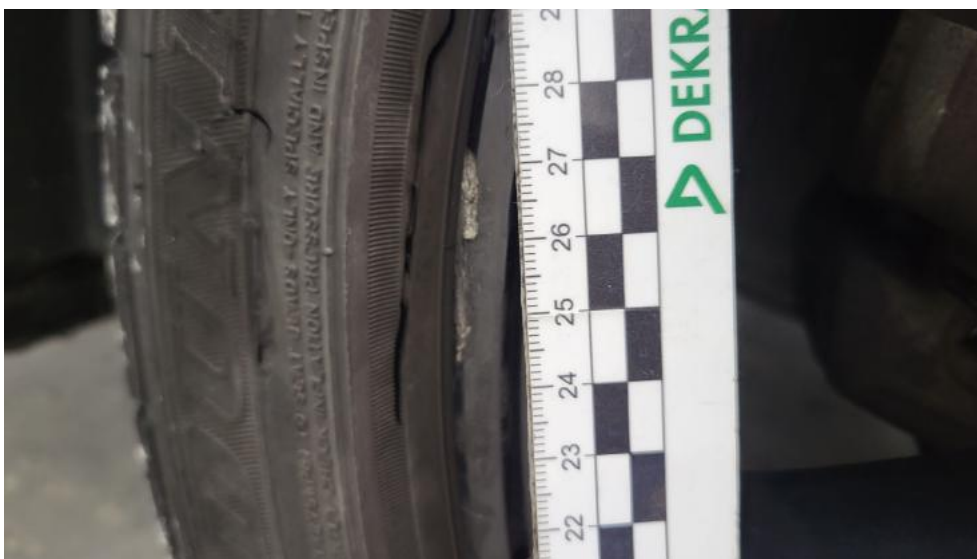
**Photo 51.**

Felga Aluminiowa przednia L - Rysa/odprysk 1

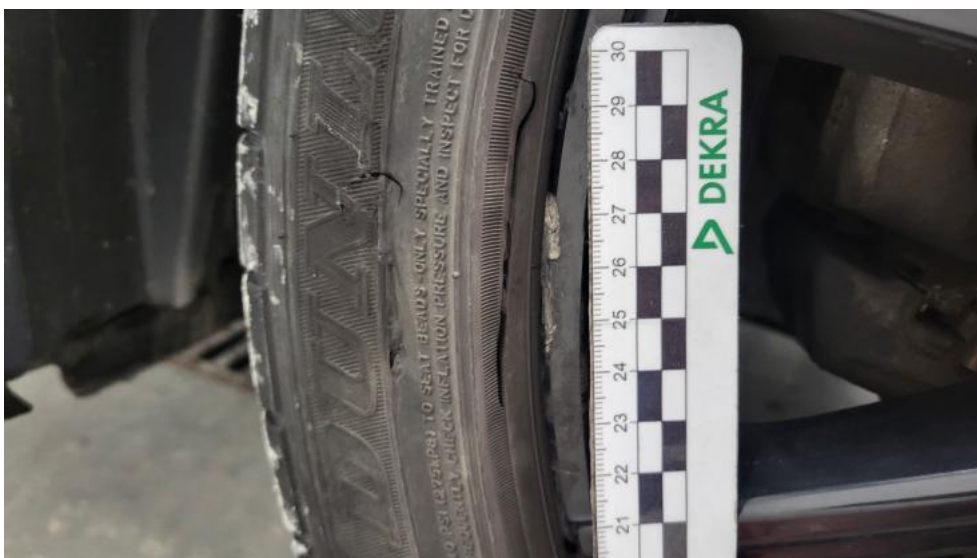
**Photo 52.**

Opona przednia L - Pęknięcie/rozerwanie 1

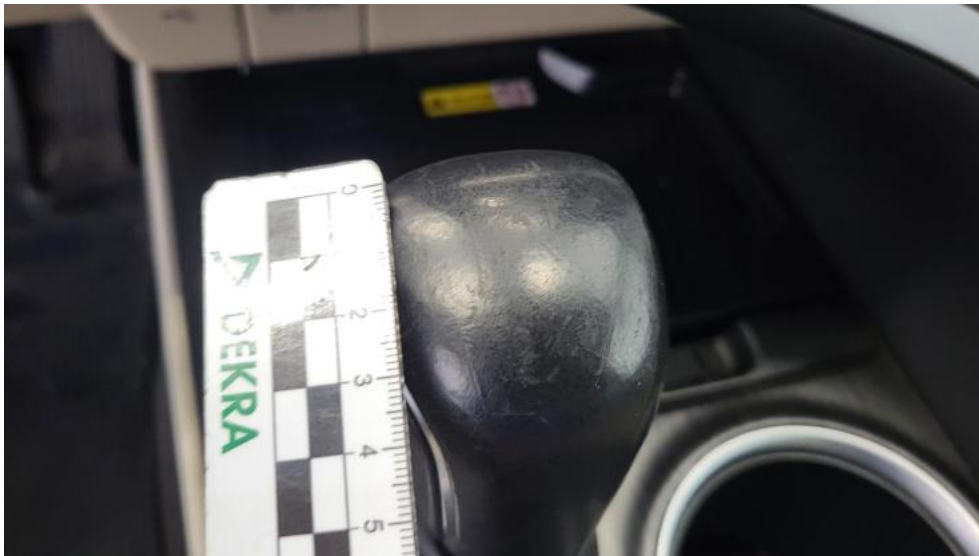
**Photo 53.**

Gałka dźwigni zmiany biegów - Rysa/odprysk 1

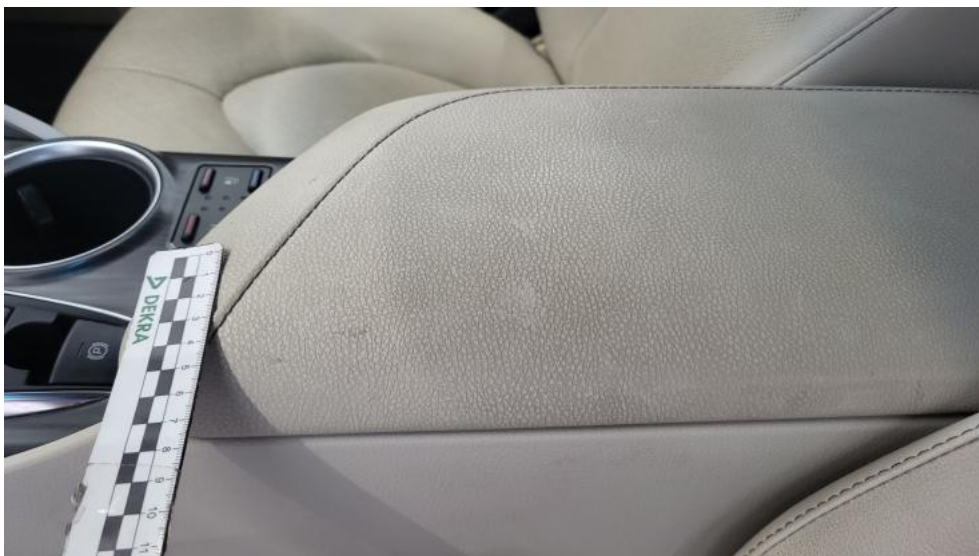
**Photo 54.**

Podłokietnik środkowy przedni - Inne 1

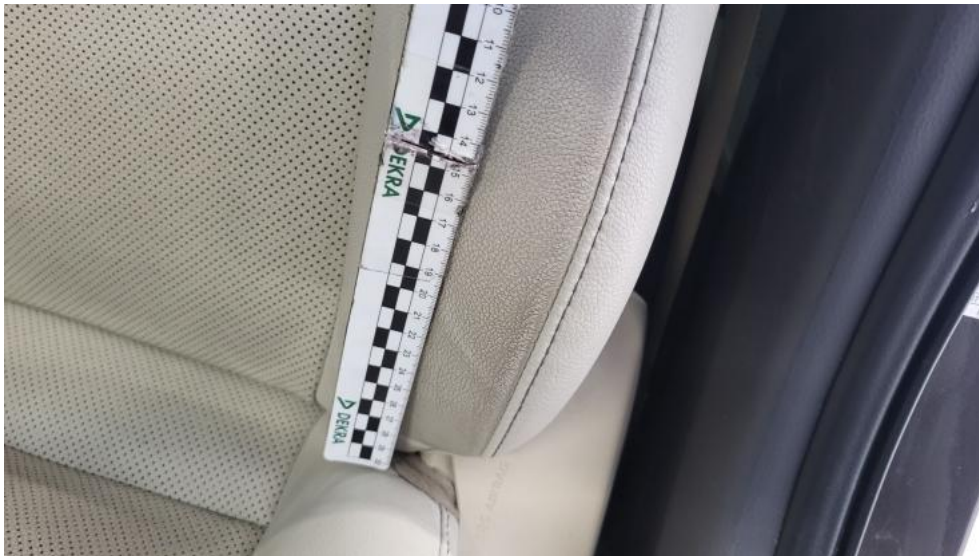
**Photo 55.**

Fotel prz. lew. - Inne 1

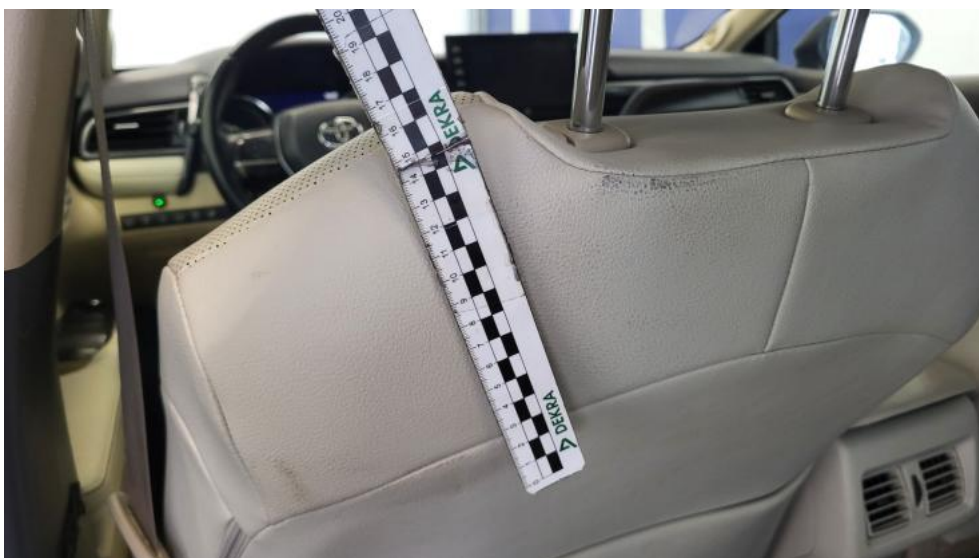
**Photo 56.**

Fotel prz. lew. - Inne 2

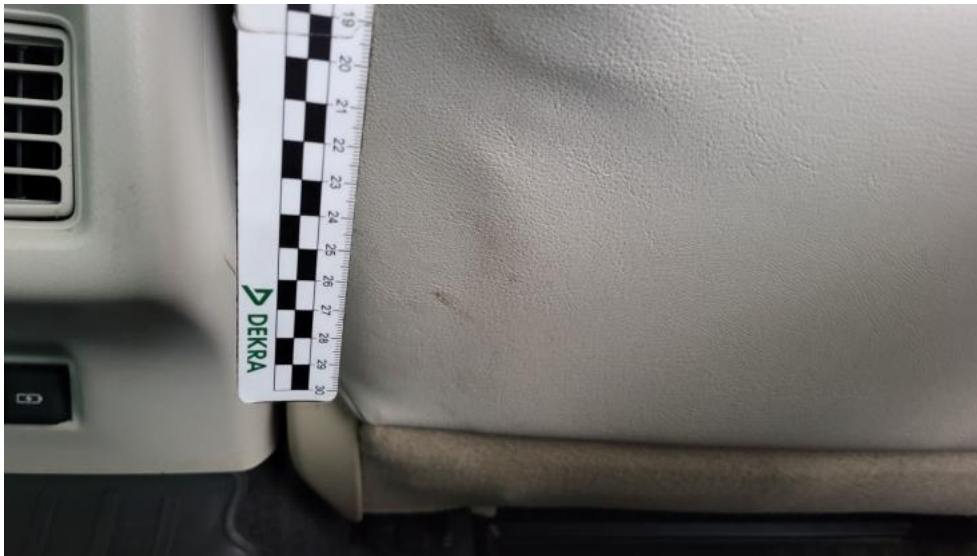
**Photo 57.**

Fotel prz. praw. - Inne 1

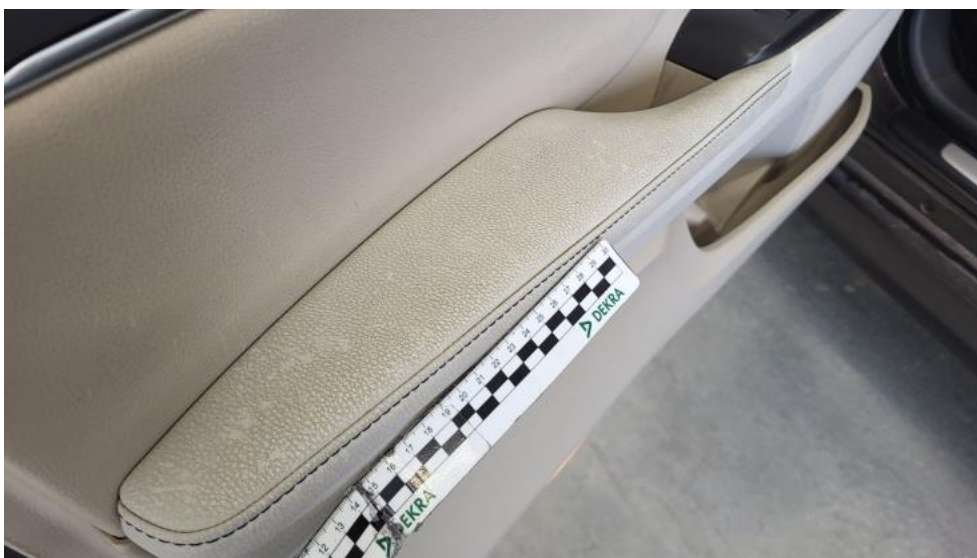
**Photo 58.**

Tapicerka drzwi przednich L - Inne 1

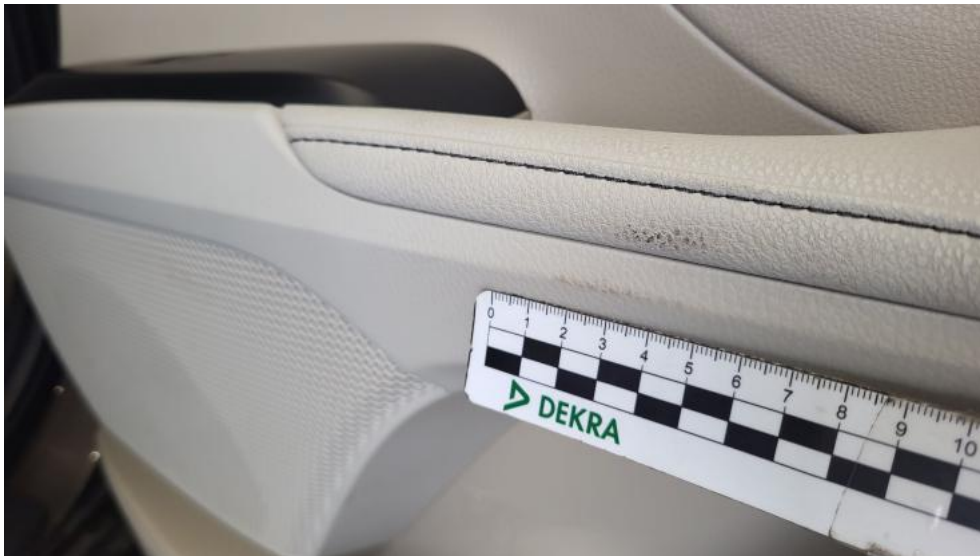
**Photo 59.**

Tapicerka drzwi tylnych P - Inne 1

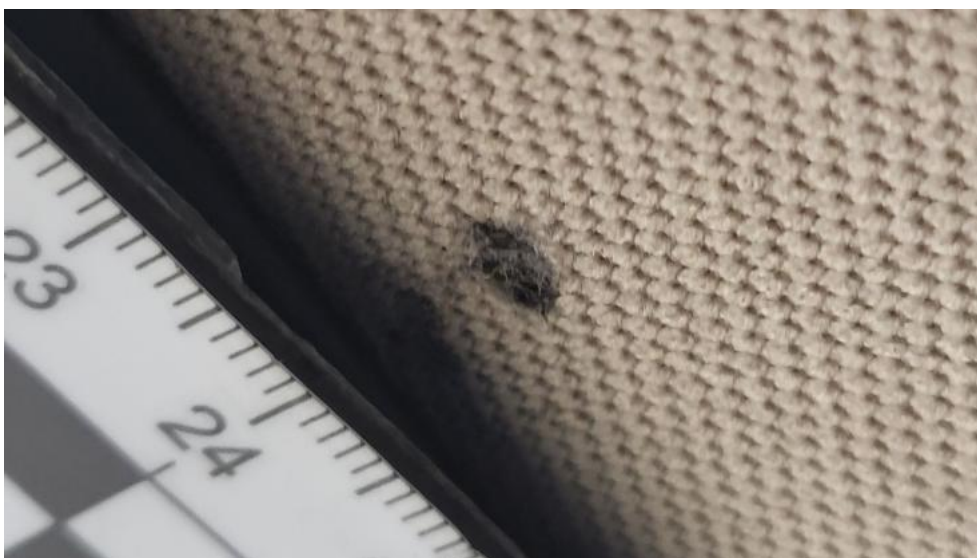
**Photo 62.**

Podsufitka - Inne 1

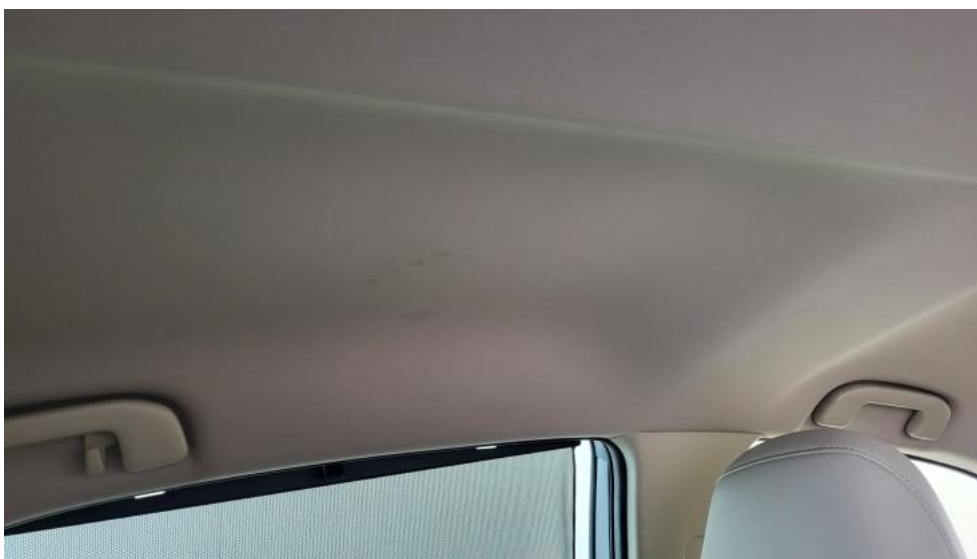
**Photo 63.**

Podsufitka - Inne 2

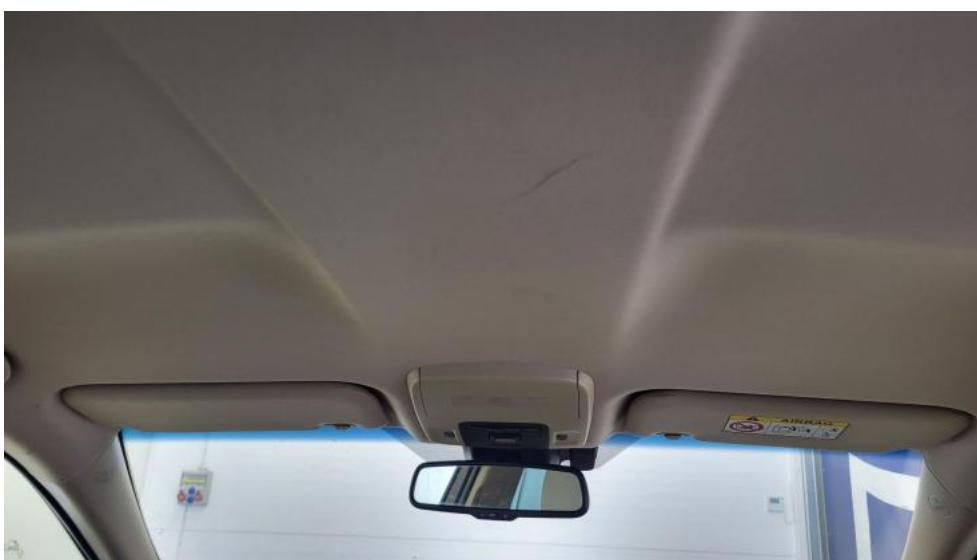
**Photo 64.**

Podsufitka() - Inne 3

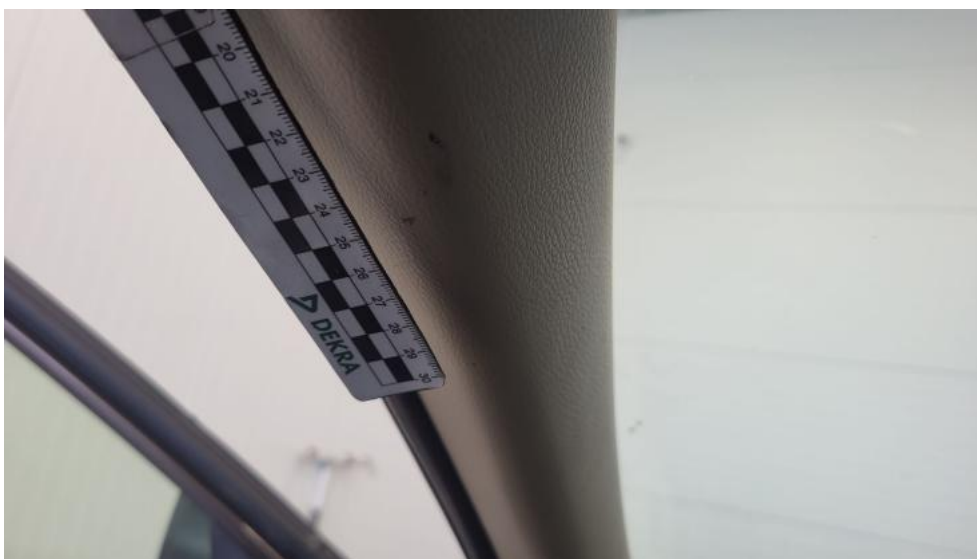
**Photo 65.**

Wykładzina(y) słupka przedniego L - Inne 1

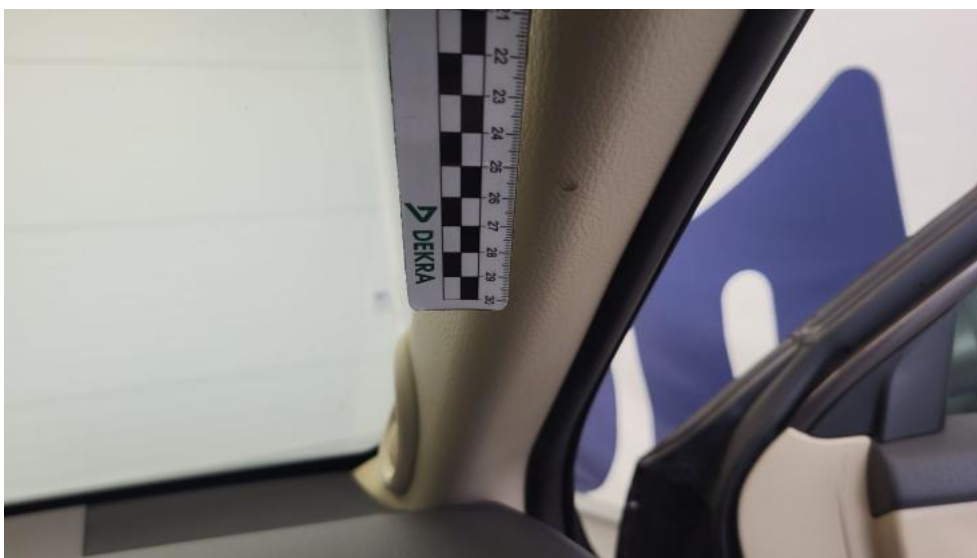
**Photo 66.**

Wykładzina(y) słupka przedniego P - Inne 1

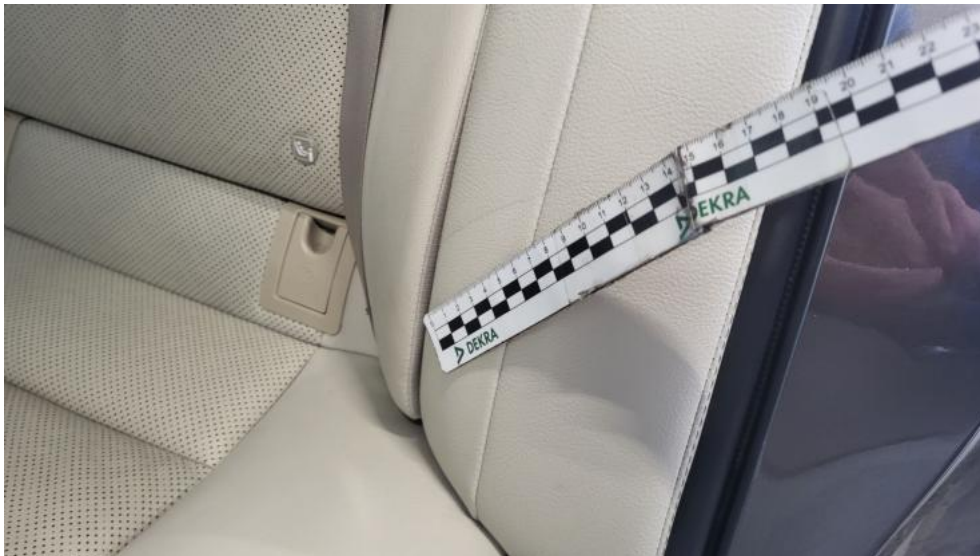
**Photo 67.**

Wykładzina(y) słupka tylnego L - Inne 1

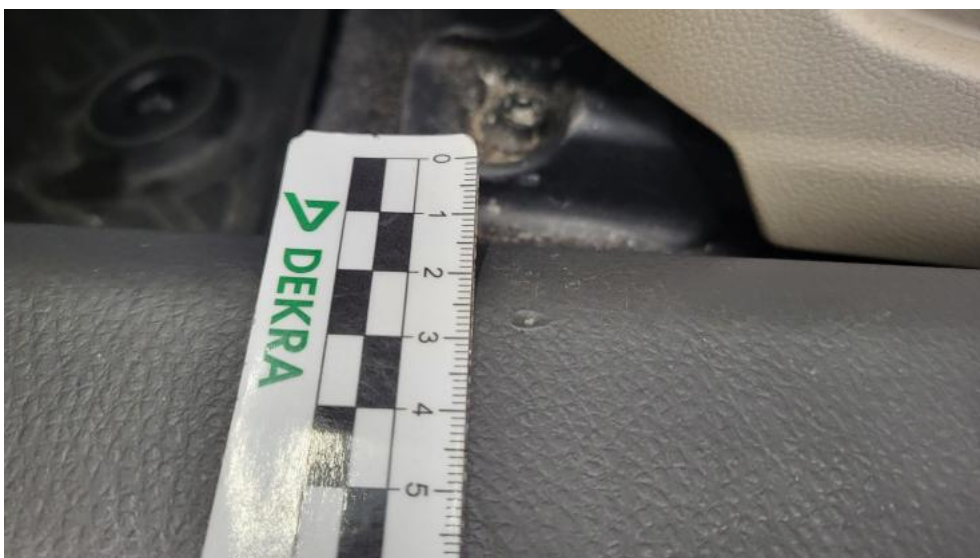
**Photo 68.**

Listwy progowe lew. - Inne 1
