DEKRA's commission No. : PKOL(W)/LODZ/64525/25/08/29  
commission/ damage No. : 21/045344  
Date of commission: 29-08-2025

**DEKRA Poland - Headquarters**  
02-673 Warszawa, ul. Konstruktorska 12A

| Manufacturer | AUDI |
| Type / version | A6 50 TDI mHEV Quattro Sport Tiptronic |

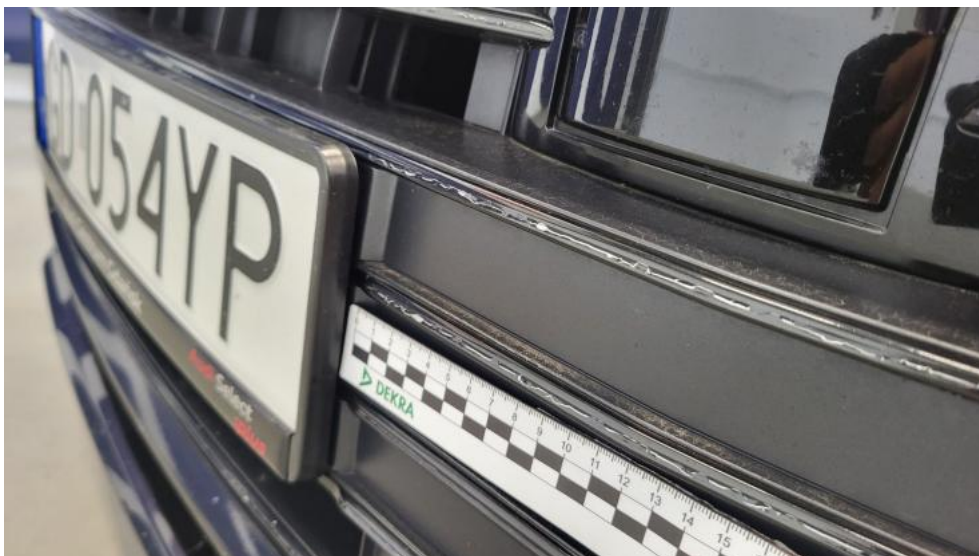
**Photo 42.**

Atrapa przednia - Rysa/odprysk 1

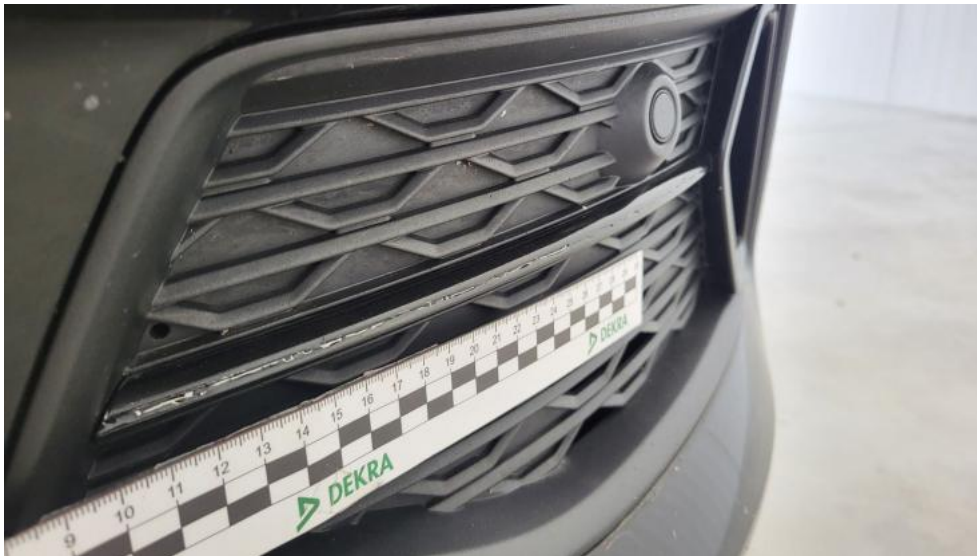
**Photo 43.**

Kratka/zaślepka halogenu L - Rysa/odprysk 1

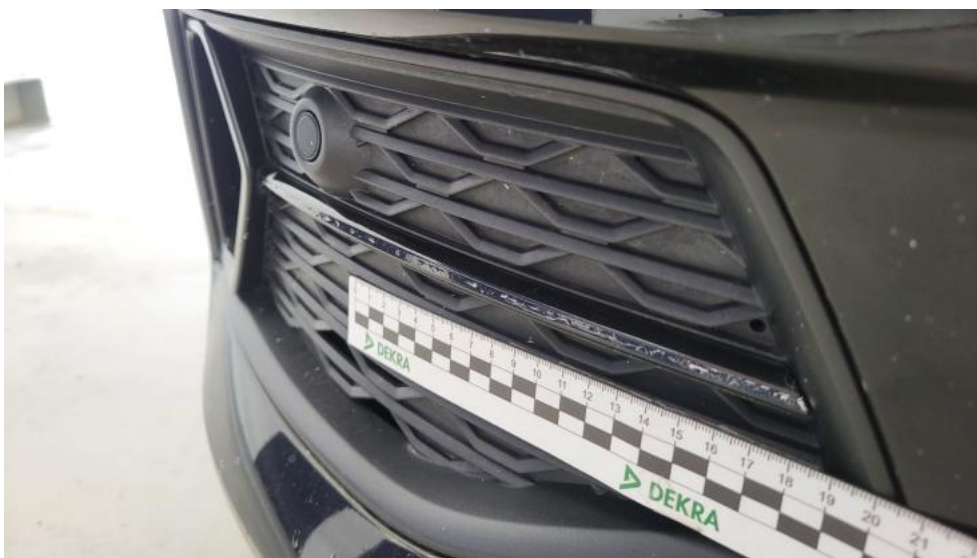
**Photo 44.**

Kratka/zaślepka halogenu P - Rysa/odprysk 1

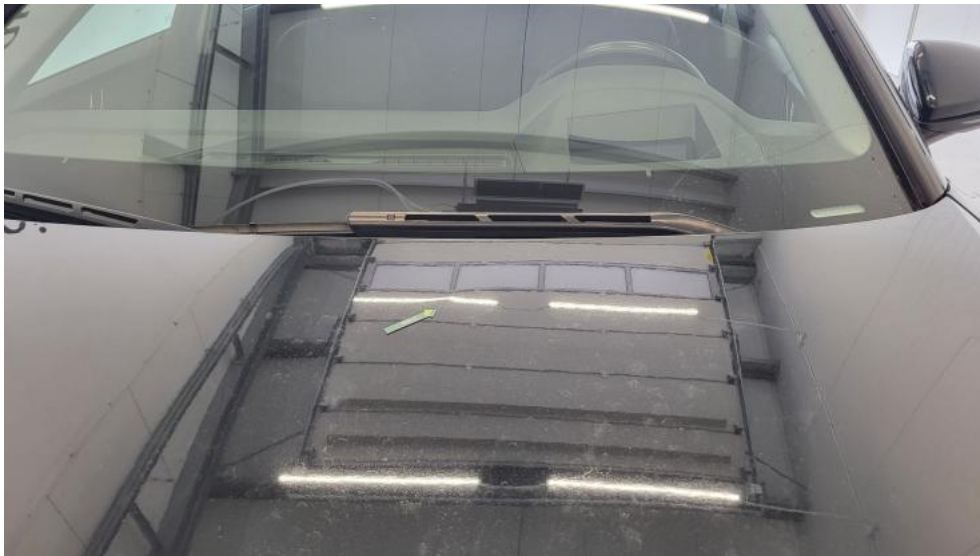
**Photo 45.**

Pokrywa komory silnika - Wgniecenie/odkształcenie 1

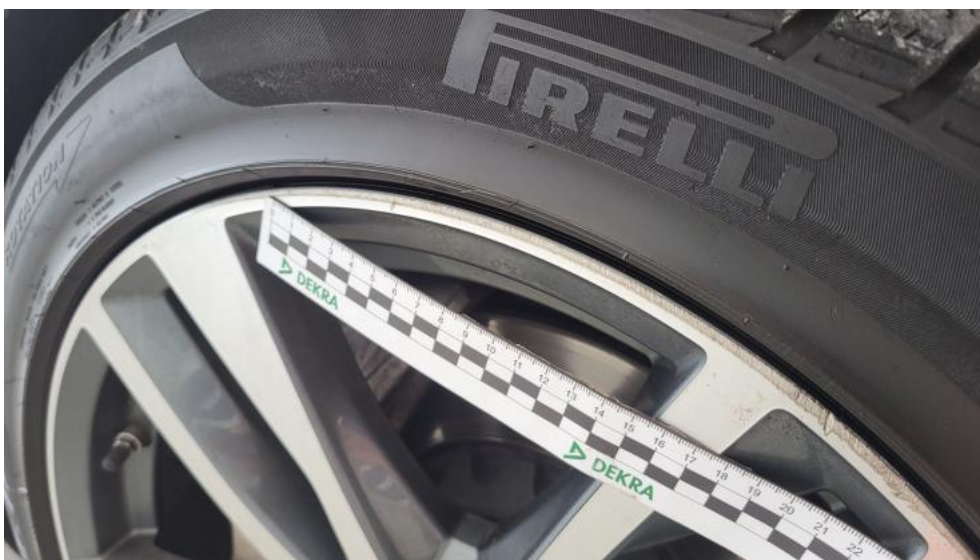
**Photo 46.**

Felga aluminiowa przednia P - Rysa/odprysk 1

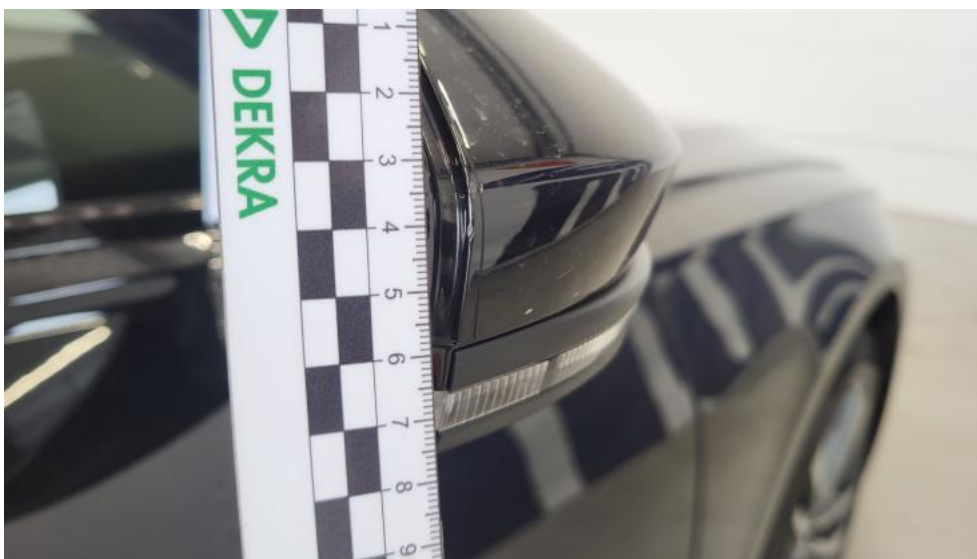
**Photo 47.**

Lusterko zew P - Rysa/odprysk 1

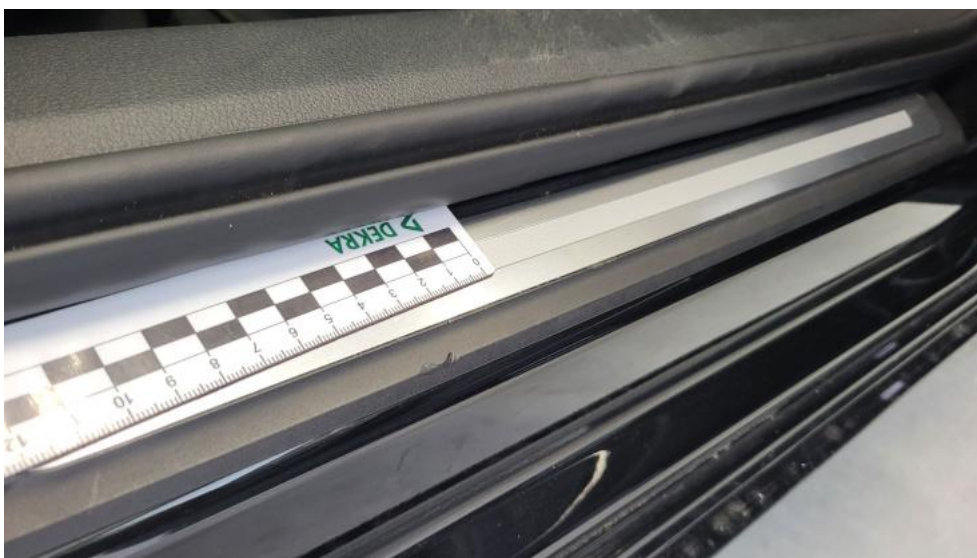
**Photo 48.**

Próg P - Rysa/odprysk 1

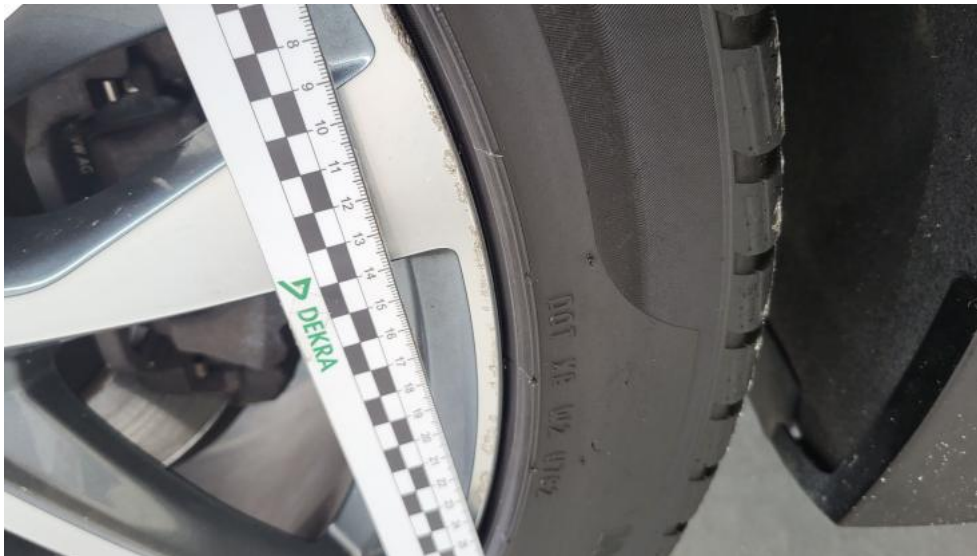
**Photo 49.**

Felga aluminiowa tylna P - Rysa/odprysk 1

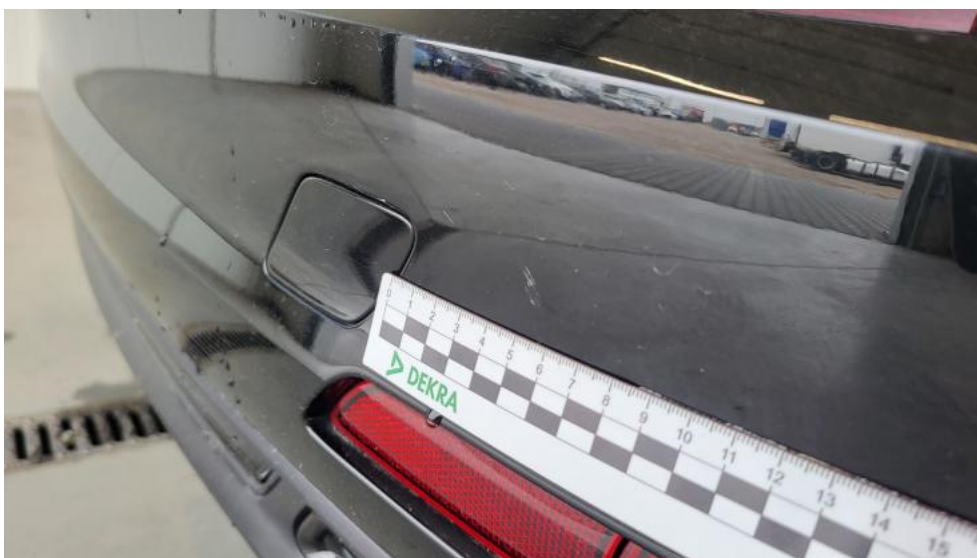
**Photo 50.**

Zderzak tylny - Rysa/odprysk 1

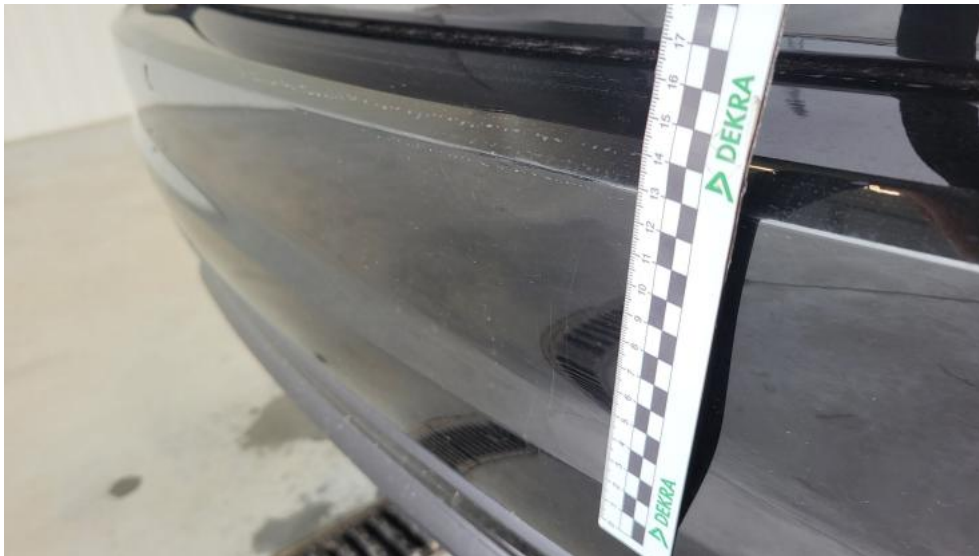
**Photo 51.**

Zderzak tylny - Rysa/odprysk 2

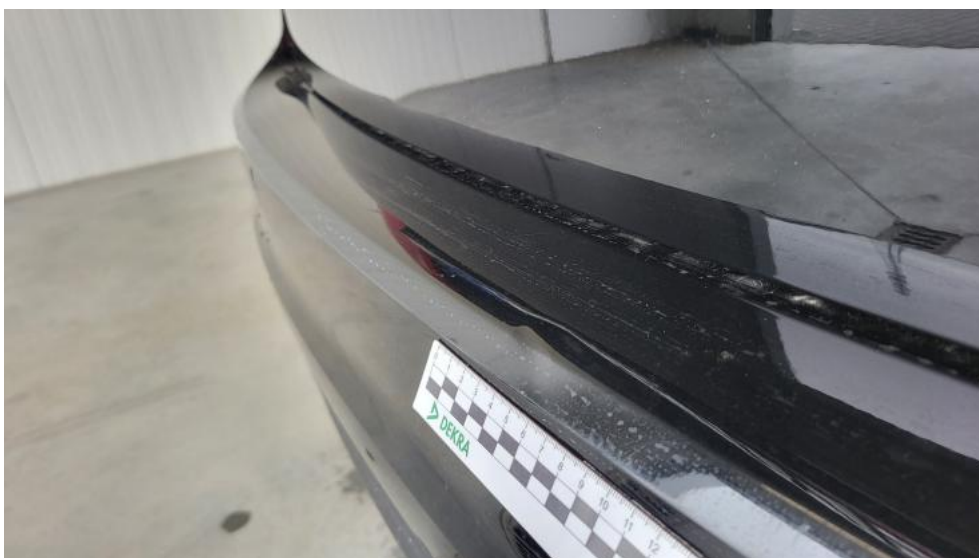
**Photo 52.**

Zderzak tylny - Wgniecenie/odkształcenie 1

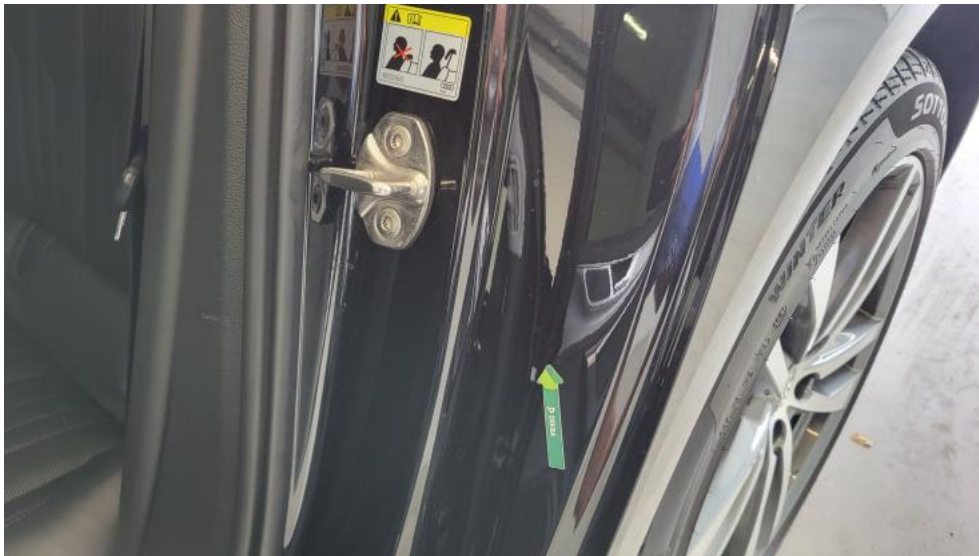
**Photo 53.**

Błotnik tylny L / Ściana boczna L - Wgniecenie/odkształcenie 1

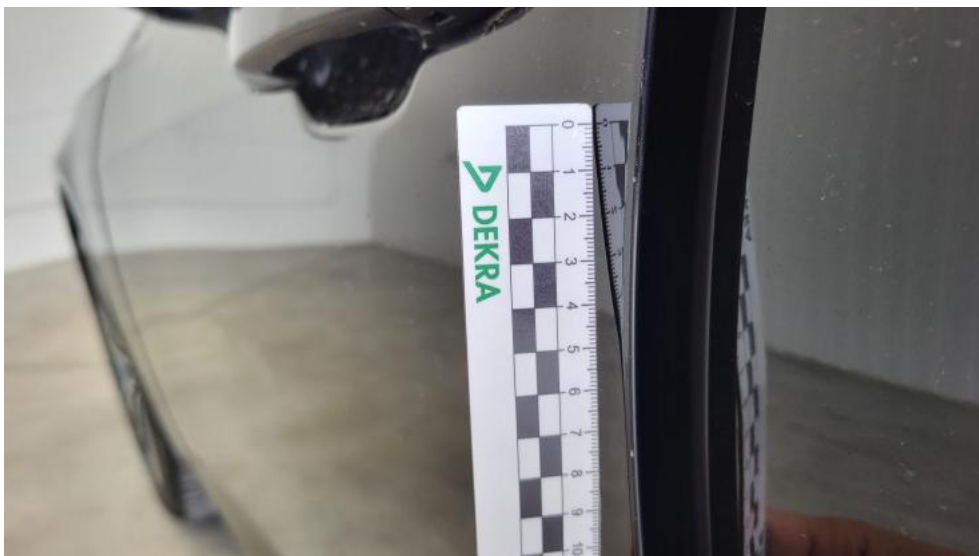
**Photo 54.**

Drzwi przed L - Rysa/odprysk 1

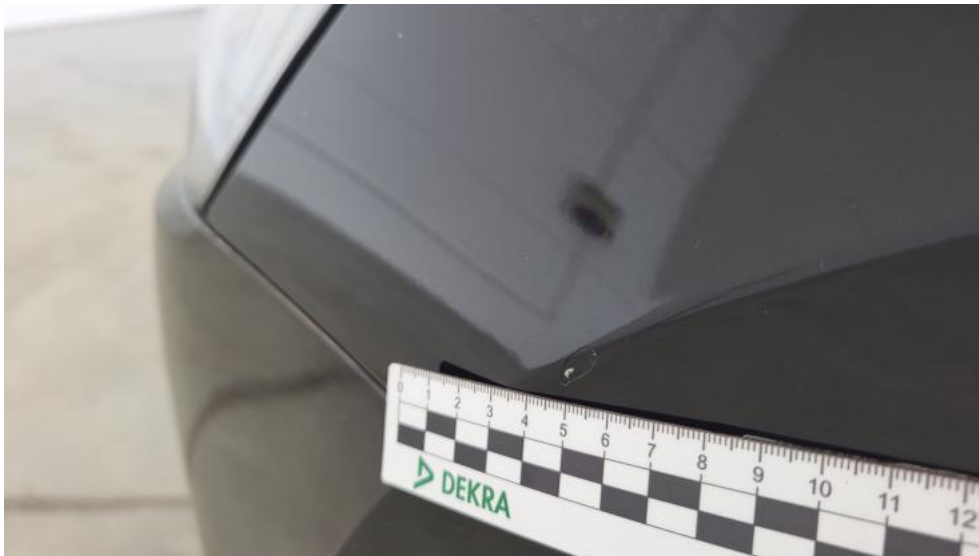
**Photo 55.**

Błotnik przedni L - Rysa/odprysk 1

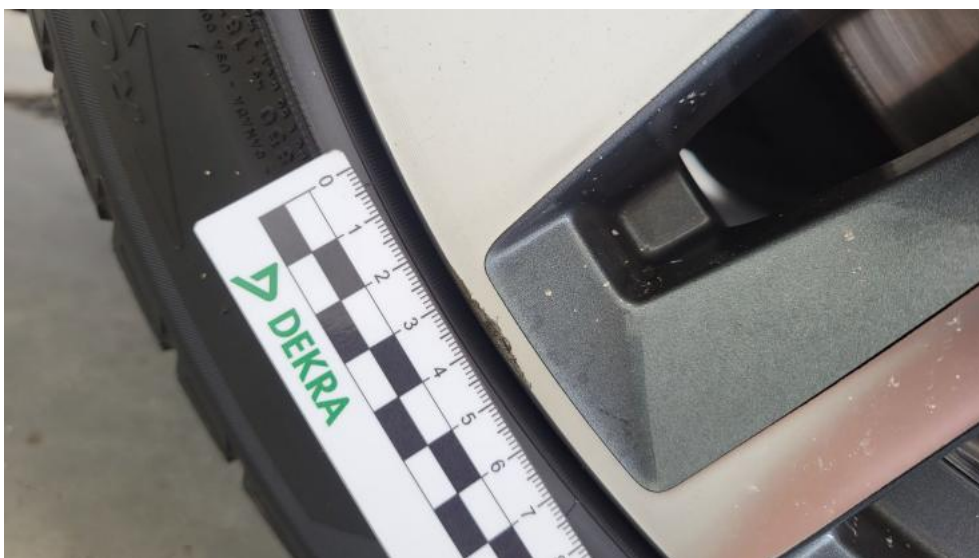
**Photo 56.**

Felga Aluminiowa przednia L - Rysa/odprysk 1

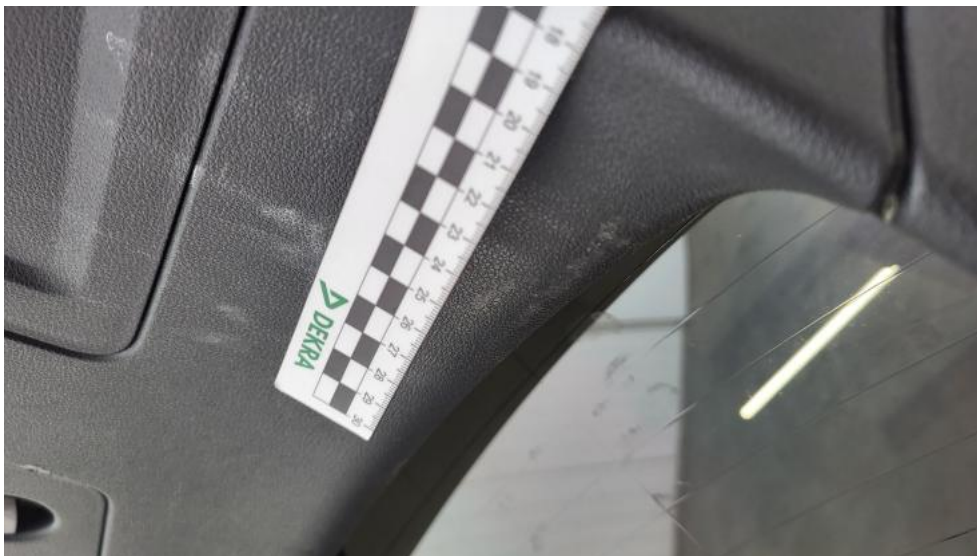
**Photo 57.**

Wykładzina pokrywy tylnej - Rysa/odprysk 1
