DEKRA's commission No. : PKOL(W)/LODZ/90584/25/11/21  
commission/ damage No. : 20/036307  
Date of commission: 21-11-2025

| Manufacturer | KIA |
| Model | Sportage 18-21 |
| Registration /record No. | PO9NJ15 |

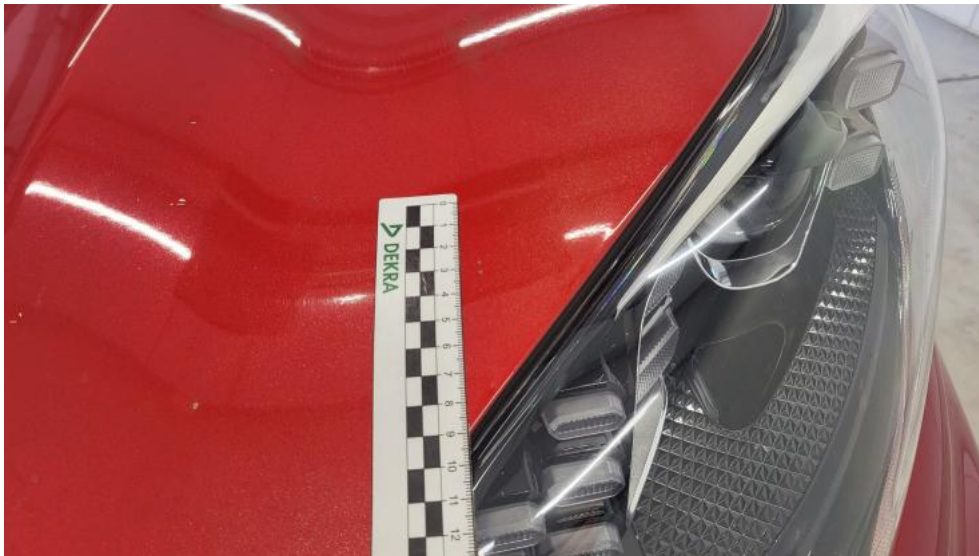
**Photo 39.**

Pokrywa komory silnika - Rysa/odprysk 1

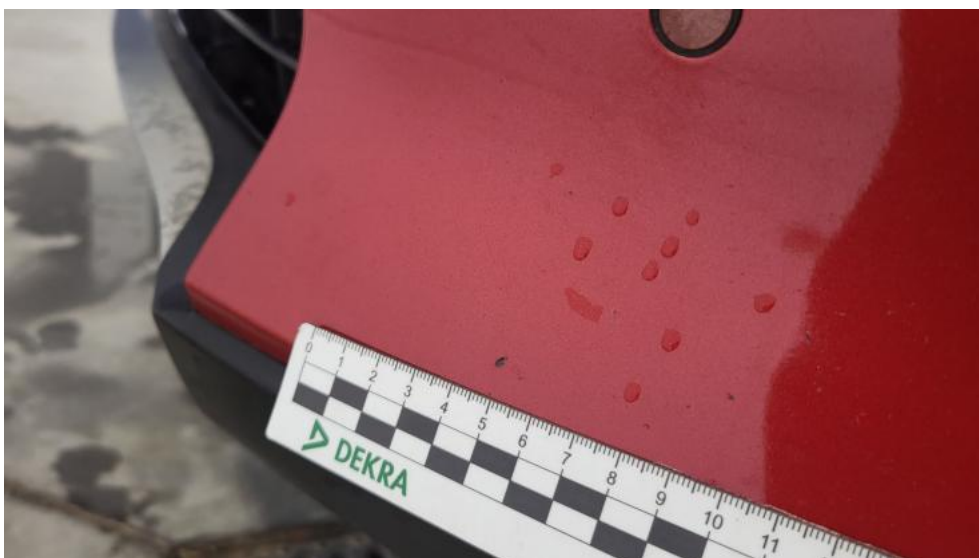
**Photo 40.**

Zderzak - Rysa/odprysk 1

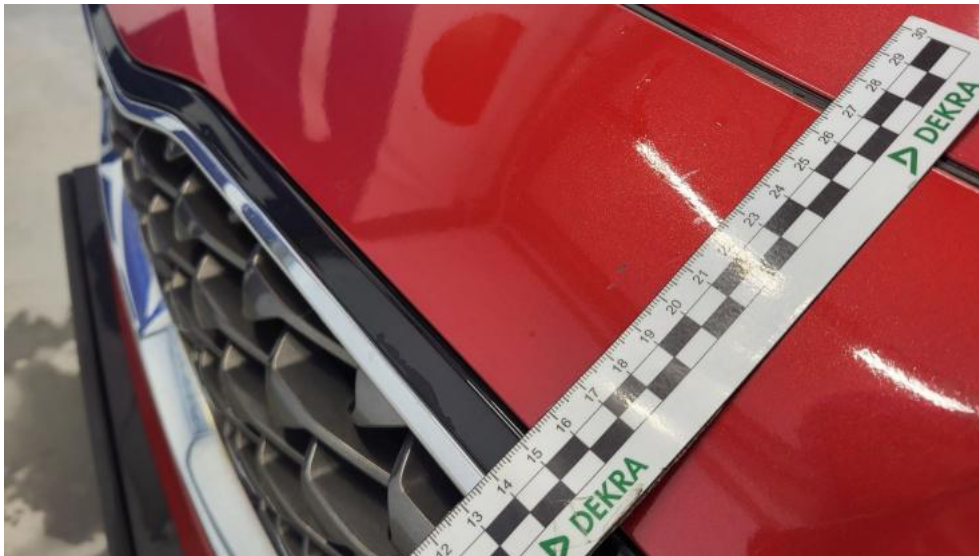
**Photo 41.**

Zderzak - Rysa/odprysk 2

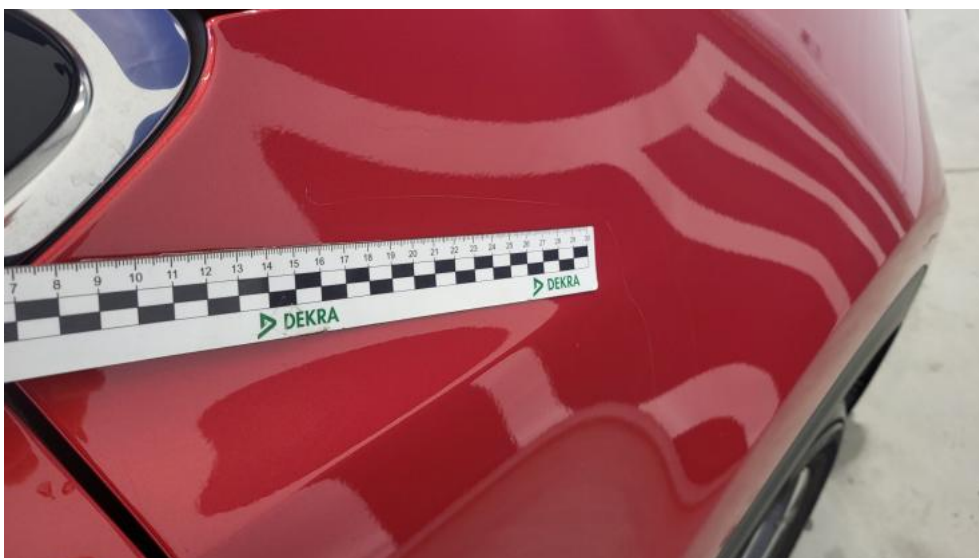
**Photo 42.**

Światnik przedni P - Rysa/odprysk 1

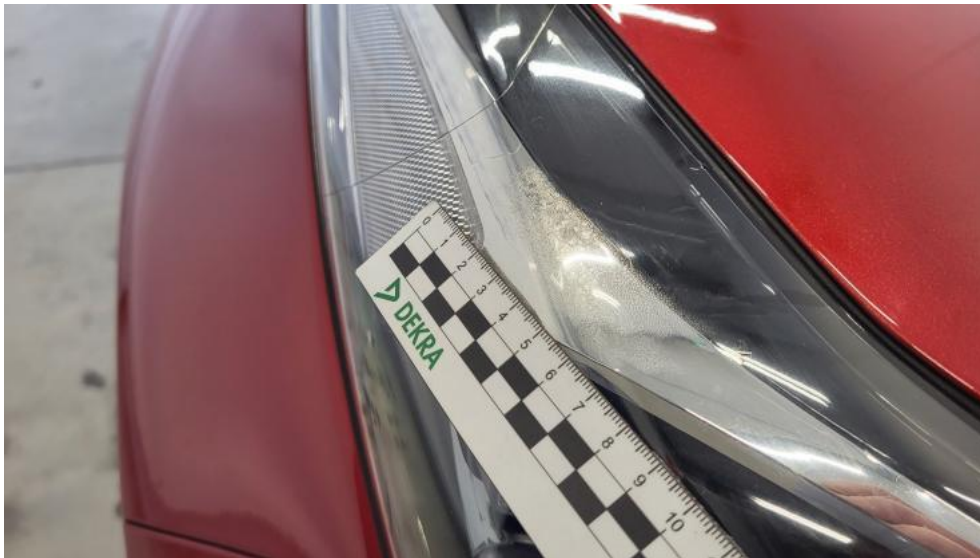
**Photo 43.**  
Reflektor P - Inne 1

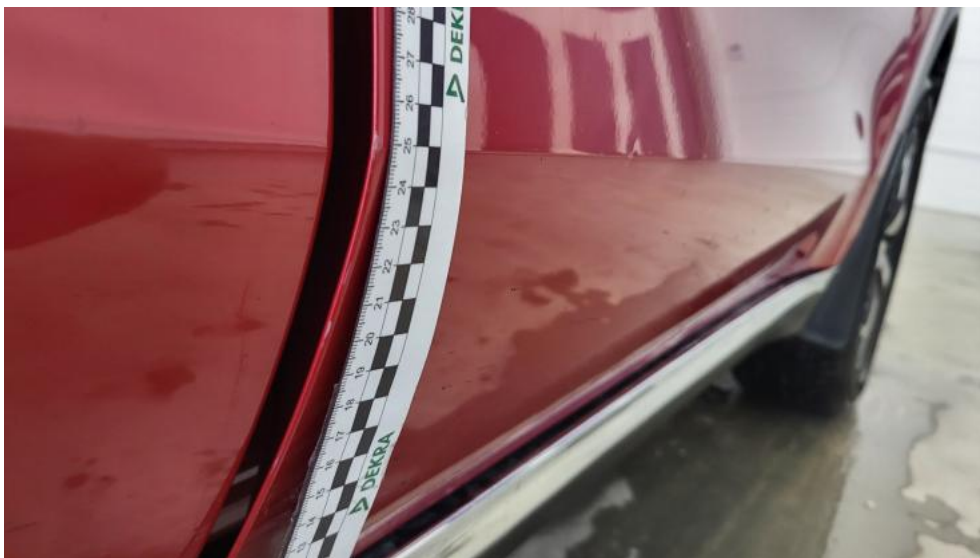
**Photo 44.**  
Drzwi przednie P - Rysa/odprysk 1

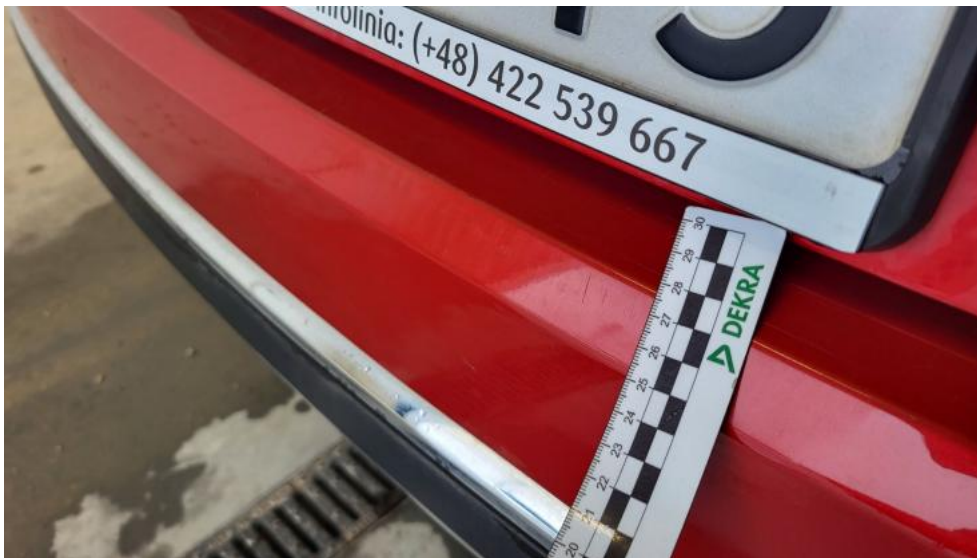
**Photo 49.**

Zderzak tylny - Rysa/odprysk 1

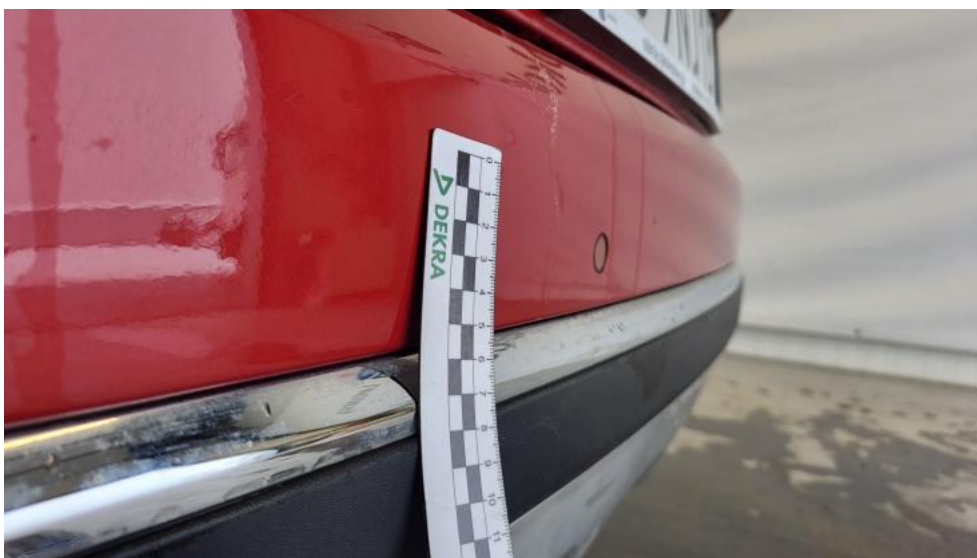
**Photo 50.**

Zderzak tylny - Wgniecenie/odkształcenie 1

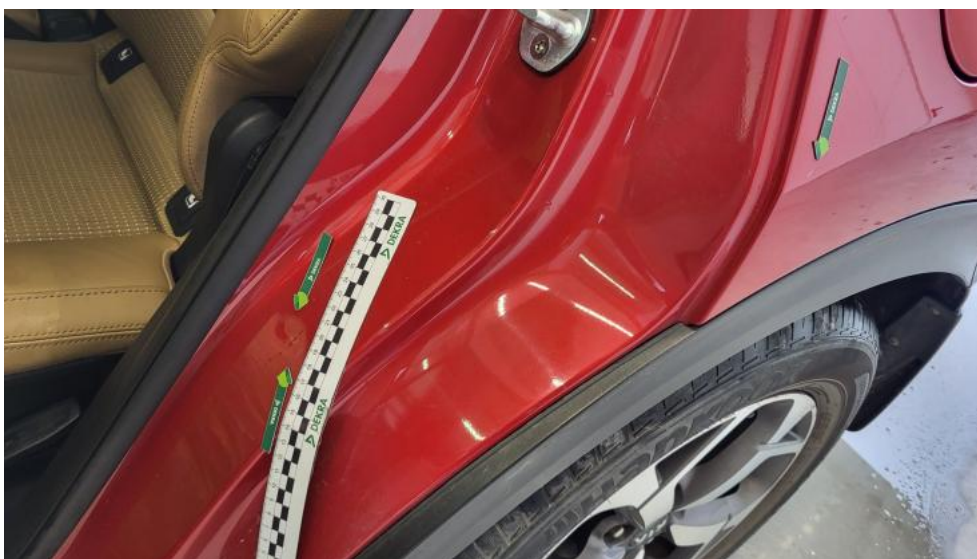
**Photo 51.**

Błotnik tylny L / Ściana boczna L - Wgniecenie/odkształcenie 1

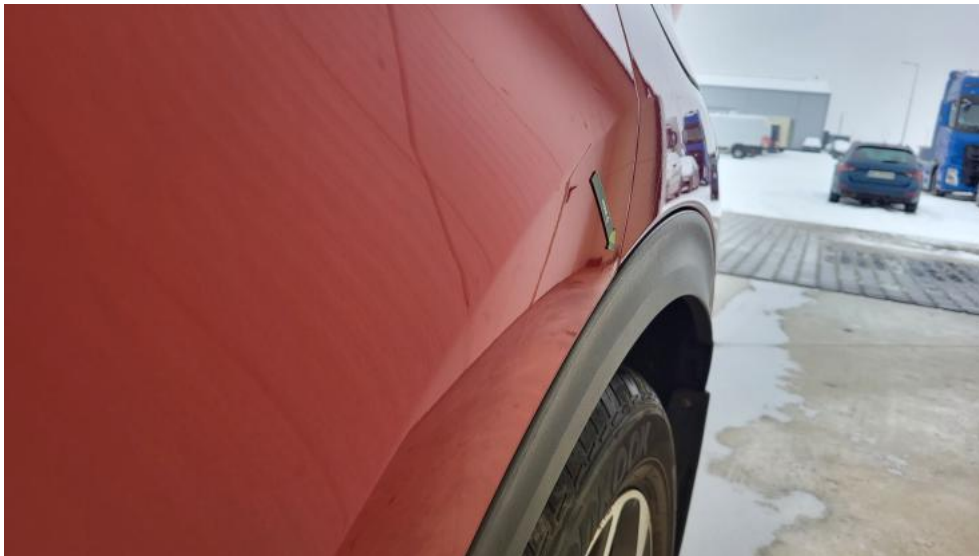
**Photo 55.**

Drzwi tylne L - Wgniecenie/odkształcenie 1

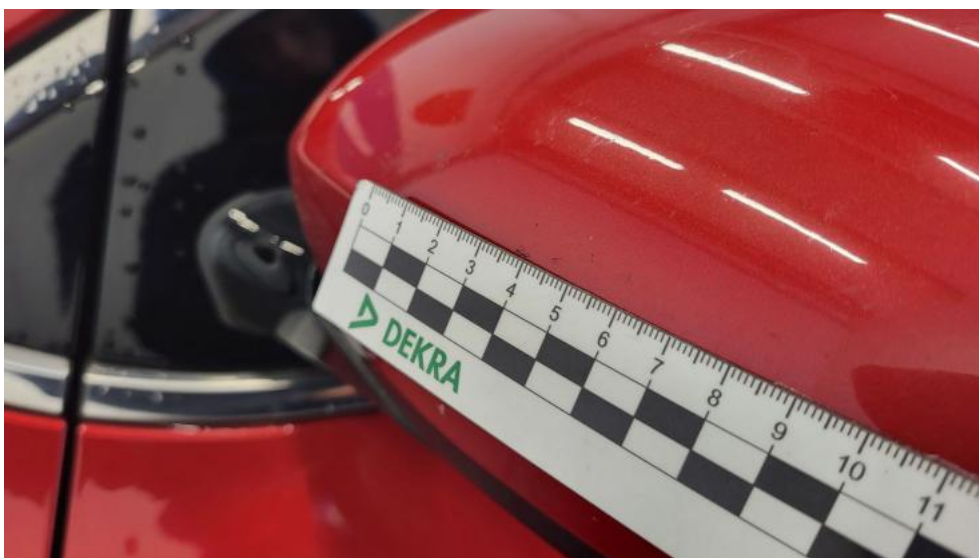
**Photo 56.**

Lusterko zew L - Rysa/odprysk 1

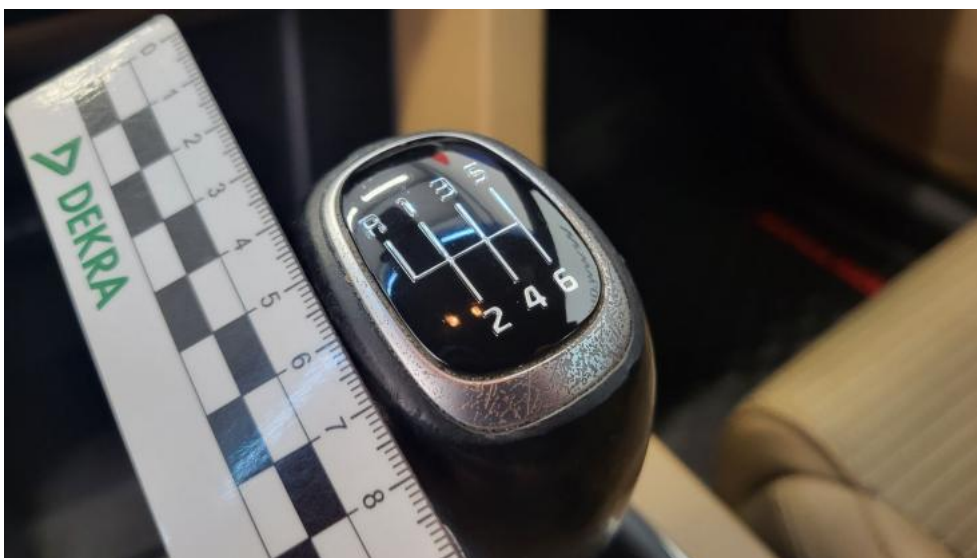
**Photo 60.**  
Gałka dźwigni zmiany biegów - Rysa/odprysk 1

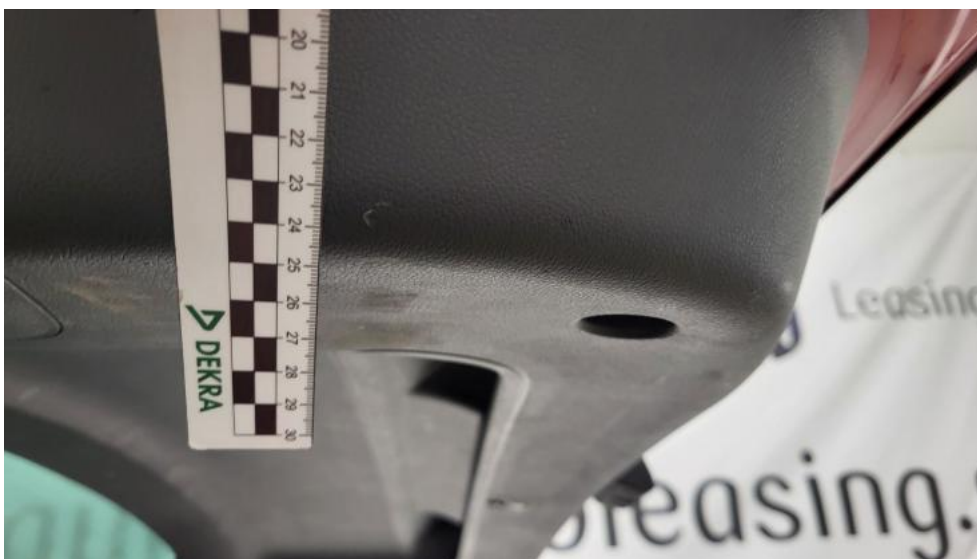
**Photo 67.**

Wykładzina pokrywy tylnej - Rysa/odprysk 1

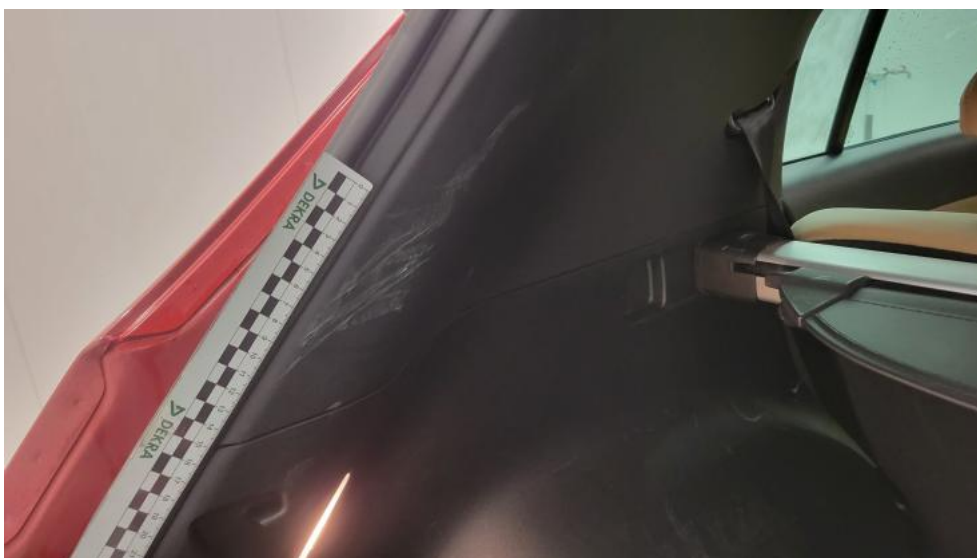
**Photo 68.**

Wykładzina przestrzeni bagażowej - Rysa/odprysk 1
