DEKRA's commission No. : PKOL(W)/LODZ/67390/24/09/02  
commission/ damage No. : 02359/LF/20  
Date of commission: 02-09-2024

**Client :**  
PKO Leasing Finance  
PKO Leasing SA  
Al. Śmigłego-Rydza 20  
93-281 Łódź

Group of objects (Eurotax)	cars
EC code (Eurotax)	0114897
Manufacturer	BMW
Model	Seria 7 [G11, G12] 15-19
Type / version	750i xDrive
Body type	sedan
Number of doors / seats	4/5
Curb weight [kg]	1870
Gross vehicle weight [kg]	2575
Wheelbase 1/2	3070
Engine type	spark ignition
Pollution reduction system	three-way catalytic converter
Engine capacity [ccm]	4395
Engine Power [hp/kW]	450/330
Gearbox	automatic 8- gear
Registration /record No.	GD777VT
VIN / serial number	WBA7B01070GD54869
Date of first registration	30-12-2015
Date of next. tech. test	19-10-2024
Year of manufacture	2015 (year has been verified with the manufacturer's base)
Readout [km]	159 472 (read)
Body color / type of coating	black/METALIK

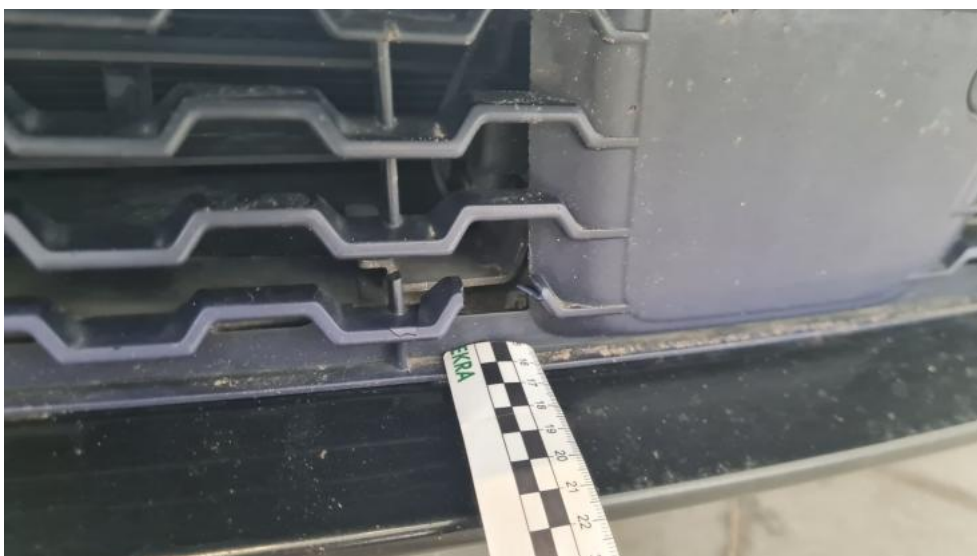
**Photo 38.**  
Kratka zderzaka prz. - Pęknięcie/rozerwanie 1

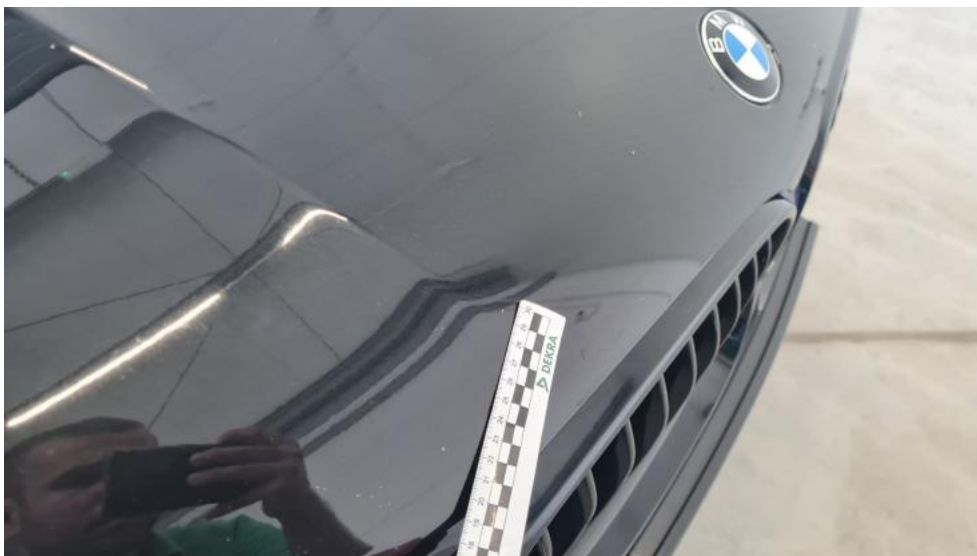
**Photo 39.**  
Pokrywa komory silnika - Rysa/odprysk 1

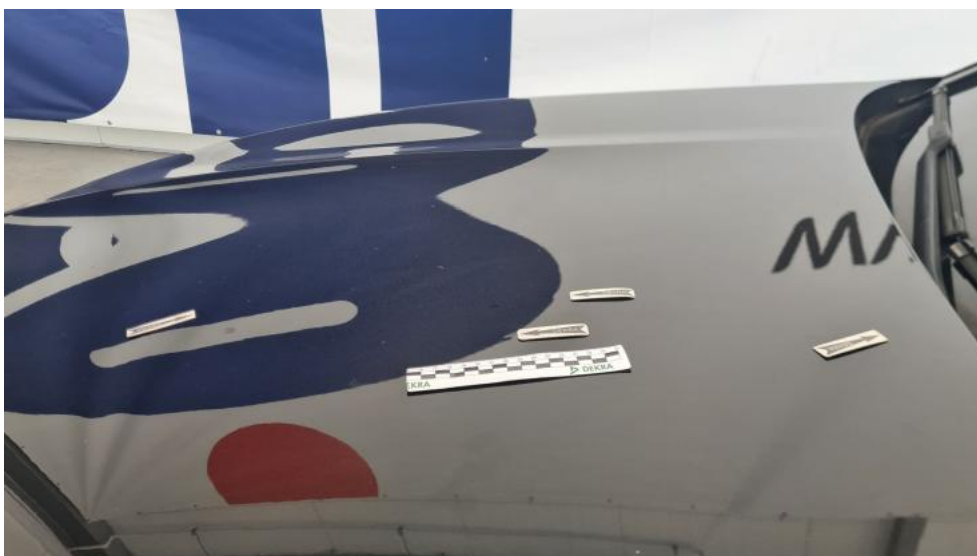
**Photo 40.**  
Pokrywa komory silnika - Wgniecenie/odkształcenie 1

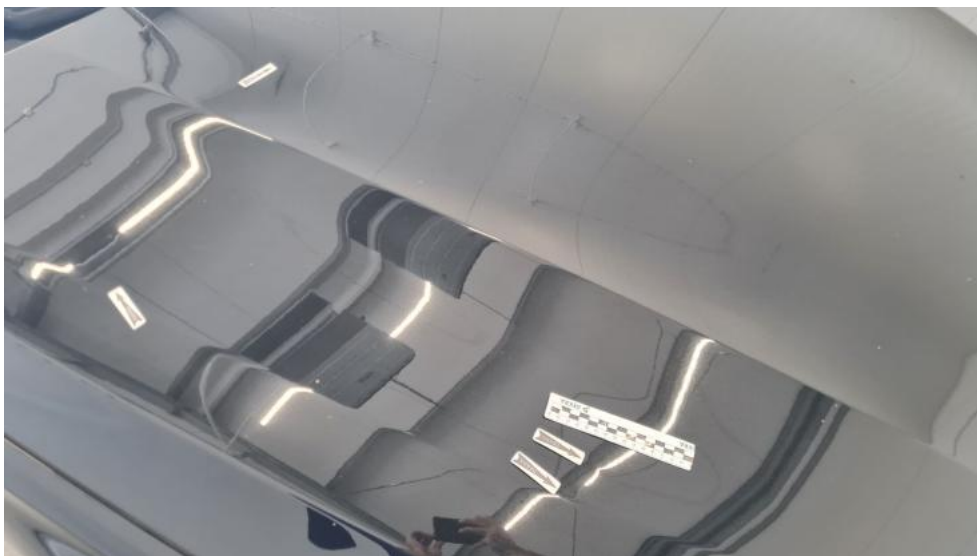
**Photo 41.**  
Pokrywa komory silnika - Wgniecenie/odkształcenie 2

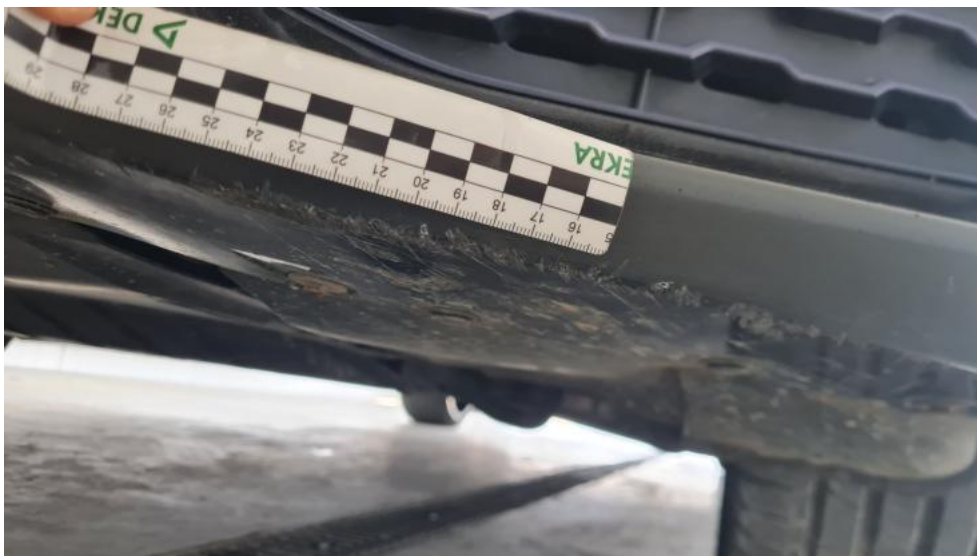
**Photo 43.**  
Zderzak - Rysa/odprysk 1

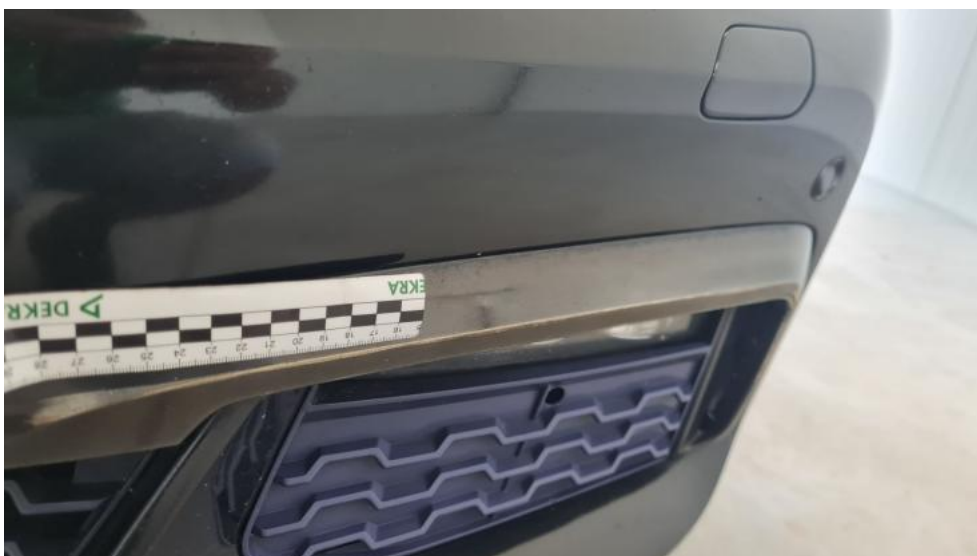
**Photo 44.**  
Zderzak - Rysa/odprysk 2

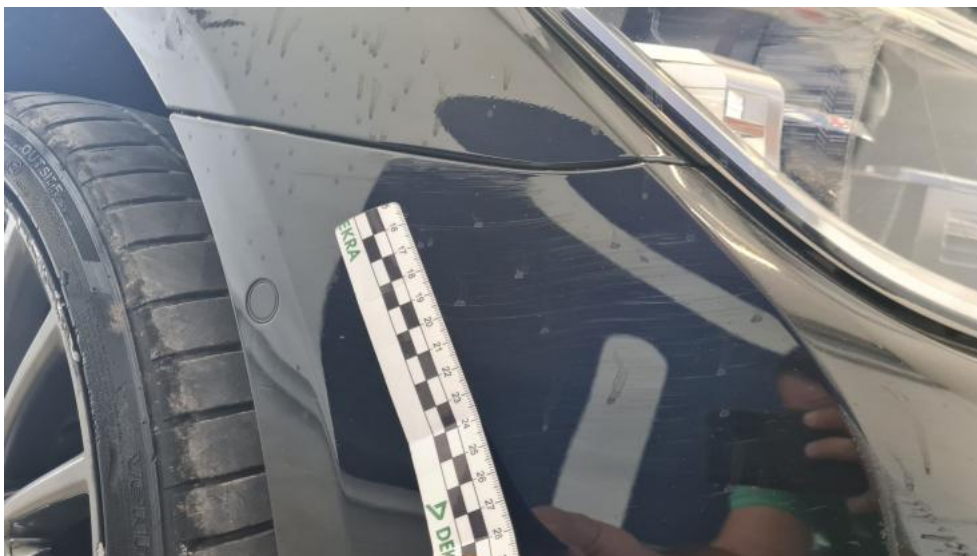
**Photo 45.**  
Zderzak() - Rysa/odprysk 3

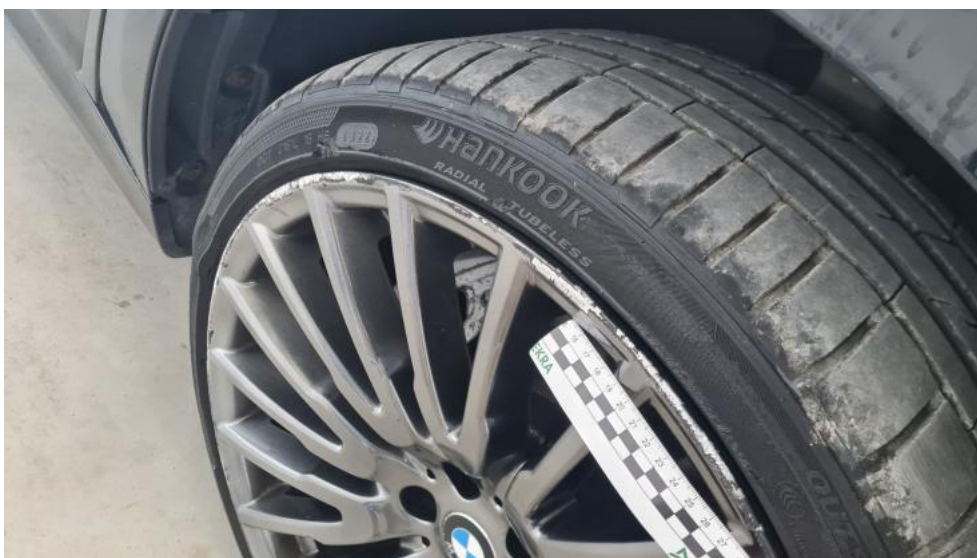
**Photo 46.**  
Felga aluminiowa przednia P - Rysa/odprysk 1

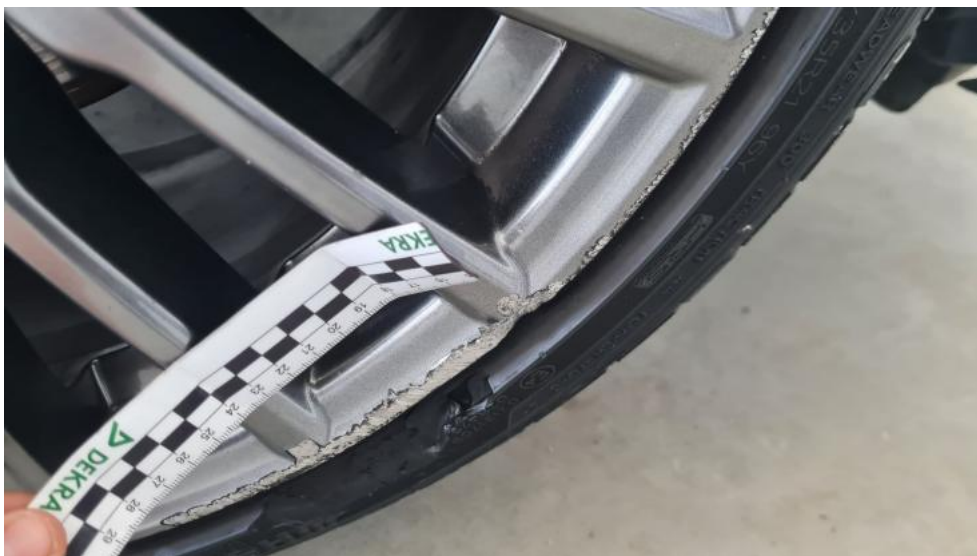
**Photo 47.**  
Felga aluminiowa przednia P - Rysa/odprysk 2

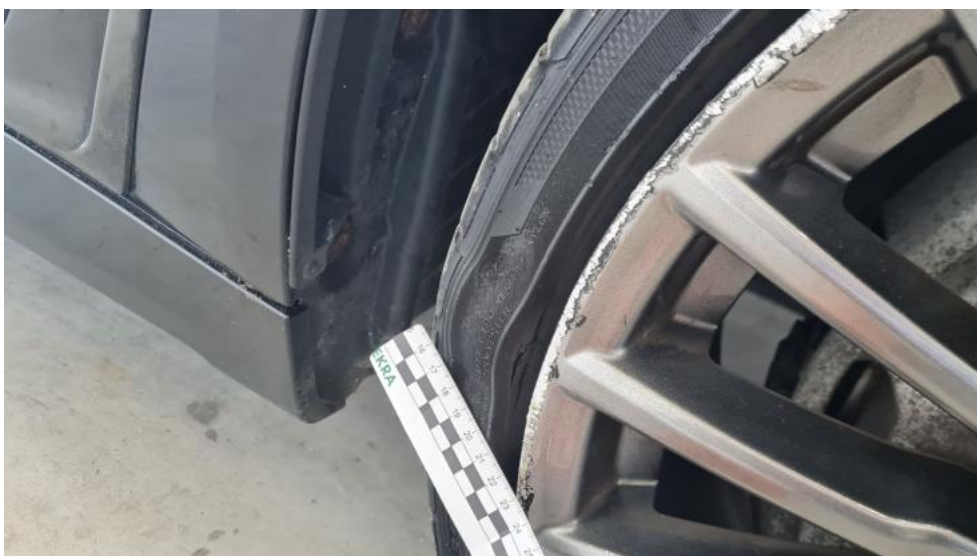
**Photo 48.**  
Opona przednia P - Wgniecenie/odkształcenie 1

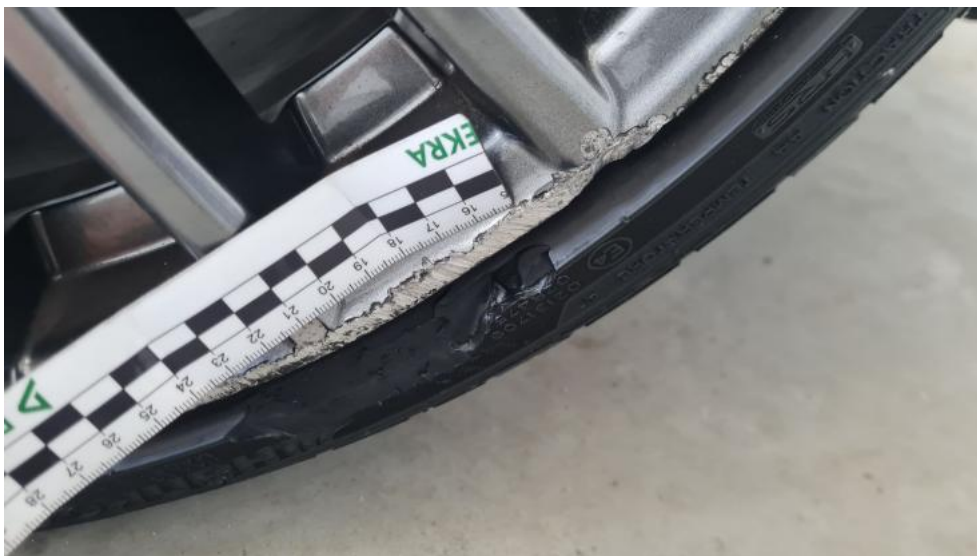
**Photo 49.**  
Opona przednia P - Pęknięcie/rozerwanie 1

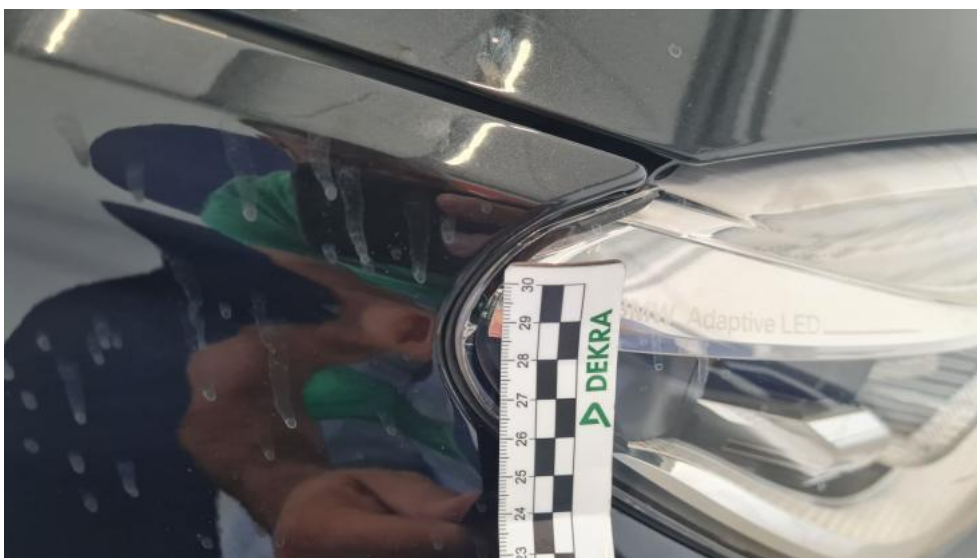
**Photo 50.**  
Reflektor P - Rysa/odprysk 1

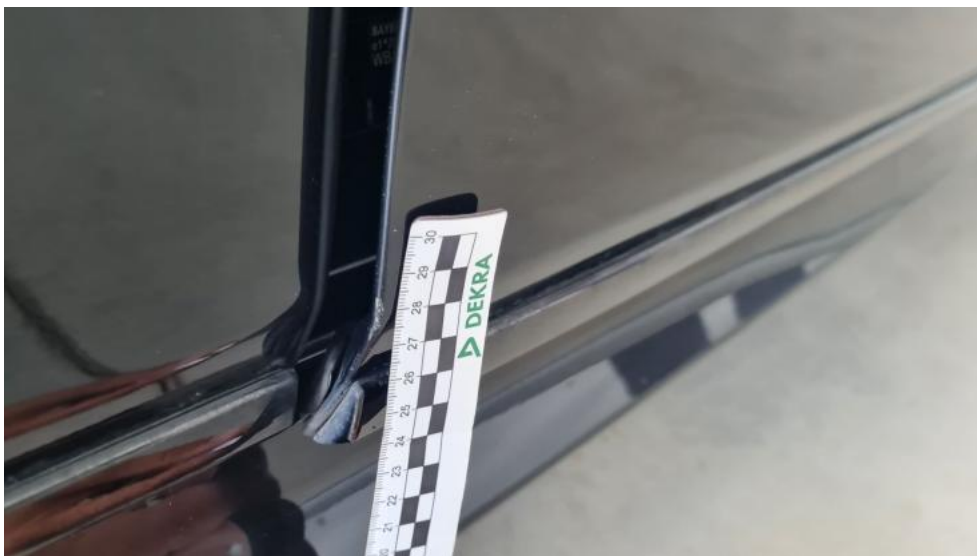
**Photo 51.**  
Drzwi przednie P - Rysa/odprysk 1

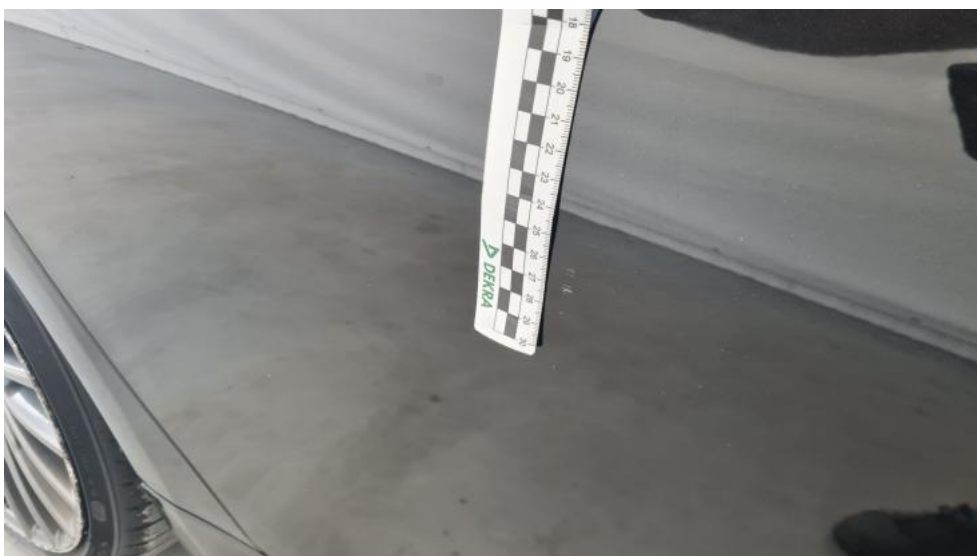
**Photo 52.**  
Drzwi tylne P - Rysa/odprysk 1

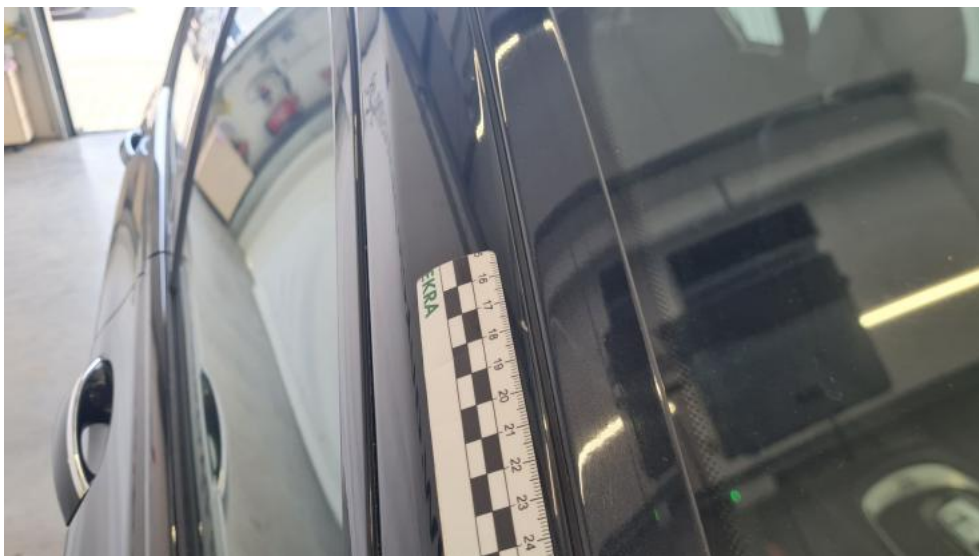
**Photo 53.**  
Stupek przedni P - Rysa/odprysk 1

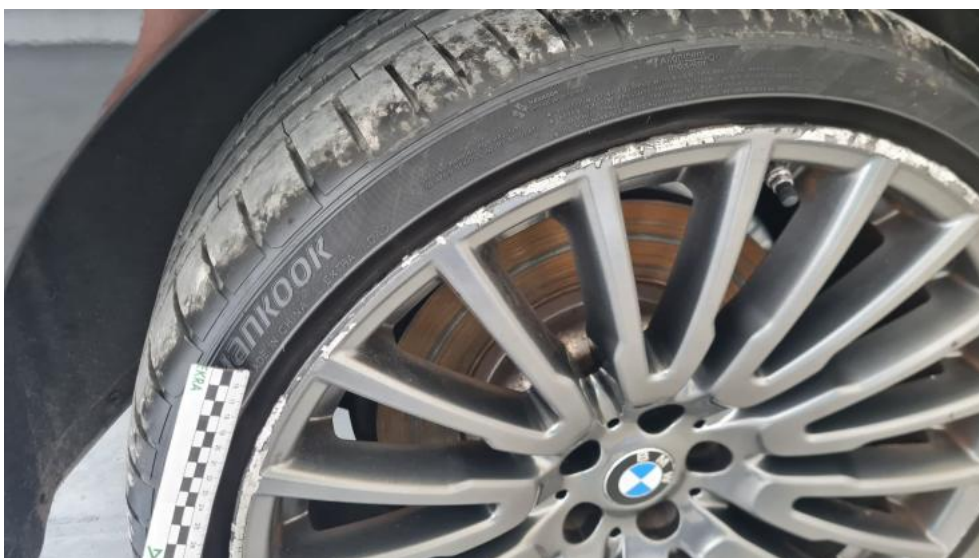
**Photo 54.**  
Felga aluminiowa tylna P - Rysa/odprysk 1

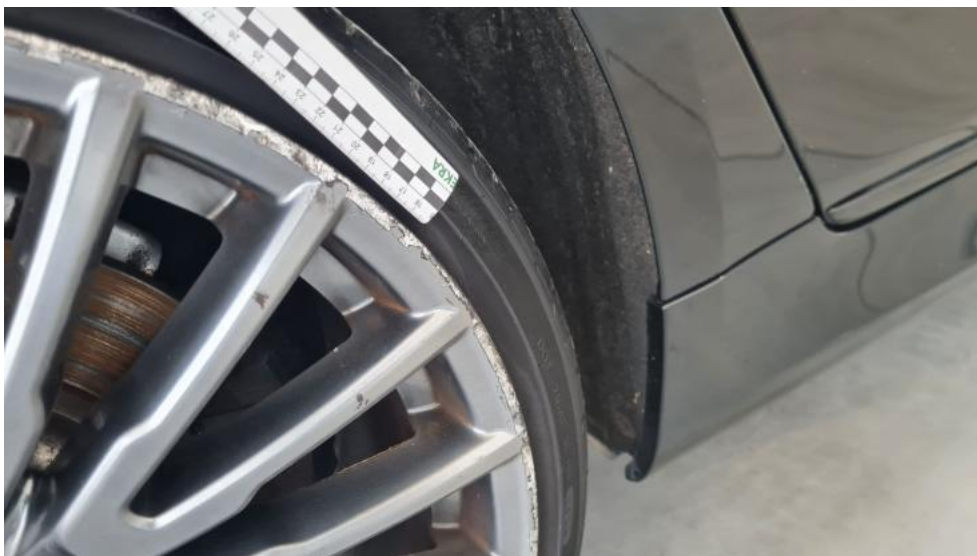
**Photo 55.**  
Felga aluminiowa tylna P - Rysa/odprysk 2

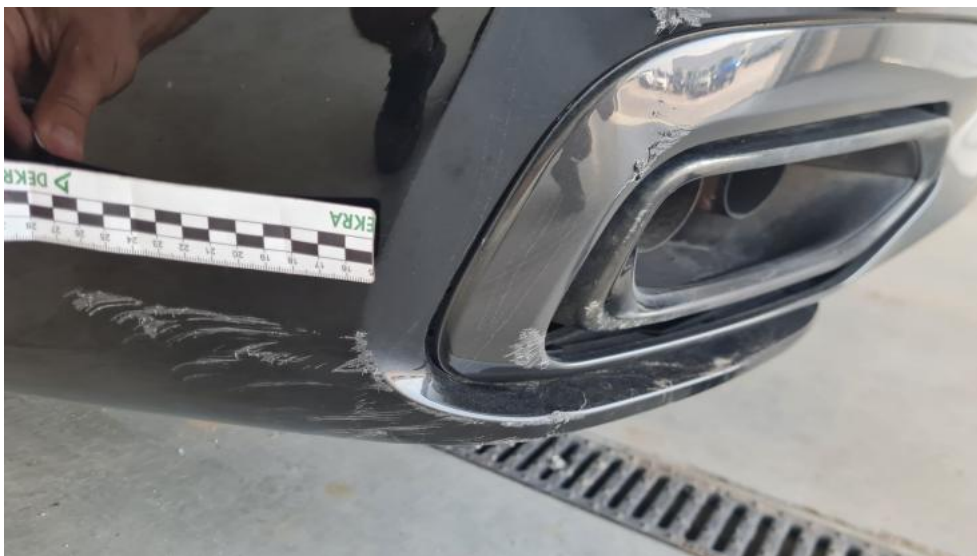
**Photo 57.**  
Zderzak tylny - Rysa/odprysk 1

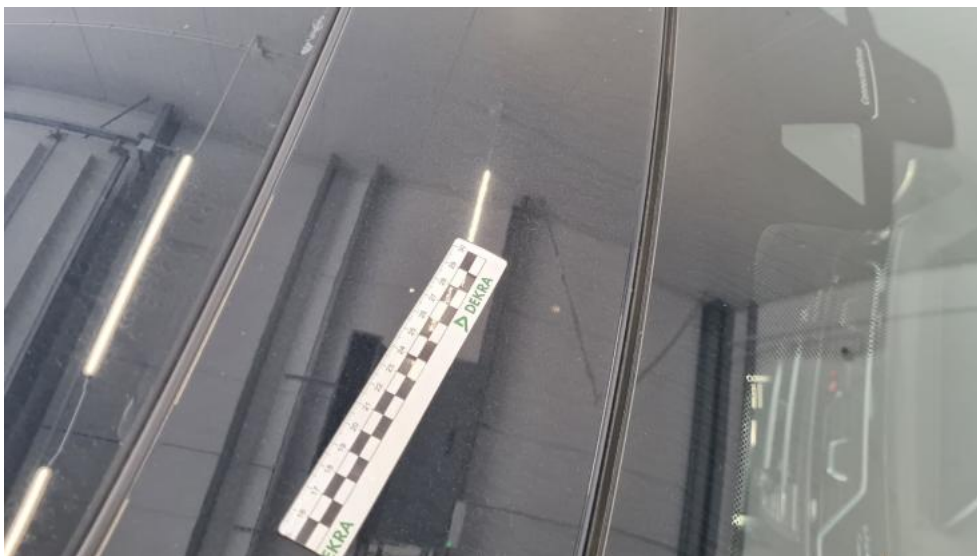
**Photo 59.**  
Dach - Rysa/odprysk 1

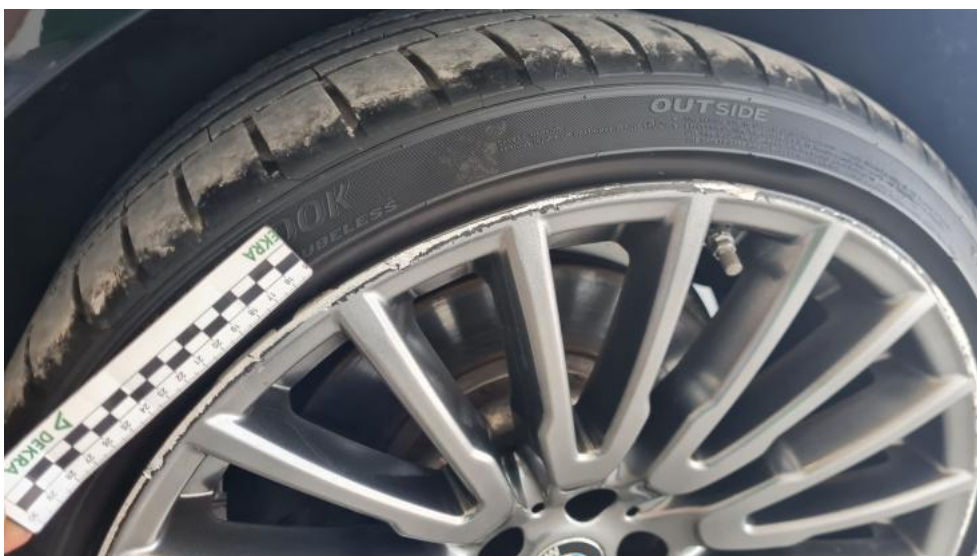
**Photo 60.**  
Felga aluminiowa tylna L - Rysa/odprysk 1

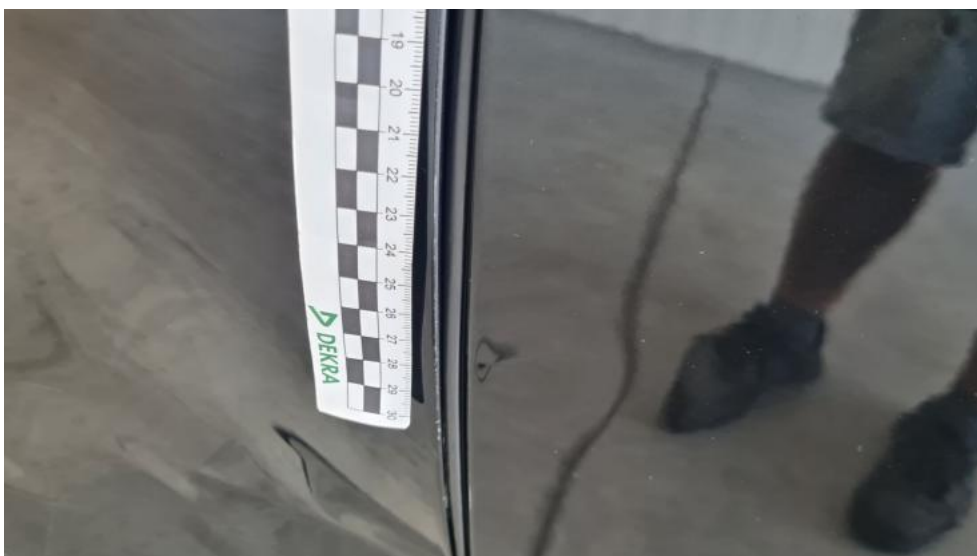
**Photo 62.**  
Drzwi przed L - Rysa/odprysk 1

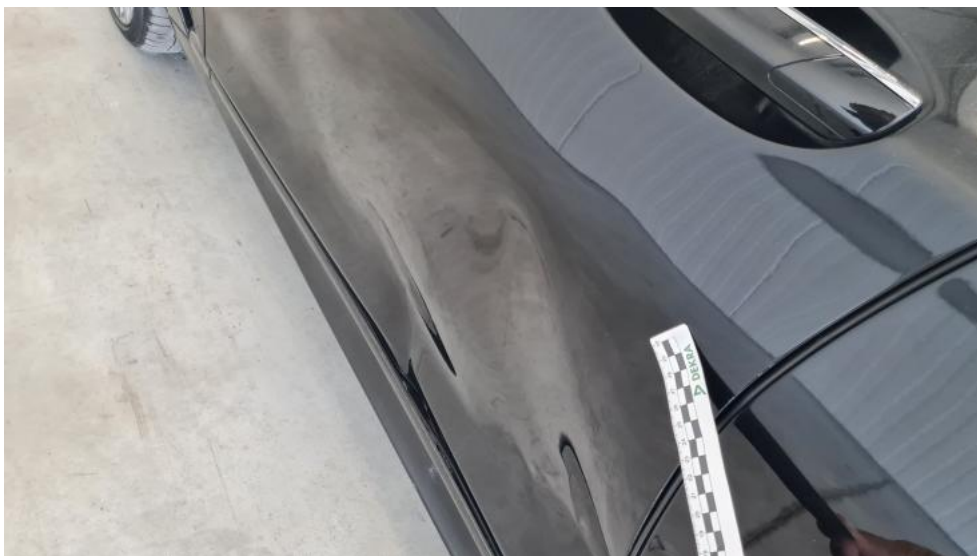
**Photo 63.**  
Drzwi przed L - Wgniecenie/odkształcenie 1

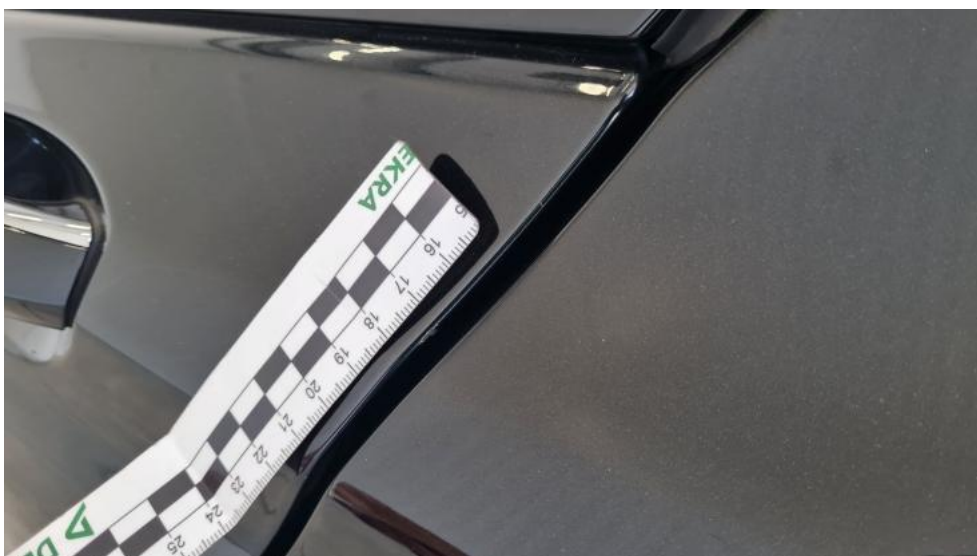
**Photo 64.**  
Drzwi tylne L - Rysa/odprysk 1

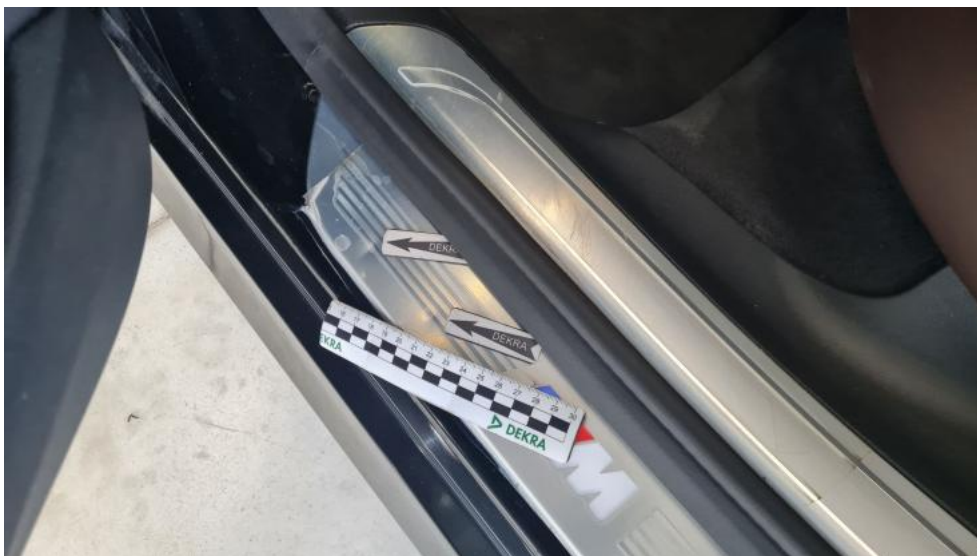
**Photo 67.**  
Próg L - Wgniecenie/odkształcenie 1

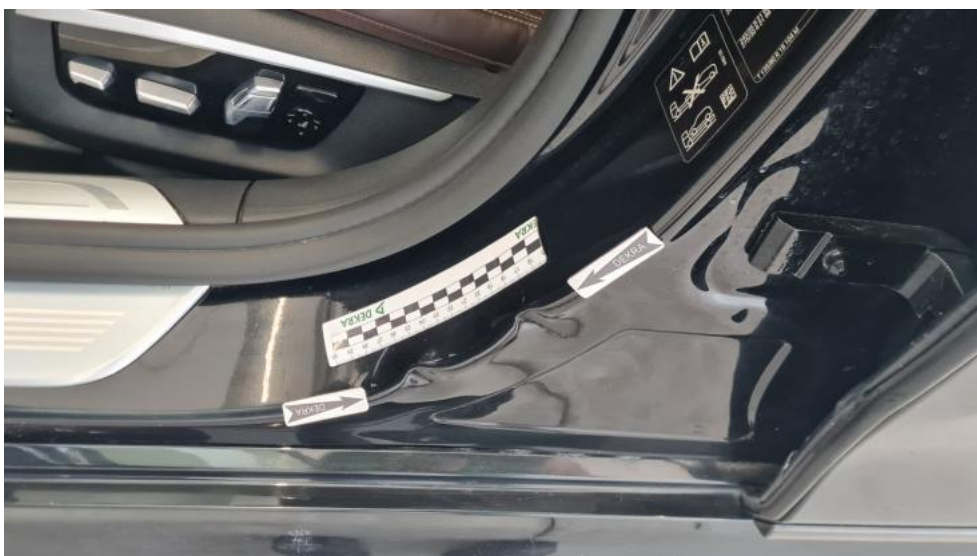
**Photo 68.**  
Słupek środkowy L - Wgniecenie/odkształcenie 1

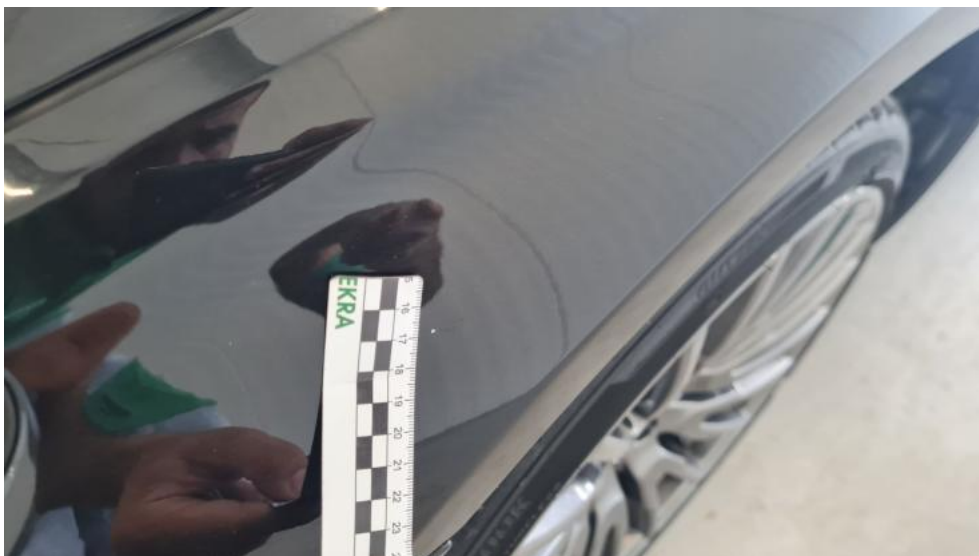
**Photo 69.**  
Błotnik przedni L - Rysa/odprysk 1

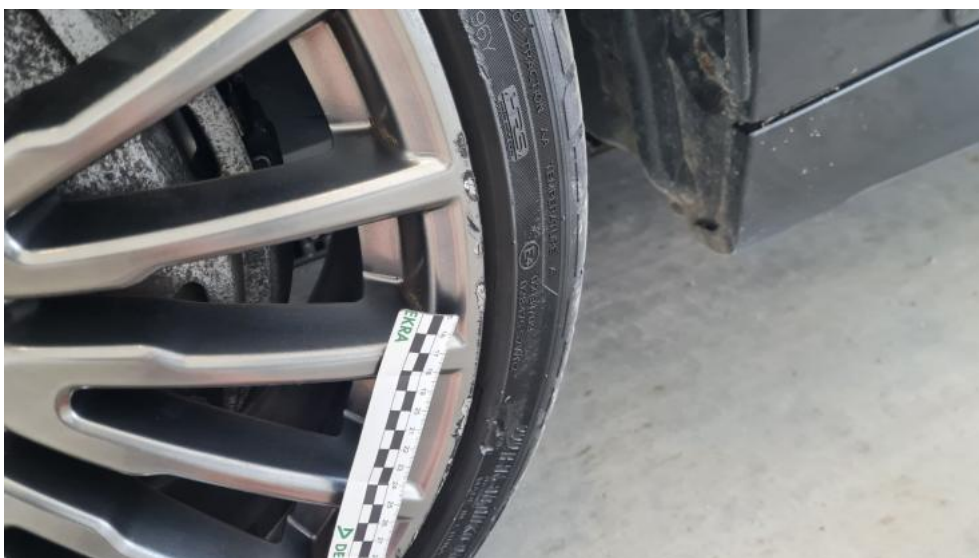
**Photo 70.**  
Felga Aluminiowa przedni L - Rysa/odprysk 1

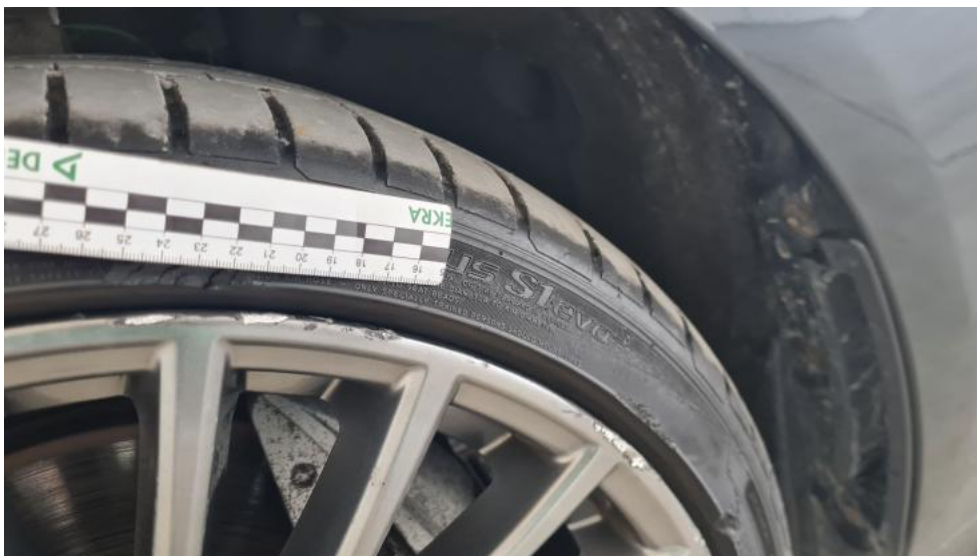
**Photo 71.**  
Felga Aluminiowa przednia L - Rysa/odprysk 2

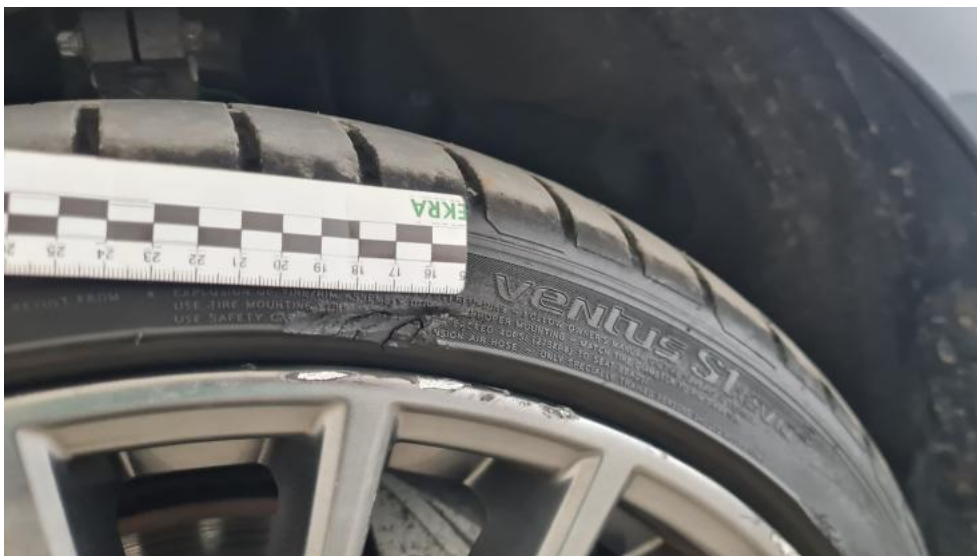
**Photo 73.**  
Opona przednia L - Pęknięcie/rozerwanie 1

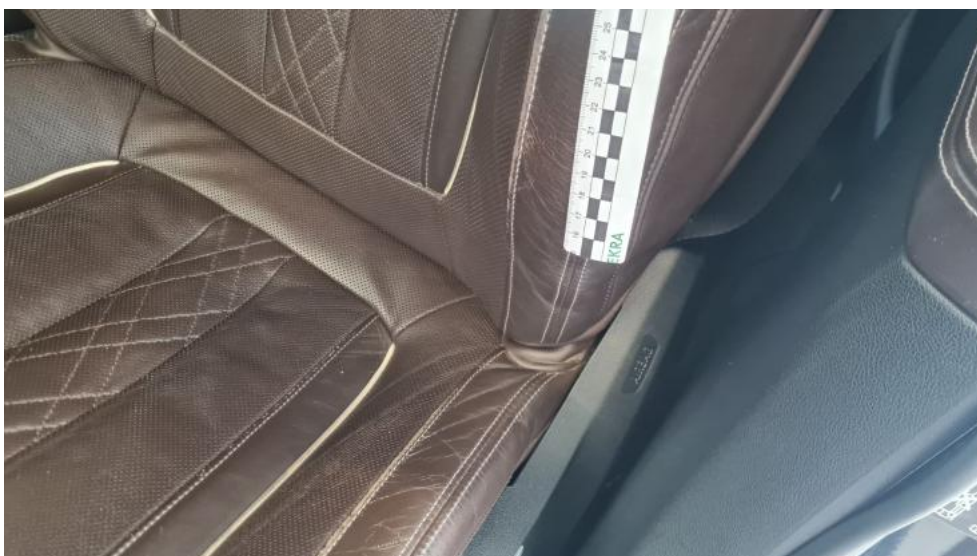
**Photo 74.**  
Fotel prz. lew. - Inne 1

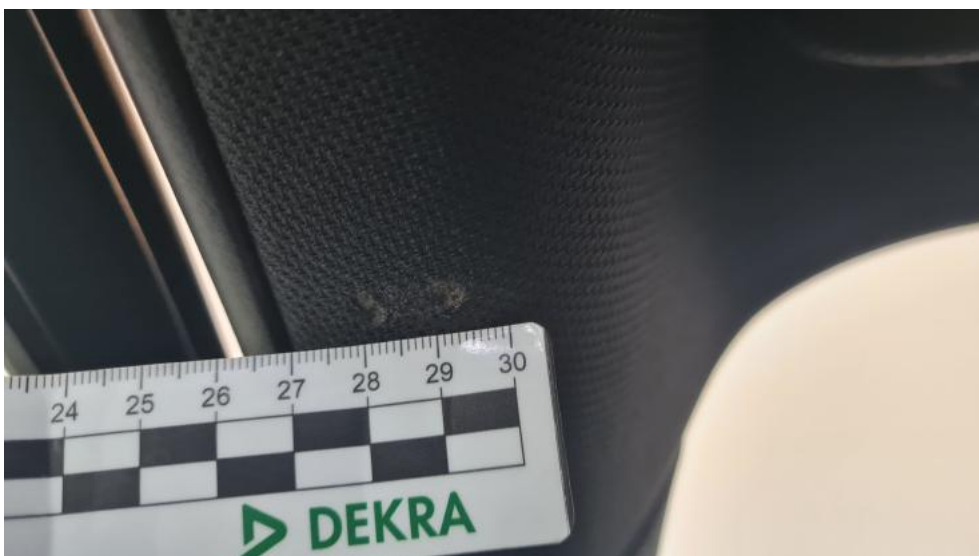
**Photo 76.**

Podsufitka - Inne 1
