DEKRA's commission No. : PKOL(W)/LODZ/16813/26/02/24  
commission/ damage No. : 22/003913  
Date of commission: 24-02-2026

| Manufacturer | FORD |
| Model | Mustang Mach-E 21- |
| Registration /record No. | DLU93043 |

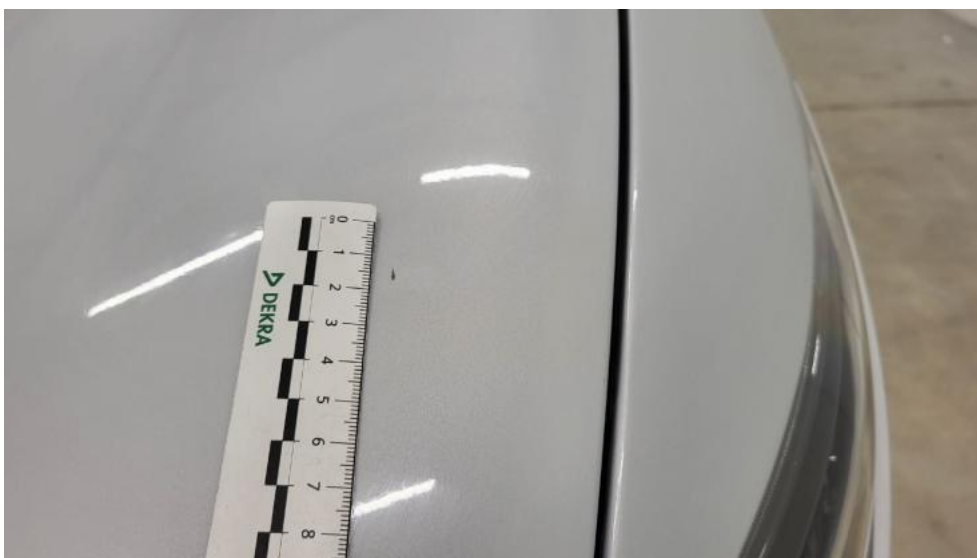
**Photo 46.**  
Pokrywa komory silnika - Rysa/odprysk 1

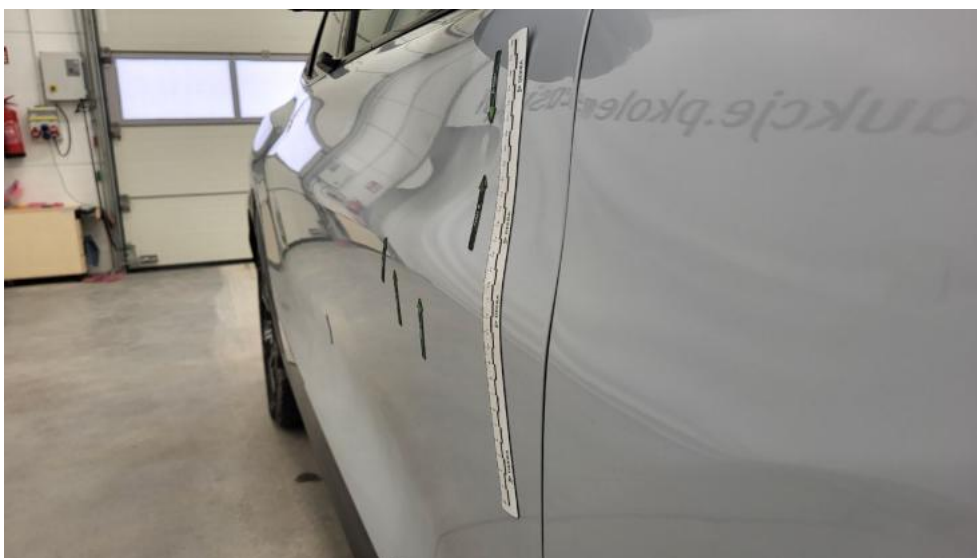
Drzwi przednie P - Wgniecenie/odkształcenie 1

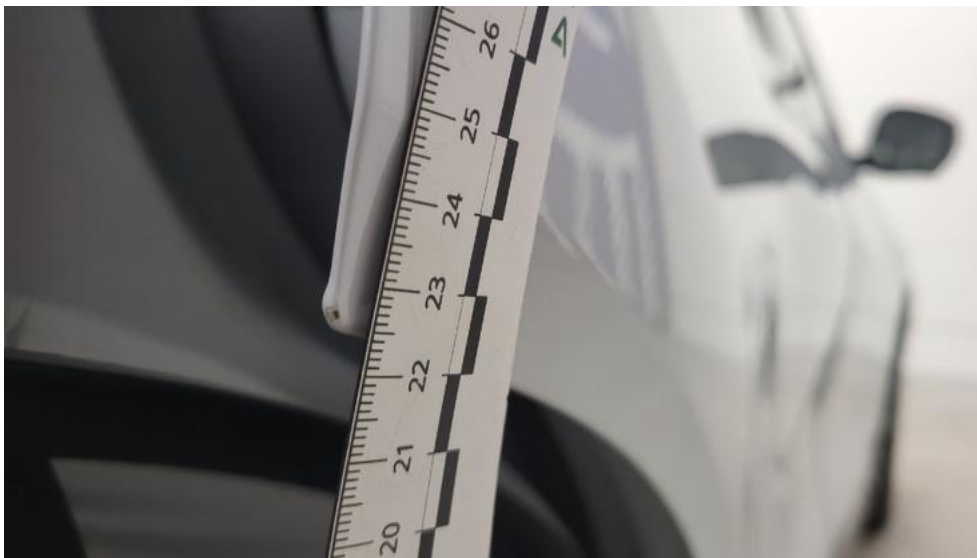
Drzwi tylne P - Rysa/odprysk 1

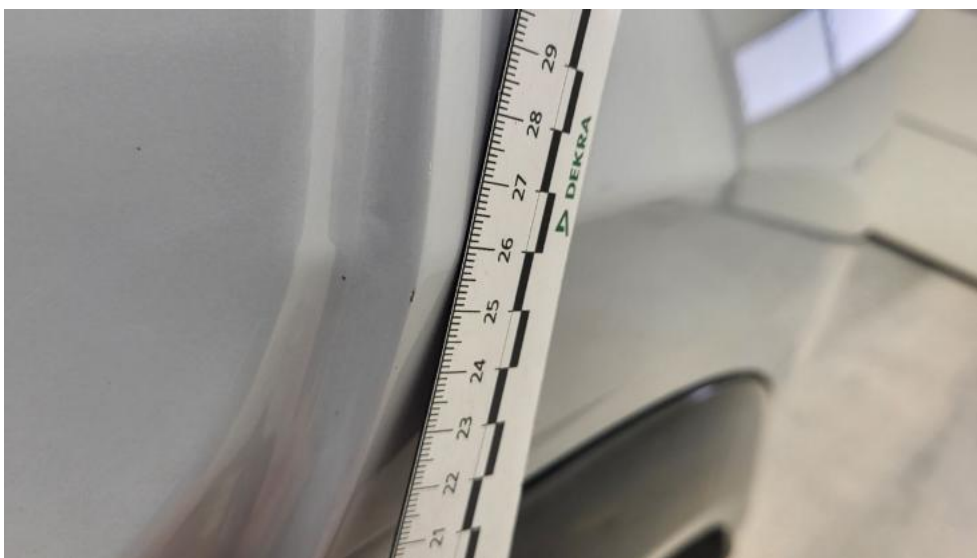
Błotnik tylny L / Ściana boczna L - Rysa/odprysk 2

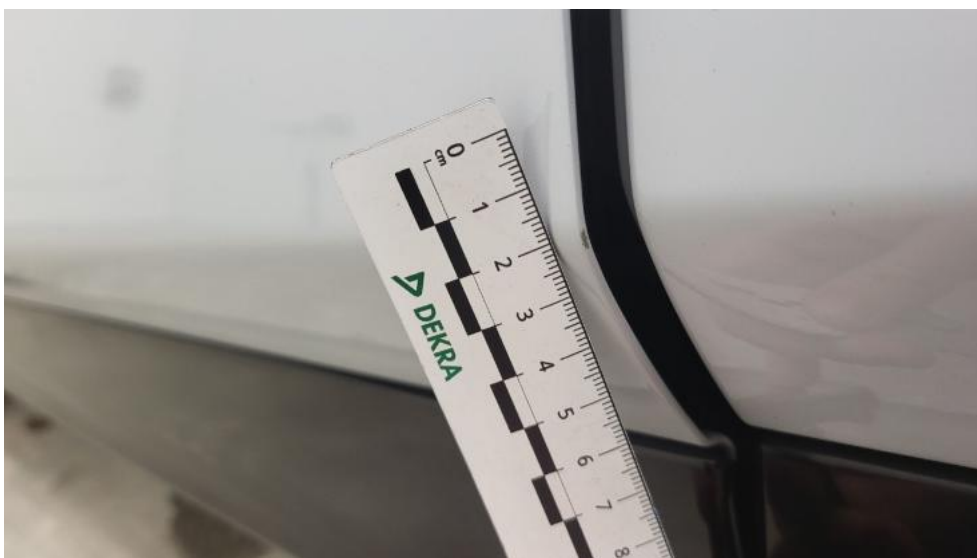
**Photo 54.**  
Drzwi przed L - Rysa/odprysk 1

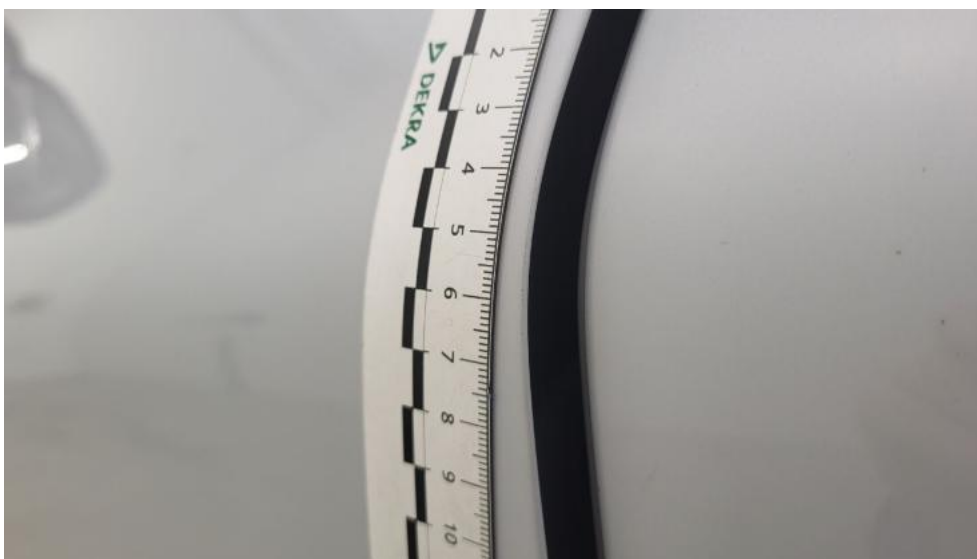
Drzwi przed L - Rysa/odprysk 2

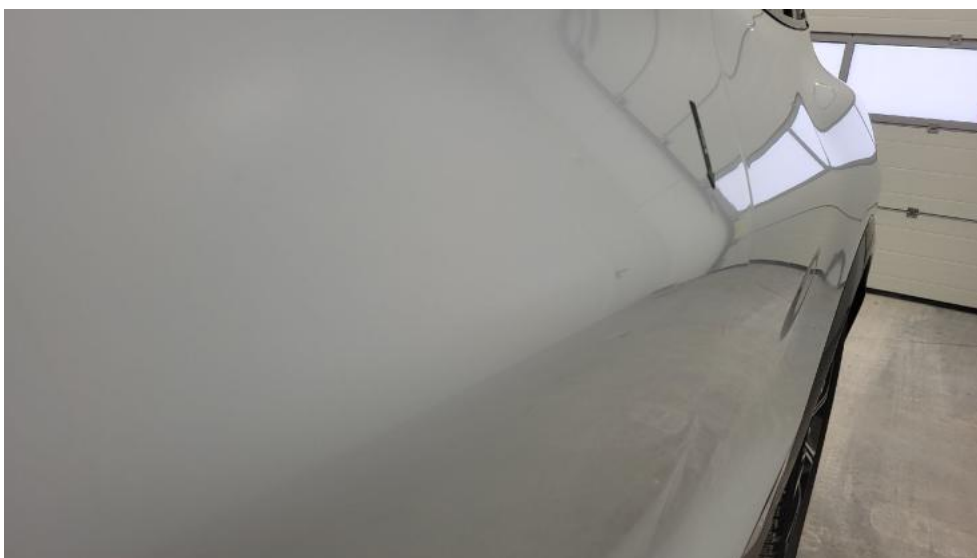
Drzwi przed L - Wgniecenie/odkształcenie 1

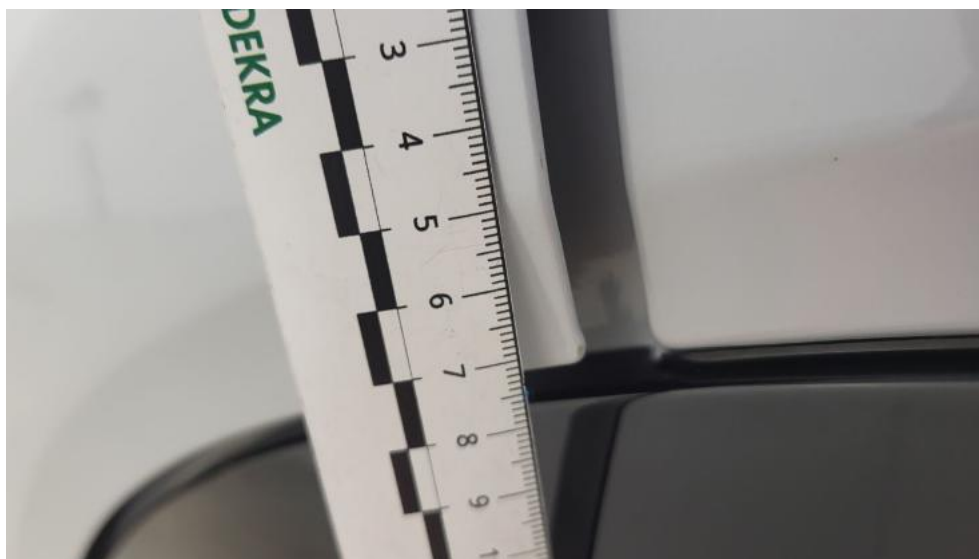
Drzwi tylne L - Rysa/odprysk 1

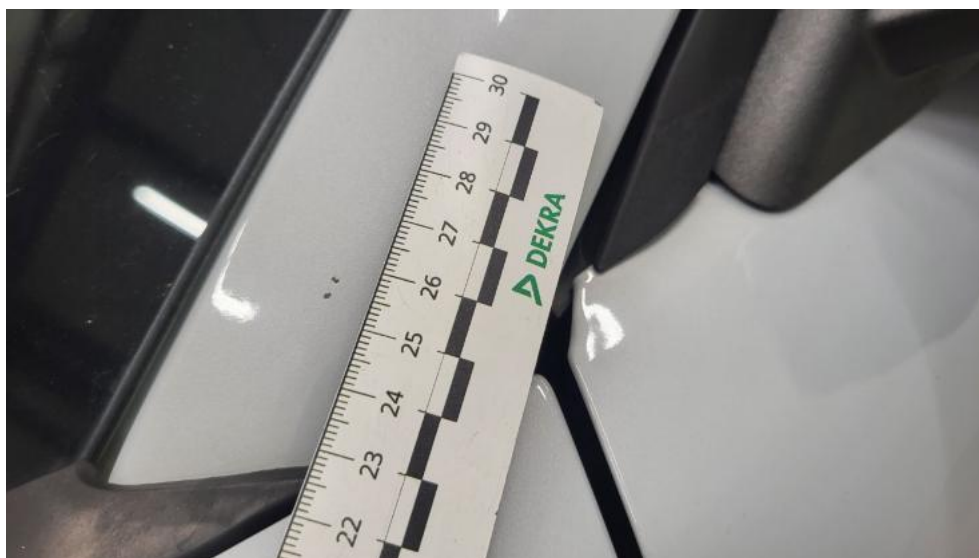
Słupek przedni L - Rysa/odprysk 1

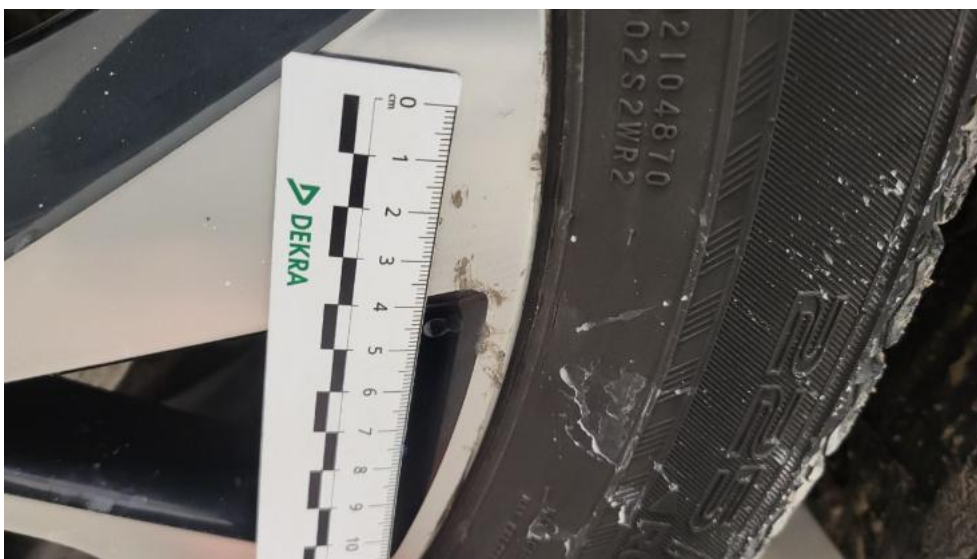
**Photo 59.**  
Felga Aluminiowa przednia L - Rysa/odprysk 1

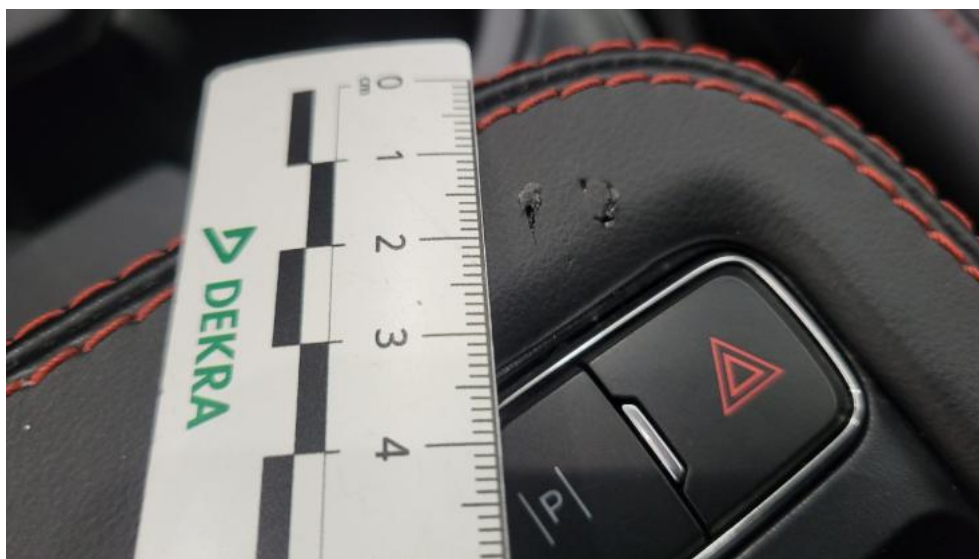
**Photo 61.**  
Konsola tunelu śr. - Pęknięcie/rozerwanie 1

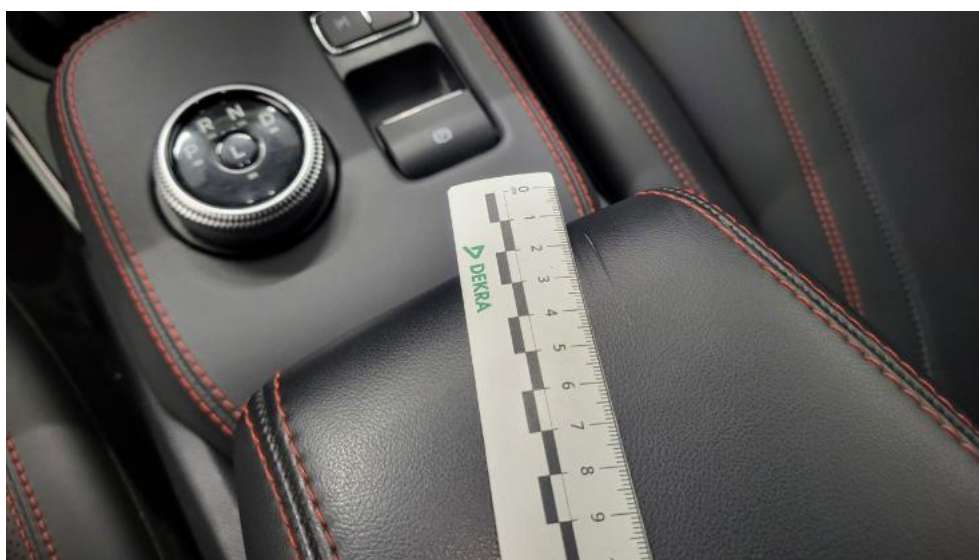
**Photo 62.**  
Podłokietnik środkowy przedni - Rysa/odprysk 1

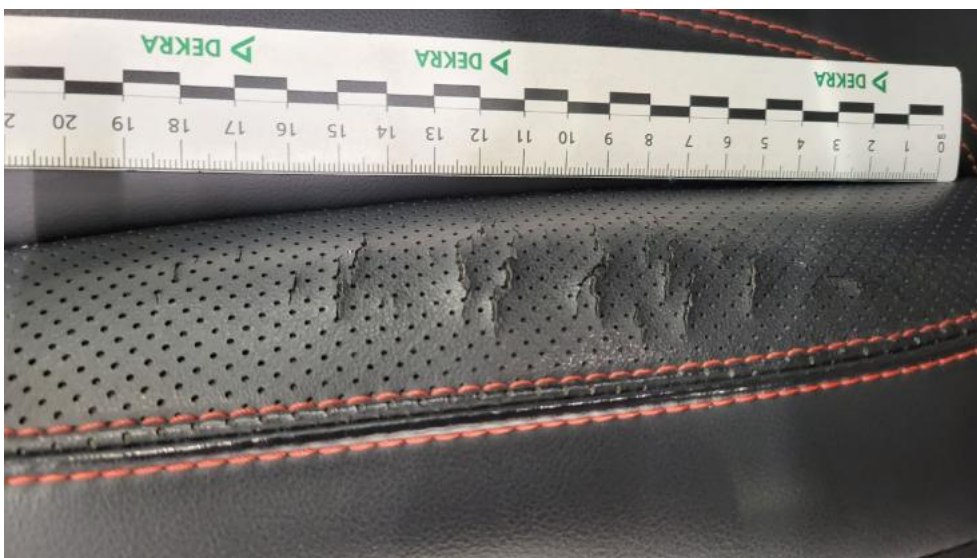
**Photo 64.**  
Fotel prz. lew. - Pęknięcie/rozerwanie 1

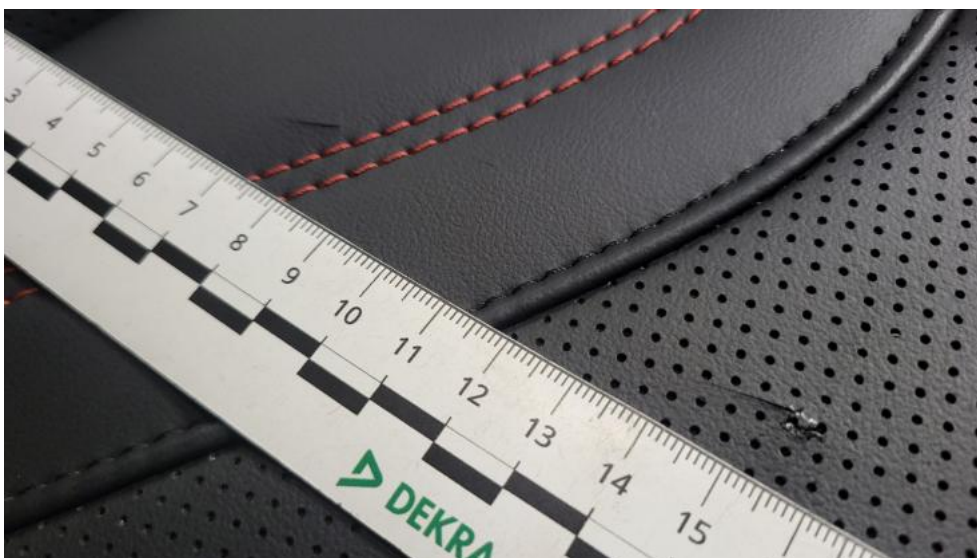
Fotel prz. praw. - Pęknięcie/rozerwanie 1

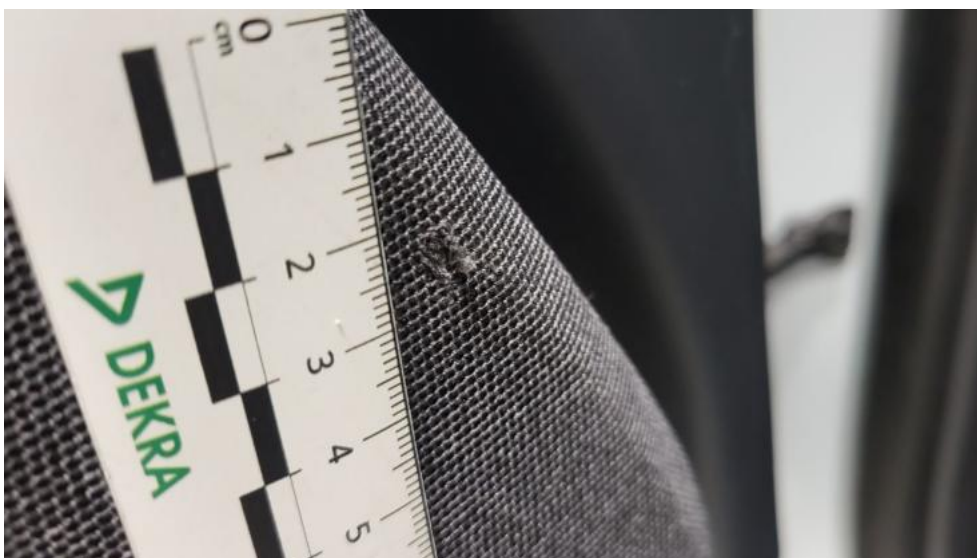
Tapicerka drzwi tylnych L - Pęknięcie/rozerwanie 1

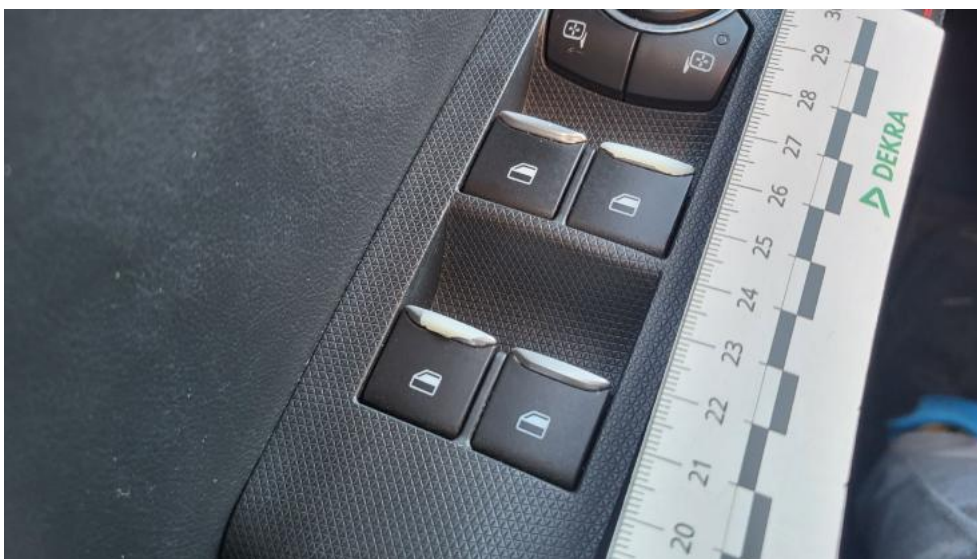
**Photo 69.**  
Włączniki/przełączniki drzwi prz L - Rysa/odprysk 1

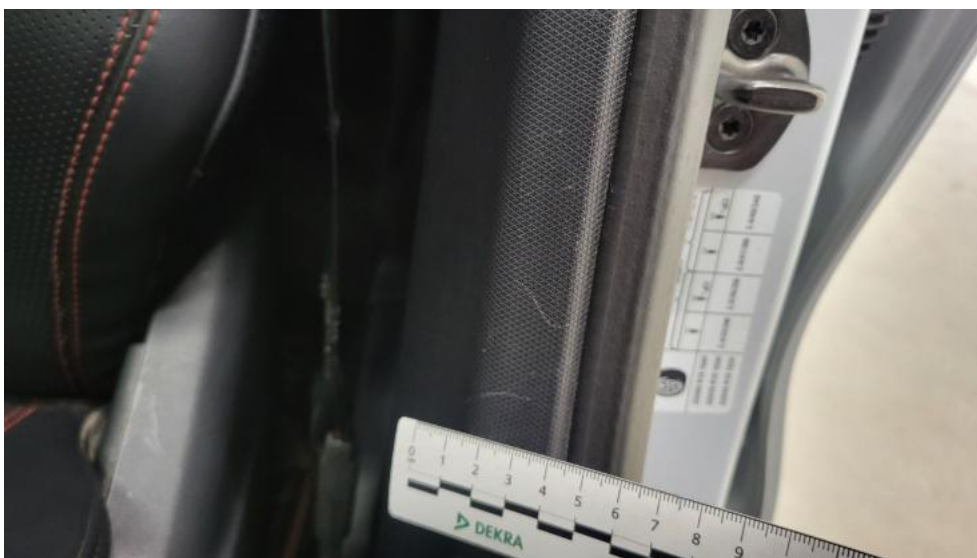
**Photo 70.**  
Wykładzina(y) słupka środkowego L - Rysa/odprysk 1

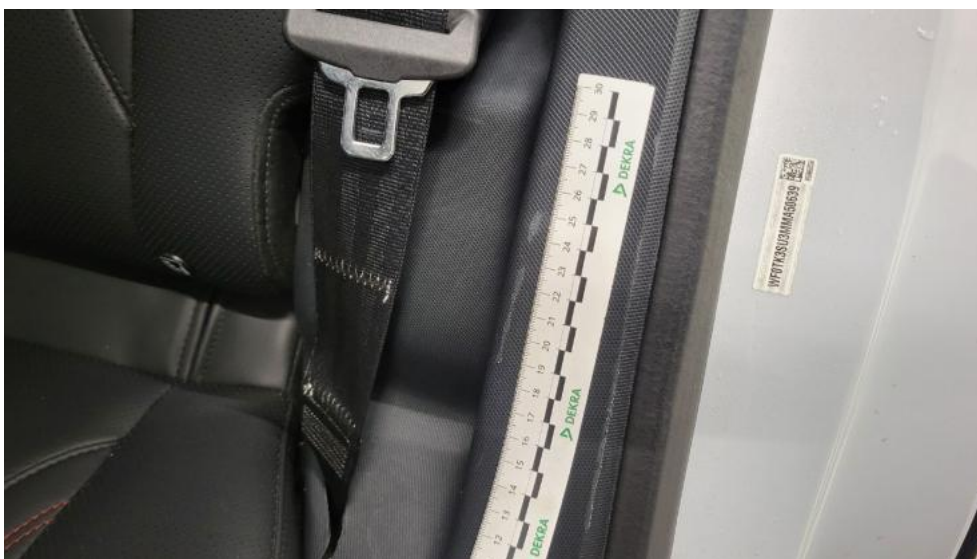
**Photo 71.**  
Wykładzina(y) słupka tylnego L - Rysa/odprysk 1

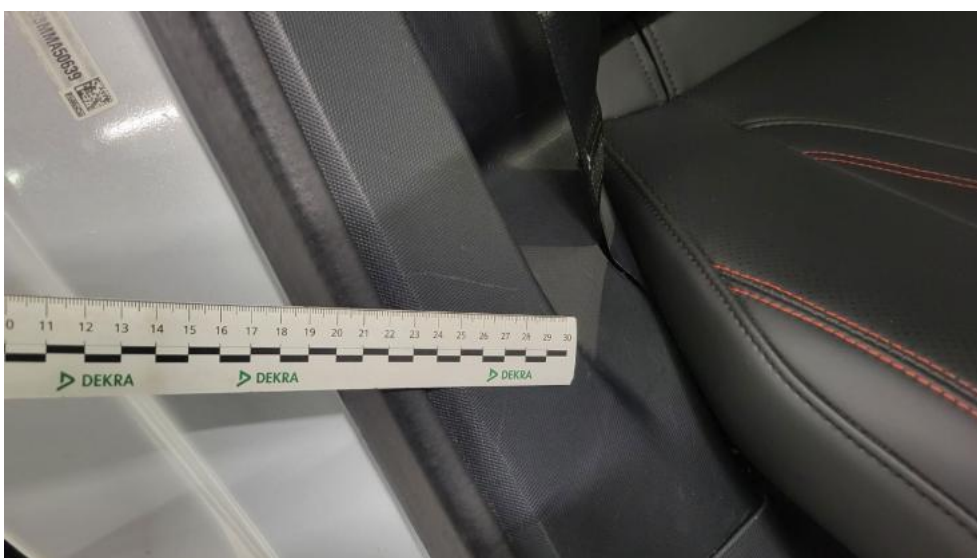
**Photo 72.**  
Wykładzina(y) słupka tylnego P - Rysa/odprysk 1

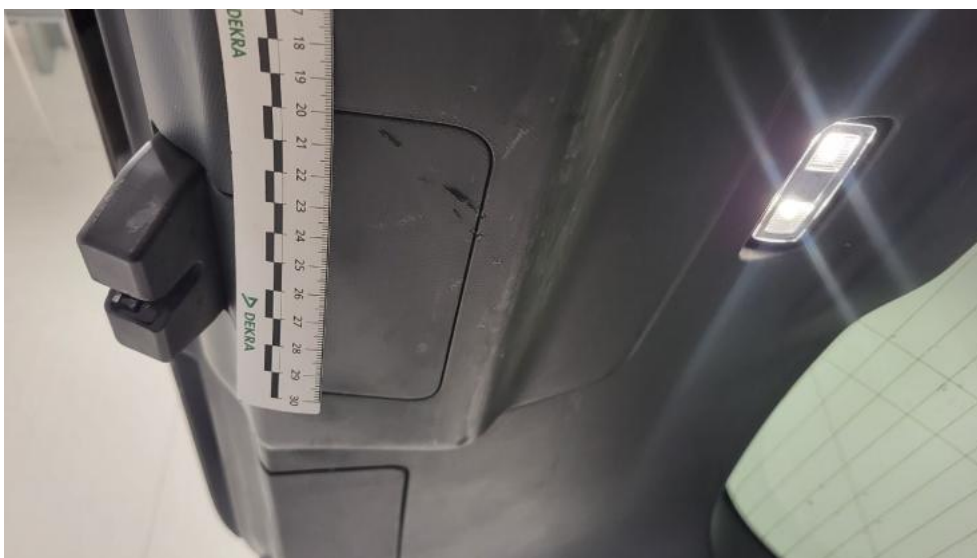
**Photo 74.**  
Wykładzina pokrywy tylnej - Rysa/odprysk 1
