DEKRA's commission No. : PKOL(W)/LODZ/73753/24/09/24
commission/ damage No. : PS23/04445
Date of commission: 24-09-2024

Vehicle data

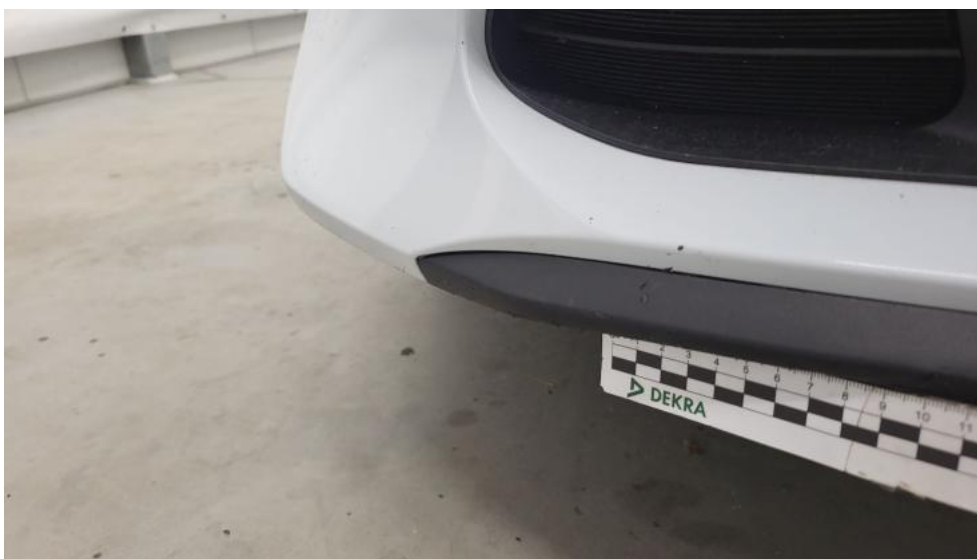
Photo 33.
Zderzak - Rysa/odprysk 1

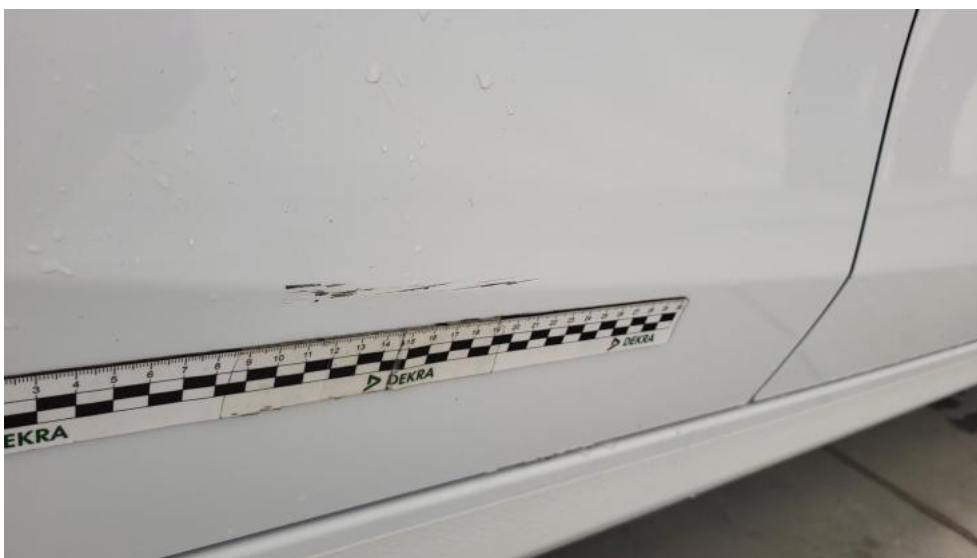
Photo 34.
Drzwi tylne P - Rysa/odprysk 1

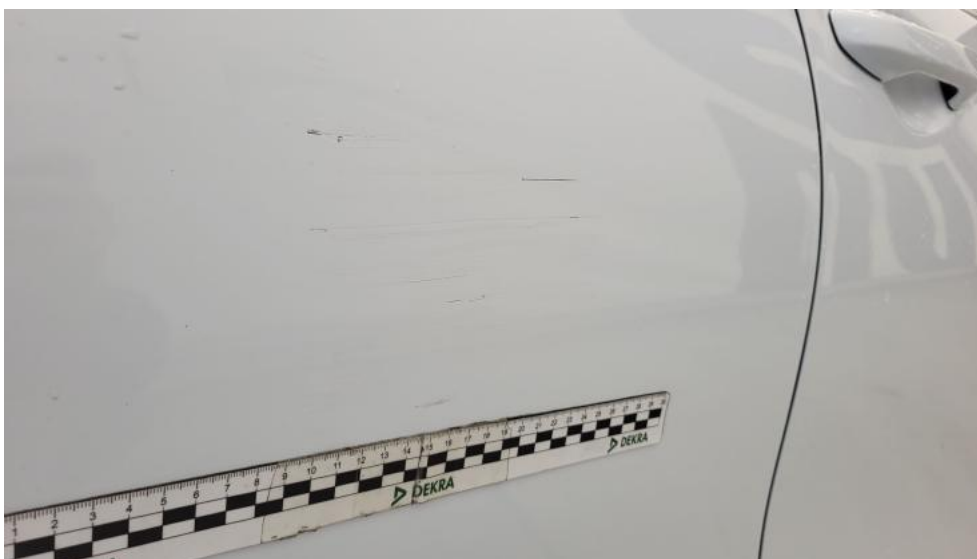
Photo 35.
Drzwi tylne P - Rysa/odprysk 2

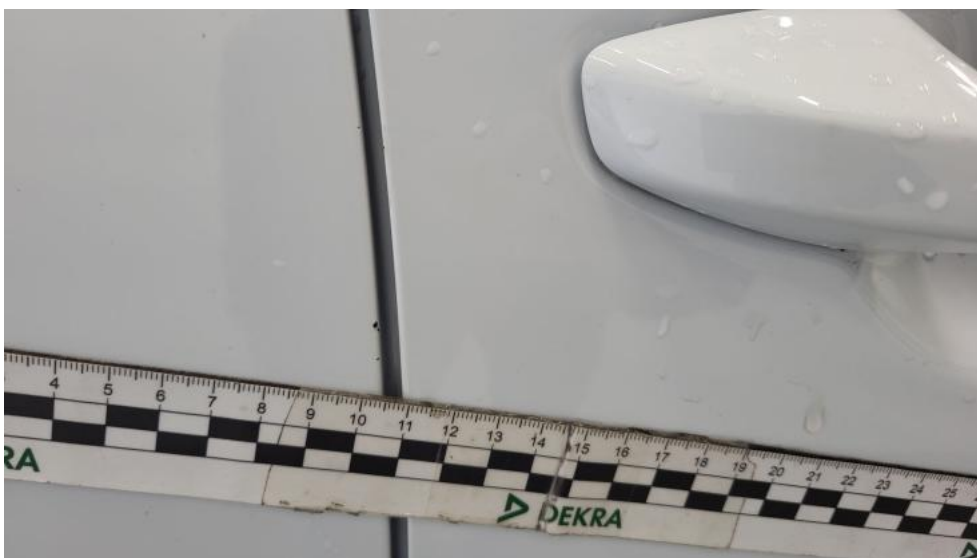
Photo 36.
Drzwi tylne P() - Rysa/odprysk 3

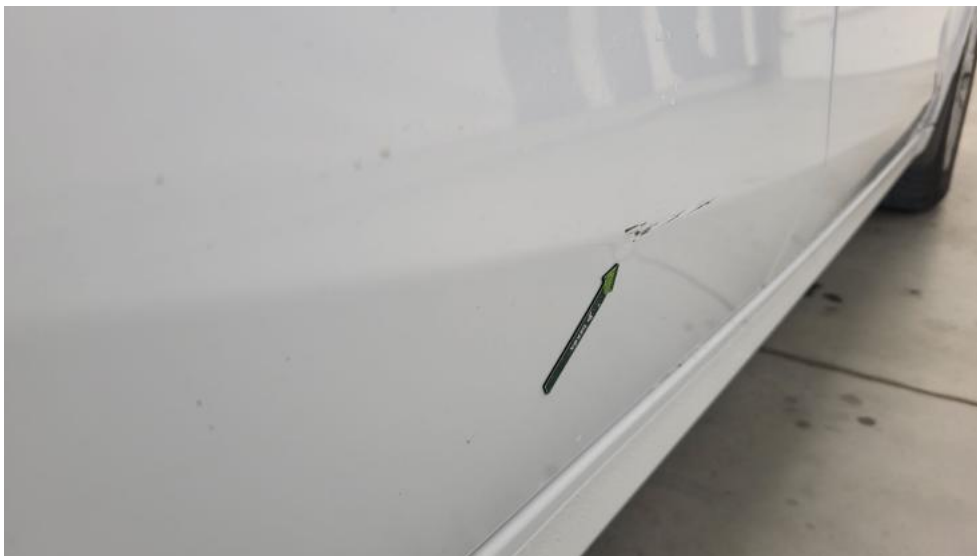
Photo 37.
Drzwi tylne P - Wgniecenie/odkształcenie 1

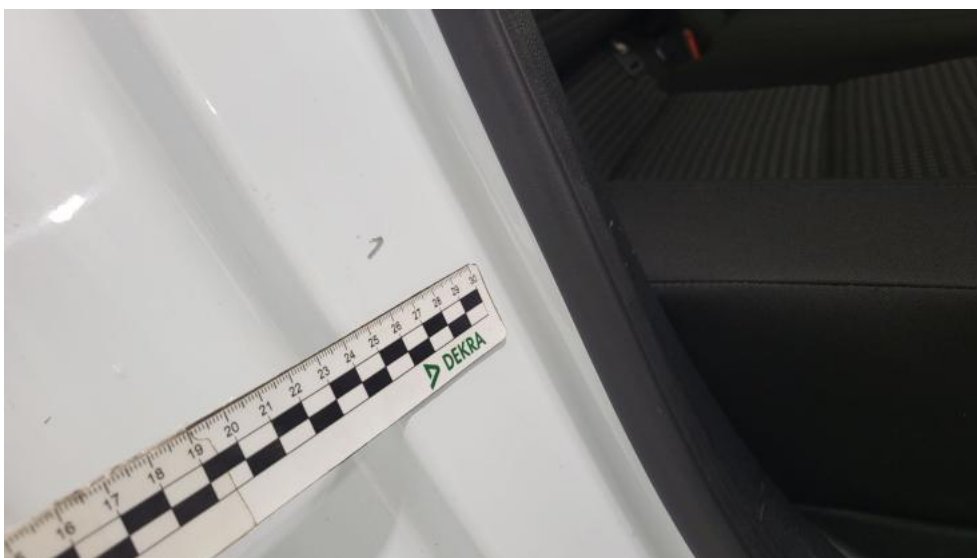
Photo 38.
Błotnik tylny P / Ściana boczna P - Rysa/odprysk 1

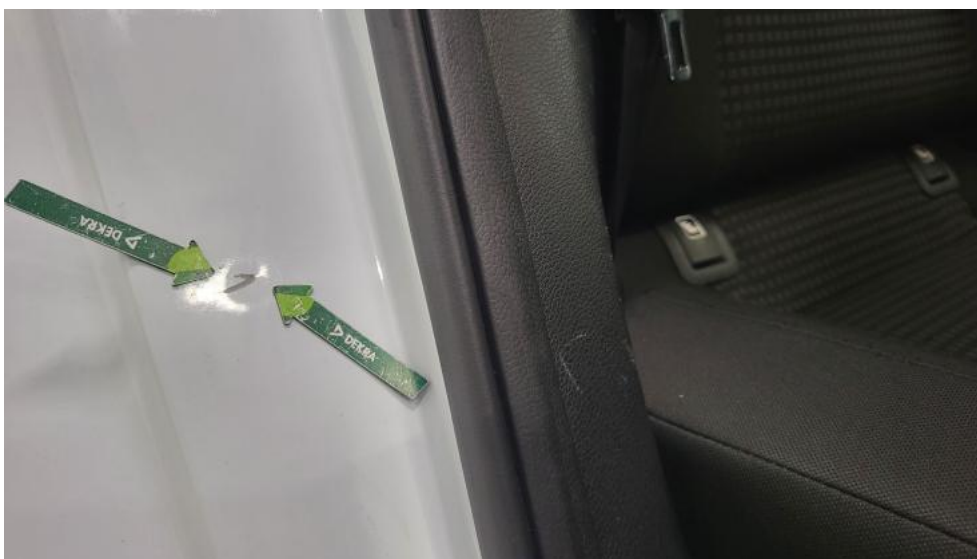
Photo 39.
Błotnik tylny P / Ściana boczna P - Wgniecenie/odkształcenie 1

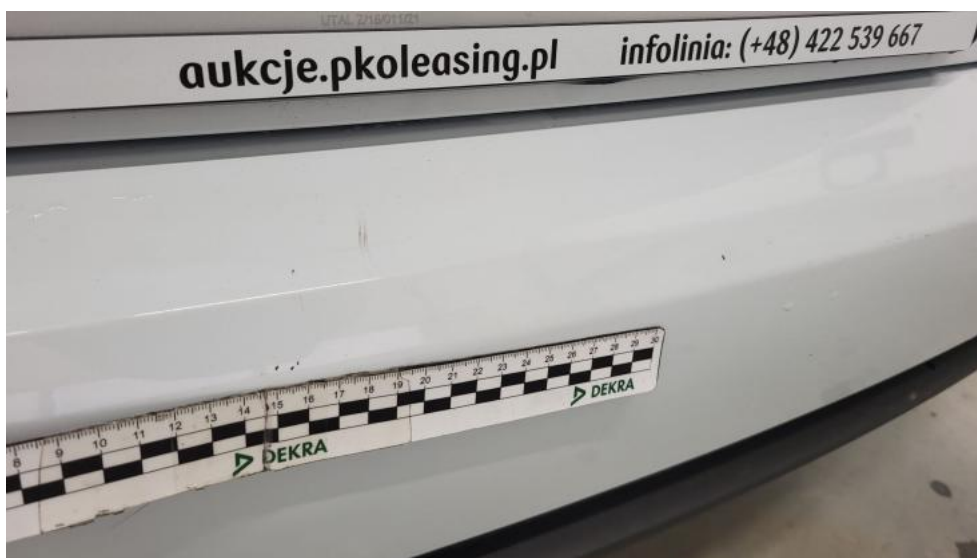
Photo 40.
Zderzak tylny - Rysa/odprysk 1

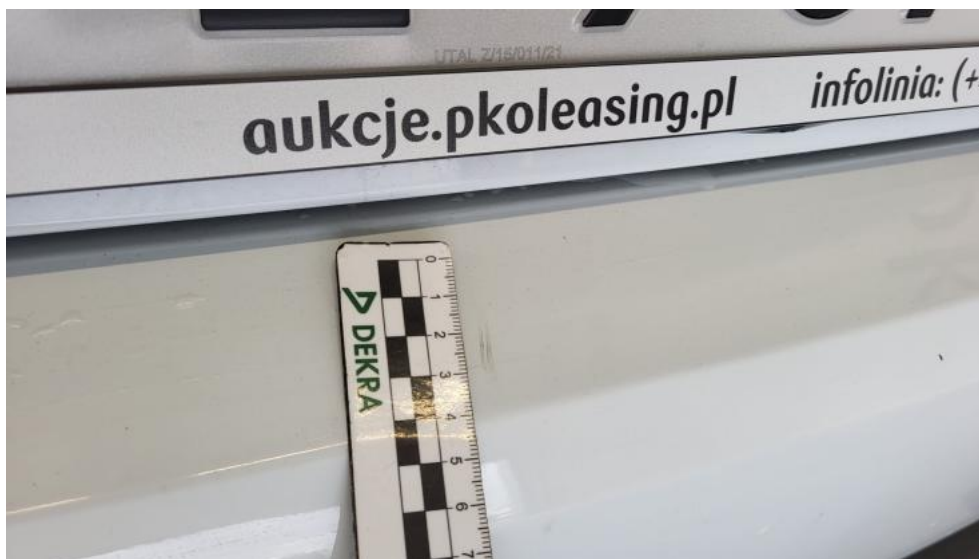
Photo 41.

Zderzak tylny - Rysa/odprysk 2

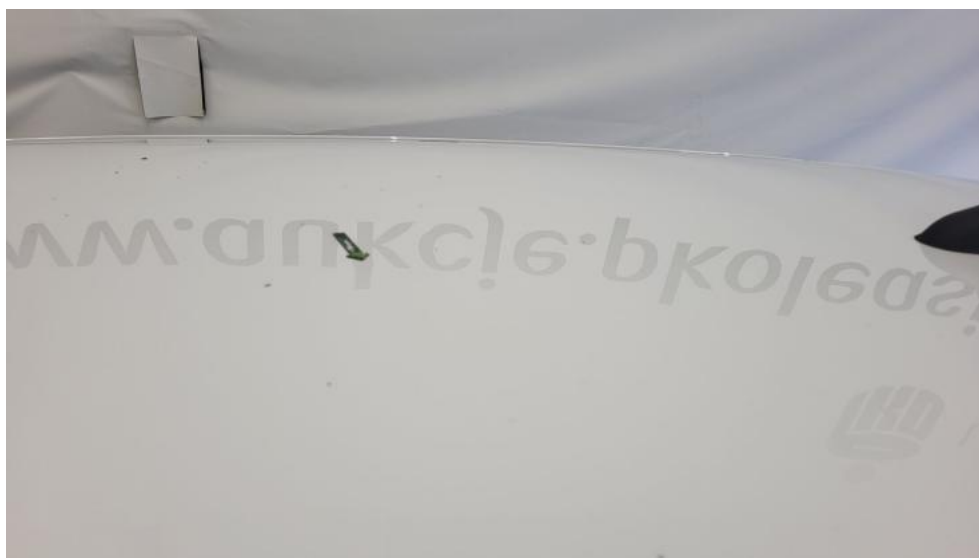
Photo 42.

Dach - Rysa/odprysk 1

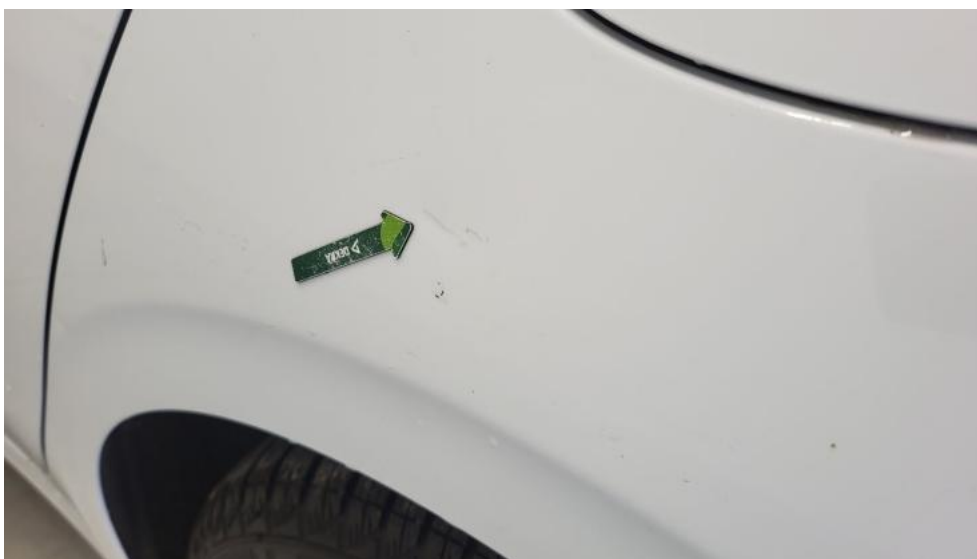
Photo 43.
Błotnik tylny L / Ściana boczna L - Rysa/odprysk 1

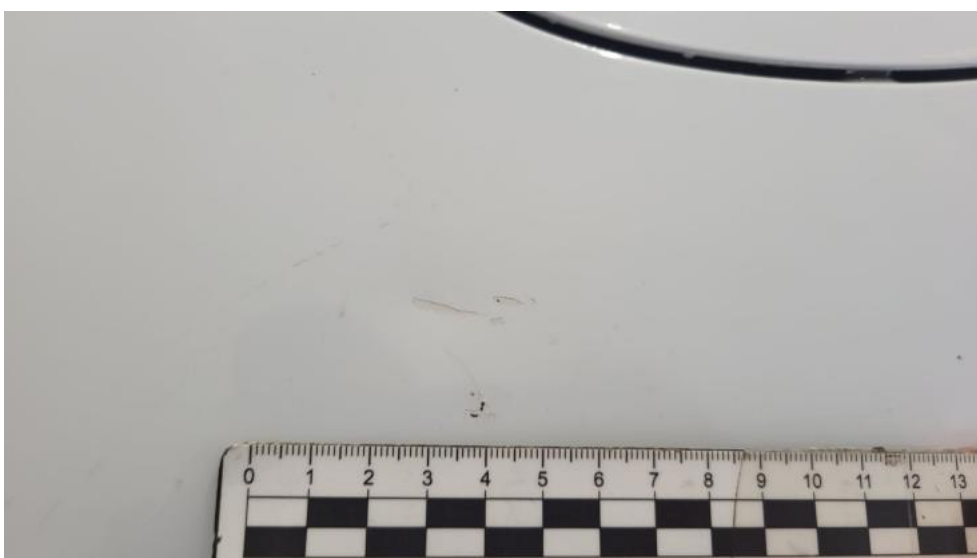
Photo 44.
Błotnik tylny L / Ściana boczna L - Rysa/odprysk 2

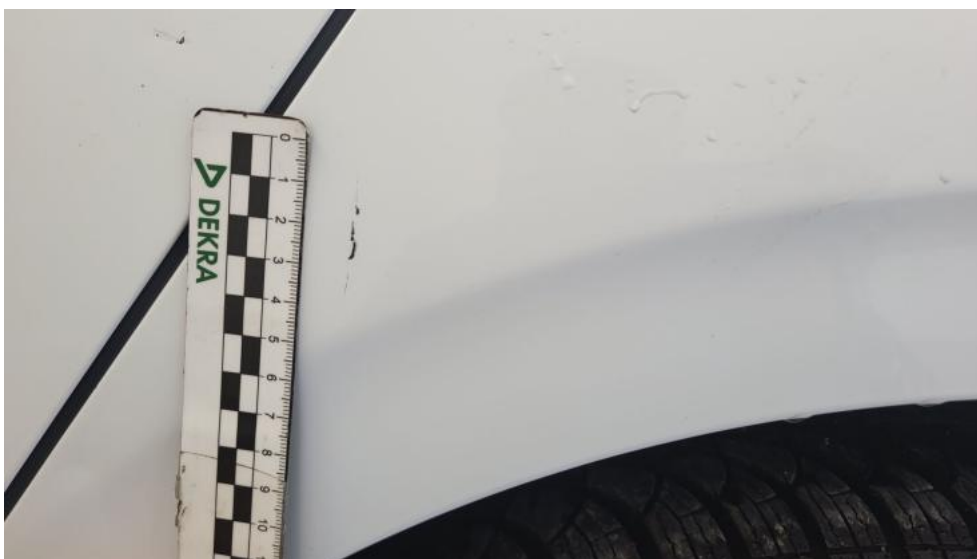
Photo 45.
Błotnik tylny L / Ściana boczna L() - Rysa/odprysk 3

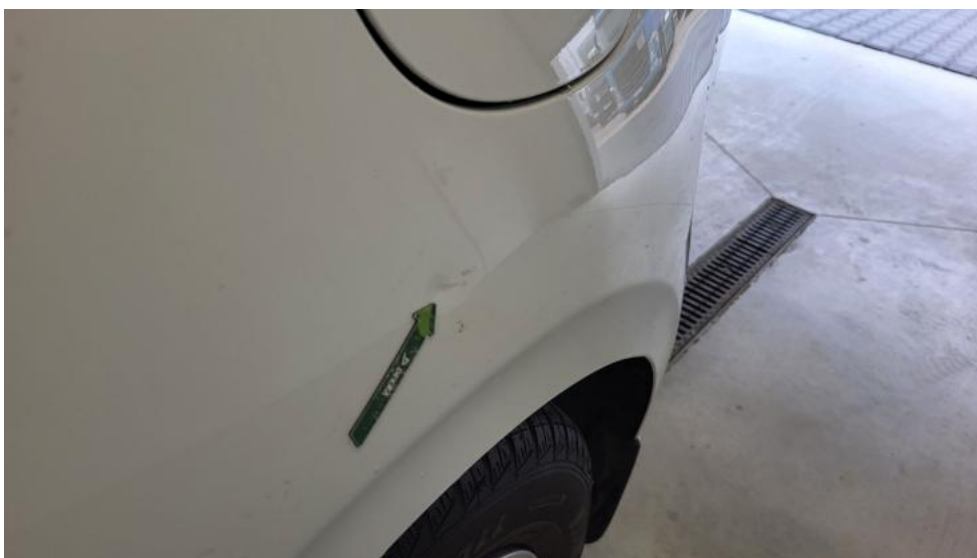
Photo 46.
Błotnik tylny L / Ściana boczna L - Wgniecenie/odkształcenie 1

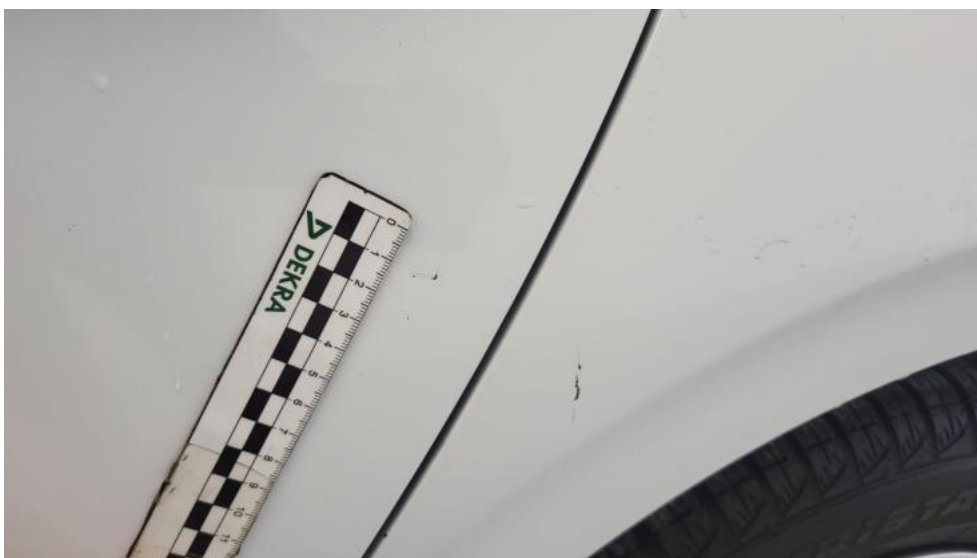
Photo 48.

Drzwi tylne L - Rysa/odprysk 1

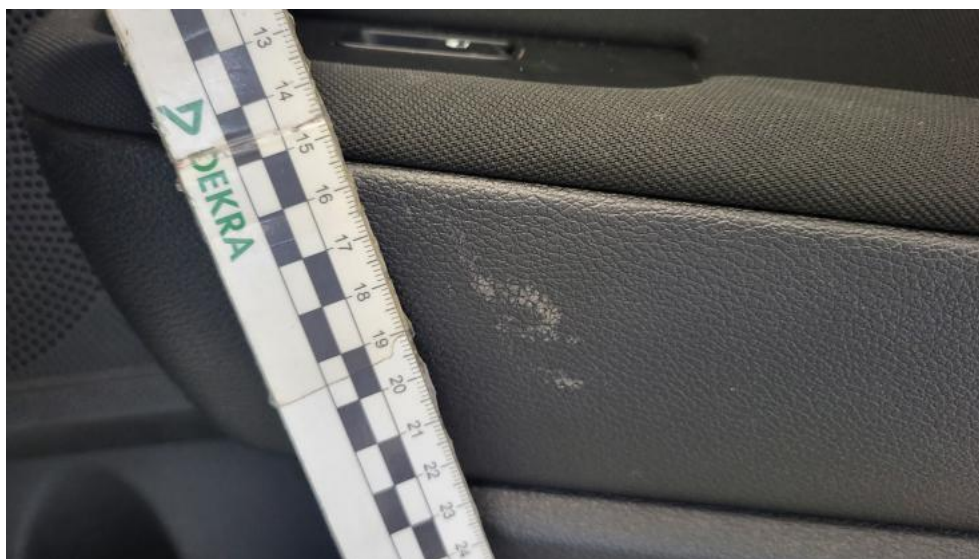
Photo 49.

Tapicerka drzwi tylnych P - Inne 1
