DEKRA's commission No. : PKOL(W)/LODZ/80738/25/10/21  
commission/ damage No. : 23/001377  
Date of commission: 21-10-2025

**DEKRA Poland - Headquarters**  
02-673 Warszawa, ul. Konstruktorska 12A

**Vehicle data**

| Model | T-Roc 17-21 |

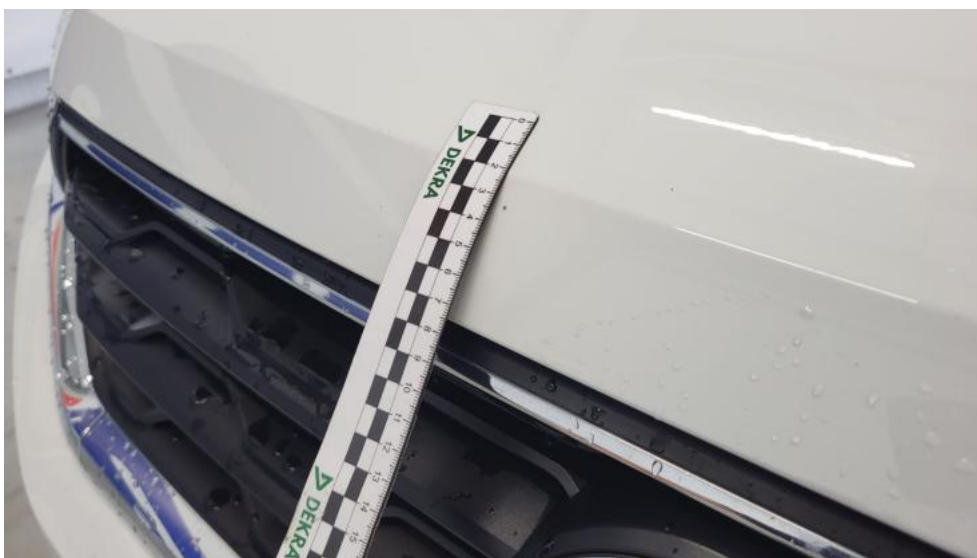
**Photo 40.**

Pokrywa komory silnika - Rysa/odprysk 1

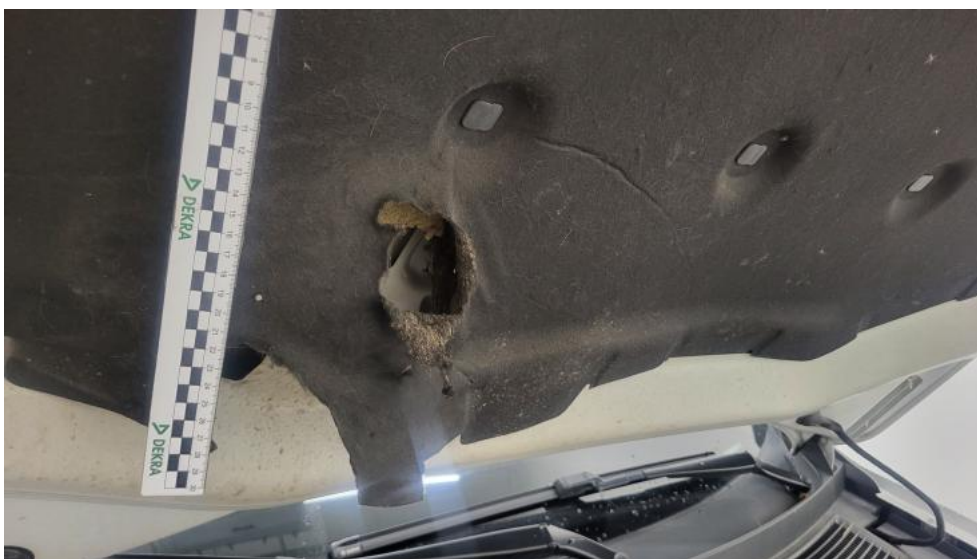
**Photo 41.**

Wykładzina pokrywy komory silnika - Pęknięcie/rozerwanie 1

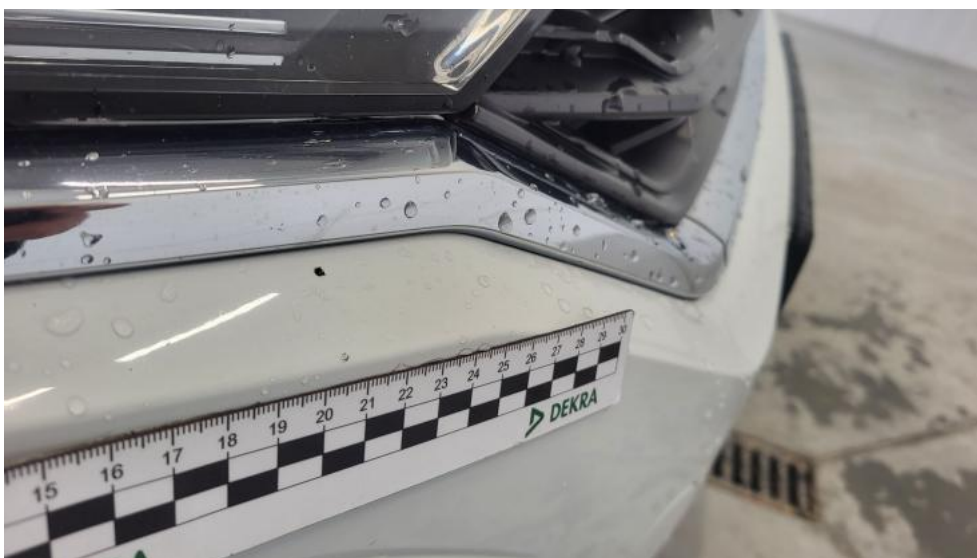
**Photo 42.**

Zderzak - Rysa/odprysk 1

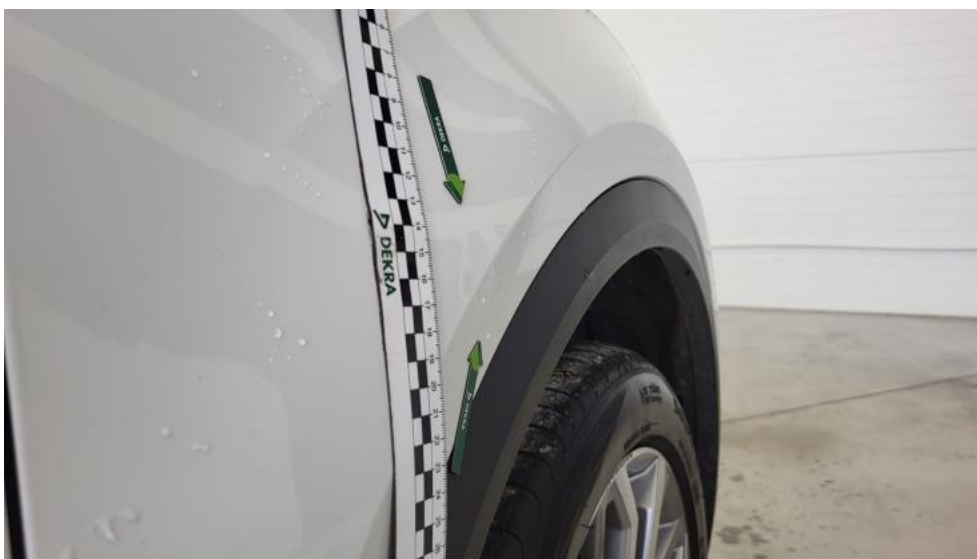
**Photo 43.**

Błotnik przedni P - Wgniecenie/odkształcenie 1

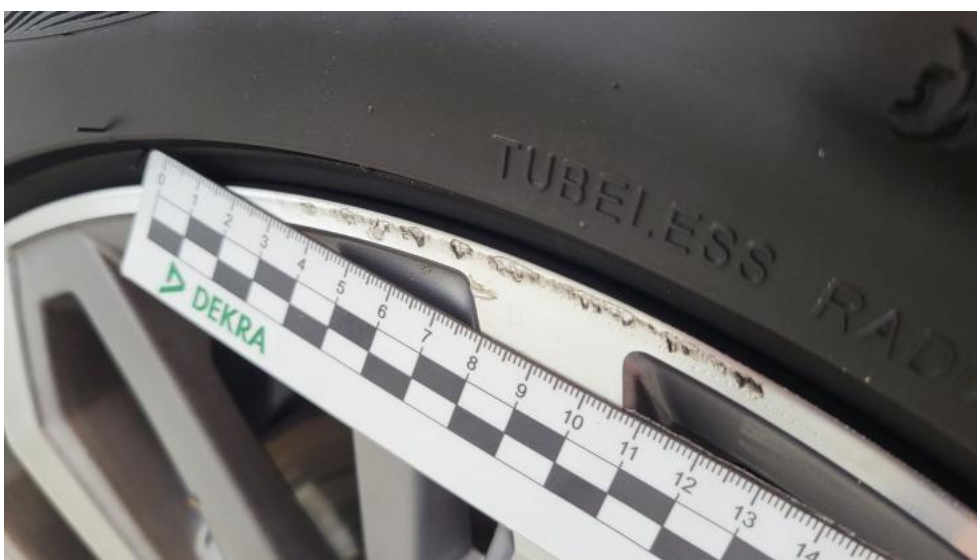
**Photo 44.**

Felga aluminiowa przednia P - Rysa/odprysk 1

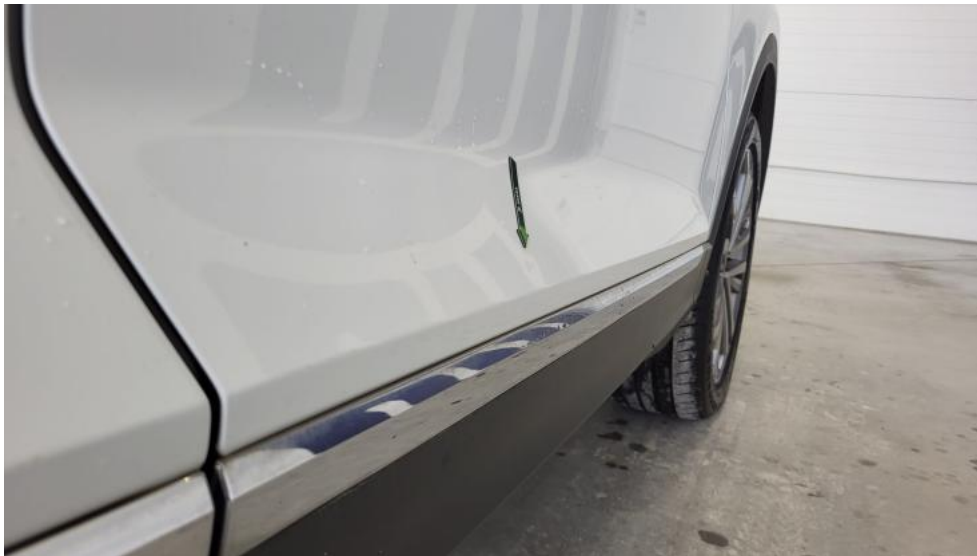
**Photo 45.**

Drzwi przednie P - Wgniecenie/odkształcenie 1

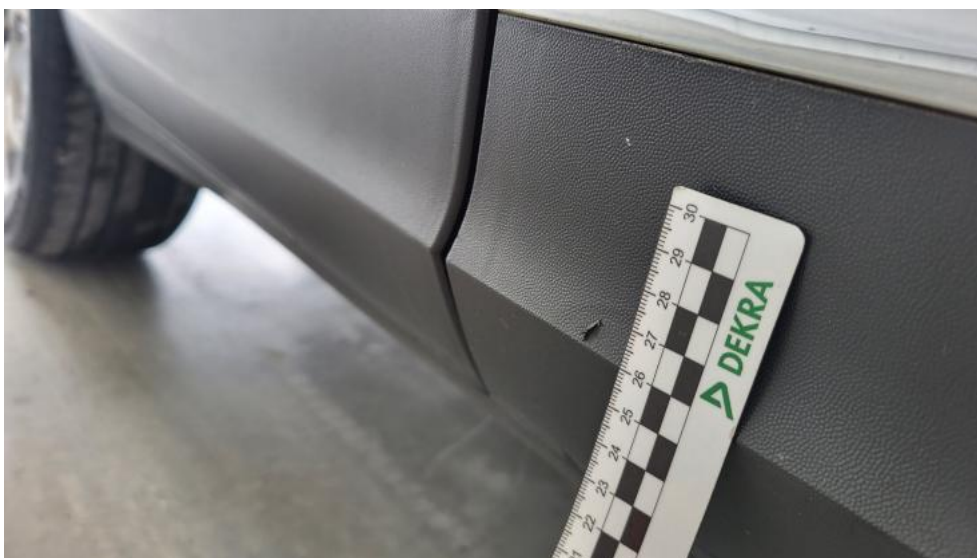
**Photo 46.**

Listwa drzwi przednich P - Rysa/odprysk 1

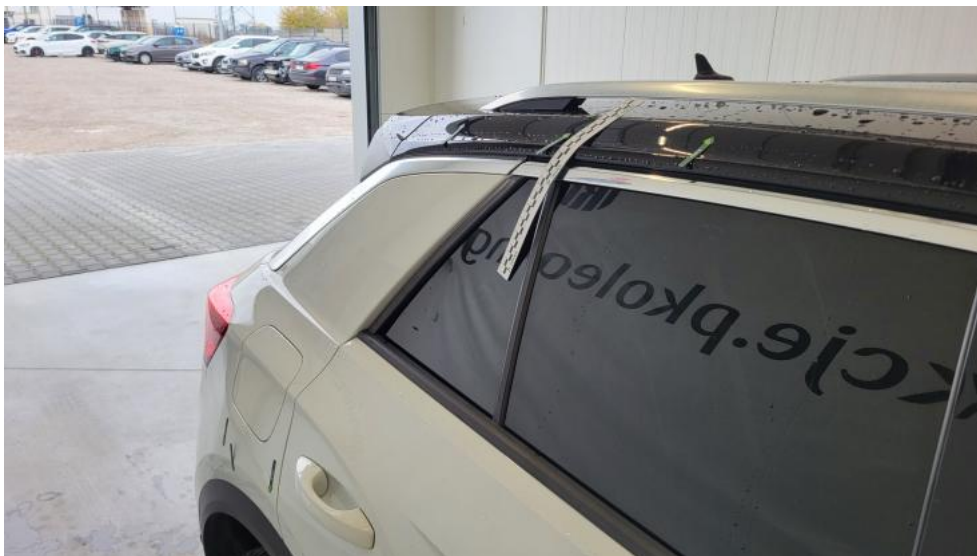
**Photo 47.**

Błotnik tylny P / Ściana boczna P - Wgniecenie/odkształcenie 1

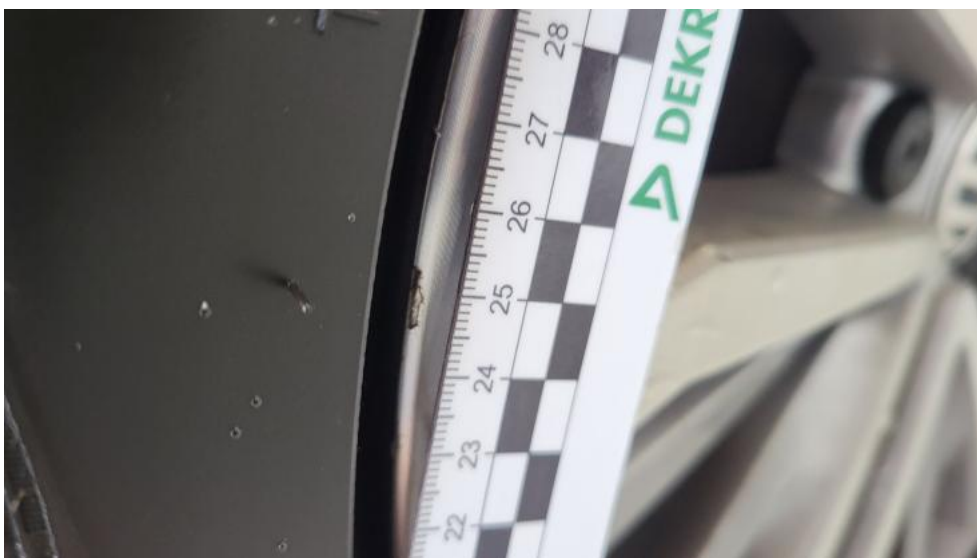
**Photo 48.**

Felga aluminiowa tylna P - Rysa/odprysk 1

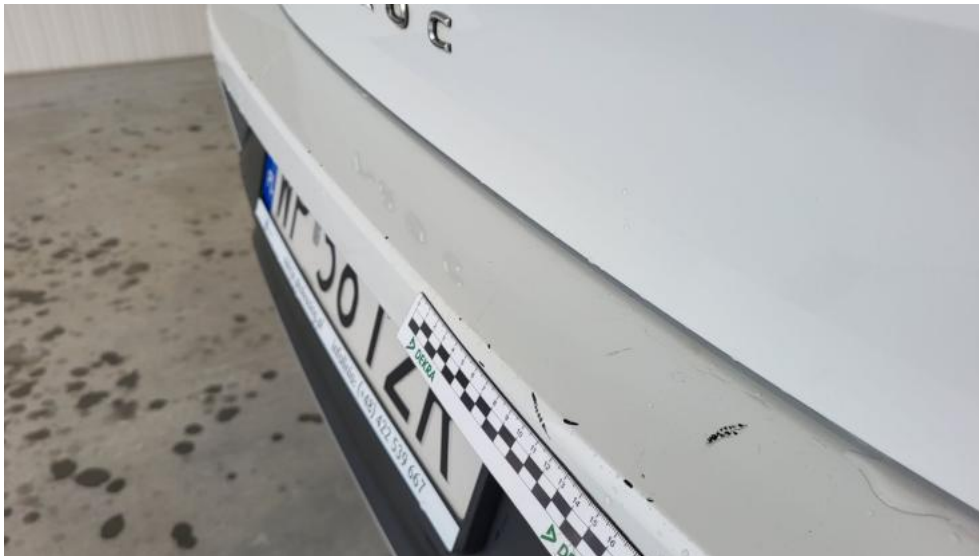
**Photo 49.**

Zderzak tylny - Rysa/odprysk 1

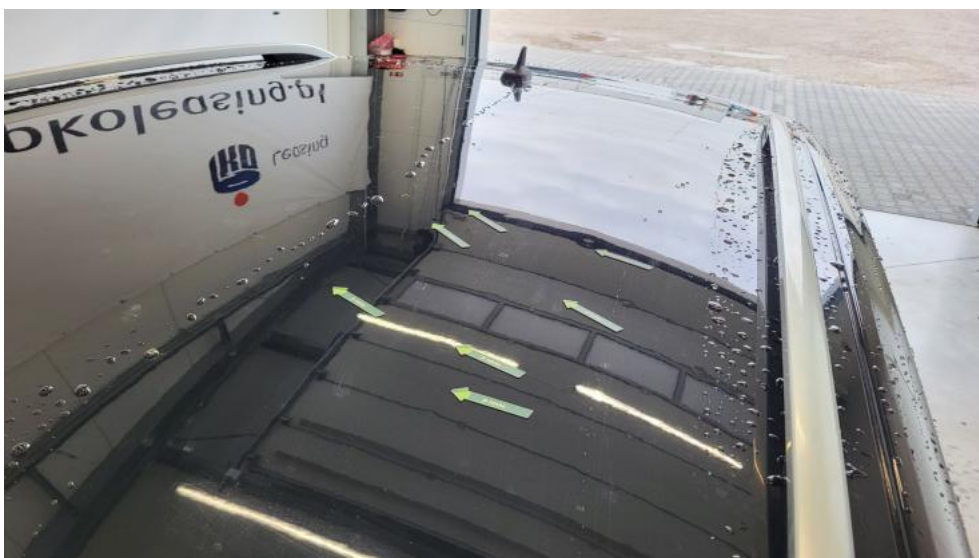
**Photo 50.**

Dach - Wgniecenie/odkształcenie 1

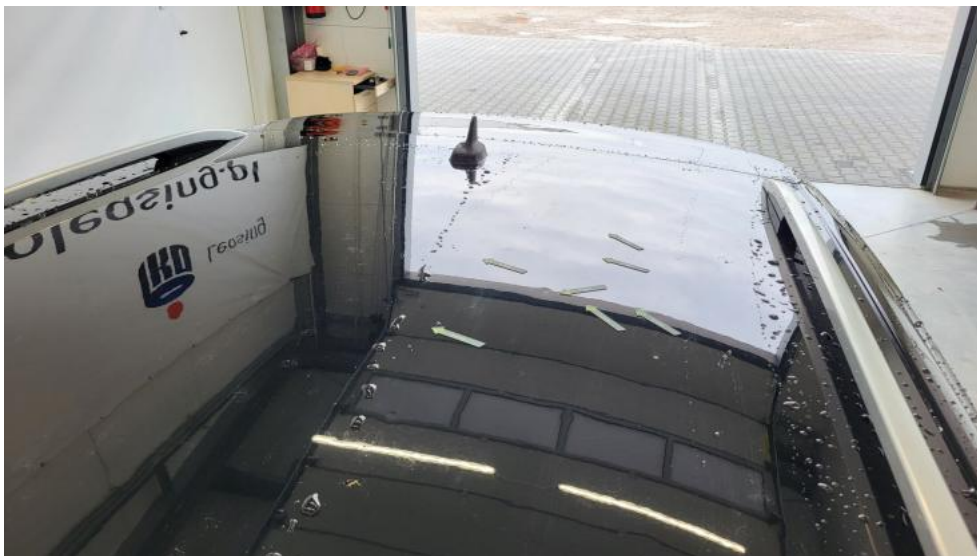
**Photo 51.**

Dach - Wgniecenie/odkształcenie 2

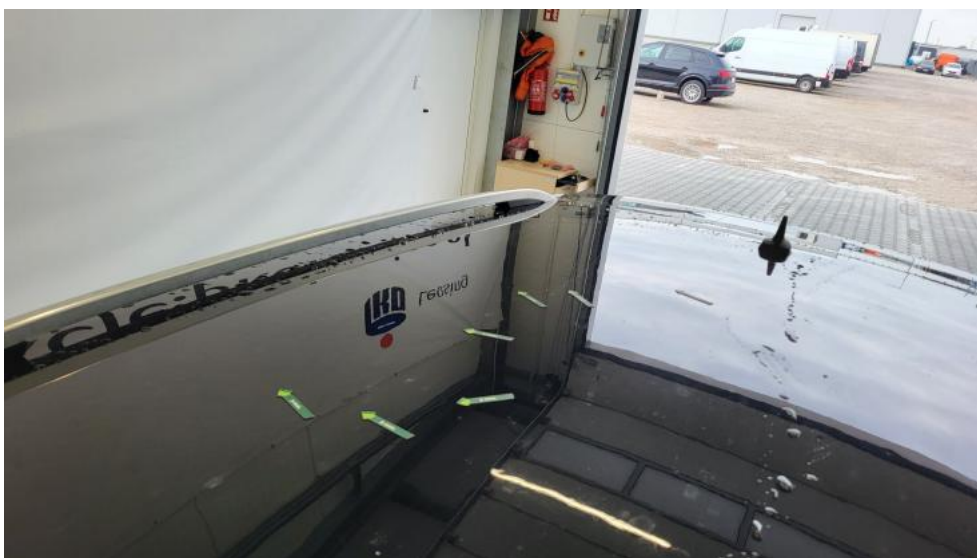
**Photo 52.**

Dach() - Wgniecenie/odkształcenie 3

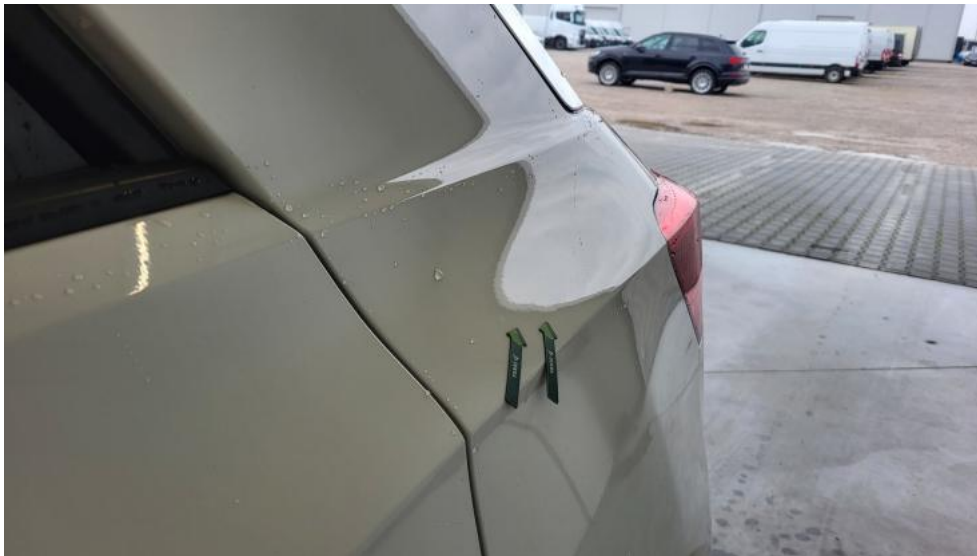
**Photo 53.**

Błotnik tylny L / Ściana boczna L - Wgniecenie/odkształcenie 1

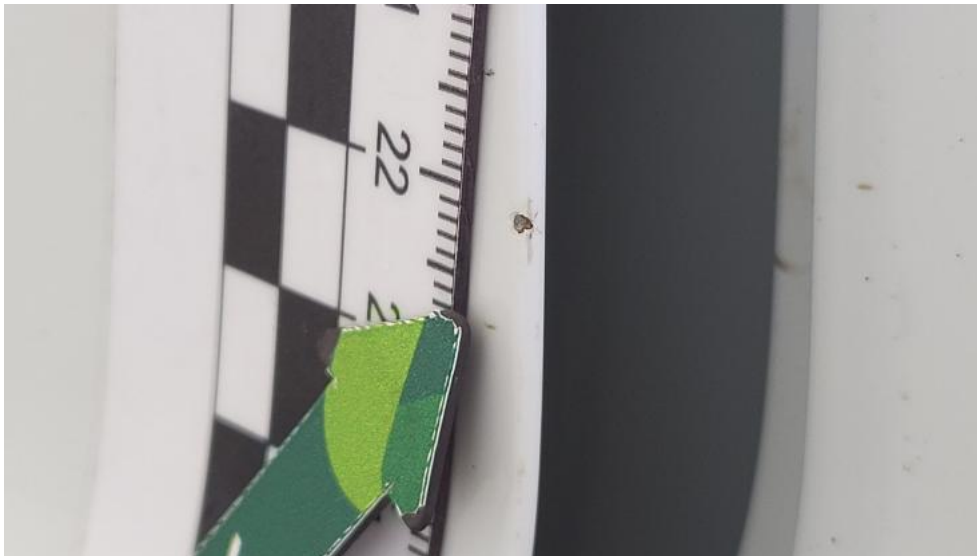
**Photo 55.**

Drzwi przed L - Inne 1

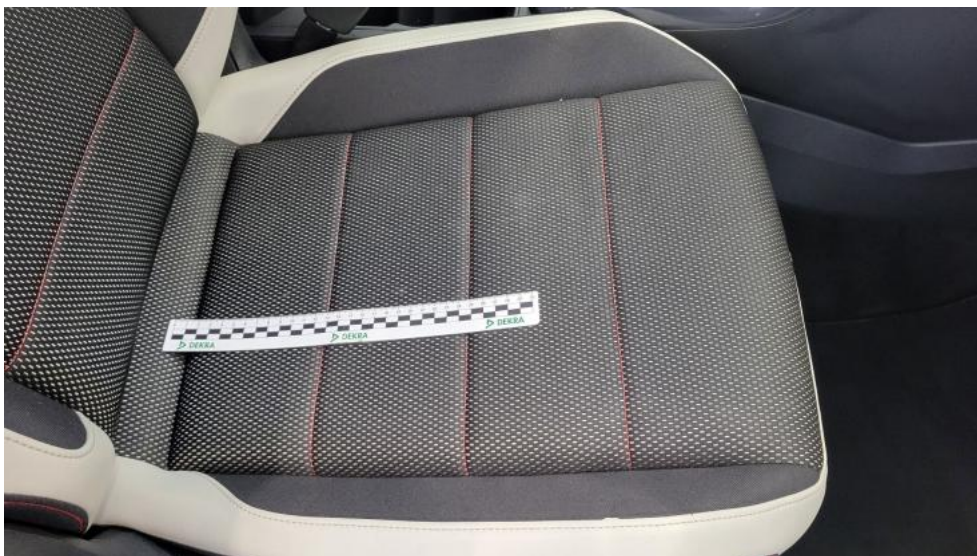
**Photo 56.**

Fotel prz. praw. - Inne 1

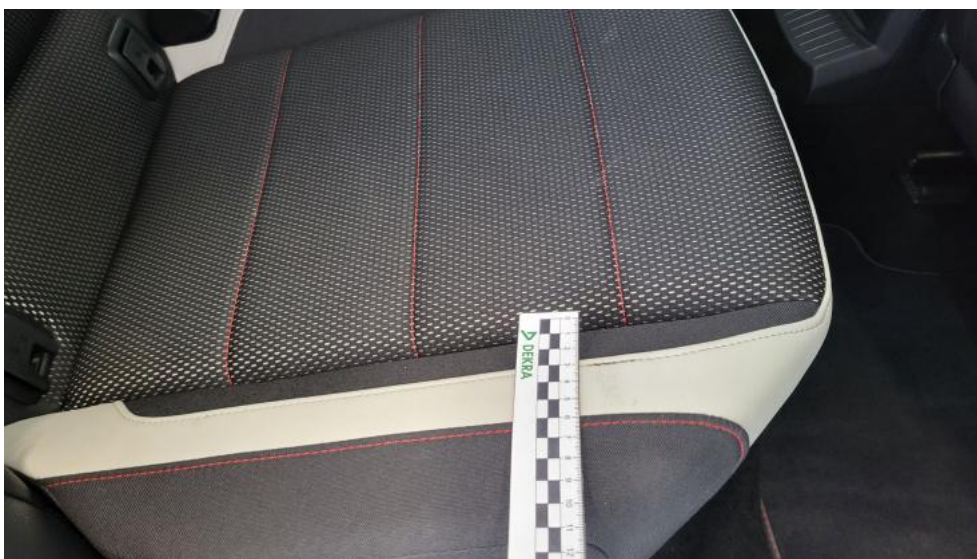
**Photo 57.**

Kanapa tyl. - Inne 1
